## Profile/Photo Observation Report

| Street: | <b>W 40th ave</b> | Flow Control: | <b>Not Controlled</b> |
| City: | <b>Hobart, IN</b> | Year Renewed: | |

| US MH: | <b>M-503-017</b> | DS MH: | <b>M-503-018</b> |

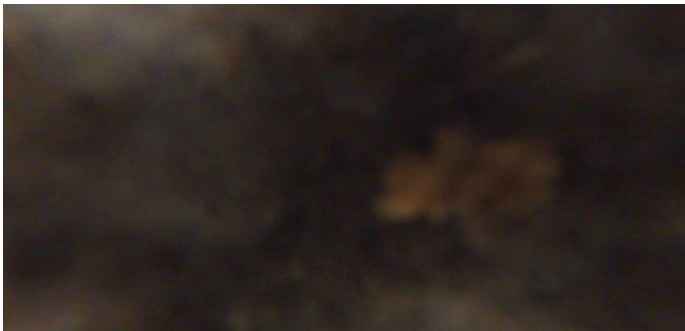
Code: **AMH**  
Description: **Manhole**

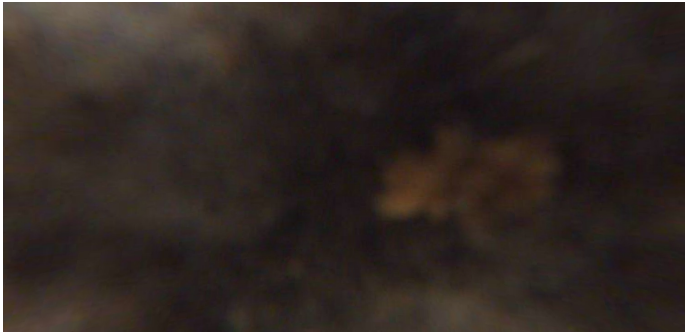
| Code: | <b>MWL</b> |
| Description: | <b>Water Level</b> |

| Value Percent: | <b>100.000</b> |

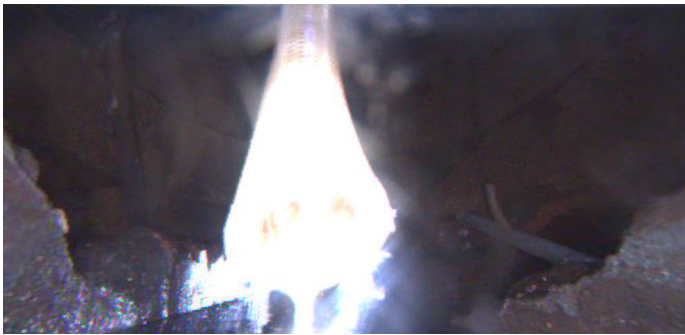
| Code: | <b>MGO</b> |
| Description: | <b>General Observation</b> |

| Remarks: | <b>rear camera</b> |

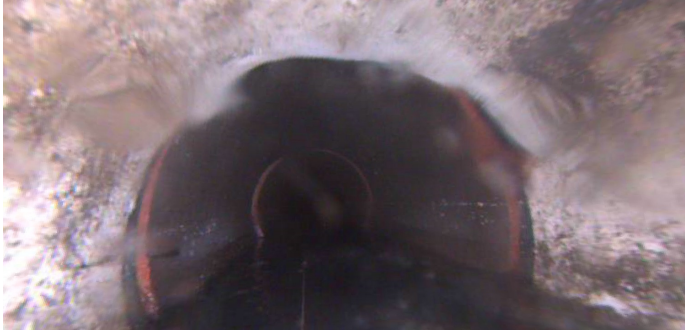
Code: **MMC**  
Description: **Material Change**

Distance (ft): **31.7**  
Structural Grade: **0**  
O&M Grade: **0**  
Clock Start/From:  
Clock To:  
1st Value:  
2nd Value:  
Value Percent:  
Continuous Index:  
Within 8" of Joint: **NO**  
Remarks: **PVC**

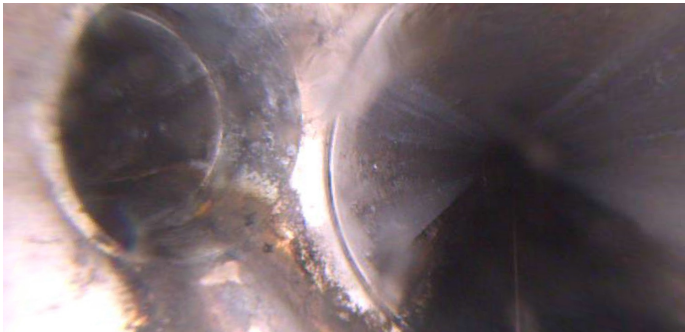
Code: **TFA**  
Description: **Tap Factory Active**

Distance (ft): **36.0**  
Structural Grade: **0**  
O&M Grade: **0**  
Clock Start/From: **3**  
Clock To:  
1st Value: **4.000**  
2nd Value:  
Value Percent:  
Continuous Index:  
Within 8" of Joint:  
Remarks:

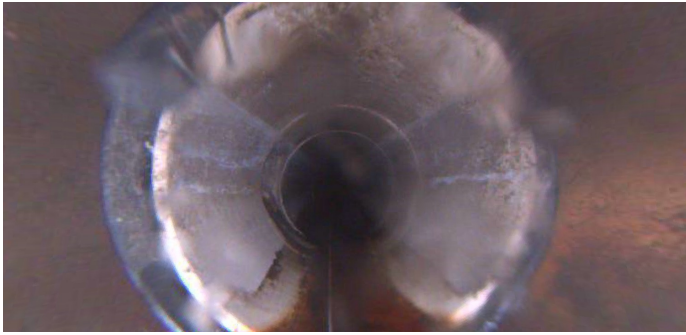
| Position | Code | Observation | Video (sec) | Grade |
|---|---|---|---|---|
| 37.8 | JSM | Joint Separated Medium | 145 | S 1 |

Code: **JSM**  
Description: **Joint Separated Medium**

Distance (ft): **37.8**  
Structural Grade: **1**  
O&M Grade: **0**  
Clock Start/From:  
Clock To:  
1st Value:  
2nd Value:  
Value Percent:  
Continuous Index:  
Within 8" of Joint: **NO**  
Remarks:

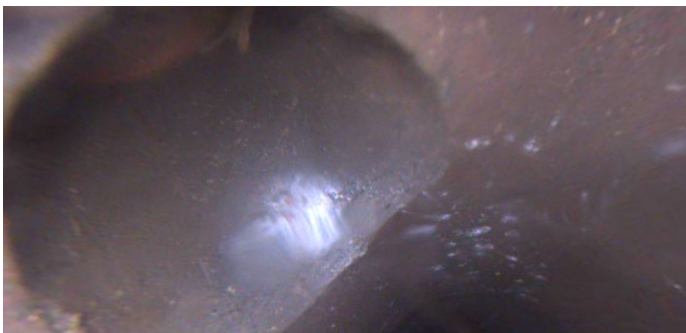
Code: **TF**  
Description: **Tap Factory**

Distance (ft): **63.4**  
Structural Grade: **0**  
O&M Grade: **0**  
Clock Start/From: **11**  
Clock To:  
1st Value: **4.000**  
2nd Value:  
Value Percent:  
Continuous Index:  
Within 8" of Joint:  
Remarks:

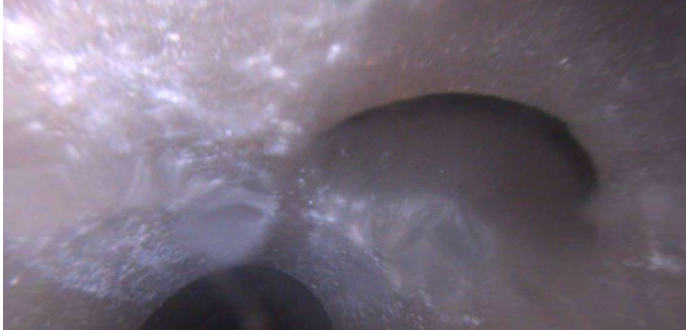
Code: **TF**  
Description: **Tap Factory**

Distance (ft): **71.7**  
Structural Grade: **0**  
O&M Grade: **0**  
Clock Start/From: **11**  
Clock To:  
1st Value: **4.000**  
2nd Value:  
Value Percent:  
Continuous Index:  
Within 8" of Joint:  
Remarks:

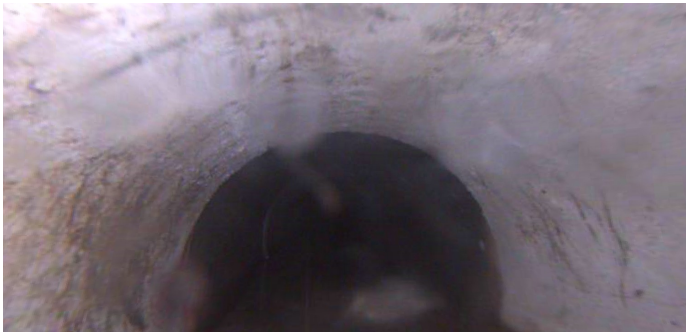
Code: **MMC**  
Description: **Material Change**

Distance (ft): **74.5**  
Structural Grade: **0**  
O&M Grade: **0**  
Clock Start/From:  
Clock To:  
1st Value:  
2nd Value:  
Value Percent:  
Continuous Index:  
Within 8" of Joint: **NO**  
Remarks: **pvc**

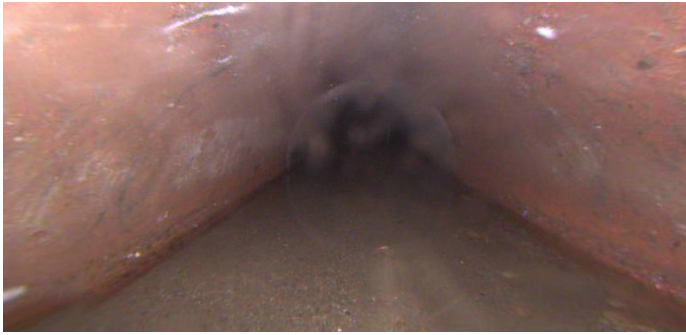
Code: **MMC**  
Description: **Material Change**

Distance (ft): **80.4**  
Structural Grade: **0**  
O&M Grade: **0**  
Clock Start/From:  
Clock To:  
1st Value:  
2nd Value:  
Value Percent:  
Continuous Index:  
Within 8" of Joint: **NO**  
Remarks: **VCP**

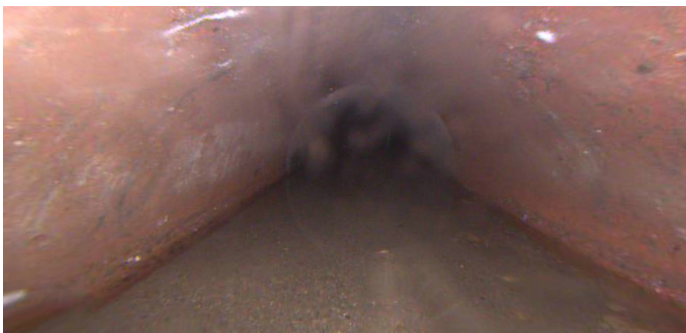
Code: **MSA**  
Description: **Abandoned Survey**

Distance (ft): **80.4**  
Structural Grade: **0**  
O&M Grade: **0**  
Clock Start/From:  
Clock To:  
1st Value:  
2nd Value:  
Value Percent:  
Continuous Index:  
Within 8" of Joint: **NO**  
Remarks: **DSF**
