Profile/Photo Observation Report

Date:	10/19/2021	Weather:		Coding:	PACP 7.0
Pipe Length (ft):	111.2	Owner:	City of Hobart	Pre Clean:	Heavy Cleaning
P.O.#:	YES502259	Surveyor:	S. Bucklin	PSR:	P-503-018-017
Customer:	City of Hobart	Clean Date:	09/05/2021	Shape:	C

Street:	West 39th Avenue	Flow Control:	Not Controlled
City:	Hobart, IN	Year Renewed:	
Location:	Alley	Tape/Media #:	
Purpose:	Routine Assessment	Dia/Height:	12"
Use:	Sanitary Sewage Pipe	Material:	VCP
Drain Area:		Lining:	
Category:	NA		
Comment:			
Location Details:		Direction of Survey:	Upstream
US MH:	M-503-017	DS MH:	M-503-018
		Total Length Surveyed (ft):	111.2

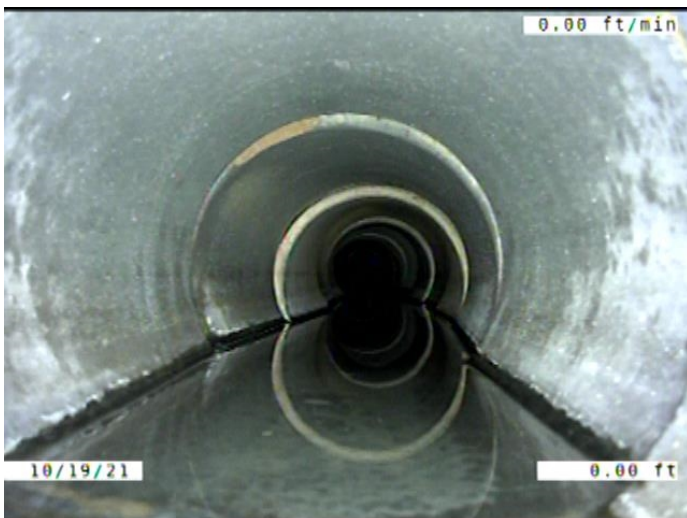
Code: **MWL**
Description: **Miscellaneous Water Level**

Distance (ft): **.0**
Structural Grade: **0**
O&M Grade: **0**
Clock Start/From:
Clock To:
1st Value:
2nd Value:
Value Percent: **10.000**
Continuous Index:
Within 8" of Joint: **NO**
Remarks:

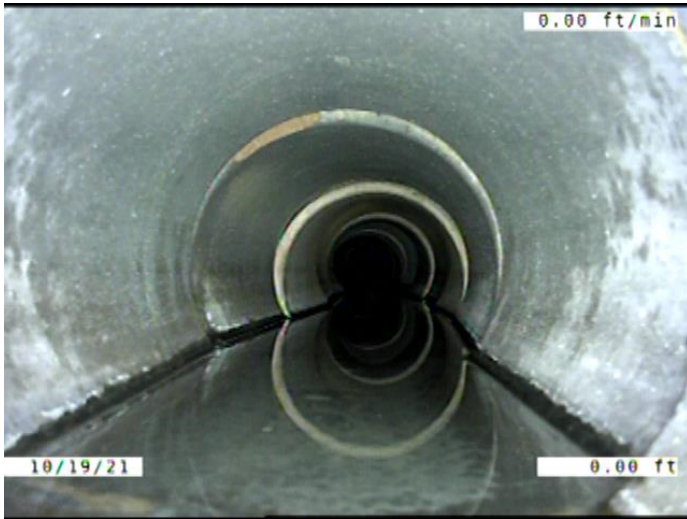
Code: **DSF**
Description: **Deposits Settled Fine**

Distance (ft): **.0**
Structural Grade: **0**
O&M Grade: **2**
Clock Start/From: **5**
Clock To: **7**
1st Value:
2nd Value:
Value Percent: **5.000**
Continuous Index: **S01**
Within 8" of Joint: **YES**
Remarks:

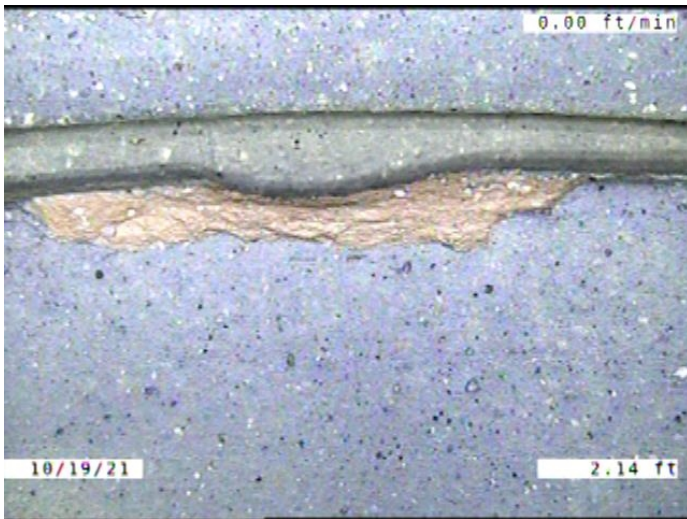
Code: **SZ**
Description: **Surface Damage Other**

Distance (ft): **2.1**
Structural Grade: **0**
O&M Grade: **0**
Clock Start/From: **11**
Clock To:
1st Value:
2nd Value:
Value Percent:
Continuous Index:
Within 8" of Joint: **YES**
Remarks: **A PIECE CHIPPED AWAY FROM THE JOINT**

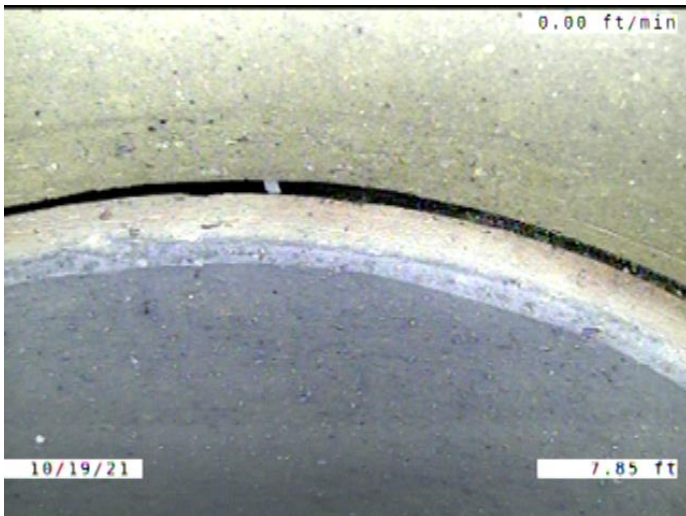
Code: **JOM**
Description: **Joint Offset Medium**

Distance (ft): **7.9**
Structural Grade: **3**
O&M Grade: **0**
Clock Start/From:
Clock To:
1st Value:
2nd Value:
Value Percent:
Continuous Index:
Within 8" of Joint: **NO**
Remarks:

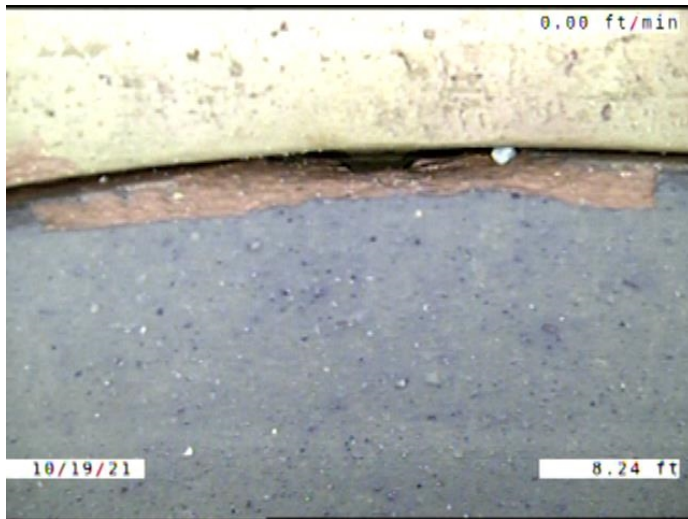
Code:	SZ
Description:	Surface Damage Other
Distance (ft):	8.2
Structural Grade:	0
O&M Grade:	0
Clock Start/From:	10
Clock To:	11
1st Value:	
2nd Value:	
Value Percent:	
Continuous Index:	
Within 8" of Joint:	YES
Remarks:	A PIECE CHIPPED AWAY FROM THE JOINT

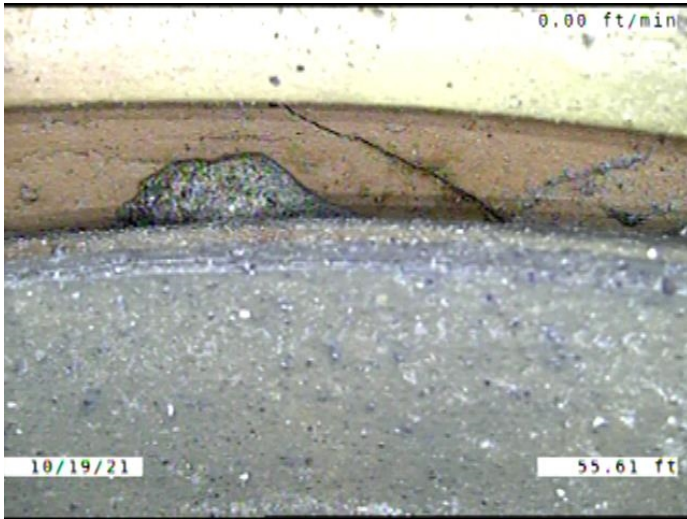
Code: **CM**
 Description: **Crack Multiple**

Distance (ft): **55.6**
 Structural Grade: **3**
 O&M Grade: **0**
 Clock Start/From: **11**
 Clock To: **2**
 1st Value:
 2nd Value:
 Value Percent:
 Continuous Index:
 Within 8" of Joint: **YES**
 Remarks:

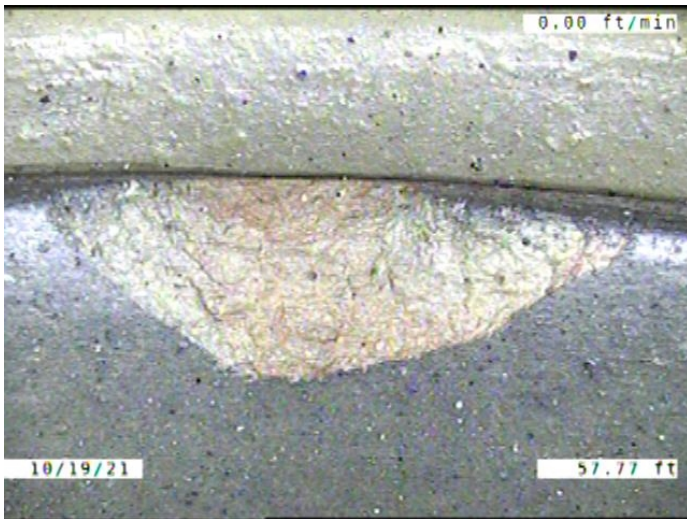
Code: **SZ**
 Description: **Surface Damage Other**

Distance (ft): **57.8**
 Structural Grade: **0**
 O&M Grade: **0**
 Clock Start/From: **1**
 Clock To:
 1st Value:
 2nd Value:
 Value Percent:
 Continuous Index:
 Within 8" of Joint: **YES**
 Remarks: **A PIECE CHIPPED AWAY FROM THE JOINT**

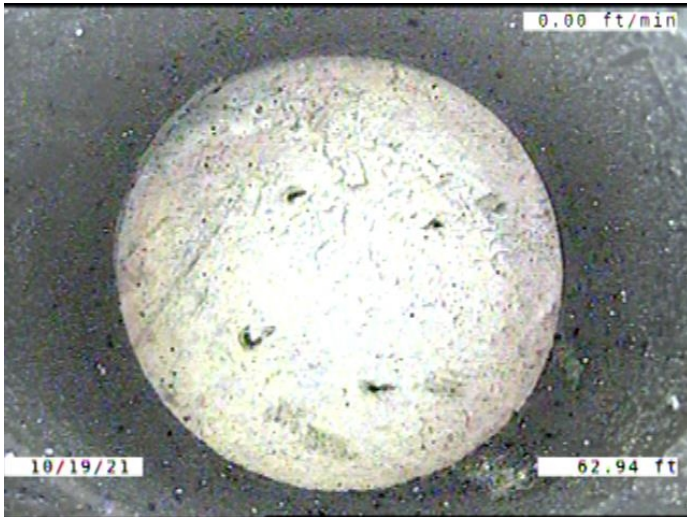
Code: **TFC**
 Description: **Tap Factory Capped**

Distance (ft): **62.9**
 Structural Grade: **0**
 O&M Grade: **0**
 Clock Start/From: **1**
 Clock To:
 1st Value: **4.000**
 2nd Value:
 Value Percent:
 Continuous Index:
 Within 8" of Joint: **YES**
 Remarks:

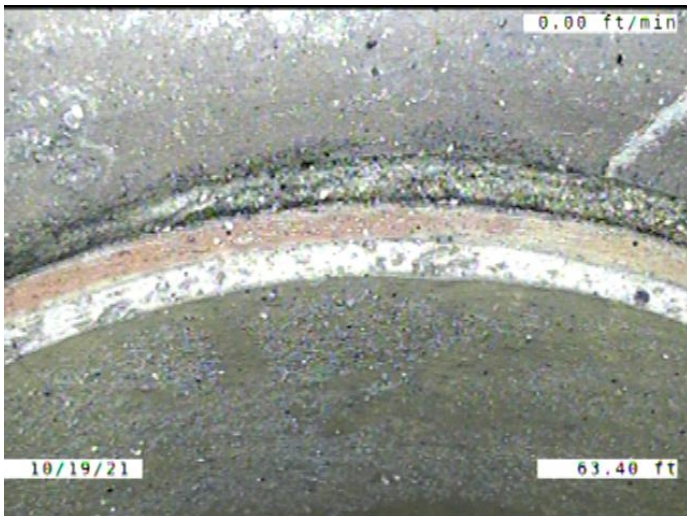
Code: **JOM**
 Description: **Joint Offset Medium**

Distance (ft): **63.4**
 Structural Grade: **3**
 O&M Grade: **0**
 Clock Start/From:
 Clock To:
 1st Value:
 2nd Value:
 Value Percent:
 Continuous Index:
 Within 8" of Joint: **NO**
 Remarks:

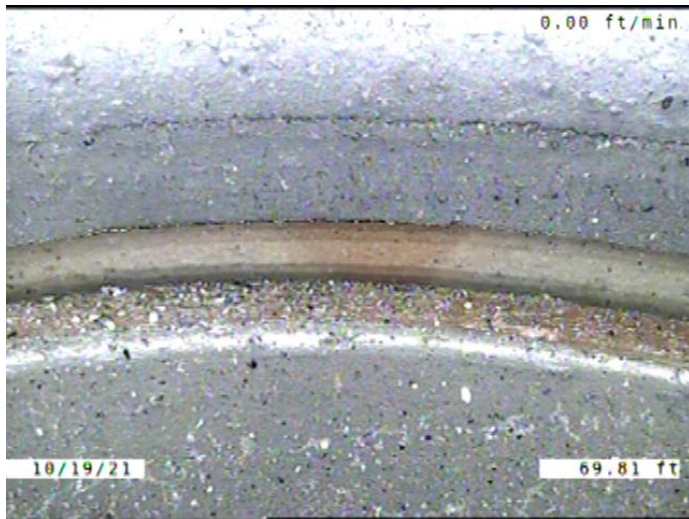
Code: **JOM**
Description: **Joint Offset Medium**

Distance (ft): **69.8**
Structural Grade: **3**
O&M Grade: **0**
Clock Start/From:
Clock To:
1st Value:
2nd Value:
Value Percent:
Continuous Index:
Within 8" of Joint: **NO**
Remarks:

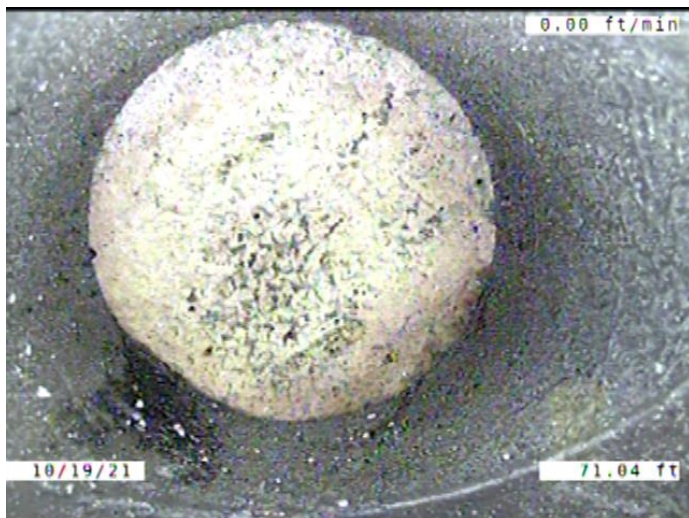
Code: **TFC**
Description: **Tap Factory Capped**

Distance (ft): **71.0**
Structural Grade: **0**
O&M Grade: **0**
Clock Start/From: **11**
Clock To:
1st Value: **4.000**
2nd Value:
Value Percent:
Continuous Index:
Within 8" of Joint: **YES**
Remarks:

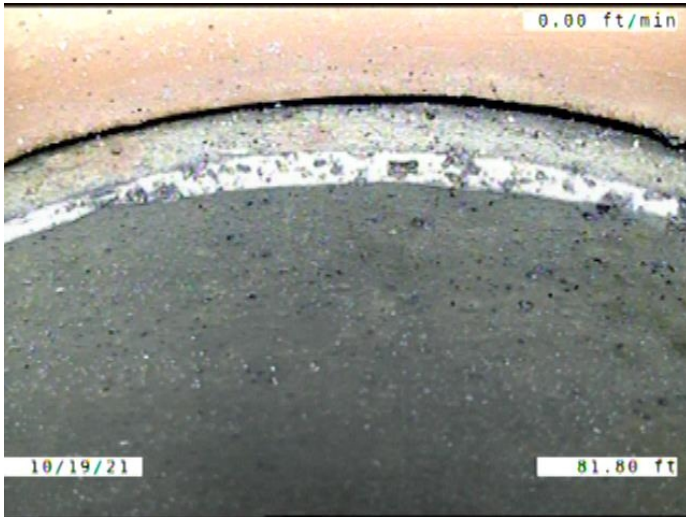
Code: **JOM**
 Description: **Joint Offset Medium**

Distance (ft): **81.8**
 Structural Grade: **3**
 O&M Grade: **0**
 Clock Start/From:
 Clock To:
 1st Value:
 2nd Value:
 Value Percent:
 Continuous Index:
 Within 8" of Joint: **NO**
 Remarks:

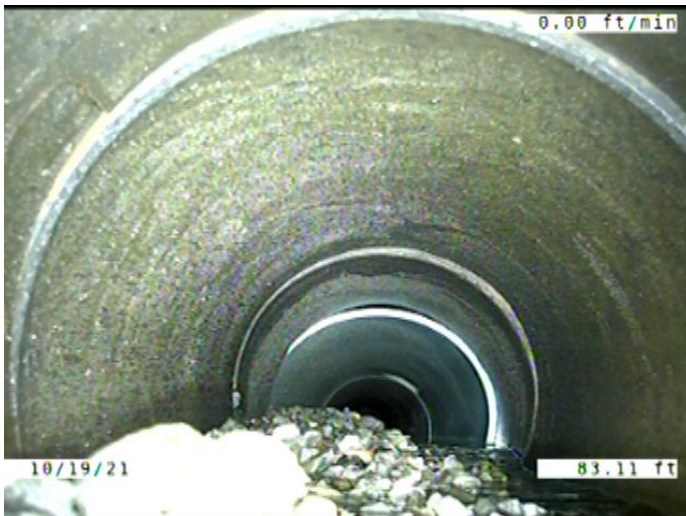
Code: **DSGV**
 Description: **Deposits Settled Gravel**

Distance (ft): **83.1**
 Structural Grade: **0**
 O&M Grade: **5**
 Clock Start/From: **5**
 Clock To: **9**
 1st Value:
 2nd Value:
 Value Percent: **35.000**
 Continuous Index: **S03**
 Within 8" of Joint: **YES**
 Remarks: **Continues underwater**

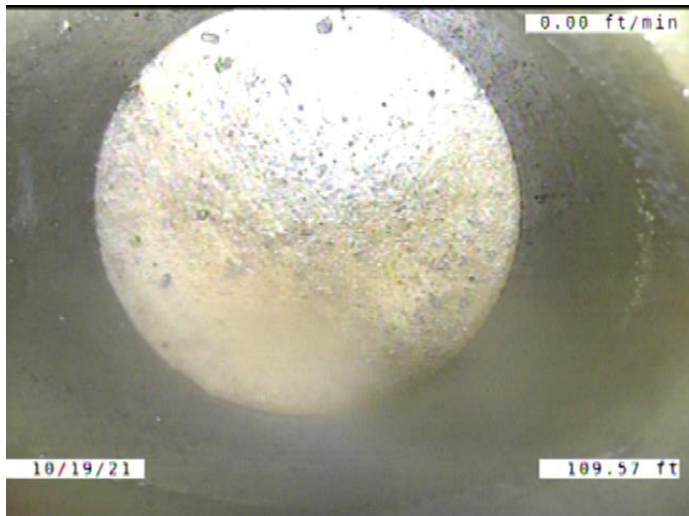
Code: **TFC**
 Description: **Tap Factory Capped**

Distance (ft): **109.6**
 Structural Grade: **0**
 O&M Grade: **0**
 Clock Start/From: **1**
 Clock To:
 1st Value: **4.000**
 2nd Value:
 Value Percent:
 Continuous Index:
 Within 8" of Joint: **YES**
 Remarks:
