Profile/Photo Observation Report

Date:	10/19/2021	Weather:		Coding:	PACP 7.0
Pipe Length (ft):	111.2	Owner:	City of Hobart	Pre Clean:	Heavy Cleaning
P.O.#:	YES502259	Surveyor:	S. Bucklin	PSR:	P-503-018-017
Customer:	City of Hobart	Clean Date:	09/05/2021	Shape:	C

Street:	West 39th Avenue	Flow Control:	Not Controlled
City:	Hobart, IN	Year Renewed:	
Location:	Alley	Tape/Media #:	
Purpose:	Routine Assessment	Dia/Height:	12"
Use:	Sanitary Sewage Pipe	Material:	VCP
Drain Area:		Lining:	
Category:	NA		
Comment:			
Location Details:		Direction of Survey:	Upstream
US MH:	M-503-017	DS MH:	M-503-018
		Total Length Surveyed (ft):	111.2

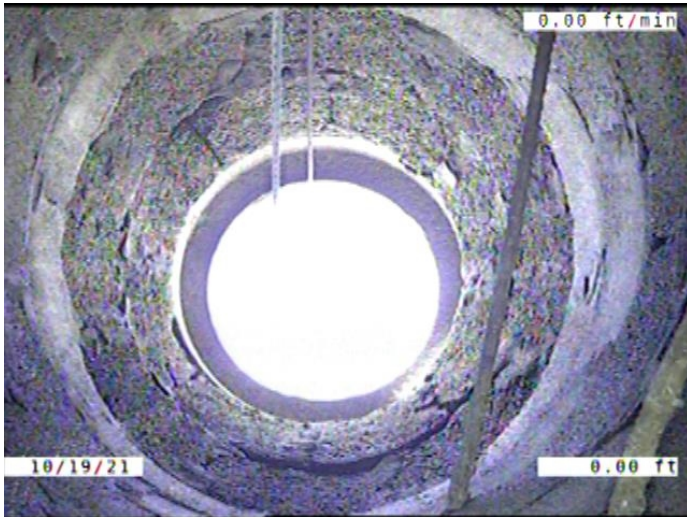
Code: **AMH**
 Description: **Manhole**

Distance (ft): **.0**
 Structural Grade: **0**
 O&M Grade: **0**
 Clock Start/From:
 Clock To:
 1st Value:
 2nd Value:
 Value Percent:
 Continuous Index:
 Within 8" of Joint: **NO**
 Remarks: **M-503-018**

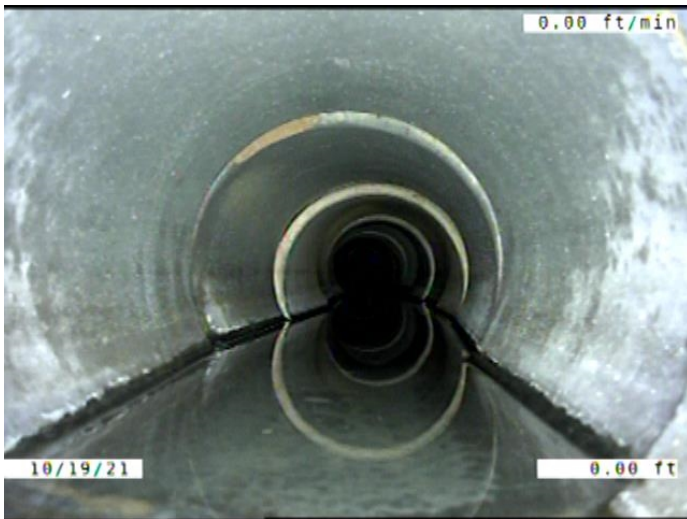
Code: **MWL**
 Description: **Miscellaneous Water Level**

Distance (ft): **.0**
 Structural Grade: **0**
 O&M Grade: **0**
 Clock Start/From:
 Clock To:
 1st Value:
 2nd Value:
 Value Percent: **10.000**
 Continuous Index:
 Within 8" of Joint: **NO**
 Remarks:

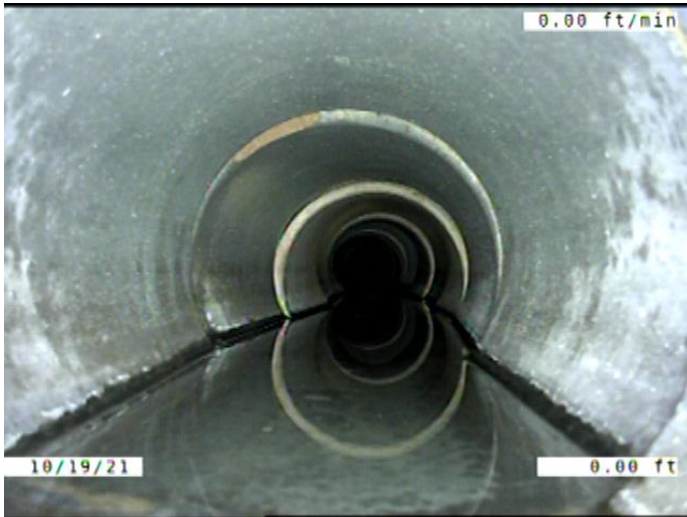
Code: **DSF**
 Description: **Deposits Settled Fine**

Distance (ft): **.0**
 Structural Grade: **0**
 O&M Grade: **2**
 Clock Start/From: **5**
 Clock To: **7**
 1st Value:
 2nd Value:
 Value Percent: **5.000**
 Continuous Index: **S01**
 Within 8" of Joint: **YES**
 Remarks:

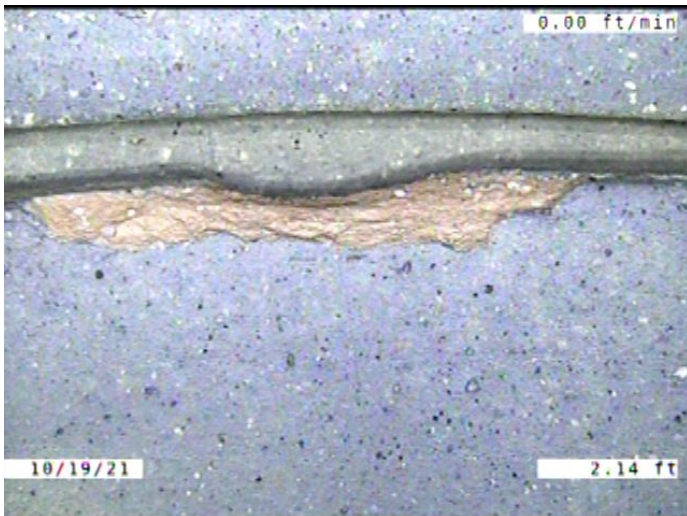
Code: **SZ**
 Description: **Surface Damage Other**

Distance (ft): **2.1**
 Structural Grade: **0**
 O&M Grade: **0**
 Clock Start/From: **11**
 Clock To:
 1st Value:
 2nd Value:
 Value Percent:
 Continuous Index:
 Within 8" of Joint: **YES**
 Remarks: **A PIECE CHIPPED AWAY FROM THE JOINT**

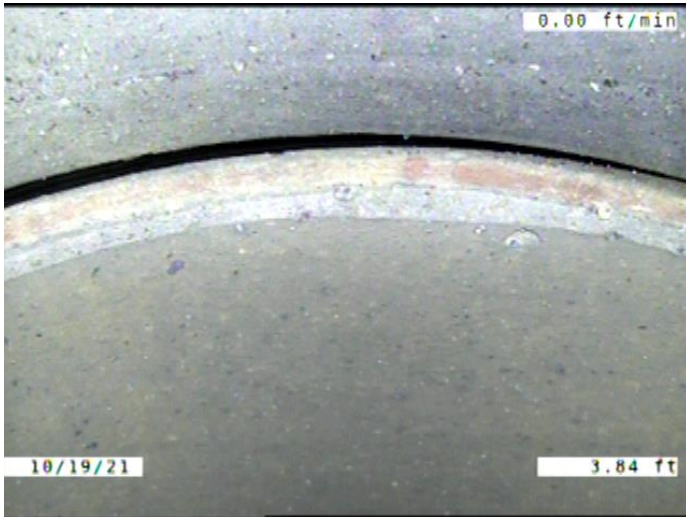
Code: **JOM**
Description: **Joint Offset Medium**

Distance (ft): **3.8**
Structural Grade: **3**
O&M Grade: **0**
Clock Start/From:
Clock To:
1st Value:
2nd Value:
Value Percent:
Continuous Index:
Within 8" of Joint: **NO**
Remarks:

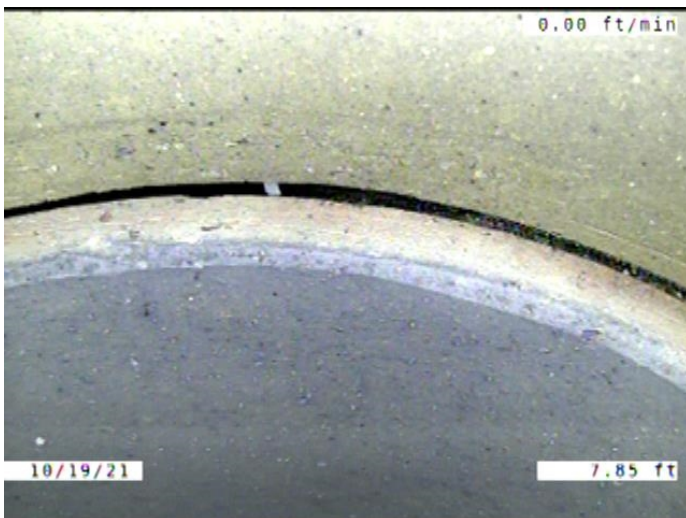
Code: **JOM**
Description: **Joint Offset Medium**

Distance (ft): **7.9**
Structural Grade: **3**
O&M Grade: **0**
Clock Start/From:
Clock To:
1st Value:
2nd Value:
Value Percent:
Continuous Index:
Within 8" of Joint: **NO**
Remarks:

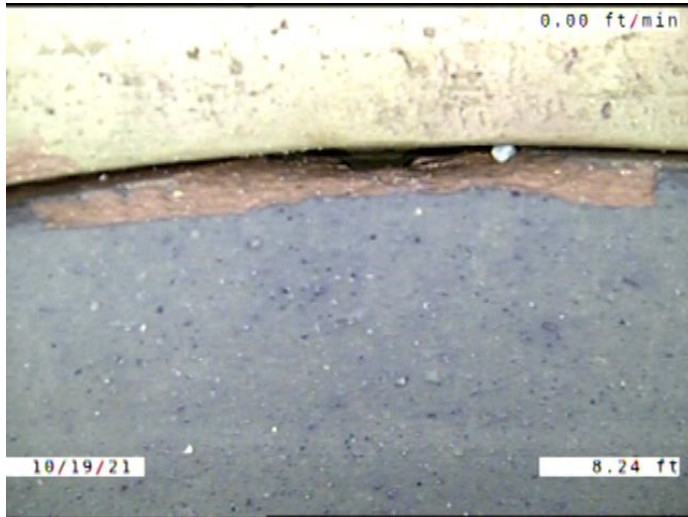
Code:	SZ
Description:	Surface Damage Other
Distance (ft):	8.2
Structural Grade:	0
O&M Grade:	0
Clock Start/From:	10
Clock To:	11
1st Value:	
2nd Value:	
Value Percent:	
Continuous Index:	
Within 8" of Joint:	YES
Remarks:	A PIECE CHIPPED AWAY FROM THE JOINT

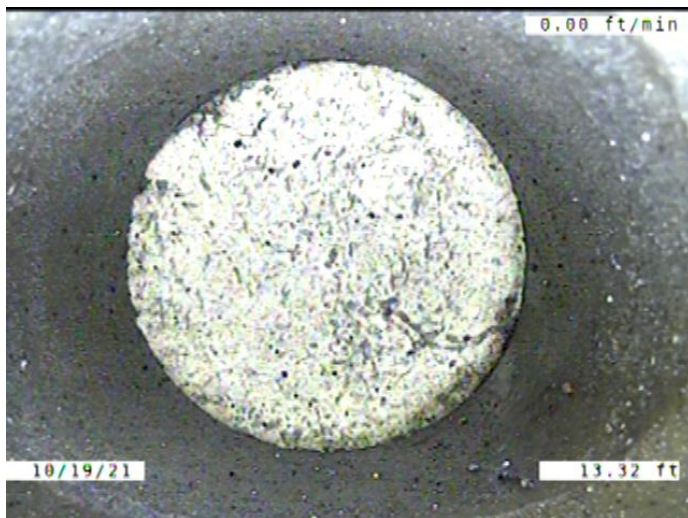
Code:	TFC
Description:	Tap Factory Capped
Distance (ft):	13.3
Structural Grade:	0
O&M Grade:	0
Clock Start/From:	1
Clock To:	
1st Value:	4.000
2nd Value:	
Value Percent:	
Continuous Index:	
Within 8" of Joint:	YES
Remarks:

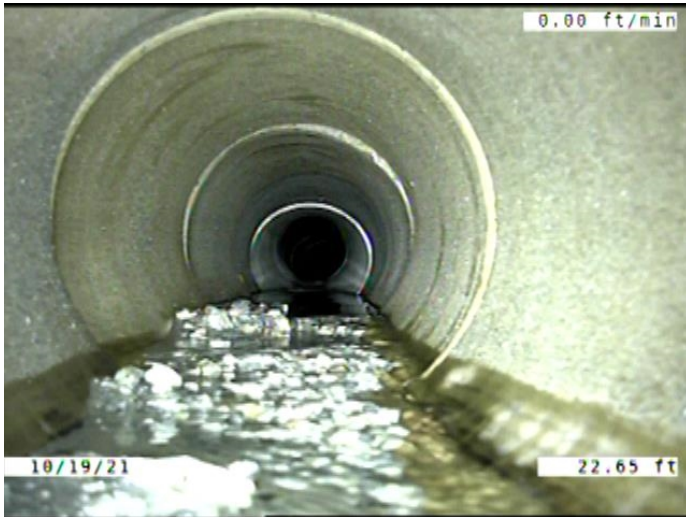
Code: **DSGV**
Description: **Deposits Settled Gravel**

Distance (ft): **22.7**
Structural Grade: **0**
O&M Grade: **2**
Clock Start/From: **5**
Clock To: **7**
1st Value:
2nd Value:
Value Percent: **5.000**
Continuous Index: **S02**
Within 8" of Joint: **YES**
Remarks:

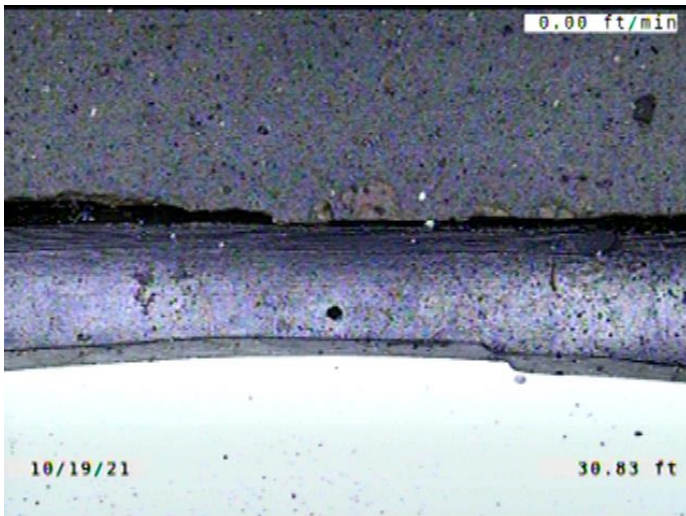
Code: **MMC**
Description: **Miscellaneous Material Change**

Distance (ft): **30.8**
Structural Grade: **0**
O&M Grade: **0**
Clock Start/From:
Clock To:
1st Value:
2nd Value:
Value Percent:
Continuous Index:
Within 8" of Joint: **NO**
Remarks: **VCP TO PVC**

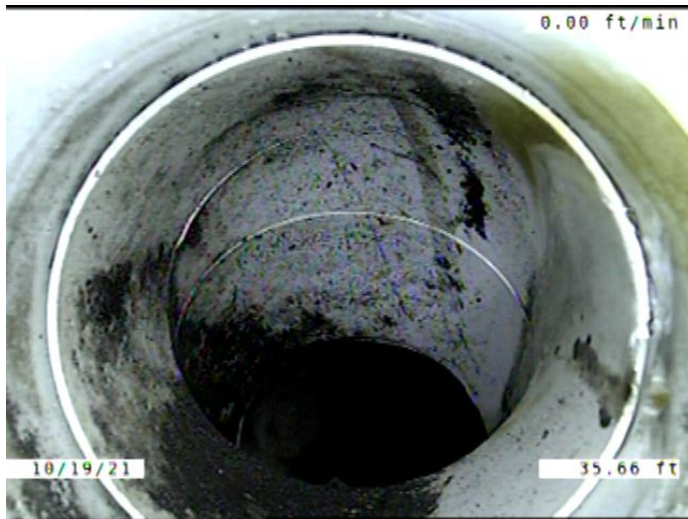
Code: **TF**
Description: **Tap Factory**

Distance (ft): **35.7**
Structural Grade: **0**
O&M Grade: **0**
Clock Start/From: **2**
Clock To:
1st Value: **4.000**
2nd Value:
Value Percent:
Continuous Index:
Within 8" of Joint: **YES**
Remarks: **CONSTANTLY RUNNING WATER**

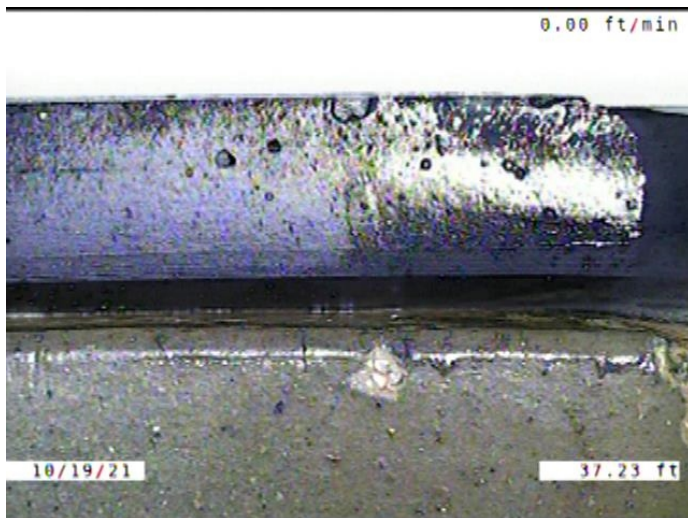
Code: **MMC**
Description: **Miscellaneous Material Change**

Distance (ft): **37.2**
Structural Grade: **0**
O&M Grade: **0**
Clock Start/From:
Clock To:
1st Value:
2nd Value:
Value Percent:
Continuous Index:
Within 8" of Joint: **NO**
Remarks: **PVC TO VCP**

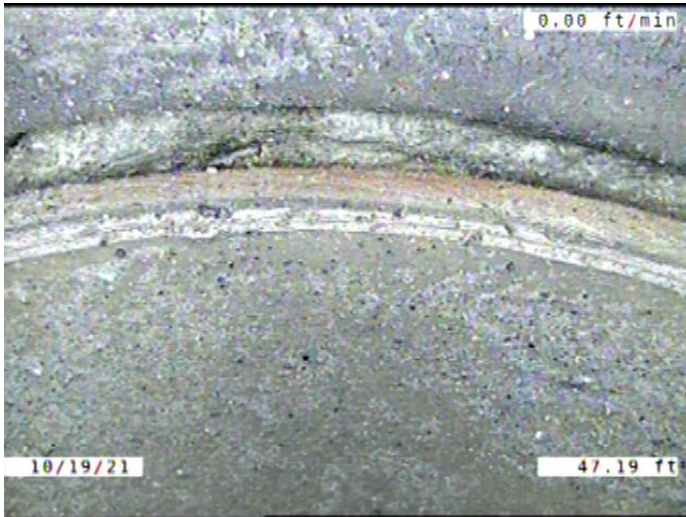
Code: **JOM**
 Description: **Joint Offset Medium**

Distance (ft): **47.2**
 Structural Grade: **3**
 O&M Grade: **0**
 Clock Start/From:
 Clock To:
 1st Value:
 2nd Value:
 Value Percent:
 Continuous Index:
 Within 8" of Joint: **NO**
 Remarks:

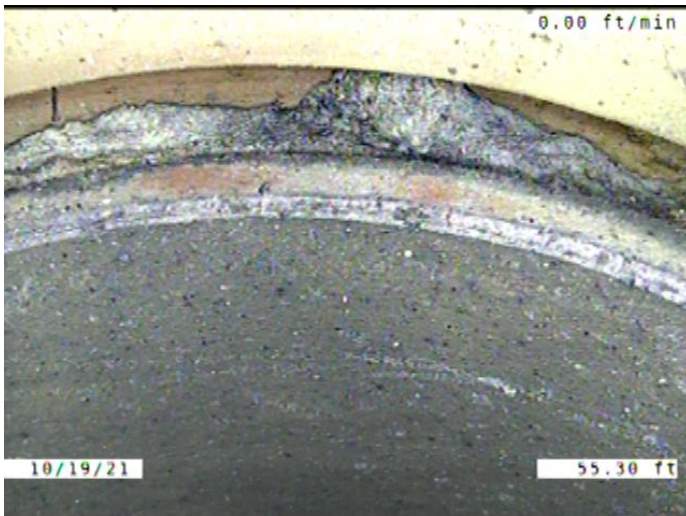
Code: **JOM**
 Description: **Joint Offset Medium**

Distance (ft): **55.3**
 Structural Grade: **3**
 O&M Grade: **0**
 Clock Start/From:
 Clock To:
 1st Value:
 2nd Value:
 Value Percent:
 Continuous Index:
 Within 8" of Joint: **NO**
 Remarks:

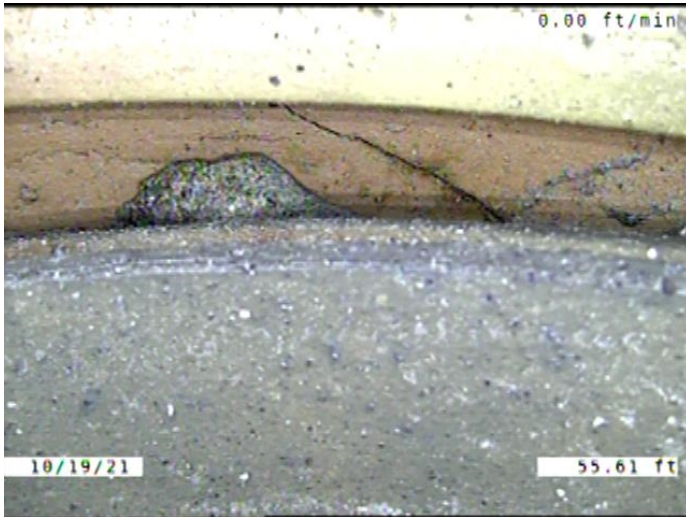
Code: **CM**
 Description: **Crack Multiple**

Distance (ft): **55.6**
 Structural Grade: **3**
 O&M Grade: **0**
 Clock Start/From: **11**
 Clock To: **2**
 1st Value:
 2nd Value:
 Value Percent:
 Continuous Index:
 Within 8" of Joint: **YES**
 Remarks:

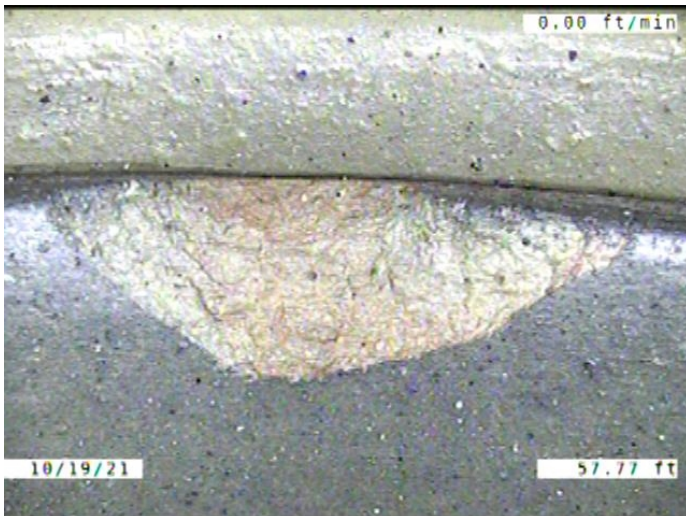
Code: **SZ**
 Description: **Surface Damage Other**

Distance (ft): **57.8**
 Structural Grade: **0**
 O&M Grade: **0**
 Clock Start/From: **1**
 Clock To:
 1st Value:
 2nd Value:
 Value Percent:
 Continuous Index:
 Within 8" of Joint: **YES**
 Remarks: **A PIECE CHIPPED AWAY FROM THE JOINT**

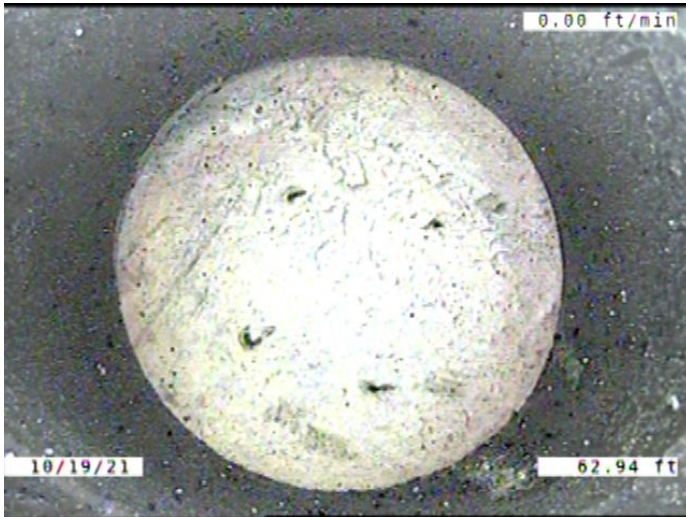
Code: **TFC**
 Description: **Tap Factory Capped**

Distance (ft): **62.9**
 Structural Grade: **0**
 O&M Grade: **0**
 Clock Start/From: **1**
 Clock To:
 1st Value: **4.000**
 2nd Value:
 Value Percent:
 Continuous Index:
 Within 8" of Joint: **YES**
 Remarks:

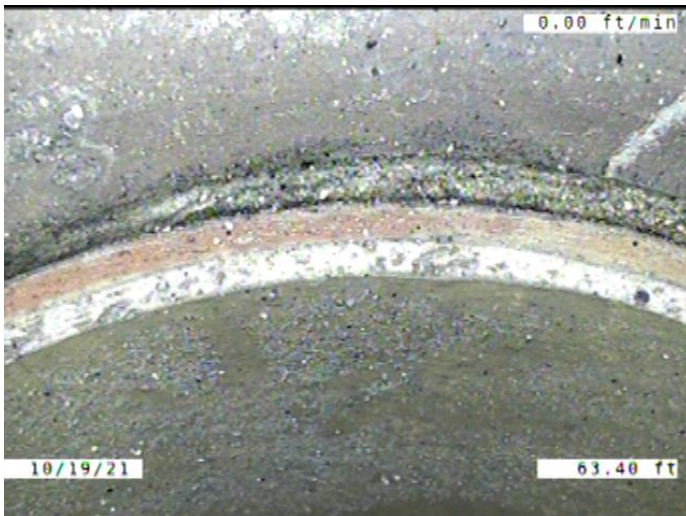
Code: **JOM**
 Description: **Joint Offset Medium**

Distance (ft): **63.4**
 Structural Grade: **3**
 O&M Grade: **0**
 Clock Start/From:
 Clock To:
 1st Value:
 2nd Value:
 Value Percent:
 Continuous Index:
 Within 8" of Joint: **NO**
 Remarks:

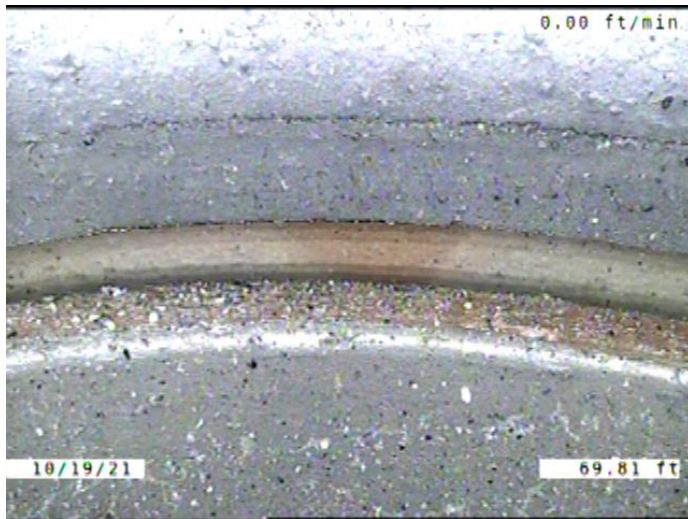
Code: **JOM**
Description: **Joint Offset Medium**

Distance (ft): **69.8**
Structural Grade: **3**
O&M Grade: **0**
Clock Start/From:
Clock To:
1st Value:
2nd Value:
Value Percent:
Continuous Index:
Within 8" of Joint: **NO**
Remarks:

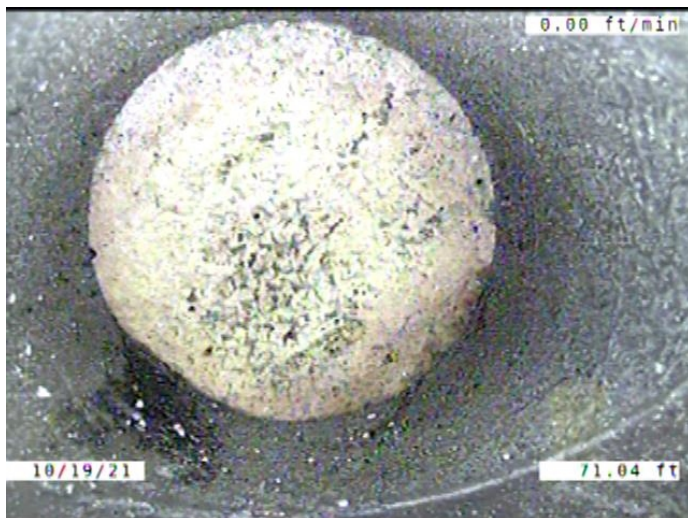
Code: **TFC**
Description: **Tap Factory Capped**

Distance (ft): **71.0**
Structural Grade: **0**
O&M Grade: **0**
Clock Start/From: **11**
Clock To:
1st Value: **4.000**
2nd Value:
Value Percent:
Continuous Index:
Within 8" of Joint: **YES**
Remarks:

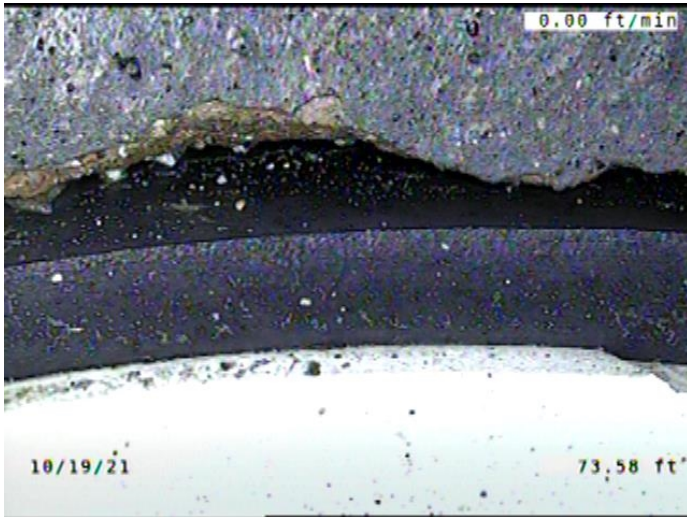
Code: **MMC**
 Description: **Miscellaneous Material Change**

Distance (ft): **73.6**
 Structural Grade: **0**
 O&M Grade: **0**
 Clock Start/From:
 Clock To:
 1st Value:
 2nd Value:
 Value Percent:
 Continuous Index:
 Within 8" of Joint: **NO**
 Remarks: **VCP TO PVC**

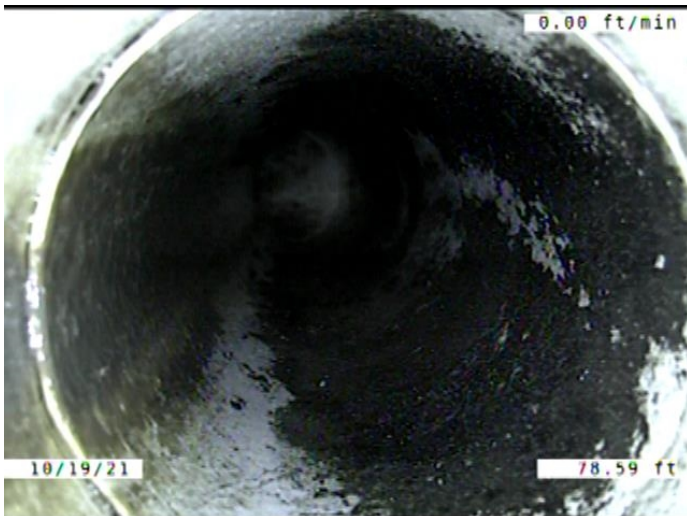
Code: **TF**
 Description: **Tap Factory**

Distance (ft): **78.6**
 Structural Grade: **0**
 O&M Grade: **0**
 Clock Start/From: **11**
 Clock To:
 1st Value: **4.000**
 2nd Value:
 Value Percent:
 Continuous Index:
 Within 8" of Joint: **YES**
 Remarks:

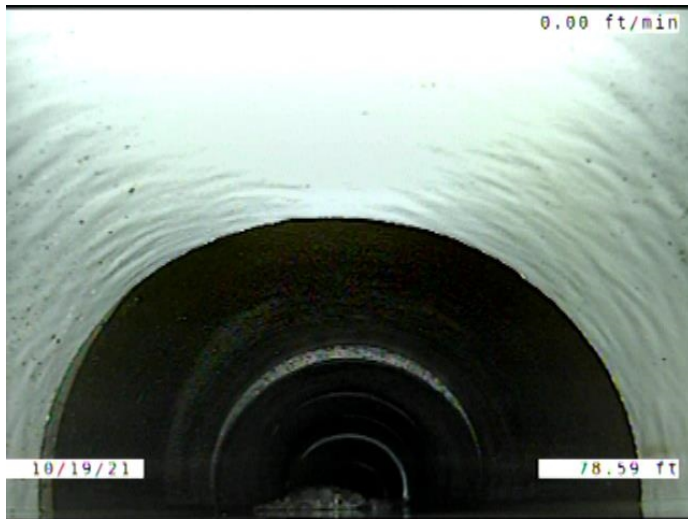
Code: **MWL**
 Description: **Miscellaneous Water Level**

Distance (ft): **78.6**
 Structural Grade: **0**
 O&M Grade: **0**
 Clock Start/From:
 Clock To:
 1st Value:
 2nd Value:
 Value Percent: **20.000**
 Continuous Index:
 Within 8" of Joint: **NO**
 Remarks:

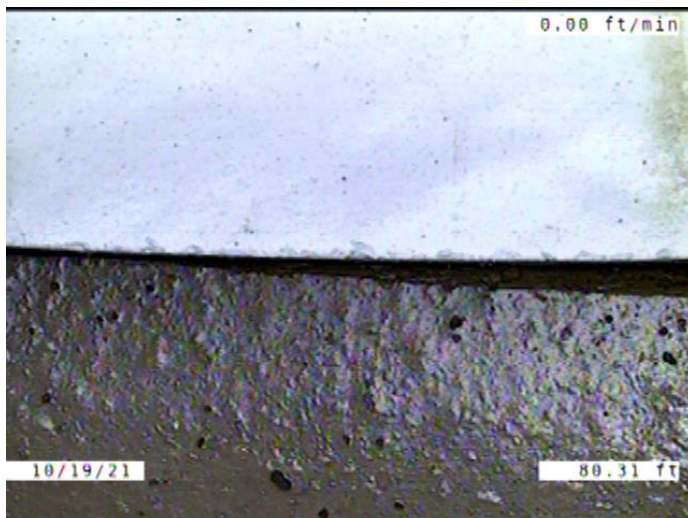
Code: **MMC**
 Description: **Miscellaneous Material Change**

Distance (ft): **80.3**
 Structural Grade: **0**
 O&M Grade: **0**
 Clock Start/From:
 Clock To:
 1st Value:
 2nd Value:
 Value Percent:
 Continuous Index:
 Within 8" of Joint: **NO**
 Remarks: **PVC TO VCP**

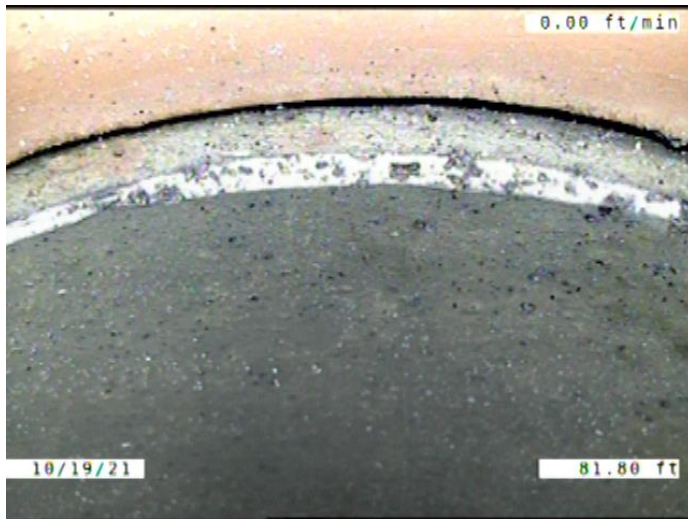
Code: **JOM**
 Description: **Joint Offset Medium**

Distance (ft): **81.8**
 Structural Grade: **3**
 O&M Grade: **0**
 Clock Start/From:
 Clock To:
 1st Value:
 2nd Value:
 Value Percent:
 Continuous Index:
 Within 8" of Joint: **NO**
 Remarks:

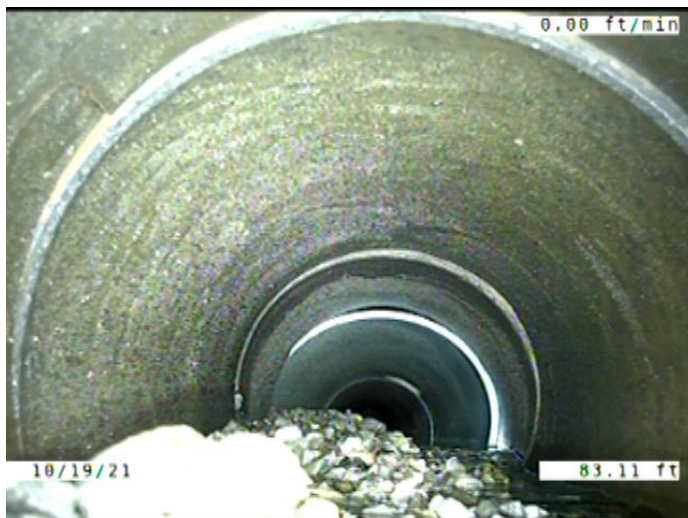
Code: **DSGV**
 Description: **Deposits Settled Gravel**

Distance (ft): **83.1**
 Structural Grade: **0**
 O&M Grade: **5**
 Clock Start/From: **5**
 Clock To: **9**
 1st Value:
 2nd Value:
 Value Percent: **35.000**
 Continuous Index: **S03**
 Within 8" of Joint: **YES**
 Remarks: **Continues underwater**

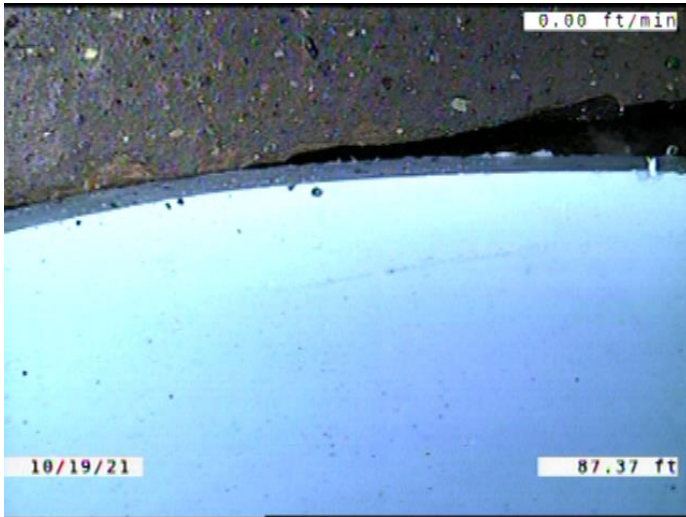
Code: **MMC**
 Description: **Miscellaneous Material Change**

Distance (ft): **87.4**
 Structural Grade: **0**
 O&M Grade: **0**
 Clock Start/From:
 Clock To:
 1st Value:
 2nd Value:
 Value Percent:
 Continuous Index:
 Within 8" of Joint: **NO**
 Remarks: **VCP TO PVC**

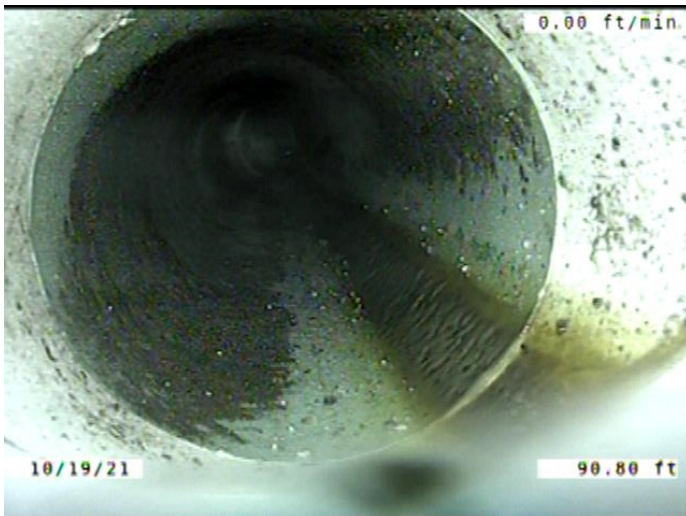
Code: **TF**
 Description: **Tap Factory**

Distance (ft): **90.8**
 Structural Grade: **0**
 O&M Grade: **0**
 Clock Start/From: **1**
 Clock To:
 1st Value: **4.000**
 2nd Value:
 Value Percent:
 Continuous Index:
 Within 8" of Joint: **YES**
 Remarks:

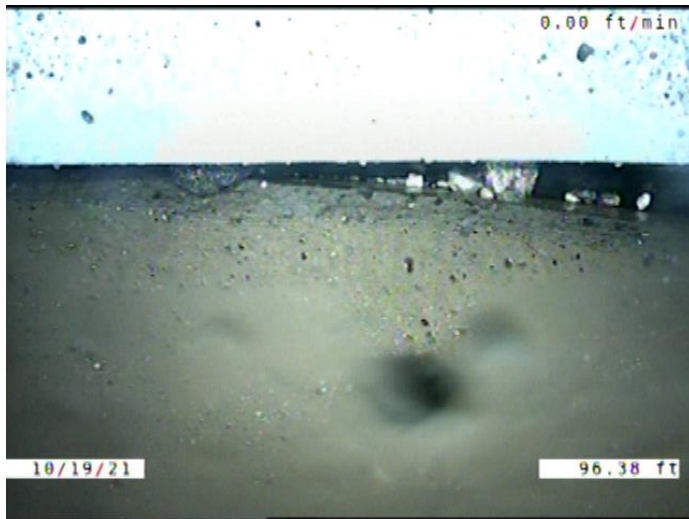
Code: **MMC**
 Description: **Miscellaneous Material Change**

Distance (ft): **96.4**
 Structural Grade: **0**
 O&M Grade: **0**
 Clock Start/From:
 Clock To:
 1st Value:
 2nd Value:
 Value Percent:
 Continuous Index:
 Within 8" of Joint: **NO**
 Remarks: **PVC TO VCP**

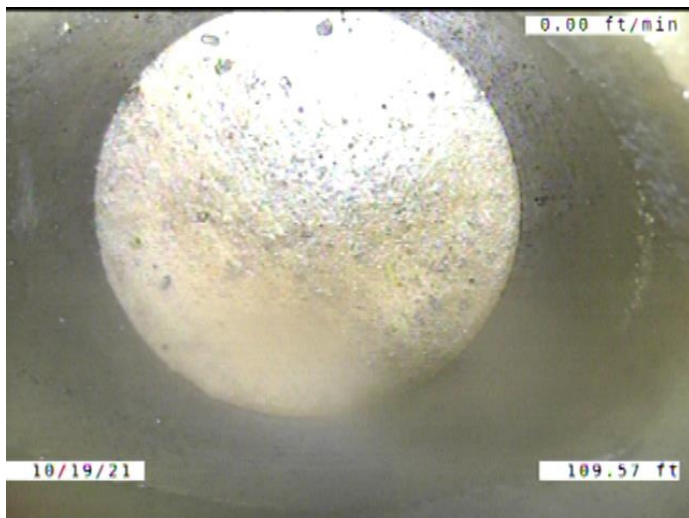
Code: **TFC**
 Description: **Tap Factory Capped**

Distance (ft): **109.6**
 Structural Grade: **0**
 O&M Grade: **0**
 Clock Start/From: **1**
 Clock To:
 1st Value: **4.000**
 2nd Value:
 Value Percent:
 Continuous Index:
 Within 8" of Joint: **YES**
 Remarks:

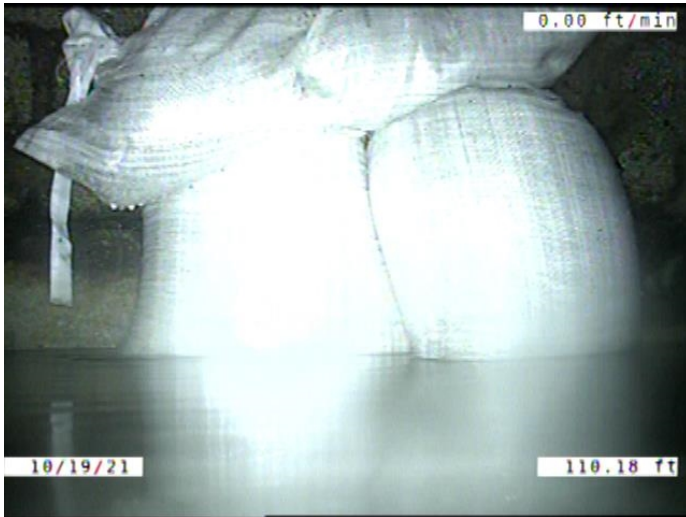
Code: **DSF**
Description: **Deposits Settled Fine**

Distance (ft): **110.2**
Structural Grade: **0**
O&M Grade: **2**
Clock Start/From: **5**
Clock To: **7**
1st Value:
2nd Value:
Value Percent: **5.000**
Continuous Index: **F01**
Within 8" of Joint: **YES**
Remarks:

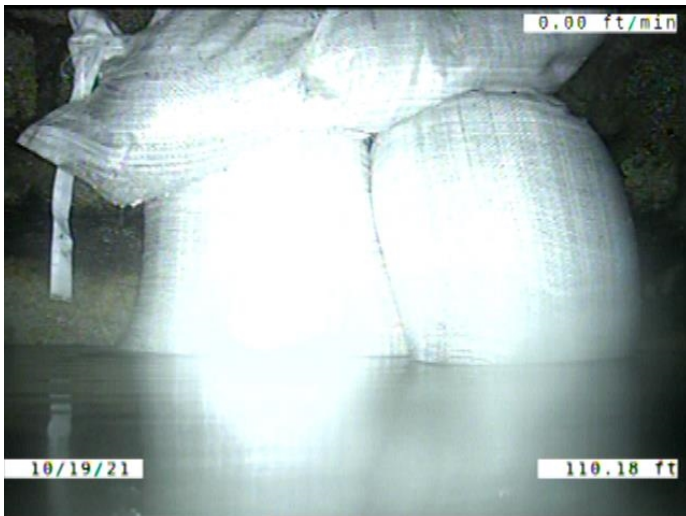
Code: **DSGV**
Description: **Deposits Settled Gravel**

Distance (ft): **110.2**
Structural Grade: **0**
O&M Grade: **2**
Clock Start/From: **5**
Clock To: **7**
1st Value:
2nd Value:
Value Percent: **5.000**
Continuous Index: **F02**
Within 8" of Joint: **YES**
Remarks:

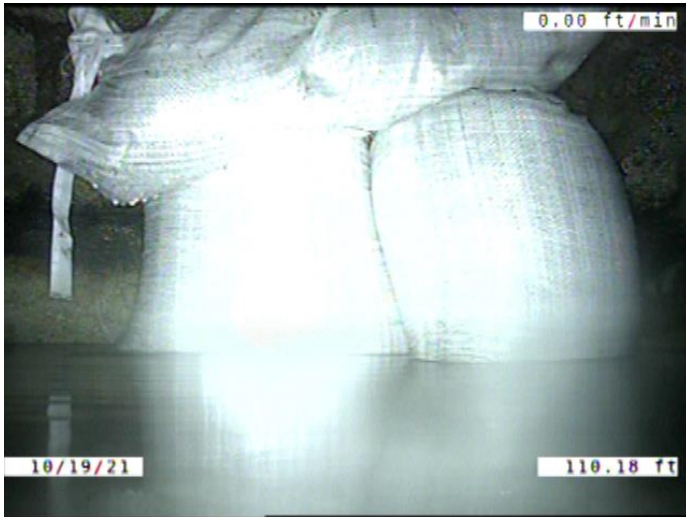
Code: **DSGV**
 Description: **Deposits Settled Gravel**

Distance (ft): **110.2**
 Structural Grade: **0**
 O&M Grade: **5**
 Clock Start/From: **5**
 Clock To: **9**
 1st Value:
 2nd Value:
 Value Percent: **35.000**
 Continuous Index: **F03**
 Within 8" of Joint: **YES**
 Remarks: **Continues underwater**

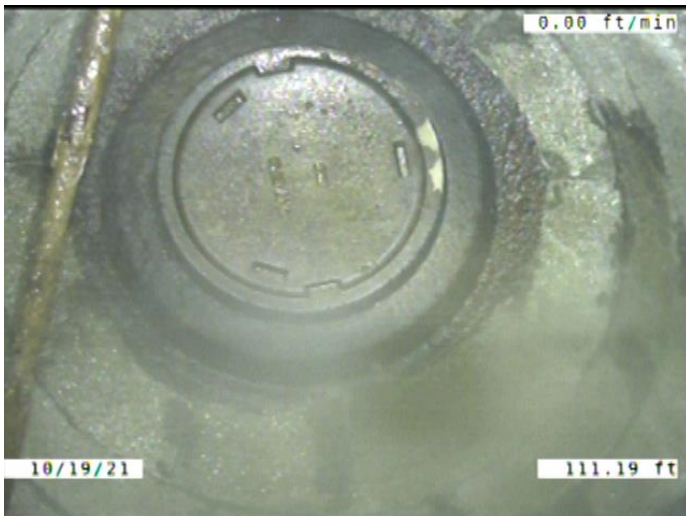
Code: **AMH**
 Description: **Manhole**

Distance (ft): **111.2**
 Structural Grade: **0**
 O&M Grade: **0**
 Clock Start/From:
 Clock To:
 1st Value:
 2nd Value:
 Value Percent:
 Continuous Index:
 Within 8" of Joint: **NO**
 Remarks: **M-503-017**
