Profile/Photo Observation Report

Street:	ALLEY BETWEEN W 39TH PL & W 39	Flow Control:	Not Controlled
City:	Hobart, IN	Year Renewed:	
Location:	Other	Tape/Media #:	
Purpose:	Not Known	Dia/Height:	10"
Use:	Sanitary	Material:	VCP
Drain Area:	NA	Lining:	
Category:	NA		
Comment:

Location Details:		Direction of Survey:	Downstream
US MH:	M-503-017	DS MH:	M-503-019
		Total Length Surveyed (ft):	8.6

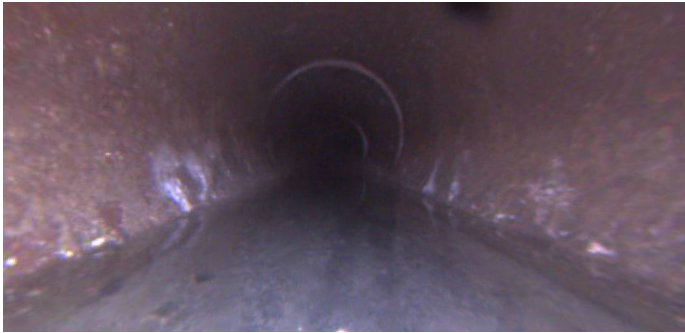
Code:	MWL
Description:	Water Level

Distance (ft):	.0
Structural Grade:	0
O&M Grade:	0
Clock Start/From:	
Clock To:	
1st Value:	
2nd Value:	
Value Percent:	20.000
Continuous Index:	
Within 8" of Joint:	NO
Remarks:

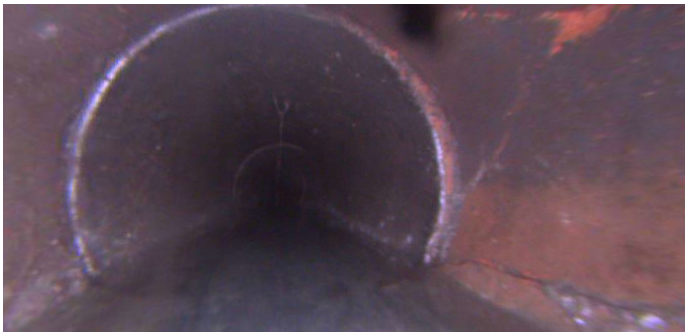
Code:	FM
Description:	Fracture Multiple

Distance (ft):	4.1
Structural Grade:	4
O&M Grade:	0
Clock Start/From:	1
Clock To:	4
1st Value:	
2nd Value:	
Value Percent:	
Continuous Index:	
Within 8" of Joint:	YES
Remarks:

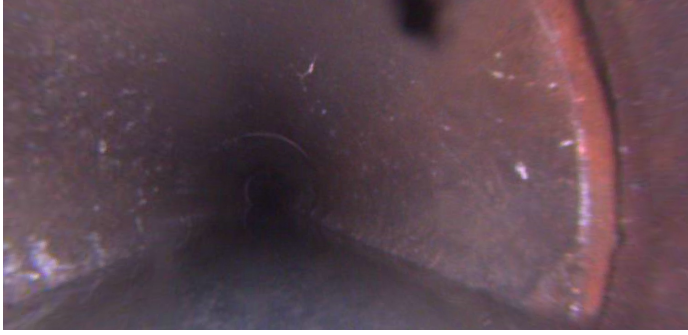
Code:	MSA
Description:	Abandoned Survey
Distance (ft):	8.6
Structural Grade:	0
O&M Grade:	0
Clock Start/From:	
Clock To:	
1st Value:	
2nd Value:	
Value Percent:	
Continuous Index:	
Within 8" of Joint:	NO
Remarks:	debris under water
