## Profile/Photo Observation Report

Street:	<b>W 40th ave</b>	Flow Control:	<b>Not Controlled</b>
City:	<b>Hobart, IN</b>	Year Renewed:	
Location:	<b>Other</b>	Tape/Media #:	
Purpose:	<b>Not Known</b>	Dia/Height:	<b>10"</b>
Use:	<b>Sanitary</b>	Material:	<b>VCP</b>
Drain Area:	<b>NA</b>	Lining:	
Category:	<b>NA</b>		
Comment:

Location Details:		Direction of Survey:	<b>Downstream</b>
US MH:	<b>M-503-017</b>	DS MH:	<b>M-503-019</b>
		Total Length Surveyed (ft):	<b>8.6</b>

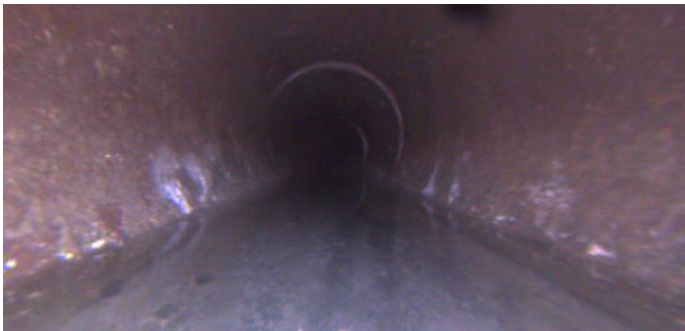
Code: **AMH**  
Description: **Manhole**

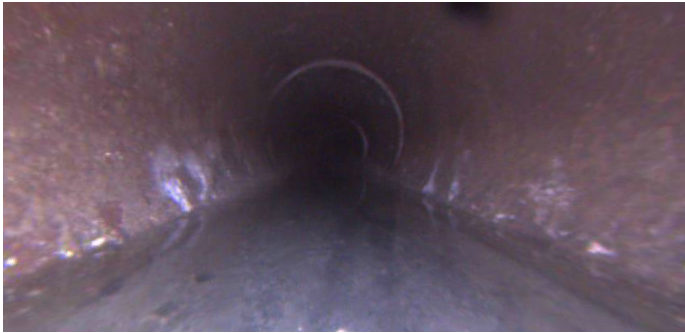
Code:	<b>MWL</b>
Description:	<b>Water Level</b>

Distance (ft):	<b>.0</b>
Structural Grade:	<b>0</b>
O&M Grade:	<b>0</b>
Clock Start/From:	
Clock To:	
1st Value:	
2nd Value:	
Value Percent:	<b>20.000</b>
Continuous Index:	
Within 8" of Joint:	<b>NO</b>
Remarks:

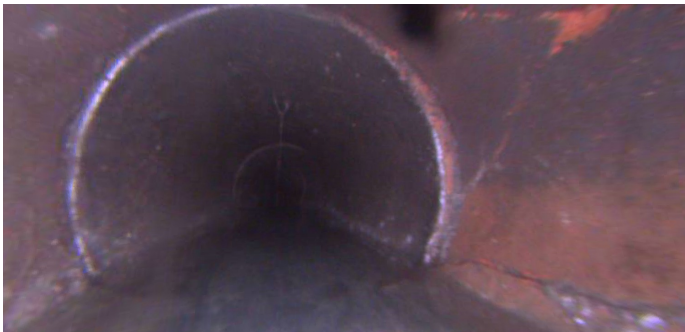
Code:	<b>FM</b>
Description:	<b>Fracture Multiple</b>

Distance (ft):	<b>4.1</b>
Structural Grade:	<b>4</b>
O&M Grade:	<b>0</b>
Clock Start/From:	<b>1</b>
Clock To:	<b>4</b>
1st Value:	
2nd Value:	
Value Percent:	
Continuous Index:	
Within 8" of Joint:	<b>YES</b>
Remarks:

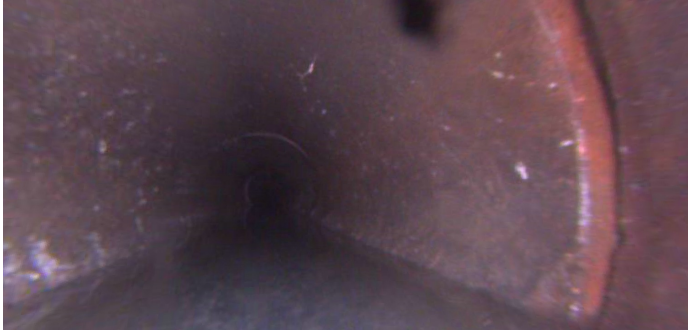
Code:	<b>MSA</b>
Description:	<b>Abandoned Survey</b>
Distance (ft):	<b>8.6</b>
Structural Grade:	<b>0</b>
O&M Grade:	<b>0</b>
Clock Start/From:	
Clock To:	
1st Value:	
2nd Value:	
Value Percent:	
Continuous Index:	
Within 8" of Joint:	<b>NO</b>
Remarks:	<b>debris under water</b>
