Profile/Photo Observation Report

Date:	10/20/2021	Weather:		Coding:	PACP 7.0
Pipe Length (ft):	161.5	Owner:	City of Hobart	Pre Clean:	Heavy Cleaning
P.O.#:	YES502259	Surveyor:	S. Bucklin	PSR:	P-503-019-017
Customer:	City of Hobart	Clean Date:	09/05/2021	Shape:	C

Street:	West 39th Avenue	Flow Control:	Not Controlled
City:	Hobart, IN	Year Renewed:	
Location:	Alley	Tape/Media #:	
Purpose:	Routine Assessment	Dia/Height:	10"
Use:	Sanitary Sewage Pipe	Material:	VCP
Drain Area:		Lining:	
Category:	NA		
Comment:

Location Details:		Direction of Survey:	Downstream
US MH:	M-503-017	DS MH:	M-503-019
		Total Length Surveyed (ft):	19.9

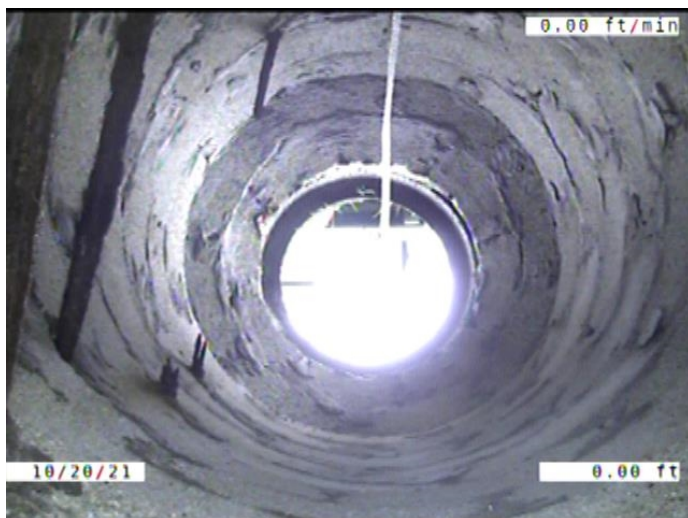
Code: **AMH**
Description: **Manhole**

Distance (ft): **.0**
Structural Grade: **0**
O&M Grade: **0**
Clock Start/From:
Clock To:
1st Value:
2nd Value:
Value Percent:
Continuous Index:
Within 8" of Joint: **NO**
Remarks: **M-503-017**

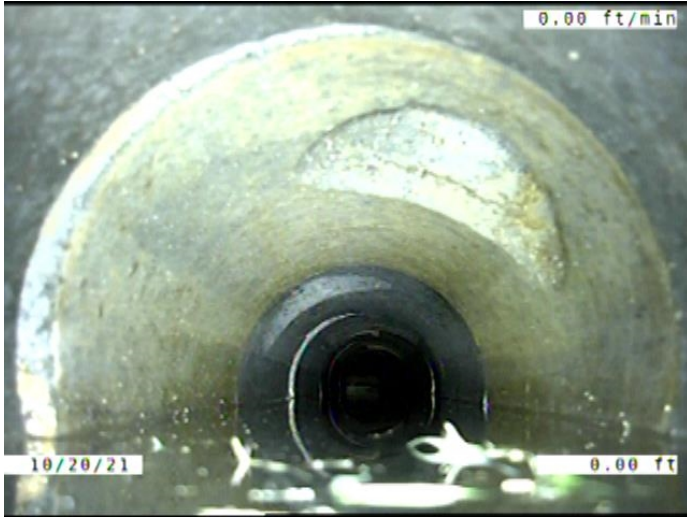
Code: **MWL**
Description: **Miscellaneous Water Level**

Distance (ft): **.0**
Structural Grade: **0**
O&M Grade: **0**
Clock Start/From:
Clock To:
1st Value:
2nd Value:
Value Percent: **15.000**
Continuous Index:
Within 8" of Joint: **NO**
Remarks:

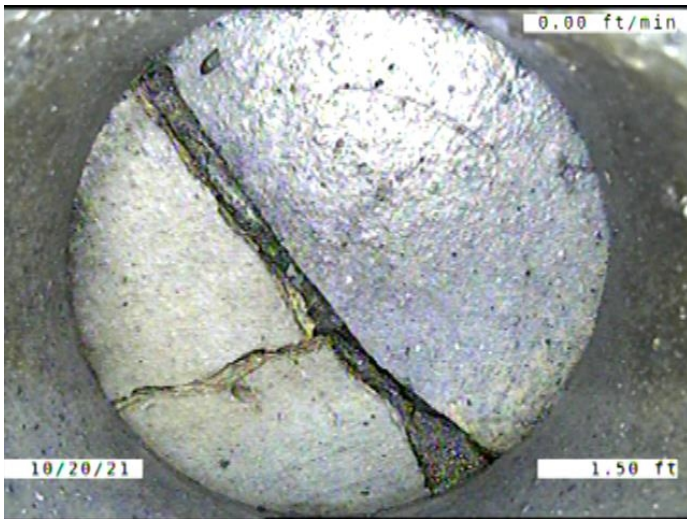
Code: **TFD**
Description: **Tap Factory Defective**

Distance (ft): **1.5**
Structural Grade: **0**
O&M Grade: **3**
Clock Start/From: **1**
Clock To:
1st Value: **4.000**
2nd Value:
Value Percent:
Continuous Index:
Within 8" of Joint: **YES**
Remarks: **CAP BROKEN. SOIL VISIBLE**

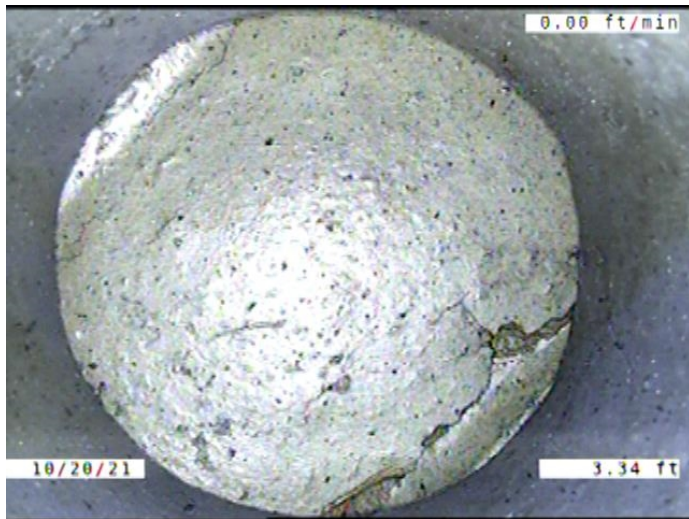
Code: **TFC**
 Description: **Tap Factory Capped**

Distance (ft): **3.3**
 Structural Grade: **0**
 O&M Grade: **0**
 Clock Start/From: **11**
 Clock To:
 1st Value: **4.000**
 2nd Value:
 Value Percent:
 Continuous Index:
 Within 8" of Joint: **YES**
 Remarks: **CAP CRACKED**

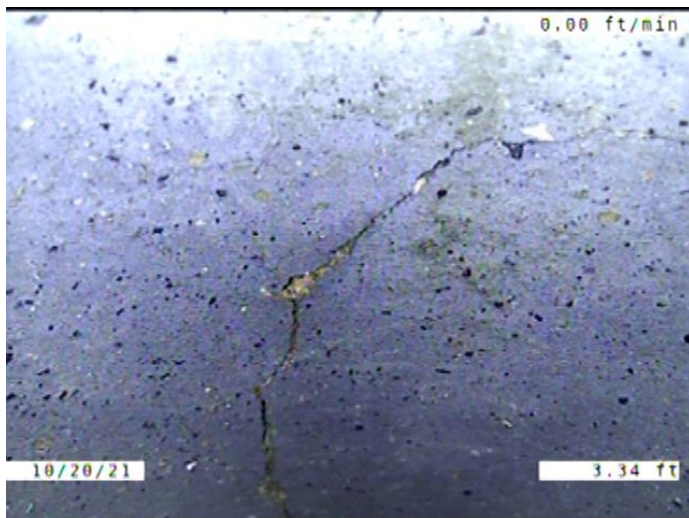
Code: **FM**
 Description: **Fracture Multiple**

Distance (ft): **3.3**
 Structural Grade: **4**
 O&M Grade: **0**
 Clock Start/From: **10**
 Clock To: **2**
 1st Value:
 2nd Value:
 Value Percent:
 Continuous Index:
 Within 8" of Joint: **YES**
 Remarks:

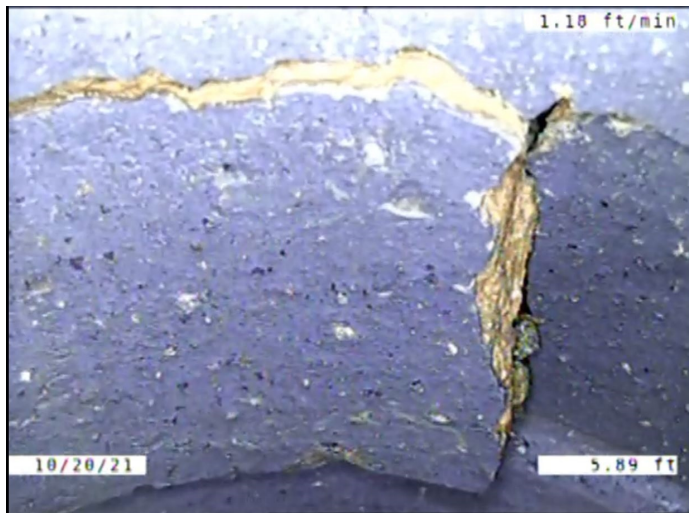
Code: **B**
 Description: **Broken**

Distance (ft): **5.9**
 Structural Grade: **4**
 O&M Grade: **0**
 Clock Start/From: **11**
 Clock To: **1**
 1st Value:
 2nd Value:
 Value Percent:
 Continuous Index:
 Within 8" of Joint: **YES**
 Remarks:

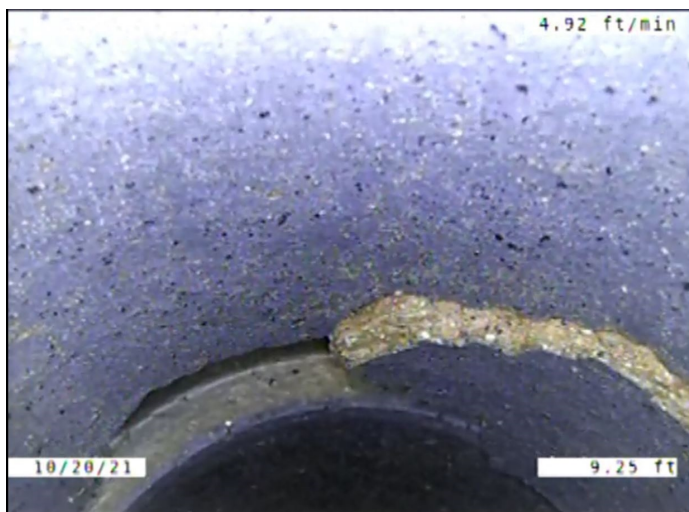
Code: **B**
 Description: **Broken**

Distance (ft): **9.3**
 Structural Grade: **4**
 O&M Grade: **0**
 Clock Start/From: **12**
 Clock To: **2**
 1st Value:
 2nd Value:
 Value Percent:
 Continuous Index:
 Within 8" of Joint: **YES**
 Remarks:

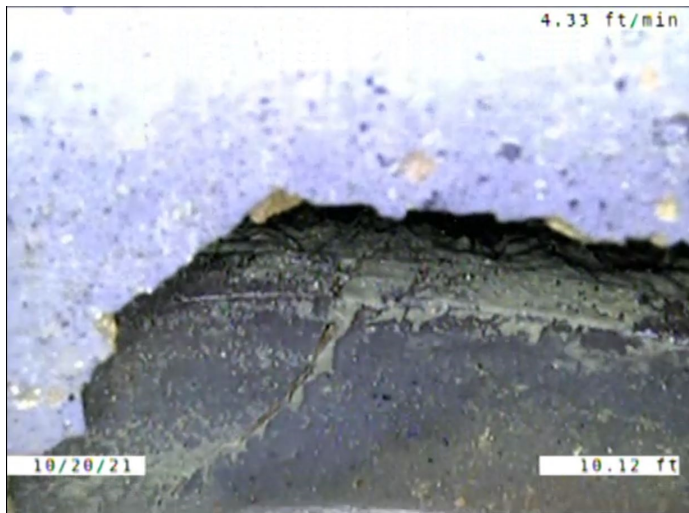
Code: **SMW**
 Description: **Surface Damage Missing Wall**

Distance (ft): **10.1**
 Structural Grade: **5**
 O&M Grade: **0**
 Clock Start/From: **10**
 Clock To: **12**
 1st Value:
 2nd Value:
 Value Percent:
 Continuous Index:
 Within 8" of Joint: **YES**
 Remarks:

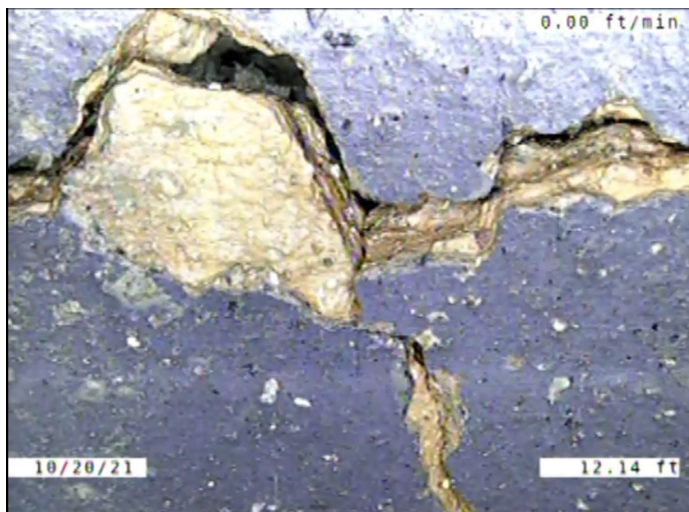
Code: **B**
 Description: **Broken**

Distance (ft): **12.1**
 Structural Grade: **4**
 O&M Grade: **0**
 Clock Start/From: **11**
 Clock To: **3**
 1st Value:
 2nd Value:
 Value Percent:
 Continuous Index:
 Within 8" of Joint: **YES**
 Remarks:

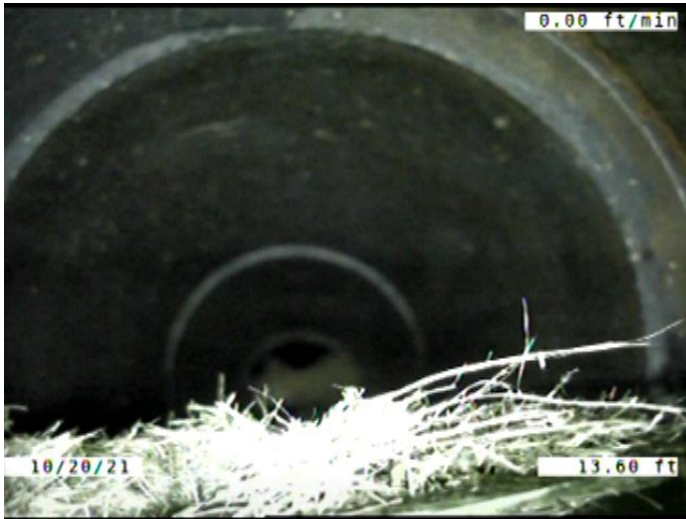
Code: **MGO**
 Description: **Miscellaneous General Observation**

Distance (ft): **13.6**
 Structural Grade: **0**
 O&M Grade: **0**
 Clock Start/From:
 Clock To:
 1st Value:
 2nd Value:
 Value Percent:
 Continuous Index:
 Within 8" of Joint: **NO**
 Remarks: **ROOTS HAVE BEEN CUT OFF BUT DIDNT MAKE IT PAST THE MISSING P**

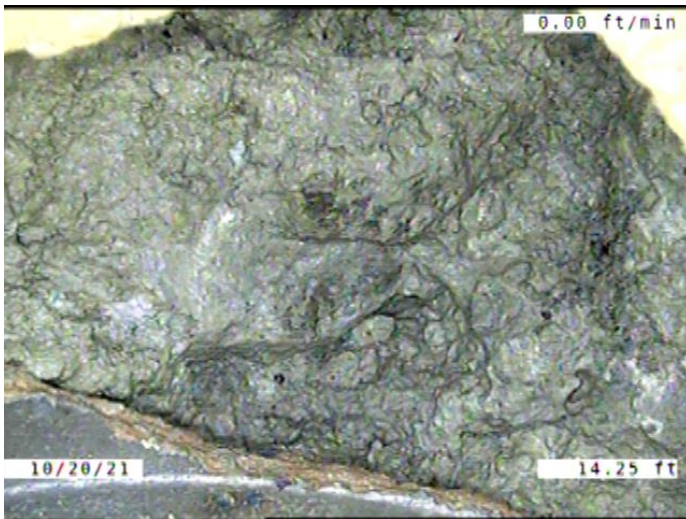
Code: **HSV**
 Description: **Hole Soil Visible**

Distance (ft): **14.2**
 Structural Grade: **5**
 O&M Grade: **0**
 Clock Start/From: **12**
 Clock To: **3**
 1st Value:
 2nd Value:
 Value Percent:
 Continuous Index:
 Within 8" of Joint: **YES**
 Remarks: **SOIL VISIBLE**

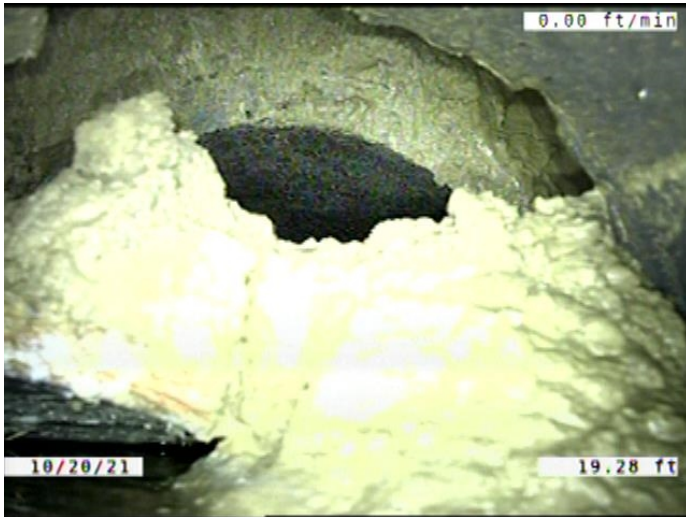
Code: **DSF**
 Description: **Deposits Settled Fine**

Distance (ft): **19.3**
 Structural Grade: **0**
 O&M Grade: **5**
 Clock Start/From: **2**
 Clock To: **10**
 1st Value:
 2nd Value:
 Value Percent: **60.000**
 Continuous Index:
 Within 8" of Joint: **YES**
 Remarks:

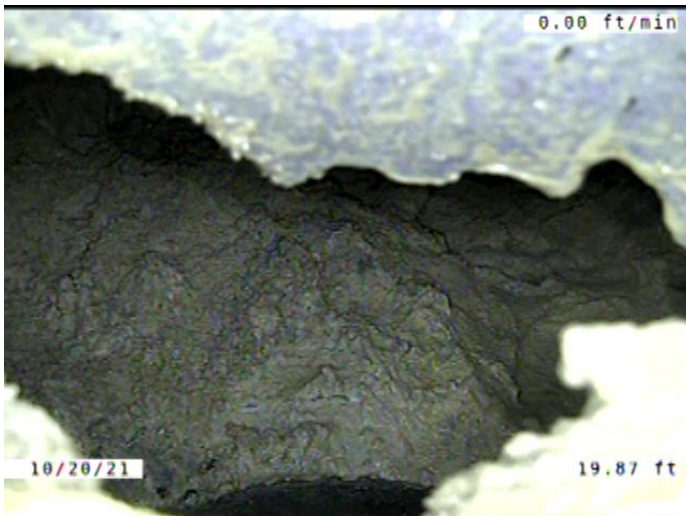
Code: **HVV**
 Description: **Hole Void Visible**

Distance (ft): **19.9**
 Structural Grade: **5**
 O&M Grade: **0**
 Clock Start/From: **8**
 Clock To: **4**
 1st Value:
 2nd Value:
 Value Percent:
 Continuous Index:
 Within 8" of Joint: **YES**
 Remarks:

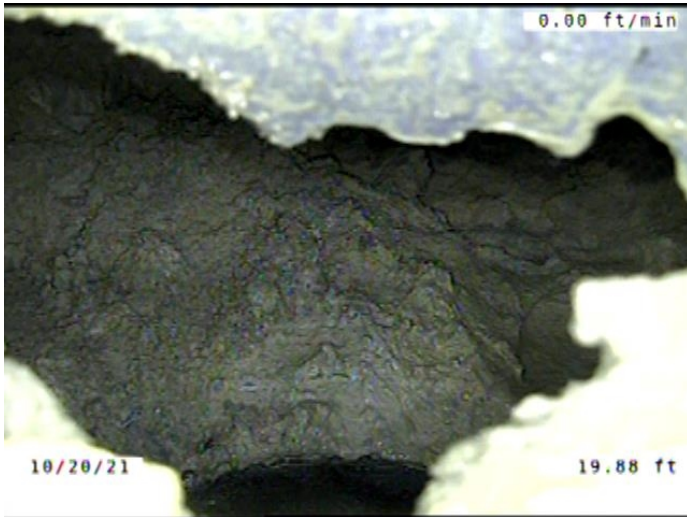
Code:	MSA
Description:	Miscellaneous Survey Abandoned
Distance (ft):	19.9
Structural Grade:	0
O&M Grade:	0
Clock Start/From:	
Clock To:	
1st Value:	
2nd Value:	
Value Percent:	
Continuous Index:	
Within 8" of Joint:	NO
Remarks:	CAMERA CANT MAKE IT PAST MISSING PIPE SECTION
