Profile/Photo Observation Report

Street:	West 39th Avenue	Flow Control:	Not Controlled
City:	Hobart, IN	Year Renewed:	
Location:	Alley	Tape/Media #:	
Purpose:	Routine Assessment	Dia/Height:	10"
Use:	Sanitary Sewage Pipe	Material:	VCP
Drain Area:		Lining:	
Category:	NA		
Comment:

Location Details:		Direction of Survey:	Downstream
US MH:	M-503-017	DS MH:	M-503-019
		Total Length Surveyed (ft):	19.9

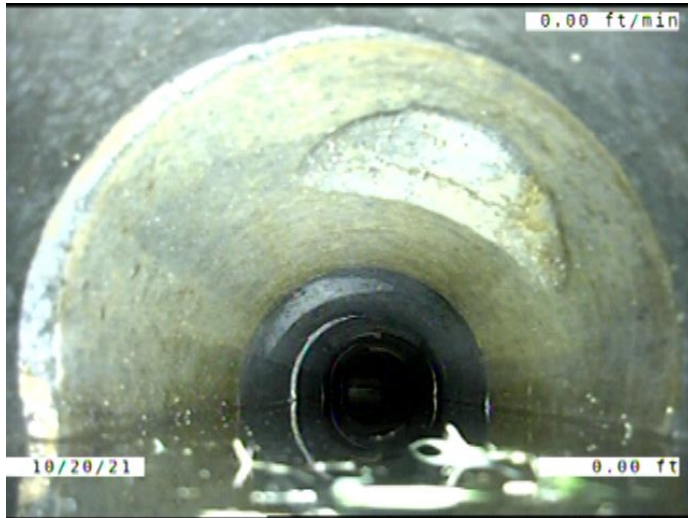
Code: **MWL**
Description: **Miscellaneous Water Level**

Distance (ft): **.0**
Structural Grade: **0**
O&M Grade: **0**
Clock Start/From:
Clock To:
1st Value:
2nd Value:
Value Percent: **15.000**
Continuous Index:
Within 8" of Joint: **NO**
Remarks:

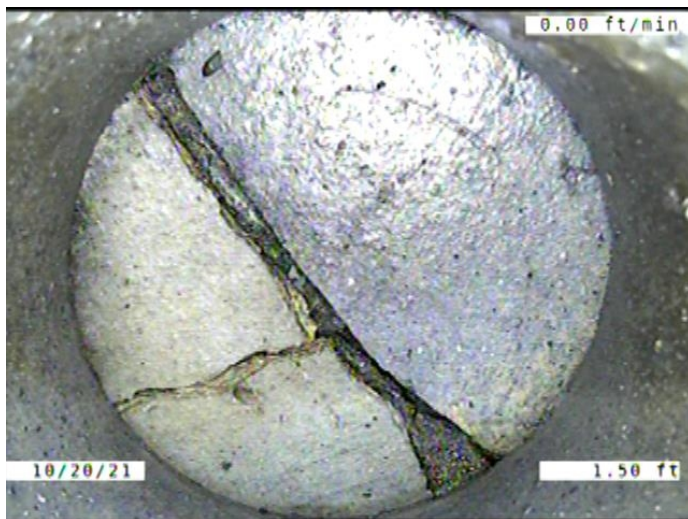
Code: **TFD**
Description: **Tap Factory Defective**

Distance (ft): **1.5**
Structural Grade: **0**
O&M Grade: **3**
Clock Start/From: **1**
Clock To:
1st Value: **4.000**
2nd Value:
Value Percent:
Continuous Index:
Within 8" of Joint: **YES**
Remarks: **CAP BROKEN. SOIL VISIBLE**

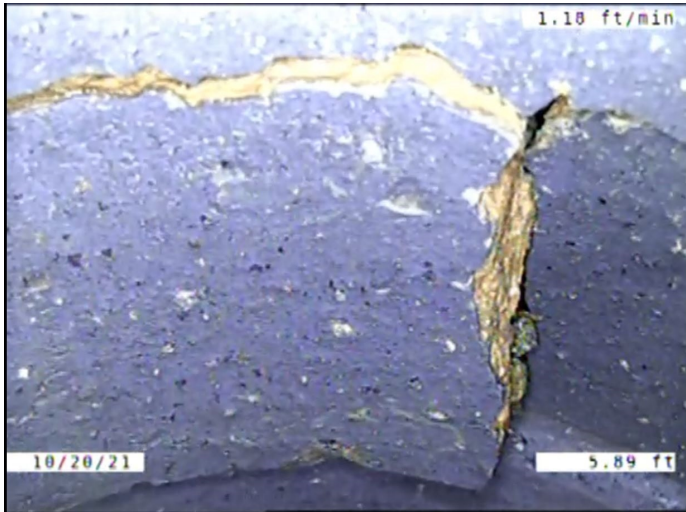
Code: **B**
Description: **Broken**

Distance (ft): **5.9**
Structural Grade: **4**
O&M Grade: **0**
Clock Start/From: **11**
Clock To: **1**
1st Value:
2nd Value:
Value Percent:
Continuous Index:
Within 8" of Joint: **YES**
Remarks:

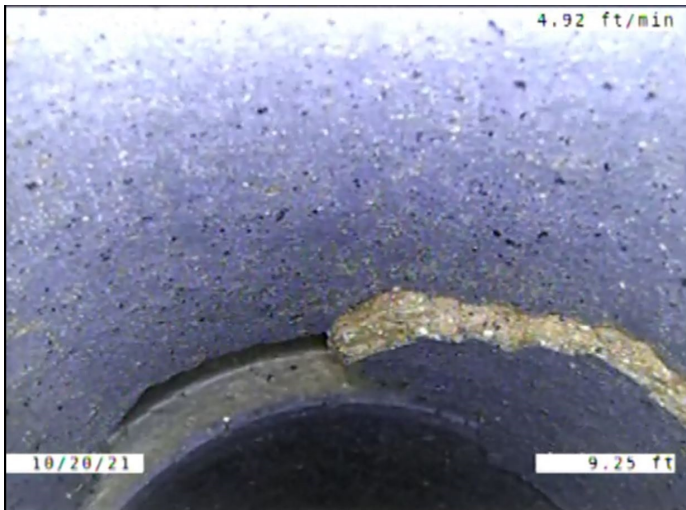
Code: **B**
Description: **Broken**

Distance (ft): **9.3**
Structural Grade: **4**
O&M Grade: **0**
Clock Start/From: **12**
Clock To: **2**
1st Value:
2nd Value:
Value Percent:
Continuous Index:
Within 8" of Joint: **YES**
Remarks:

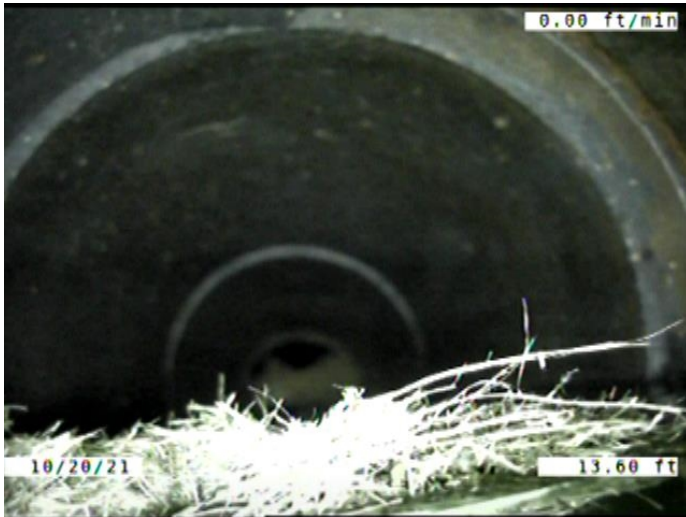
Code: **MGO**
 Description: **Miscellaneous General Observation**

Distance (ft): **13.6**
 Structural Grade: **0**
 O&M Grade: **0**
 Clock Start/From:
 Clock To:
 1st Value:
 2nd Value:
 Value Percent:
 Continuous Index:
 Within 8" of Joint: **NO**
 Remarks: **ROOTS HAVE BEEN CUT OFF BUT DIDNT MAKE IT PAST THE MISSING P**

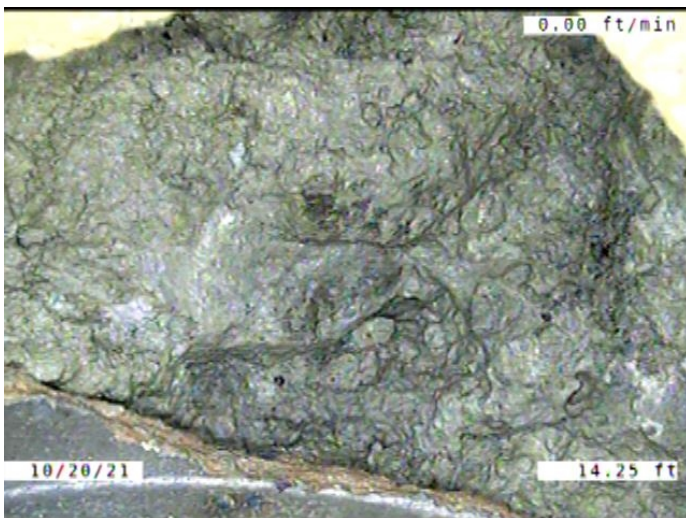
Code: **HSV**
 Description: **Hole Soil Visible**

Distance (ft): **14.2**
 Structural Grade: **5**
 O&M Grade: **0**
 Clock Start/From: **12**
 Clock To: **3**
 1st Value:
 2nd Value:
 Value Percent:
 Continuous Index:
 Within 8" of Joint: **YES**
 Remarks: **SOIL VISIBLE**

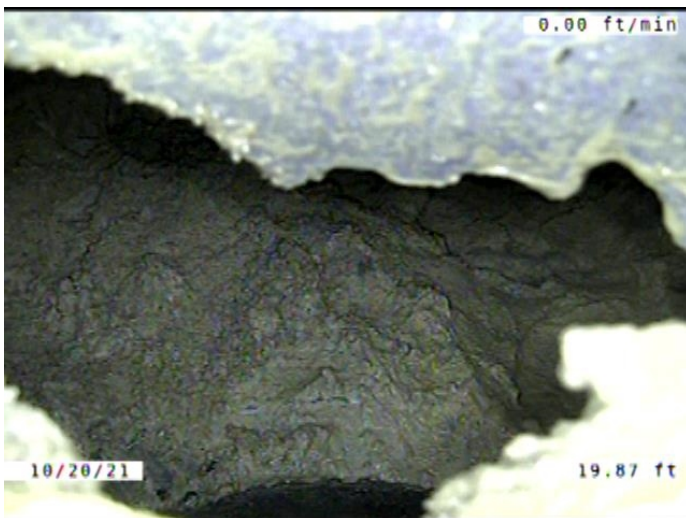
Code: **HVV**
 Description: **Hole Void Visible**

Distance (ft): **19.9**
 Structural Grade: **5**
 O&M Grade: **0**
 Clock Start/From: **8**
 Clock To: **4**
 1st Value:
 2nd Value:
 Value Percent:
 Continuous Index:
 Within 8" of Joint: **YES**
 Remarks:
