Profile/Photo Observation Report

Date:	10/20/2021	Weather:		Coding:	PACP 7.0
Pipe Length (ft):	161.5	Owner:	City of Hobart	Pre Clean:	Heavy Cleaning
P.O.#:	YES502259	Surveyor:	S. Bucklin	PSR:	P-503-019-017
Customer:	City of Hobart	Clean Date:	09/05/2021	Shape:	C

Street:	West 39th Avenue	Flow Control:	Not Controlled
City:	Hobart, IN	Year Renewed:	
Location:	Alley	Tape/Media #:	
Purpose:	Routine Assessment	Dia/Height:	10"
Use:	Sanitary Sewage Pipe	Material:	VCP
Drain Area:		Lining:	
Category:	NA		
Comment:			
Location Details:		Direction of Survey:	Upstream
US MH:	M-503-017	DS MH:	M-503-019
		Total Length Surveyed (ft):	161.5

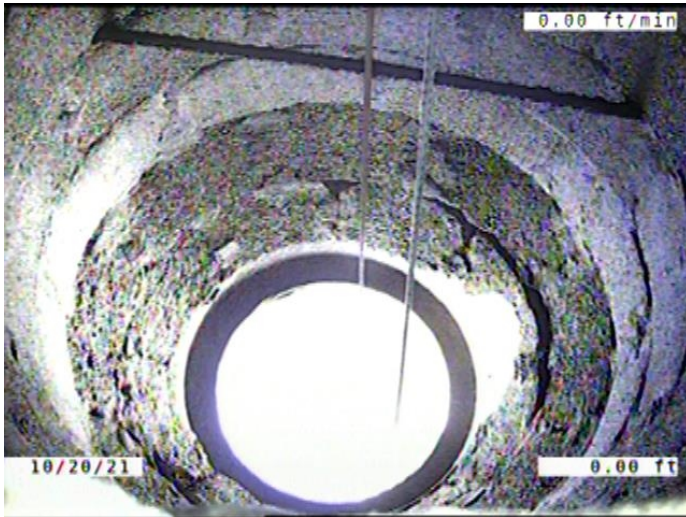
Code: **AMH**
Description: **Manhole**

Distance (ft): **.0**
Structural Grade: **0**
O&M Grade: **0**
Clock Start/From:
Clock To:
1st Value:
2nd Value:
Value Percent:
Continuous Index:
Within 8" of Joint: **NO**
Remarks: **M-503-019**

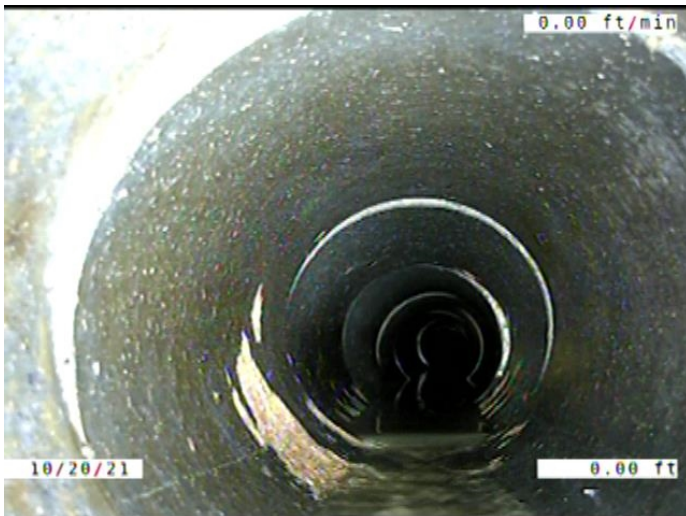
Code: **MWL**
Description: **Miscellaneous Water Level**

Distance (ft): **.0**
Structural Grade: **0**
O&M Grade: **0**
Clock Start/From:
Clock To:
1st Value:
2nd Value:
Value Percent: **5.000**
Continuous Index:
Within 8" of Joint: **NO**
Remarks:

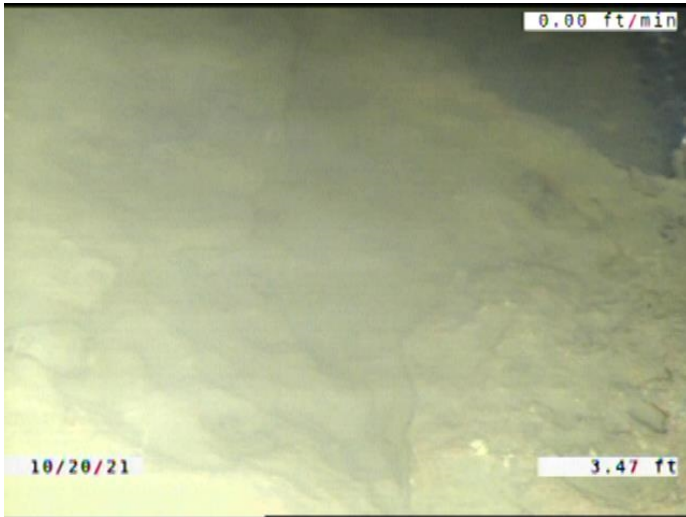
Code: **BSV**
Description: **Broken Soil Visible**

Distance (ft): **3.5**
Structural Grade: **5**
O&M Grade: **0**
Clock Start/From: **12**
Clock To: **5**
1st Value:
2nd Value:
Value Percent:
Continuous Index:
Within 8" of Joint: **YES**
Remarks:

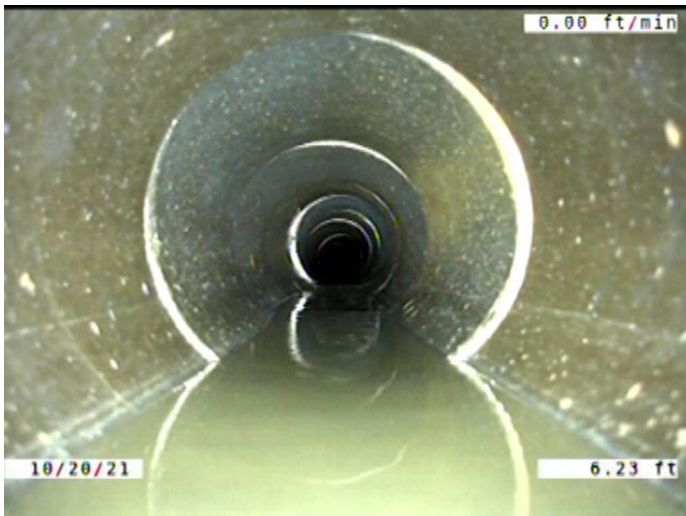
Code: **SSS**
Description: **Surface Damage Surface Spalling**

Distance (ft): **6.2**
Structural Grade: **2**
O&M Grade: **0**
Clock Start/From: **12**
Clock To: **12**
1st Value:
2nd Value:
Value Percent:
Continuous Index: **F01**
Within 8" of Joint: **YES**
Remarks:

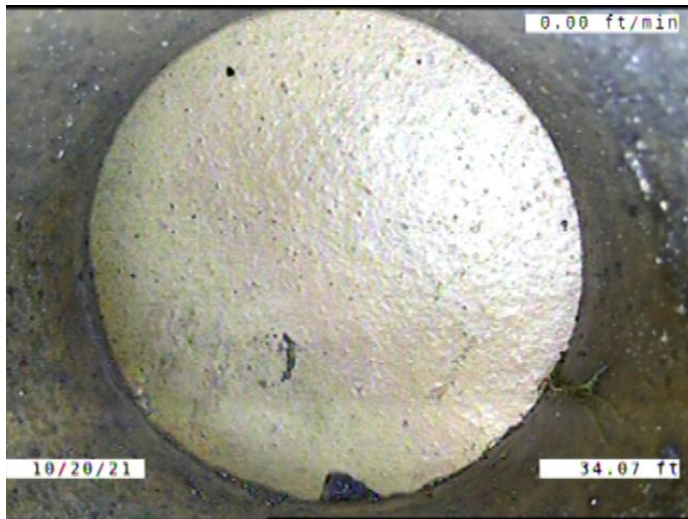
Code: **TFC**
Description: **Tap Factory Capped**

Distance (ft): **34.1**
Structural Grade: **0**
O&M Grade: **0**
Clock Start/From: **1**
Clock To:
1st Value: **4.000**
2nd Value:
Value Percent:
Continuous Index:
Within 8" of Joint: **YES**
Remarks: **ROOTS GROWING AROUND THE CAP**

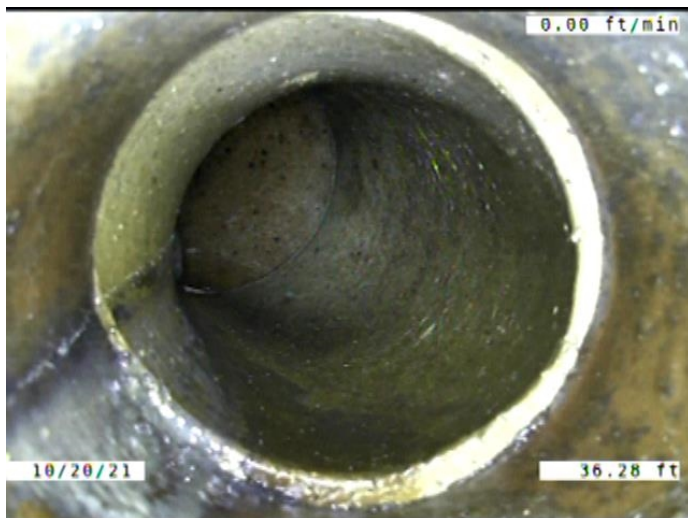
Code: **TF**
Description: **Tap Factory**

Distance (ft): **36.3**
Structural Grade: **0**
O&M Grade: **0**
Clock Start/From: **11**
Clock To:
1st Value: **4.000**
2nd Value:
Value Percent:
Continuous Index:
Within 8" of Joint: **YES**
Remarks: **CONSTANTLY RUNNING WATER**

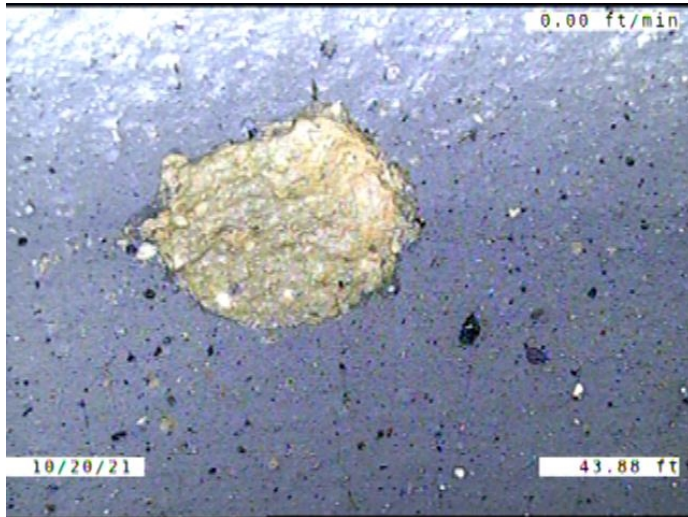
Code:	SSS
Description:	Surface Damage Surface Spalling
Distance (ft):	43.9
Structural Grade:	2
O&M Grade:	0
Clock Start/From:	11
Clock To:	
1st Value:	
2nd Value:	
Value Percent:	
Continuous Index:	
Within 8" of Joint:	YES
Remarks:

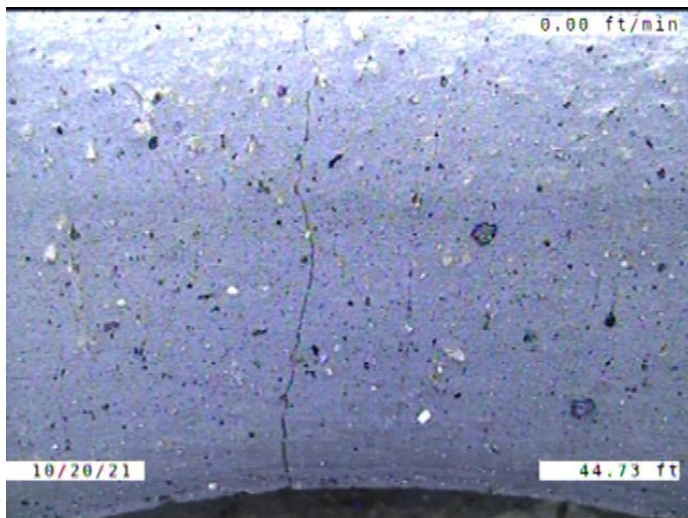
Code:	CM
Description:	Crack Multiple
Distance (ft):	44.7
Structural Grade:	3
O&M Grade:	0
Clock Start/From:	11
Clock To:	12
1st Value:	
2nd Value:	
Value Percent:	
Continuous Index:	
Within 8" of Joint:	YES
Remarks:

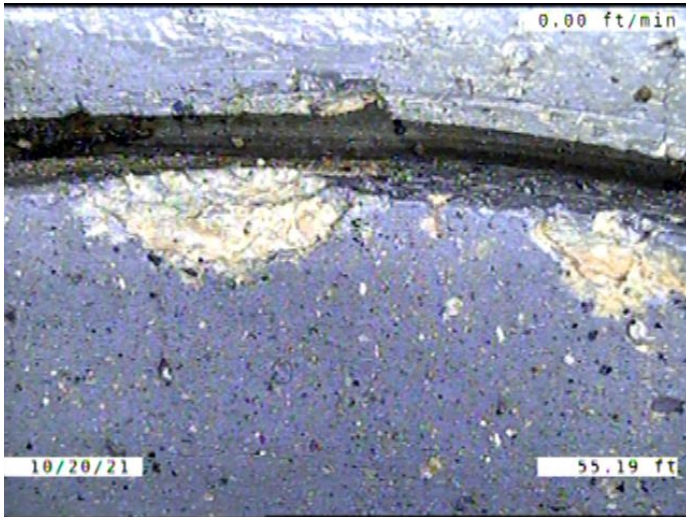
Code: **SSS**
 Description: **Surface Damage Surface Spalling**

Distance (ft): **55.2**
 Structural Grade: **2**
 O&M Grade: **0**
 Clock Start/From: **1**
 Clock To: **2**
 1st Value:
 2nd Value:
 Value Percent:
 Continuous Index:
 Within 8" of Joint: **YES**
 Remarks:

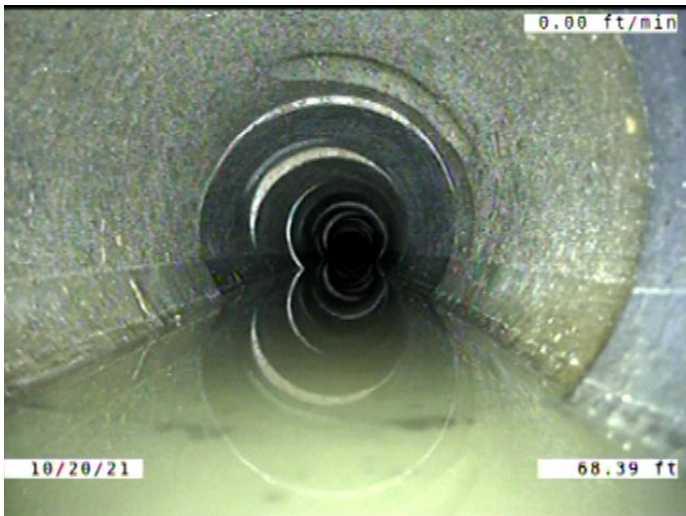
Code: **MWLS**
 Description: **Miscellaneous Water Level Sag**

Distance (ft): **68.4**
 Structural Grade: **2**
 O&M Grade: **0**
 Clock Start/From:
 Clock To:
 1st Value:
 2nd Value:
 Value Percent: **10.000**
 Continuous Index: **S03**
 Within 8" of Joint: **NO**
 Remarks:

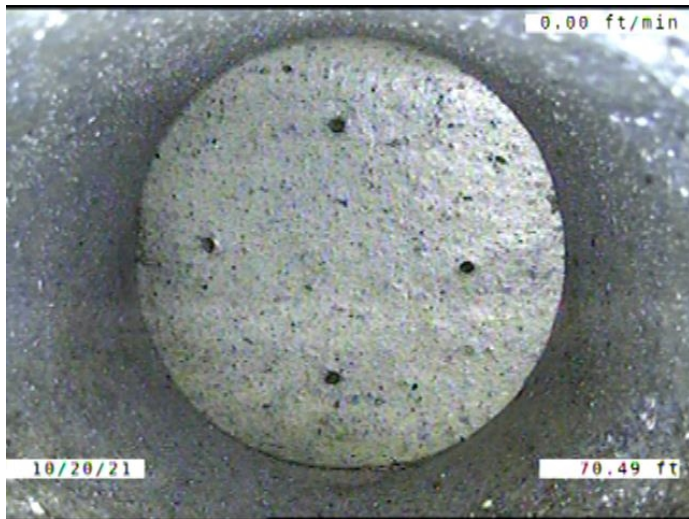
Code: **TFC**
Description: **Tap Factory Capped**

Distance (ft): **70.5**
Structural Grade: **0**
O&M Grade: **0**
Clock Start/From: **1**
Clock To:
1st Value: **4.000**
2nd Value:
Value Percent:
Continuous Index:
Within 8" of Joint: **YES**
Remarks:

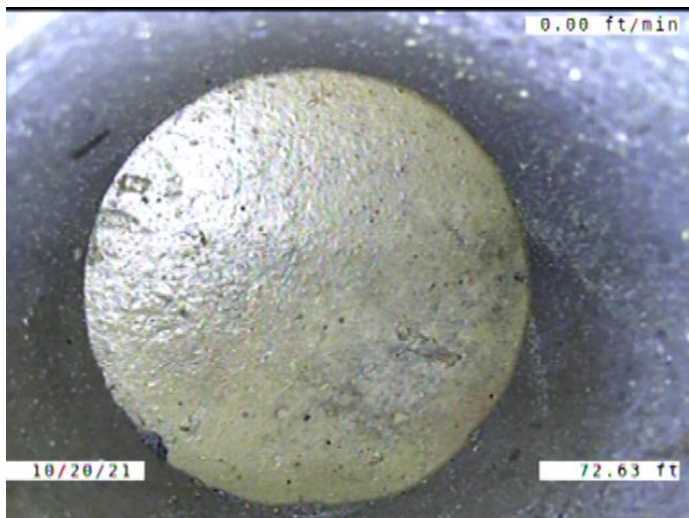
Code: **TFC**
Description: **Tap Factory Capped**

Distance (ft): **72.6**
Structural Grade: **0**
O&M Grade: **0**
Clock Start/From: **11**
Clock To:
1st Value: **4.000**
2nd Value:
Value Percent:
Continuous Index:
Within 8" of Joint: **YES**
Remarks:

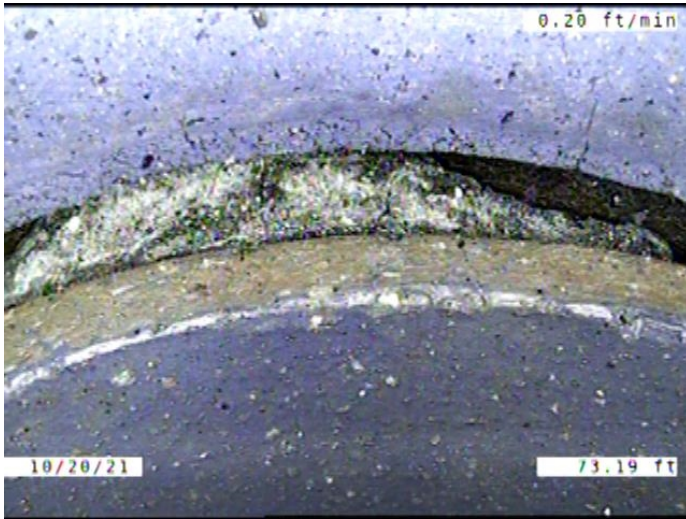
Code: **JOM**
 Description: **Joint Offset Medium**

Distance (ft): **73.2**
 Structural Grade: **3**
 O&M Grade: **0**
 Clock Start/From:
 Clock To:
 1st Value:
 2nd Value:
 Value Percent:
 Continuous Index:
 Within 8" of Joint: **NO**
 Remarks:

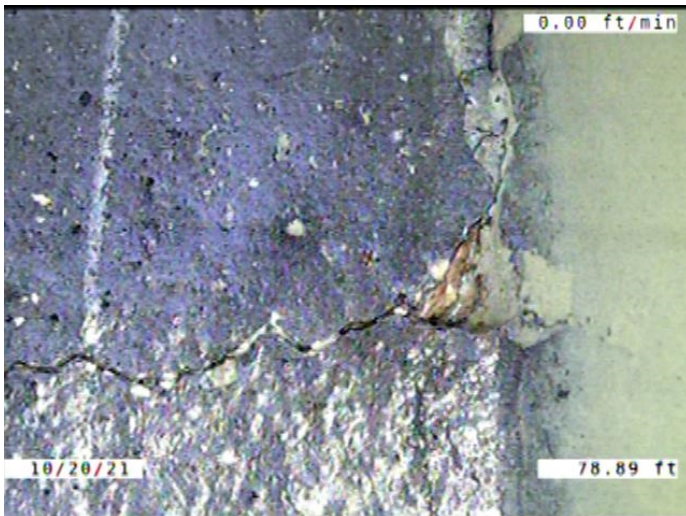
Code: **B**
 Description: **Broken**

Distance (ft): **78.9**
 Structural Grade: **4**
 O&M Grade: **0**
 Clock Start/From: **1**
 Clock To: **10**
 1st Value:
 2nd Value:
 Value Percent:
 Continuous Index:
 Within 8" of Joint: **YES**
 Remarks:

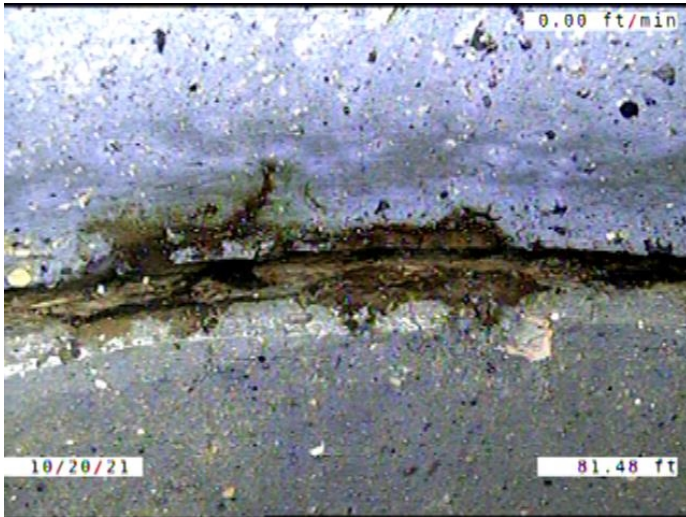
Code: **ISJ**
 Description: **Infiltration Stain Joint**

Distance (ft): **81.5**
 Structural Grade: **0**
 O&M Grade: **1**
 Clock Start/From: **8**
 Clock To: **11**
 1st Value:
 2nd Value:
 Value Percent:
 Continuous Index:
 Within 8" of Joint: **YES**
 Remarks:

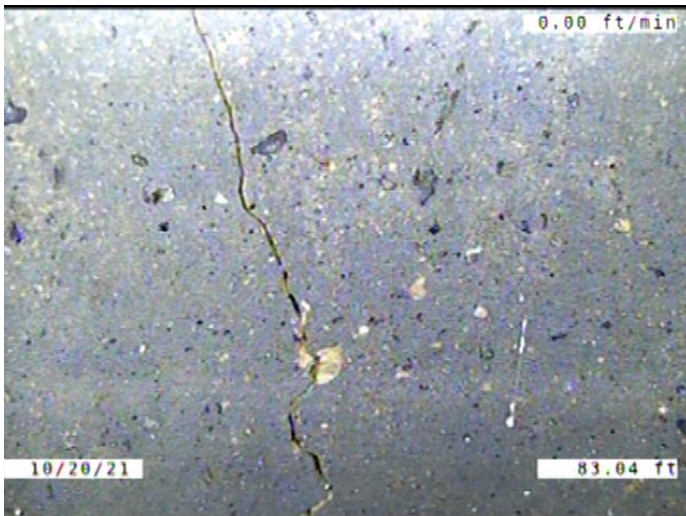
Code: **FM**
 Description: **Fracture Multiple**

Distance (ft): **83.0**
 Structural Grade: **4**
 O&M Grade: **0**
 Clock Start/From: **11**
 Clock To: **12**
 1st Value:
 2nd Value:
 Value Percent:
 Continuous Index:
 Within 8" of Joint: **YES**
 Remarks:

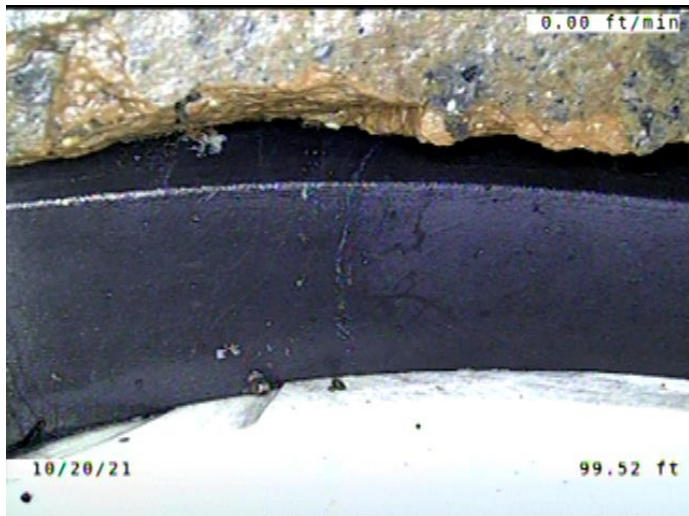
Code: **MMC**
 Description: **Miscellaneous Material Change**

Distance (ft): **99.5**
 Structural Grade: **0**
 O&M Grade: **0**
 Clock Start/From:
 Clock To:
 1st Value:
 2nd Value:
 Value Percent:
 Continuous Index:
 Within 8" of Joint: **NO**
 Remarks: **VCP TO PVC**

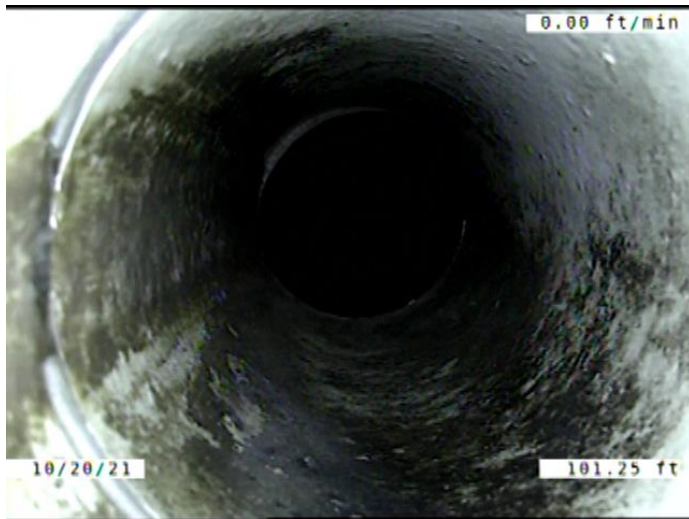
Code: **TF**
Description: **Tap Factory**

Distance (ft): **101.3**
Structural Grade: **0**
O&M Grade: **0**
Clock Start/From: **10**
Clock To:
1st Value: **4.000**
2nd Value:
Value Percent:
Continuous Index:
Within 8" of Joint: **YES**
Remarks:

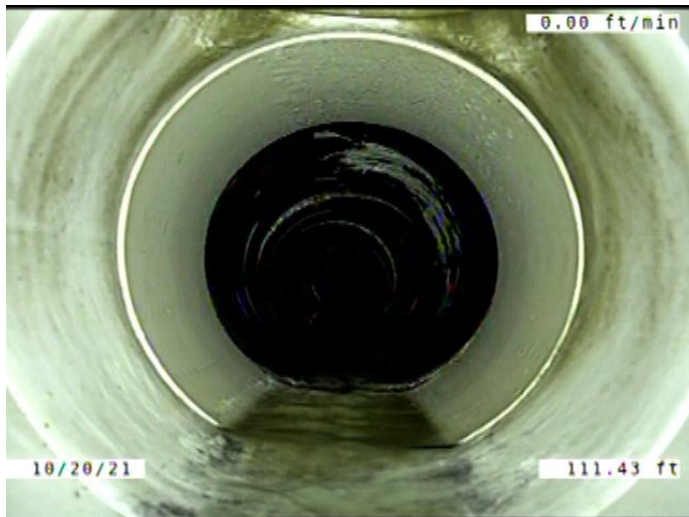
Code: **MWLS**
Description: **Miscellaneous Water Level Sag**

Distance (ft): **111.4**
Structural Grade: **2**
O&M Grade: **0**
Clock Start/From:
Clock To:
1st Value:
2nd Value:
Value Percent: **10.000**
Continuous Index: **F03**
Within 8" of Joint: **NO**
Remarks:

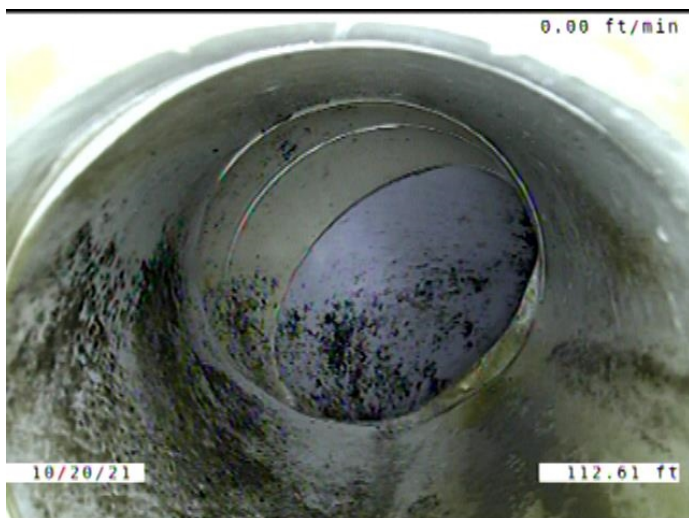
Code: **TF**
Description: **Tap Factory**

Distance (ft): **112.6**
Structural Grade: **0**
O&M Grade: **0**
Clock Start/From: **12**
Clock To:
1st Value: **4.000**
2nd Value:
Value Percent:
Continuous Index:
Within 8" of Joint: **YES**
Remarks: **CONSTANTLY DRIPPING WATER**

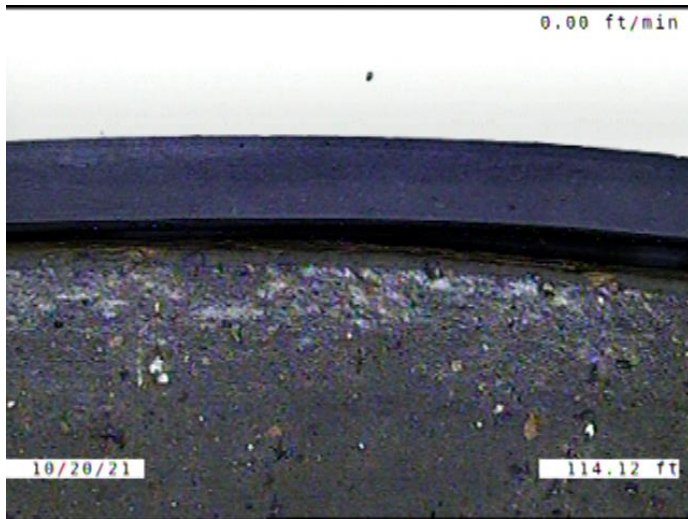
Code: **MMC**
Description: **Miscellaneous Material Change**

Distance (ft): **114.1**
Structural Grade: **0**
O&M Grade: **0**
Clock Start/From:
Clock To:
1st Value:
2nd Value:
Value Percent:
Continuous Index:
Within 8" of Joint: **NO**
Remarks: **PVC TO VCP**

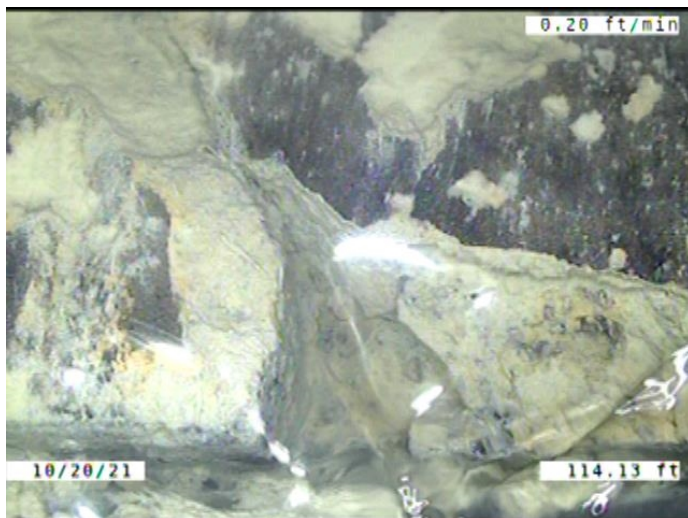
Code: **FM**
Description: **Fracture Multiple**

Distance (ft): **114.1**
Structural Grade: **4**
O&M Grade: **0**
Clock Start/From: **12**
Clock To: **12**
1st Value:
2nd Value:
Value Percent:
Continuous Index: **S05**
Within 8" of Joint: **YES**
Remarks:

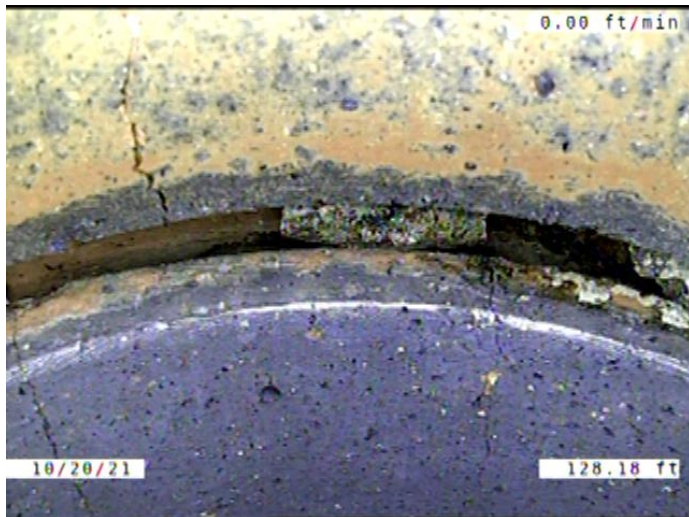
Code: **JOM**
 Description: **Joint Offset Medium**

Distance (ft): **128.2**
 Structural Grade: **3**
 O&M Grade: **0**
 Clock Start/From:
 Clock To:
 1st Value:
 2nd Value:
 Value Percent:
 Continuous Index:
 Within 8" of Joint: **NO**
 Remarks:

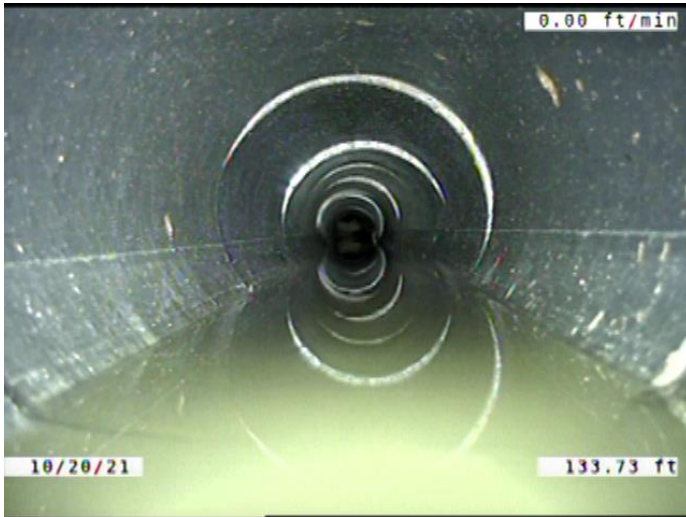
Code: **DAE**
 Description: **Deposits Attached Encrustation**

Distance (ft): **133.7**
 Structural Grade: **0**
 O&M Grade: **2**
 Clock Start/From: **3**
 Clock To: **5**
 1st Value:
 2nd Value:
 Value Percent: **5.000**
 Continuous Index: **F06**
 Within 8" of Joint: **YES**
 Remarks:

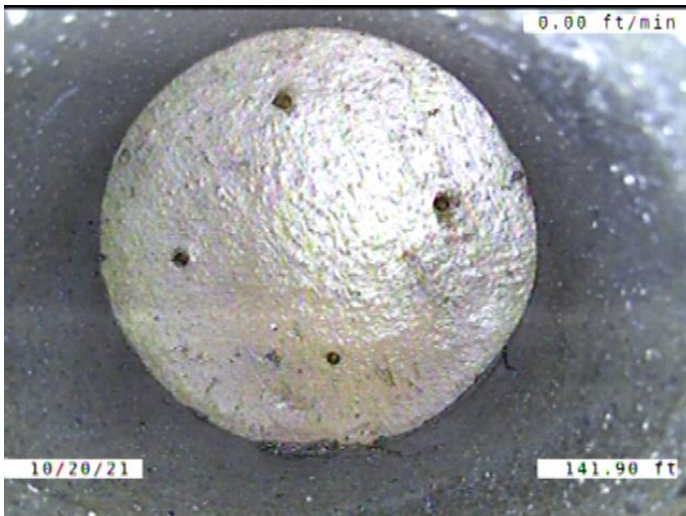
Code: **TFC**
 Description: **Tap Factory Capped**

Distance (ft): **141.9**
 Structural Grade: **0**
 O&M Grade: **0**
 Clock Start/From: **1**
 Clock To:
 1st Value: **4.000**
 2nd Value:
 Value Percent:
 Continuous Index:
 Within 8" of Joint: **YES**
 Remarks:

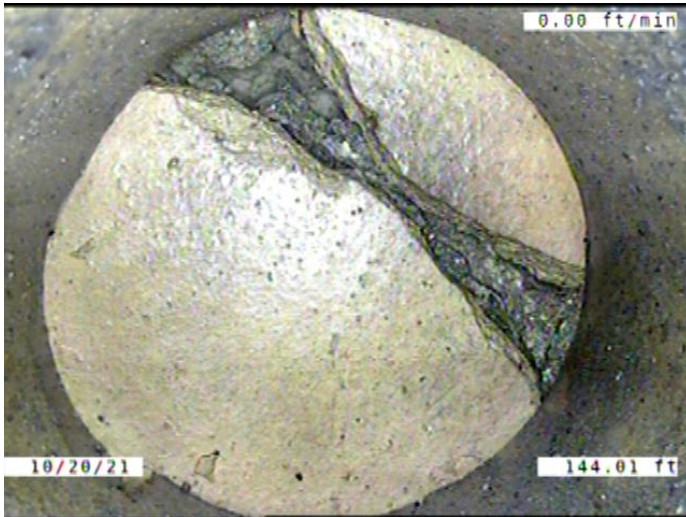
Code: **TFD**
 Description: **Tap Factory Defective**

Distance (ft): **144.0**
 Structural Grade: **0**
 O&M Grade: **3**
 Clock Start/From: **11**
 Clock To:
 1st Value: **4.000**
 2nd Value:
 Value Percent:
 Continuous Index:
 Within 8" of Joint: **YES**
 Remarks: **CAP BROKEN. SOIL VISIBLE**

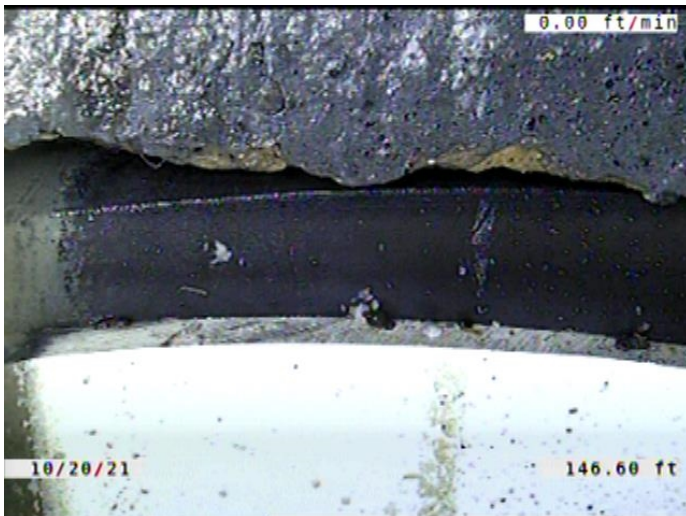
Code: **MMC**
 Description: **Miscellaneous Material Change**

Distance (ft): **146.6**
 Structural Grade: **0**
 O&M Grade: **0**
 Clock Start/From:
 Clock To:
 1st Value:
 2nd Value:
 Value Percent:
 Continuous Index:
 Within 8" of Joint: **NO**
 Remarks: **VCP TO PVC**

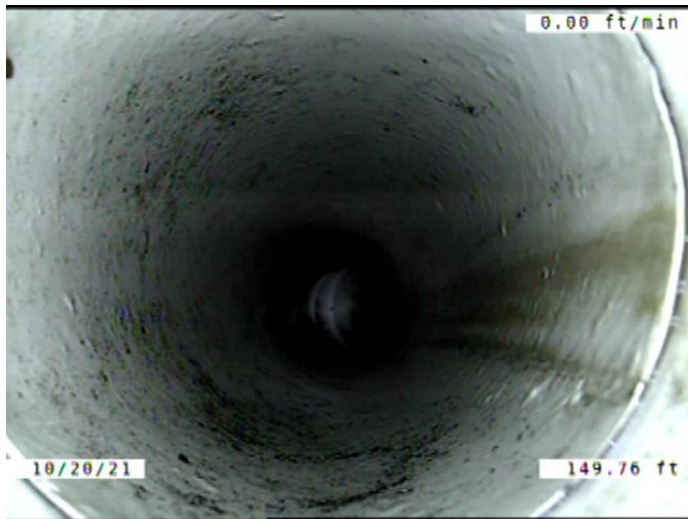
Code: **TF**
Description: **Tap Factory**

Distance (ft): **149.8**
Structural Grade: **0**
O&M Grade: **0**
Clock Start/From: **1**
Clock To:
1st Value: **4.000**
2nd Value:
Value Percent:
Continuous Index:
Within 8" of Joint: **YES**
Remarks:

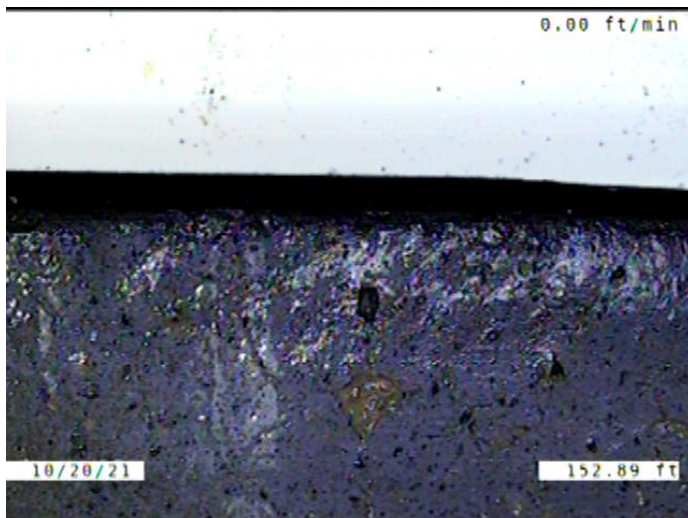
Code: **MMC**
Description: **Miscellaneous Material Change**

Distance (ft): **152.9**
Structural Grade: **0**
O&M Grade: **0**
Clock Start/From:
Clock To:
1st Value:
2nd Value:
Value Percent:
Continuous Index:
Within 8" of Joint: **NO**
Remarks: **PVC TO VCP**

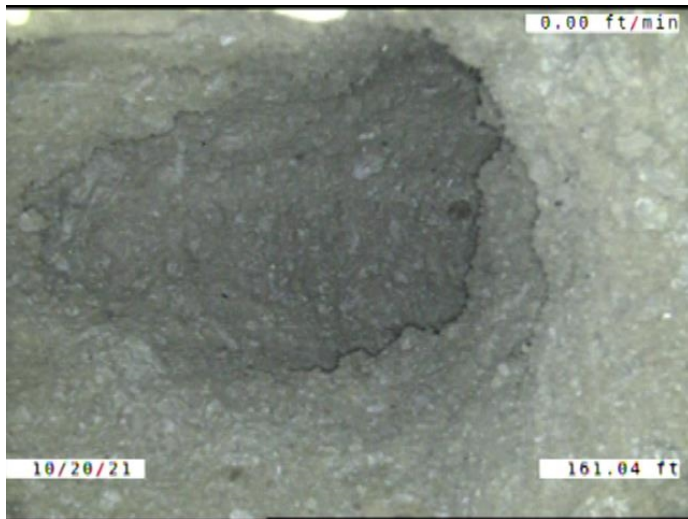
Code:	SMW
Description:	Surface Damage Missing Wall
Distance (ft):	161.0
Structural Grade:	5
O&M Grade:	0
Clock Start/From:	8
Clock To:	4
1st Value:	
2nd Value:	
Value Percent:	
Continuous Index:	
Within 8" of Joint:	YES
Remarks:	SOIL AND VOID VISIBLE

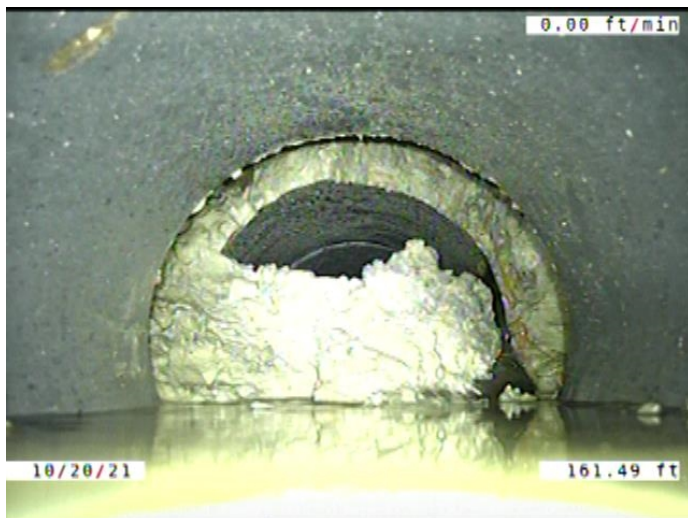
Code:	DSF
Description:	Deposits Settled Fine
Distance (ft):	161.5
Structural Grade:	0
O&M Grade:	5
Clock Start/From:	2
Clock To:	10
1st Value:	
2nd Value:	
Value Percent:	75.000
Continuous Index:	
Within 8" of Joint:	YES
Remarks:
