Profile/Photo Observation Report

Date:	10/20/2021	Weather:		Coding:	PACP 7.0
Pipe Length (ft):	161.5	Owner:	City of Hobart	Pre Clean:	Heavy Cleaning
P.O.#:	YES502259	Surveyor:	S. Bucklin	PSR:	P-503-019-017
Customer:	City of Hobart	Clean Date:	09/05/2021	Shape:	C

Street:	West 39th Avenue	Flow Control:	Not Controlled
City:	Hobart, IN	Year Renewed:	
Location:	Alley	Tape/Media #:	
Purpose:	Routine Assessment	Dia/Height:	10"
Use:	Sanitary Sewage Pipe	Material:	VCP
Drain Area:		Lining:	
Category:	NA		
Comment:			
Location Details:		Direction of Survey:	Upstream
US MH:	M-503-017	DS MH:	M-503-019
		Total Length Surveyed (ft):	161.5

O&M Index:	2.38	O&M Quick:	5131	O&M Rating:	19.00
Structural Index:	2.63	Structural Quick:	534A	Structural Rating:	163.00
Overall Index:	2.60	Overall Quick:	544A	Overall Rating:	182.00

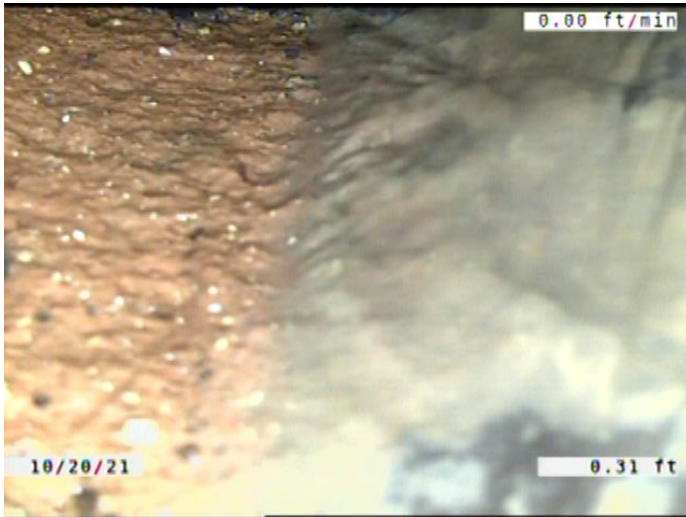
Code: **SSS**
 Description: **Surface Damage Surface Spalling**

Distance (ft): **.3**
 Structural Grade: **2**
 O&M Grade: **0**
 Clock Start/From: **12**
 Clock To: **12**
 1st Value:
 2nd Value:
 Value Percent:
 Continuous Index: **S01**
 Within 8" of Joint: **YES**
 Remarks:

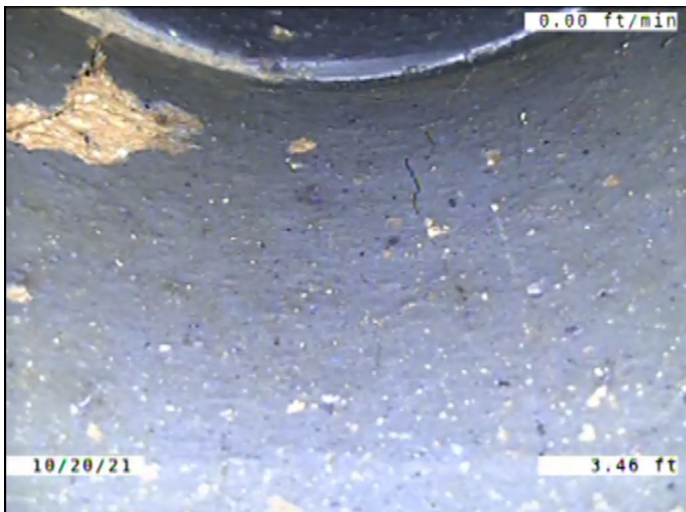
Code: **CL**
 Description: **Crack Longitudinal**

Distance (ft): **3.5**
 Structural Grade: **2**
 O&M Grade: **0**
 Clock Start/From: **12**
 Clock To:
 1st Value:
 2nd Value:
 Value Percent:
 Continuous Index:
 Within 8" of Joint: **YES**
 Remarks:

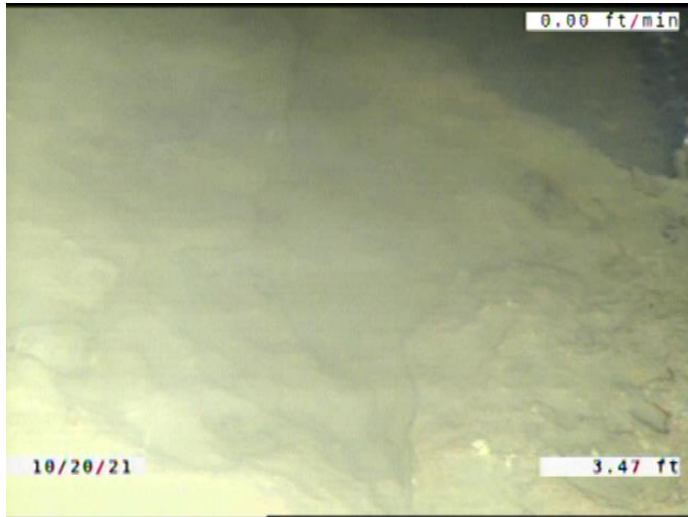
Code: **BSV**
 Description: **Broken Soil Visible**

Distance (ft): **3.5**
 Structural Grade: **5**
 O&M Grade: **0**
 Clock Start/From: **12**
 Clock To: **5**
 1st Value:
 2nd Value:
 Value Percent:
 Continuous Index:
 Within 8" of Joint: **YES**
 Remarks:

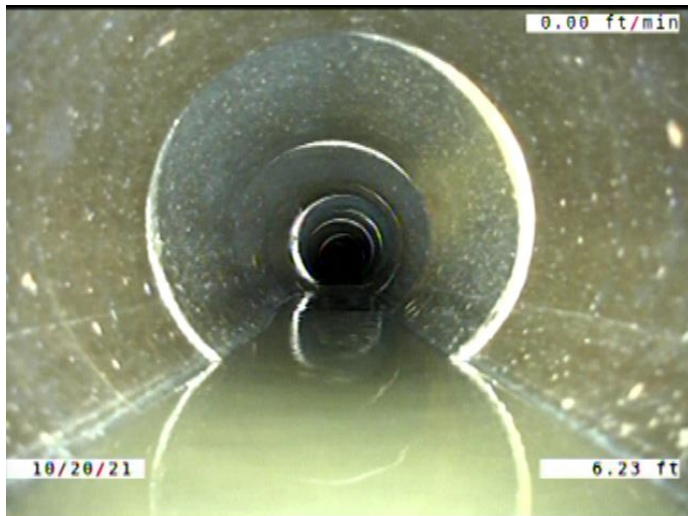
Code: **SSS**
 Description: **Surface Damage Surface Spalling**

Distance (ft): **6.2**
 Structural Grade: **2**
 O&M Grade: **0**
 Clock Start/From: **12**
 Clock To: **12**
 1st Value:
 2nd Value:
 Value Percent:
 Continuous Index: **F01**
 Within 8" of Joint: **YES**
 Remarks:

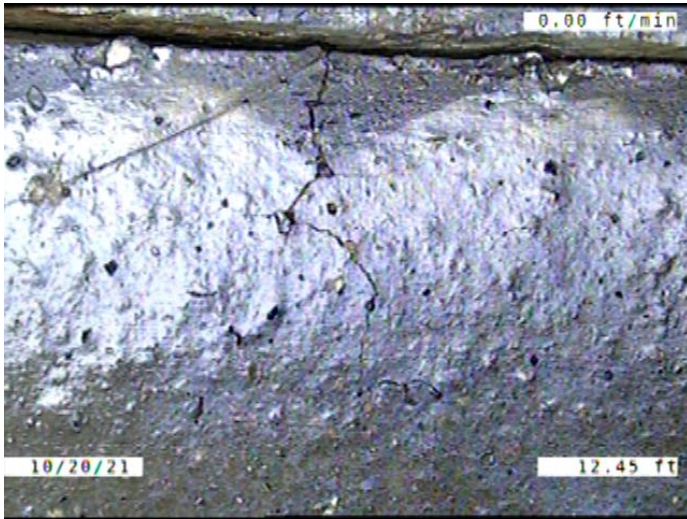
Code: **CM**
 Description: **Crack Multiple**

Distance (ft): **12.4**
 Structural Grade: **3**
 O&M Grade: **0**
 Clock Start/From: **1**
 Clock To: **3**
 1st Value:
 2nd Value:
 Value Percent:
 Continuous Index:
 Within 8" of Joint: **YES**
 Remarks:

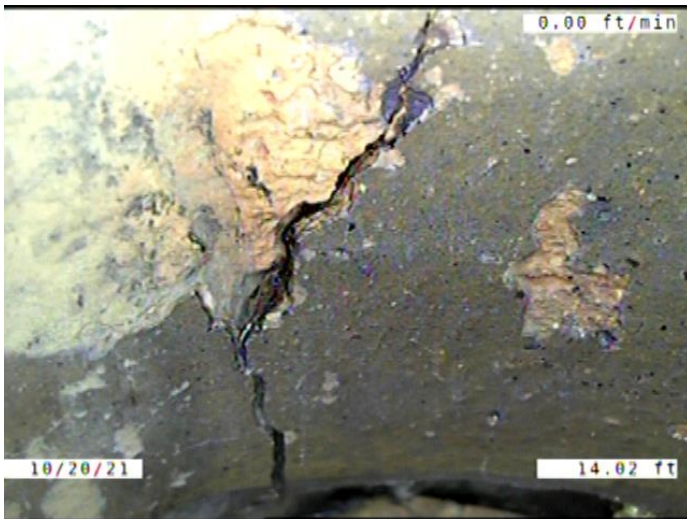
Code: **FM**
 Description: **Fracture Multiple**

Distance (ft): **14.0**
 Structural Grade: **4**
 O&M Grade: **0**
 Clock Start/From: **7**
 Clock To: **3**
 1st Value:
 2nd Value:
 Value Percent:
 Continuous Index:
 Within 8" of Joint: **YES**
 Remarks:

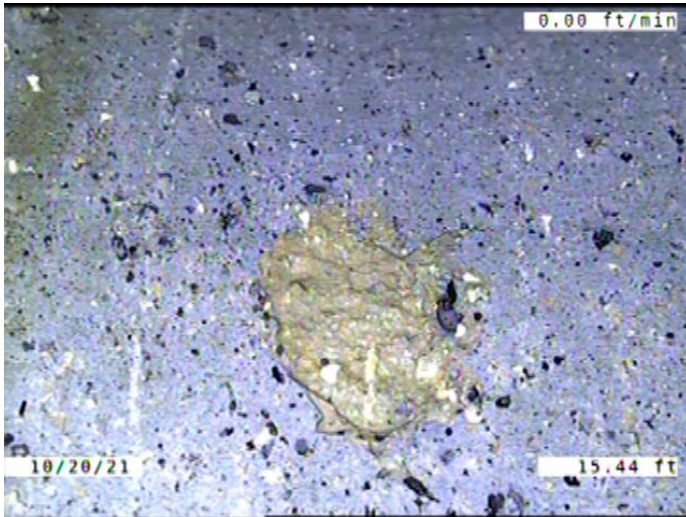
Code: **SSS**
 Description: **Surface Damage Surface Spalling**

Distance (ft): **15.4**
 Structural Grade: **2**
 O&M Grade: **0**
 Clock Start/From: **3**
 Clock To: **9**
 1st Value:
 2nd Value:
 Value Percent:
 Continuous Index: **S02**
 Within 8" of Joint: **YES**
 Remarks:

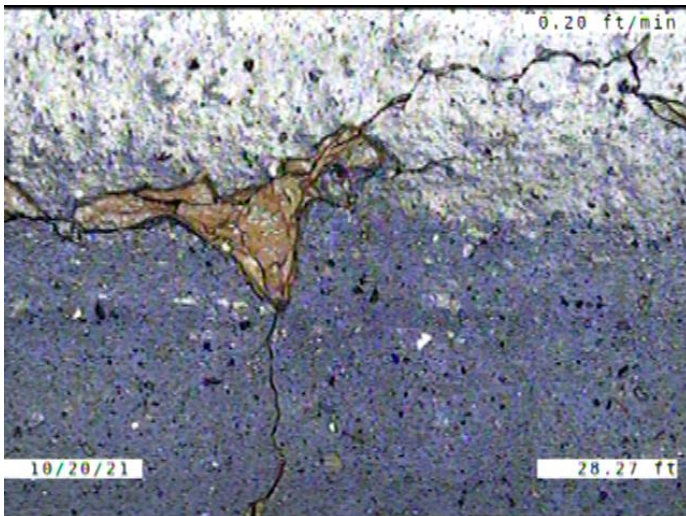
Code: **FM**
 Description: **Fracture Multiple**

Distance (ft): **28.3**
 Structural Grade: **4**
 O&M Grade: **0**
 Clock Start/From: **11**
 Clock To: **3**
 1st Value:
 2nd Value:
 Value Percent:
 Continuous Index:
 Within 8" of Joint: **YES**
 Remarks:

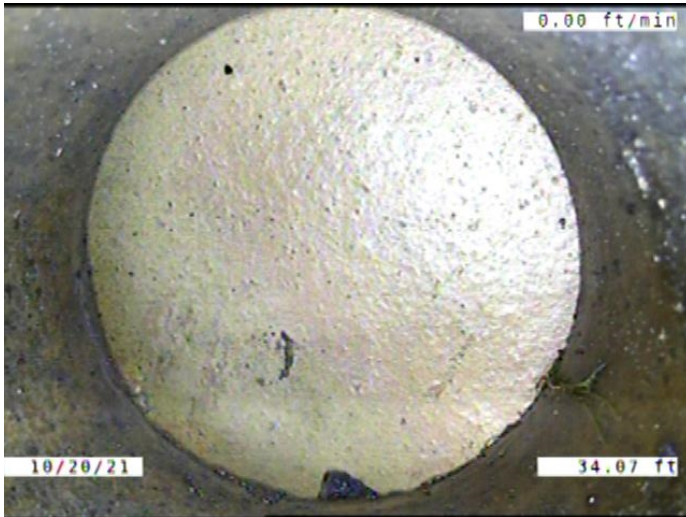
Code:	TFC
Description:	Tap Factory Capped
Distance (ft):	34.1
Structural Grade:	0
O&M Grade:	0
Clock Start/From:	1
Clock To:	
1st Value:	4.000
2nd Value:	
Value Percent:	
Continuous Index:	
Within 8" of Joint:	YES
Remarks:	ROOTS GROWING AROUND THE CAP

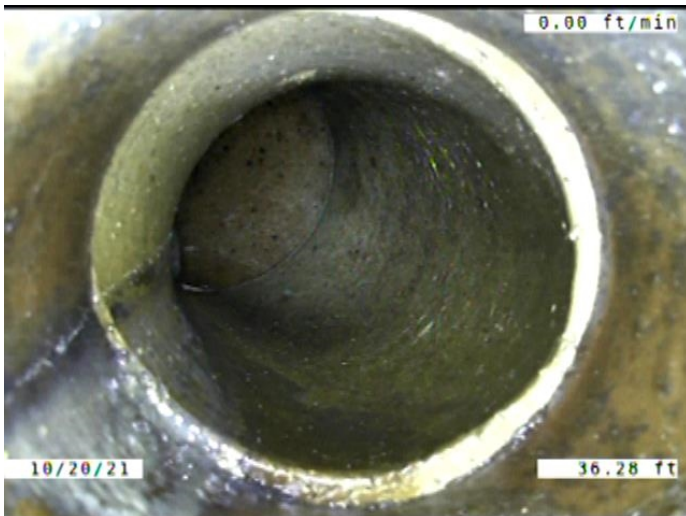
Code:	TF
Description:	Tap Factory
Distance (ft):	36.3
Structural Grade:	0
O&M Grade:	0
Clock Start/From:	11
Clock To:	
1st Value:	4.000
2nd Value:	
Value Percent:	
Continuous Index:	
Within 8" of Joint:	YES
Remarks:	CONSTANTLY RUNNING WATER

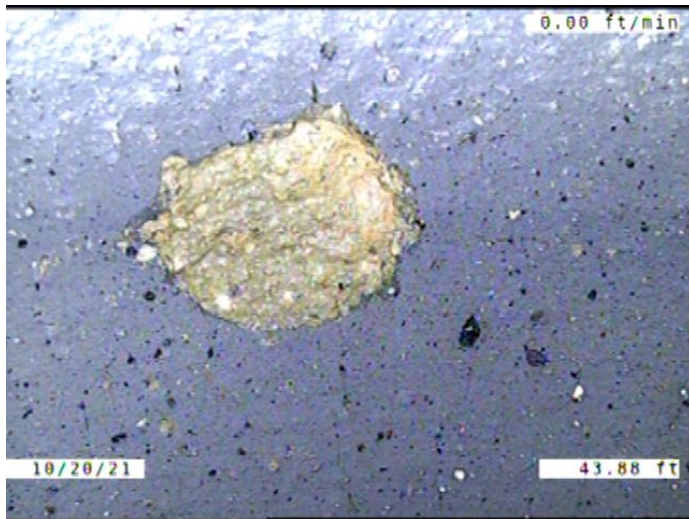
Code:	SSS
Description:	Surface Damage Surface Spalling
Distance (ft):	43.9
Structural Grade:	2
O&M Grade:	0
Clock Start/From:	11
Clock To:	
1st Value:	
2nd Value:	
Value Percent:	
Continuous Index:	
Within 8" of Joint:	YES
Remarks:

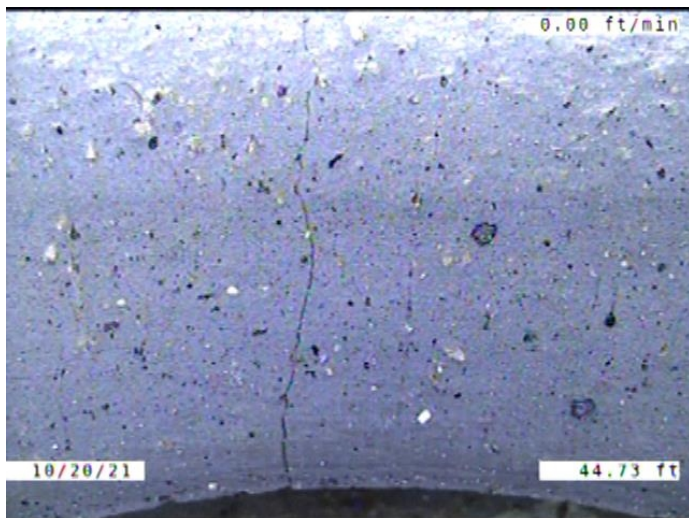
Code:	CM
Description:	Crack Multiple
Distance (ft):	44.7
Structural Grade:	3
O&M Grade:	0
Clock Start/From:	11
Clock To:	12
1st Value:	
2nd Value:	
Value Percent:	
Continuous Index:	
Within 8" of Joint:	YES
Remarks:

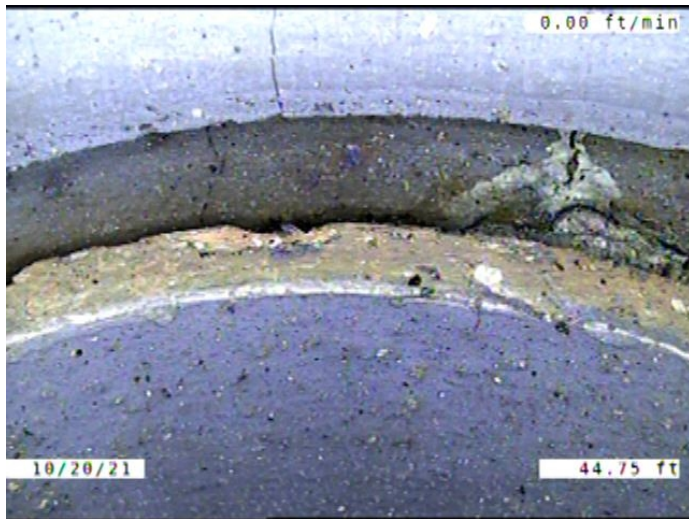
Code: **JAM**
 Description: **Joint Angular Medium**

Distance (ft): **44.8**
 Structural Grade: **3**
 O&M Grade: **0**
 Clock Start/From:
 Clock To:
 1st Value:
 2nd Value:
 Value Percent:
 Continuous Index:
 Within 8" of Joint: **NO**
 Remarks:

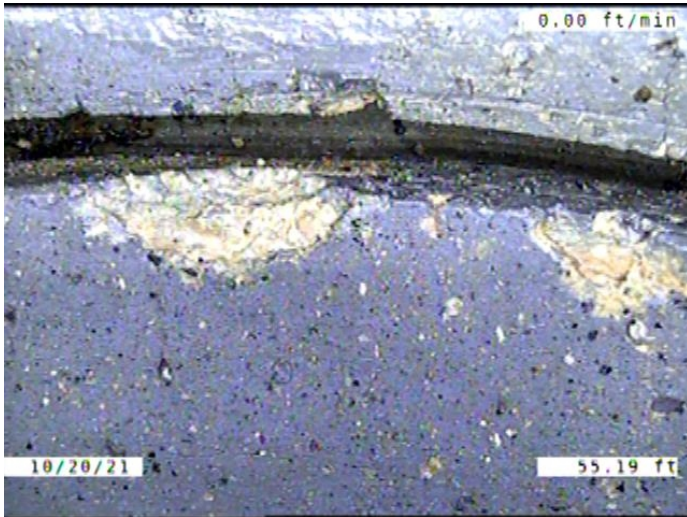
Code: **SSS**
 Description: **Surface Damage Surface Spalling**

Distance (ft): **55.2**
 Structural Grade: **2**
 O&M Grade: **0**
 Clock Start/From: **1**
 Clock To: **2**
 1st Value:
 2nd Value:
 Value Percent:
 Continuous Index:
 Within 8" of Joint: **YES**
 Remarks:

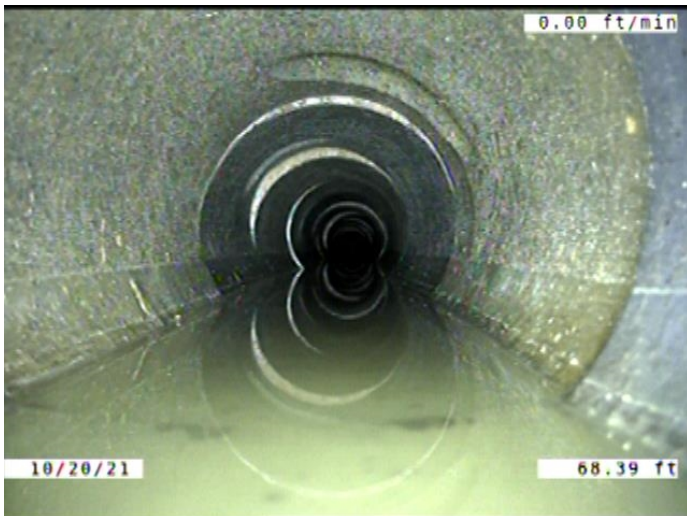
Code: **MWLS**
 Description: **Miscellaneous Water Level Sag**

Distance (ft): **68.4**
 Structural Grade: **2**
 O&M Grade: **0**
 Clock Start/From:
 Clock To:
 1st Value:
 2nd Value:
 Value Percent: **10.000**
 Continuous Index: **S03**
 Within 8" of Joint: **NO**
 Remarks:

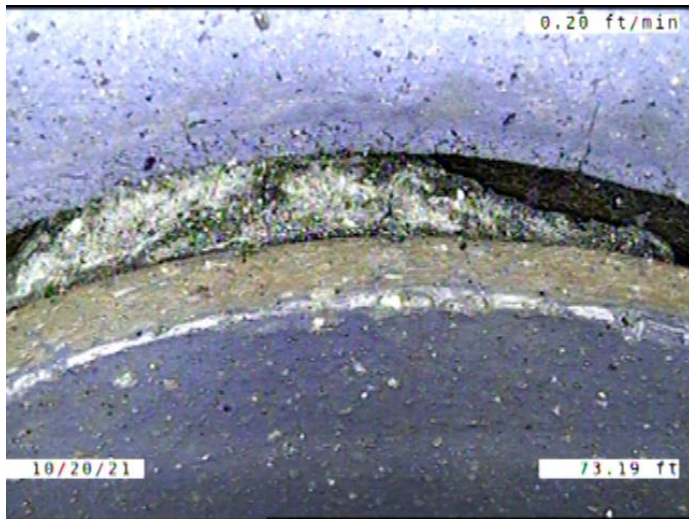
Code: **JOM**
 Description: **Joint Offset Medium**

Distance (ft): **73.2**
 Structural Grade: **3**
 O&M Grade: **0**
 Clock Start/From:
 Clock To:
 1st Value:
 2nd Value:
 Value Percent:
 Continuous Index:
 Within 8" of Joint: **NO**
 Remarks:

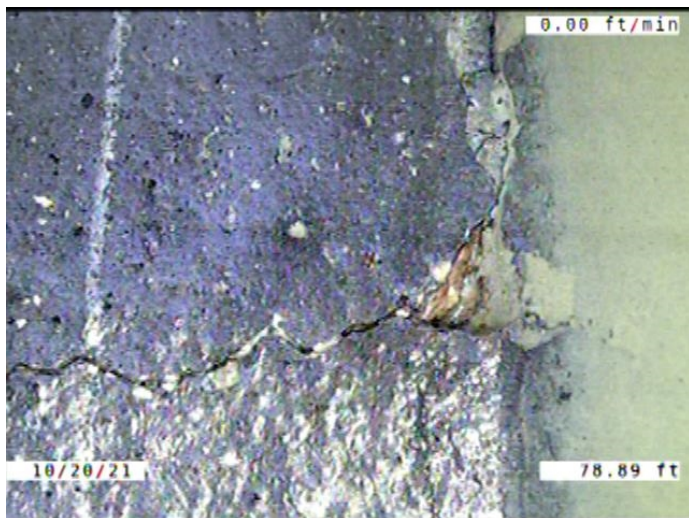
Code: **B**
 Description: **Broken**

Distance (ft): **78.9**
 Structural Grade: **4**
 O&M Grade: **0**
 Clock Start/From: **1**
 Clock To: **10**
 1st Value:
 2nd Value:
 Value Percent:
 Continuous Index:
 Within 8" of Joint: **YES**
 Remarks:

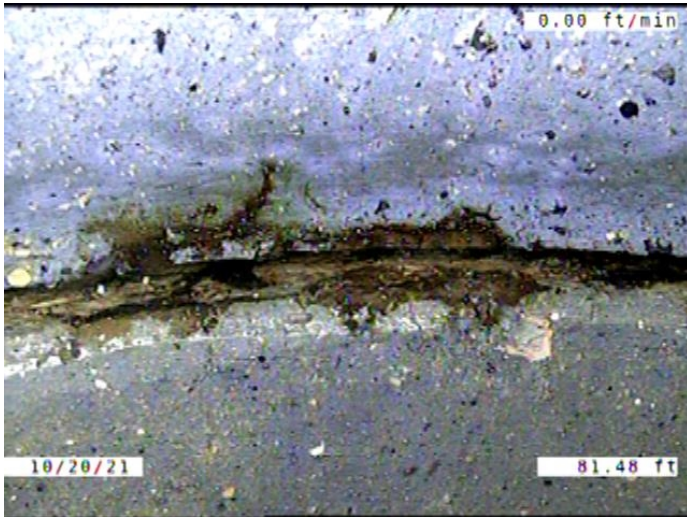
Code: **ISJ**
 Description: **Infiltration Stain Joint**

Distance (ft): **81.5**
 Structural Grade: **0**
 O&M Grade: **1**
 Clock Start/From: **8**
 Clock To: **11**
 1st Value:
 2nd Value:
 Value Percent:
 Continuous Index:
 Within 8" of Joint: **YES**
 Remarks:

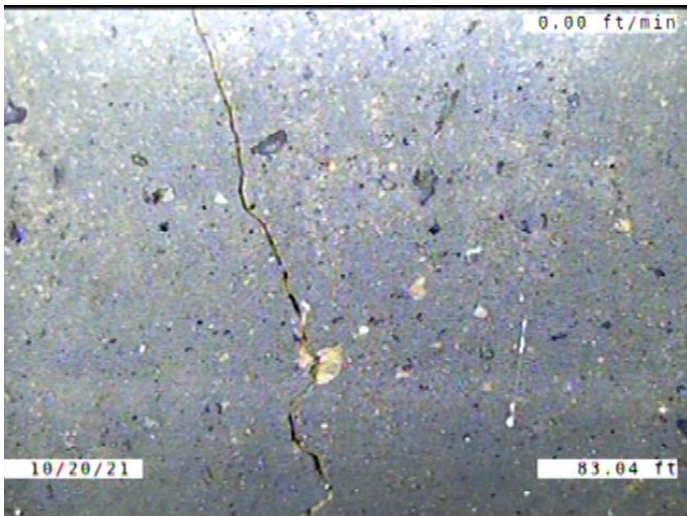
Code: **FM**
 Description: **Fracture Multiple**

Distance (ft): **83.0**
 Structural Grade: **4**
 O&M Grade: **0**
 Clock Start/From: **11**
 Clock To: **12**
 1st Value:
 2nd Value:
 Value Percent:
 Continuous Index:
 Within 8" of Joint: **YES**
 Remarks:

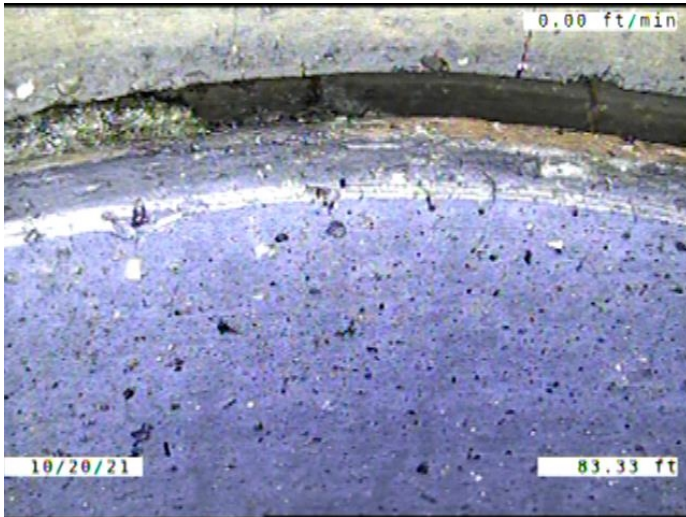
Code: **JOM**
 Description: **Joint Offset Medium**

Distance (ft): **83.3**
 Structural Grade: **3**
 O&M Grade: **0**
 Clock Start/From:
 Clock To:
 1st Value:
 2nd Value:
 Value Percent:
 Continuous Index:
 Within 8" of Joint: **NO**
 Remarks:

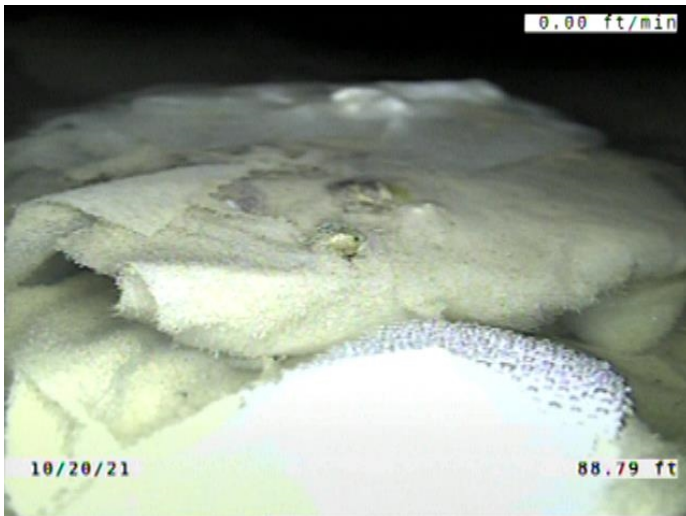
Code: **DAR**
 Description: **Deposits Attached Ragging**

Distance (ft): **88.8**
 Structural Grade: **0**
 O&M Grade: **2**
 Clock Start/From: **5**
 Clock To: **7**
 1st Value:
 2nd Value:
 Value Percent: **5.000**
 Continuous Index:
 Within 8" of Joint: **YES**
 Remarks:

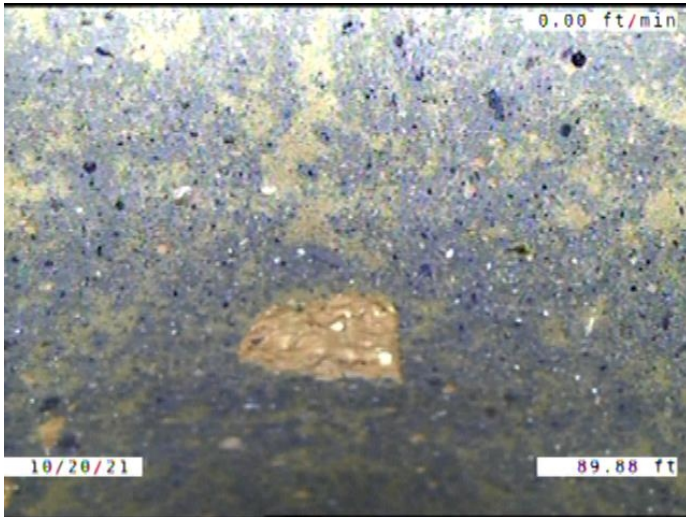
Code: **SSS**
Description: **Surface Damage Surface Spalling**

Distance (ft): **89.9**
Structural Grade: **2**
O&M Grade: **0**
Clock Start/From: **10**
Clock To: **1**
1st Value:
2nd Value:
Value Percent:
Continuous Index:
Within 8" of Joint: **YES**
Remarks:

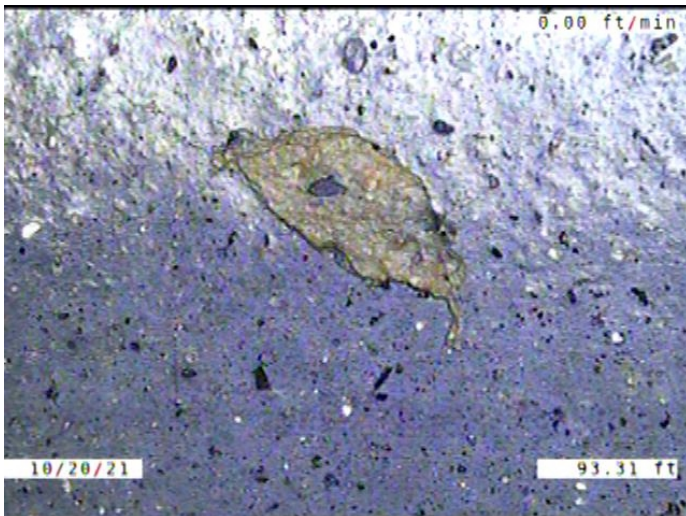
Code: **SSS**
Description: **Surface Damage Surface Spalling**

Distance (ft): **93.3**
Structural Grade: **2**
O&M Grade: **0**
Clock Start/From: **2**
Clock To:
1st Value:
2nd Value:
Value Percent:
Continuous Index:
Within 8" of Joint: **NO**
Remarks:

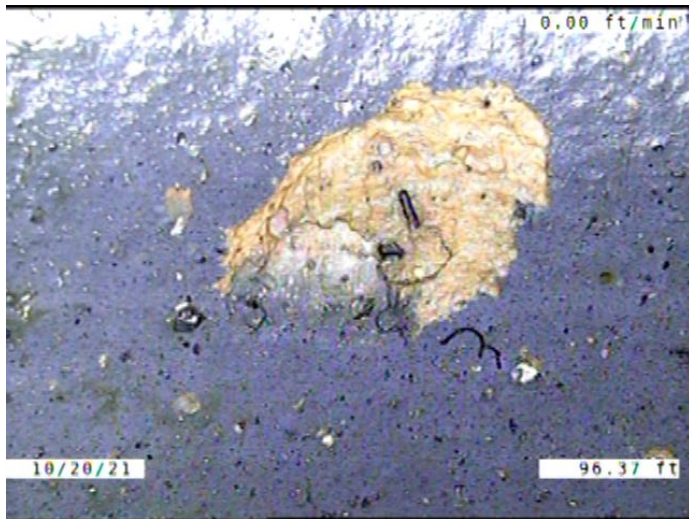
Code: **SSS**
 Description: **Surface Damage Surface Spalling**

Distance (ft): **96.4**
 Structural Grade: **2**
 O&M Grade: **0**
 Clock Start/From: **10**
 Clock To:
 1st Value:
 2nd Value:
 Value Percent:
 Continuous Index:
 Within 8" of Joint: **NO**
 Remarks:

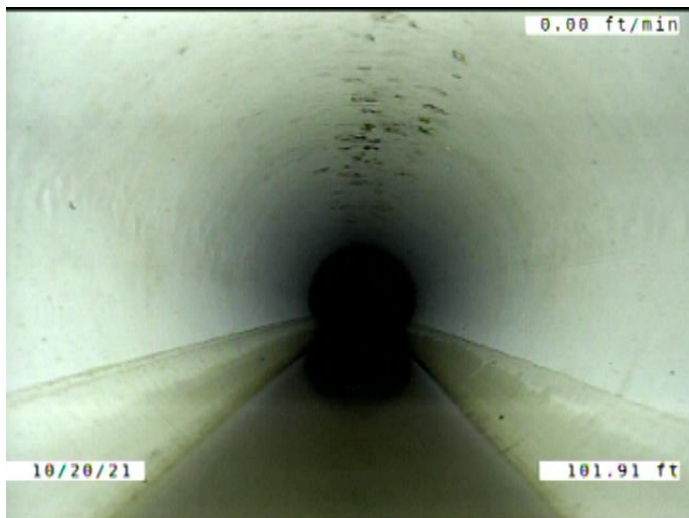
Code: **SSS**
 Description: **Surface Damage Surface Spalling**

Distance (ft): **101.9**
 Structural Grade: **2**
 O&M Grade: **0**
 Clock Start/From: **3**
 Clock To: **9**
 1st Value:
 2nd Value:
 Value Percent:
 Continuous Index: **F02**
 Within 8" of Joint: **YES**
 Remarks:

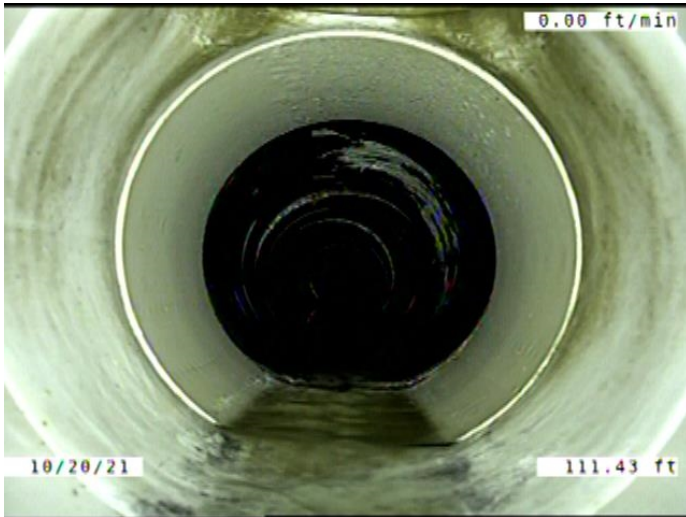
Code: **MWLS**
Description: **Miscellaneous Water Level Sag**

Distance (ft): **111.4**
Structural Grade: **2**
O&M Grade: **0**
Clock Start/From:
Clock To:
1st Value:
2nd Value:
Value Percent: **10.000**
Continuous Index: **F03**
Within 8" of Joint: **NO**
Remarks:

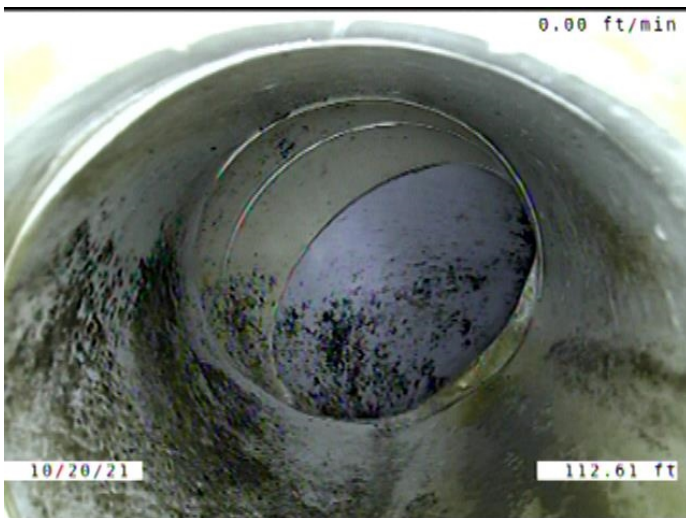
Code: **TF**
Description: **Tap Factory**

Distance (ft): **112.6**
Structural Grade: **0**
O&M Grade: **0**
Clock Start/From: **12**
Clock To:
1st Value: **4.000**
2nd Value:
Value Percent:
Continuous Index:
Within 8" of Joint: **YES**
Remarks: **CONSTANTLY DRIPPING WATER**

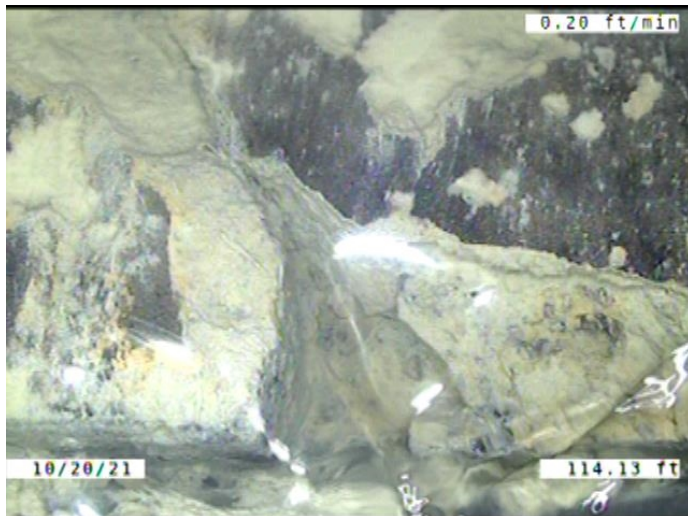
Code: **FM**
 Description: **Fracture Multiple**

Distance (ft): **114.1**
 Structural Grade: **4**
 O&M Grade: **0**
 Clock Start/From: **12**
 Clock To: **12**
 1st Value:
 2nd Value:
 Value Percent:
 Continuous Index: **S05**
 Within 8" of Joint: **YES**
 Remarks:

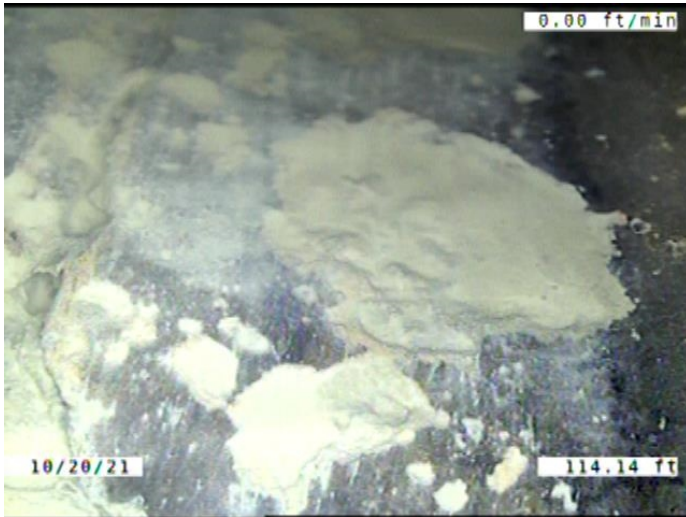
Code: **SSS**
 Description: **Surface Damage Surface Spalling**

Distance (ft): **114.1**
 Structural Grade: **2**
 O&M Grade: **0**
 Clock Start/From: **12**
 Clock To: **12**
 1st Value:
 2nd Value:
 Value Percent:
 Continuous Index: **S04**
 Within 8" of Joint: **YES**
 Remarks:

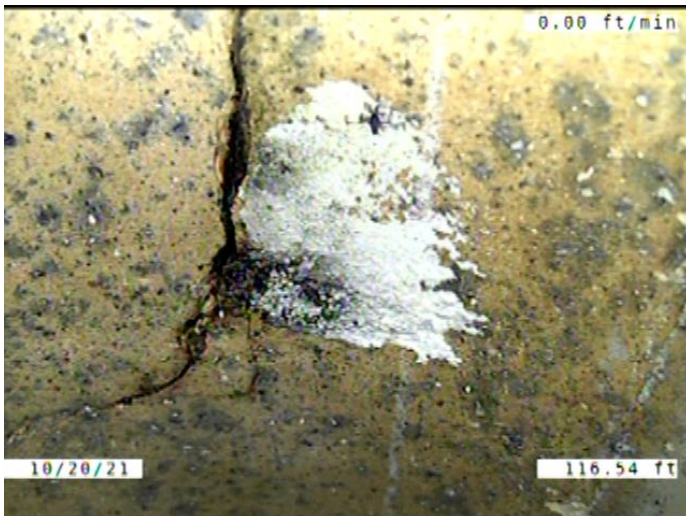
Code: **DAE**
 Description: **Deposits Attached Encrustation**

Distance (ft): **116.5**
 Structural Grade: **0**
 O&M Grade: **2**
 Clock Start/From: **9**
 Clock To: **3**
 1st Value:
 2nd Value:
 Value Percent: **5.000**
 Continuous Index:
 Within 8" of Joint: **YES**
 Remarks:

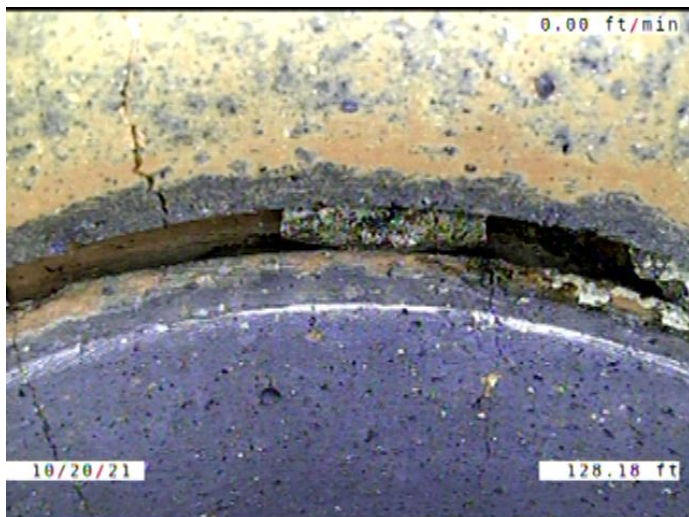
Code: **JOM**
 Description: **Joint Offset Medium**

Distance (ft): **128.2**
 Structural Grade: **3**
 O&M Grade: **0**
 Clock Start/From:
 Clock To:
 1st Value:
 2nd Value:
 Value Percent:
 Continuous Index:
 Within 8" of Joint: **NO**
 Remarks:

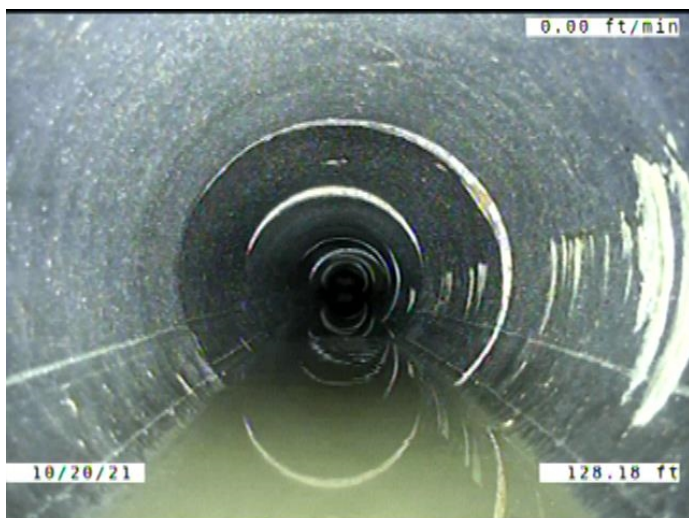
Code: **DAE**
 Description: **Deposits Attached Encrustation**

Distance (ft): **128.2**
 Structural Grade: **0**
 O&M Grade: **2**
 Clock Start/From: **3**
 Clock To: **5**
 1st Value:
 2nd Value:
 Value Percent: **5.000**
 Continuous Index: **S06**
 Within 8" of Joint: **YES**
 Remarks:

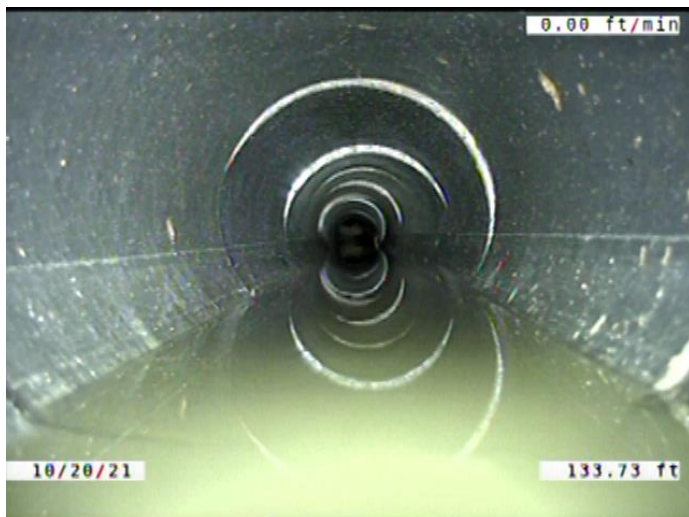
Code: **DAE**
 Description: **Deposits Attached Encrustation**

Distance (ft): **133.7**
 Structural Grade: **0**
 O&M Grade: **2**
 Clock Start/From: **3**
 Clock To: **5**
 1st Value:
 2nd Value:
 Value Percent: **5.000**
 Continuous Index: **F06**
 Within 8" of Joint: **YES**
 Remarks:

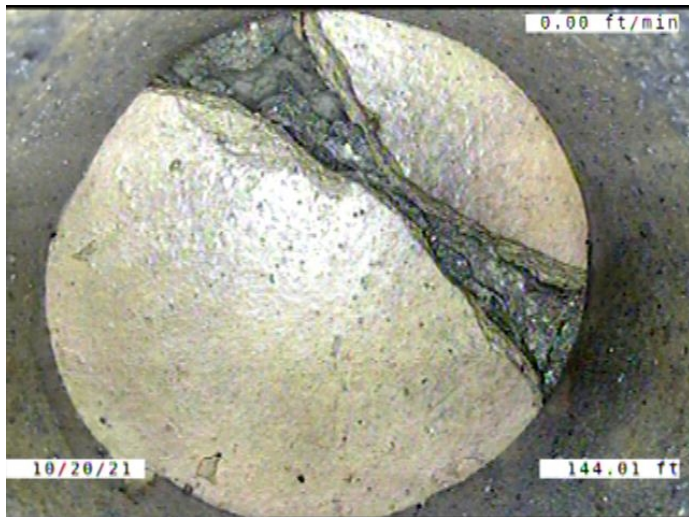
Code: **TFD**
 Description: **Tap Factory Defective**

Distance (ft): **144.0**
 Structural Grade: **0**
 O&M Grade: **3**
 Clock Start/From: **11**
 Clock To:
 1st Value: **4.000**
 2nd Value:
 Value Percent:
 Continuous Index:
 Within 8" of Joint: **YES**
 Remarks: **CAP BROKEN. SOIL VISIBLE**

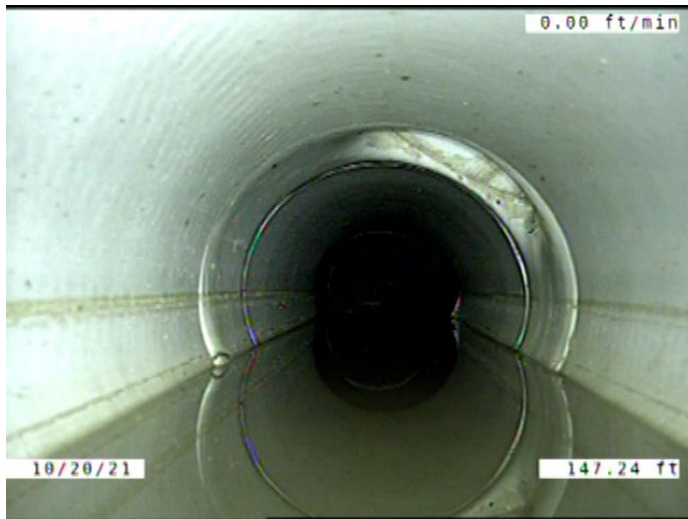
Code: **SSS**
 Description: **Surface Damage Surface Spalling**

Distance (ft): **147.2**
 Structural Grade: **2**
 O&M Grade: **0**
 Clock Start/From: **12**
 Clock To: **12**
 1st Value:
 2nd Value:
 Value Percent:
 Continuous Index: **F04**
 Within 8" of Joint: **YES**
 Remarks:

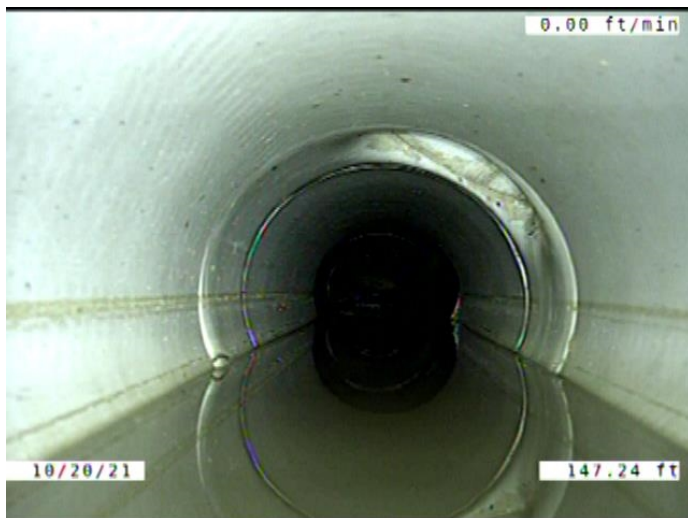
Code: **FM**
 Description: **Fracture Multiple**

Distance (ft): **147.2**
 Structural Grade: **4**
 O&M Grade: **0**
 Clock Start/From: **12**
 Clock To: **12**
 1st Value:
 2nd Value:
 Value Percent:
 Continuous Index: **F05**
 Within 8" of Joint: **YES**
 Remarks:

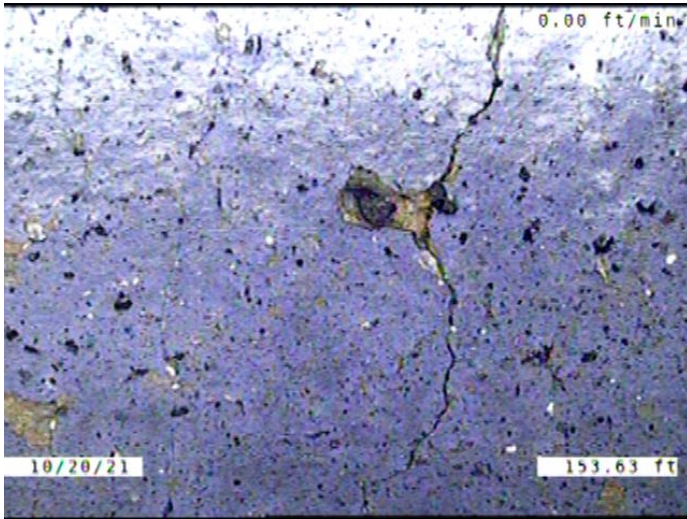
Code: **FM**
 Description: **Fracture Multiple**

Distance (ft): **153.6**
 Structural Grade: **4**
 O&M Grade: **0**
 Clock Start/From: **8**
 Clock To: **4**
 1st Value:
 2nd Value:
 Value Percent:
 Continuous Index:
 Within 8" of Joint: **YES**
 Remarks:

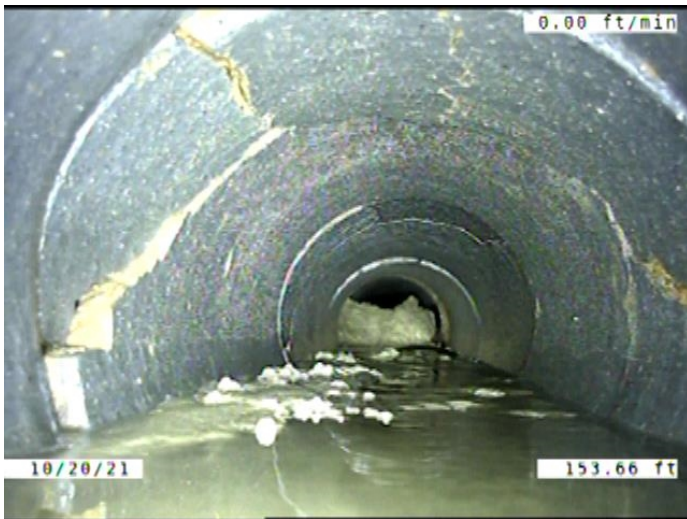
Code: **DSF**
 Description: **Deposits Settled Fine**

Distance (ft): **153.7**
 Structural Grade: **0**
 O&M Grade: **2**
 Clock Start/From: **5**
 Clock To: **7**
 1st Value:
 2nd Value:
 Value Percent: **10.000**
 Continuous Index:
 Within 8" of Joint: **YES**
 Remarks:

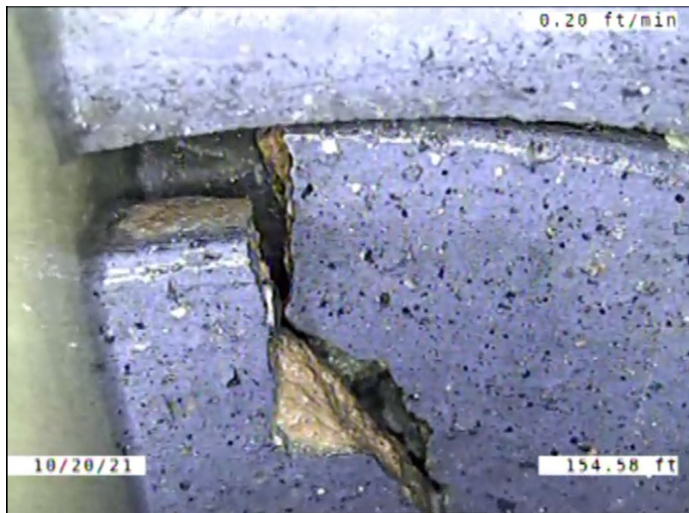
Code: **HVV**
 Description: **Hole Void Visible**

Distance (ft): **154.6**
 Structural Grade: **5**
 O&M Grade: **0**
 Clock Start/From: **8**
 Clock To: **4**
 1st Value:
 2nd Value:
 Value Percent:
 Continuous Index:
 Within 8" of Joint: **YES**
 Remarks:

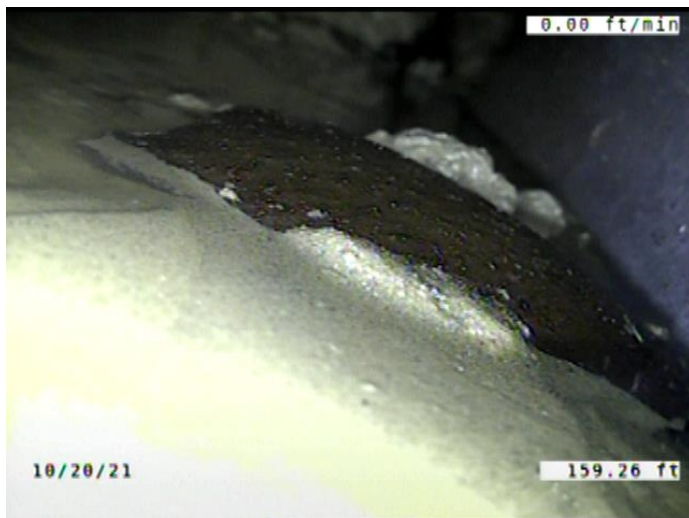
Code: **OBM**
 Description: **Obstruction Pipe Material in Invert**

Distance (ft): **159.3**
 Structural Grade: **0**
 O&M Grade: **2**
 Clock Start/From: **4**
 Clock To: **6**
 1st Value:
 2nd Value:
 Value Percent: **5.000**
 Continuous Index:
 Within 8" of Joint: **YES**
 Remarks:

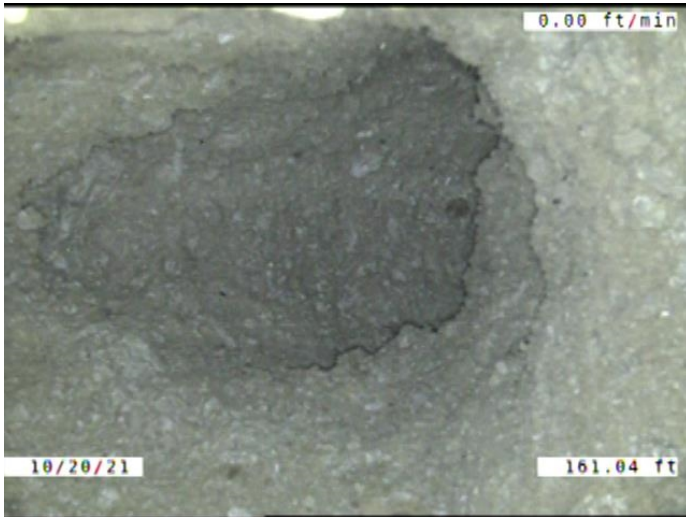
Code: **SMW**
 Description: **Surface Damage Missing Wall**

Distance (ft): **161.0**
 Structural Grade: **5**
 O&M Grade: **0**
 Clock Start/From: **8**
 Clock To: **4**
 1st Value:
 2nd Value:
 Value Percent:
 Continuous Index:
 Within 8" of Joint: **YES**
 Remarks: **SOIL AND VOID VISIBLE**

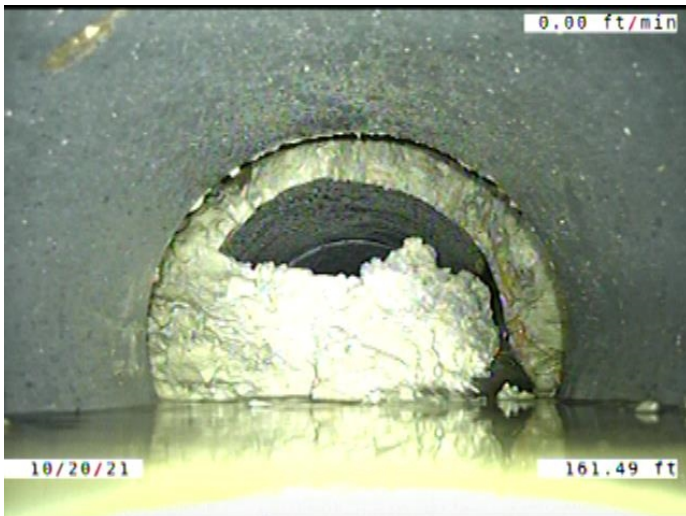
Code: **DSF**
 Description: **Deposits Settled Fine**

Distance (ft): **161.5**
 Structural Grade: **0**
 O&M Grade: **5**
 Clock Start/From: **2**
 Clock To: **10**
 1st Value:
 2nd Value:
 Value Percent: **75.000**
 Continuous Index:
 Within 8" of Joint: **YES**
 Remarks:

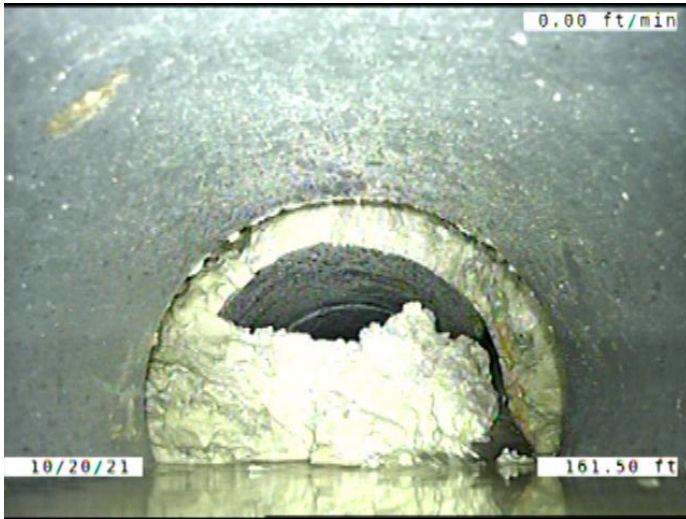
Miscellaneous Survey Abandoned

**PIPE MISSING SOIL FALLING INTO
THE PIPE. CAMERA CANT GET PAST S**
