Profile/Photo Observation Report

Date:	04/10/2018	Weather:		Coding:	PACP 6.0
Pipe Length (ft):	194.5	Owner:	NA	Pre Clean:	Not Known
P.O.#:		Surveyor:	Byrd Fitzgerald	PSR:	P-503-020-019
Customer:		Clean Date:	01/01/1900	Shape:	C

Street:	ALLEY BETWEEN W 39TH PL & W 39	Flow Control:	Not Controlled
City:	Hobart, IN	Year Renewed:	
Location:	Other	Tape/Media #:	
Purpose:	Not Known	Dia/Height:	10"
Use:	Sanitary	Material:	VCP
Drain Area:	NA	Lining:	
Category:	NA		
Comment:

Location Details:		Direction of Survey:	Downstream
US MH:	M-503-019	DS MH:	M-503-020
		Total Length Surveyed (ft):	42.9

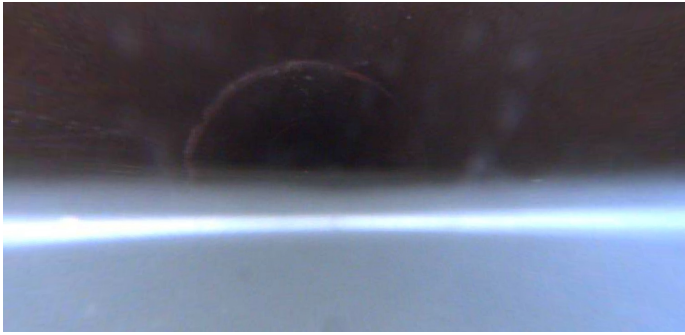
Code: **MCU**
Description: **Camera Underwater**

Distance (ft): **6.9**
Structural Grade: **0**
O&M Grade: **4**
Clock Start/From:
Clock To:
1st Value:
2nd Value:
Value Percent:
Continuous Index: **F01**
Within 8" of Joint: **NO**
Remarks:

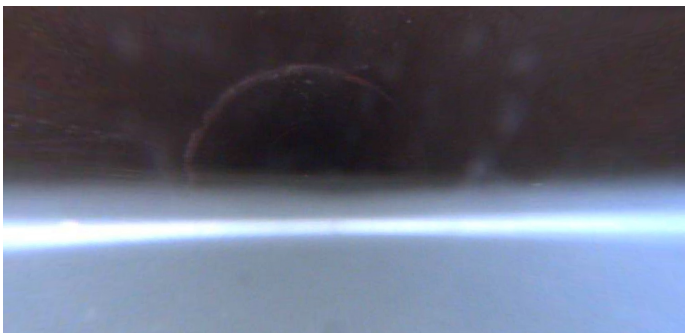
Code: **MWL**
Description: **Water Level**

Distance (ft): **6.9**
Structural Grade: **0**
O&M Grade: **0**
Clock Start/From:
Clock To:
1st Value:
2nd Value:
Value Percent: **50.000**
Continuous Index:
Within 8" of Joint: **NO**
Remarks:

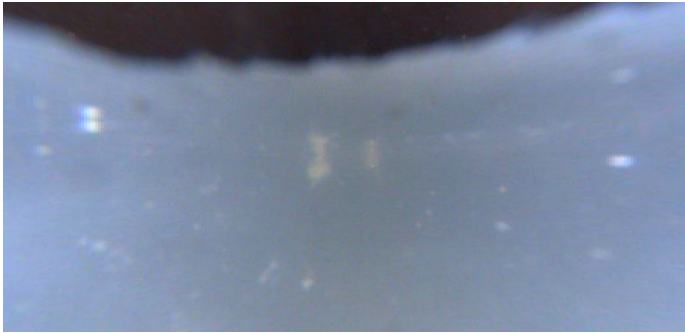
Code: **MCU**
Description: **Camera Underwater**

Distance (ft): **9.9**
Structural Grade: **0**
O&M Grade: **4**
Clock Start/From:
Clock To:
1st Value:
2nd Value:
Value Percent:
Continuous Index:
Within 8" of Joint: **NO**
Remarks:

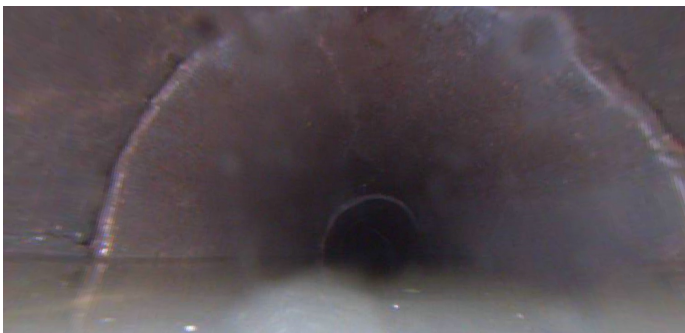
Code: **CM**
Description: **Crack Multiple**

Distance (ft): **15.5**
Structural Grade: **3**
O&M Grade: **0**
Clock Start/From: **8**
Clock To: **4**
1st Value:
2nd Value:
Value Percent:
Continuous Index: **S02**
Within 8" of Joint: **YES**
Remarks: **wandering**

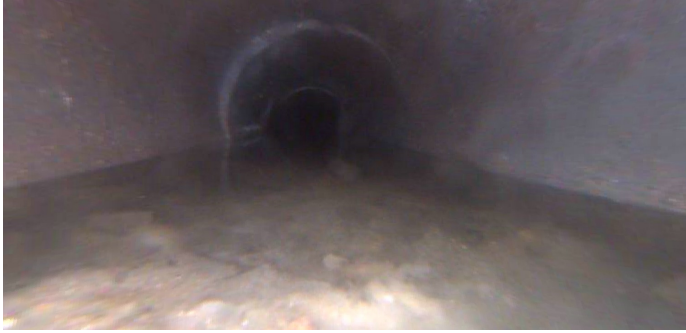
Code: **DSZ**
Description: **Deposits Settled Other**

Distance (ft): **21.4**
Structural Grade: **0**
O&M Grade: **2**
Clock Start/From: **6**
Clock To:
1st Value:
2nd Value:
Value Percent: **5.000**
Continuous Index:
Within 8" of Joint: **NO**
Remarks: **debris**

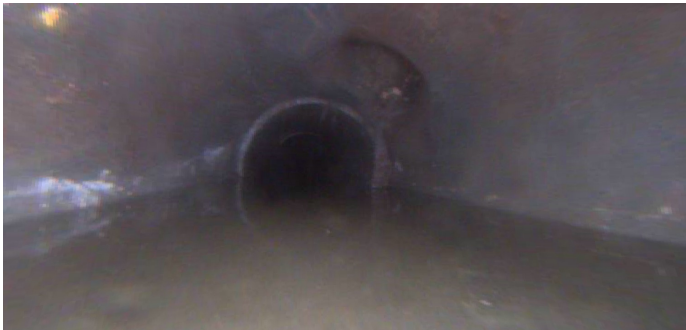
Code: **MWL**
Description: **Water Level**

Distance (ft): **23.1**
Structural Grade: **0**
O&M Grade: **0**
Clock Start/From:
Clock To:
1st Value:
2nd Value:
Value Percent: **25.000**
Continuous Index:
Within 8" of Joint: **NO**
Remarks:

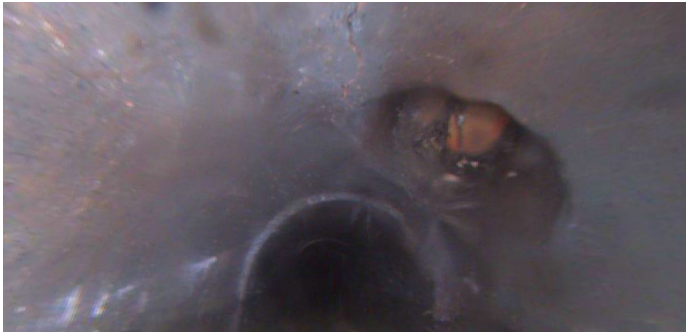
Code: **TFC**
Description: **Tap Factory Capped**

Distance (ft): **23.5**
Structural Grade: **0**
O&M Grade: **0**
Clock Start/From: **1**
Clock To:
1st Value: **4.000**
2nd Value:
Value Percent:
Continuous Index:
Within 8" of Joint: **YES**
Remarks:

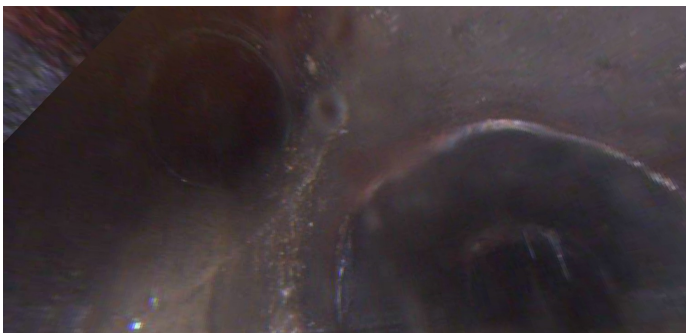
Code: **TF**
Description: **Tap Factory**

Distance (ft): **26.0**
Structural Grade: **0**
O&M Grade: **0**
Clock Start/From: **11**
Clock To:
1st Value: **4.000**
2nd Value:
Value Percent:
Continuous Index:
Within 8" of Joint: **YES**
Remarks:

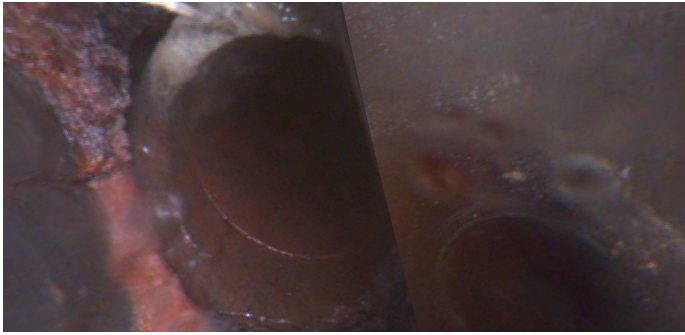
Code: **TB**
Description: **Tap Break-in**

Distance (ft): **26.0**
Structural Grade: **0**
O&M Grade: **0**
Clock Start/From: **12**
Clock To:
1st Value: **6.000**
2nd Value:
Value Percent:
Continuous Index:
Within 8" of Joint:
Remarks:

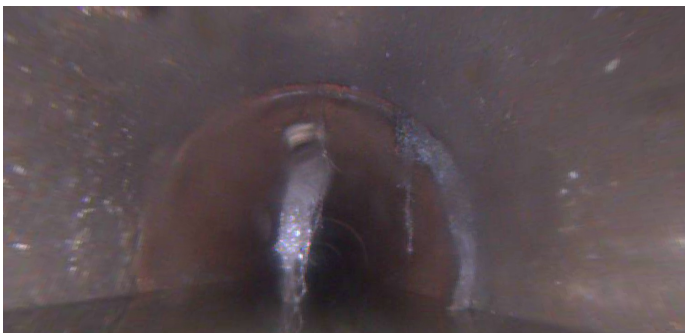
Code: **RMJ**
Description: **Roots Medium Joint**

Distance (ft): **27.6**
Structural Grade: **0**
O&M Grade: **3**
Clock Start/From: **12**
Clock To: **4**
1st Value:
2nd Value:
Value Percent: **5.000**
Continuous Index:
Within 8" of Joint: **YES**
Remarks:

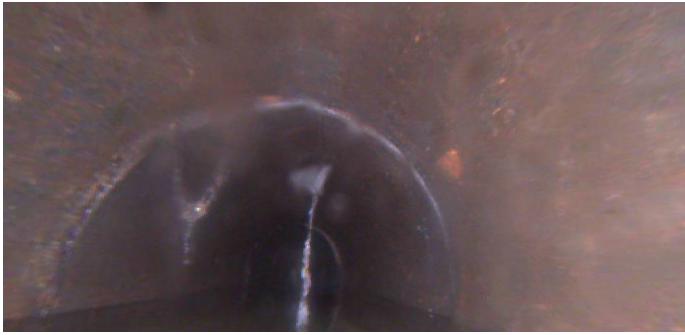
Code: **RFJ**
Description: **Roots Fine Joint**

Distance (ft): **33.7**
Structural Grade: **0**
O&M Grade: **1**
Clock Start/From: **11**
Clock To: **1**
1st Value:
2nd Value:
Value Percent:
Continuous Index: **S03**
Within 8" of Joint: **YES**
Remarks:

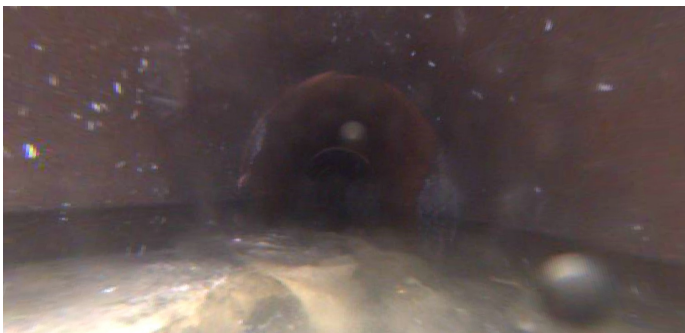
Code: **DSZ**
Description: **Deposits Settled Other**

Distance (ft): **37.2**
Structural Grade: **0**
O&M Grade: **2**
Clock Start/From: **6**
Clock To:
1st Value:
2nd Value:
Value Percent: **10.000**
Continuous Index:
Within 8" of Joint: **NO**
Remarks: **tissue/sediments/debris**

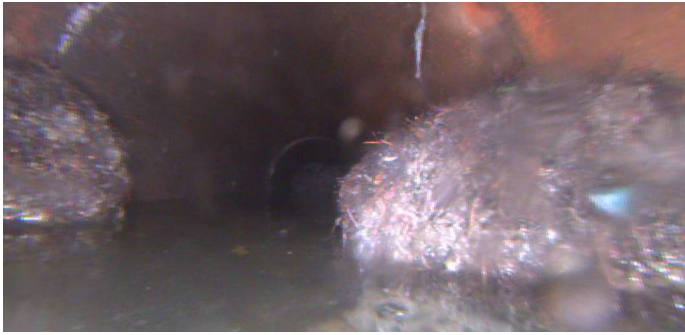
Code: **RMJ**
Description: **Roots Medium Joint**

Distance (ft): **39.9**
Structural Grade: **0**
O&M Grade: **3**
Clock Start/From: **8**
Clock To: **4**
1st Value:
2nd Value:
Value Percent: **25.000**
Continuous Index:
Within 8" of Joint: **YES**
Remarks:

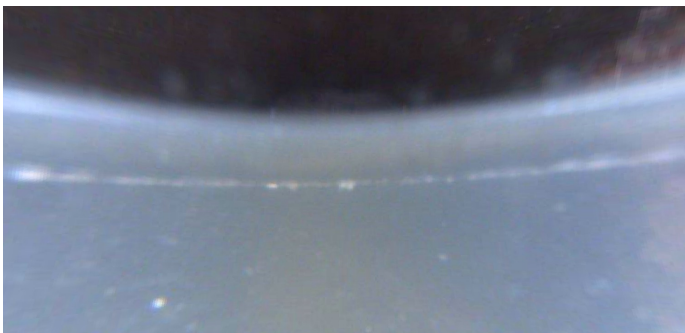
Code: **MCU**
Description: **Camera Underwater**

Distance (ft): **42.3**
Structural Grade: **0**
O&M Grade: **4**
Clock Start/From:
Clock To:
1st Value:
2nd Value:
Value Percent:
Continuous Index:
Within 8" of Joint: **NO**
Remarks:

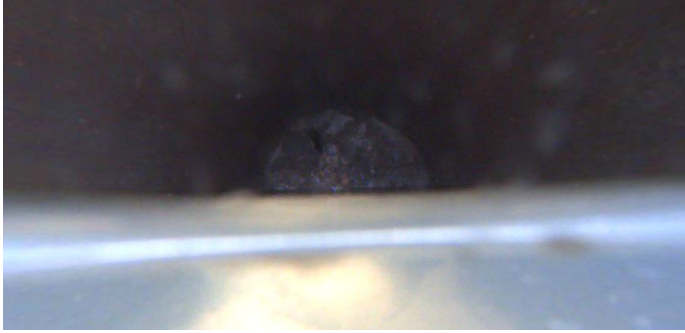
Code: **RBJ**
Description: **Roots Ball Joint**

Distance (ft): **42.7**
Structural Grade: **0**
O&M Grade: **4**
Clock Start/From: **9**
Clock To: **3**
1st Value:
2nd Value:
Value Percent: **55.000**
Continuous Index:
Within 8" of Joint: **YES**
Remarks:

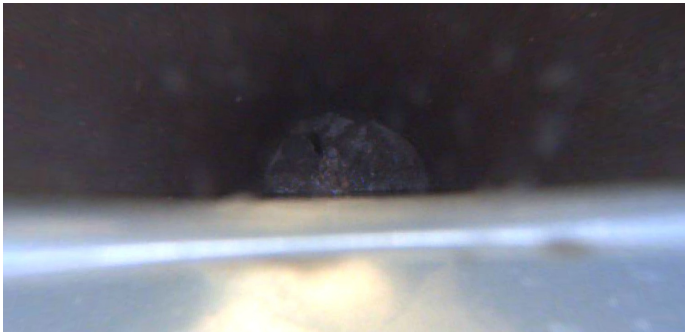
Code: **MWL**
Description: **Water Level**

Distance (ft): **42.7**
Structural Grade: **0**
O&M Grade: **0**
Clock Start/From:
Clock To:
1st Value:
2nd Value:
Value Percent: **50.000**
Continuous Index:
Within 8" of Joint: **NO**
Remarks:

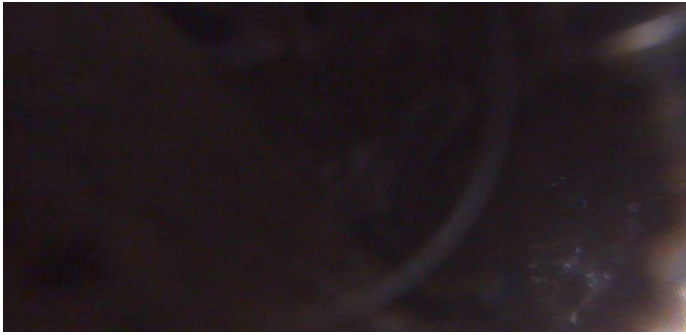
Code: **MSA**
Description: **Abandoned Survey**

Distance (ft): **42.9**
Structural Grade: **0**
O&M Grade: **0**
Clock Start/From:
Clock To:
1st Value:
2nd Value:
Value Percent:
Continuous Index:
Within 8" of Joint: **NO**
Remarks: **rbj**

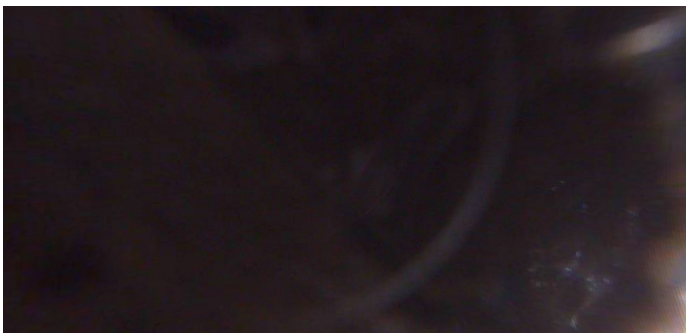
Code: **RFJ**
Description: **Roots Fine Joint**

Distance (ft): **42.9**
Structural Grade: **0**
O&M Grade: **1**
Clock Start/From: **11**
Clock To: **1**
1st Value:
2nd Value:
Value Percent:
Continuous Index: **F03**
Within 8" of Joint: **YES**
Remarks:

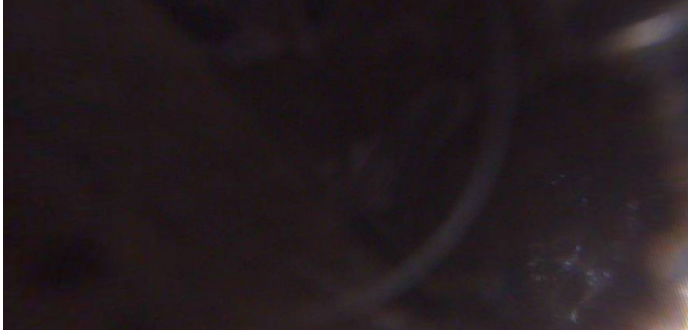
Code:	CM
Description:	Crack Multiple
Distance (ft):	42.9
Structural Grade:	3
O&M Grade:	0
Clock Start/From:	8
Clock To:	4
1st Value:	
2nd Value:	
Value Percent:	
Continuous Index:	F02
Within 8" of Joint:	YES
Remarks:	wandering
