Profile/Photo Observation Report

Date:	04/10/2018	Weather:		Coding:	PACP 6.0
Pipe Length (ft):	194.5	Owner:	NA	Pre Clean:	Not Known
P.O.#:		Surveyor:	Byrd Fitzgerald	PSR:	P-503-020-019
Customer:		Clean Date:	01/01/1900	Shape:	C

Street:	W 40th ave	Flow Control:	Not Controlled
City:	Hobart, IN	Year Renewed:	
Location:	Other	Tape/Media #:	
Purpose:	Not Known	Dia/Height:	10"
Use:	Sanitary	Material:	VCP
Drain Area:	NA	Lining:	
Category:	NA		
Comment:

Location Details:		Direction of Survey:	Downstream
US MH:	M-503-019	DS MH:	M-503-020
		Total Length Surveyed (ft):	42.9

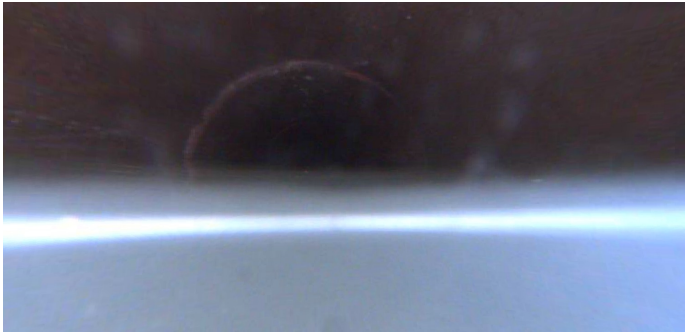
Code: **MCU**
Description: **Camera Underwater**

Distance (ft): **6.9**
Structural Grade: **0**
O&M Grade: **4**
Clock Start/From:
Clock To:
1st Value:
2nd Value:
Value Percent:
Continuous Index: **F01**
Within 8" of Joint: **NO**
Remarks:

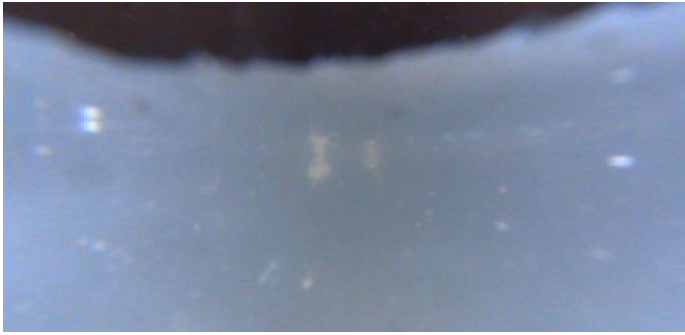
Code: **MCU**
Description: **Camera Underwater**

Distance (ft): **9.9**
Structural Grade: **0**
O&M Grade: **4**
Clock Start/From:
Clock To:
1st Value:
2nd Value:
Value Percent:
Continuous Index:
Within 8" of Joint: **NO**
Remarks:

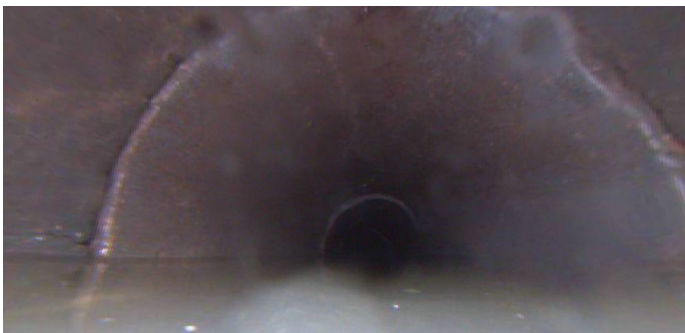
Code: **CM**
Description: **Crack Multiple**

Distance (ft): **15.5**
Structural Grade: **3**
O&M Grade: **0**
Clock Start/From: **8**
Clock To: **4**
1st Value:
2nd Value:
Value Percent:
Continuous Index: **S02**
Within 8" of Joint: **YES**
Remarks: **wandering**

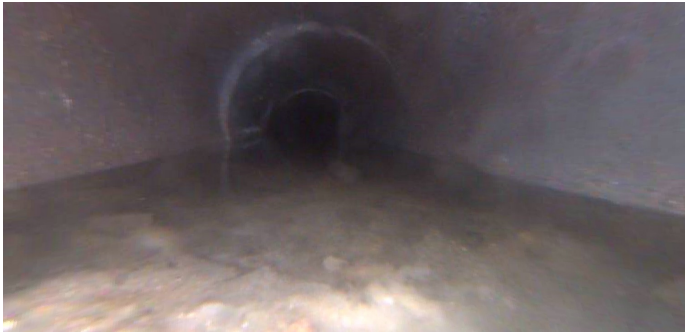
Code: **DSZ**
Description: **Deposits Settled Other**

Distance (ft): **21.4**
Structural Grade: **0**
O&M Grade: **2**
Clock Start/From: **6**
Clock To:
1st Value:
2nd Value:
Value Percent: **5.000**
Continuous Index:
Within 8" of Joint: **NO**
Remarks: **debris**

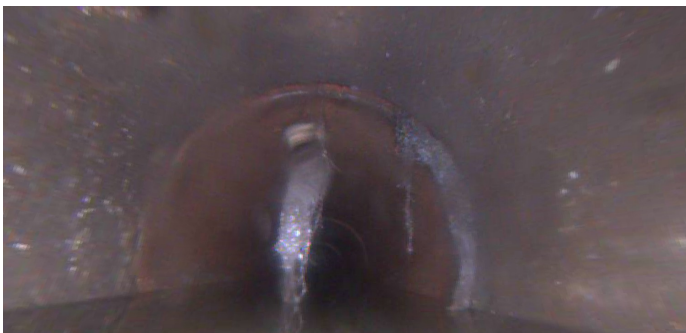
Code: **RMJ**
Description: **Roots Medium Joint**

Distance (ft): **27.6**
Structural Grade: **0**
O&M Grade: **3**
Clock Start/From: **12**
Clock To: **4**
1st Value:
2nd Value:
Value Percent: **5.000**
Continuous Index:
Within 8" of Joint: **YES**
Remarks:

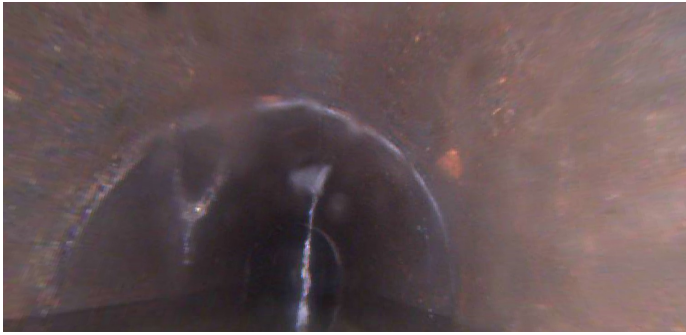
Code: **RFJ**
Description: **Roots Fine Joint**

Distance (ft): **33.7**
Structural Grade: **0**
O&M Grade: **1**
Clock Start/From: **11**
Clock To: **1**
1st Value:
2nd Value:
Value Percent:
Continuous Index: **S03**
Within 8" of Joint: **YES**
Remarks:

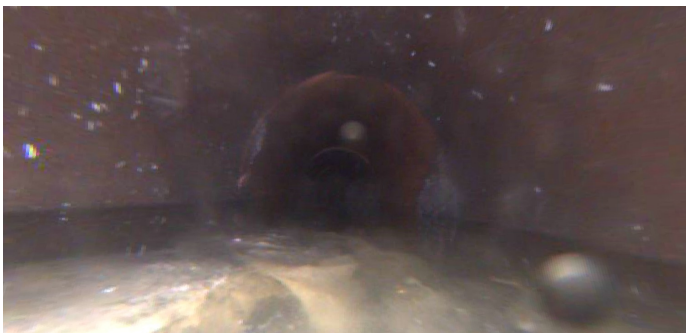
Code: **DSZ**
Description: **Deposits Settled Other**

Distance (ft): **37.2**
Structural Grade: **0**
O&M Grade: **2**
Clock Start/From: **6**
Clock To:
1st Value:
2nd Value:
Value Percent: **10.000**
Continuous Index:
Within 8" of Joint: **NO**
Remarks: **tissue/sediments/debris**

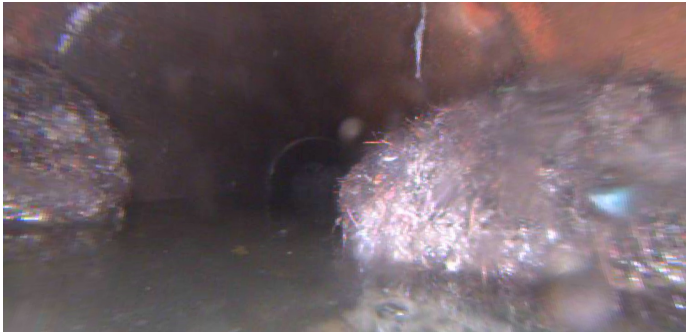
Code: **RMJ**
Description: **Roots Medium Joint**

Distance (ft): **39.9**
Structural Grade: **0**
O&M Grade: **3**
Clock Start/From: **8**
Clock To: **4**
1st Value:
2nd Value:
Value Percent: **25.000**
Continuous Index:
Within 8" of Joint: **YES**
Remarks:

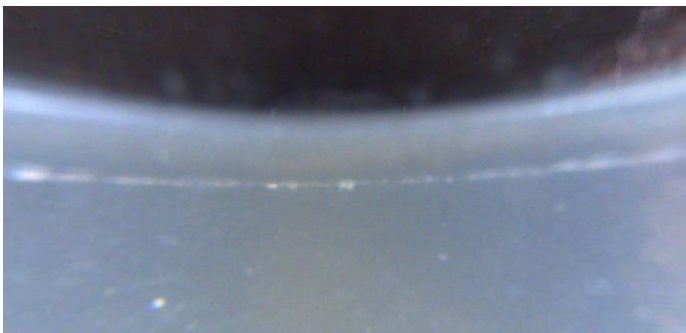
Code: **MCU**
Description: **Camera Underwater**

Distance (ft): **42.3**
Structural Grade: **0**
O&M Grade: **4**
Clock Start/From:
Clock To:
1st Value:
2nd Value:
Value Percent:
Continuous Index:
Within 8" of Joint: **NO**
Remarks:

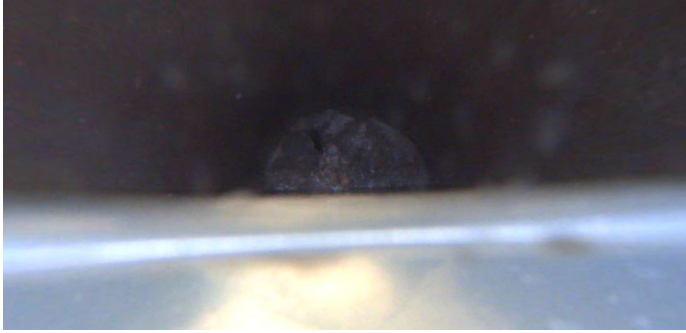
Code: **RBJ**
Description: **Roots Ball Joint**

Distance (ft): **42.7**
Structural Grade: **0**
O&M Grade: **4**
Clock Start/From: **9**
Clock To: **3**
1st Value:
2nd Value:
Value Percent: **55.000**
Continuous Index:
Within 8" of Joint: **YES**
Remarks:

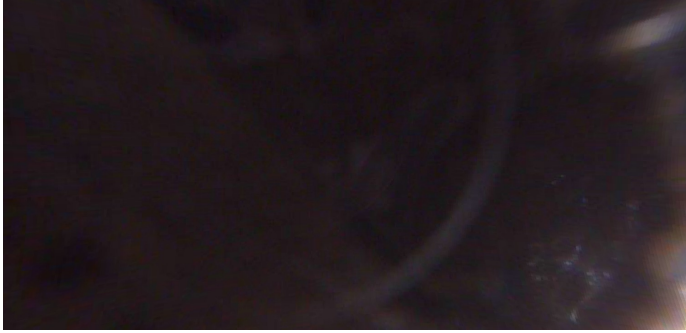
Code: **MSA**
Description: **Abandoned Survey**

Distance (ft): **42.9**
Structural Grade: **0**
O&M Grade: **0**
Clock Start/From:
Clock To:
1st Value:
2nd Value:
Value Percent:
Continuous Index:
Within 8" of Joint: **NO**
Remarks: **rbj**

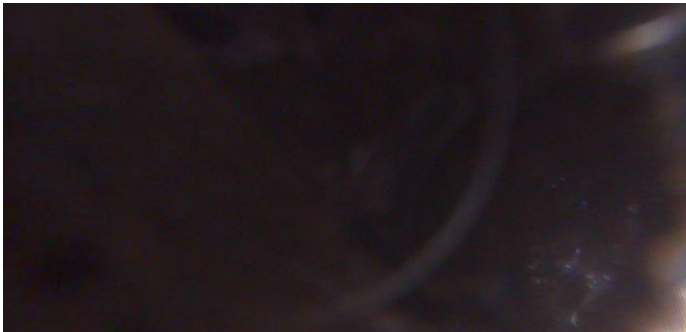
Code: **RFJ**
Description: **Roots Fine Joint**

Distance (ft): **42.9**
Structural Grade: **0**
O&M Grade: **1**
Clock Start/From: **11**
Clock To: **1**
1st Value:
2nd Value:
Value Percent:
Continuous Index: **F03**
Within 8" of Joint: **YES**
Remarks:

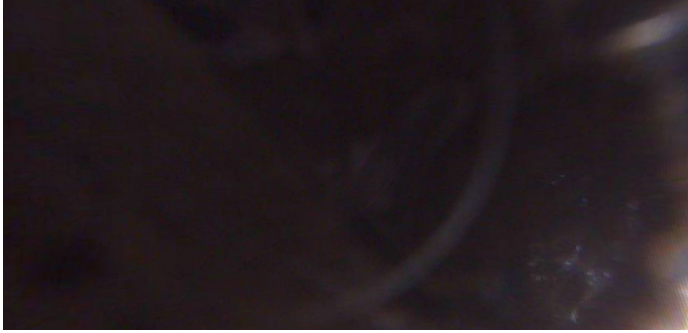
Code:	CM
Description:	Crack Multiple
Distance (ft):	42.9
Structural Grade:	3
O&M Grade:	0
Clock Start/From:	8
Clock To:	4
1st Value:	
2nd Value:	
Value Percent:	
Continuous Index:	F02
Within 8" of Joint:	YES
Remarks:	wandering
