Profile/Photo Observation Report

Date:	09/19/2021	Weather:		Coding:	PACP 7.0
Pipe Length (ft):	194.0	Owner:	City of Hobart	Pre Clean:	Heavy Cleaning
P.O.#:	YES502259	Surveyor:	S. Bucklin	PSR:	P-503-020-019
Customer:	City of Hobart	Clean Date:	09/05/2021	Shape:	C

Street:	West 39th Avenue	Flow Control:	Not Controlled
City:	Hobart, IN	Year Renewed:	
Location:	Alley	Tape/Media #:	
Purpose:	Routine Assessment	Dia/Height:	10"
Use:	Sanitary Sewage Pipe	Material:	VCP
Drain Area:		Lining:	None
Category:	NA		
Comment:			
Location Details:		Direction of Survey:	Downstream
US MH:	M-503-019	DS MH:	M-503-020
		Total Length Surveyed (ft):	133.5

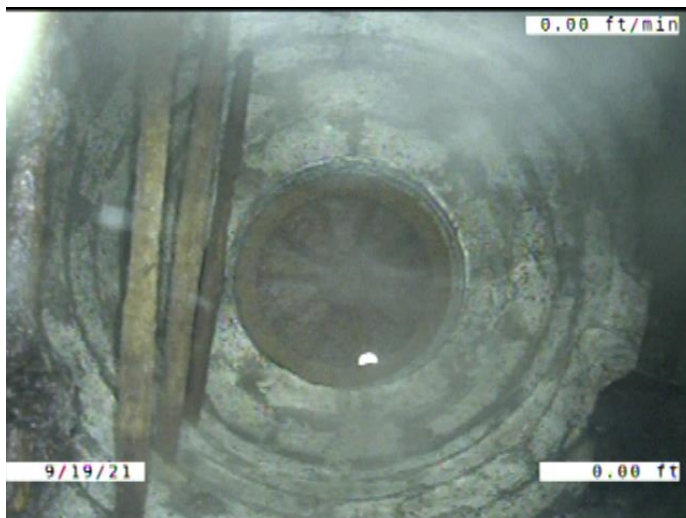
Code: **AMH**
Description: **Manhole**

Distance (ft): **.0**
Structural Grade: **0**
O&M Grade: **0**
Clock Start/From:
Clock To:
1st Value:
2nd Value:
Value Percent:
Continuous Index:
Within 8" of Joint: **NO**
Remarks: **M-503-019**

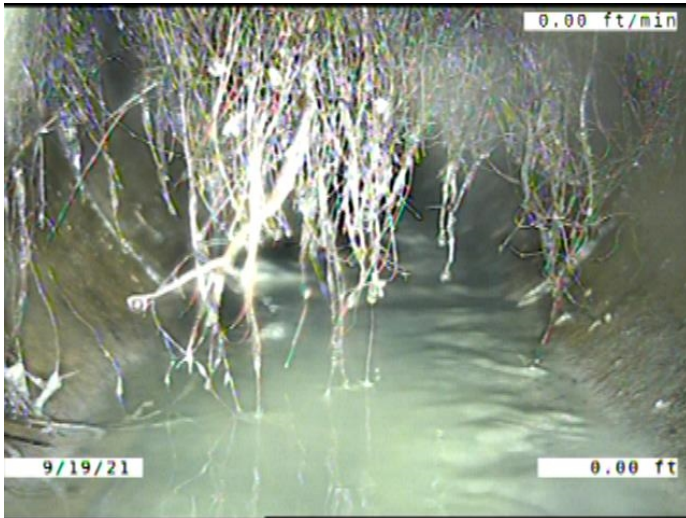
Code:	MWL
Description:	Miscellaneous Water Level
Distance (ft):	.0
Structural Grade:	0
O&M Grade:	0
Clock Start/From:	
Clock To:	
1st Value:	
2nd Value:	
Value Percent:	5.000
Continuous Index:	
Within 8" of Joint:	NO
Remarks:

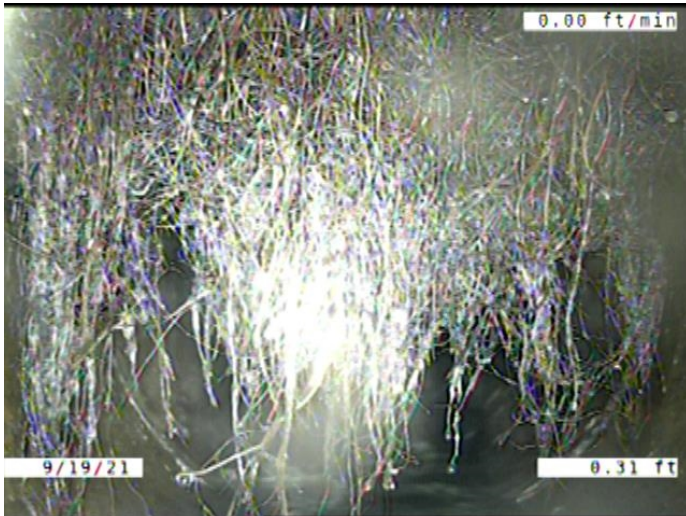
Code:	RBC
Description:	Roots Ball Connection
Distance (ft):	.3
Structural Grade:	0
O&M Grade:	4
Clock Start/From:	8
Clock To:	4
1st Value:	
2nd Value:	
Value Percent:	70.000
Continuous Index:	
Within 8" of Joint:	NO
Remarks:

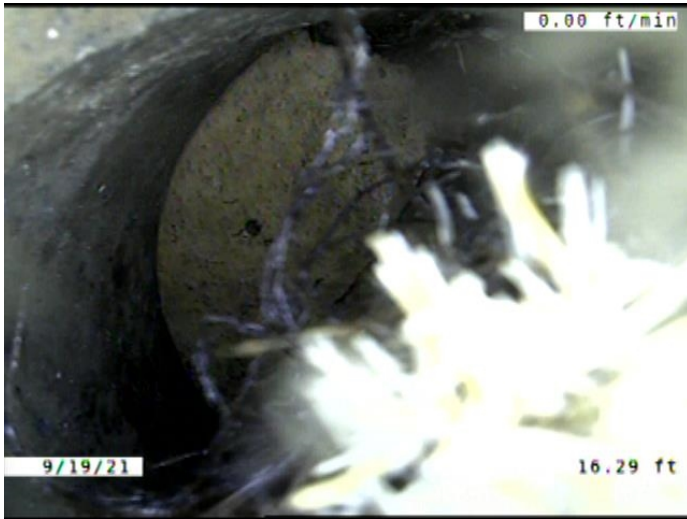
Code:	TFD
Description:	Tap Factory Defective
Distance (ft):	16.3
Structural Grade:	0
O&M Grade:	3
Clock Start/From:	1
Clock To:	
1st Value:	4.000
2nd Value:	
Value Percent:	
Continuous Index:	
Within 8" of Joint:	YES
Remarks:	CAPPED. ROOTS GROWING INTO THE MAIN

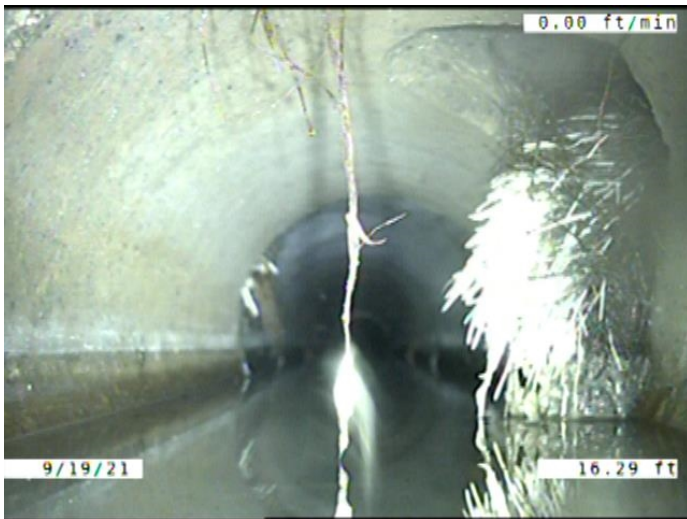
Code:	RML
Description:	Roots Medium Lateral
Distance (ft):	16.3
Structural Grade:	0
O&M Grade:	3
Clock Start/From:	2
Clock To:	4
1st Value:	
2nd Value:	
Value Percent:	10.000
Continuous Index:	
Within 8" of Joint:	NO
Remarks:

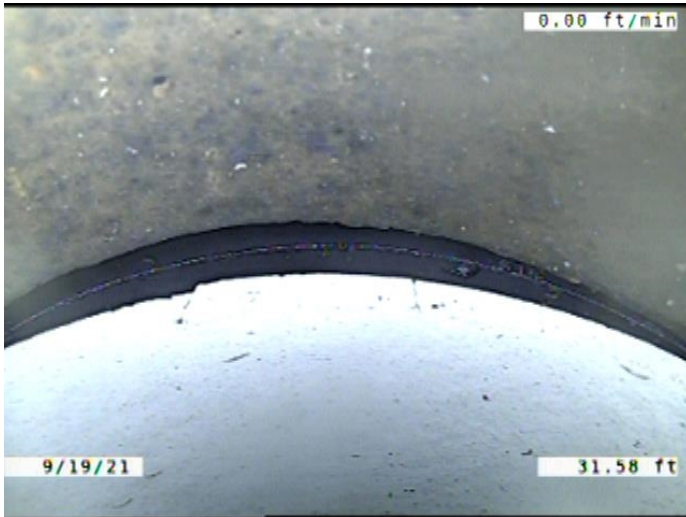
Code: **JOM**
Description: **Joint Offset Medium**

Distance (ft): **31.6**
Structural Grade: **3**
O&M Grade: **0**
Clock Start/From:
Clock To:
1st Value:
2nd Value:
Value Percent:
Continuous Index:
Within 8" of Joint: **NO**
Remarks:

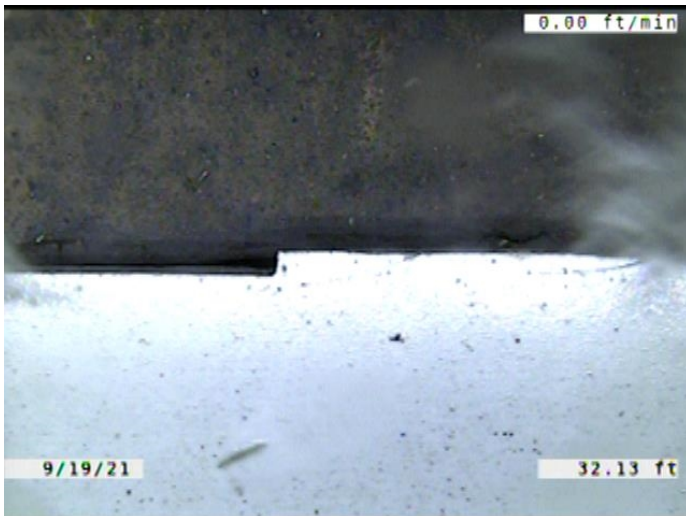
Code: **MMC**
Description: **Miscellaneous Material Change**

Distance (ft): **32.1**
Structural Grade: **0**
O&M Grade: **0**
Clock Start/From:
Clock To:
1st Value:
2nd Value:
Value Percent:
Continuous Index:
Within 8" of Joint: **NO**
Remarks: **VCP TO PVC**

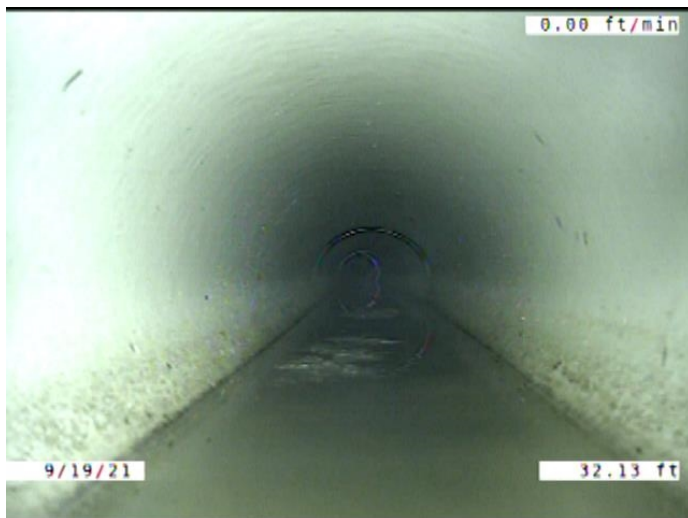
Code: **MWL**
Description: **Miscellaneous Water Level**

Distance (ft): **32.1**
Structural Grade: **0**
O&M Grade: **0**
Clock Start/From:
Clock To:
1st Value:
2nd Value:
Value Percent: **15.000**
Continuous Index:
Within 8" of Joint: **NO**
Remarks:

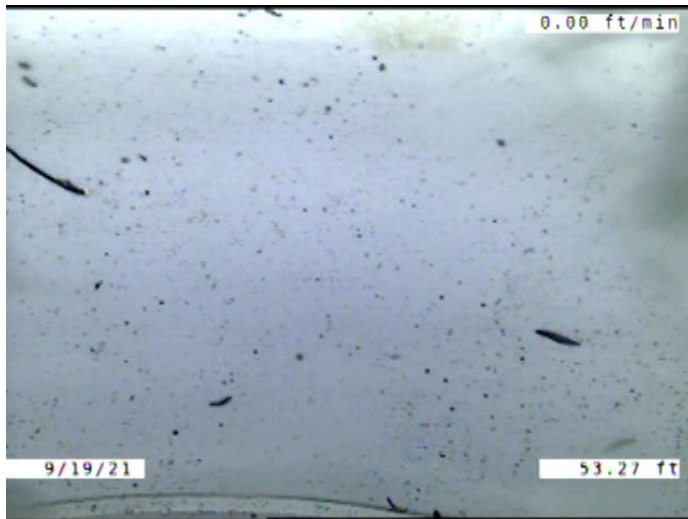
Code: **MGO**
 Description: **Miscellaneous General Observation**

Distance (ft): **53.3**
 Structural Grade: **0**
 O&M Grade: **0**
 Clock Start/From:
 Clock To:
 1st Value:
 2nd Value:
 Value Percent:
 Continuous Index:
 Within 8" of Joint: **NO**
 Remarks: **JOINT/ PIPES NOT PUSHED ALL THE WAY TOGETHER WHEN INSTALLED**

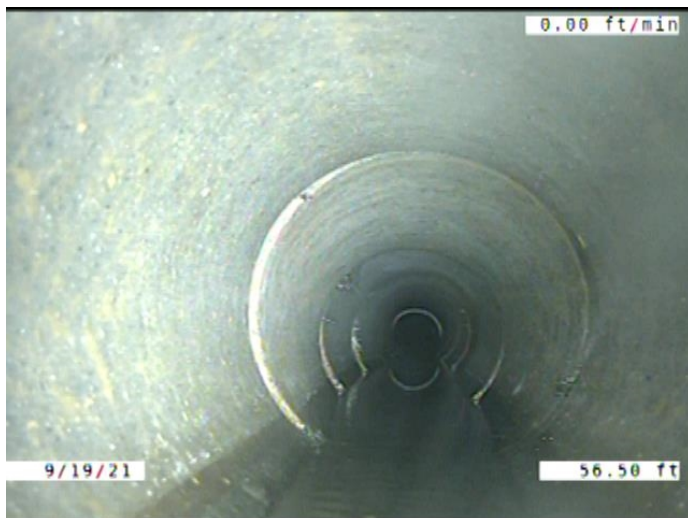
Code: **MWL**
 Description: **Miscellaneous Water Level**

Distance (ft): **56.5**
 Structural Grade: **0**
 O&M Grade: **0**
 Clock Start/From:
 Clock To:
 1st Value:
 2nd Value:
 Value Percent: **5.000**
 Continuous Index:
 Within 8" of Joint: **NO**
 Remarks:

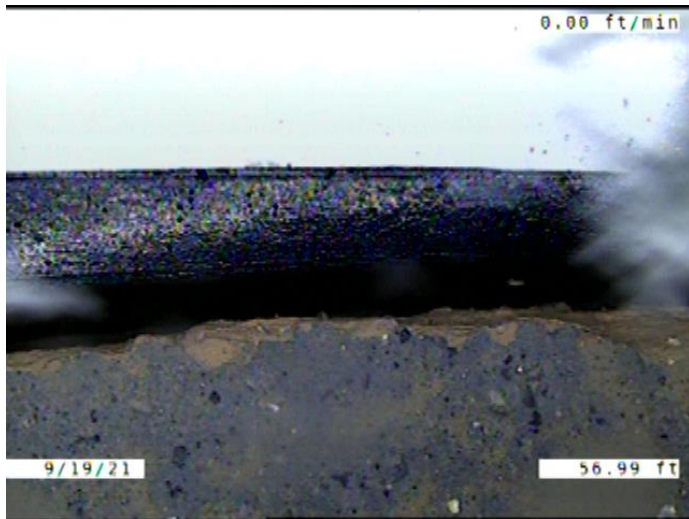
Code: **MMC**
Description: **Miscellaneous Material Change**

Distance (ft): **57.0**
Structural Grade: **0**
O&M Grade: **0**
Clock Start/From:
Clock To:
1st Value:
2nd Value:
Value Percent:
Continuous Index:
Within 8" of Joint: **NO**
Remarks: **PVC TO VCP**

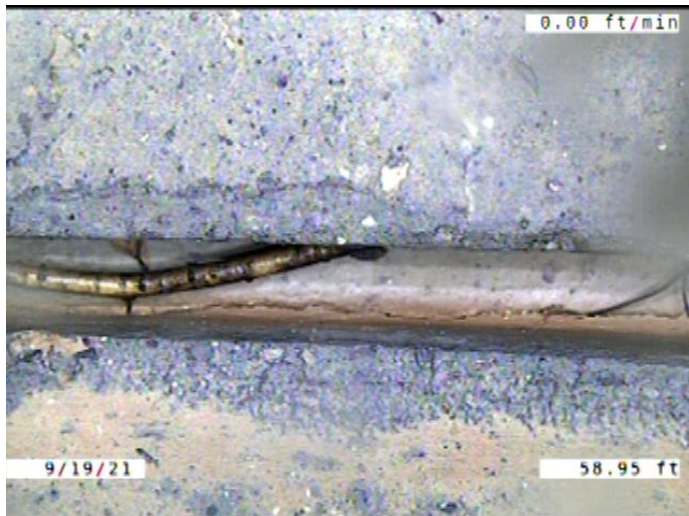
Code: **RFJ**
Description: **Roots Fine Joint**

Distance (ft): **58.9**
Structural Grade: **0**
O&M Grade: **1**
Clock Start/From: **8**
Clock To: **4**
1st Value:
2nd Value:
Value Percent:
Continuous Index: **S04**
Within 8" of Joint: **YES**
Remarks:

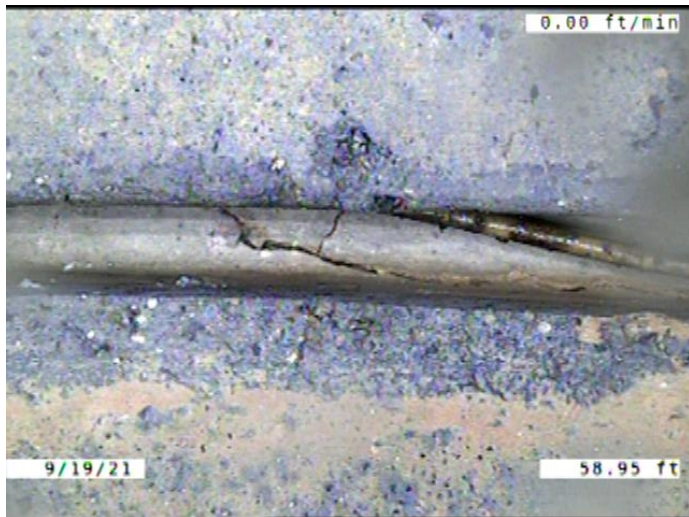
Code: **CM**
 Description: **Crack Multiple**

Distance (ft): **58.9**
 Structural Grade: **3**
 O&M Grade: **0**
 Clock Start/From: **12**
 Clock To: **4**
 1st Value:
 2nd Value:
 Value Percent:
 Continuous Index:
 Within 8" of Joint: **YES**
 Remarks:

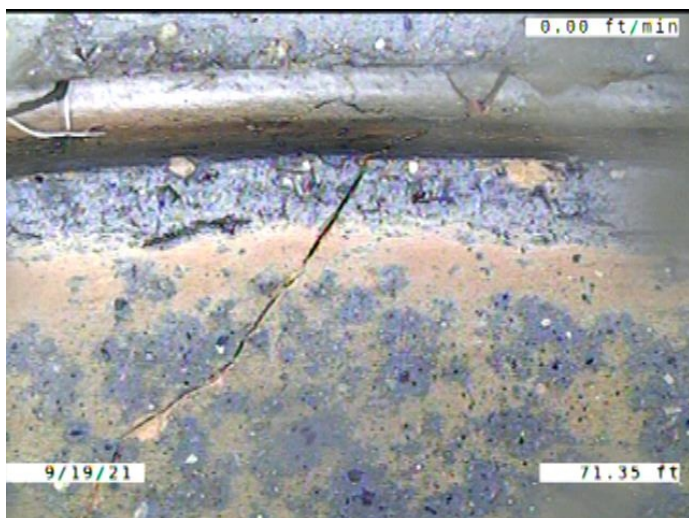
Code: **FM**
 Description: **Fracture Multiple**

Distance (ft): **71.4**
 Structural Grade: **4**
 O&M Grade: **0**
 Clock Start/From: **12**
 Clock To: **12**
 1st Value:
 2nd Value:
 Value Percent:
 Continuous Index:
 Within 8" of Joint: **YES**
 Remarks:

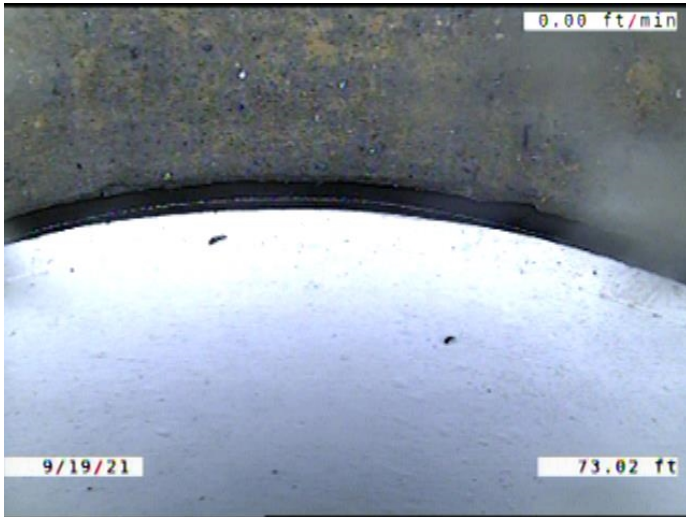
Code: **JOM**
Description: **Joint Offset Medium**

Distance (ft): **73.0**
Structural Grade: **3**
O&M Grade: **0**
Clock Start/From:
Clock To:
1st Value:
2nd Value:
Value Percent:
Continuous Index:
Within 8" of Joint: **NO**
Remarks:

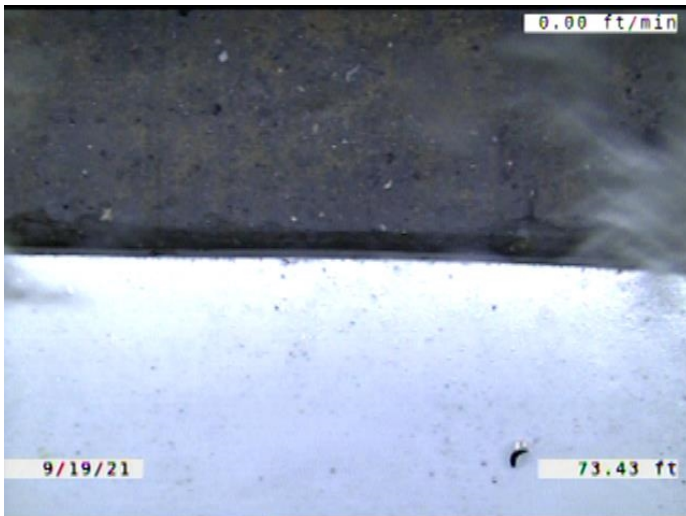
Code: **MMC**
Description: **Miscellaneous Material Change**

Distance (ft): **73.4**
Structural Grade: **0**
O&M Grade: **0**
Clock Start/From:
Clock To:
1st Value:
2nd Value:
Value Percent:
Continuous Index:
Within 8" of Joint: **NO**
Remarks: **VCP TO PVC**

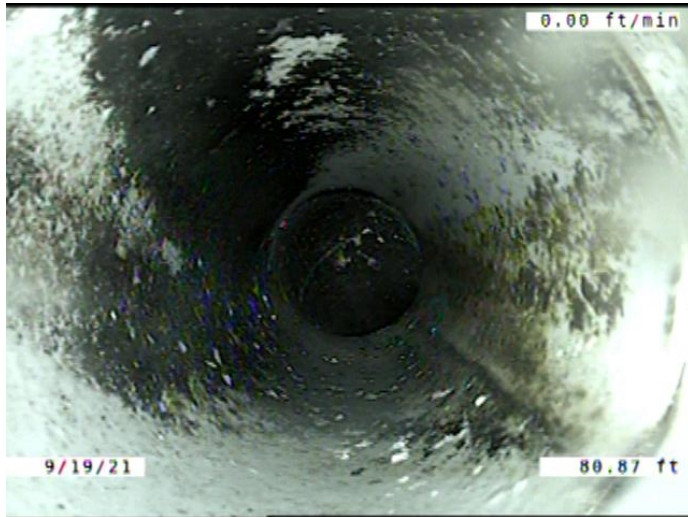
Code: **TF**
 Description: **Tap Factory**

Distance (ft): **80.9**
 Structural Grade: **0**
 O&M Grade: **0**
 Clock Start/From: **1**
 Clock To:
 1st Value: **4.000**
 2nd Value:
 Value Percent:
 Continuous Index:
 Within 8" of Joint: **YES**
 Remarks:

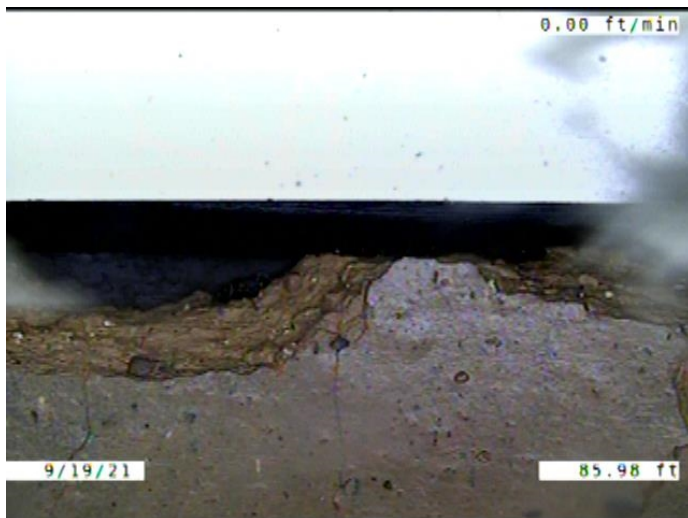
Code: **MMC**
 Description: **Miscellaneous Material Change**

Distance (ft): **86.0**
 Structural Grade: **0**
 O&M Grade: **0**
 Clock Start/From:
 Clock To:
 1st Value:
 2nd Value:
 Value Percent:
 Continuous Index:
 Within 8" of Joint: **NO**
 Remarks: **PVC TO VCP**

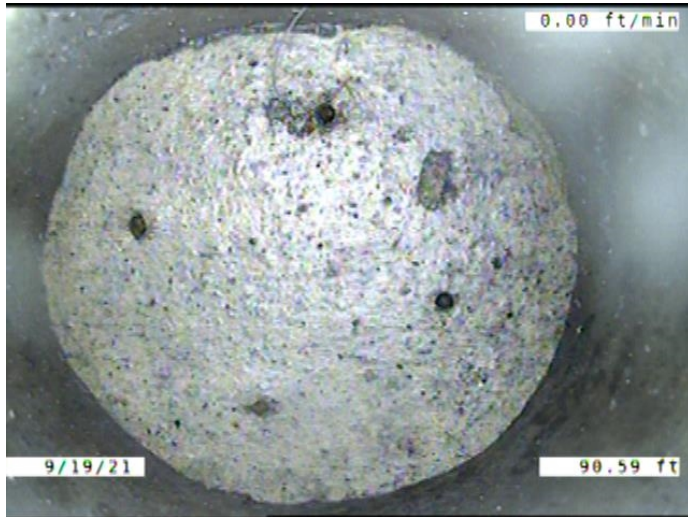
Code: **TFC**
 Description: **Tap Factory Capped**

Distance (ft): **90.6**
 Structural Grade: **0**
 O&M Grade: **0**
 Clock Start/From: **11**
 Clock To:
 1st Value: **4.000**
 2nd Value:
 Value Percent:
 Continuous Index:
 Within 8" of Joint: **YES**
 Remarks:

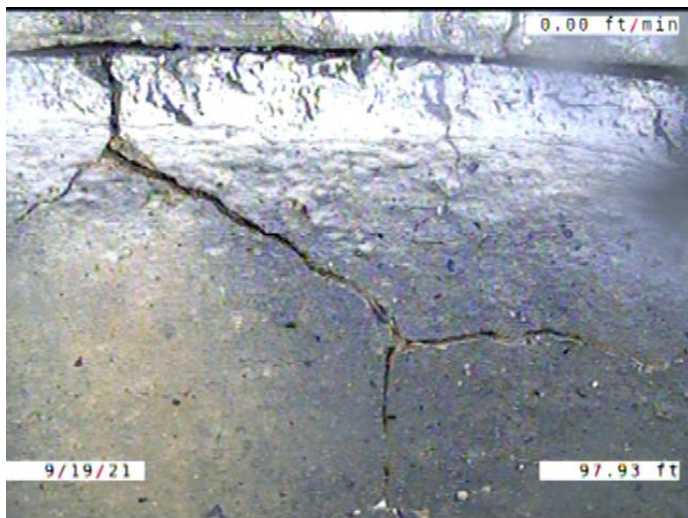
Code: **FM**
 Description: **Fracture Multiple**

Distance (ft): **97.9**
 Structural Grade: **4**
 O&M Grade: **0**
 Clock Start/From: **10**
 Clock To: **2**
 1st Value:
 2nd Value:
 Value Percent:
 Continuous Index: **S05**
 Within 8" of Joint: **YES**
 Remarks:

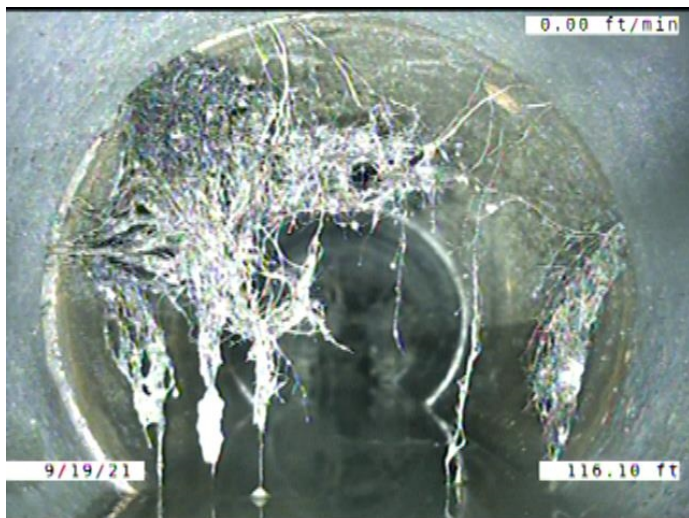
Code: **RMJ**
 Description: **Roots Medium Joint**

Distance (ft): **116.1**
 Structural Grade: **0**
 O&M Grade: **3**
 Clock Start/From: **9**
 Clock To: **3**
 1st Value:
 2nd Value:
 Value Percent: **10.000**
 Continuous Index:
 Within 8" of Joint: **YES**
 Remarks:

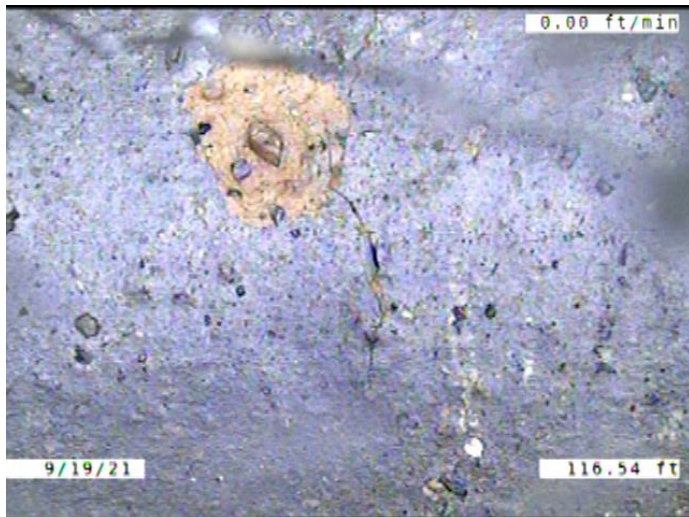
Code: **SSS**
 Description: **Surface Damage Surface Spalling**

Distance (ft): **116.5**
 Structural Grade: **2**
 O&M Grade: **0**
 Clock Start/From: **1**
 Clock To:
 1st Value:
 2nd Value:
 Value Percent:
 Continuous Index:
 Within 8" of Joint: **YES**
 Remarks:

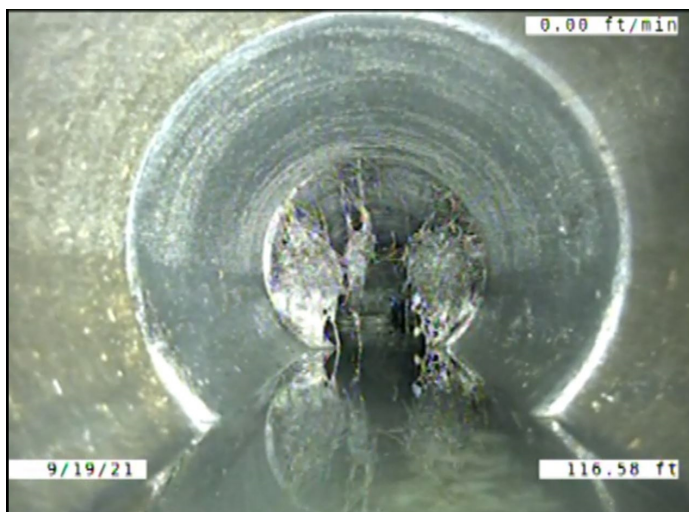
Code: **FM**
 Description: **Fracture Multiple**

Distance (ft): **116.6**
 Structural Grade: **4**
 O&M Grade: **0**
 Clock Start/From: **10**
 Clock To: **2**
 1st Value:
 2nd Value:
 Value Percent:
 Continuous Index: **F05**
 Within 8" of Joint: **YES**
 Remarks:

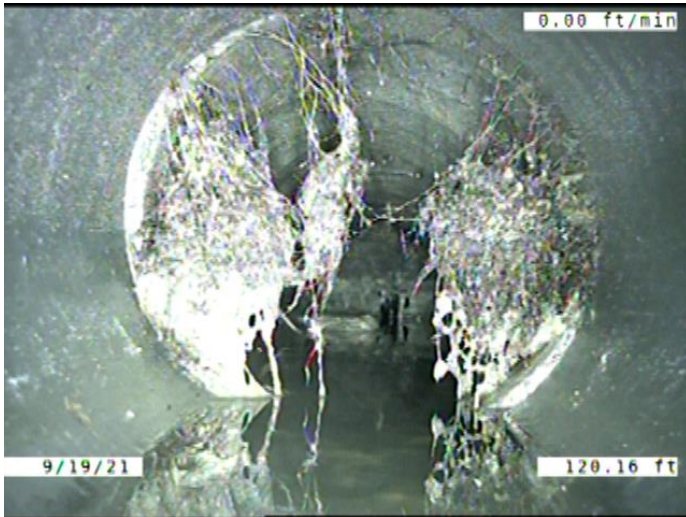
Code: **RMJ**
Description: **Roots Medium Joint**

Distance (ft): **120.2**
Structural Grade: **0**
O&M Grade: **3**
Clock Start/From: **7**
Clock To: **4**
1st Value:
2nd Value:
Value Percent: **20.000**
Continuous Index:
Within 8" of Joint: **YES**
Remarks:

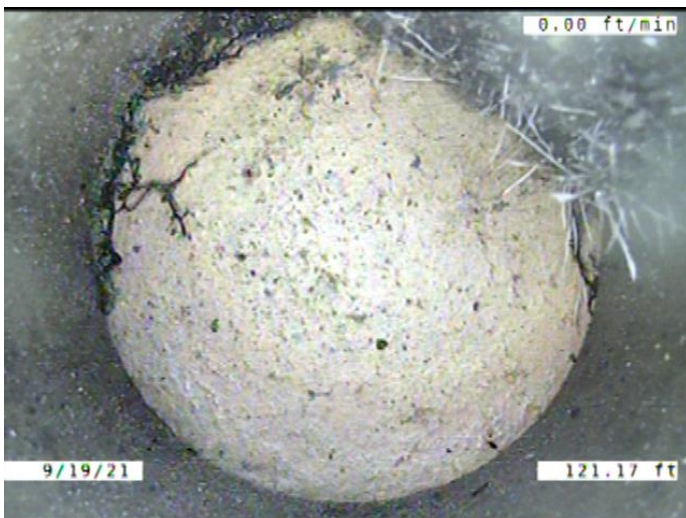
Code: **TFD**
Description: **Tap Factory Defective**

Distance (ft): **121.2**
Structural Grade: **0**
O&M Grade: **3**
Clock Start/From: **1**
Clock To:
1st Value: **4.000**
2nd Value:
Value Percent:
Continuous Index:
Within 8" of Joint: **YES**
Remarks: **CAPPED. ROOTS GROWING AROUND THE CAP**

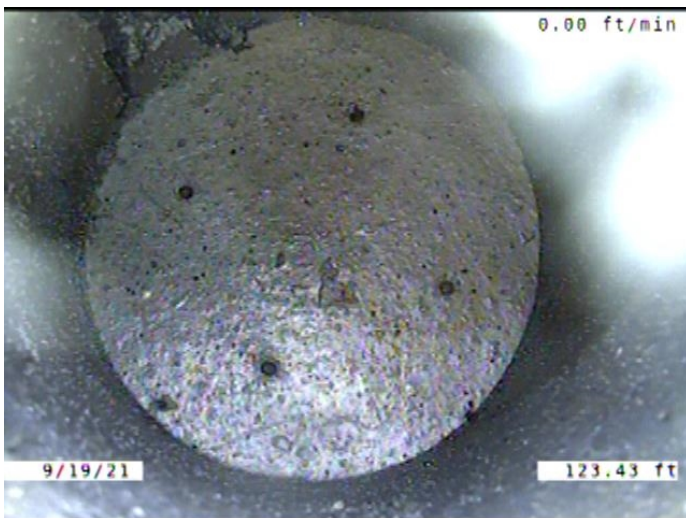
Code: **TFC**
Description: **Tap Factory Capped**

Distance (ft): **123.4**
Structural Grade: **0**
O&M Grade: **0**
Clock Start/From: **11**
Clock To:
1st Value: **4.000**
2nd Value:
Value Percent:
Continuous Index:
Within 8" of Joint: **YES**
Remarks: **ROOTS STARTING TO GROW
AROUND THE CAP**

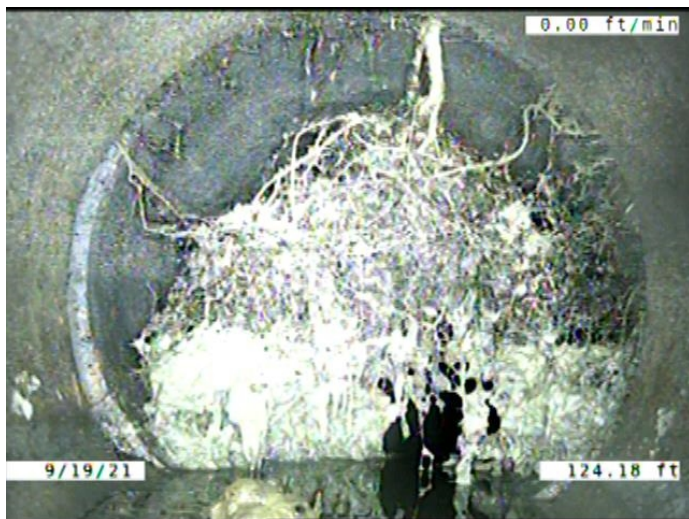
Code: **RBJ**
 Description: **Roots Ball Joint**

Distance (ft): **124.2**
 Structural Grade: **0**
 O&M Grade: **4**
 Clock Start/From: **7**
 Clock To: **5**
 1st Value:
 2nd Value:
 Value Percent: **80.000**
 Continuous Index:
 Within 8" of Joint: **YES**
 Remarks:

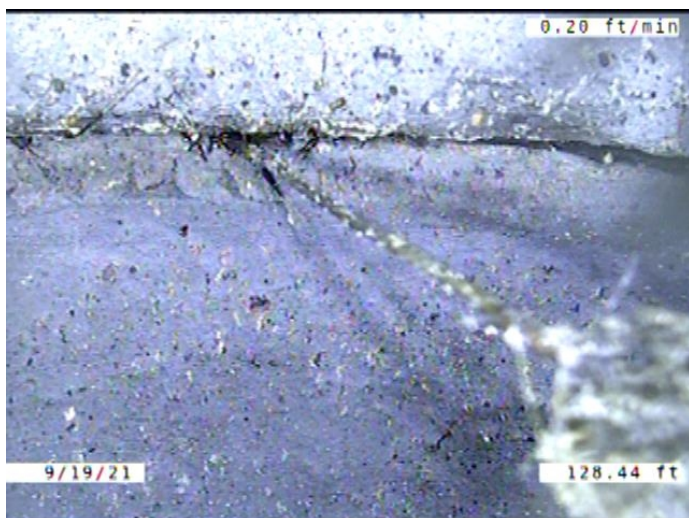
Code: **RFJ**
 Description: **Roots Fine Joint**

Distance (ft): **128.4**
 Structural Grade: **0**
 O&M Grade: **1**
 Clock Start/From: **9**
 Clock To: **3**
 1st Value:
 2nd Value:
 Value Percent:
 Continuous Index:
 Within 8" of Joint: **YES**
 Remarks:

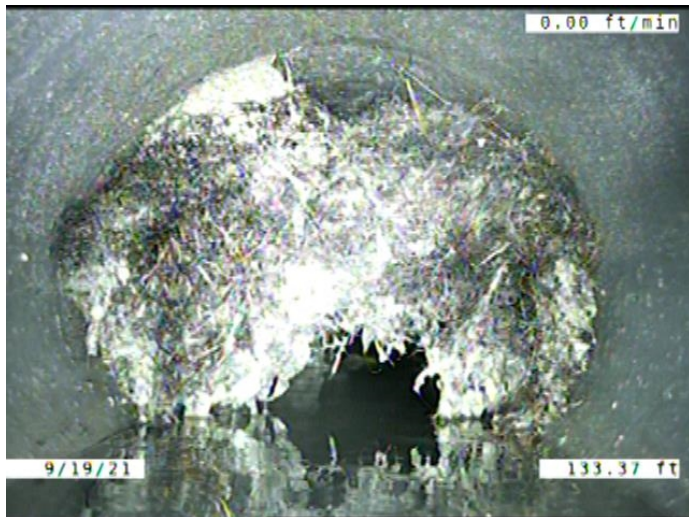
Code: **DSF**
 Description: **Deposits Settled Fine**

Distance (ft): **133.4**
 Structural Grade: **0**
 O&M Grade: **2**
 Clock Start/From: **5**
 Clock To: **7**
 1st Value:
 2nd Value:
 Value Percent: **5.000**
 Continuous Index: **F02**
 Within 8" of Joint: **YES**
 Remarks:

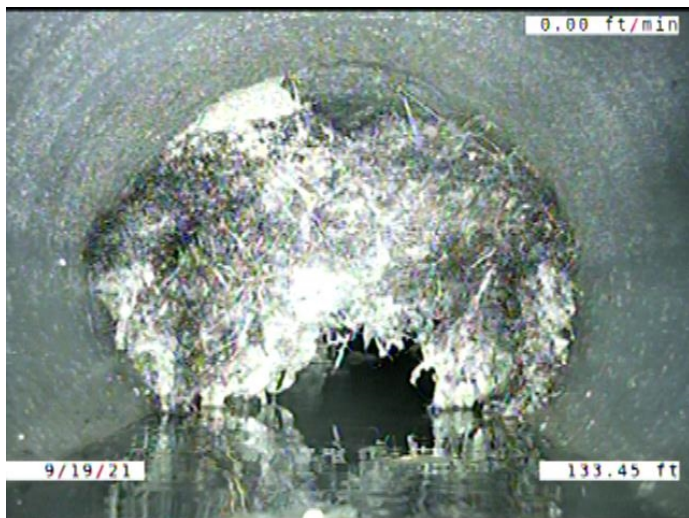
Code: **MSA**
 Description: **Miscellaneous Survey Abandoned**

Distance (ft): **133.5**
 Structural Grade: **0**
 O&M Grade: **0**
 Clock Start/From:
 Clock To:
 1st Value:
 2nd Value:
 Value Percent:
 Continuous Index:
 Within 8" of Joint: **NO**
 Remarks: **CAMERA CANT MAKE IT PAST ROOTS**
