Profile/Photo Observation Report

Date:	09/19/2021	Weather:		Coding:	PACP 7.0
Pipe Length (ft):	194.0	Owner:	City of Hobart	Pre Clean:	Heavy Cleaning
P.O.#:	YES502259	Surveyor:	S. Bucklin	PSR:	P-503-020-019
Customer:	City of Hobart	Clean Date:	09/05/2021	Shape:	C

Street:	West 39th Avenue	Flow Control:	Not Controlled
City:	Hobart, IN	Year Renewed:	
Location:	Alley	Tape/Media #:	
Purpose:	Routine Assessment	Dia/Height:	10"
Use:	Sanitary Sewage Pipe	Material:	VCP
Drain Area:		Lining:	None
Category:	NA		
Comment:			
Location Details:		Direction of Survey:	Downstream
US MH:	M-503-019	DS MH:	M-503-020
		Total Length Surveyed (ft):	133.5

M-503-020

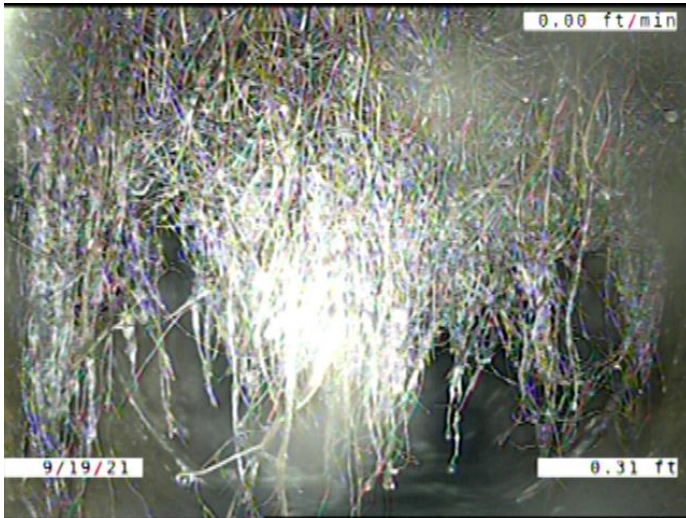
Code: **RBC**
Description: **Roots Ball Connection**

Distance (ft): **.3**
Structural Grade: **0**
O&M Grade: **4**
Clock Start/From: **8**
Clock To: **4**
1st Value:
2nd Value:
Value Percent: **70.000**
Continuous Index:
Within 8" of Joint: **NO**
Remarks:

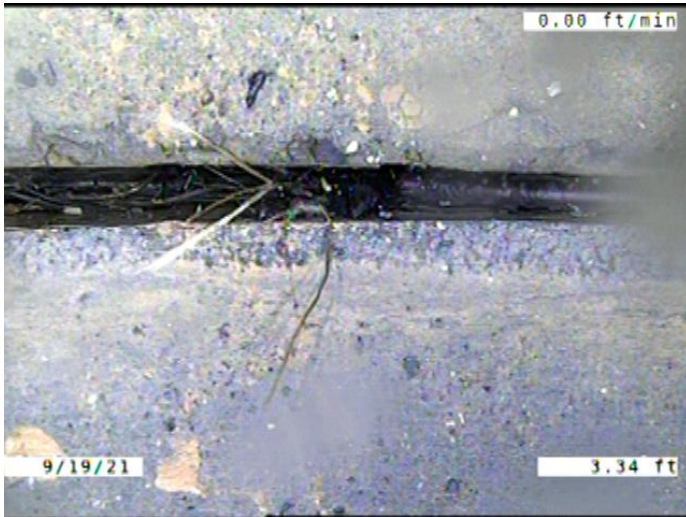
Code: **RFJ**
 Description: **Roots Fine Joint**

Distance (ft): **3.3**
 Structural Grade: **0**
 O&M Grade: **1**
 Clock Start/From: **8**
 Clock To: **4**
 1st Value:
 2nd Value:
 Value Percent:
 Continuous Index: **S01**
 Within 8" of Joint: **YES**
 Remarks:

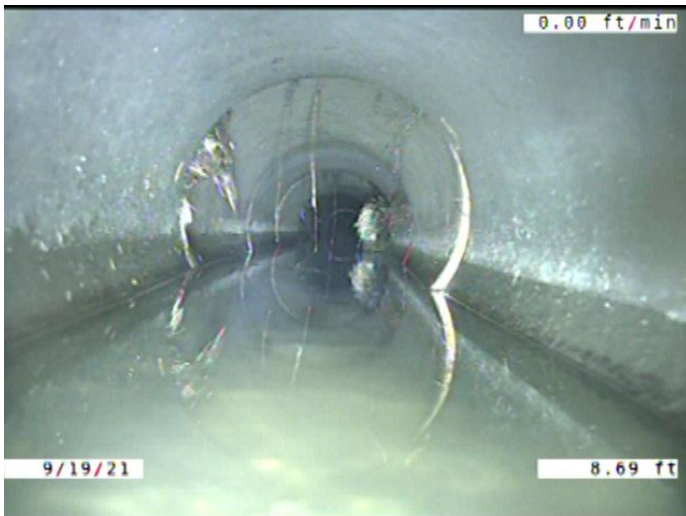
Code: **DSF**
 Description: **Deposits Settled Fine**

Distance (ft): **8.7**
 Structural Grade: **0**
 O&M Grade: **2**
 Clock Start/From: **5**
 Clock To: **7**
 1st Value:
 2nd Value:
 Value Percent: **5.000**
 Continuous Index: **S02**
 Within 8" of Joint: **YES**
 Remarks:

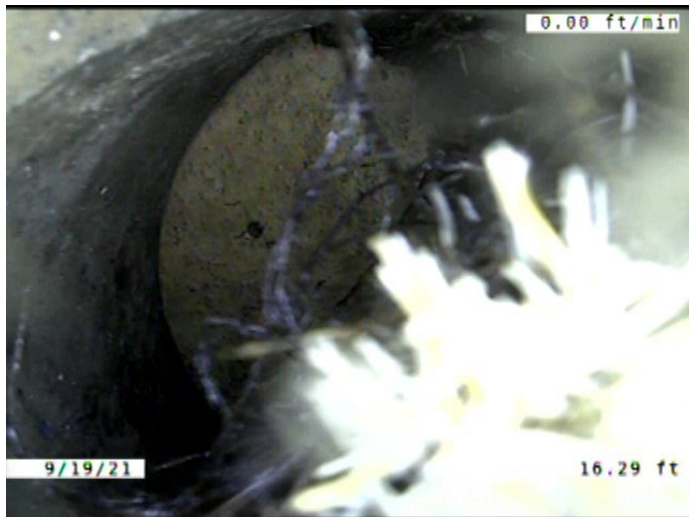
Code: **TFD**
 Description: **Tap Factory Defective**

Distance (ft): **16.3**
 Structural Grade: **0**
 O&M Grade: **3**
 Clock Start/From: **1**
 Clock To:
 1st Value: **4.000**
 2nd Value:
 Value Percent:
 Continuous Index:
 Within 8" of Joint: **YES**
 Remarks: **CAPPED. ROOTS GROWING INTO THE MAIN**

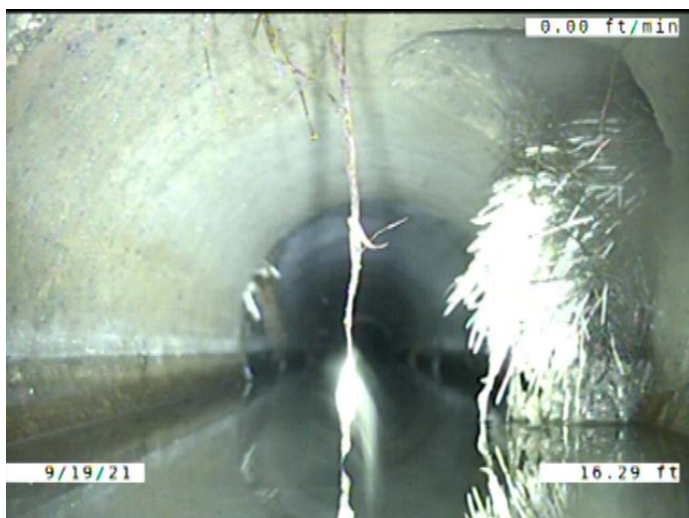
Code: **RML**
 Description: **Roots Medium Lateral**

Distance (ft): **16.3**
 Structural Grade: **0**
 O&M Grade: **3**
 Clock Start/From: **2**
 Clock To: **4**
 1st Value:
 2nd Value:
 Value Percent: **10.000**
 Continuous Index:
 Within 8" of Joint: **NO**
 Remarks:

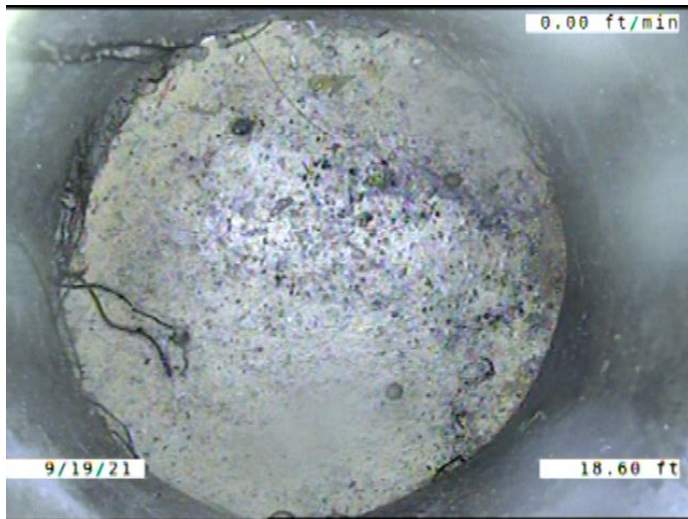
Code:	TFD
Description:	Tap Factory Defective
Distance (ft):	18.6
Structural Grade:	0
O&M Grade:	3
Clock Start/From:	11
Clock To:	
1st Value:	4.000
2nd Value:	
Value Percent:	
Continuous Index:	
Within 8" of Joint:	YES
Remarks:	CAPPED. ROOTS GROWING AROUND THE CAP

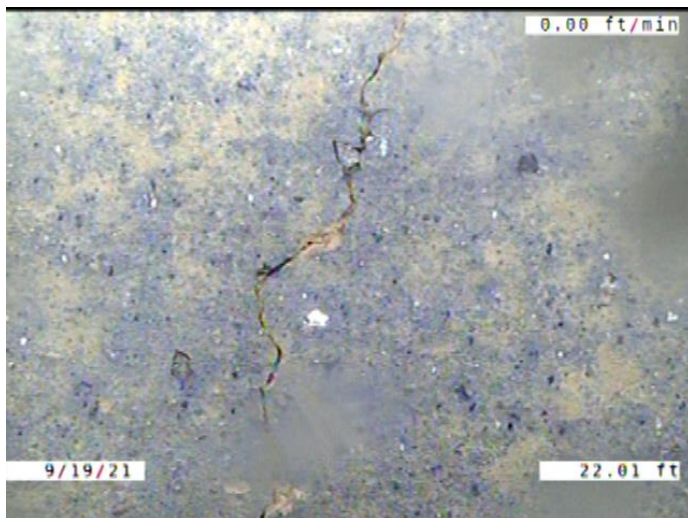
Code:	FM
Description:	Fracture Multiple
Distance (ft):	22.0
Structural Grade:	4
O&M Grade:	0
Clock Start/From:	9
Clock To:	3
1st Value:	
2nd Value:	
Value Percent:	
Continuous Index:	
Within 8" of Joint:	YES
Remarks:

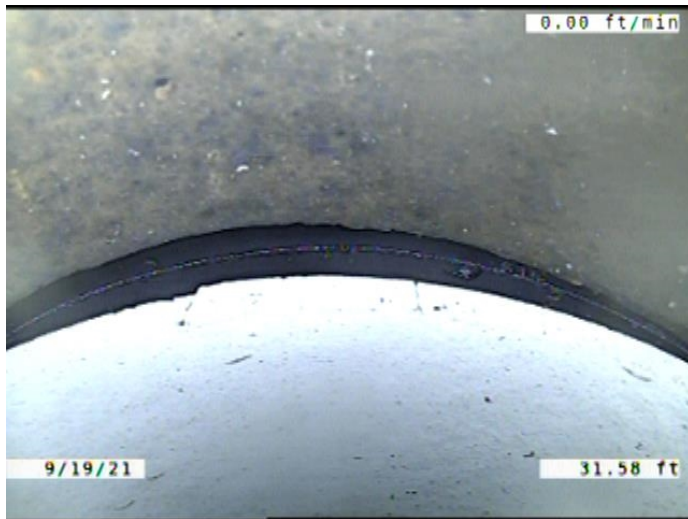
Code: **JOM**
 Description: **Joint Offset Medium**

Distance (ft): **31.6**
 Structural Grade: **3**
 O&M Grade: **0**
 Clock Start/From:
 Clock To:
 1st Value:
 2nd Value:
 Value Percent:
 Continuous Index:
 Within 8" of Joint: **NO**
 Remarks:

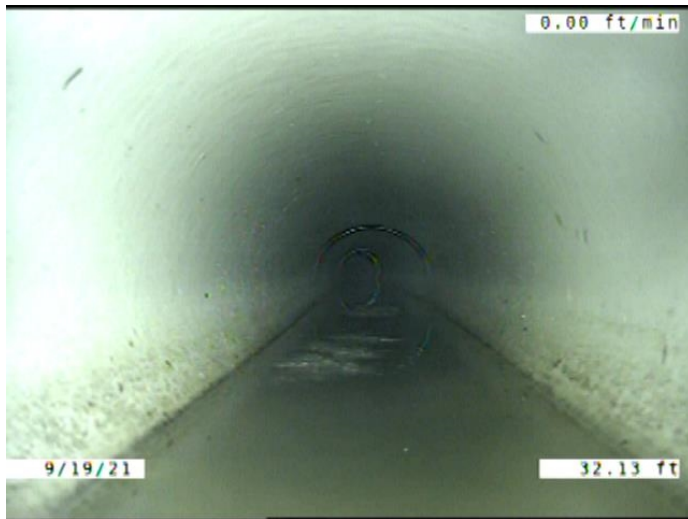
Code: **RFJ**
Description: **Roots Fine Joint**

Distance (ft): **32.1**
Structural Grade: **0**
O&M Grade: **1**
Clock Start/From: **8**
Clock To: **4**
1st Value:
2nd Value:
Value Percent:
Continuous Index: **F01**
Within 8" of Joint: **YES**
Remarks:

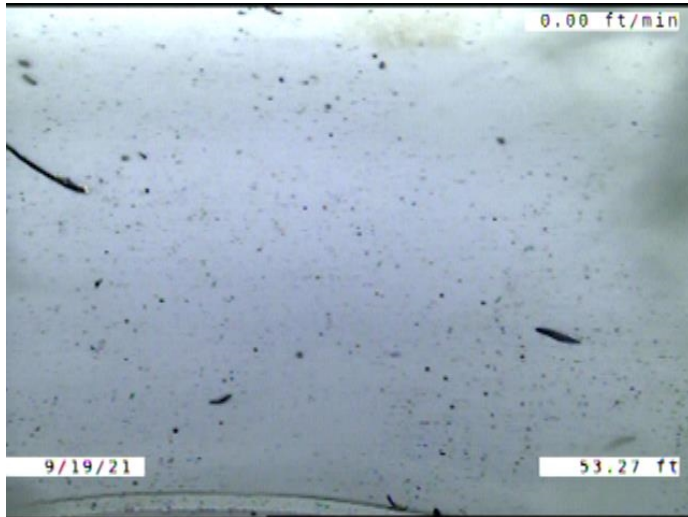
Code: **MGO**
 Description: **Miscellaneous General Observation**

Distance (ft): **53.3**
 Structural Grade: **0**
 O&M Grade: **0**
 Clock Start/From:
 Clock To:
 1st Value:
 2nd Value:
 Value Percent:
 Continuous Index:
 Within 8" of Joint: **NO**
 Remarks: **JOINT/ PIPES NOT PUSHED ALL THE WAY TOGETHER WHEN INSTALLED**

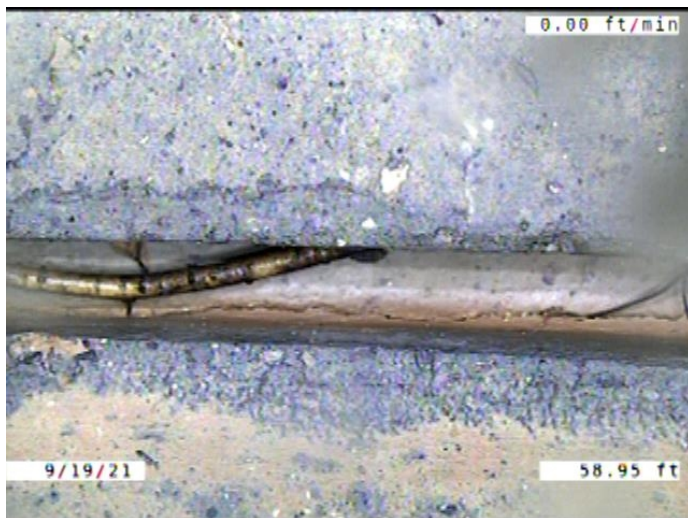
Code: **RFJ**
 Description: **Roots Fine Joint**

Distance (ft): **58.9**
 Structural Grade: **0**
 O&M Grade: **1**
 Clock Start/From: **8**
 Clock To: **4**
 1st Value:
 2nd Value:
 Value Percent:
 Continuous Index: **S04**
 Within 8" of Joint: **YES**
 Remarks:

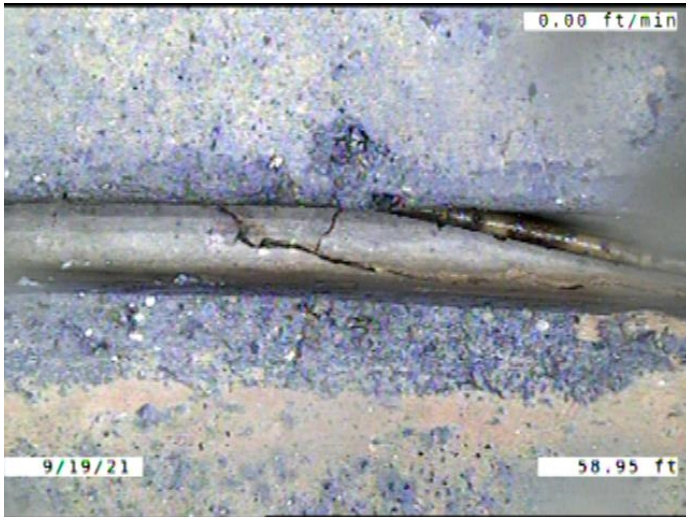
Code: **CM**
 Description: **Crack Multiple**

Distance (ft): **58.9**
 Structural Grade: **3**
 O&M Grade: **0**
 Clock Start/From: **12**
 Clock To: **4**
 1st Value:
 2nd Value:
 Value Percent:
 Continuous Index:
 Within 8" of Joint: **YES**
 Remarks:

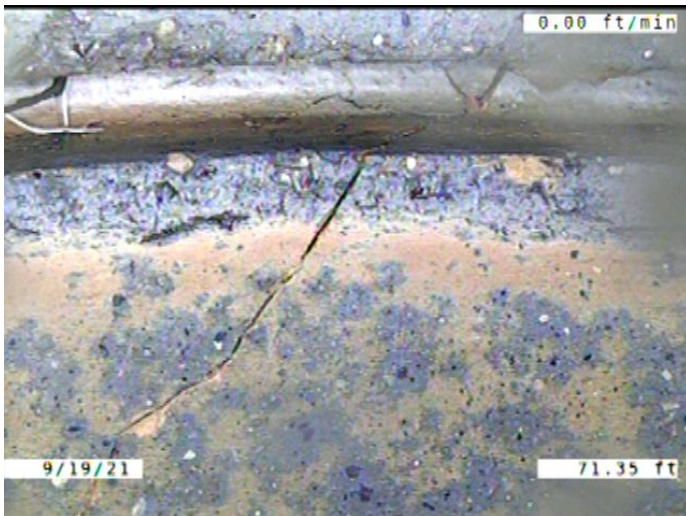
Code: **FM**
 Description: **Fracture Multiple**

Distance (ft): **71.4**
 Structural Grade: **4**
 O&M Grade: **0**
 Clock Start/From: **12**
 Clock To: **12**
 1st Value:
 2nd Value:
 Value Percent:
 Continuous Index:
 Within 8" of Joint: **YES**
 Remarks:

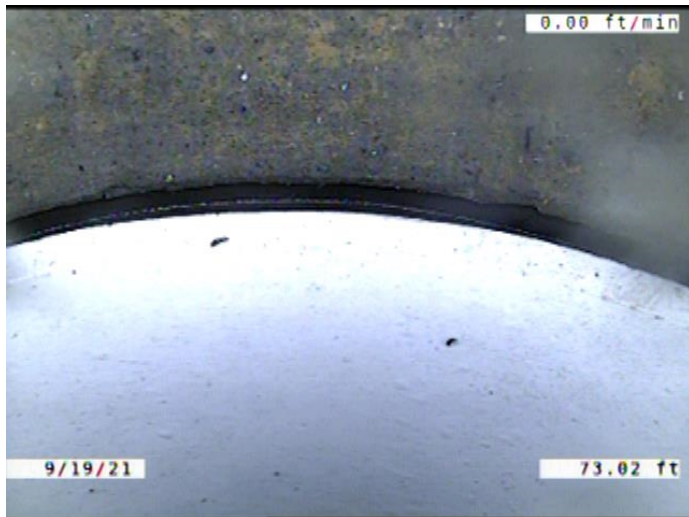
Code: **JOM**
 Description: **Joint Offset Medium**

Distance (ft): **73.0**
 Structural Grade: **3**
 O&M Grade: **0**
 Clock Start/From:
 Clock To:
 1st Value:
 2nd Value:
 Value Percent:
 Continuous Index:
 Within 8" of Joint: **NO**
 Remarks:

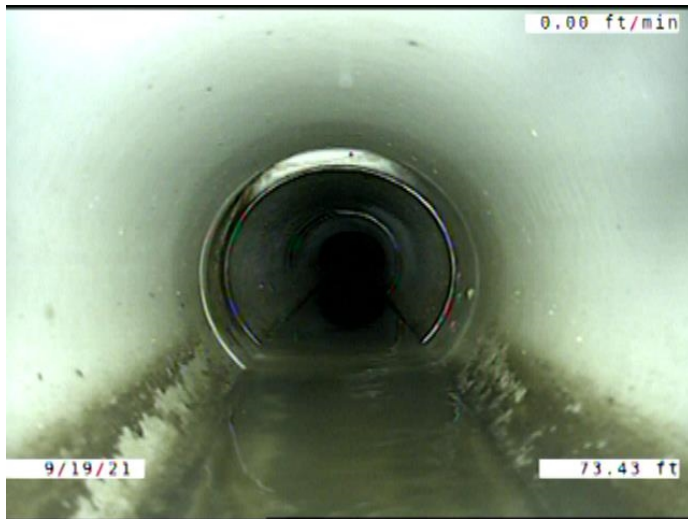
Code: **RFJ**
 Description: **Roots Fine Joint**

Distance (ft): **73.4**
 Structural Grade: **0**
 O&M Grade: **1**
 Clock Start/From: **8**
 Clock To: **4**
 1st Value:
 2nd Value:
 Value Percent:
 Continuous Index: **F04**
 Within 8" of Joint: **YES**
 Remarks:

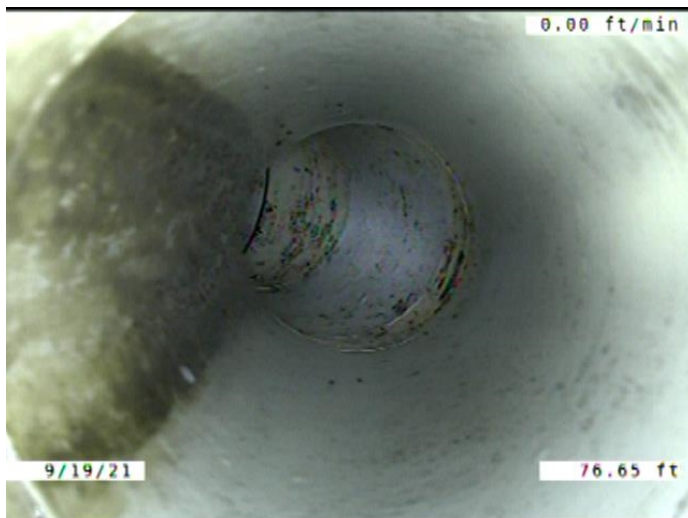
Code: **TF**
 Description: **Tap Factory**

Distance (ft): **76.7**
 Structural Grade: **0**
 O&M Grade: **0**
 Clock Start/From: **11**
 Clock To:
 1st Value: **4.000**
 2nd Value:
 Value Percent:
 Continuous Index:
 Within 8" of Joint: **YES**
 Remarks: **CONSTANTLY RUNNING WATER**

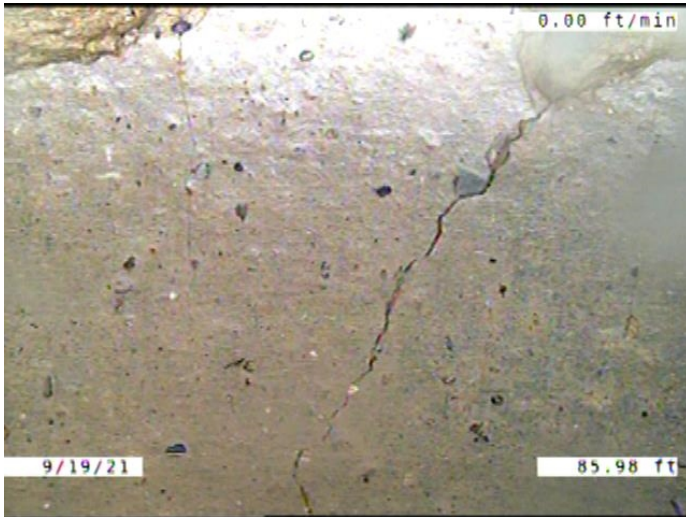
Code: **CM**
 Description: **Crack Multiple**

Distance (ft): **86.0**
 Structural Grade: **3**
 O&M Grade: **0**
 Clock Start/From: **12**
 Clock To: **12**
 1st Value:
 2nd Value:
 Value Percent:
 Continuous Index:
 Within 8" of Joint: **YES**
 Remarks:

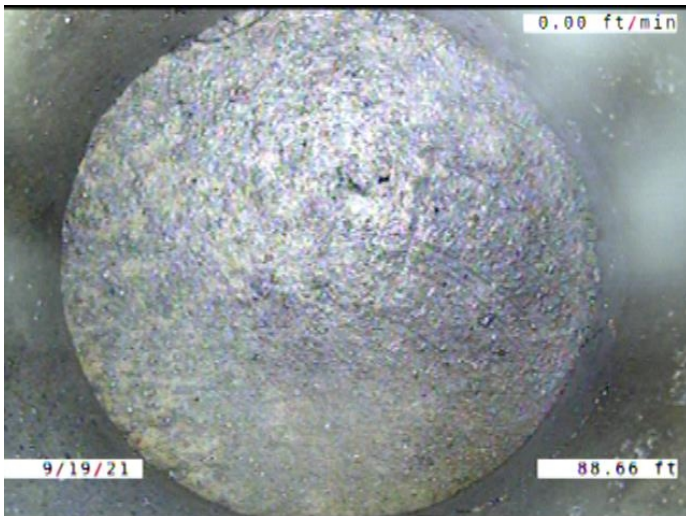
Code: **TFD**
 Description: **Tap Factory Defective**

Distance (ft): **88.7**
 Structural Grade: **0**
 O&M Grade: **3**
 Clock Start/From: **2**
 Clock To:
 1st Value: **4.000**
 2nd Value:
 Value Percent:
 Continuous Index:
 Within 8" of Joint: **YES**
 Remarks: **CAPPED**

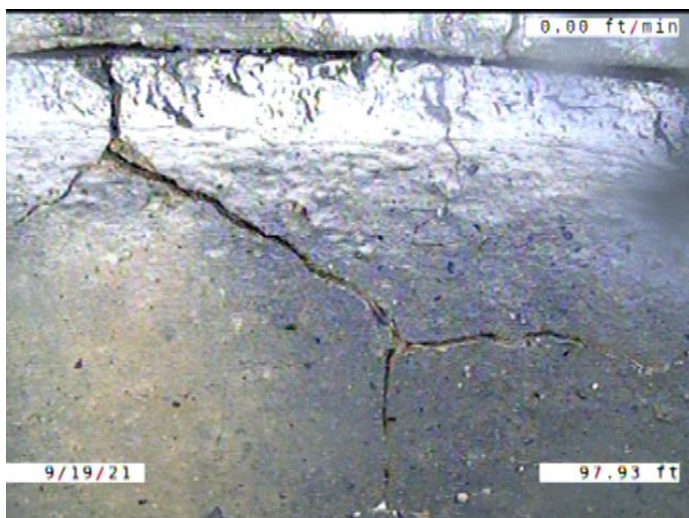
Code: **FM**
 Description: **Fracture Multiple**

Distance (ft): **97.9**
 Structural Grade: **4**
 O&M Grade: **0**
 Clock Start/From: **10**
 Clock To: **2**
 1st Value:
 2nd Value:
 Value Percent:
 Continuous Index: **S05**
 Within 8" of Joint: **YES**
 Remarks:

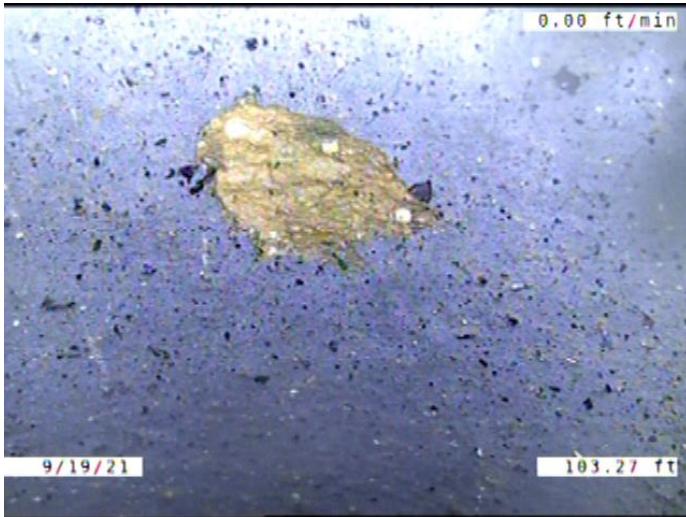
Code: **SSS**
 Description: **Surface Damage Surface Spalling**

Distance (ft): **103.3**
 Structural Grade: **2**
 O&M Grade: **0**
 Clock Start/From: **2**
 Clock To:
 1st Value:
 2nd Value:
 Value Percent:
 Continuous Index:
 Within 8" of Joint: **NO**
 Remarks:

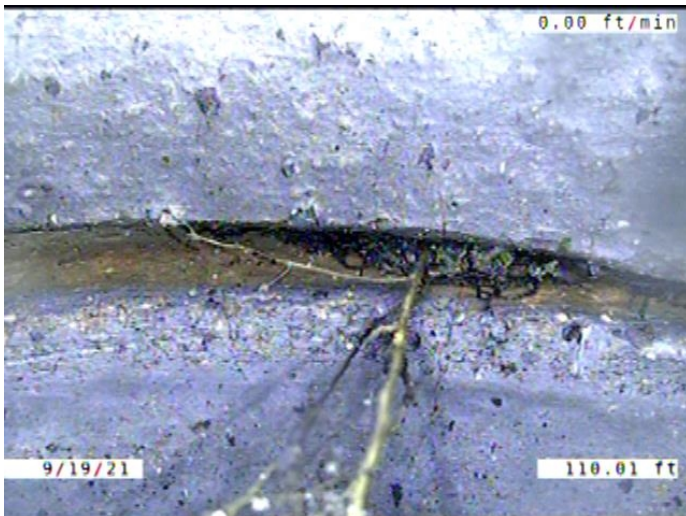
Code: **RFJ**
 Description: **Roots Fine Joint**

Distance (ft): **110.0**
 Structural Grade: **0**
 O&M Grade: **1**
 Clock Start/From: **10**
 Clock To: **2**
 1st Value:
 2nd Value:
 Value Percent:
 Continuous Index:
 Within 8" of Joint: **YES**
 Remarks:

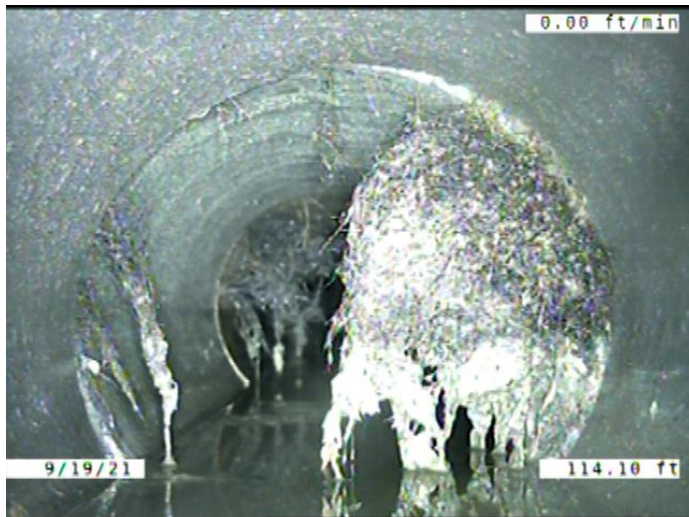
Code: **RMJ**
 Description: **Roots Medium Joint**

Distance (ft): **114.1**
 Structural Grade: **0**
 O&M Grade: **3**
 Clock Start/From: **8**
 Clock To: **5**
 1st Value:
 2nd Value:
 Value Percent: **40.000**
 Continuous Index:
 Within 8" of Joint: **YES**
 Remarks:

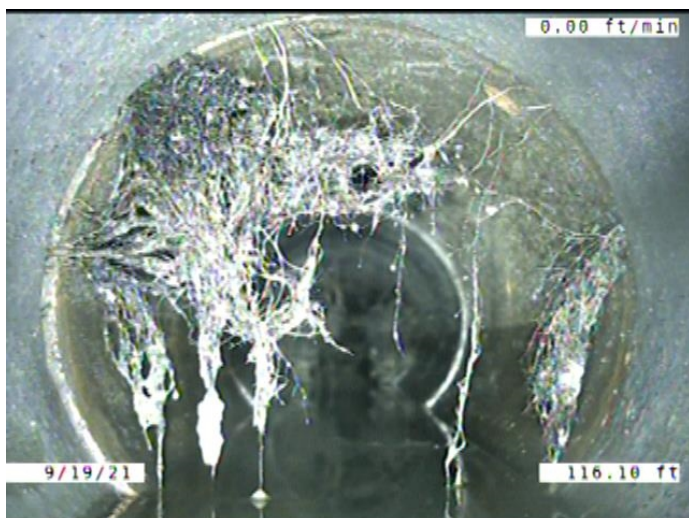
Code: **RMJ**
 Description: **Roots Medium Joint**

Distance (ft): **116.1**
 Structural Grade: **0**
 O&M Grade: **3**
 Clock Start/From: **9**
 Clock To: **3**
 1st Value:
 2nd Value:
 Value Percent: **10.000**
 Continuous Index:
 Within 8" of Joint: **YES**
 Remarks:

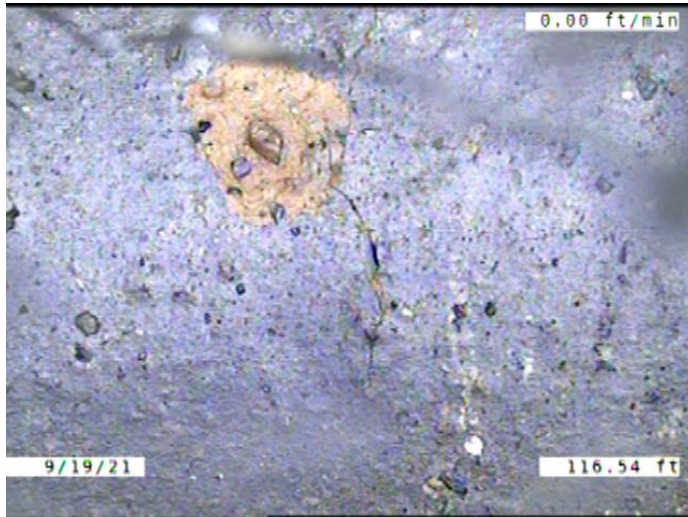
Code:	SSS
Description:	Surface Damage Surface Spalling
Distance (ft):	116.5
Structural Grade:	2
O&M Grade:	0
Clock Start/From:	1
Clock To:	
1st Value:	
2nd Value:	
Value Percent:	
Continuous Index:	
Within 8" of Joint:	YES
Remarks:

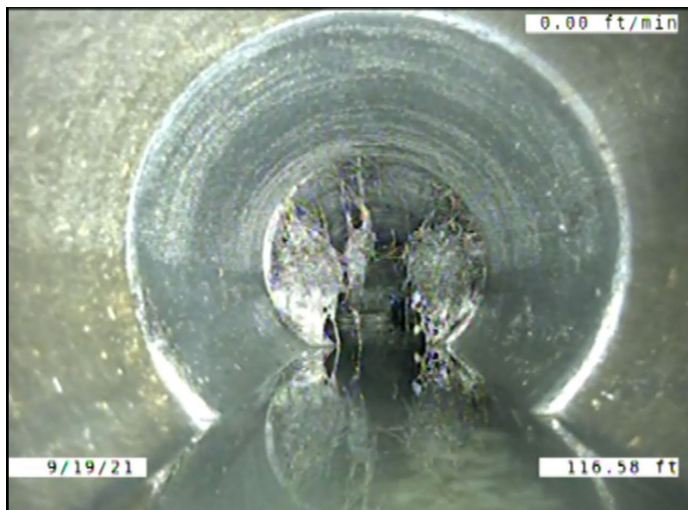
Code:	FM
Description:	Fracture Multiple
Distance (ft):	116.6
Structural Grade:	4
O&M Grade:	0
Clock Start/From:	10
Clock To:	2
1st Value:	
2nd Value:	
Value Percent:	
Continuous Index:	F05
Within 8" of Joint:	YES
Remarks:

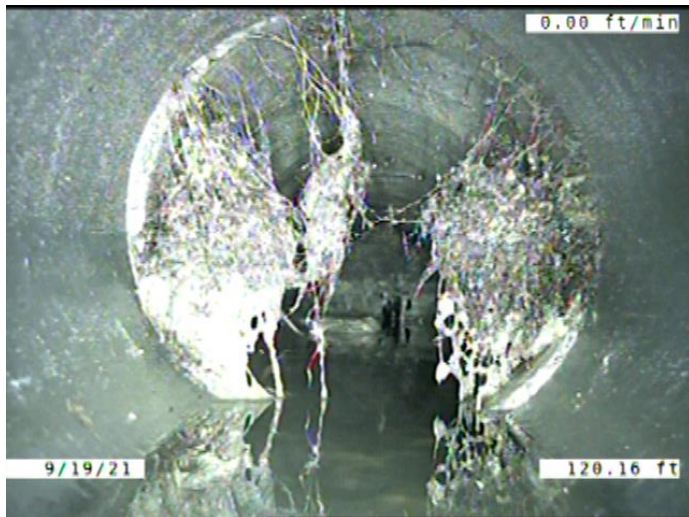
Code: **RMJ**
 Description: **Roots Medium Joint**

Distance (ft): **120.2**
 Structural Grade: **0**
 O&M Grade: **3**
 Clock Start/From: **7**
 Clock To: **4**
 1st Value:
 2nd Value:
 Value Percent: **20.000**
 Continuous Index:
 Within 8" of Joint: **YES**
 Remarks:

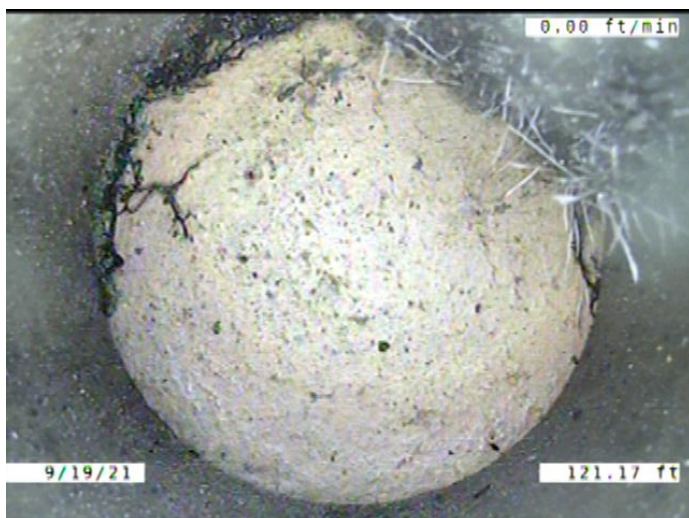
Code: **TFD**
 Description: **Tap Factory Defective**

Distance (ft): **121.2**
 Structural Grade: **0**
 O&M Grade: **3**
 Clock Start/From: **1**
 Clock To:
 1st Value: **4.000**
 2nd Value:
 Value Percent:
 Continuous Index:
 Within 8" of Joint: **YES**
 Remarks: **CAPPED. ROOTS GROWING AROUND THE CAP**

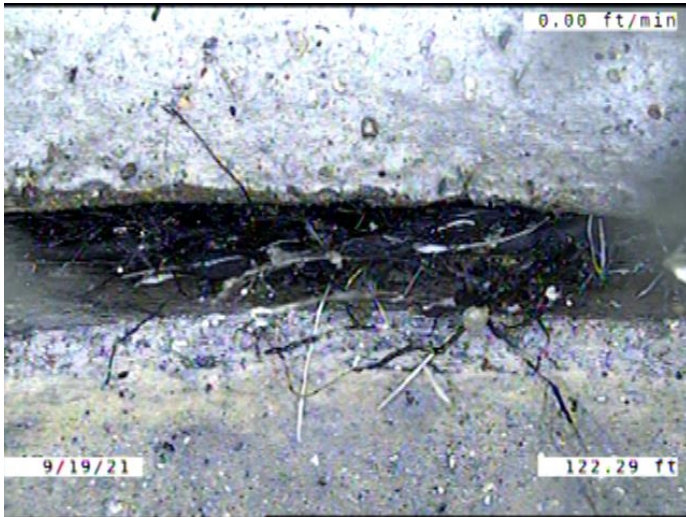
Code: **RFJ**
 Description: **Roots Fine Joint**

Distance (ft): **122.3**
 Structural Grade: **0**
 O&M Grade: **1**
 Clock Start/From: **10**
 Clock To: **3**
 1st Value:
 2nd Value:
 Value Percent:
 Continuous Index:
 Within 8" of Joint: **YES**
 Remarks:

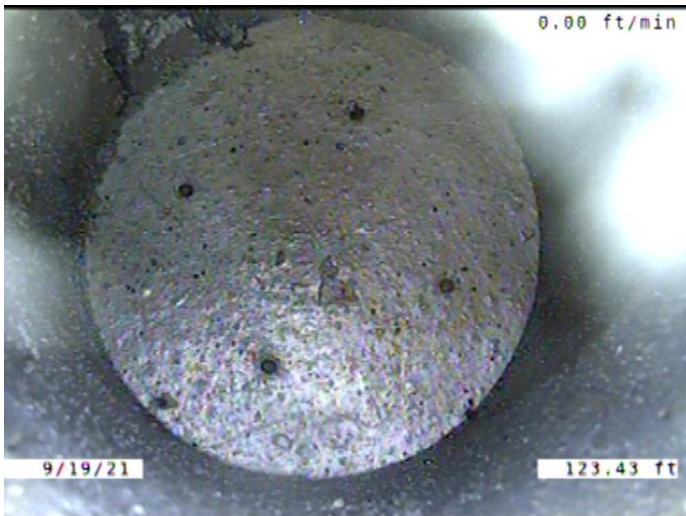
Code: **TFC**
 Description: **Tap Factory Capped**

Distance (ft): **123.4**
 Structural Grade: **0**
 O&M Grade: **0**
 Clock Start/From: **11**
 Clock To:
 1st Value: **4.000**
 2nd Value:
 Value Percent:
 Continuous Index:
 Within 8" of Joint: **YES**
 Remarks: **ROOTS STARTING TO GROW
 AROUND THE CAP**

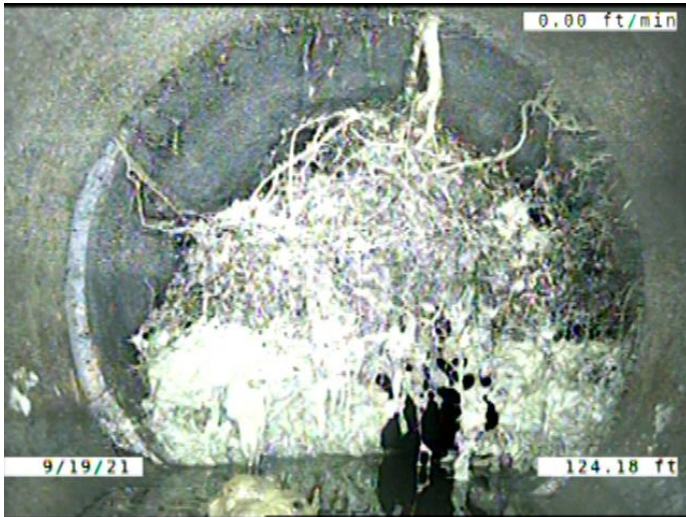
Code: **RBJ**
 Description: **Roots Ball Joint**

Distance (ft): **124.2**
 Structural Grade: **0**
 O&M Grade: **4**
 Clock Start/From: **7**
 Clock To: **5**
 1st Value:
 2nd Value:
 Value Percent: **80.000**
 Continuous Index:
 Within 8" of Joint: **YES**
 Remarks:

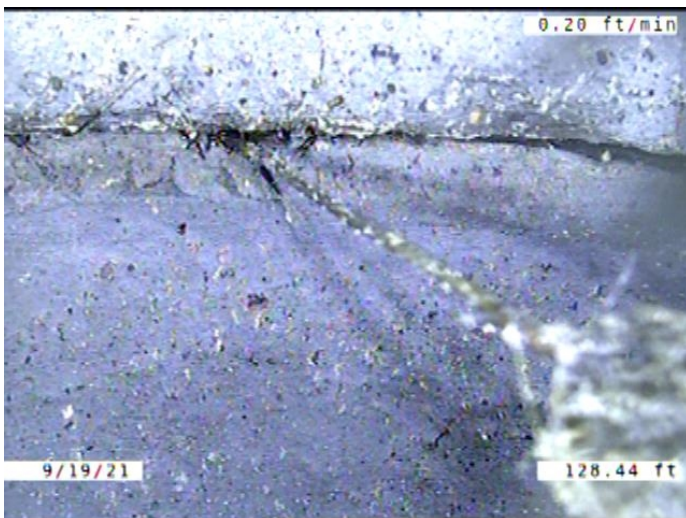
Code: **RFJ**
 Description: **Roots Fine Joint**

Distance (ft): **128.4**
 Structural Grade: **0**
 O&M Grade: **1**
 Clock Start/From: **9**
 Clock To: **3**
 1st Value:
 2nd Value:
 Value Percent:
 Continuous Index:
 Within 8" of Joint: **YES**
 Remarks:

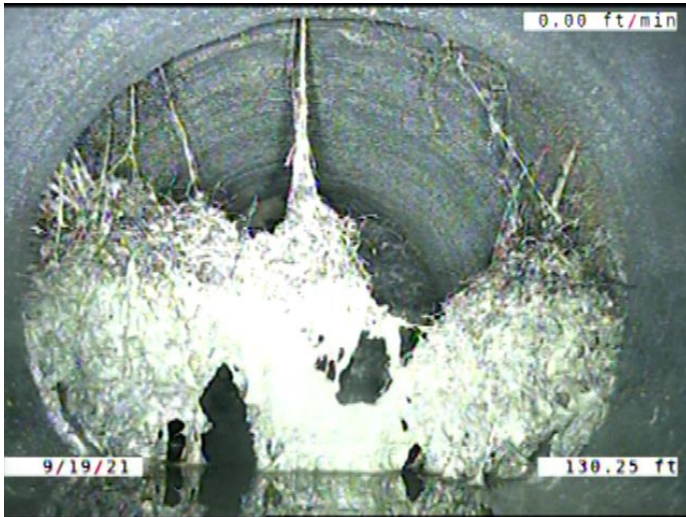
Code: **RMJ**
 Description: **Roots Medium Joint**

Distance (ft): **130.2**
 Structural Grade: **0**
 O&M Grade: **3**
 Clock Start/From: **7**
 Clock To: **5**
 1st Value:
 2nd Value:
 Value Percent: **30.000**
 Continuous Index:
 Within 8" of Joint: **YES**
 Remarks:

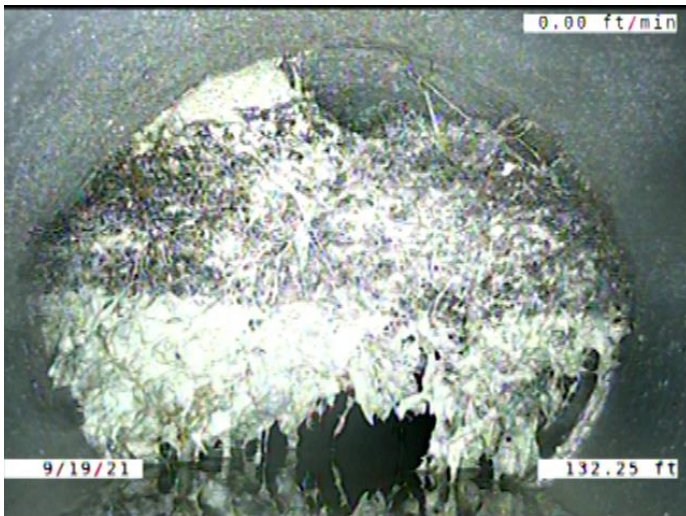
Code: **RBJ**
 Description: **Roots Ball Joint**

Distance (ft): **132.3**
 Structural Grade: **0**
 O&M Grade: **4**
 Clock Start/From: **7**
 Clock To: **4**
 1st Value:
 2nd Value:
 Value Percent: **90.000**
 Continuous Index:
 Within 8" of Joint: **YES**
 Remarks:

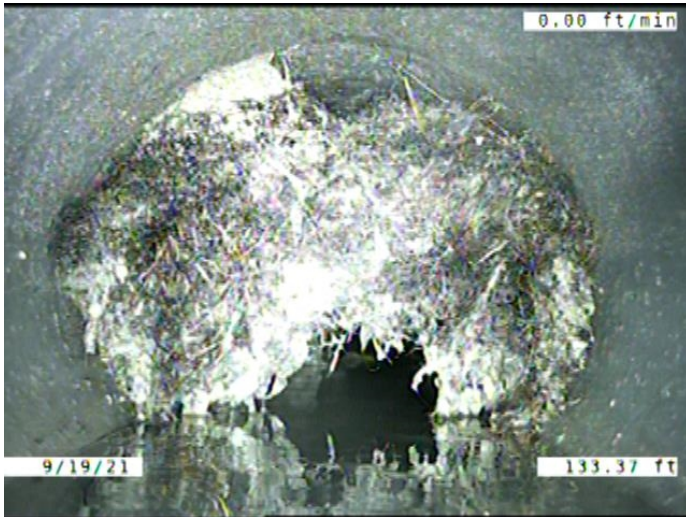
Code: **DSF**
 Description: **Deposits Settled Fine**

Distance (ft): **133.4**
 Structural Grade: **0**
 O&M Grade: **2**
 Clock Start/From: **5**
 Clock To: **7**
 1st Value:
 2nd Value:
 Value Percent: **5.000**
 Continuous Index: **F02**
 Within 8" of Joint: **YES**
 Remarks:

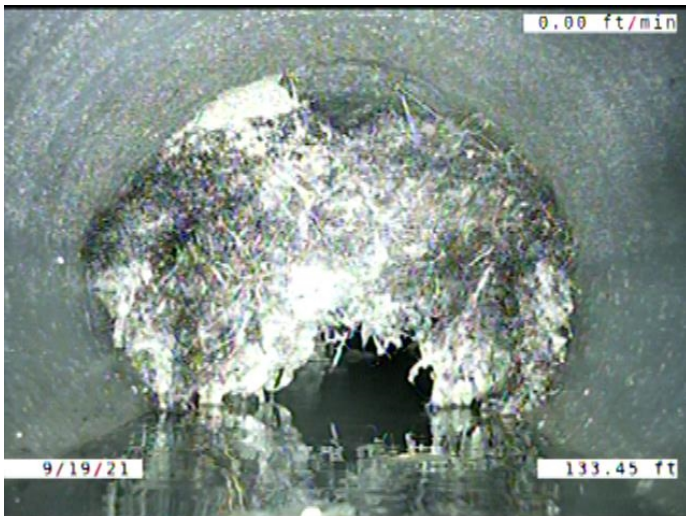
Code: **MSA**
 Description: **Miscellaneous Survey Abandoned**

Distance (ft): **133.5**
 Structural Grade: **0**
 O&M Grade: **0**
 Clock Start/From:
 Clock To:
 1st Value:
 2nd Value:
 Value Percent:
 Continuous Index:
 Within 8" of Joint: **NO**
 Remarks: **CAMERA CANT MAKE IT PAST ROOTS**
