Profile/Photo Observation Report

Date:	10/20/2021	Weather:		Coding:	PACP 7.0
Pipe Length (ft):	194.0	Owner:	City of Hobart	Pre Clean:	Heavy Cleaning
P.O.#:	YES502259	Surveyor:	S. Bucklin	PSR:	P-503-020-019
Customer:	City of Hobart	Clean Date:	09/05/2021	Shape:	C

Street:	West 39th Avenue	Flow Control:	Not Controlled
City:	Hobart, IN	Year Renewed:	
Location:	Alley	Tape/Media #:	
Purpose:	Routine Assessment	Dia/Height:	10"
Use:	Sanitary Sewage Pipe	Material:	VCP
Drain Area:		Lining:	None
Category:	NA		
Comment:

Location Details:		Direction of Survey:	Upstream
US MH:	M-503-019	DS MH:	M-503-020
		Total Length Surveyed (ft):	50.0

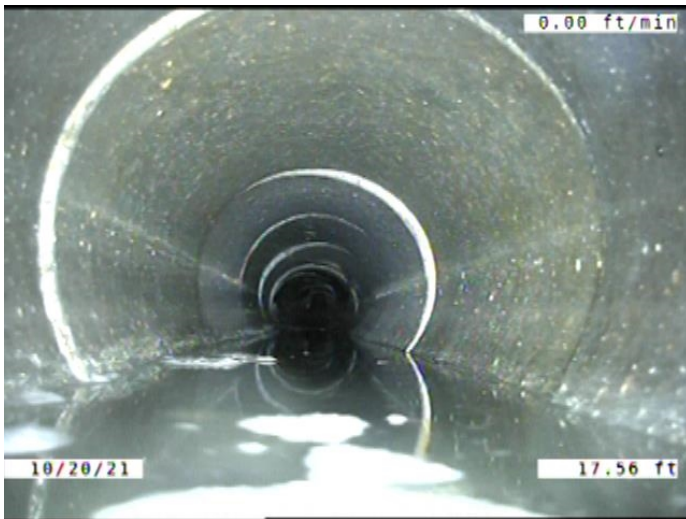
Code: **DSF**
 Description: **Deposits Settled Fine**

Distance (ft): **17.6**
 Structural Grade: **0**
 O&M Grade: **2**
 Clock Start/From: **5**
 Clock To: **7**
 1st Value:
 2nd Value:
 Value Percent: **5.000**
 Continuous Index:
 Within 8" of Joint: **YES**
 Remarks:

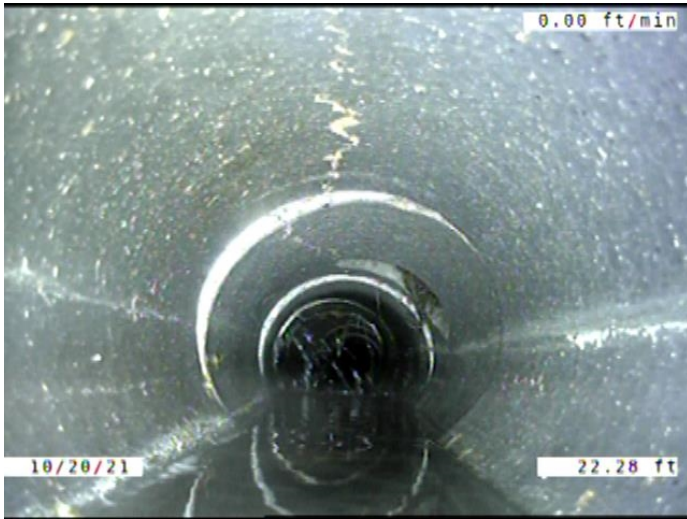
Code: **FM**
Description: **Fracture Multiple**

Distance (ft): **22.3**
Structural Grade: **4**
O&M Grade: **0**
Clock Start/From: **8**
Clock To: **4**
1st Value:
2nd Value:
Value Percent:
Continuous Index:
Within 8" of Joint: **YES**
Remarks:

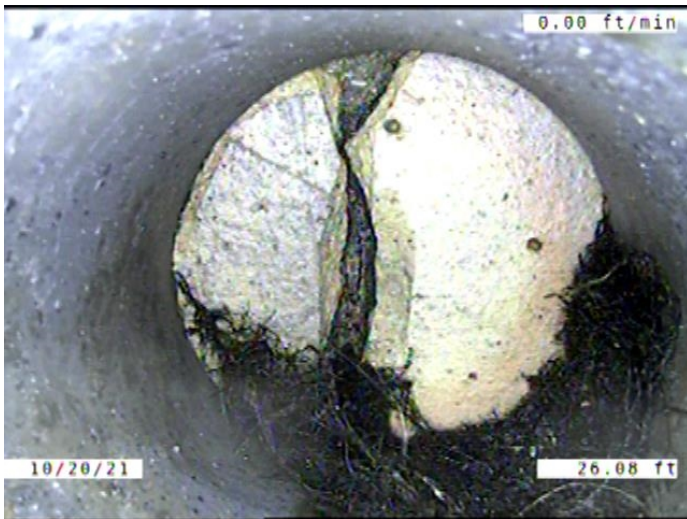
Code: **TFD**
Description: **Tap Factory Defective**

Distance (ft): **26.1**
Structural Grade: **0**
O&M Grade: **3**
Clock Start/From: **1**
Clock To:
1st Value: **4.000**
2nd Value:
Value Percent:
Continuous Index:
Within 8" of Joint: **YES**
Remarks: **CAP BROKEN. ROOTS VISIBLE**

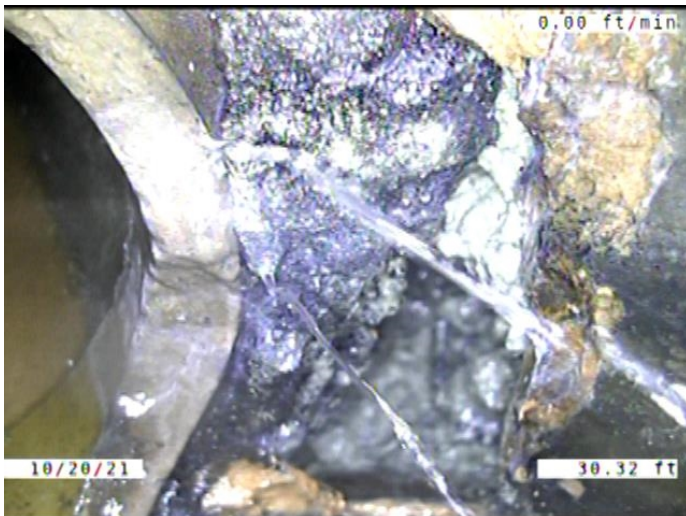
Code: **BSV**
 Description: **Broken Soil Visible**

Distance (ft): **30.3**
 Structural Grade: **5**
 O&M Grade: **0**
 Clock Start/From: **8**
 Clock To: **2**
 1st Value:
 2nd Value:
 Value Percent:
 Continuous Index:
 Within 8" of Joint: **YES**
 Remarks:

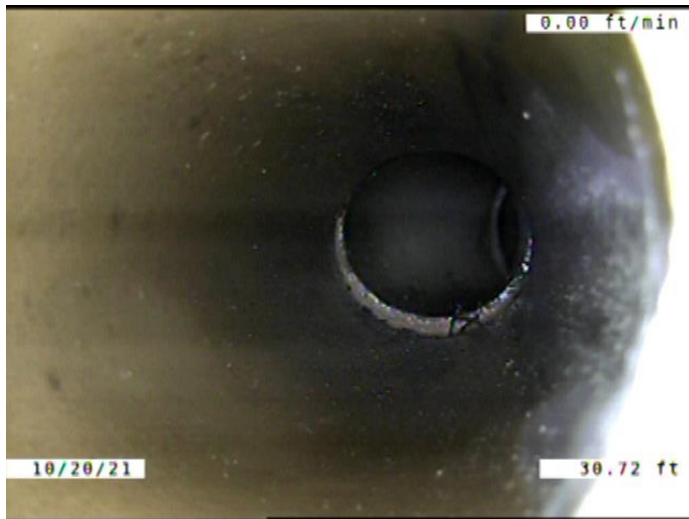
Code:	TBI
Description:	Tap Break-in Intruding
Distance (ft):	30.7
Structural Grade:	0
O&M Grade:	2
Clock Start/From:	12
Clock To:	
1st Value:	4.000
2nd Value:	1.000
Value Percent:	
Continuous Index:	
Within 8" of Joint:	YES
Remarks:	CONSTANTLY RUNNING WATER

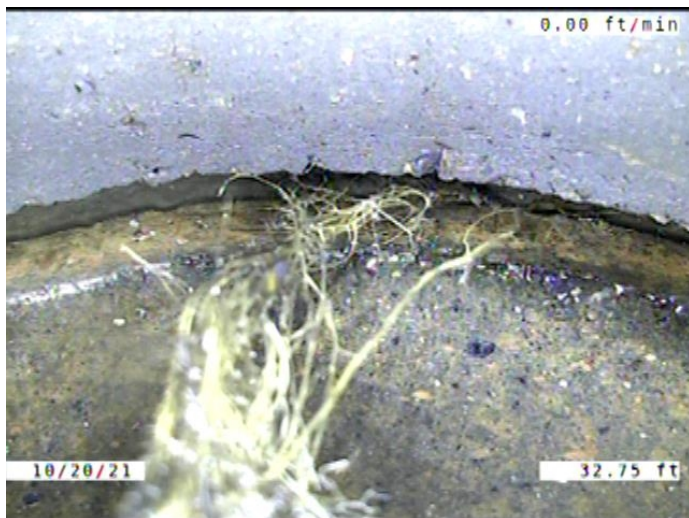
Code:	RFJ
Description:	Roots Fine Joint
Distance (ft):	32.8
Structural Grade:	0
O&M Grade:	1
Clock Start/From:	12
Clock To:	
1st Value:	
2nd Value:	
Value Percent:	
Continuous Index:	
Within 8" of Joint:	YES
Remarks:

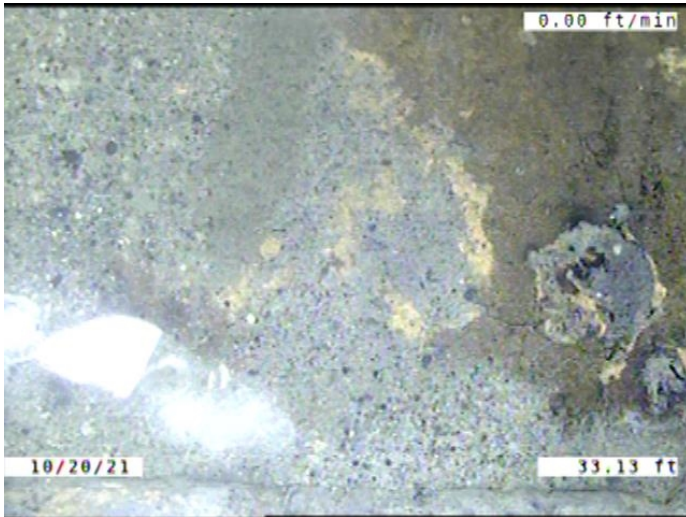
Code: **SSS**
 Description: **Surface Damage Surface Spalling**

Distance (ft): **33.1**
 Structural Grade: **2**
 O&M Grade: **0**
 Clock Start/From: **4**
 Clock To: **8**
 1st Value:
 2nd Value:
 Value Percent:
 Continuous Index: **S02**
 Within 8" of Joint: **YES**
 Remarks:

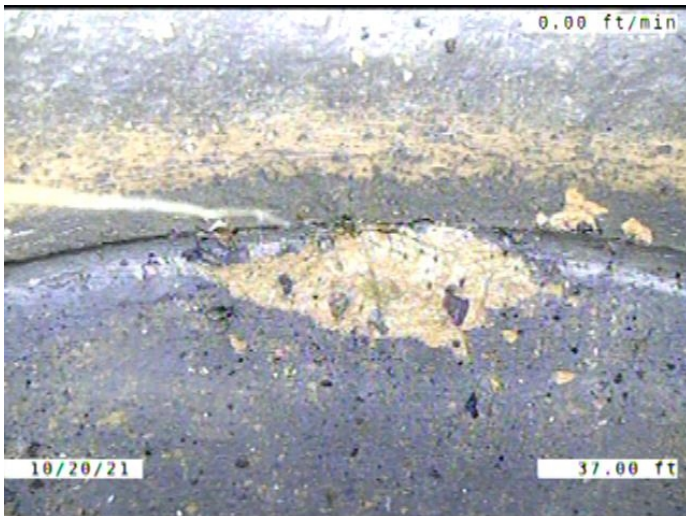
Code: **RFJ**
 Description: **Roots Fine Joint**

Distance (ft): **37.0**
 Structural Grade: **0**
 O&M Grade: **1**
 Clock Start/From: **11**
 Clock To: **2**
 1st Value:
 2nd Value:
 Value Percent:
 Continuous Index:
 Within 8" of Joint: **YES**
 Remarks:

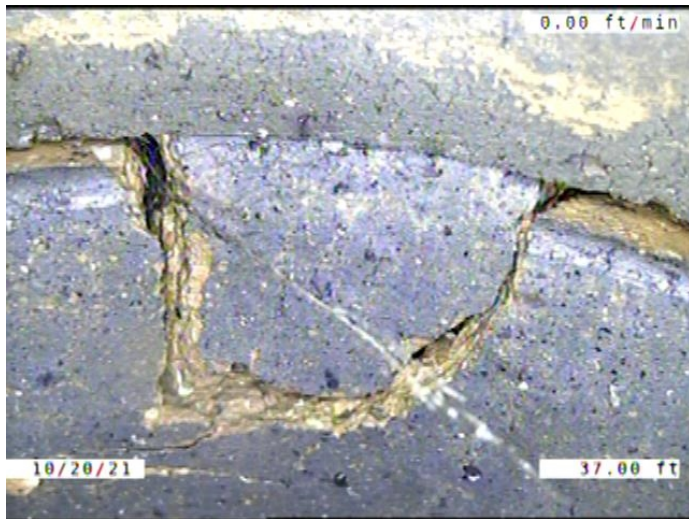
Code: **B**
 Description: **Broken**

Distance (ft): **37.0**
 Structural Grade: **4**
 O&M Grade: **0**
 Clock Start/From: **12**
 Clock To: **3**
 1st Value:
 2nd Value:
 Value Percent:
 Continuous Index:
 Within 8" of Joint: **YES**
 Remarks:

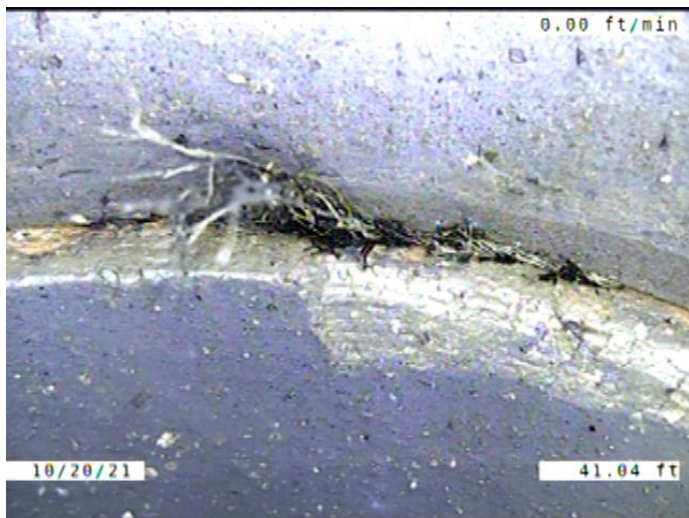
Code: **RFJ**
 Description: **Roots Fine Joint**

Distance (ft): **41.0**
 Structural Grade: **0**
 O&M Grade: **1**
 Clock Start/From: **2**
 Clock To: **3**
 1st Value:
 2nd Value:
 Value Percent:
 Continuous Index:
 Within 8" of Joint: **YES**
 Remarks:

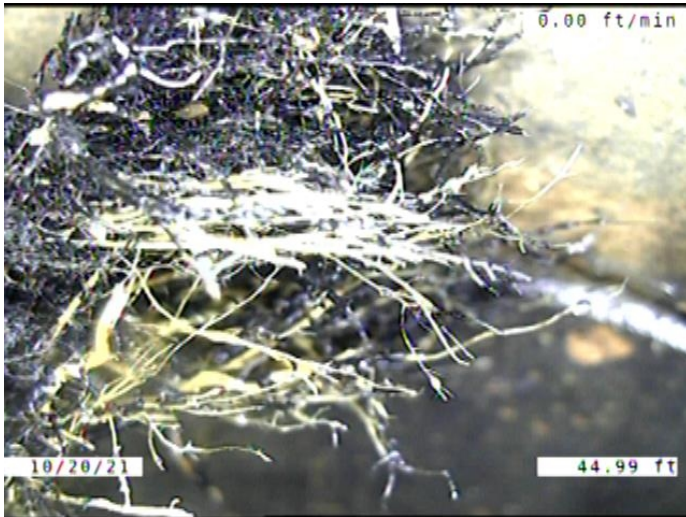
Code: **RMJ**
 Description: **Roots Medium Joint**

Distance (ft): **45.0**
 Structural Grade: **0**
 O&M Grade: **3**
 Clock Start/From: **1**
 Clock To: **4**
 1st Value:
 2nd Value:
 Value Percent: **5.000**
 Continuous Index:
 Within 8" of Joint: **YES**
 Remarks:

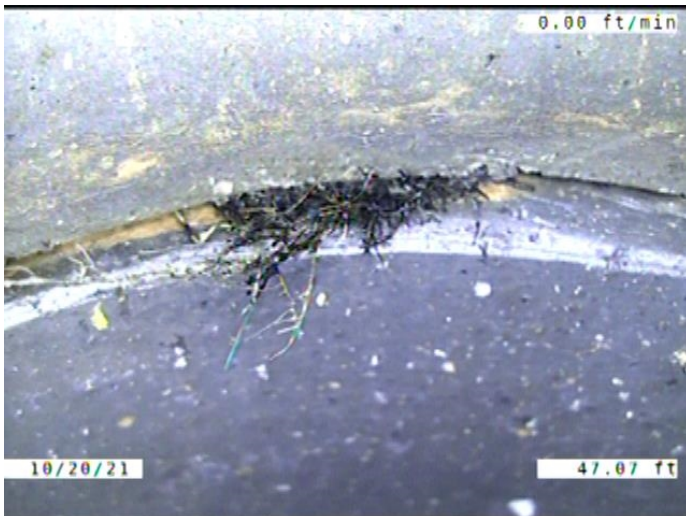
Code: **RFJ**
 Description: **Roots Fine Joint**

Distance (ft): **47.1**
 Structural Grade: **0**
 O&M Grade: **1**
 Clock Start/From: **9**
 Clock To: **10**
 1st Value:
 2nd Value:
 Value Percent:
 Continuous Index:
 Within 8" of Joint: **YES**
 Remarks:

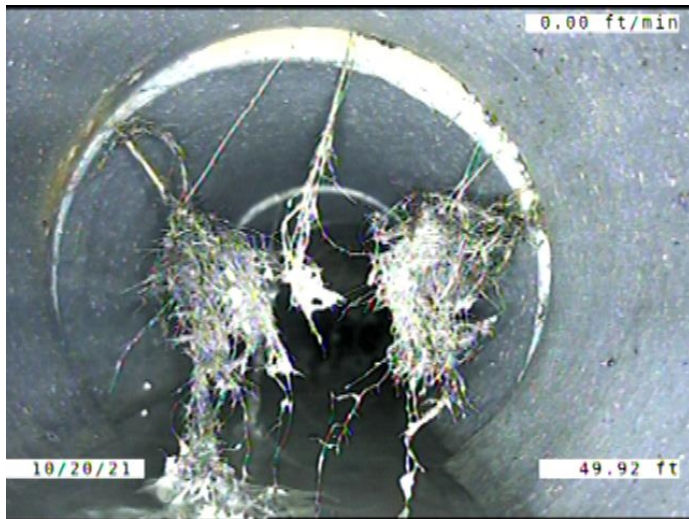
Code: **CM**
 Description: **Crack Multiple**

Distance (ft): **49.9**
 Structural Grade: **3**
 O&M Grade: **0**
 Clock Start/From: **8**
 Clock To: **4**
 1st Value:
 2nd Value:
 Value Percent:
 Continuous Index: **F01**
 Within 8" of Joint: **YES**
 Remarks:

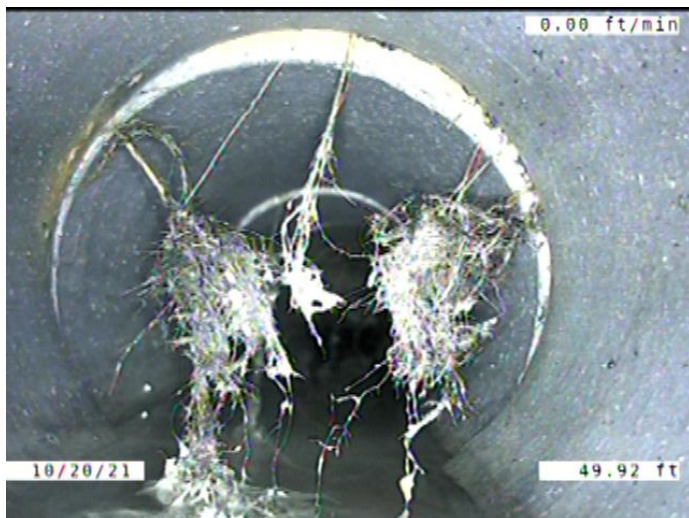
Code: **SSS**
 Description: **Surface Damage Surface Spalling**

Distance (ft): **49.9**
 Structural Grade: **2**
 O&M Grade: **0**
 Clock Start/From: **4**
 Clock To: **8**
 1st Value:
 2nd Value:
 Value Percent:
 Continuous Index: **F02**
 Within 8" of Joint: **YES**
 Remarks:
