Profile/Photo Observation Report

Date:	10/20/2021	Weather:		Coding:	PACP 7.0
Pipe Length (ft):	194.0	Owner:	City of Hobart	Pre Clean:	Heavy Cleaning
P.O.#:	YES502259	Surveyor:	S. Bucklin	PSR:	P-503-020-019
Customer:	City of Hobart	Clean Date:	09/05/2021	Shape:	C

Street:	West 39th Avenue	Flow Control:	Not Controlled
City:	Hobart, IN	Year Renewed:	
Location:	Alley	Tape/Media #:	
Purpose:	Routine Assessment	Dia/Height:	10"
Use:	Sanitary Sewage Pipe	Material:	VCP
Drain Area:		Lining:	None
Category:	NA		
Comment:

Location Details:		Direction of Survey:	Upstream
US MH:	M-503-019	DS MH:	M-503-020
		Total Length Surveyed (ft):	50.0

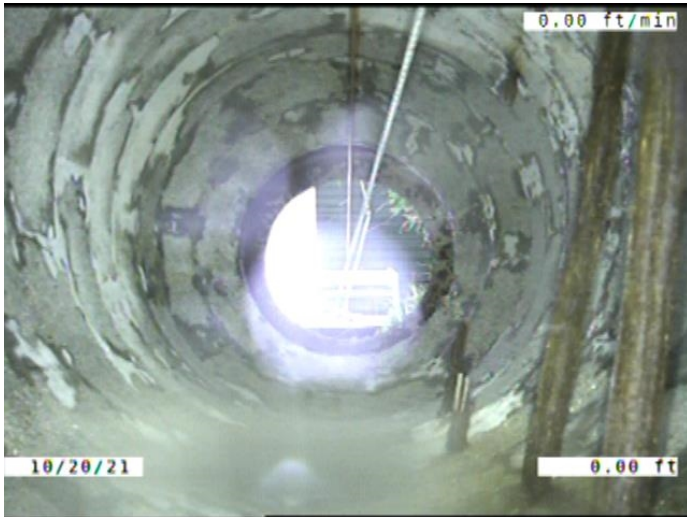
Code: **AMH**
 Description: **Manhole**

Distance (ft): **.0**
 Structural Grade: **0**
 O&M Grade: **0**
 Clock Start/From:
 Clock To:
 1st Value:
 2nd Value:
 Value Percent:
 Continuous Index:
 Within 8" of Joint: **NO**
 Remarks: **M-503-020**

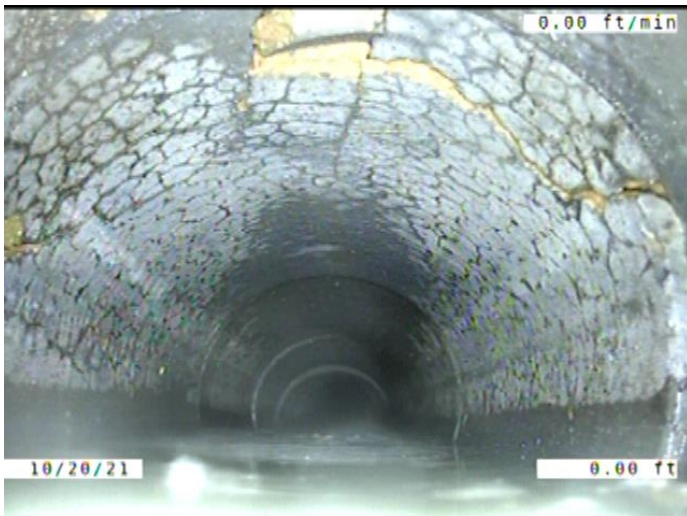
Code: **MWL**
 Description: **Miscellaneous Water Level**

Distance (ft): **.0**
 Structural Grade: **0**
 O&M Grade: **0**
 Clock Start/From:
 Clock To:
 1st Value:
 2nd Value:
 Value Percent: **15.000**
 Continuous Index:
 Within 8" of Joint: **NO**
 Remarks:

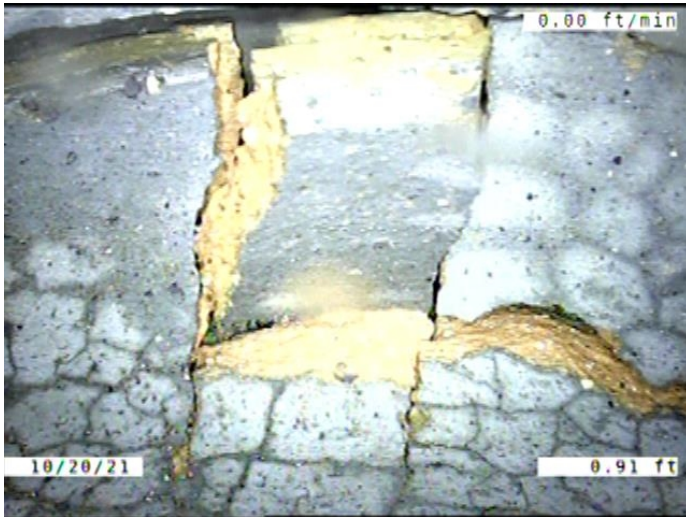
Code: **BSV**
 Description: **Broken Soil Visible**

Distance (ft): **.9**
 Structural Grade: **5**
 O&M Grade: **0**
 Clock Start/From: **8**
 Clock To: **4**
 1st Value:
 2nd Value:
 Value Percent:
 Continuous Index:
 Within 8" of Joint: **YES**
 Remarks:

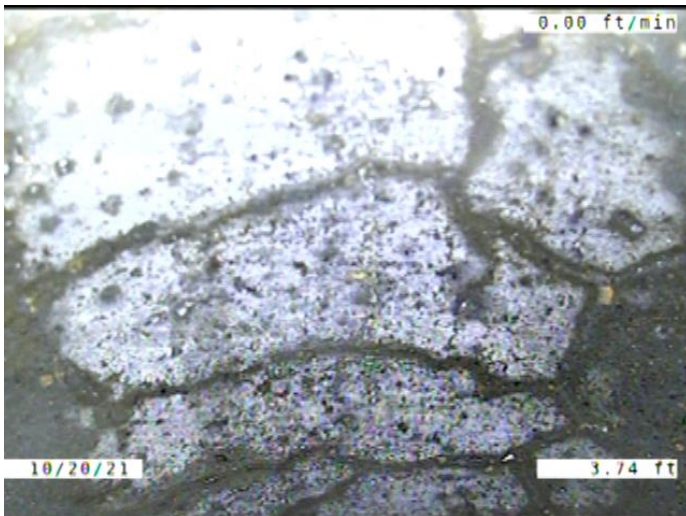
Code: **CM**
 Description: **Crack Multiple**

Distance (ft): **3.7**
 Structural Grade: **3**
 O&M Grade: **0**
 Clock Start/From: **8**
 Clock To: **4**
 1st Value:
 2nd Value:
 Value Percent:
 Continuous Index: **S01**
 Within 8" of Joint: **YES**
 Remarks:

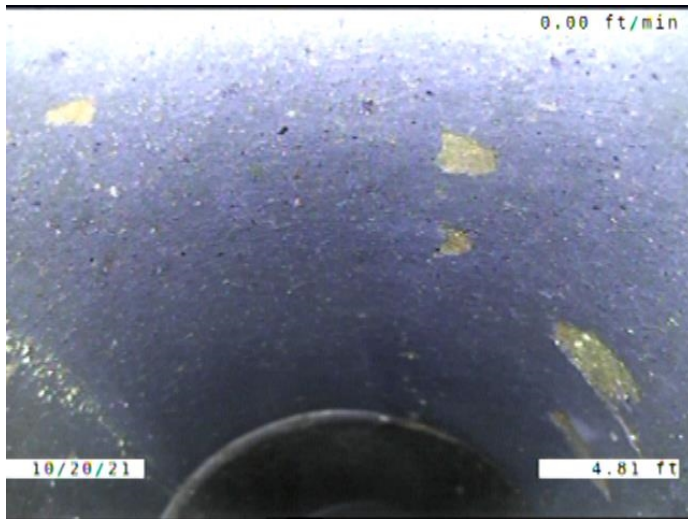
Code: **SSS**
 Description: **Surface Damage Surface Spalling**

Distance (ft): **4.8**
 Structural Grade: **2**
 O&M Grade: **0**
 Clock Start/From: **11**
 Clock To: **2**
 1st Value:
 2nd Value:
 Value Percent:
 Continuous Index:
 Within 8" of Joint: **YES**
 Remarks:

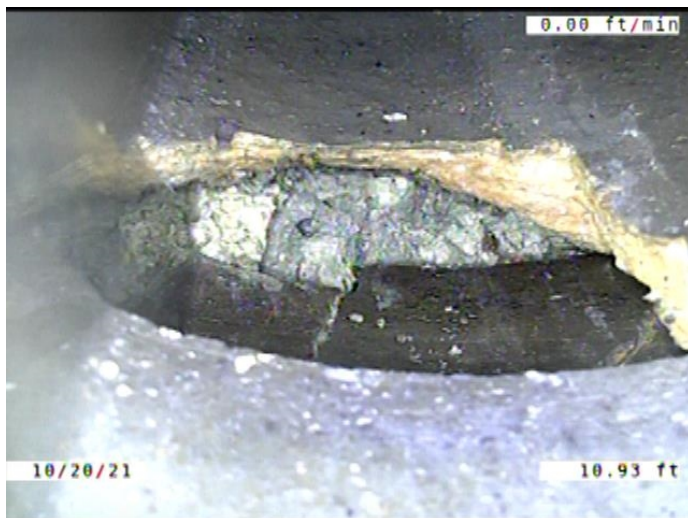
Code: **BSV**
 Description: **Broken Soil Visible**

Distance (ft): **10.9**
 Structural Grade: **5**
 O&M Grade: **0**
 Clock Start/From: **3**
 Clock To: **5**
 1st Value:
 2nd Value:
 Value Percent:
 Continuous Index:
 Within 8" of Joint: **YES**
 Remarks:

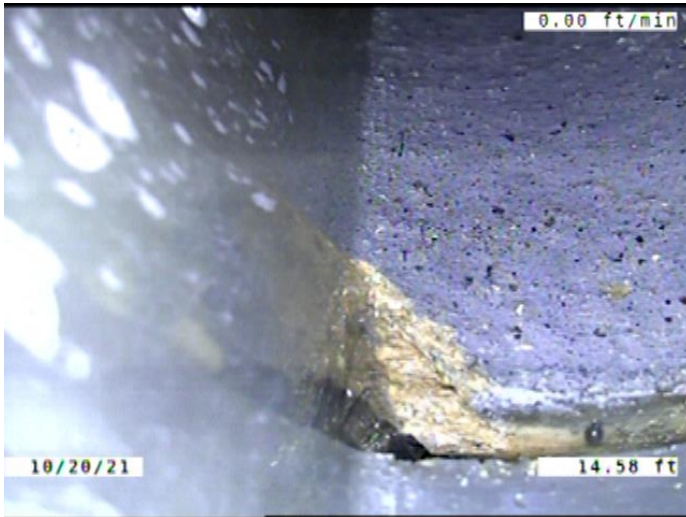
Code: **HVV**
 Description: **Hole Void Visible**

Distance (ft): **14.6**
 Structural Grade: **5**
 O&M Grade: **0**
 Clock Start/From: **4**
 Clock To: **5**
 1st Value:
 2nd Value:
 Value Percent:
 Continuous Index:
 Within 8" of Joint: **YES**
 Remarks:

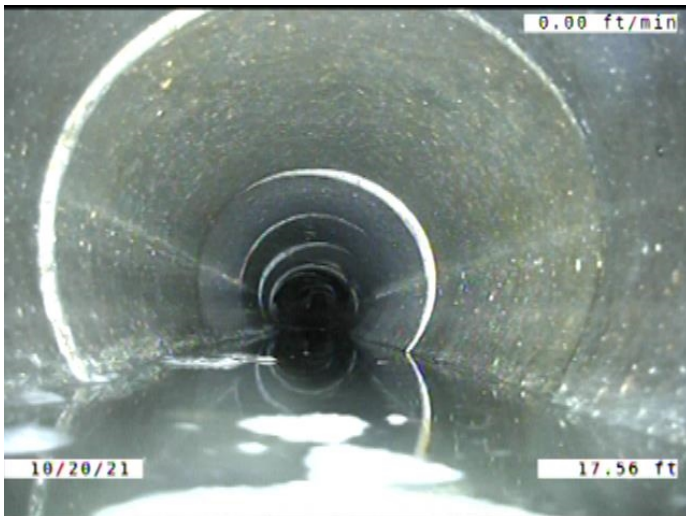
Code: **DSF**
 Description: **Deposits Settled Fine**

Distance (ft): **17.6**
 Structural Grade: **0**
 O&M Grade: **2**
 Clock Start/From: **5**
 Clock To: **7**
 1st Value:
 2nd Value:
 Value Percent: **5.000**
 Continuous Index:
 Within 8" of Joint: **YES**
 Remarks:

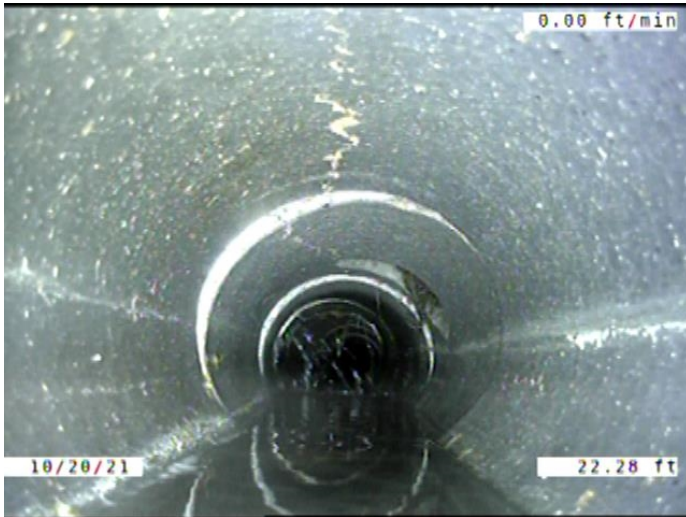
Code: **FM**
Description: **Fracture Multiple**

Distance (ft): **22.3**
Structural Grade: **4**
O&M Grade: **0**
Clock Start/From: **8**
Clock To: **4**
1st Value:
2nd Value:
Value Percent:
Continuous Index:
Within 8" of Joint: **YES**
Remarks:

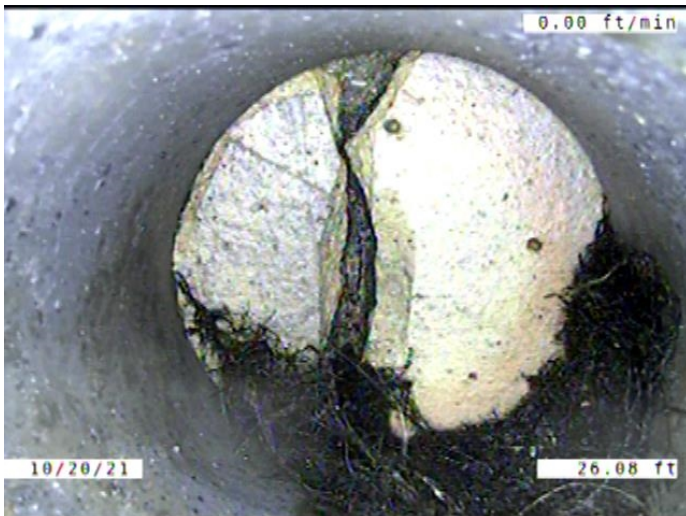
Code: **TFD**
Description: **Tap Factory Defective**

Distance (ft): **26.1**
Structural Grade: **0**
O&M Grade: **3**
Clock Start/From: **1**
Clock To:
1st Value: **4.000**
2nd Value:
Value Percent:
Continuous Index:
Within 8" of Joint: **YES**
Remarks: **CAP BROKEN. ROOTS VISIBLE**

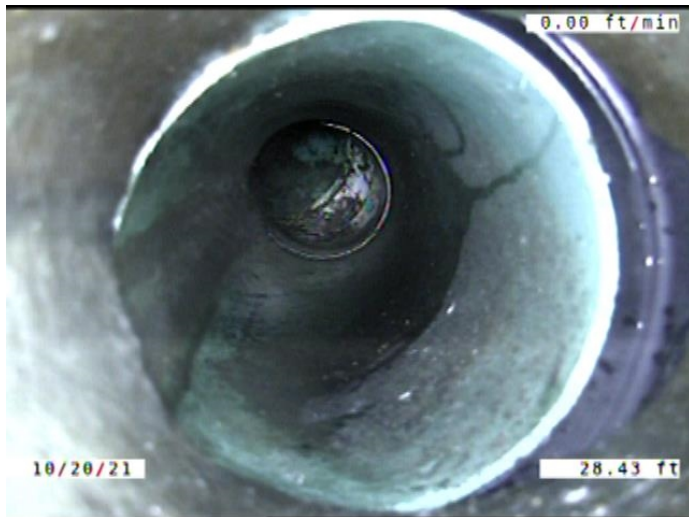
Code: **TFA**
 Description: **Tap Factory Activity**

Distance (ft): **28.4**
 Structural Grade: **0**
 O&M Grade: **0**
 Clock Start/From: **10**
 Clock To:
 1st Value: **4.000**
 2nd Value:
 Value Percent:
 Continuous Index:
 Within 8" of Joint: **YES**
 Remarks:

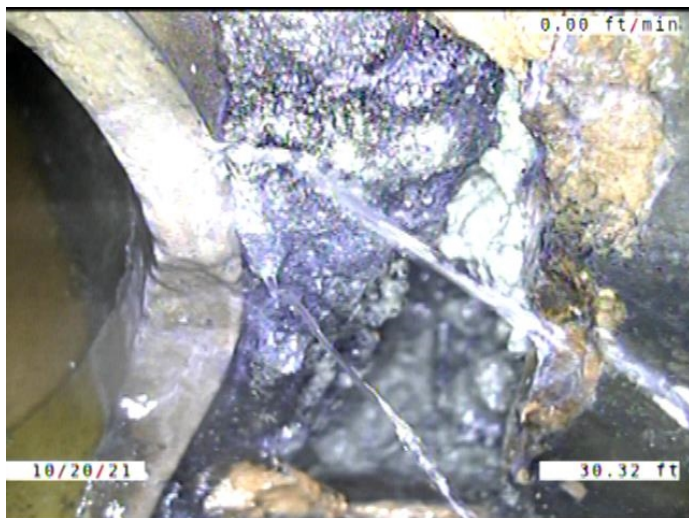
Code: **BSV**
 Description: **Broken Soil Visible**

Distance (ft): **30.3**
 Structural Grade: **5**
 O&M Grade: **0**
 Clock Start/From: **8**
 Clock To: **2**
 1st Value:
 2nd Value:
 Value Percent:
 Continuous Index:
 Within 8" of Joint: **YES**
 Remarks:

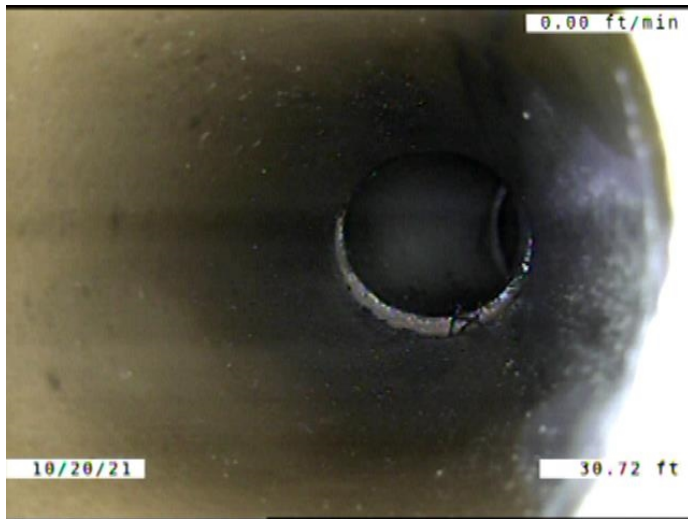
Code:	TBI
Description:	Tap Break-in Intruding
Distance (ft):	30.7
Structural Grade:	0
O&M Grade:	2
Clock Start/From:	12
Clock To:	
1st Value:	4.000
2nd Value:	1.000
Value Percent:	
Continuous Index:	
Within 8" of Joint:	YES
Remarks:	CONSTANTLY RUNNING WATER

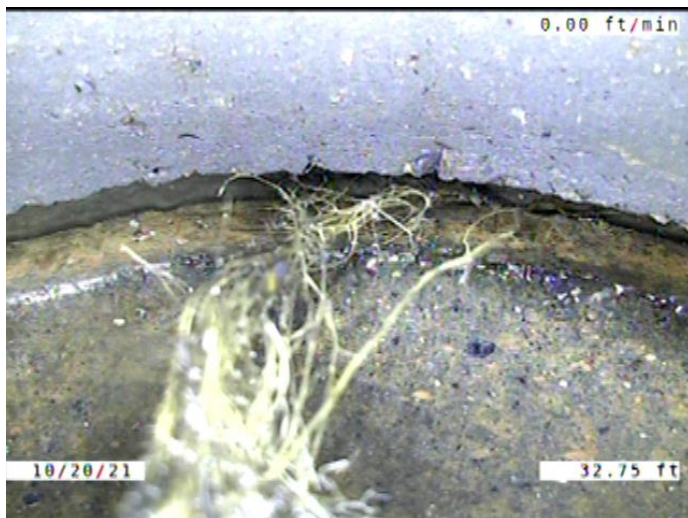
Code:	RFJ
Description:	Roots Fine Joint
Distance (ft):	32.8
Structural Grade:	0
O&M Grade:	1
Clock Start/From:	12
Clock To:	
1st Value:	
2nd Value:	
Value Percent:	
Continuous Index:	
Within 8" of Joint:	YES
Remarks:

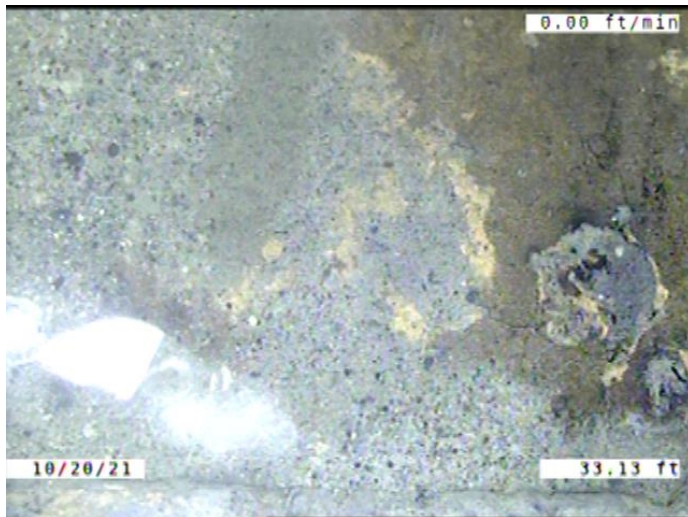
Code: **SSS**
 Description: **Surface Damage Surface Spalling**

Distance (ft): **33.1**
 Structural Grade: **2**
 O&M Grade: **0**
 Clock Start/From: **4**
 Clock To: **8**
 1st Value:
 2nd Value:
 Value Percent:
 Continuous Index: **S02**
 Within 8" of Joint: **YES**
 Remarks:

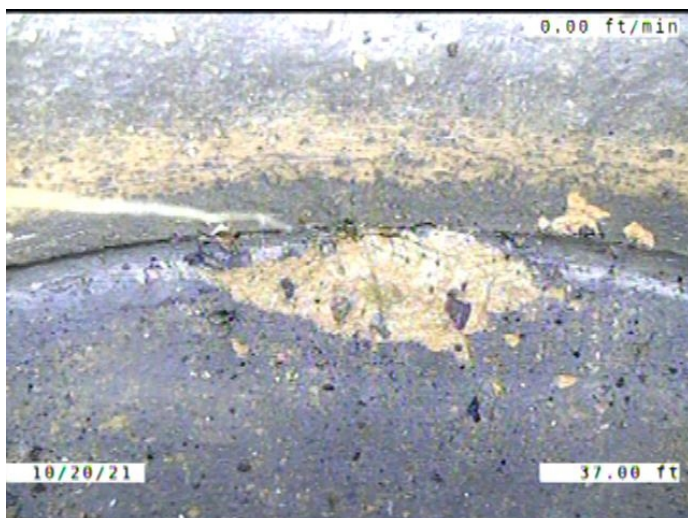
Code: **RFJ**
 Description: **Roots Fine Joint**

Distance (ft): **37.0**
 Structural Grade: **0**
 O&M Grade: **1**
 Clock Start/From: **11**
 Clock To: **2**
 1st Value:
 2nd Value:
 Value Percent:
 Continuous Index:
 Within 8" of Joint: **YES**
 Remarks:

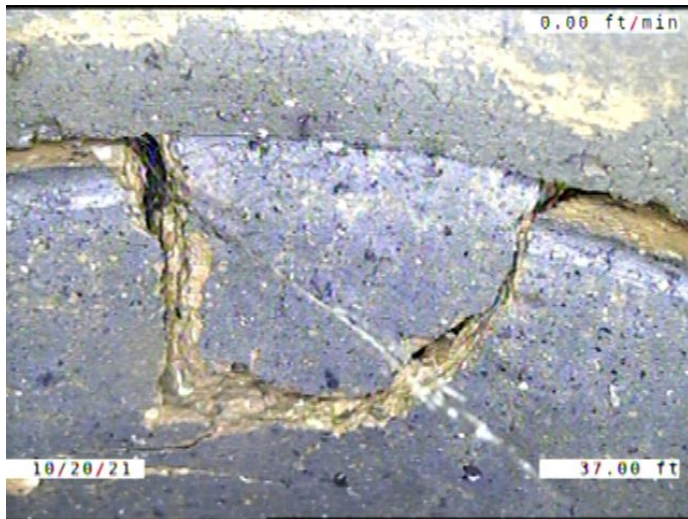
Code: **B**
 Description: **Broken**

Distance (ft): **37.0**
 Structural Grade: **4**
 O&M Grade: **0**
 Clock Start/From: **12**
 Clock To: **3**
 1st Value:
 2nd Value:
 Value Percent:
 Continuous Index:
 Within 8" of Joint: **YES**
 Remarks:

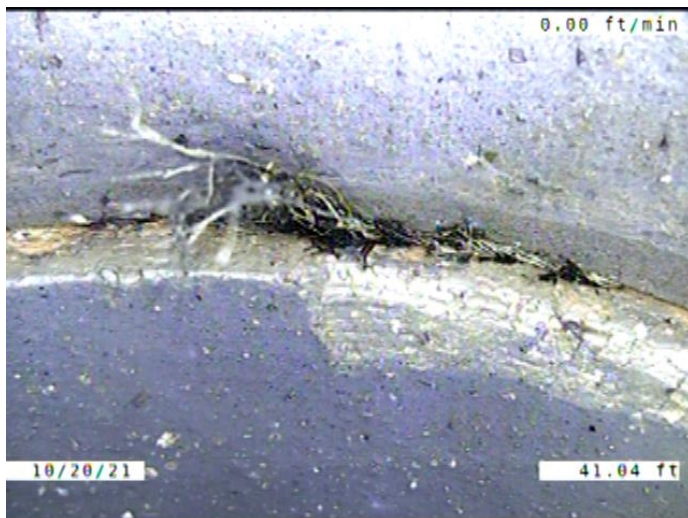
Code: **RFJ**
 Description: **Roots Fine Joint**

Distance (ft): **41.0**
 Structural Grade: **0**
 O&M Grade: **1**
 Clock Start/From: **2**
 Clock To: **3**
 1st Value:
 2nd Value:
 Value Percent:
 Continuous Index:
 Within 8" of Joint: **YES**
 Remarks:

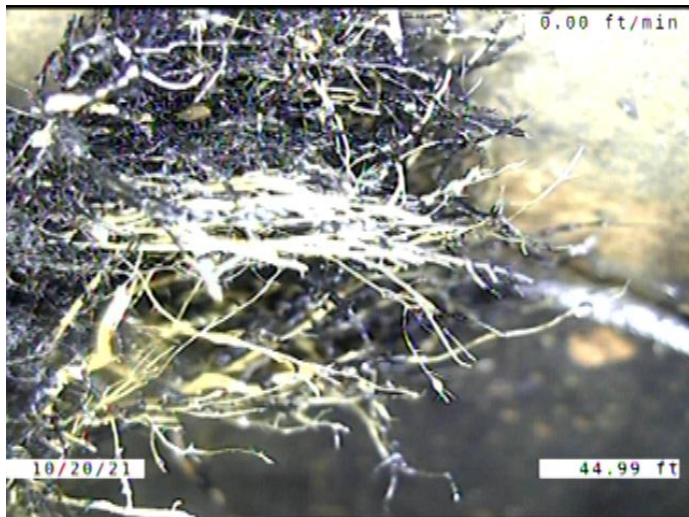
Code: **RMJ**
 Description: **Roots Medium Joint**

Distance (ft): **45.0**
 Structural Grade: **0**
 O&M Grade: **3**
 Clock Start/From: **1**
 Clock To: **4**
 1st Value:
 2nd Value:
 Value Percent: **5.000**
 Continuous Index:
 Within 8" of Joint: **YES**
 Remarks:

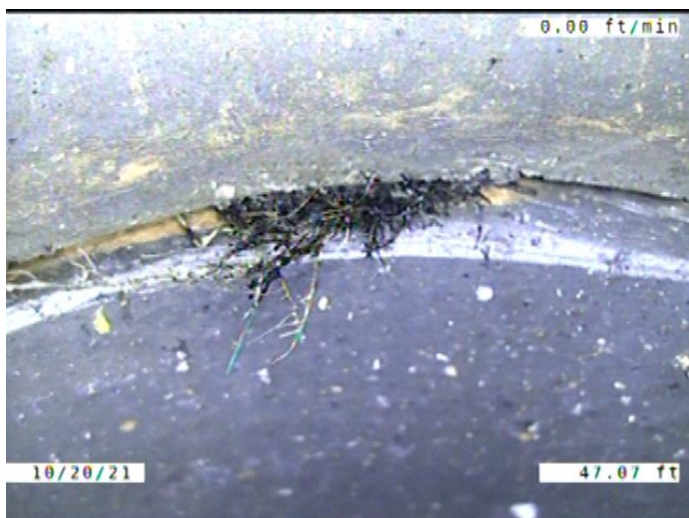
Code: **RFJ**
 Description: **Roots Fine Joint**

Distance (ft): **47.1**
 Structural Grade: **0**
 O&M Grade: **1**
 Clock Start/From: **9**
 Clock To: **10**
 1st Value:
 2nd Value:
 Value Percent:
 Continuous Index:
 Within 8" of Joint: **YES**
 Remarks:

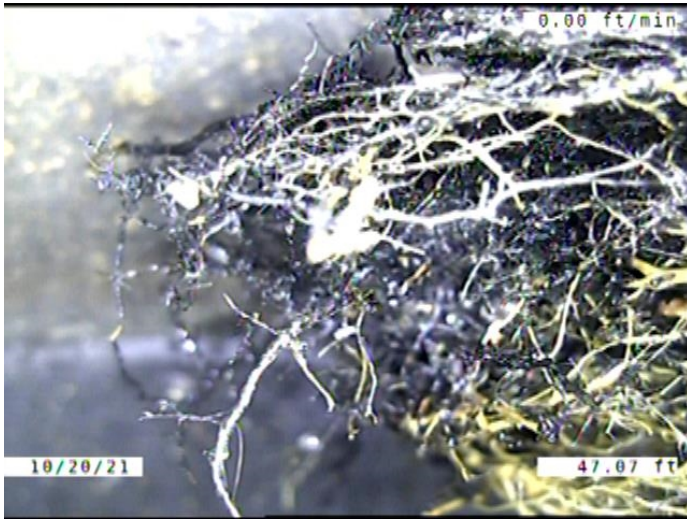
Code: **RMJ**
 Description: **Roots Medium Joint**

Distance (ft): **47.1**
 Structural Grade: **0**
 O&M Grade: **3**
 Clock Start/From: **2**
 Clock To: **4**
 1st Value:
 2nd Value:
 Value Percent: **10.000**
 Continuous Index:
 Within 8" of Joint: **YES**
 Remarks:

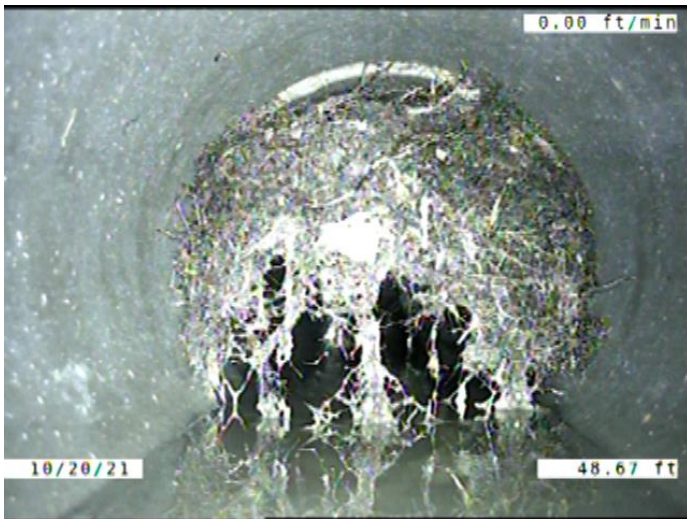
Code: **RBJ**
 Description: **Roots Ball Joint**

Distance (ft): **48.7**
 Structural Grade: **0**
 O&M Grade: **4**
 Clock Start/From: **7**
 Clock To: **5**
 1st Value:
 2nd Value:
 Value Percent: **60.000**
 Continuous Index:
 Within 8" of Joint: **YES**
 Remarks:

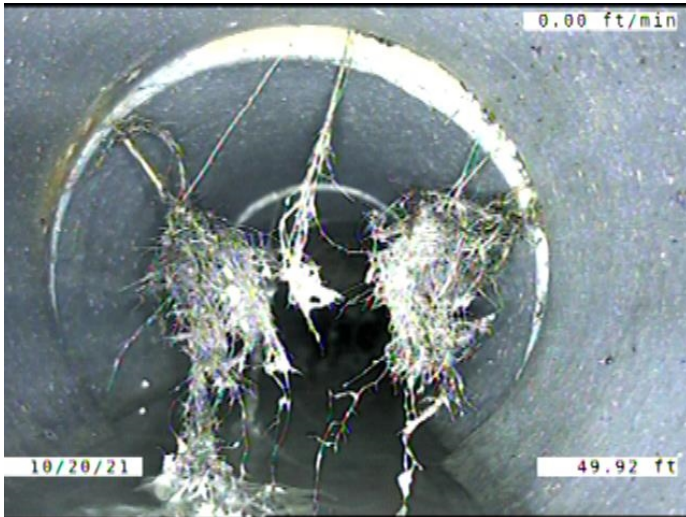
Code: **CM**
 Description: **Crack Multiple**

Distance (ft): **49.9**
 Structural Grade: **3**
 O&M Grade: **0**
 Clock Start/From: **8**
 Clock To: **4**
 1st Value:
 2nd Value:
 Value Percent:
 Continuous Index: **F01**
 Within 8" of Joint: **YES**
 Remarks:

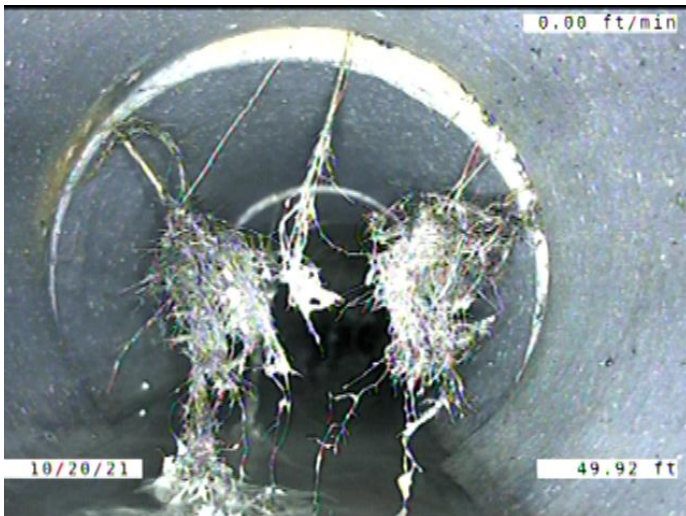
Code: **SSS**
 Description: **Surface Damage Surface Spalling**

Distance (ft): **49.9**
 Structural Grade: **2**
 O&M Grade: **0**
 Clock Start/From: **4**
 Clock To: **8**
 1st Value:
 2nd Value:
 Value Percent:
 Continuous Index: **F02**
 Within 8" of Joint: **YES**
 Remarks:

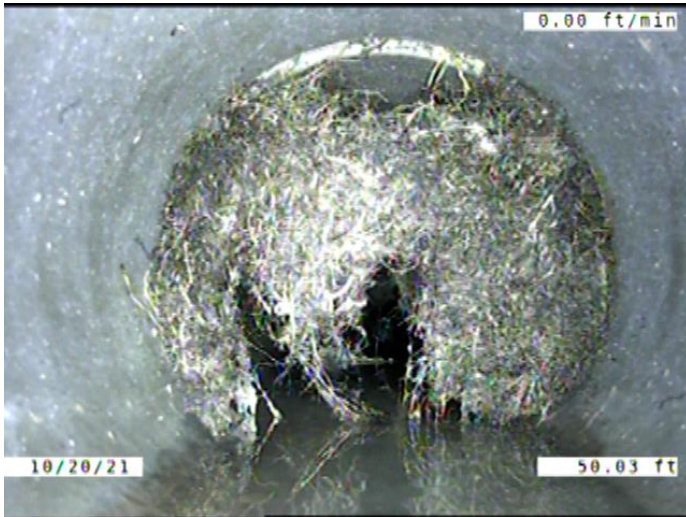
MSA

Miscellaneous Survey Abandoned

50.0

CAMERA CANT MAKE IT PAST ROOTS
