Profile/Photo Observation Report

Date:	10/21/2021	Weather:		Coding:	PACP 7.0
Pipe Length (ft):	194.0	Owner:	City of Hobart	Pre Clean:	Heavy Cleaning
P.O.#:	YES502259	Surveyor:	S. Bucklin	PSR:	P-503-020-019
Customer:	City of Hobart	Clean Date:	09/05/2021	Shape:	C

Street:	West 39th Avenue	Flow Control:	Not Controlled
City:	Hobart, IN	Year Renewed:	
Location:	Alley	Tape/Media #:	
Purpose:	Routine Assessment	Dia/Height:	10"
Use:	Sanitary Sewage Pipe	Material:	VCP
Drain Area:		Lining:	None
Category:	NA		
Comment:

Location Details:		Direction of Survey:	Upstream
US MH:	M-503-019	DS MH:	M-503-020
		Total Length Surveyed (ft):	69.8

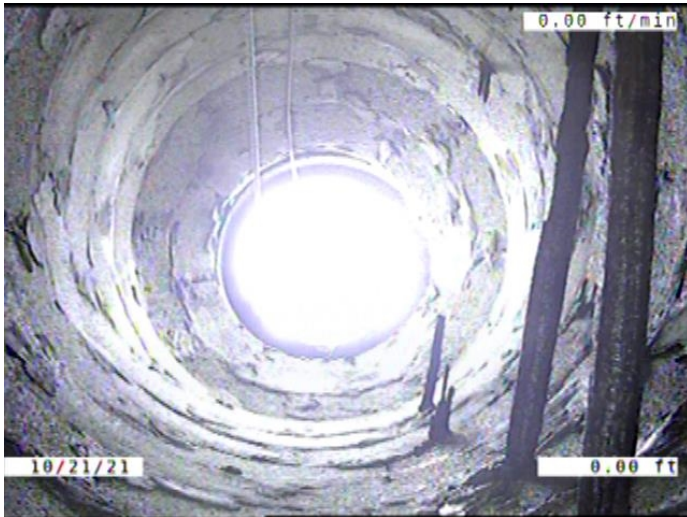
Code: **AMH**
 Description: **Manhole**

Distance (ft): **.0**
 Structural Grade: **0**
 O&M Grade: **0**
 Clock Start/From:
 Clock To:
 1st Value:
 2nd Value:
 Value Percent:
 Continuous Index:
 Within 8" of Joint: **NO**
 Remarks: **M-503-020**

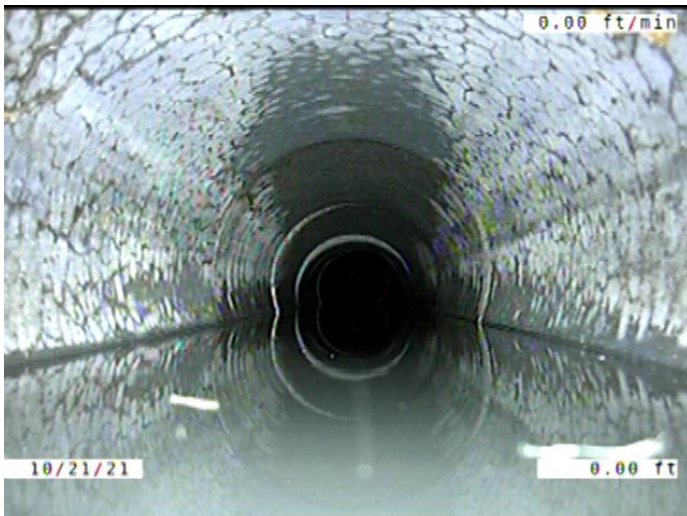
Code: **MWL**
 Description: **Miscellaneous Water Level**

Distance (ft): **.0**
 Structural Grade: **0**
 O&M Grade: **0**
 Clock Start/From:
 Clock To:
 1st Value:
 2nd Value:
 Value Percent: **15.000**
 Continuous Index:
 Within 8" of Joint: **NO**
 Remarks:

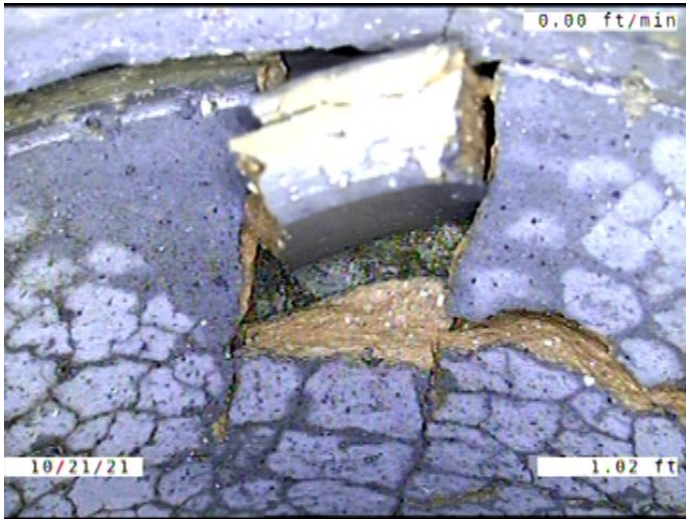
Code: **BVV**
 Description: **Broken Void Visible**

Distance (ft): **1.0**
 Structural Grade: **5**
 O&M Grade: **0**
 Clock Start/From: **12**
 Clock To:
 1st Value:
 2nd Value:
 Value Percent:
 Continuous Index:
 Within 8" of Joint: **YES**
 Remarks:

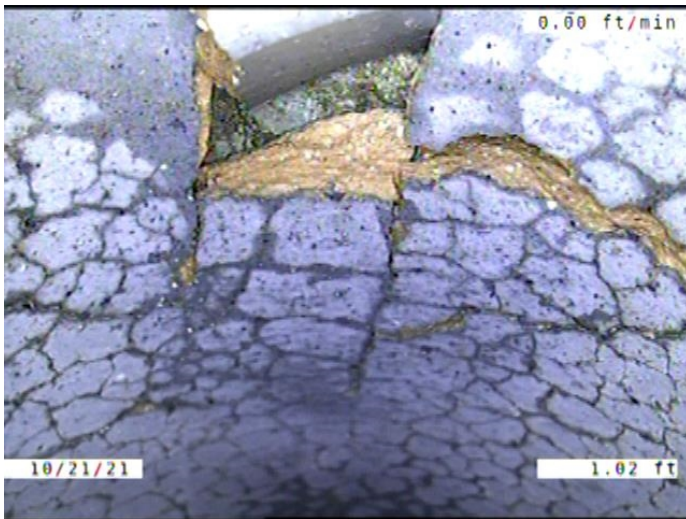
Code: **CM**
 Description: **Crack Multiple**

Distance (ft): **1.0**
 Structural Grade: **3**
 O&M Grade: **0**
 Clock Start/From: **8**
 Clock To: **4**
 1st Value:
 2nd Value:
 Value Percent:
 Continuous Index: **S01**
 Within 8" of Joint: **YES**
 Remarks:

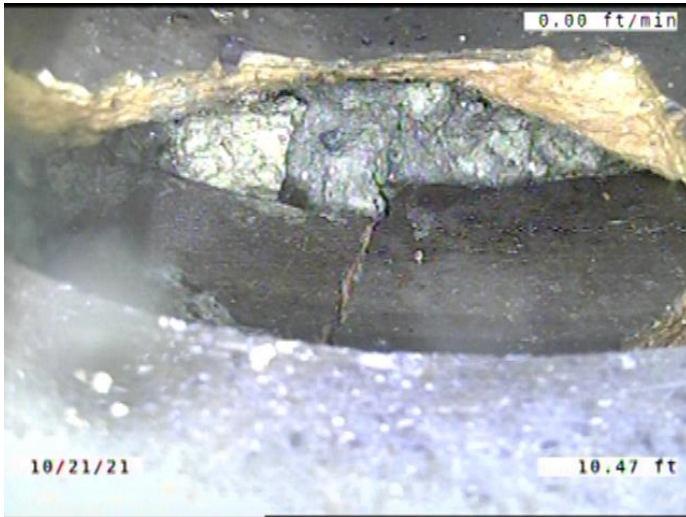
Code: **BVV**
Description: **Broken Void Visible**

Distance (ft): **10.5**
Structural Grade: **5**
O&M Grade: **0**
Clock Start/From: **3**
Clock To: **5**
1st Value:
2nd Value:
Value Percent:
Continuous Index:
Within 8" of Joint: **YES**
Remarks: **SOIL VISIBLE**

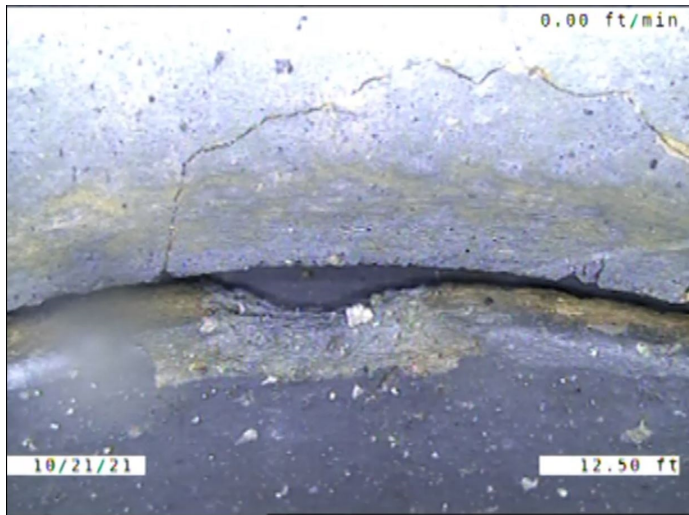
Code: **CM**
 Description: **Crack Multiple**

Distance (ft): **12.5**
 Structural Grade: **3**
 O&M Grade: **0**
 Clock Start/From: **8**
 Clock To: **4**
 1st Value:
 2nd Value:
 Value Percent:
 Continuous Index: **F01**
 Within 8" of Joint: **YES**
 Remarks:

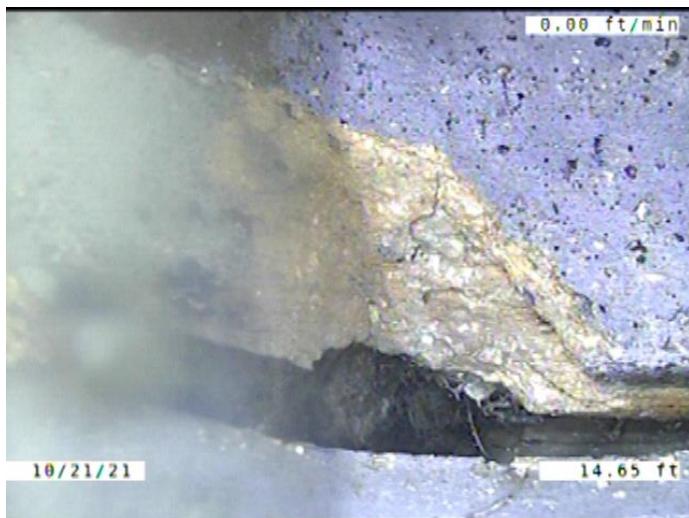
Code: **HSV**
 Description: **Hole Soil Visible**

Distance (ft): **14.7**
 Structural Grade: **5**
 O&M Grade: **0**
 Clock Start/From: **4**
 Clock To: **6**
 1st Value:
 2nd Value:
 Value Percent:
 Continuous Index:
 Within 8" of Joint: **YES**
 Remarks: **THE INSIDE OF THE JOINT HAS CHIPPED OFF**

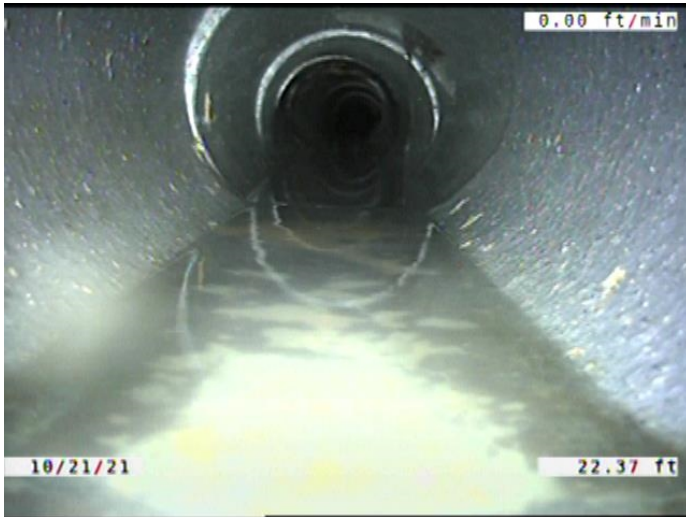
Code: **SSS**
Description: **Surface Damage Surface Spalling**

Distance (ft): **22.4**
Structural Grade: **2**
O&M Grade: **0**
Clock Start/From: **3**
Clock To: **9**
1st Value:
2nd Value:
Value Percent:
Continuous Index: **S02**
Within 8" of Joint: **YES**
Remarks:

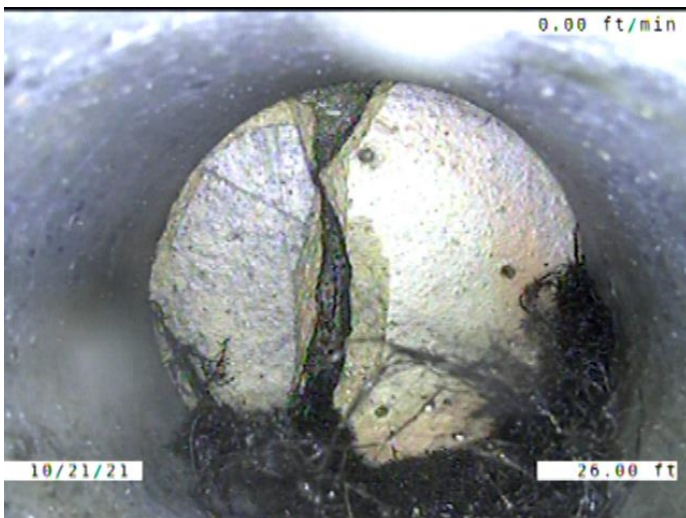
Code: **TFD**
Description: **Tap Factory Defective**

Distance (ft): **26.0**
Structural Grade: **0**
O&M Grade: **3**
Clock Start/From: **1**
Clock To:
1st Value: **4.000**
2nd Value:
Value Percent:
Continuous Index:
Within 8" of Joint: **YES**
Remarks: **CAP BROKEN. ROOTS GROWING AROUND THE CAP. SOIL VISIBLE**

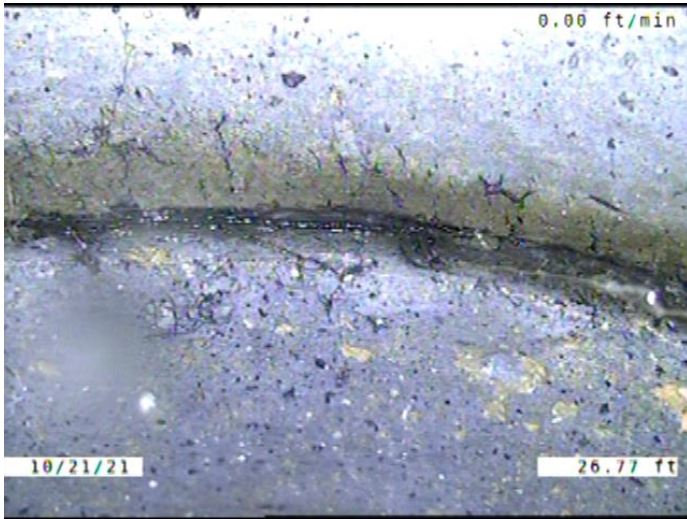
Code: **RFJ**
Description: **Roots Fine Joint**

Distance (ft): **26.8**
Structural Grade: **0**
O&M Grade: **1**
Clock Start/From: **12**
Clock To: **2**
1st Value:
2nd Value:
Value Percent:
Continuous Index:
Within 8" of Joint: **YES**
Remarks:

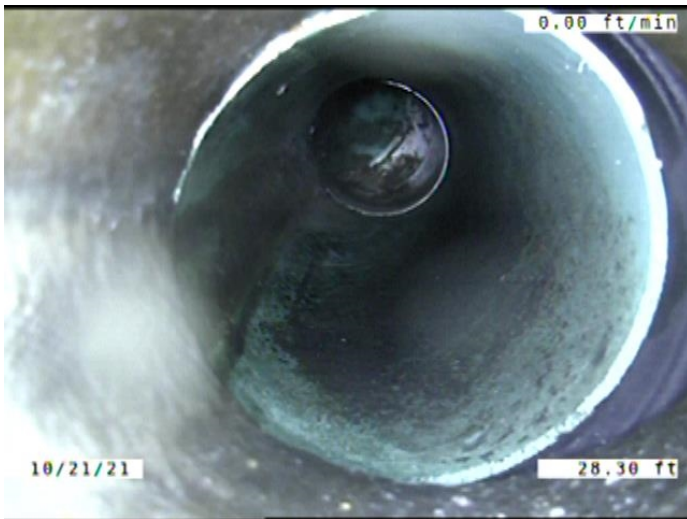
Code: **TF**
Description: **Tap Factory**

Distance (ft): **28.3**
Structural Grade: **0**
O&M Grade: **0**
Clock Start/From: **10**
Clock To:
1st Value: **4.000**
2nd Value:
Value Percent:
Continuous Index:
Within 8" of Joint: **YES**
Remarks: **CONSTANTLY RUNNING WATER**

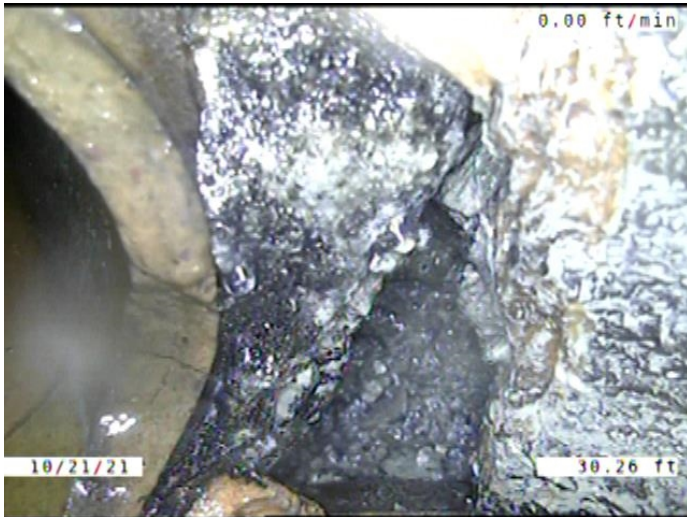
Code: **BSV**
 Description: **Broken Soil Visible**

Distance (ft): **30.3**
 Structural Grade: **5**
 O&M Grade: **0**
 Clock Start/From: **10**
 Clock To: **2**
 1st Value:
 2nd Value:
 Value Percent:
 Continuous Index:
 Within 8" of Joint: **YES**
 Remarks:

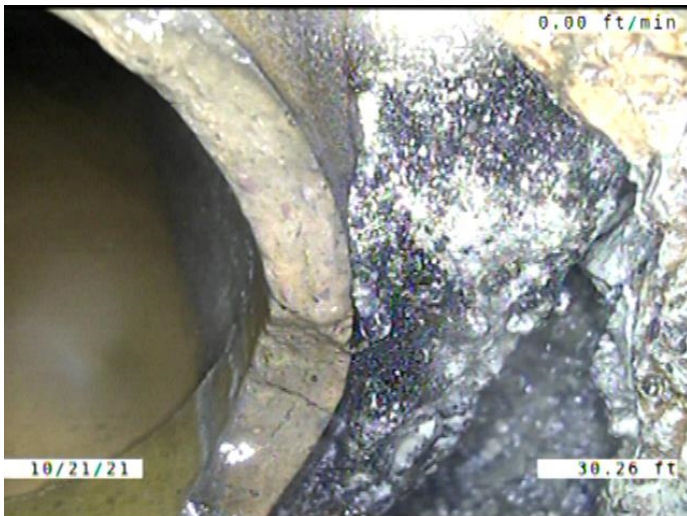
Code: **IDB**
 Description: **Infiltration Dripper Barrel**

Distance (ft): **30.3**
 Structural Grade: **0**
 O&M Grade: **3**
 Clock Start/From: **11**
 Clock To: **1**
 1st Value:
 2nd Value:
 Value Percent:
 Continuous Index:
 Within 8" of Joint: **YES**
 Remarks:

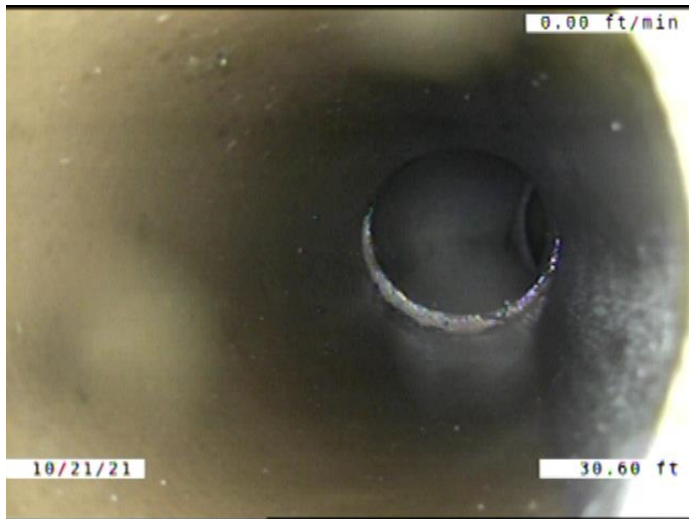
Code: **TBI**
 Description: **Tap Break-in Intruding**

Distance (ft): **30.6**
 Structural Grade: **0**
 O&M Grade: **2**
 Clock Start/From: **12**
 Clock To:
 1st Value: **4.000**
 2nd Value: **1.000**
 Value Percent:
 Continuous Index:
 Within 8" of Joint: **YES**
 Remarks:

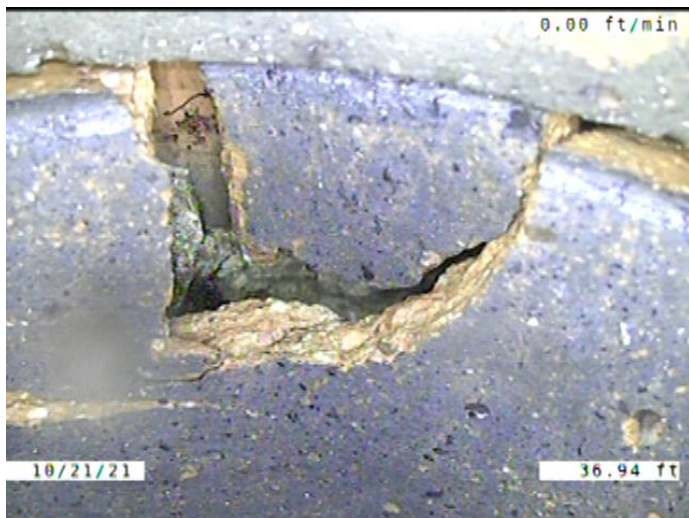
Code: **BSV**
 Description: **Broken Soil Visible**

Distance (ft): **36.9**
 Structural Grade: **5**
 O&M Grade: **0**
 Clock Start/From: **2**
 Clock To: **3**
 1st Value:
 2nd Value:
 Value Percent:
 Continuous Index:
 Within 8" of Joint: **YES**
 Remarks: **PIECE IS PUSHED BACK AND SOIL VISIBLE**

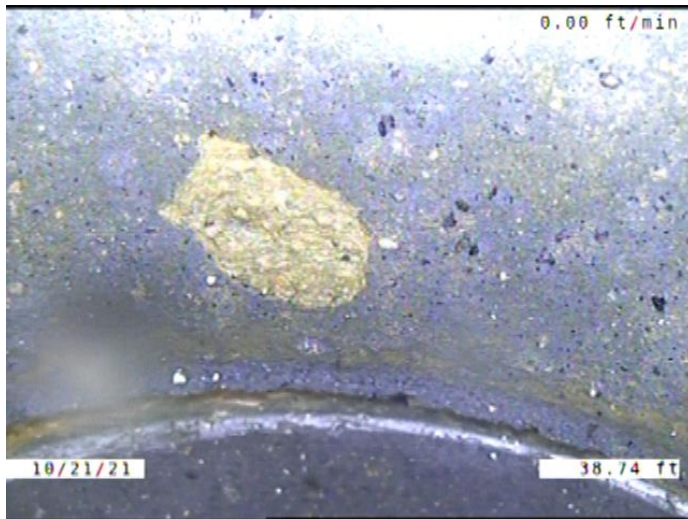
Code:	SSS
Description:	Surface Damage Surface Spalling
Distance (ft):	38.7
Structural Grade:	2
O&M Grade:	0
Clock Start/From:	2
Clock To:	
1st Value:	
2nd Value:	
Value Percent:	
Continuous Index:	
Within 8" of Joint:	YES
Remarks:

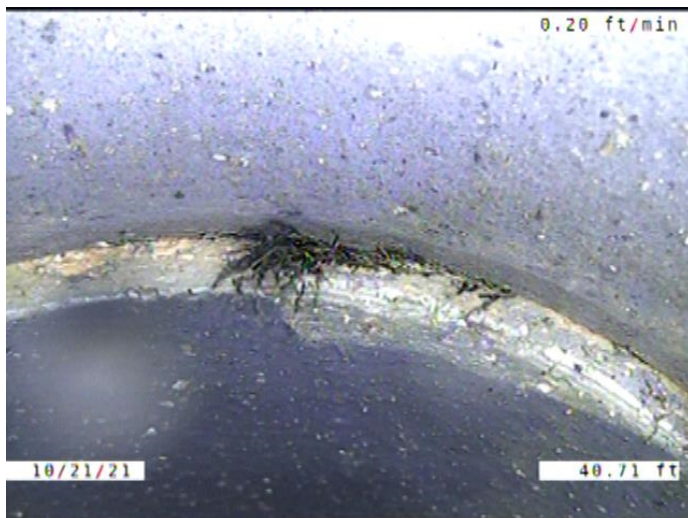
Code:	RFJ
Description:	Roots Fine Joint
Distance (ft):	40.7
Structural Grade:	0
O&M Grade:	1
Clock Start/From:	2
Clock To:	
1st Value:	
2nd Value:	
Value Percent:	
Continuous Index:	
Within 8" of Joint:	YES
Remarks:

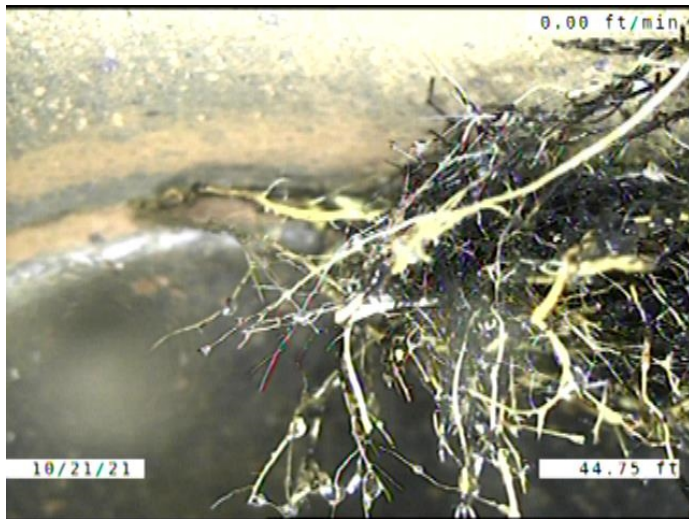
Code: **RMJ**
 Description: **Roots Medium Joint**

Distance (ft): **44.8**
 Structural Grade: **0**
 O&M Grade: **3**
 Clock Start/From: **2**
 Clock To: **4**
 1st Value:
 2nd Value:
 Value Percent: **5.000**
 Continuous Index:
 Within 8" of Joint: **YES**
 Remarks:

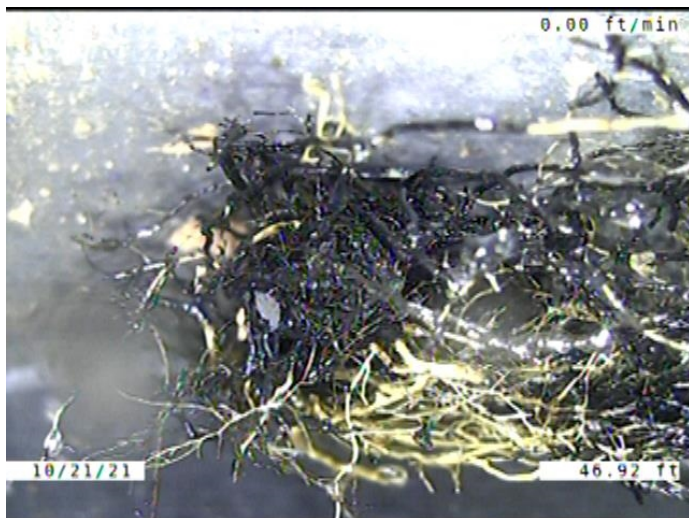
Code: **RMJ**
 Description: **Roots Medium Joint**

Distance (ft): **46.9**
 Structural Grade: **0**
 O&M Grade: **3**
 Clock Start/From: **2**
 Clock To: **4**
 1st Value:
 2nd Value:
 Value Percent: **5.000**
 Continuous Index:
 Within 8" of Joint: **YES**
 Remarks:

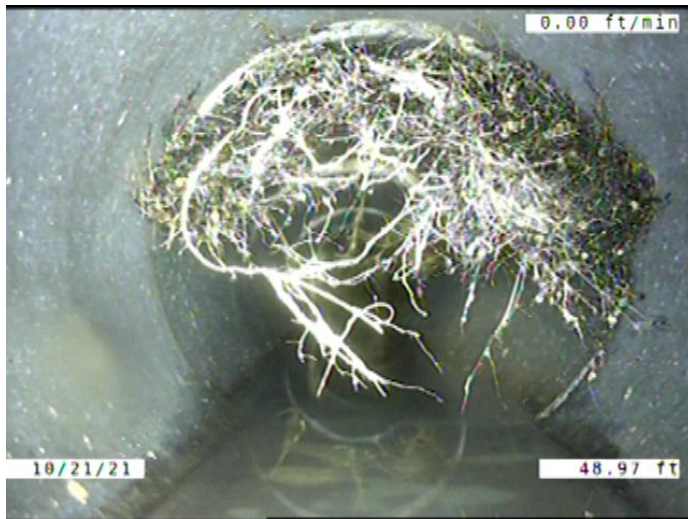
Code: **RMJ**
 Description: **Roots Medium Joint**

Distance (ft): **49.0**
 Structural Grade: **0**
 O&M Grade: **3**
 Clock Start/From: **9**
 Clock To: **3**
 1st Value:
 2nd Value:
 Value Percent: **25.000**
 Continuous Index:
 Within 8" of Joint: **YES**
 Remarks:

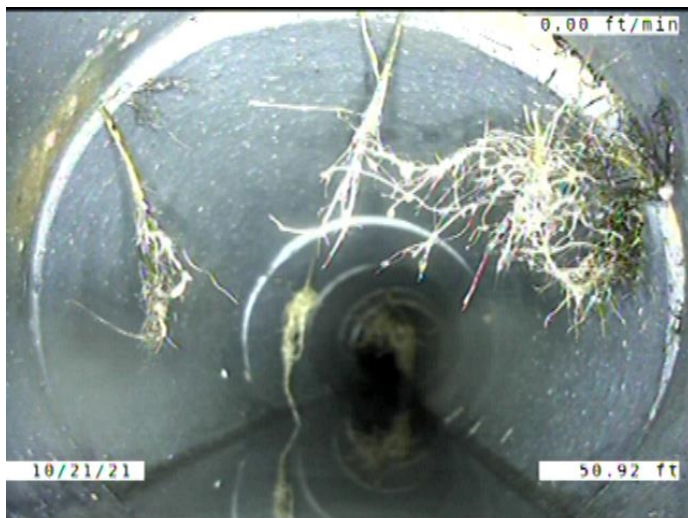
Code: **RMJ**
 Description: **Roots Medium Joint**

Distance (ft): **50.9**
 Structural Grade: **0**
 O&M Grade: **3**
 Clock Start/From: **10**
 Clock To: **2**
 1st Value:
 2nd Value:
 Value Percent: **5.000**
 Continuous Index:
 Within 8" of Joint: **YES**
 Remarks:

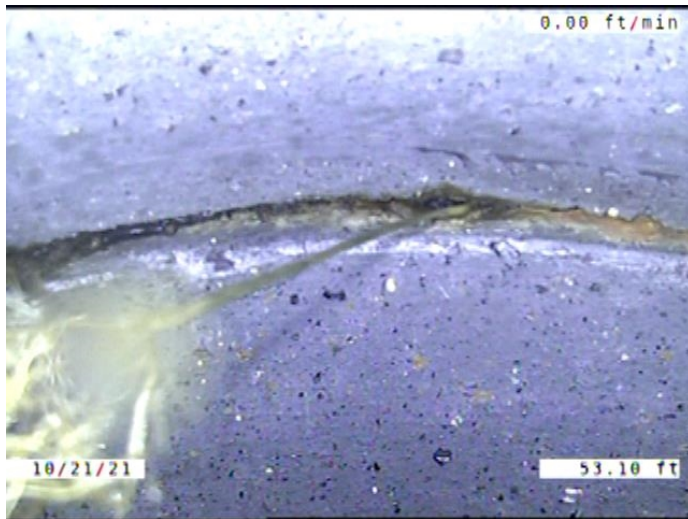
Code: **RFJ**
Description: **Roots Fine Joint**

Distance (ft): **53.1**
Structural Grade: **0**
O&M Grade: **1**
Clock Start/From: **11**
Clock To:
1st Value:
2nd Value:
Value Percent:
Continuous Index:
Within 8" of Joint: **YES**
Remarks:

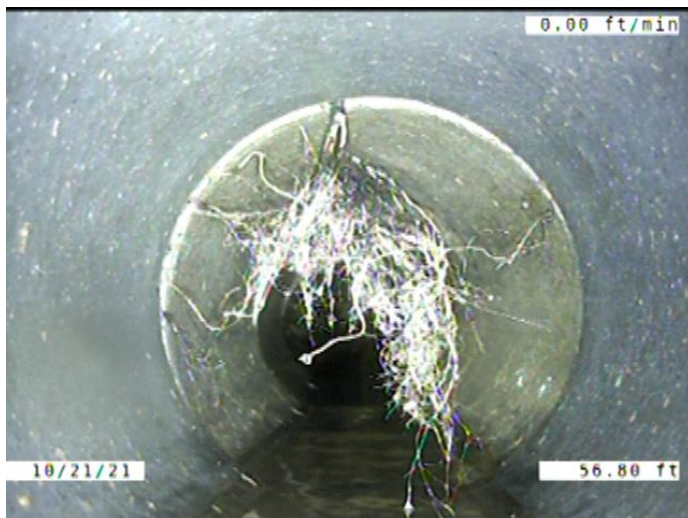
Code: **RMJ**
Description: **Roots Medium Joint**

Distance (ft): **56.8**
Structural Grade: **0**
O&M Grade: **3**
Clock Start/From: **9**
Clock To: **2**
1st Value:
2nd Value:
Value Percent: **15.000**
Continuous Index:
Within 8" of Joint: **YES**
Remarks:

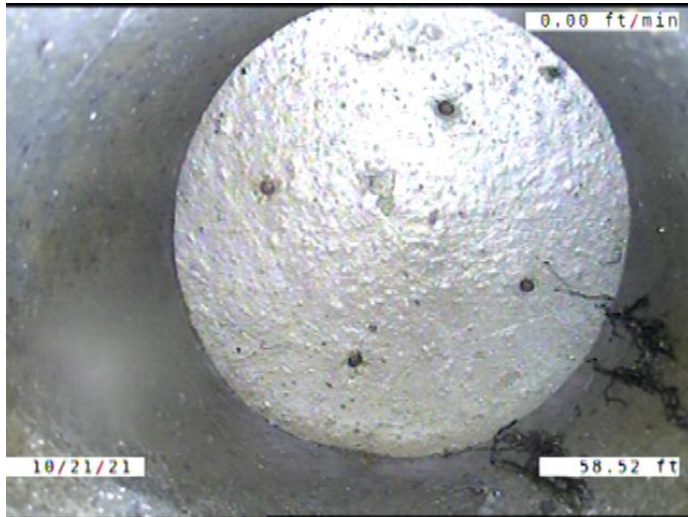
Code:	TFC
Description:	Tap Factory Capped
Distance (ft):	58.5
Structural Grade:	0
O&M Grade:	0
Clock Start/From:	1
Clock To:	
1st Value:	4.000
2nd Value:	
Value Percent:	
Continuous Index:	
Within 8" of Joint:	YES
Remarks:	ROOTS GROWING AROUND THE CAP

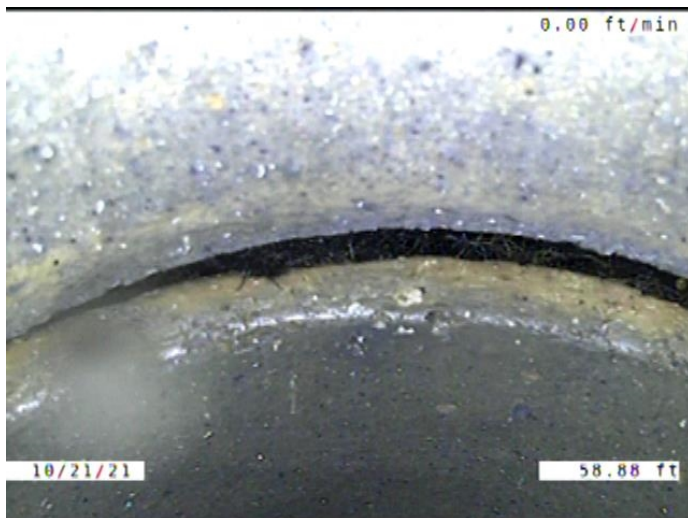
Code:	JOM
Description:	Joint Offset Medium
Distance (ft):	58.9
Structural Grade:	3
O&M Grade:	0
Clock Start/From:	
Clock To:	
1st Value:	
2nd Value:	
Value Percent:	
Continuous Index:	
Within 8" of Joint:	NO
Remarks:

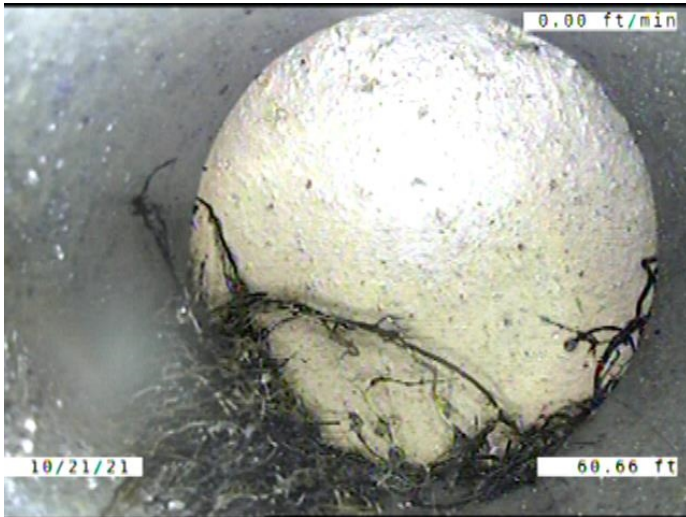
Code:	TFC
Description:	Tap Factory Capped
Distance (ft):	60.7
Structural Grade:	0
O&M Grade:	0
Clock Start/From:	11
Clock To:	
1st Value:	4.000
2nd Value:	
Value Percent:	
Continuous Index:	
Within 8" of Joint:	YES
Remarks:	ROOTS GROWING AROUND THE CAP

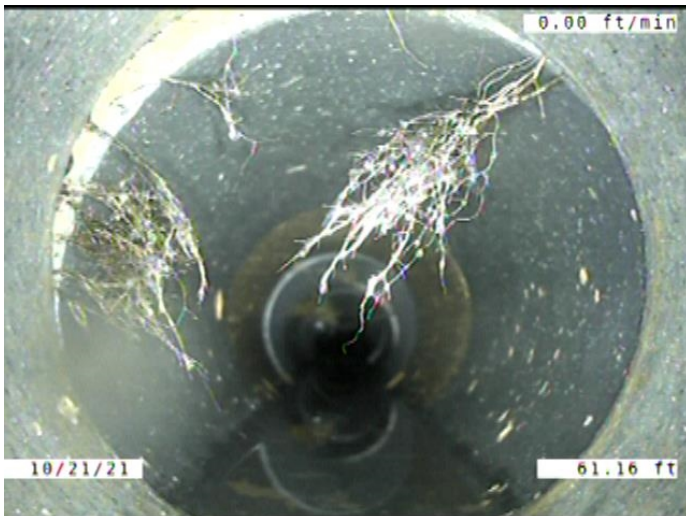
Code:	RMJ
Description:	Roots Medium Joint
Distance (ft):	61.2
Structural Grade:	0
O&M Grade:	3
Clock Start/From:	9
Clock To:	2
1st Value:	
2nd Value:	
Value Percent:	5.000
Continuous Index:	S03
Within 8" of Joint:	YES
Remarks:

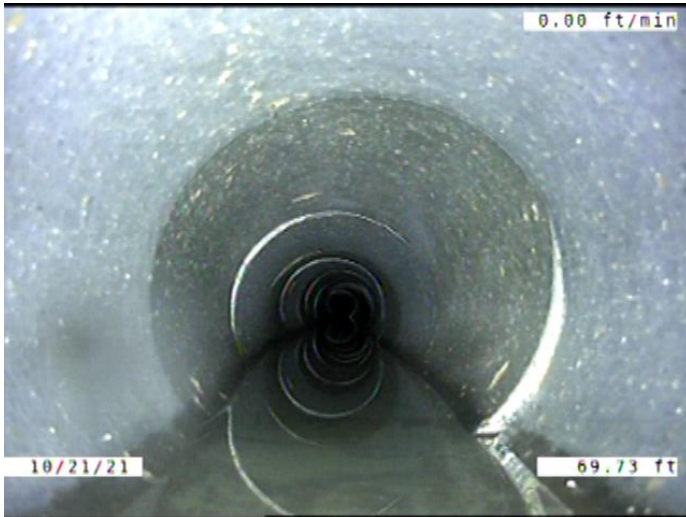
Code: **SSS**
Description: **Surface Damage Surface Spalling**

Distance (ft): **69.7**
Structural Grade: **2**
O&M Grade: **0**
Clock Start/From: **3**
Clock To: **9**
1st Value:
2nd Value:
Value Percent:
Continuous Index: **F02**
Within 8" of Joint: **YES**
Remarks:

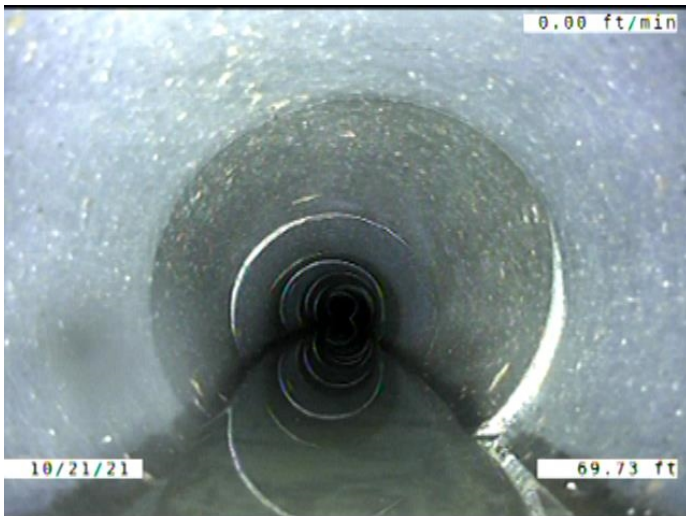
Code: **RMJ**
Description: **Roots Medium Joint**

Distance (ft): **69.7**
Structural Grade: **0**
O&M Grade: **3**
Clock Start/From: **9**
Clock To: **2**
1st Value:
2nd Value:
Value Percent: **5.000**
Continuous Index: **F03**
Within 8" of Joint: **YES**
Remarks:

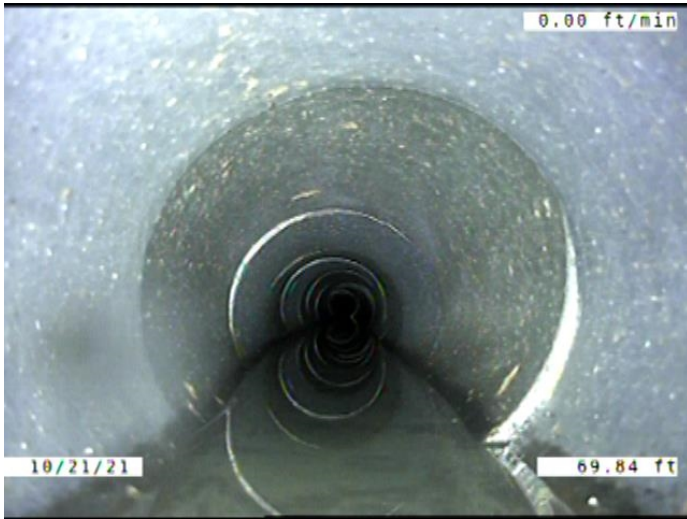
MSA

Miscellaneous Survey Abandoned

**MADE IT TO THE POINT OF OVERLAP.
REVERSAL COMPLETE**
