## Profile/Photo Observation Report

Date:	<b>10/21/2021</b>	Weather:		Coding:	<b>PACP 7.0</b>
Pipe Length (ft):	<b>194.0</b>	Owner:	<b>City of Hobart</b>	Pre Clean:	<b>Heavy Cleaning</b>
P.O.#:	<b>YES502259</b>	Surveyor:	<b>S. Bucklin</b>	PSR:	<b>P-503-020-019</b>
Customer:	<b>City of Hobart</b>	Clean Date:	<b>09/05/2021</b>	Shape:	<b>C</b>

Street:	<b>West 39th Avenue</b>	Flow Control:	<b>Not Controlled</b>
City:	<b>Hobart, IN</b>	Year Renewed:	
Location:	<b>Alley</b>	Tape/Media #:	
Purpose:	<b>Routine Assessment</b>	Dia/Height:	<b>10"</b>
Use:	<b>Sanitary Sewage Pipe</b>	Material:	<b>VCP</b>
Drain Area:		Lining:	<b>None</b>
Category:	<b>NA</b>		
Comment:

Location Details:		Direction of Survey:	<b>Upstream</b>
US MH:	<b>M-503-019</b>	DS MH:	<b>M-503-020</b>
		Total Length Surveyed (ft):	<b>69.8</b>

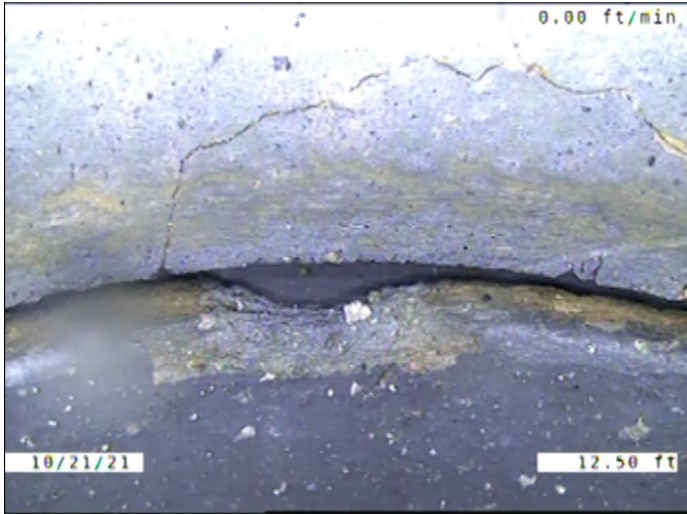
Code: **CM**  
 Description: **Crack Multiple**

Distance (ft): **12.5**  
 Structural Grade: **3**  
 O&M Grade: **0**  
 Clock Start/From: **8**  
 Clock To: **4**  
 1st Value:  
 2nd Value:  
 Value Percent:  
 Continuous Index: **F01**  
 Within 8" of Joint: **YES**  
 Remarks:

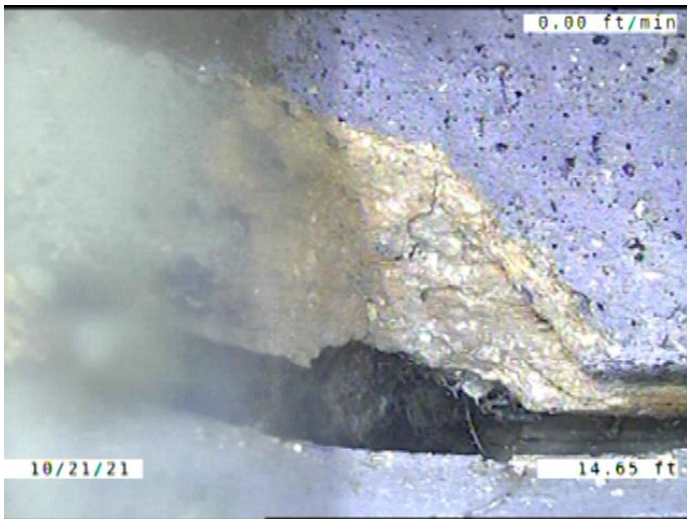
Code: **HSV**  
 Description: **Hole Soil Visible**

Distance (ft): **14.7**  
 Structural Grade: **5**  
 O&M Grade: **0**  
 Clock Start/From: **4**  
 Clock To: **6**  
 1st Value:  
 2nd Value:  
 Value Percent:  
 Continuous Index:  
 Within 8" of Joint: **YES**  
 Remarks: **THE INSIDE OF THE JOINT HAS CHIPPED OFF**

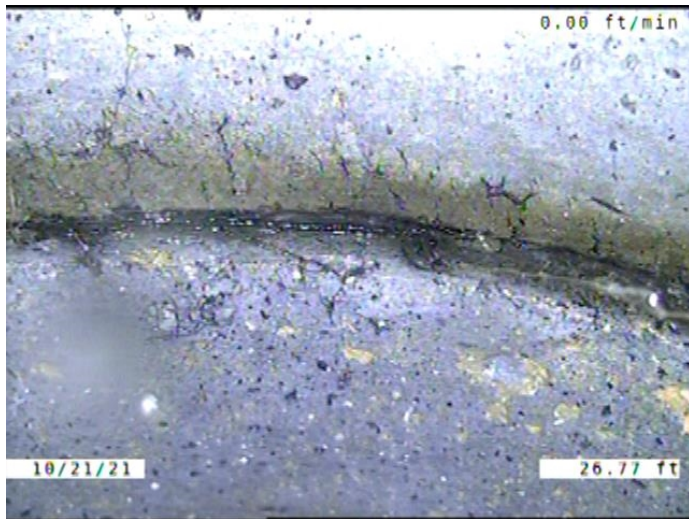
Code: **RFJ**  
 Description: **Roots Fine Joint**

Distance (ft): **26.8**  
 Structural Grade: **0**  
 O&M Grade: **1**  
 Clock Start/From: **12**  
 Clock To: **2**  
 1st Value:  
 2nd Value:  
 Value Percent:  
 Continuous Index:  
 Within 8" of Joint: **YES**  
 Remarks:

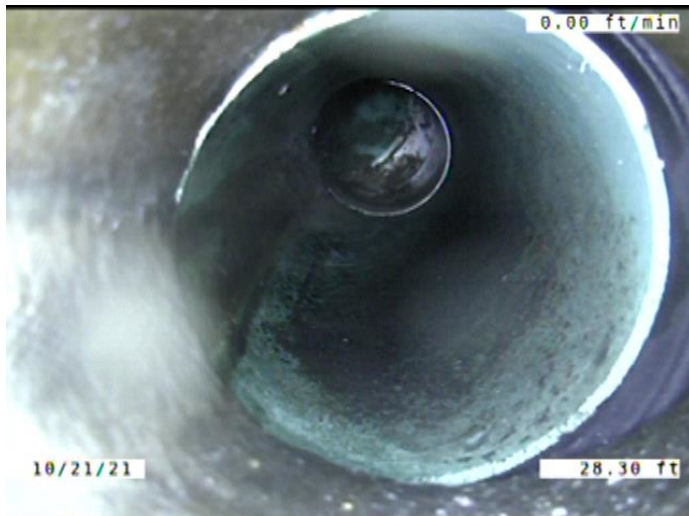
Code: **TF**  
 Description: **Tap Factory**

Distance (ft): **28.3**  
 Structural Grade: **0**  
 O&M Grade: **0**  
 Clock Start/From: **10**  
 Clock To:  
 1st Value: **4.000**  
 2nd Value:  
 Value Percent:  
 Continuous Index:  
 Within 8" of Joint: **YES**  
 Remarks: **CONSTANTLY RUNNING WATER**

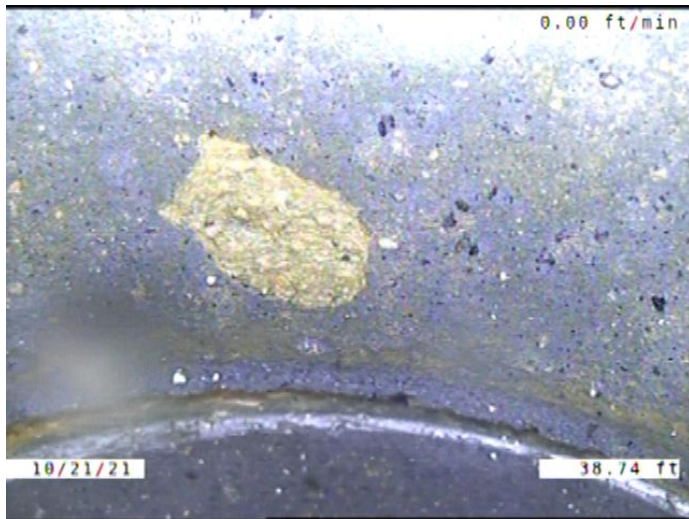
Code:	<b>SSS</b>
Description:	<b>Surface Damage Surface Spalling</b>
Distance (ft):	<b>38.7</b>
Structural Grade:	<b>2</b>
O&M Grade:	<b>0</b>
Clock Start/From:	<b>2</b>
Clock To:	
1st Value:	
2nd Value:	
Value Percent:	
Continuous Index:	
Within 8" of Joint:	<b>YES</b>
Remarks:

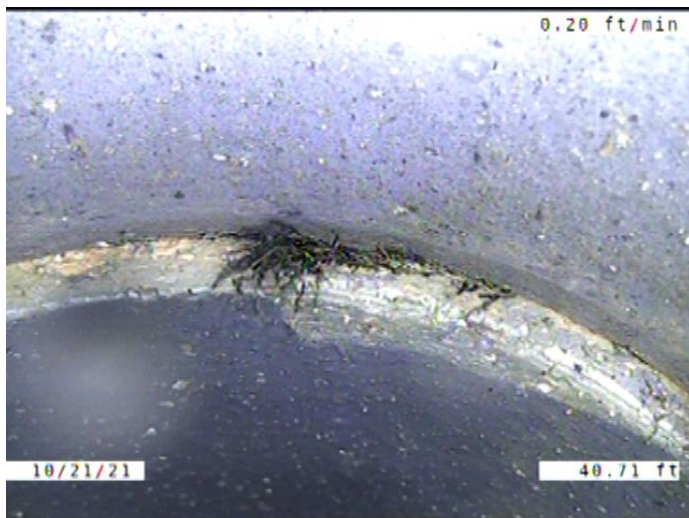
Code:	<b>RFJ</b>
Description:	<b>Roots Fine Joint</b>
Distance (ft):	<b>40.7</b>
Structural Grade:	<b>0</b>
O&M Grade:	<b>1</b>
Clock Start/From:	<b>2</b>
Clock To:	
1st Value:	
2nd Value:	
Value Percent:	
Continuous Index:	
Within 8" of Joint:	<b>YES</b>
Remarks:

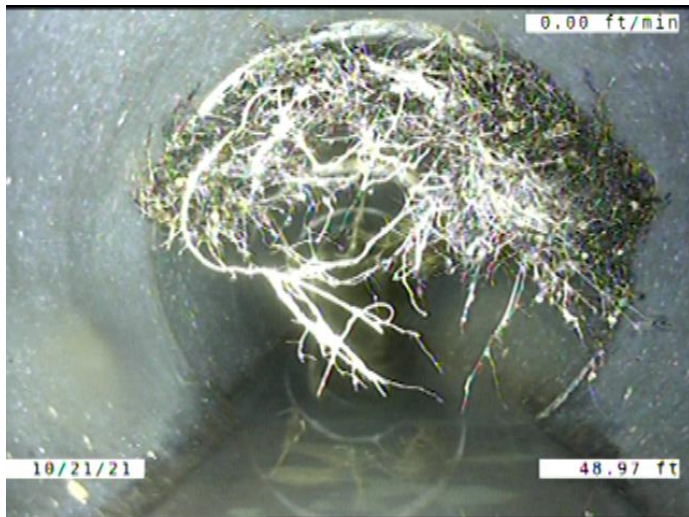
Code: **RMJ**  
 Description: **Roots Medium Joint**

Distance (ft): **49.0**  
 Structural Grade: **0**  
 O&M Grade: **3**  
 Clock Start/From: **9**  
 Clock To: **3**  
 1st Value:  
 2nd Value:  
 Value Percent: **25.000**  
 Continuous Index:  
 Within 8" of Joint: **YES**  
 Remarks:

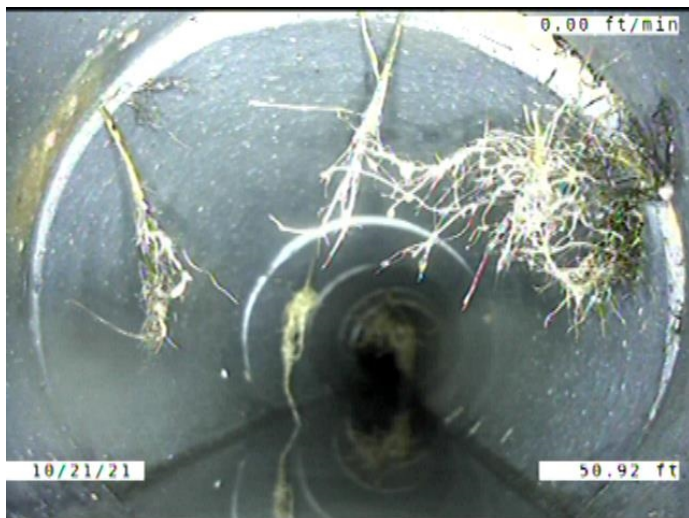
Code: **RMJ**  
 Description: **Roots Medium Joint**

Distance (ft): **50.9**  
 Structural Grade: **0**  
 O&M Grade: **3**  
 Clock Start/From: **10**  
 Clock To: **2**  
 1st Value:  
 2nd Value:  
 Value Percent: **5.000**  
 Continuous Index:  
 Within 8" of Joint: **YES**  
 Remarks:

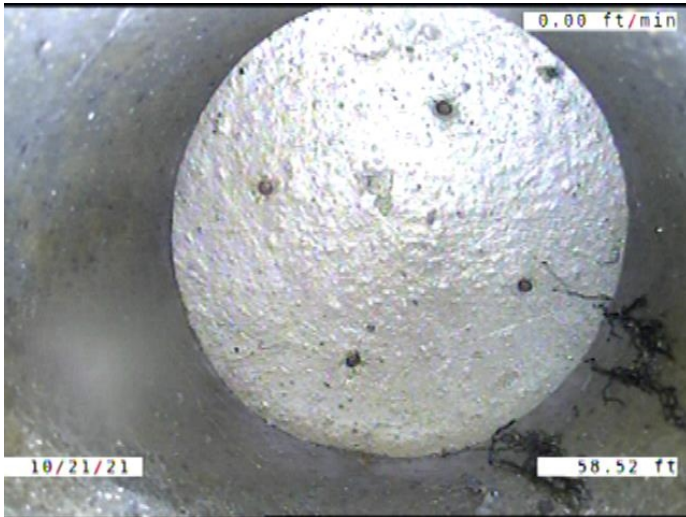
Code: **TFC**  
 Description: **Tap Factory Capped**

Distance (ft): **58.5**  
 Structural Grade: **0**  
 O&M Grade: **0**  
 Clock Start/From: **1**  
 Clock To:  
 1st Value: **4.000**  
 2nd Value:  
 Value Percent:  
 Continuous Index:  
 Within 8" of Joint: **YES**  
 Remarks: **ROOTS GROWING AROUND THE CAP**

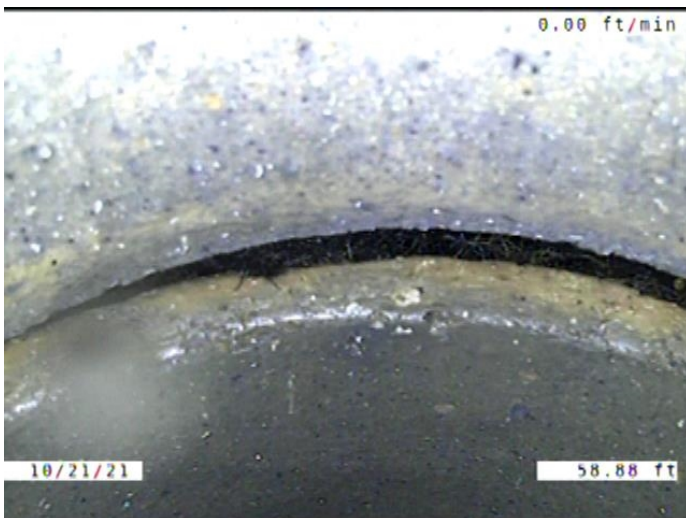
Code: **JOM**  
 Description: **Joint Offset Medium**

Distance (ft): **58.9**  
 Structural Grade: **3**  
 O&M Grade: **0**  
 Clock Start/From:  
 Clock To:  
 1st Value:  
 2nd Value:  
 Value Percent:  
 Continuous Index:  
 Within 8" of Joint: **NO**  
 Remarks:

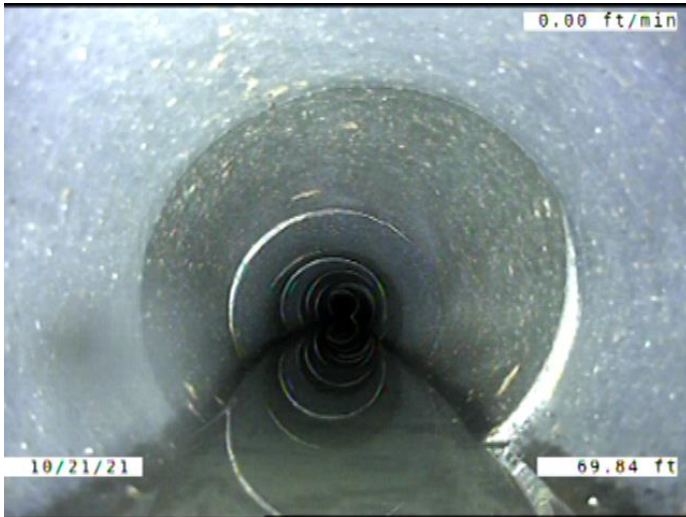
Code:	<b>MSA</b>
Description:	<b>Miscellaneous Survey Abandoned</b>
Distance (ft):	<b>69.8</b>
Structural Grade:	<b>0</b>
O&M Grade:	<b>0</b>
Clock Start/From:	
Clock To:	
1st Value:	
2nd Value:	
Value Percent:	
Continuous Index:	
Within 8" of Joint:	<b>NO</b>
Remarks:	<b>MADE IT TO THE POINT OF OVERLAP. REVERSAL COMPLETE</b>
