Profile/Photo Observation Report

Date:	04/10/2018	Weather:		Coding:	PACP 6.0
Pipe Length (ft):	178.0	Owner:	NA	Pre Clean:	Not Known
P.O.#:		Surveyor:	Mark Ruby	PSR:	P-503-021-020
Customer:		Clean Date:	01/01/1900	Shape:	C

Street:	N VIRGINIA ST	Flow Control:	Not Controlled
City:	Hobart, IN	Year Renewed:	
Location:	Other	Tape/Media #:	
Purpose:	Not Known	Dia/Height:	10"
Use:	Sanitary	Material:	VCP
Drain Area:	NA	Lining:	
Category:	NA		
Comment:

Location Details:		Direction of Survey:	Downstream
US MH:	M-503-020	DS MH:	M-503-021
		Total Length Surveyed (ft):	105.7

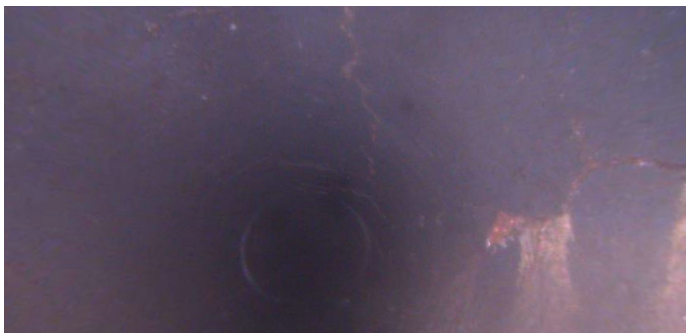
Code: **FM**
Description: **Fracture Multiple**

Distance (ft): **.0**
Structural Grade: **4**
O&M Grade: **0**
Clock Start/From: **12**
Clock To: **2**
1st Value:
2nd Value:
Value Percent:
Continuous Index:
Within 8" of Joint:
Remarks:

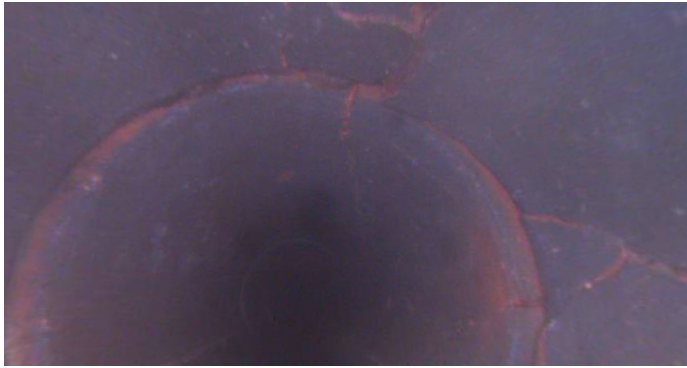
Code:	FM
Description:	Fracture Multiple
Distance (ft):	2.8
Structural Grade:	4
O&M Grade:	0
Clock Start/From:	10
Clock To:	5
1st Value:	
2nd Value:	
Value Percent:	
Continuous Index:	
Within 8" of Joint:	YES
Remarks:

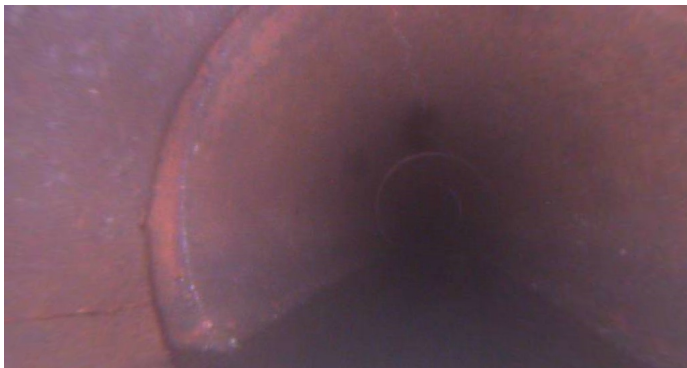
Code:	CM
Description:	Crack Multiple
Distance (ft):	32.7
Structural Grade:	3
O&M Grade:	0
Clock Start/From:	7
Clock To:	12
1st Value:	
2nd Value:	
Value Percent:	
Continuous Index:	
Within 8" of Joint:	
Remarks:

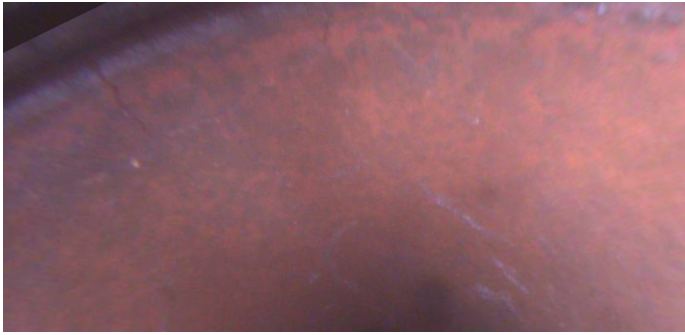
Code: **FM**
Description: **Fracture Multiple**

Distance (ft): **37.1**
Structural Grade: **4**
O&M Grade: **0**
Clock Start/From: **10**
Clock To: **12**
1st Value:
2nd Value:
Value Percent:
Continuous Index:
Within 8" of Joint: **YES**
Remarks:

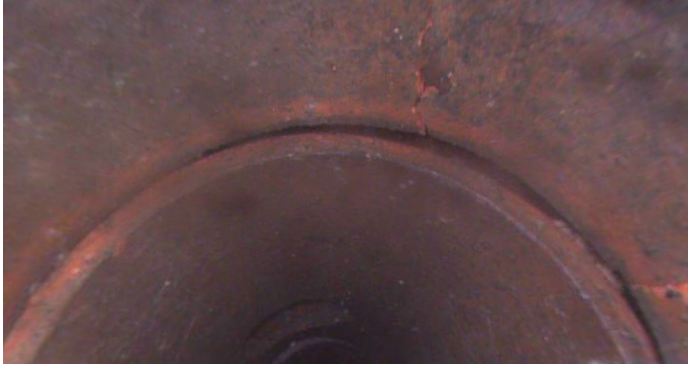
Code: **FM**
Description: **Fracture Multiple**

Distance (ft): **45.7**
Structural Grade: **4**
O&M Grade: **0**
Clock Start/From: **11**
Clock To: **9**
1st Value:
2nd Value:
Value Percent:
Continuous Index:
Within 8" of Joint: **YES**
Remarks:

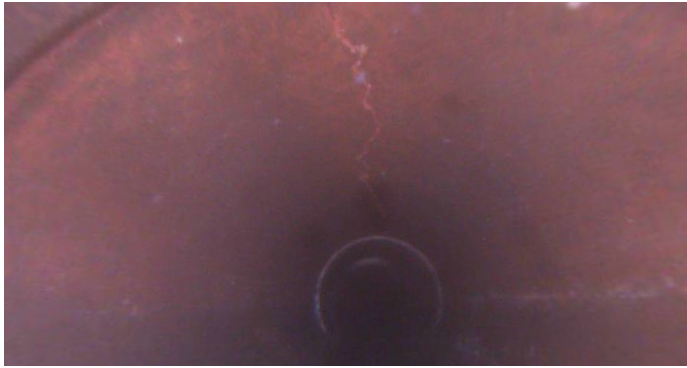
Code:	FL
Description:	Fracture Longitudinal
Distance (ft):	51.0
Structural Grade:	3
O&M Grade:	0
Clock Start/From:	12
Clock To:	
1st Value:	
2nd Value:	
Value Percent:	
Continuous Index:	
Within 8" of Joint:	YES
Remarks:

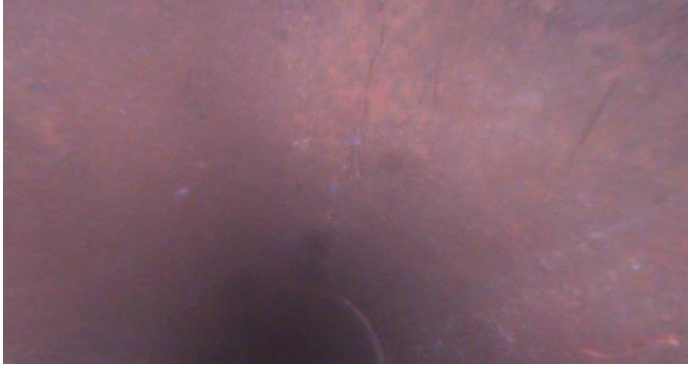
Code: **FL**
Description: **Fracture Longitudinal**

Distance (ft): **65.8**
Structural Grade: **3**
O&M Grade: **0**
Clock Start/From: **1**
Clock To:
1st Value:
2nd Value:
Value Percent:
Continuous Index: **S01**
Within 8" of Joint:
Remarks:

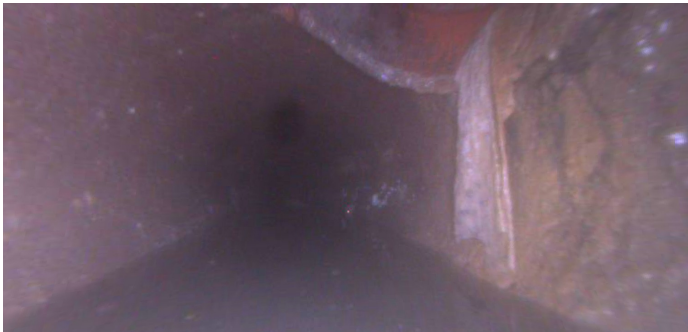
Code: **DAR**
Description: **Deposits Attached Ragging**

Distance (ft): **79.5**
Structural Grade: **0**
O&M Grade: **2**
Clock Start/From: **1**
Clock To:
1st Value:
2nd Value:
Value Percent: **5.000**
Continuous Index:
Within 8" of Joint: **NO**
Remarks:

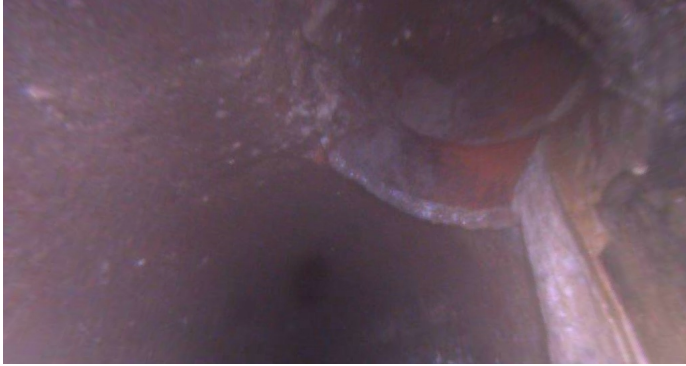
Code: **TBI**
Description: **Tap Break-in Intruding**

Distance (ft): **79.5**
Structural Grade: **0**
O&M Grade: **2**
Clock Start/From: **2**
Clock To:
1st Value: **4.000**
2nd Value: **1.000**
Value Percent:
Continuous Index:
Within 8" of Joint:
Remarks:

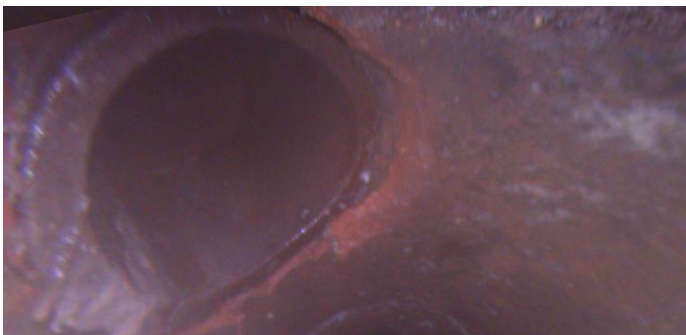
Code: **TBA**
Description: **Tap Break-in Active**

Distance (ft): **84.4**
Structural Grade: **0**
O&M Grade: **0**
Clock Start/From: **11**
Clock To:
1st Value: **4.000**
2nd Value:
Value Percent:
Continuous Index:
Within 8" of Joint:
Remarks:

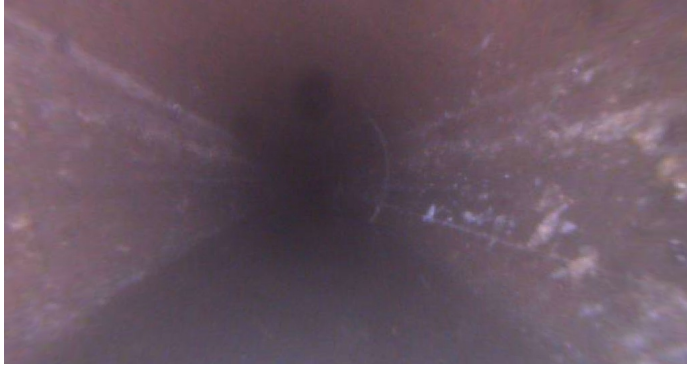
Code: **FL**
Description: **Fracture Longitudinal**

Distance (ft): **85.9**
Structural Grade: **3**
O&M Grade: **0**
Clock Start/From: **1**
Clock To:
1st Value:
2nd Value:
Value Percent:
Continuous Index: **F01**
Within 8" of Joint:
Remarks:

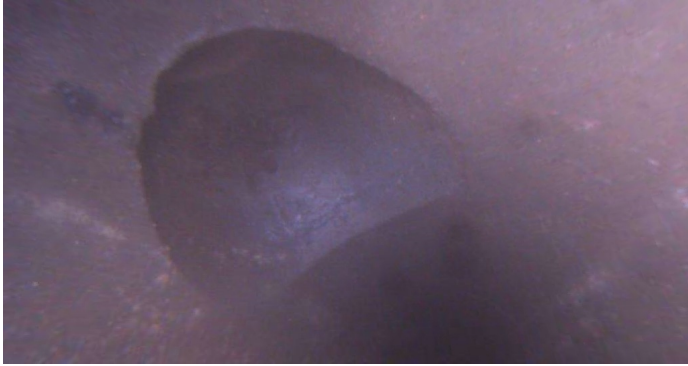
Code:	MSA
Description:	Abandoned Survey
Distance (ft):	105.7
Structural Grade:	0
O&M Grade:	0
Clock Start/From:	
Clock To:	
1st Value:	
2nd Value:	
Value Percent:	
Continuous Index:	
Within 8" of Joint:	NO
Remarks:	Debris
