Profile/Photo Observation Report

Date:	04/10/2018	Weather:		Coding:	PACP 6.0
Pipe Length (ft):	178.0	Owner:	NA	Pre Clean:	Not Known
P.O.#:		Surveyor:	Mark Ruby	PSR:	P-503-021-020
Customer:		Clean Date:	01/01/1900	Shape:	C

Street:	W 40th ave	Flow Control:	Not Controlled
City:	Hobart, IN	Year Renewed:	
Location:	Other	Tape/Media #:	
Purpose:	Not Known	Dia/Height:	10"
Use:	Sanitary	Material:	VCP
Drain Area:	NA	Lining:	
Category:	NA		
Comment:

Location Details:		Direction of Survey:	Downstream
US MH:	M-503-020	DS MH:	M-503-021
		Total Length Surveyed (ft):	105.7

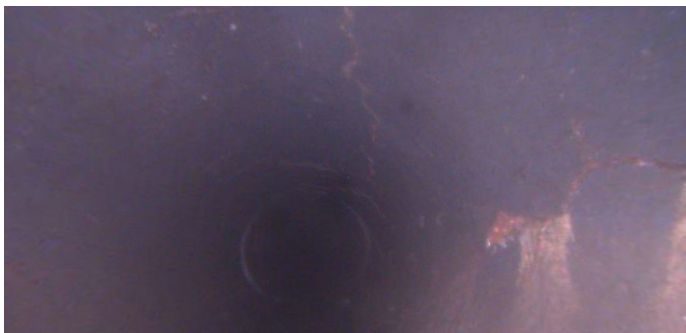
Code: **FM**
Description: **Fracture Multiple**

Distance (ft): **.0**
Structural Grade: **4**
O&M Grade: **0**
Clock Start/From: **12**
Clock To: **2**
1st Value:
2nd Value:
Value Percent:
Continuous Index:
Within 8" of Joint:
Remarks:

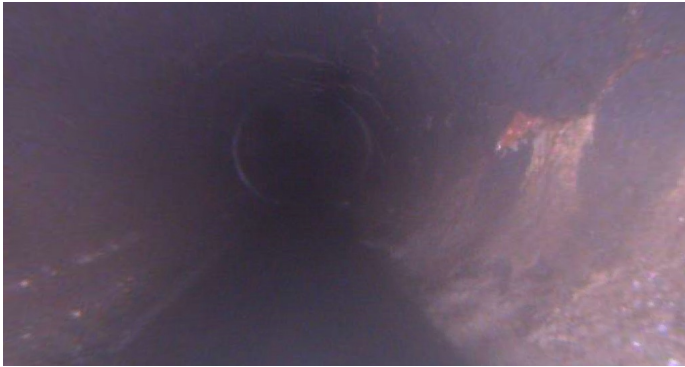
Code:	AMH
Description:	Manhole

Distance (ft):	.0
Structural Grade:	0
O&M Grade:	0
Clock Start/From:	
Clock To:	
1st Value:	
2nd Value:	
Value Percent:	
Continuous Index:	
Within 8" of Joint:	NO
Remarks:	M-503-020

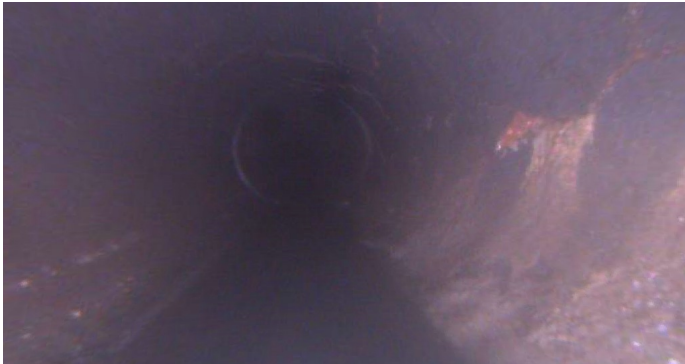
Code:	MWL
Description:	Water Level

Distance (ft):	.0
Structural Grade:	0
O&M Grade:	0
Clock Start/From:	
Clock To:	
1st Value:	
2nd Value:	
Value Percent:	10.000
Continuous Index:	
Within 8" of Joint:	NO
Remarks:

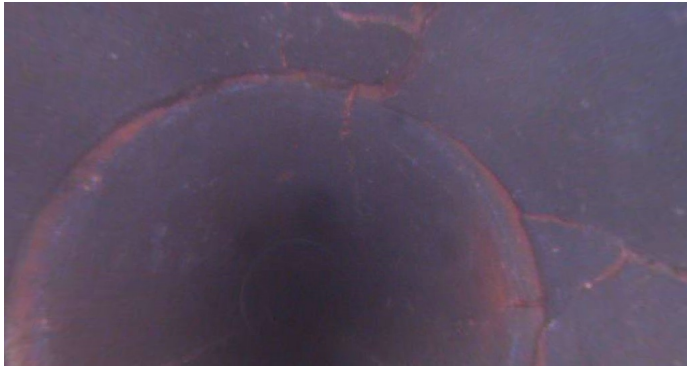
Code:	FM
Description:	Fracture Multiple
Distance (ft):	2.8
Structural Grade:	4
O&M Grade:	0
Clock Start/From:	10
Clock To:	5
1st Value:	
2nd Value:	
Value Percent:	
Continuous Index:	
Within 8" of Joint:	YES
Remarks:

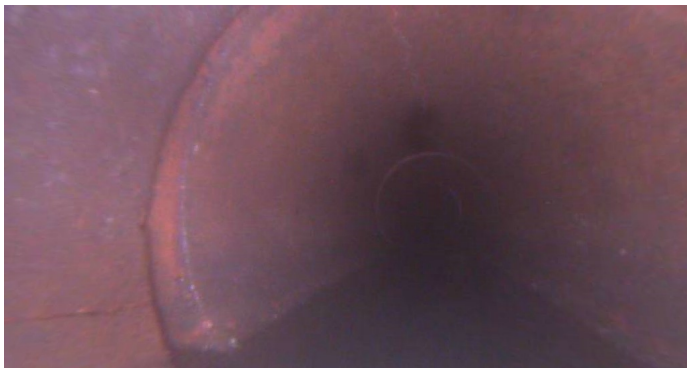
Code:	CM
Description:	Crack Multiple
Distance (ft):	32.7
Structural Grade:	3
O&M Grade:	0
Clock Start/From:	7
Clock To:	12
1st Value:	
2nd Value:	
Value Percent:	
Continuous Index:	
Within 8" of Joint:	
Remarks:

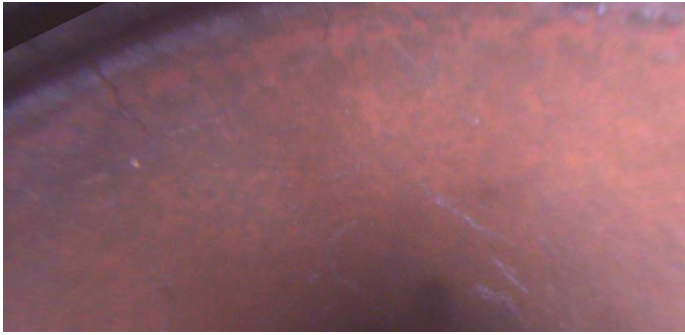
Code: **FM**
Description: **Fracture Multiple**

Distance (ft): **37.1**
Structural Grade: **4**
O&M Grade: **0**
Clock Start/From: **10**
Clock To: **12**
1st Value:
2nd Value:
Value Percent:
Continuous Index:
Within 8" of Joint: **YES**
Remarks:

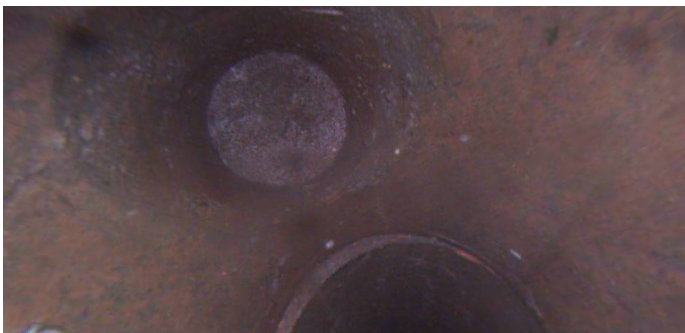
Code: **TFC**
Description: **Tap Factory Capped**

Distance (ft): **44.3**
Structural Grade: **0**
O&M Grade: **0**
Clock Start/From: **1**
Clock To:
1st Value: **4.000**
2nd Value:
Value Percent:
Continuous Index:
Within 8" of Joint:
Remarks:

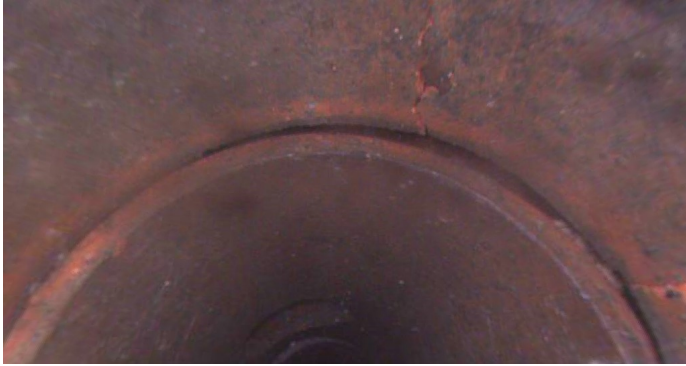
Code: **FM**
Description: **Fracture Multiple**

Distance (ft): **45.7**
Structural Grade: **4**
O&M Grade: **0**
Clock Start/From: **11**
Clock To: **9**
1st Value:
2nd Value:
Value Percent:
Continuous Index:
Within 8" of Joint: **YES**
Remarks:

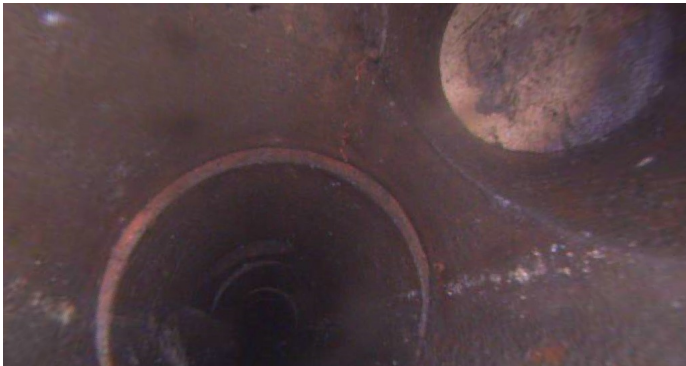
Code: **TFC**
Description: **Tap Factory Capped**

Distance (ft): **46.1**
Structural Grade: **0**
O&M Grade: **0**
Clock Start/From: **10**
Clock To:
1st Value: **4.000**
2nd Value:
Value Percent:
Continuous Index:
Within 8" of Joint:
Remarks:

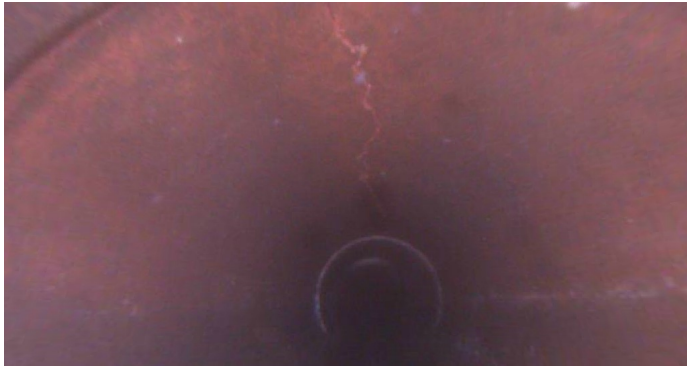
Code:	FL
Description:	Fracture Longitudinal
Distance (ft):	51.0
Structural Grade:	3
O&M Grade:	0
Clock Start/From:	12
Clock To:	
1st Value:	
2nd Value:	
Value Percent:	
Continuous Index:	
Within 8" of Joint:	YES
Remarks:

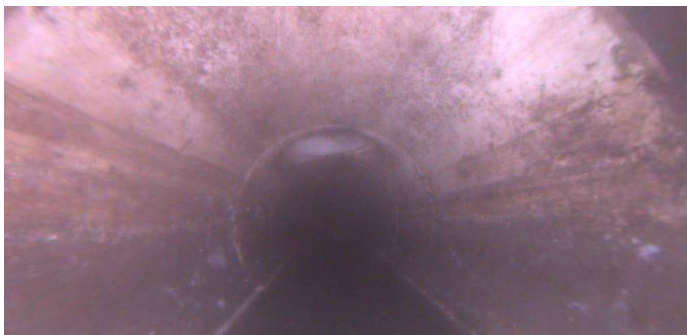
Code:	MMC
Description:	Material Change
Distance (ft):	53.1
Structural Grade:	0
O&M Grade:	0
Clock Start/From:	
Clock To:	
1st Value:	
2nd Value:	
Value Percent:	
Continuous Index:	
Within 8" of Joint:	NO
Remarks:	PVC

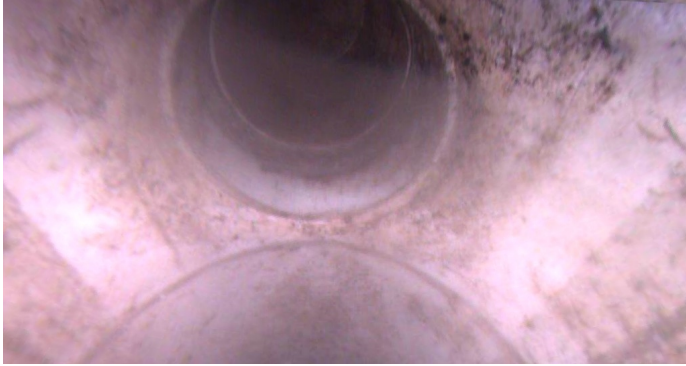
Code: **TF**
Description: **Tap Factory**

Distance (ft): **54.3**
Structural Grade: **0**
O&M Grade: **0**
Clock Start/From: **12**
Clock To:
1st Value: **4.000**
2nd Value:
Value Percent:
Continuous Index:
Within 8" of Joint:
Remarks:

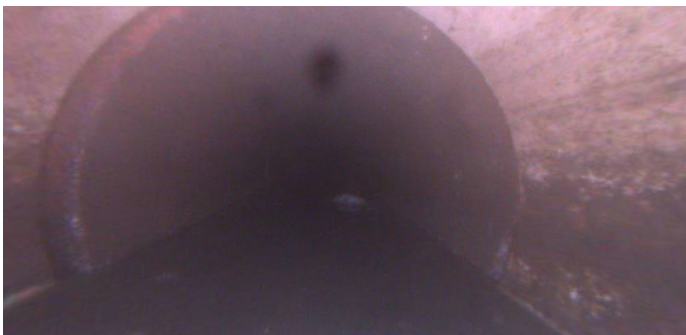
Code: **MMC**
Description: **Material Change**

Distance (ft): **59.0**
Structural Grade: **0**
O&M Grade: **0**
Clock Start/From:
Clock To:
1st Value:
2nd Value:
Value Percent:
Continuous Index:
Within 8" of Joint: **NO**
Remarks: **vcp**

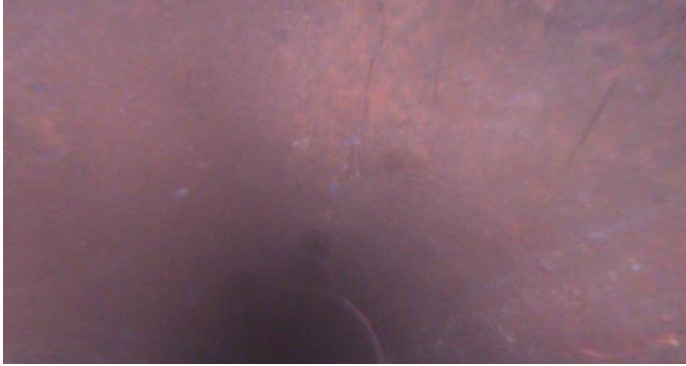
Code: **FL**
Description: **Fracture Longitudinal**

Distance (ft): **65.8**
Structural Grade: **3**
O&M Grade: **0**
Clock Start/From: **1**
Clock To:
1st Value:
2nd Value:
Value Percent:
Continuous Index: **S01**
Within 8" of Joint:
Remarks:

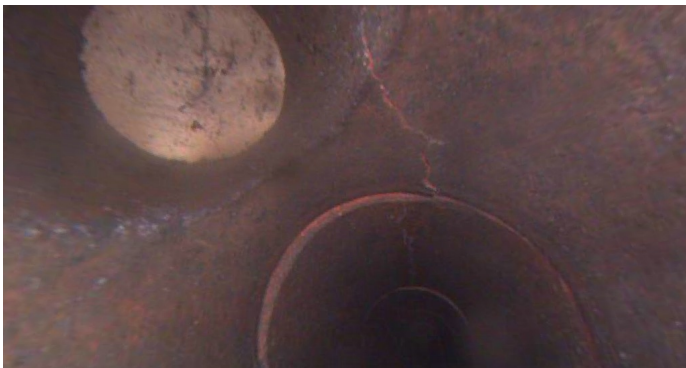
Code: **TFC**
Description: **Tap Factory Capped**

Distance (ft): **76.4**
Structural Grade: **0**
O&M Grade: **0**
Clock Start/From: **2**
Clock To:
1st Value: **4.000**
2nd Value:
Value Percent:
Continuous Index:
Within 8" of Joint:
Remarks:

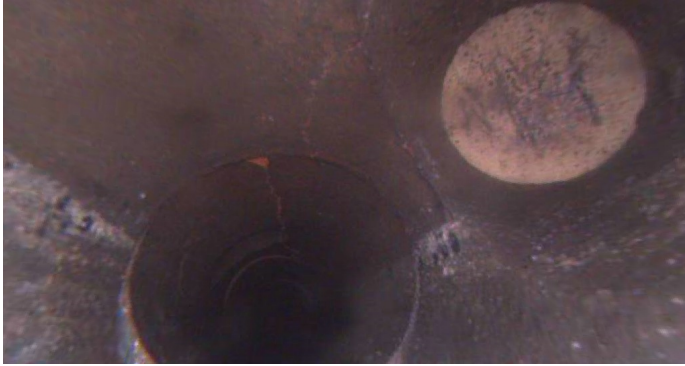
Code: **TFC**
Description: **Tap Factory Capped**

Distance (ft): **78.4**
Structural Grade: **0**
O&M Grade: **0**
Clock Start/From: **10**
Clock To:
1st Value: **4.000**
2nd Value:
Value Percent:
Continuous Index:
Within 8" of Joint:
Remarks:

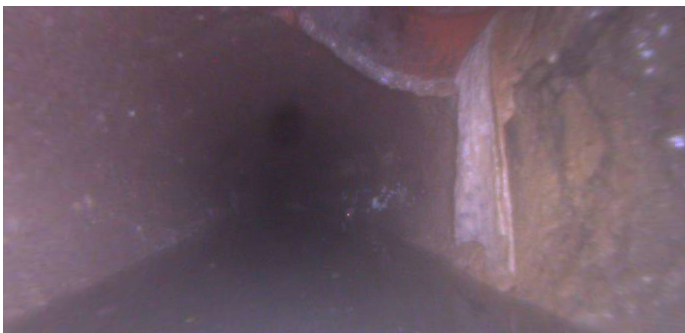
Code: **DAR**
Description: **Deposits Attached Ragging**

Distance (ft): **79.5**
Structural Grade: **0**
O&M Grade: **2**
Clock Start/From: **1**
Clock To:
1st Value:
2nd Value:
Value Percent: **5.000**
Continuous Index:
Within 8" of Joint: **NO**
Remarks:

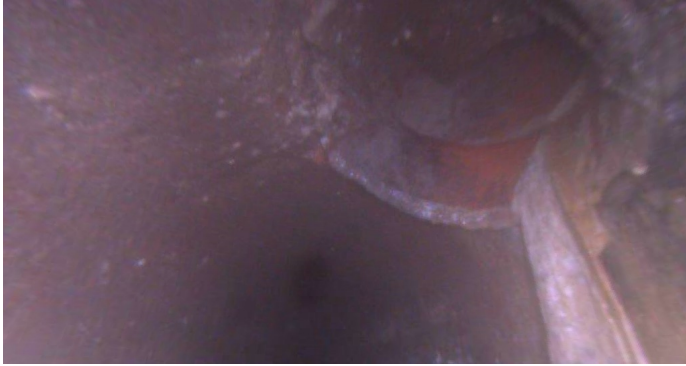
Code: **TBI**
Description: **Tap Break-in Intruding**

Distance (ft): **79.5**
Structural Grade: **0**
O&M Grade: **2**
Clock Start/From: **2**
Clock To:
1st Value: **4.000**
2nd Value: **1.000**
Value Percent:
Continuous Index:
Within 8" of Joint:
Remarks:

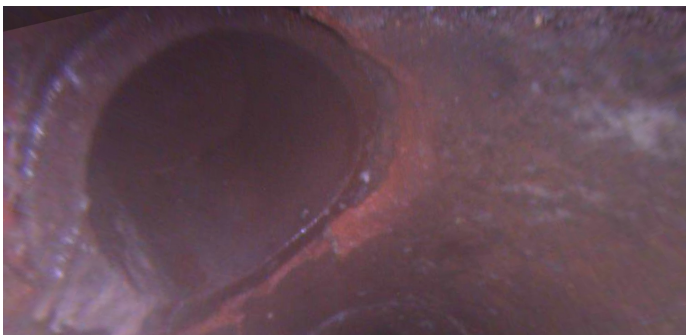
Code: **TBA**
Description: **Tap Break-in Active**

Distance (ft): **84.4**
Structural Grade: **0**
O&M Grade: **0**
Clock Start/From: **11**
Clock To:
1st Value: **4.000**
2nd Value:
Value Percent:
Continuous Index:
Within 8" of Joint:
Remarks:

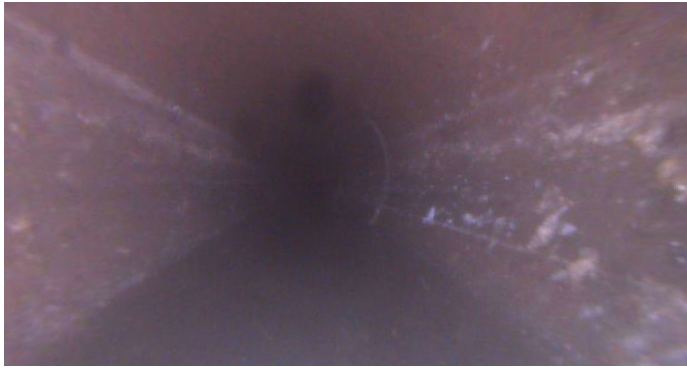
Code: **FL**
Description: **Fracture Longitudinal**

Distance (ft): **85.9**
Structural Grade: **3**
O&M Grade: **0**
Clock Start/From: **1**
Clock To:
1st Value:
2nd Value:
Value Percent:
Continuous Index: **F01**
Within 8" of Joint:
Remarks:

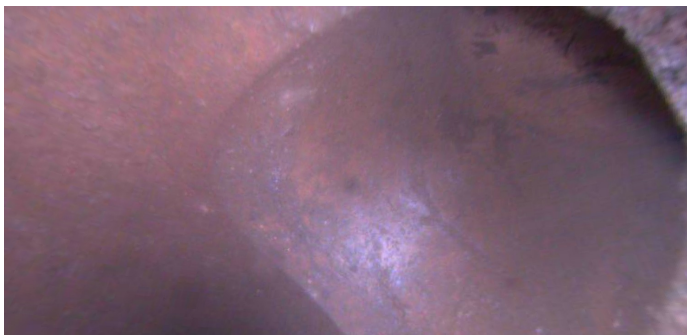
Code: **TFC**
Description: **Tap Factory Capped**

Distance (ft): **104.0**
Structural Grade: **0**
O&M Grade: **0**
Clock Start/From: **2**
Clock To:
1st Value: **4.000**
2nd Value:
Value Percent:
Continuous Index:
Within 8" of Joint:
Remarks:

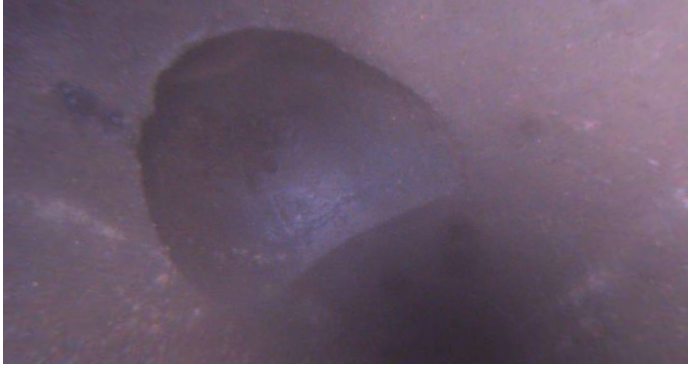
Code:	MSA
Description:	Abandoned Survey
Distance (ft):	105.7
Structural Grade:	0
O&M Grade:	0
Clock Start/From:	
Clock To:	
1st Value:	
2nd Value:	
Value Percent:	
Continuous Index:	
Within 8" of Joint:	NO
Remarks:	Debris
