Profile/Photo Observation Report

RUBUIICS
Date:	09/19/2021	Weather:		Coding:	PACP 7.0
Pipe Length (ft):	187.5	Owner:	City of Hobart	Pre Clean:	Heavy Cleaning
P.O.#:	YES502259	Surveyor:	S. Bucklin	PSR:	P-503-021-020
Customer:	City of Hobart	Clean Date	e: 09/05/2021	Shape:	С
Street:	North Virginia Stre	et	Flow Control:	Not Controlled	ł
City:	Hobart, IN		Year Renewed:		
Location:	Local rural streets	with light traffi	c, t Tape/Media #:		
Purpose:	Routine Assessme	nt	Dia/Height:	10"	
Use:	Sanitary Sewage P	ipe	Material:	VCP	
Drain Area:			Lining:	None	
Category:	NA				
Comment:					
Location Details	:		Direction of Surv	ey: Downstream	
US MH:	M-503-020	DS MH:	M-503-021	Total Length Surveyed (ft): 187.5
0&M Index:	1.71	O&M Quick		GO&M Rating:	116.00
structural Index:	3.21	Structural C	Quick: 534	B Structural Rating	125.00
Overall Index:	2.25	Overall Qui	ck: 534I	B Overall Rating:	241.00

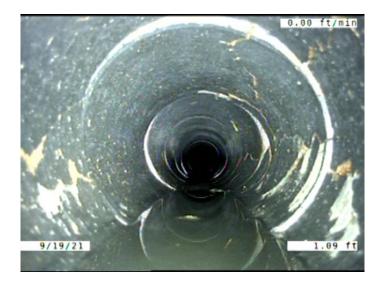
Code:	FM
Description:	Fracture Multiple
Distance (ft):	1.1
Structural Grade:	4
O&M Grade:	0
Clock Start/From:	8
Clock To:	4
1st Value:	
2nd Value:	
Value Percent:	
Continuous Index:	S01
Within 8" of Joint:	YES
Remarks:

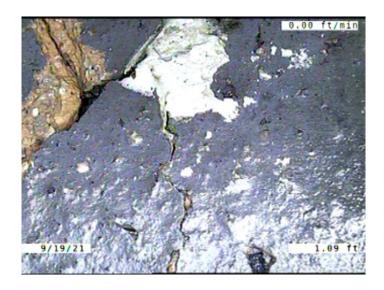
Distance (ft): 1.1	Code: Description:	DAE Deposits Attached Encrustation
	Distance (ft):	1.1
Structural Grade: 0	Structural Grade:	0
O&M Grade: 2	O&M Grade:	2
Clock Start/From: 7	Clock Start/From:	7
Clock To: 9	Clock To:	9
1st Value:	1st Value:	
2nd Value:	2nd Value:	
Value Percent: 5.000	Value Percent:	5.000
Continuous Index:	Continuous Index:	
Within 8" of Joint: YES	Within 8" of Joint:	YES
Remarks:	Remarks:

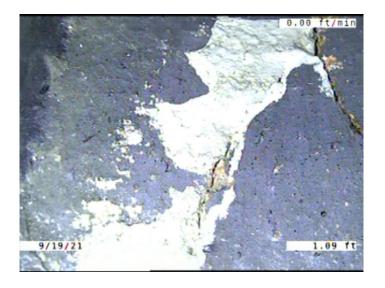
Code: Description:	DAE Deposits Attached Encrustation
Distance (ft):	1.1
Structural Grade:	0
O&M Grade:	2
Clock Start/From:	3
Clock To:	5
1st Value:	
2nd Value:	
Value Percent:	5.000
Continuous Index:	
Within 8" of Joint:	YES
Remarks:

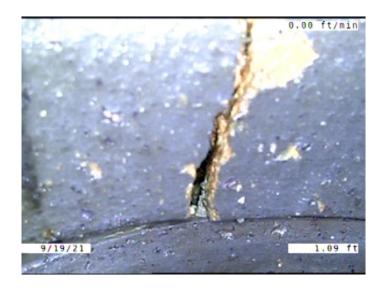
Code: Description:	BSV Broken Soil Visible
Distance (ft): Structural Grade: O&M Grade: Clock Start/From: Clock To: 1st Value: 2nd Value: Value Percent: Continuous Index: Within 8" of Joint: Remarks:	1.1 5 0 8 9
Remarks:	-

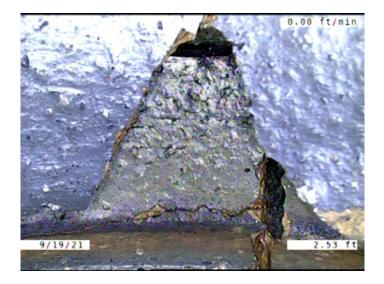
Code: Description:	SMW Surface Damage Missing Wall
Distance (ft):	2.5
Structural Grade:	5
O&M Grade:	0
Clock Start/From:	2
Clock To:	3
1st Value:	
2nd Value:	
Value Percent:	
Continuous Index:	
Within 8" of Joint:	YES
Remarks:	SOIL VISIBLE

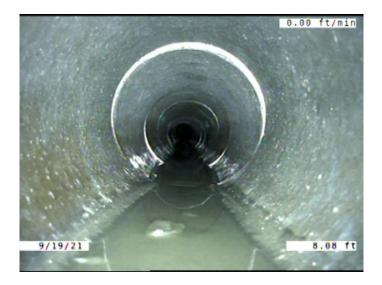
Code: Description:	DSF Deposits Settled Fine
Distance (ft):	8.1
Structural Grade: O&M Grade:	0 2
Clock Start/From:	5
Clock To:	7
1st Value: 2nd Value:	
Value Percent:	5.000
Continuous Index:	S03
Within 8" of Joint:	YES
Remarks:

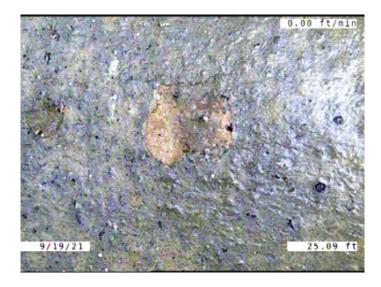
Code: Description:	SSS Surface Damage Surface Spalling
Distance (ft): Structural Grade: O&M Grade: Clock Start/From: Clock To: 1st Value: 2nd Value: Value Percent: Continuous Index: Within 8" of Joint:	25.1 2 0 1 2
Remarks:

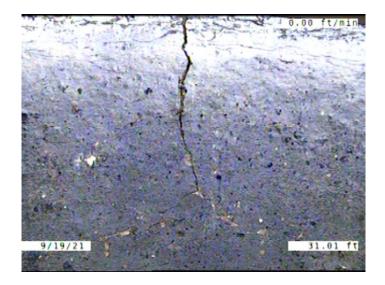
Code:	FM
Description:	Fracture Multiple
Distance (ft):	31.0
Structural Grade:	4
O&M Grade:	0
Clock Start/From:	8
Clock To:	4
1st Value:	
2nd Value:	
Value Percent:	
Continuous Index:	S04
Within 8" of Joint:	YES
Remarks:

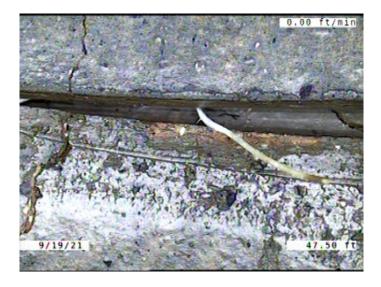
Code: Description:	RFJ Roots Fine Joint
Distance (ft):	47.5
Structural Grade:	0
O&M Grade:	1
Clock Start/From:	12
Clock To:	1
1st Value:	
2nd Value:	
Value Percent:	
Continuous Index:	
Within 8" of Joint:	YES
Remarks:

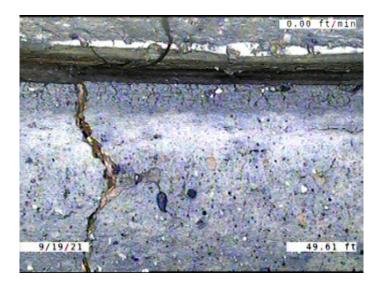
Code:	RFJ
Description:	Roots Fine Joint
Distance (ft):	49.6
Structural Grade:	0
	•
O&M Grade:	1
Clock Start/From:	12
Clock To:	
1st Value:	
2nd Value:	
Value Percent:	
Continuous Index:	
Within 8" of Joint:	YES
Remarks:

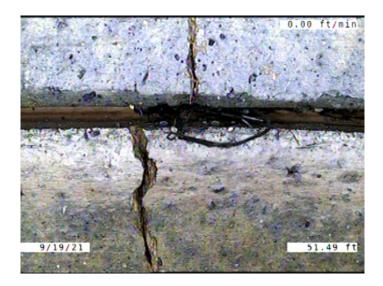
Code: Description:	RFJ Roots Fine Joint
Distance (ft):	51.5
Structural Grade:	0
O&M Grade:	1
Clock Start/From:	12
Clock To:	1
1st Value:	
2nd Value:	
Value Percent:	
Continuous Index:	
Within 8" of Joint:	YES
Remarks:

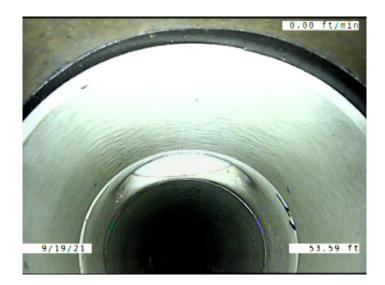
Code: Description:	JOM Joint Offset Medium
Distance (ft):	53.6
Structural Grade:	3
O&M Grade:	0
Clock Start/From:	
Clock To:	
1st Value:	
2nd Value:	
Value Percent:	
Continuous Index:	
Within 8" of Joint:	NO
Remarks:

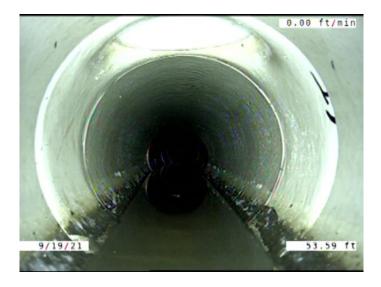
Code:	FM
Description:	Fracture Multiple
Distance (ft):	53.6
Structural Grade:	4
O&M Grade:	0
Clock Start/From:	8
Clock To:	4
1st Value:	
2nd Value:	
Value Percent:	
Continuous Index:	F04
Within 8" of Joint:	YES
Remarks:

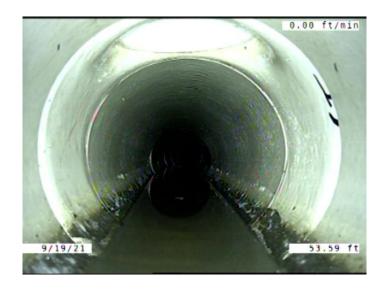
MWLS Miscellaneous Water Level Sag
53.6
2
0
10.000
S05
NO

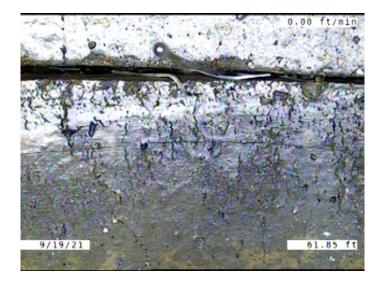
Code:	RFJ
Description:	Roots Fine Joint
Distance (ft):	61.9
	-
Structural Grade:	0
O&M Grade:	1
Clock Start/From:	11
Clock To:	3
1st Value:	
2nd Value:	
Value Percent:	
Continuous Index:	
Within 8" of Joint:	YES
Remarks:

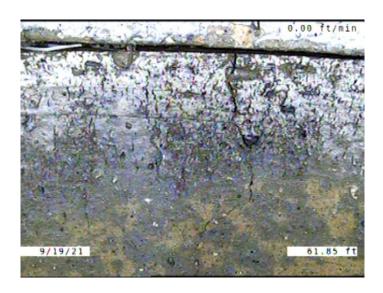
Code: Description:	FM Fracture Multiple
Distance (ft):	61.9
Structural Grade:	4
O&M Grade:	0
Clock Start/From:	8
Clock To:	4
1st Value:	
2nd Value:	
Value Percent:	
Continuous Index:	S06
Within 8" of Joint:	YES
Remarks:

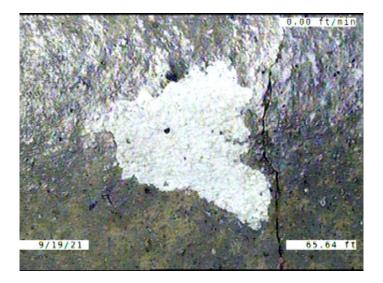
Code: Description:	DAE Deposits Attached Encrustation
Distance (ft):	65.6
Structural Grade:	0
O&M Grade:	2
Clock Start/From:	9
Clock To:	
1st Value:	
2nd Value:	
Value Percent:	5.000
Continuous Index:	
Within 8" of Joint:	YES
Remarks:

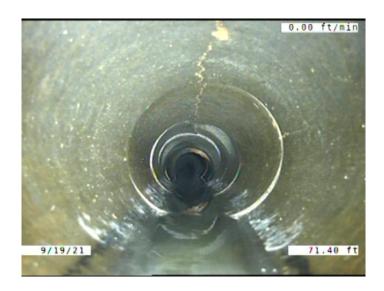
Code: Description:	MWLS Miscellaneous Water Level Sag
Distance (ft):	71.4
Structural Grade:	2
O&M Grade:	0
Clock Start/From:	
Clock To:	
1st Value:	
2nd Value:	
Value Percent:	10.000
Continuous Index:	F05
Within 8" of Joint:	NO
Remarks:

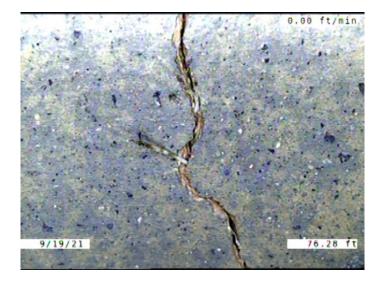
Code:	RFB
Description:	Roots Fine Barrel
Distance (ft):	76.3
Structural Grade:	0
O&M Grade:	2
Clock Start/From:	12
Clock To:	1
1st Value:	
2nd Value:	
Value Percent:	
Continuous Index:	
Within 8" of Joint:	NO
Remarks:

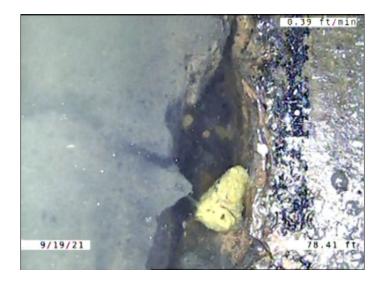
Code: Description:	BVV Broken Void Visible
Distance (ft):	78.4
Structural Grade:	5
O&M Grade:	0
Clock Start/From:	5
Clock To:	
1st Value:	
2nd Value:	
Value Percent:	
Continuous Index:	
Within 8" of Joint:	YES
Remarks:

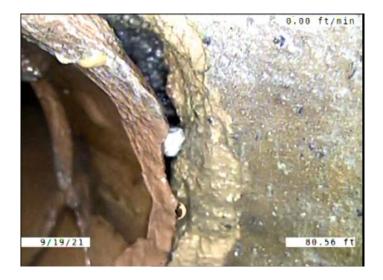
Code: SSS Description: Surface Damage Surface Spalling Distance (ft): 80.6 Structural Grade: 2 O&M Grade: 0 Clock Start/From: 1 3 Clock To: 1st Value: 2nd Value:

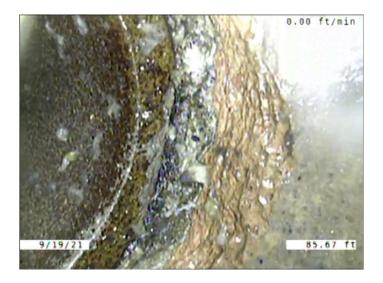
Code: Description:	SSS Surface Damage Surface Spalling
Distance (ft):	85.7
Structural Grade:	2
O&M Grade:	0
Clock Start/From:	10
Clock To:	12
1st Value:	
2nd Value:

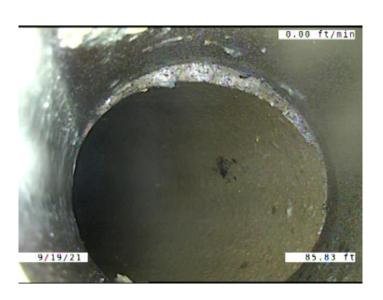
Code: Description:	TBI Tap Break-in Intruding
Distance (ft): Structural Grade: O&M Grade: Clock Start/From: Clock To: 1st Value: 2nd Value: Value Percent: Continuous Index: Within 8" of Joint:	85.8 0 2 11 4.000 1.000
Remarks:

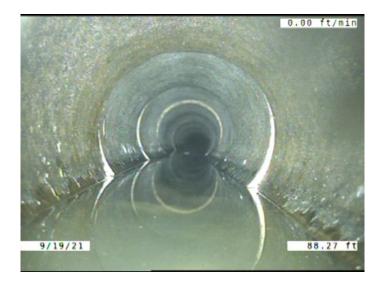
Code: Description:	FM Fracture Multiple
Distance (ft):	88.3
Structural Grade:	4
O&M Grade:	0
Clock Start/From:	8
Clock To:	4
1st Value:	
2nd Value:	
Value Percent:	
Continuous Index:	F06
Within 8" of Joint:	YES
Remarks:

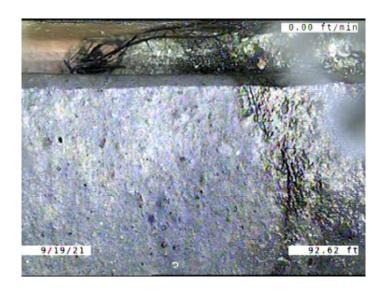
Code: Description:	RFJ Roots Fine Joint
Distance (ft):	92.6
Structural Grade:	0
O&M Grade:	1
Clock Start/From:	8
Clock To:	
1st Value:	
2nd Value:	
Value Percent:	
Continuous Index:	
Within 8" of Joint:	YES
Remarks:

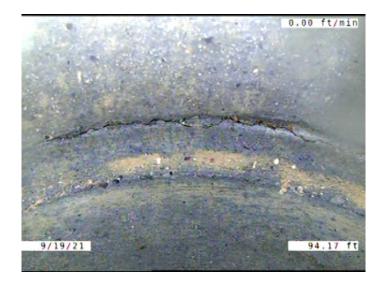
Code: Description:	JOM Joint Offset Medium
Distance (ft):	94.2
Structural Grade:	3
O&M Grade:	0
Clock Start/From:	
Clock To:	
1st Value:	
2nd Value:	
Value Percent:	
Continuous Index:	
Within 8" of Joint:	NO
Remarks:

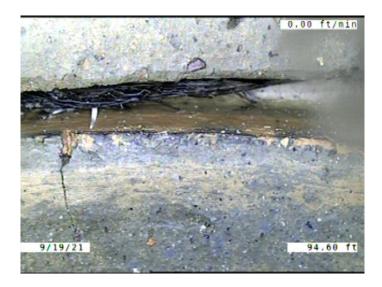
Code: Description:	RFJ Roots Fine Joint
Distance (ft):	94.6
Structural Grade:	0
O&M Grade:	1
Clock Start/From:	8
Clock To:	4
1st Value:	
2nd Value:	
Value Percent:	
Continuous Index:	S08
Within 8" of Joint:	YES
Remarks:

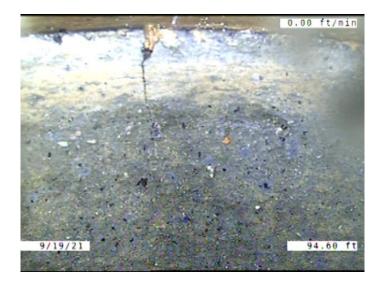
Code: Description:	CM Crack Multiple
Distance (ft):	94.6
Structural Grade:	3
O&M Grade:	0
Clock Start/From:	9
Clock To:	3
1st Value:	
2nd Value:	
Value Percent:	
Continuous Index:	
Within 8" of Joint:	YES
Remarks:

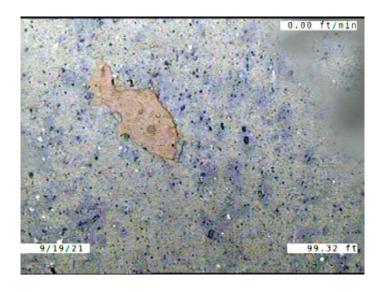
Code: Description:	SSS Surface Damage Surface Spalling
Distance (ft): Structural Grade: O&M Grade: Clock Start/From: Clock To: 1st Value: 2nd Value: Value Percent:	99.3 2 0 12
Continuous Index: Within 8" of Joint: Remarks:	ΝΟ

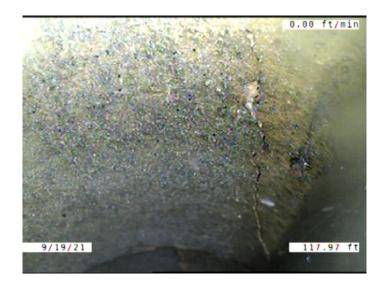
Code:	FM
Description:	Fracture Multiple
Distance (ft): Structural Grade: O&M Grade: Clock Start/From: Clock To: 1st Value: 2nd Value: Value Percent: Continuous Index: Within 8" of Joint: Remarks:	118.0 4 0 8 4 3 509 YES

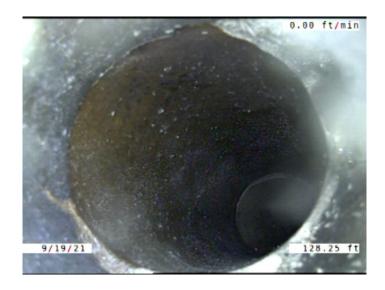
Code:	TFD
Description:	Tap Factory Defective
Distance (ft):	128.2
Structural Grade:	0
O&M Grade:	3
Clock Start/From:	1
Clock To: 1st Value: 2nd Value: Value Percent:	4.000
Continuous Index: Within 8" of Joint: Remarks:	YES Defective

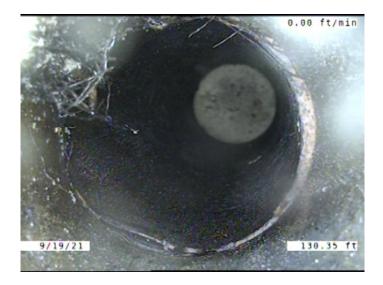
Code: Description:	TFD Tap Factory Defective
Distance (ft):	130.4
Structural Grade:	0
O&M Grade:	3
Clock Start/From:	11
Clock To:	
1st Value:	4.000
2nd Value:	
Value Percent:	
Continuous Index:	
Within 8" of Joint:	YES
Remarks:	CAPPED

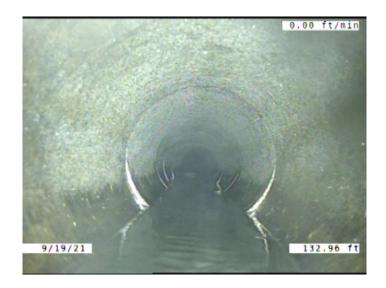
Code:	FM
Description:	Fracture Multiple
Distance (ft): Structural Grade: O&M Grade: Clock Start/From: Clock To: 1st Value: 2nd Value: Value Percent: Continuous Index: Within 8" of Joint: Remarks:	133.0 4 0 8 4 709 YES

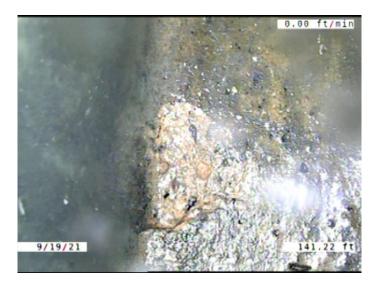
SSS Surface Damage Surface Spalling
141.2
2
0
3
4
NO

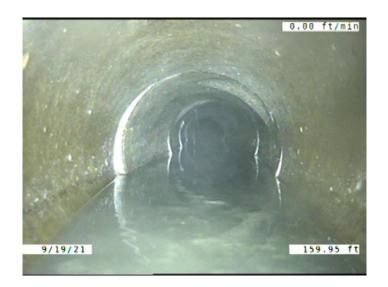
MWLS Miscellaneous Water Level Sag
160.0
2
0
20.000
S10
NO

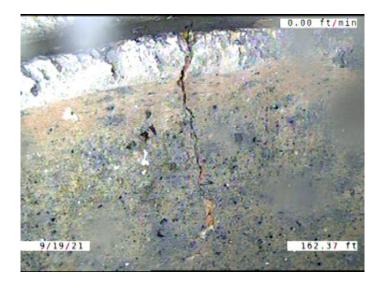
Code: Description:	FL Fracture Longitudinal
Distance (ft):	162.4
Structural Grade:	3
O&M Grade:	0
Clock Start/From:	10
Clock To:	
1st Value:	
2nd Value:	
Value Percent:	
Continuous Index:	
Within 8" of Joint:	YES
Remarks:

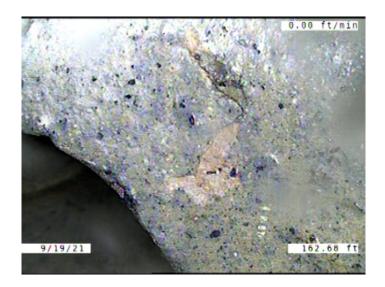
Code:	SSS
Description:	Surface Damage Surface Spalling
Distance (ft): Structural Grade: O&M Grade: Clock Start/From: Clock To: 1st Value: 2nd Value: Value Percent: Continuous Index: Within 8" of Joint: Remarks:	162.7 2 0 2 YES

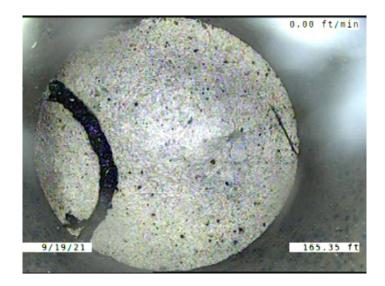
Code: Description:	TFD Tap Factory Defective
Distance (ft): Structural Grade: O&M Grade: Clock Start/From: Clock To:	165.4 0 3 11
1st Value: 2nd Value: Value Percent: Continuous Index: Within 8" of Joint:	4.000 YES
Remarks:	CAPPED

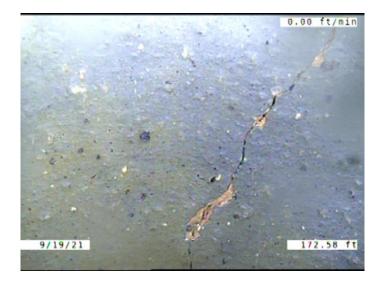
Code:	FM
Description:	Fracture Multiple
Distance (ft):	172.6
Structural Grade:	4
O&M Grade:	0
Clock Start/From:	8
Clock To:	4
1st Value:	
2nd Value:	
Value Percent:	
Continuous Index:	S11
Within 8" of Joint:	YES
Remarks:

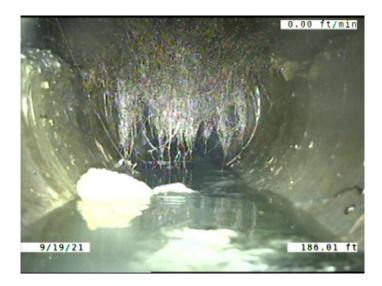
Code: Description:	RFJ Roots Fine Joint
Distance (ft): Structural Grade: O&M Grade: Clock Start/From: Clock To: 1st Value: 2nd Value:	186.0 0 1 8 4
Value Percent: Continuous Index: Within 8" of Joint: Remarks:	F08 YES

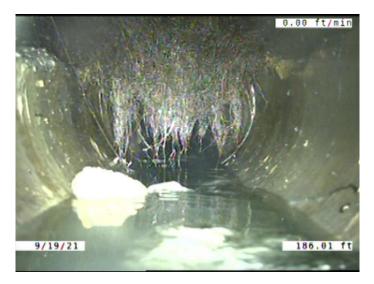
Code: Description:	MWLS Miscellaneous Water Level Sag
Distance (ft):	186.0
Structural Grade:	2
O&M Grade:	0
Clock Start/From:	
Clock To:	
1st Value:	
2nd Value:	
Value Percent:	20.000
Continuous Index:	F10
Within 8" of Joint:	NO

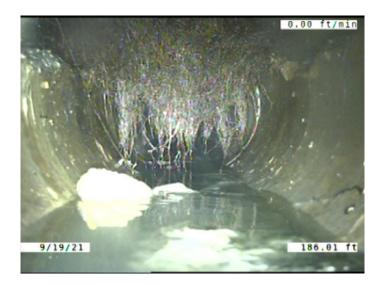
Code: Description:	FM Fracture Multiple
Distance (ft): Structural Grade: O&M Grade: Clock Start/From: Clock To: 1st Value: 2nd Value: Value Percent: Continuous Index: Within 8" of Joint: Remarks:	186.0 4 0 8 4 F11 F11 YES

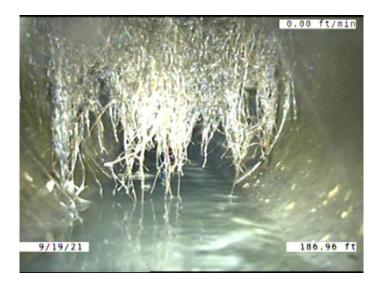
Code: Description:	DSF Deposits Settled Fine
Distance (ft):	187.0
Structural Grade:	0
O&M Grade:	2
Clock Start/From:	5
Clock To:	7
1st Value:	
2nd Value:	
Value Percent:	5.000
Continuous Index:	F03
Within 8" of Joint:	YES
Remarks:
