Profile/Photo Observation Report

Date:	09/19/2021	Weather:		Coding:	PACP 7.0
Pipe Length (ft):	187.5	Owner:	City of Hobart	Pre Clean:	Heavy Cleaning
P.O.#:	YES502259	Surveyor:	S. Bucklin	PSR:	P-503-021-020
Customer:	City of Hobart	Clean Date:	09/05/2021	Shape:	C

Street:	North Virginia Street	Flow Control:	Not Controlled
City:	Hobart, IN	Year Renewed:	
Location:	Local rural streets with light traffic, t	Tape/Media #:	
Purpose:	Routine Assessment	Dia/Height:	10"
Use:	Sanitary Sewage Pipe	Material:	VCP
Drain Area:		Lining:	None
Category:	NA		
Comment:			
Location Details:		Direction of Survey:	Downstream
US MH:	M-503-020	DS MH:	M-503-021
		Total Length Surveyed (ft):	187.5

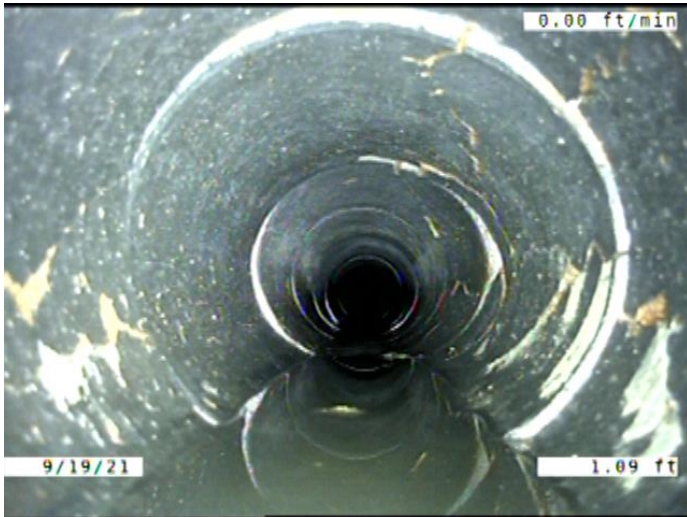
Code: **FM**
 Description: **Fracture Multiple**

Distance (ft): **1.1**
 Structural Grade: **4**
 O&M Grade: **0**
 Clock Start/From: **8**
 Clock To: **4**
 1st Value:
 2nd Value:
 Value Percent:
 Continuous Index: **S01**
 Within 8" of Joint: **YES**
 Remarks:

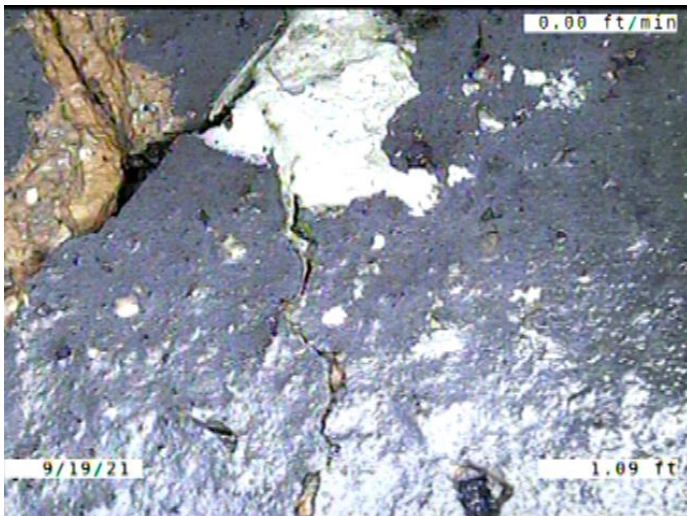
Code: **DAE**
 Description: **Deposits Attached Encrustation**

Distance (ft): **1.1**
 Structural Grade: **0**
 O&M Grade: **2**
 Clock Start/From: **7**
 Clock To: **9**
 1st Value:
 2nd Value:
 Value Percent: **5.000**
 Continuous Index:
 Within 8" of Joint: **YES**
 Remarks:

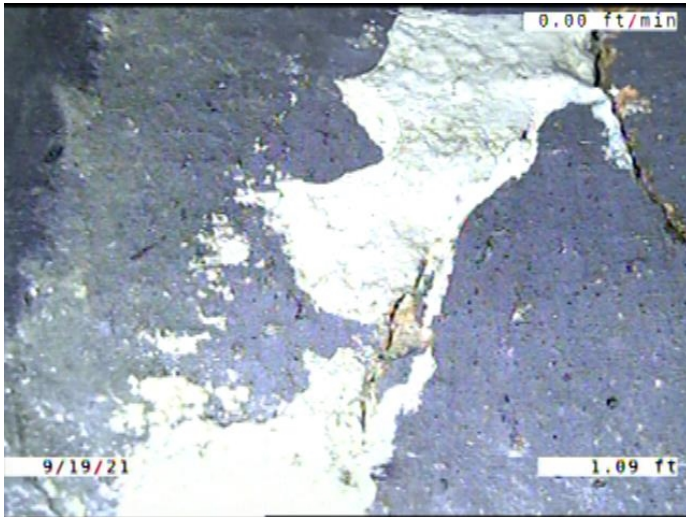
Code: **DAE**
 Description: **Deposits Attached Encrustation**

Distance (ft): **1.1**
 Structural Grade: **0**
 O&M Grade: **2**
 Clock Start/From: **3**
 Clock To: **5**
 1st Value:
 2nd Value:
 Value Percent: **5.000**
 Continuous Index:
 Within 8" of Joint: **YES**
 Remarks:

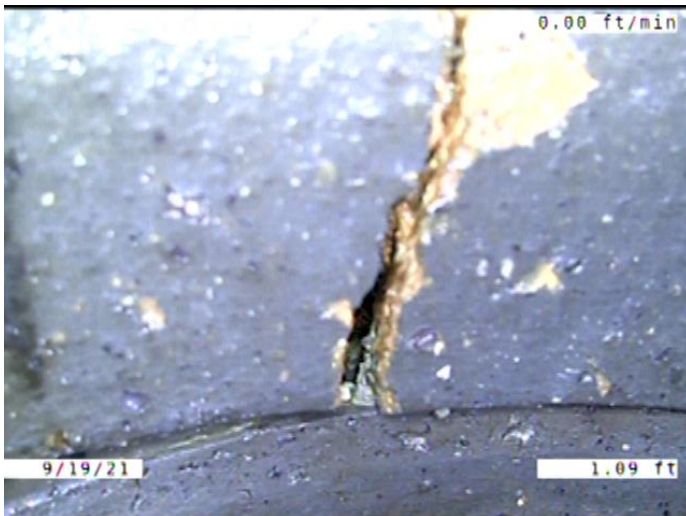
Code: **BSV**
 Description: **Broken Soil Visible**

Distance (ft): **1.1**
 Structural Grade: **5**
 O&M Grade: **0**
 Clock Start/From: **8**
 Clock To: **9**
 1st Value:
 2nd Value:
 Value Percent:
 Continuous Index:
 Within 8" of Joint: **YES**
 Remarks:

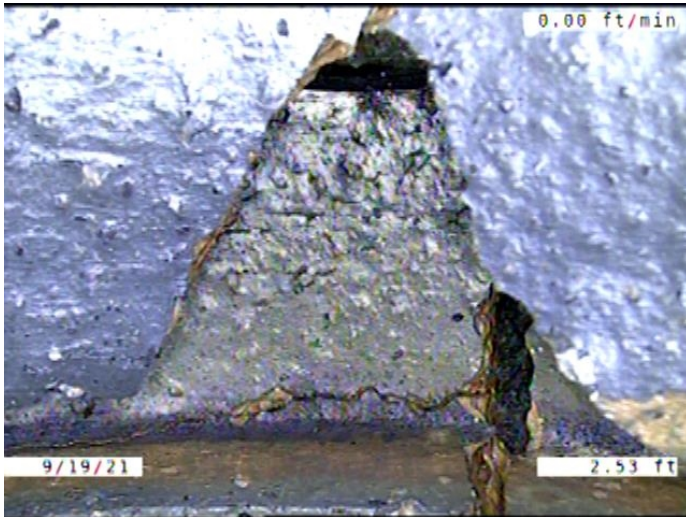
Code: **SMW**
 Description: **Surface Damage Missing Wall**

Distance (ft): **2.5**
 Structural Grade: **5**
 O&M Grade: **0**
 Clock Start/From: **2**
 Clock To: **3**
 1st Value:
 2nd Value:
 Value Percent:
 Continuous Index:
 Within 8" of Joint: **YES**
 Remarks: **SOIL VISIBLE**

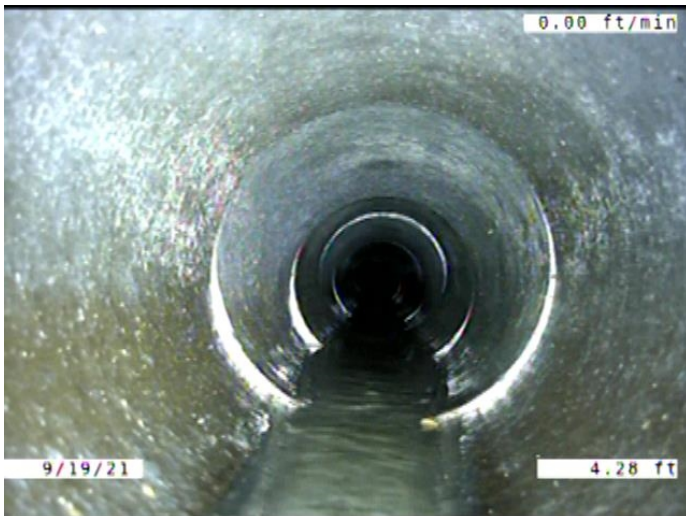
Code: **FM**
 Description: **Fracture Multiple**

Distance (ft): **4.3**
 Structural Grade: **4**
 O&M Grade: **0**
 Clock Start/From: **8**
 Clock To: **4**
 1st Value:
 2nd Value:
 Value Percent:
 Continuous Index: **F01**
 Within 8" of Joint: **YES**
 Remarks:

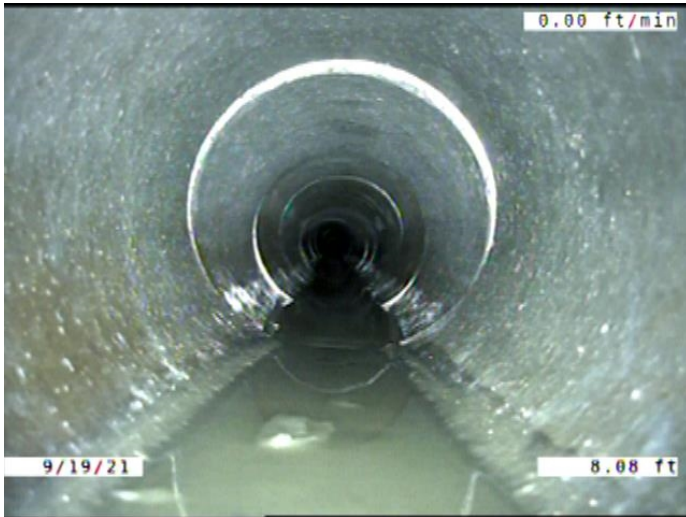
Code: **DSF**
 Description: **Deposits Settled Fine**

Distance (ft): **8.1**
 Structural Grade: **0**
 O&M Grade: **2**
 Clock Start/From: **5**
 Clock To: **7**
 1st Value:
 2nd Value:
 Value Percent: **5.000**
 Continuous Index: **S03**
 Within 8" of Joint: **YES**
 Remarks:

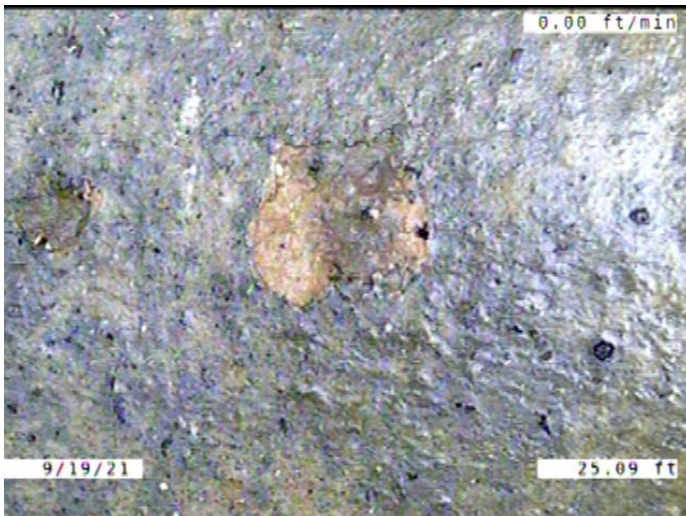
Code: **SSS**
 Description: **Surface Damage Surface Spalling**

Distance (ft): **25.1**
 Structural Grade: **2**
 O&M Grade: **0**
 Clock Start/From: **1**
 Clock To: **2**
 1st Value:
 2nd Value:
 Value Percent:
 Continuous Index:
 Within 8" of Joint: **NO**
 Remarks:

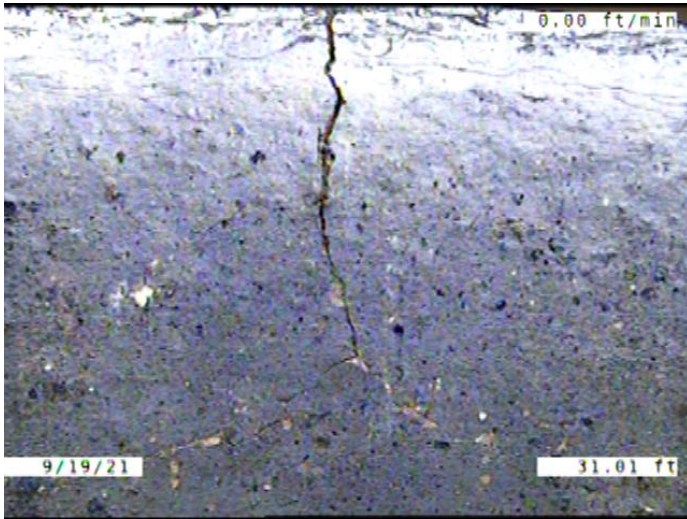
Code: **FM**
 Description: **Fracture Multiple**

Distance (ft): **31.0**
 Structural Grade: **4**
 O&M Grade: **0**
 Clock Start/From: **8**
 Clock To: **4**
 1st Value:
 2nd Value:
 Value Percent:
 Continuous Index: **S04**
 Within 8" of Joint: **YES**
 Remarks:

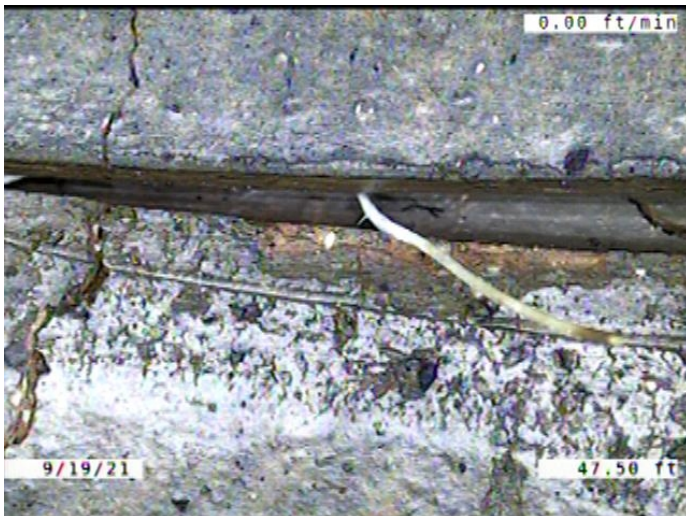
Code: **RFJ**
 Description: **Roots Fine Joint**

Distance (ft): **47.5**
 Structural Grade: **0**
 O&M Grade: **1**
 Clock Start/From: **12**
 Clock To: **1**
 1st Value:
 2nd Value:
 Value Percent:
 Continuous Index:
 Within 8" of Joint: **YES**
 Remarks:

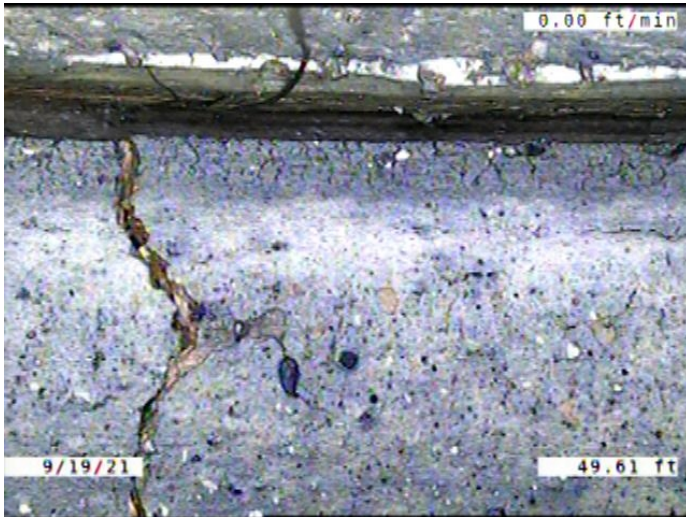
Code: **RFJ**
 Description: **Roots Fine Joint**

Distance (ft): **49.6**
 Structural Grade: **0**
 O&M Grade: **1**
 Clock Start/From: **12**
 Clock To:
 1st Value:
 2nd Value:
 Value Percent:
 Continuous Index:
 Within 8" of Joint: **YES**
 Remarks:

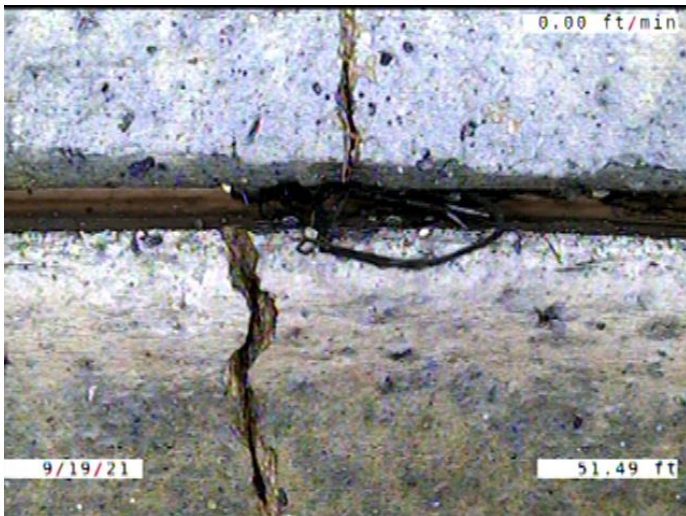
Code: **RFJ**
 Description: **Roots Fine Joint**

Distance (ft): **51.5**
 Structural Grade: **0**
 O&M Grade: **1**
 Clock Start/From: **12**
 Clock To: **1**
 1st Value:
 2nd Value:
 Value Percent:
 Continuous Index:
 Within 8" of Joint: **YES**
 Remarks:

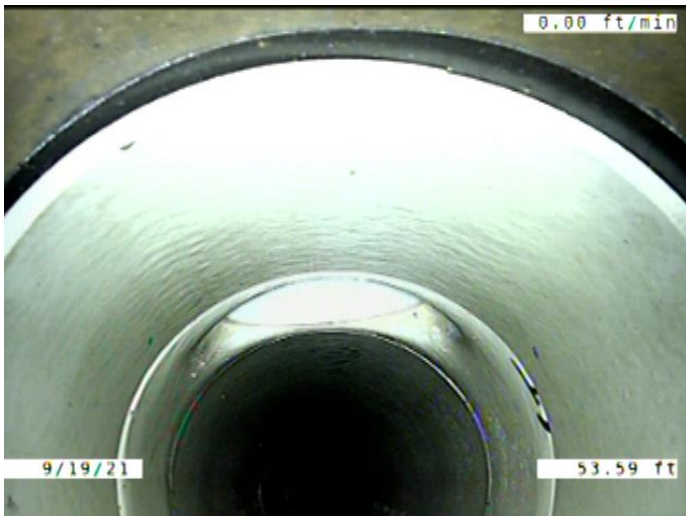
Code: **JOM**
 Description: **Joint Offset Medium**

Distance (ft): **53.6**
 Structural Grade: **3**
 O&M Grade: **0**
 Clock Start/From:
 Clock To:
 1st Value:
 2nd Value:
 Value Percent:
 Continuous Index:
 Within 8" of Joint: **NO**
 Remarks:

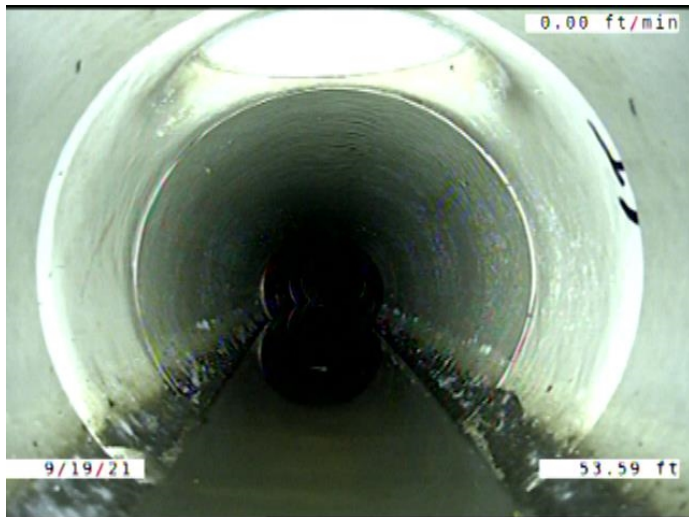
Code: **FM**
 Description: **Fracture Multiple**

Distance (ft): **53.6**
 Structural Grade: **4**
 O&M Grade: **0**
 Clock Start/From: **8**
 Clock To: **4**
 1st Value:
 2nd Value:
 Value Percent:
 Continuous Index: **F04**
 Within 8" of Joint: **YES**
 Remarks:

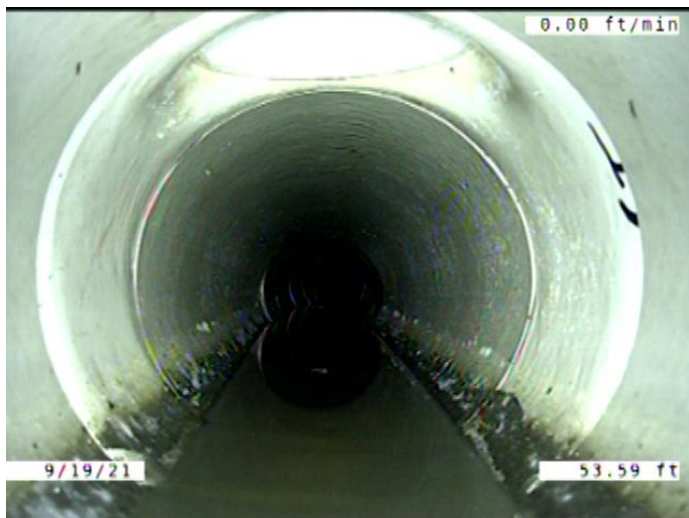
Code: **MWLS**
 Description: **Miscellaneous Water Level Sag**

Distance (ft): **53.6**
 Structural Grade: **2**
 O&M Grade: **0**
 Clock Start/From:
 Clock To:
 1st Value:
 2nd Value:
 Value Percent: **10.000**
 Continuous Index: **S05**
 Within 8" of Joint: **NO**
 Remarks:

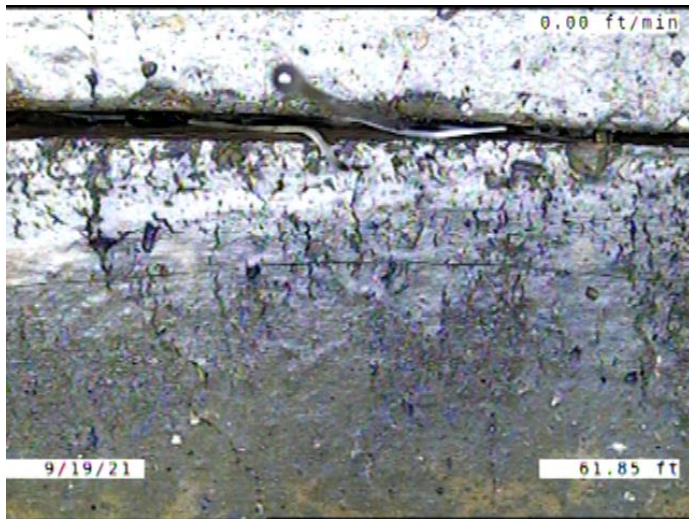
Code: **RFJ**
 Description: **Roots Fine Joint**

Distance (ft): **61.9**
 Structural Grade: **0**
 O&M Grade: **1**
 Clock Start/From: **11**
 Clock To: **3**
 1st Value:
 2nd Value:
 Value Percent:
 Continuous Index:
 Within 8" of Joint: **YES**
 Remarks:

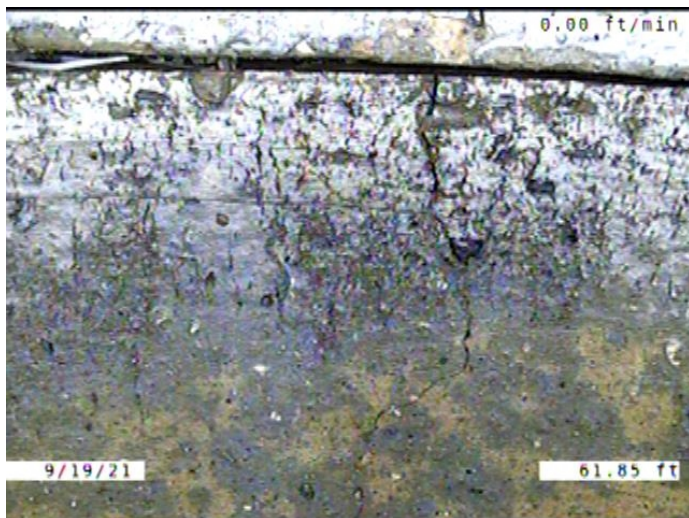
Code: **FM**
 Description: **Fracture Multiple**

Distance (ft): **61.9**
 Structural Grade: **4**
 O&M Grade: **0**
 Clock Start/From: **8**
 Clock To: **4**
 1st Value:
 2nd Value:
 Value Percent:
 Continuous Index: **S06**
 Within 8" of Joint: **YES**
 Remarks:

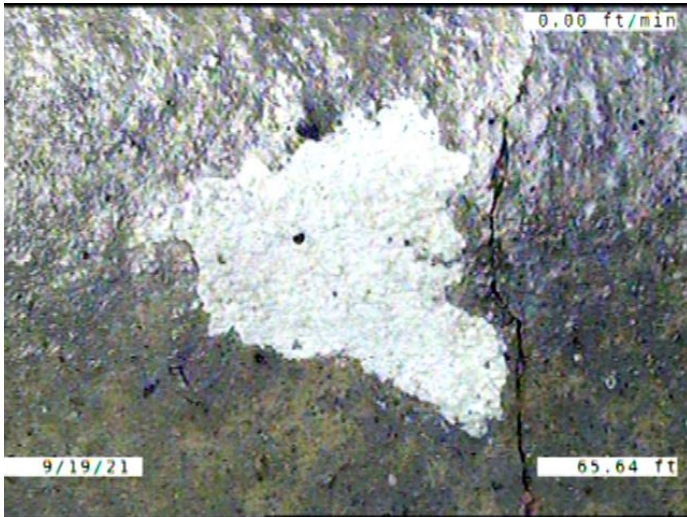
Code: **DAE**
 Description: **Deposits Attached Encrustation**

Distance (ft): **65.6**
 Structural Grade: **0**
 O&M Grade: **2**
 Clock Start/From: **9**
 Clock To:
 1st Value:
 2nd Value:
 Value Percent: **5.000**
 Continuous Index:
 Within 8" of Joint: **YES**
 Remarks:

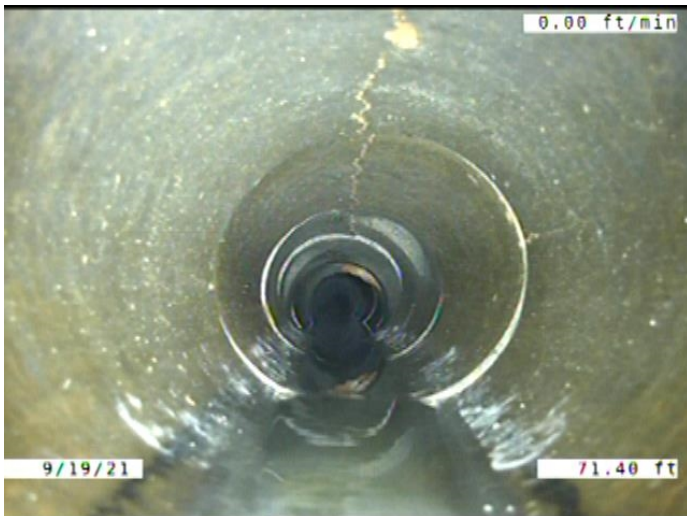
Code: **MWLS**
 Description: **Miscellaneous Water Level Sag**

Distance (ft): **71.4**
 Structural Grade: **2**
 O&M Grade: **0**
 Clock Start/From:
 Clock To:
 1st Value:
 2nd Value:
 Value Percent: **10.000**
 Continuous Index: **F05**
 Within 8" of Joint: **NO**
 Remarks:

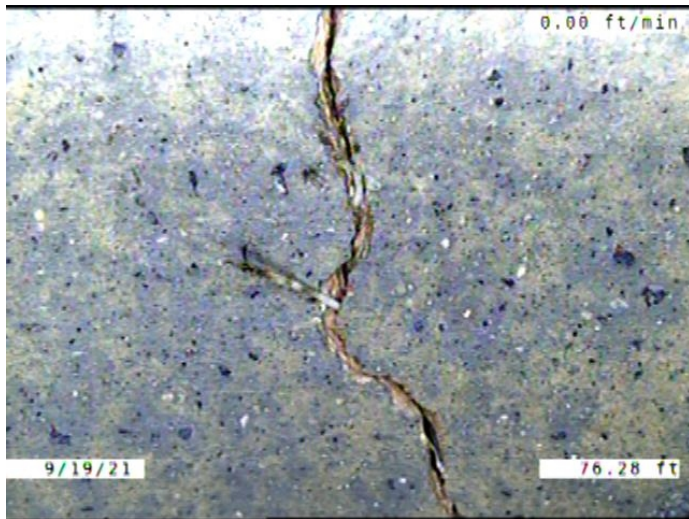
Code: **RFB**
 Description: **Roots Fine Barrel**

Distance (ft): **76.3**
 Structural Grade: **0**
 O&M Grade: **2**
 Clock Start/From: **12**
 Clock To: **1**
 1st Value:
 2nd Value:
 Value Percent:
 Continuous Index:
 Within 8" of Joint: **NO**
 Remarks:

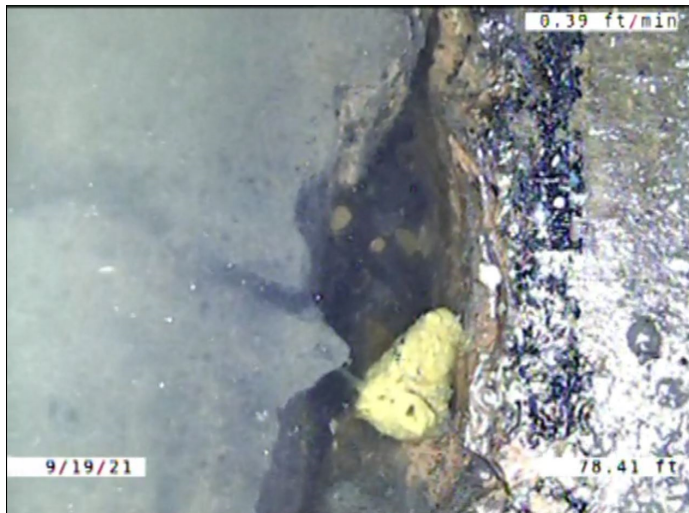
Code: **BVV**
 Description: **Broken Void Visible**

Distance (ft): **78.4**
 Structural Grade: **5**
 O&M Grade: **0**
 Clock Start/From: **5**
 Clock To:
 1st Value:
 2nd Value:
 Value Percent:
 Continuous Index:
 Within 8" of Joint: **YES**
 Remarks:

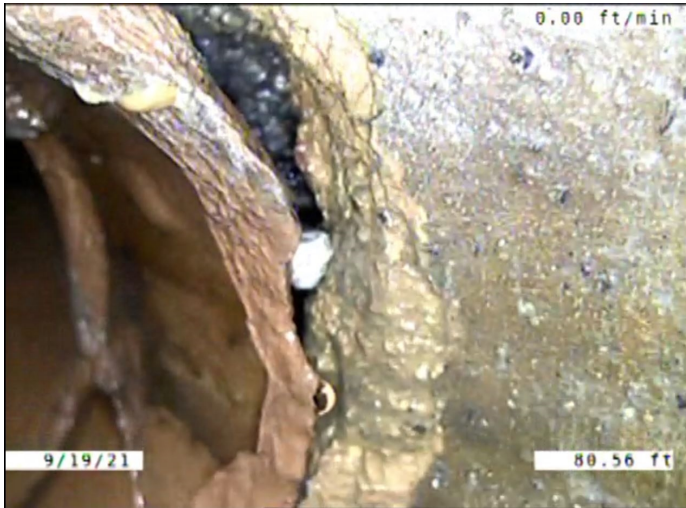
Code: **SSS**
 Description: **Surface Damage Surface Spalling**

Distance (ft): **80.6**
 Structural Grade: **2**
 O&M Grade: **0**
 Clock Start/From: **1**
 Clock To: **3**
 1st Value:
 2nd Value:
 Value Percent:
 Continuous Index:
 Within 8" of Joint: **NO**
 Remarks:

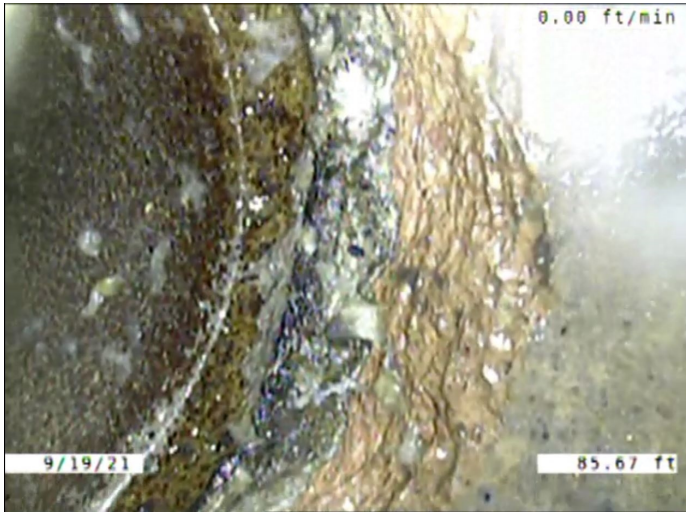
Code: **SSS**
Description: **Surface Damage Surface Spalling**

Distance (ft): **85.7**
Structural Grade: **2**
O&M Grade: **0**
Clock Start/From: **10**
Clock To: **12**
1st Value:
2nd Value:
Value Percent:
Continuous Index:
Within 8" of Joint: **YES**
Remarks:

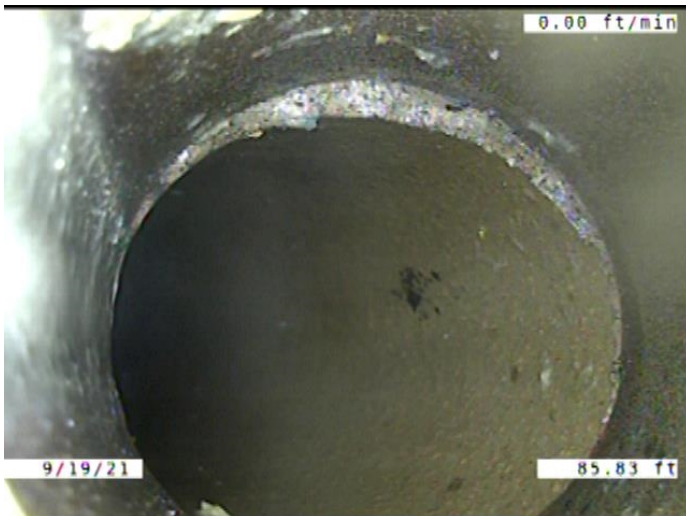
Code: **TBI**
Description: **Tap Break-in Intruding**

Distance (ft): **85.8**
Structural Grade: **0**
O&M Grade: **2**
Clock Start/From: **11**
Clock To:
1st Value: **4.000**
2nd Value: **1.000**
Value Percent:
Continuous Index:
Within 8" of Joint: **NO**
Remarks:

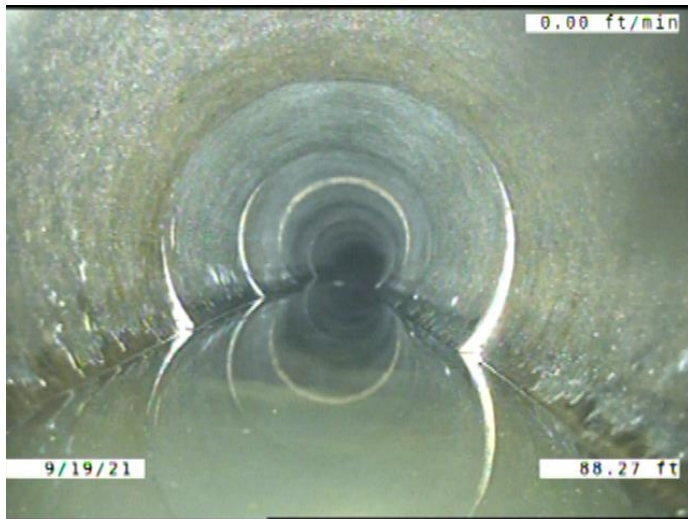
Code: **FM**
 Description: **Fracture Multiple**

Distance (ft): **88.3**
 Structural Grade: **4**
 O&M Grade: **0**
 Clock Start/From: **8**
 Clock To: **4**
 1st Value:
 2nd Value:
 Value Percent:
 Continuous Index: **F06**
 Within 8" of Joint: **YES**
 Remarks:

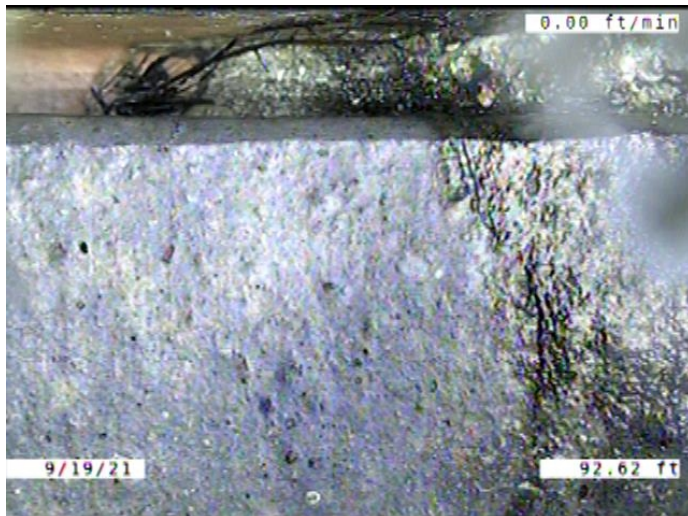
Code: **RFJ**
 Description: **Roots Fine Joint**

Distance (ft): **92.6**
 Structural Grade: **0**
 O&M Grade: **1**
 Clock Start/From: **8**
 Clock To:
 1st Value:
 2nd Value:
 Value Percent:
 Continuous Index:
 Within 8" of Joint: **YES**
 Remarks:

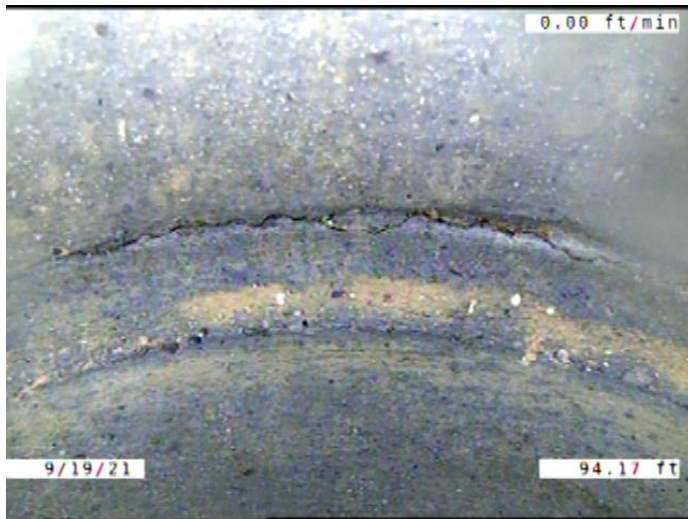
Code: **JOM**
Description: **Joint Offset Medium**

Distance (ft): **94.2**
Structural Grade: **3**
O&M Grade: **0**
Clock Start/From:
Clock To:
1st Value:
2nd Value:
Value Percent:
Continuous Index:
Within 8" of Joint: **NO**
Remarks:

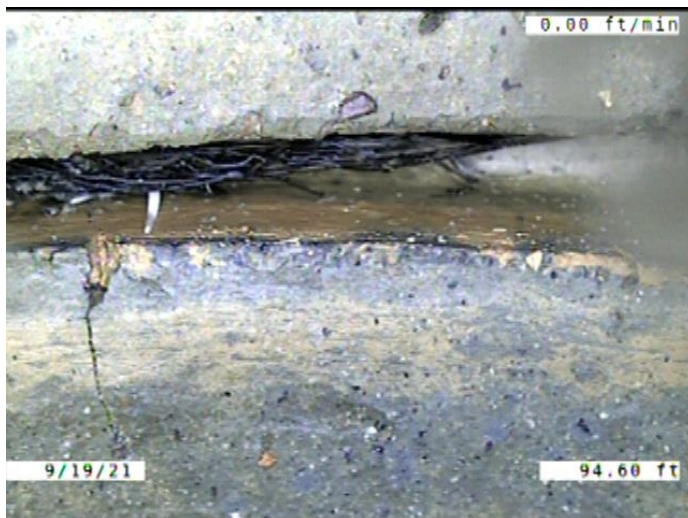
Code: **RFJ**
Description: **Roots Fine Joint**

Distance (ft): **94.6**
Structural Grade: **0**
O&M Grade: **1**
Clock Start/From: **8**
Clock To: **4**
1st Value:
2nd Value:
Value Percent:
Continuous Index: **S08**
Within 8" of Joint: **YES**
Remarks:

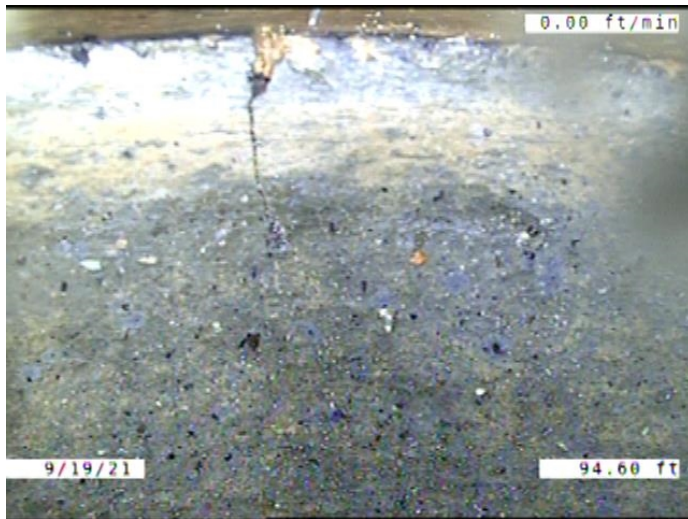
Code: **CM**
 Description: **Crack Multiple**

Distance (ft): **94.6**
 Structural Grade: **3**
 O&M Grade: **0**
 Clock Start/From: **9**
 Clock To: **3**
 1st Value:
 2nd Value:
 Value Percent:
 Continuous Index:
 Within 8" of Joint: **YES**
 Remarks:

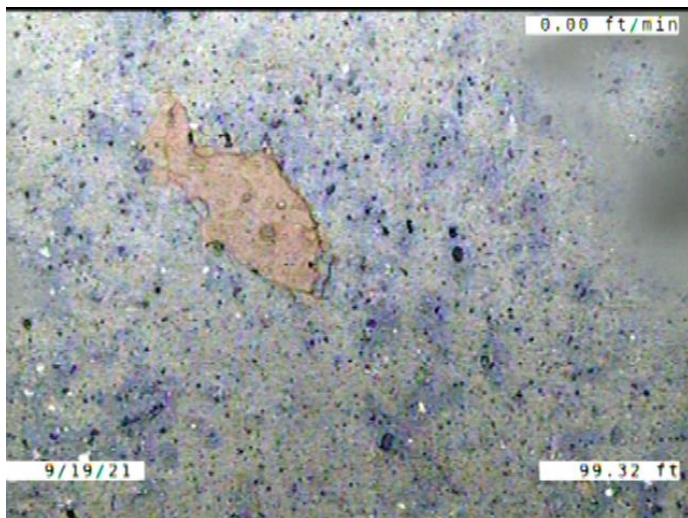
Code: **SSS**
 Description: **Surface Damage Surface Spalling**

Distance (ft): **99.3**
 Structural Grade: **2**
 O&M Grade: **0**
 Clock Start/From: **12**
 Clock To:
 1st Value:
 2nd Value:
 Value Percent:
 Continuous Index:
 Within 8" of Joint: **NO**
 Remarks:

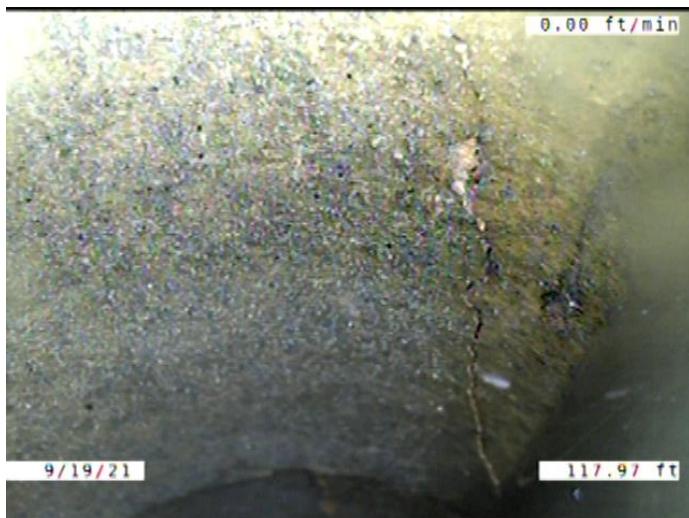
Code: **FM**
 Description: **Fracture Multiple**

Distance (ft): **118.0**
 Structural Grade: **4**
 O&M Grade: **0**
 Clock Start/From: **8**
 Clock To: **4**
 1st Value:
 2nd Value:
 Value Percent:
 Continuous Index: **S09**
 Within 8" of Joint: **YES**
 Remarks:

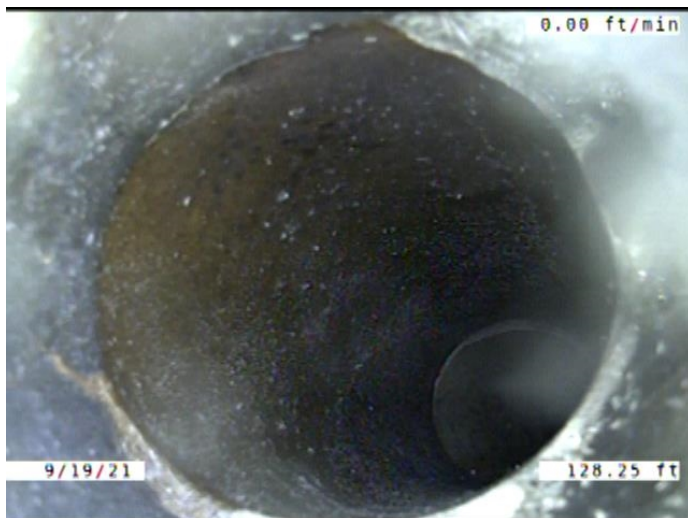
Code: **TFD**
Description: **Tap Factory Defective**

Distance (ft): **128.2**
Structural Grade: **0**
O&M Grade: **3**
Clock Start/From: **1**
Clock To:
1st Value: **4.000**
2nd Value:
Value Percent:
Continuous Index:
Within 8" of Joint: **YES**
Remarks: **Defective**

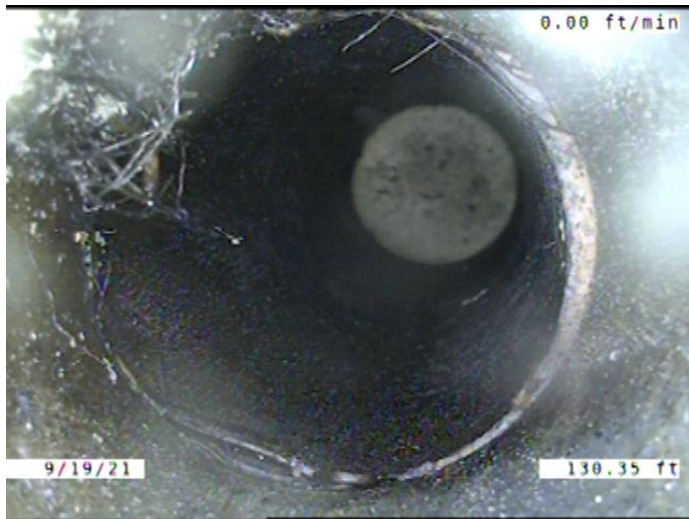
Code: **TFD**
 Description: **Tap Factory Defective**

Distance (ft): **130.4**
 Structural Grade: **0**
 O&M Grade: **3**
 Clock Start/From: **11**
 Clock To:
 1st Value: **4.000**
 2nd Value:
 Value Percent:
 Continuous Index:
 Within 8" of Joint: **YES**
 Remarks: **CAPPED**

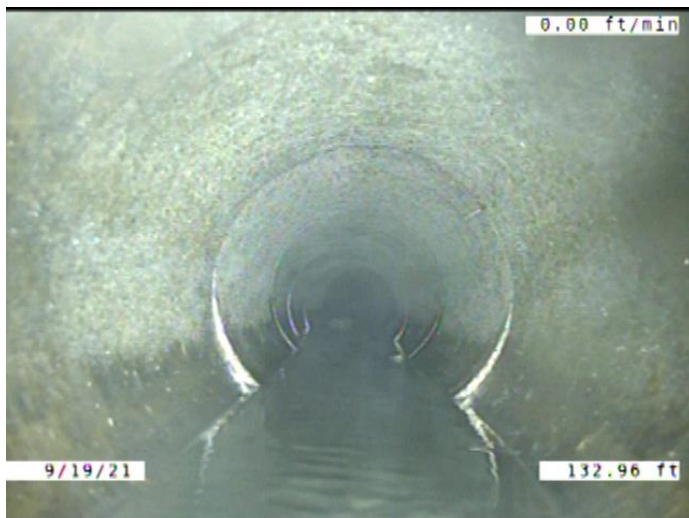
Code: **FM**
 Description: **Fracture Multiple**

Distance (ft): **133.0**
 Structural Grade: **4**
 O&M Grade: **0**
 Clock Start/From: **8**
 Clock To: **4**
 1st Value:
 2nd Value:
 Value Percent:
 Continuous Index: **F09**
 Within 8" of Joint: **YES**
 Remarks:

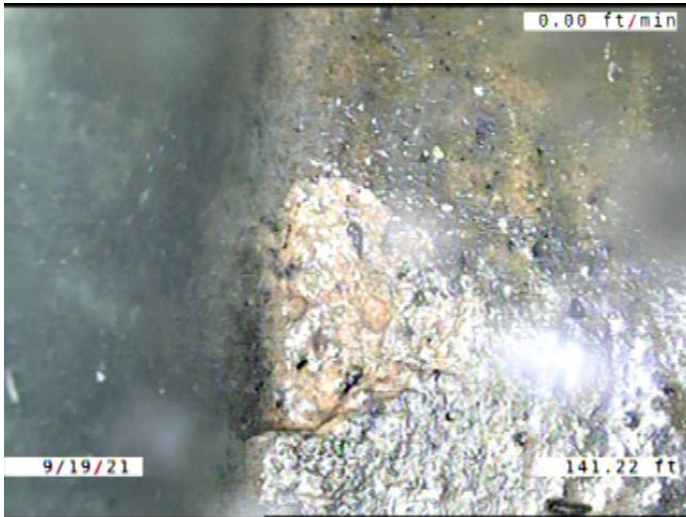
Code: **SSS**
 Description: **Surface Damage Surface Spalling**

Distance (ft): **141.2**
 Structural Grade: **2**
 O&M Grade: **0**
 Clock Start/From: **3**
 Clock To: **4**
 1st Value:
 2nd Value:
 Value Percent:
 Continuous Index:
 Within 8" of Joint: **NO**
 Remarks:

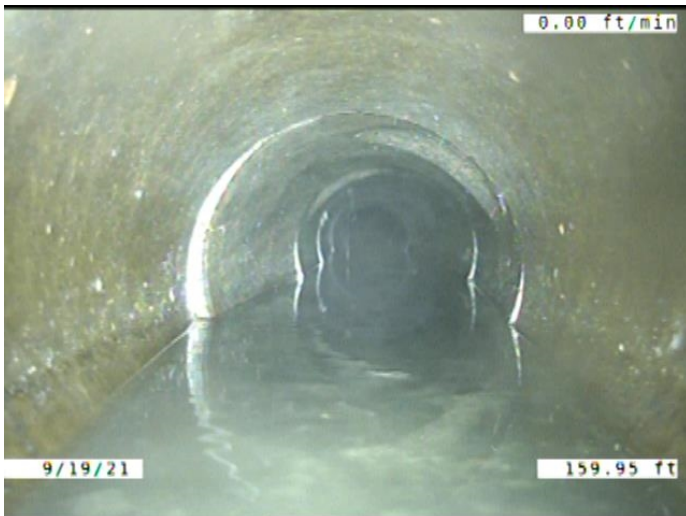
Code: **MWLS**
 Description: **Miscellaneous Water Level Sag**

Distance (ft): **160.0**
 Structural Grade: **2**
 O&M Grade: **0**
 Clock Start/From:
 Clock To:
 1st Value:
 2nd Value:
 Value Percent: **20.000**
 Continuous Index: **S10**
 Within 8" of Joint: **NO**
 Remarks:

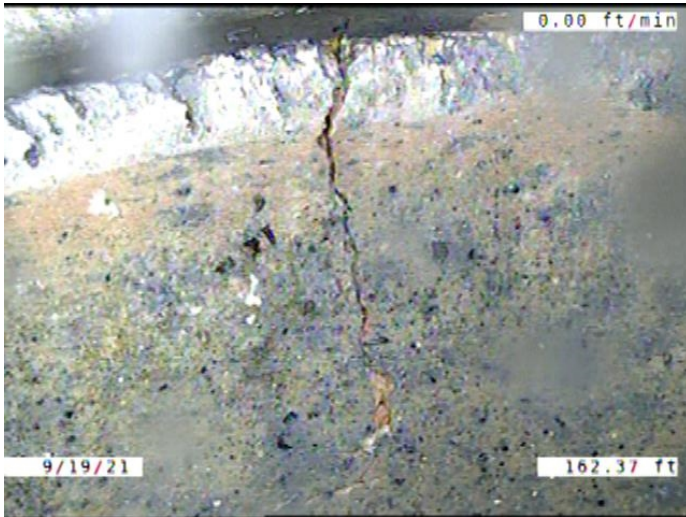
Code: **FL**
 Description: **Fracture Longitudinal**

Distance (ft): **162.4**
 Structural Grade: **3**
 O&M Grade: **0**
 Clock Start/From: **10**
 Clock To:
 1st Value:
 2nd Value:
 Value Percent:
 Continuous Index:
 Within 8" of Joint: **YES**
 Remarks:

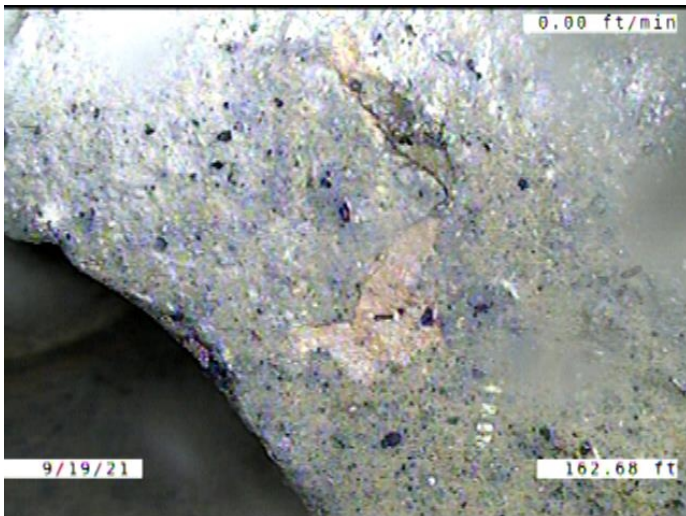
Code: **SSS**
 Description: **Surface Damage Surface Spalling**

Distance (ft): **162.7**
 Structural Grade: **2**
 O&M Grade: **0**
 Clock Start/From: **2**
 Clock To:
 1st Value:
 2nd Value:
 Value Percent:
 Continuous Index:
 Within 8" of Joint: **YES**
 Remarks:

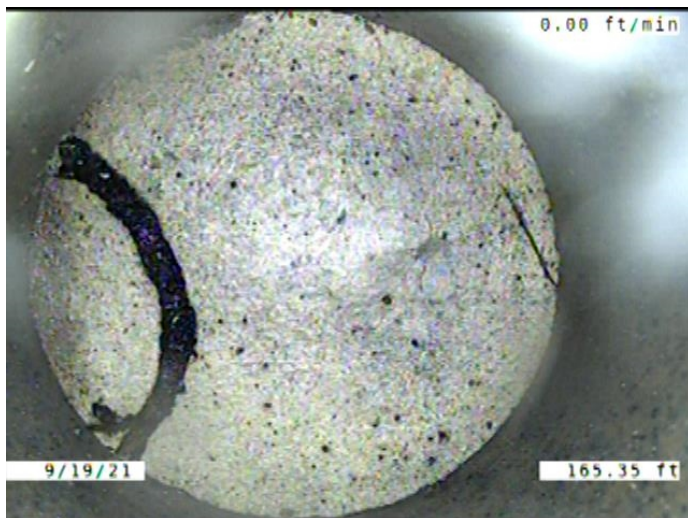
Code: **TFD**
Description: **Tap Factory Defective**

Distance (ft): **165.4**
Structural Grade: **0**
O&M Grade: **3**
Clock Start/From: **11**
Clock To:
1st Value: **4.000**
2nd Value:
Value Percent:
Continuous Index:
Within 8" of Joint: **YES**
Remarks: **CAPPED**

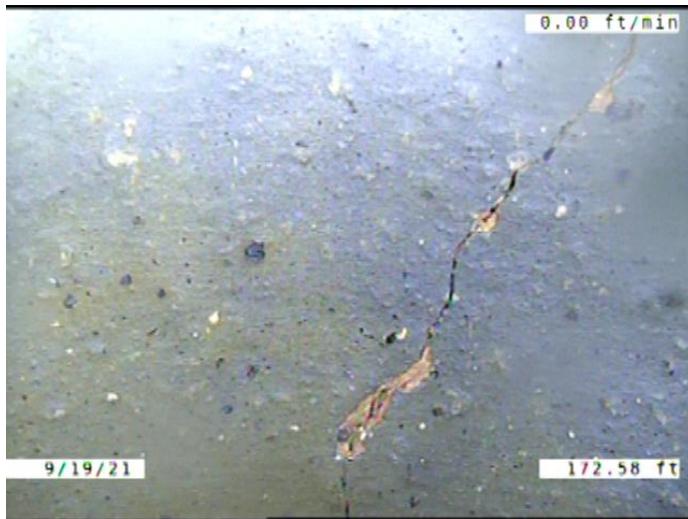
Code: **FM**
Description: **Fracture Multiple**

Distance (ft): **172.6**
Structural Grade: **4**
O&M Grade: **0**
Clock Start/From: **8**
Clock To: **4**
1st Value:
2nd Value:
Value Percent:
Continuous Index: **S11**
Within 8" of Joint: **YES**
Remarks:

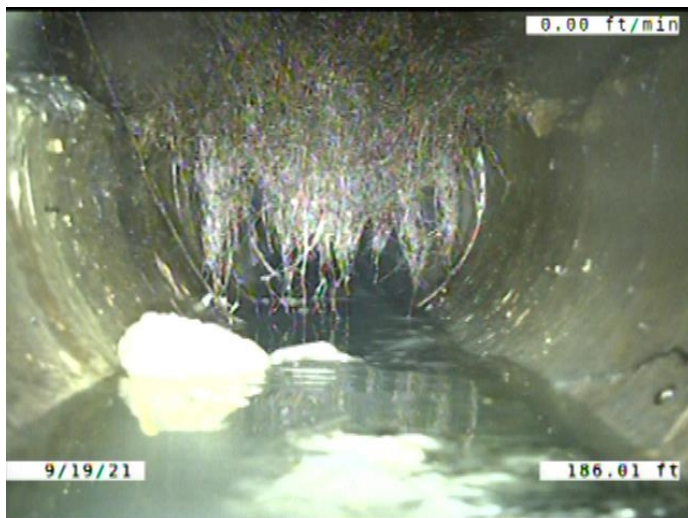
Code: **RFJ**
Description: **Roots Fine Joint**

Distance (ft): **186.0**
Structural Grade: **0**
O&M Grade: **1**
Clock Start/From: **8**
Clock To: **4**
1st Value:
2nd Value:
Value Percent:
Continuous Index: **F08**
Within 8" of Joint: **YES**
Remarks:

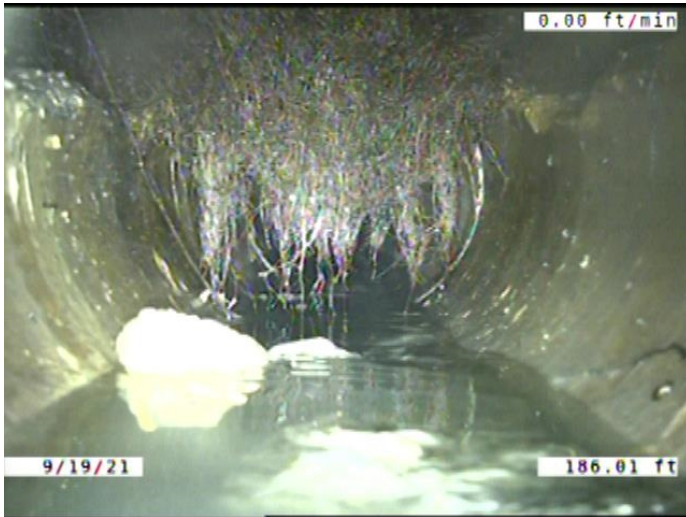
Code: **MWLS**
 Description: **Miscellaneous Water Level Sag**

Distance (ft): **186.0**
 Structural Grade: **2**
 O&M Grade: **0**
 Clock Start/From:
 Clock To:
 1st Value:
 2nd Value:
 Value Percent: **20.000**
 Continuous Index: **F10**
 Within 8" of Joint: **NO**
 Remarks:

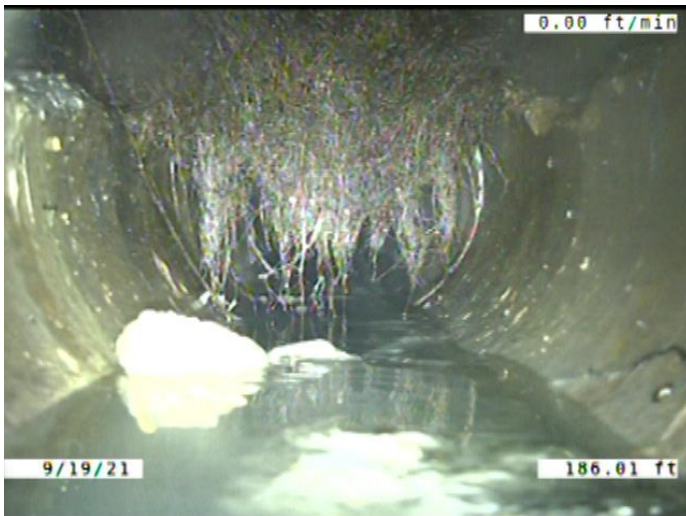
Code: **FM**
 Description: **Fracture Multiple**

Distance (ft): **186.0**
 Structural Grade: **4**
 O&M Grade: **0**
 Clock Start/From: **8**
 Clock To: **4**
 1st Value:
 2nd Value:
 Value Percent:
 Continuous Index: **F11**
 Within 8" of Joint: **YES**
 Remarks:

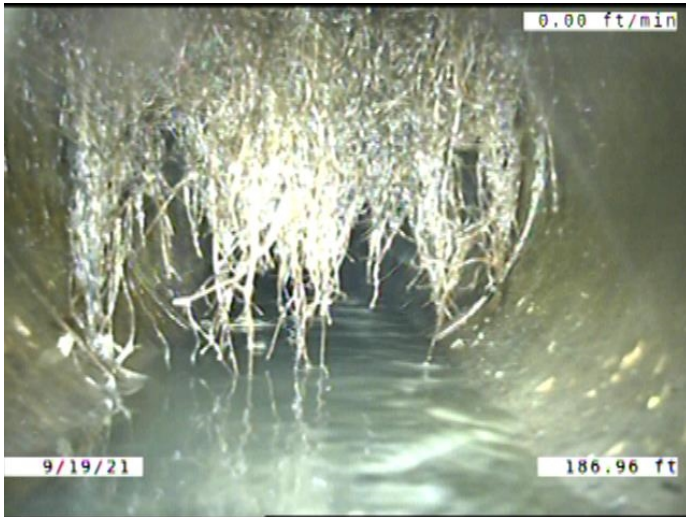
Code: **DSF**
 Description: **Deposits Settled Fine**

Distance (ft): **187.0**
 Structural Grade: **0**
 O&M Grade: **2**
 Clock Start/From: **5**
 Clock To: **7**
 1st Value:
 2nd Value:
 Value Percent: **5.000**
 Continuous Index: **F03**
 Within 8" of Joint: **YES**
 Remarks:
