Profile/Photo Observation Report

Street:	W 40th ave	Flow Control:	Not Controlled
City:	Hobart, IN	Year Renewed:	
Location:	Other	Tape/Media #:	
Purpose:	Not Known	Dia/Height:	10"
Use:	Sanitary	Material:	VCP
Drain Area:	NA	Lining:	
Category:	NA		
Comment:

Location Details:		Direction of Survey:	Downstream
US MH:	M-503-022	DS MH:	M-503-023
		Total Length Surveyed (ft):	10.7

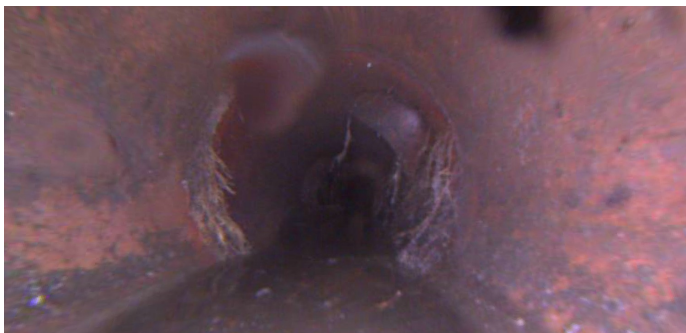
Code: **AMH**
Description: **Manhole**

Distance (ft): **.0**
Structural Grade: **0**
O&M Grade: **0**
Clock Start/From:
Clock To:
1st Value:
2nd Value:
Value Percent:
Continuous Index:
Within 8" of Joint: **NO**
Remarks: **M-503-022**

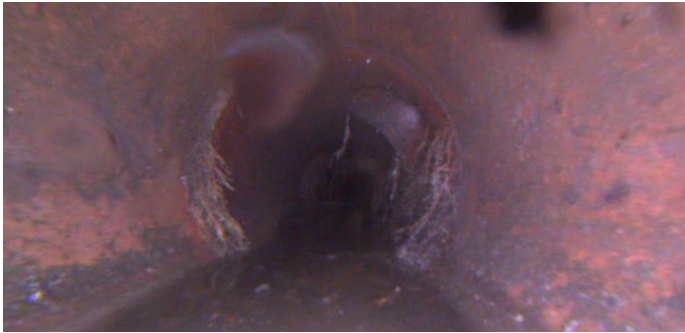
Code:	MWL
Description:	Water Level

Distance (ft):	.0
Structural Grade:	0
O&M Grade:	0
Clock Start/From:	
Clock To:	
1st Value:	
2nd Value:	
Value Percent:	10.000
Continuous Index:	
Within 8" of Joint:	NO
Remarks:

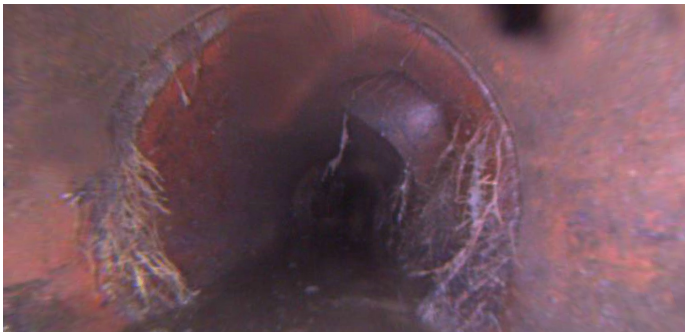
Code:	RMJ
Description:	Roots Medium Joint

Distance (ft):	1.0
Structural Grade:	0
O&M Grade:	3
Clock Start/From:	8
Clock To:	4
1st Value:	
2nd Value:	
Value Percent:	10.000
Continuous Index:	
Within 8" of Joint:	YES
Remarks:

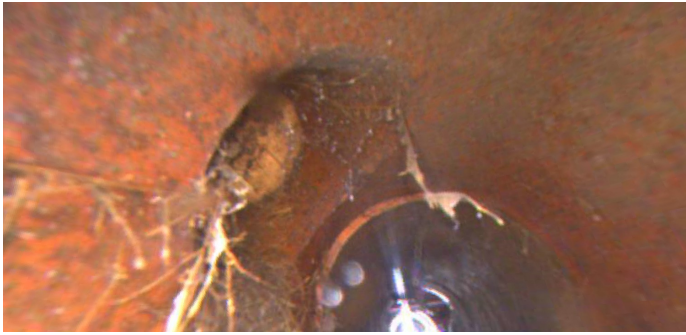
Code: **TFD**
Description: **Tap Factory Defective**

Distance (ft): **3.4**
Structural Grade: **0**
O&M Grade: **2**
Clock Start/From: **2**
Clock To:
1st Value: **4.000**
2nd Value:
Value Percent:
Continuous Index:
Within 8" of Joint:
Remarks: **capped, rfl**

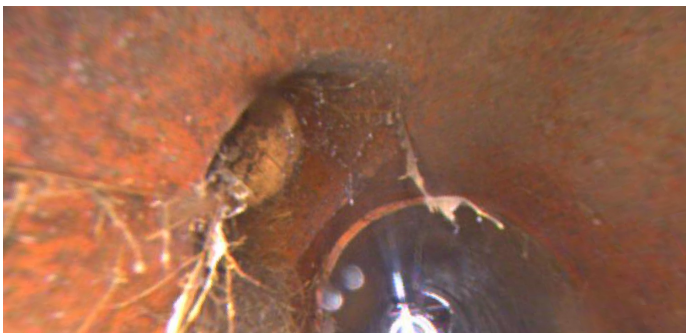
Code: **RFL**
Description: **Roots Fine Lateral**

Distance (ft): **3.4**
Structural Grade: **0**
O&M Grade: **1**
Clock Start/From: **1**
Clock To: **3**
1st Value:
2nd Value:
Value Percent:
Continuous Index:
Within 8" of Joint: **NO**
Remarks:

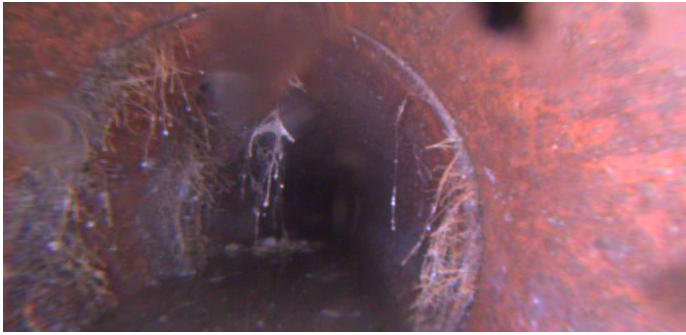
Code: **RMJ**
Description: **Roots Medium Joint**

Distance (ft): **3.7**
Structural Grade: **0**
O&M Grade: **3**
Clock Start/From: **8**
Clock To: **4**
1st Value:
2nd Value:
Value Percent: **10.000**
Continuous Index: **S01**
Within 8" of Joint: **YES**
Remarks:

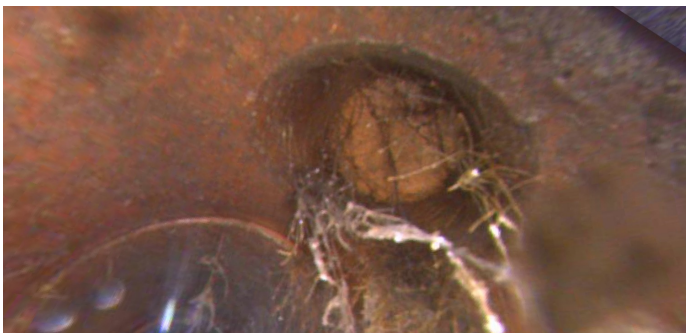
Code: **TFD**
Description: **Tap Factory Defective**

Distance (ft): **5.3**
Structural Grade: **0**
O&M Grade: **2**
Clock Start/From: **11**
Clock To:
1st Value: **4.000**
2nd Value:
Value Percent:
Continuous Index:
Within 8" of Joint:
Remarks: **rfl, capped**

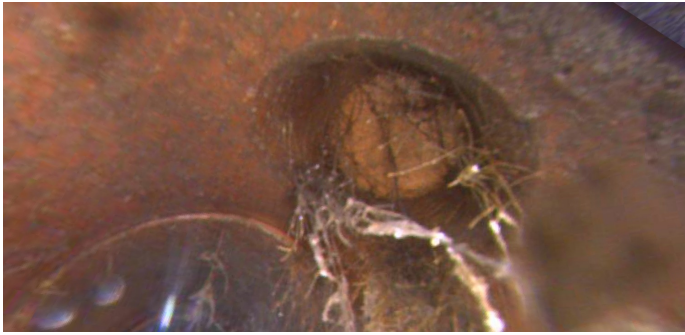
Code: **RFL**
Description: **Roots Fine Lateral**

Distance (ft): **5.3**
Structural Grade: **0**
O&M Grade: **1**
Clock Start/From: **10**
Clock To: **12**
1st Value:
2nd Value:
Value Percent:
Continuous Index:
Within 8" of Joint: **NO**
Remarks:

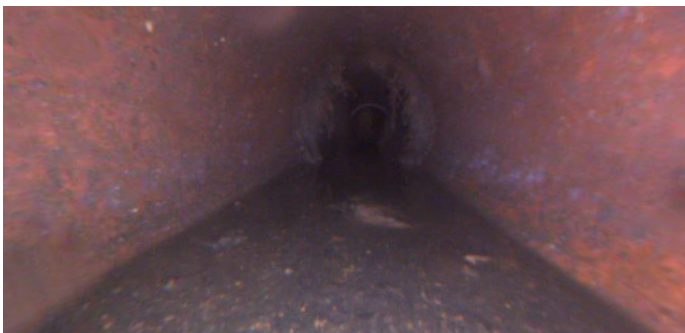
Code: **RMJ**
Description: **Roots Medium Joint**

Distance (ft): **10.7**
Structural Grade: **0**
O&M Grade: **3**
Clock Start/From: **8**
Clock To: **4**
1st Value:
2nd Value:
Value Percent: **10.000**
Continuous Index: **F01**
Within 8" of Joint: **YES**
Remarks:

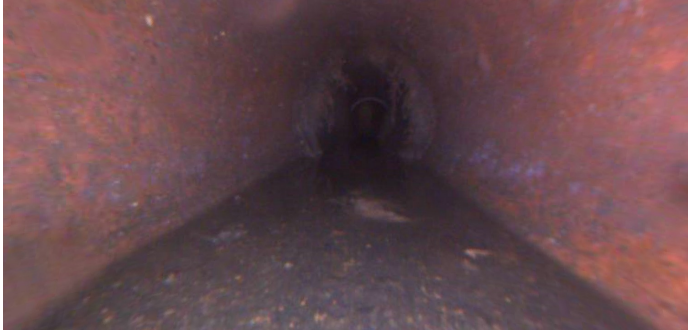
Code:	MSA
Description:	Abandoned Survey
Distance (ft):	10.7
Structural Grade:	0
O&M Grade:	0
Clock Start/From:	
Clock To:	
1st Value:	
2nd Value:	
Value Percent:	
Continuous Index:	
Within 8" of Joint:	NO
Remarks:	rmj
