Profile/Photo Observation Report

Customer: City of Hobart Clean Date: 09/04/2021 Shape: C

Street: West 39th Avenue Flow Control: Not Controlled

US MH: M-503-022 DS MH: M-503-023 Total Length Surveyed (ft): 145.7

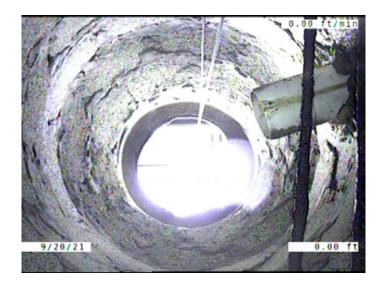
Code: AMH Description: Manhole

Distance (ft): .0 Structural Grade: 0 0 O&M Grade:

Remarks: M-503-023

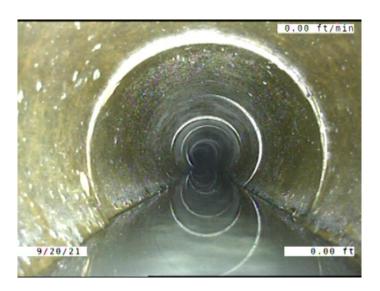
MWL Code:

Description: **Miscellaneous Water Level**

Distance (ft): .0 Structural Grade: 0 O&M Grade: 0

Value Percent: 5.000

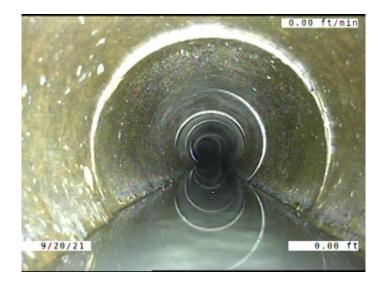
Code: **DSF**

Description: **Deposits Settled Fine**

Distance (ft): .0 Structural Grade: 0 2 O&M Grade: Clock Start/From: 5 Clock To: 7

Value Percent: 5.000 Continuous Index: **S01** Within 8" of Joint: YES

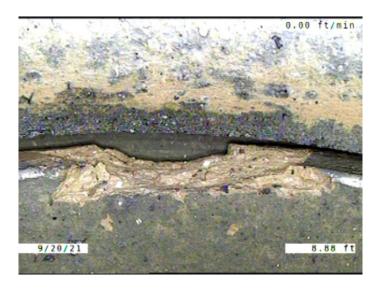
Code: SZ

Description: **Surface Damage Other**

Distance (ft): 8.9 Structural Grade: 0 O&M Grade: 0 Clock Start/From: 12 Clock To: 1 1st Value: 2nd Value:

A PIECE CHIPPED AWAY FROM THE Remarks:

JOINT

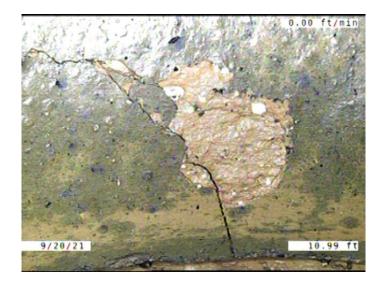
Code: SSS

Description: Surface Damage Surface Spalling

Distance (ft): 11.0
Structural Grade: 2
O&M Grade: 0
Clock Start/From: 9

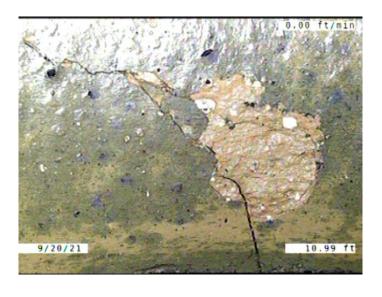
Code: CM

Description: Crack Multiple

Distance (ft): 11.0
Structural Grade: 3
O&M Grade: 0
Clock Start/From: 8
Clock To: 9
1st Value:
2nd Value:
Value Percent:
Continuous Index:

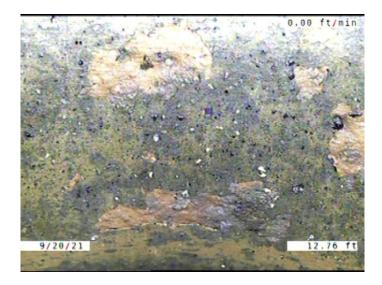
Code: SSS

Description: Surface Damage Surface Spalling

Distance (ft): 12.8
Structural Grade: 2
O&M Grade: 0
Clock Start/From: 12
Clock To: 2

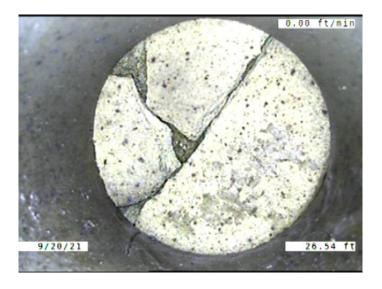
Code: **TFD**

Description: Tap Factory Defective

Distance (ft): 26.5
Structural Grade: 0
O&M Grade: 3
Clock Start/From: 1

Remarks: CAP BROKEN

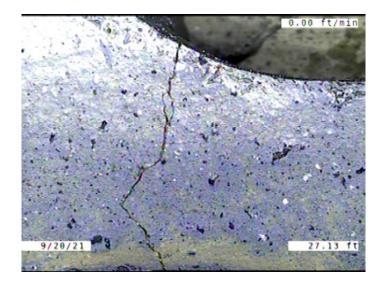
Code: CL

Description: Crack Longitudinal

Distance (ft): 27.1
Structural Grade: 2
O&M Grade: 0
Clock Start/From: 1

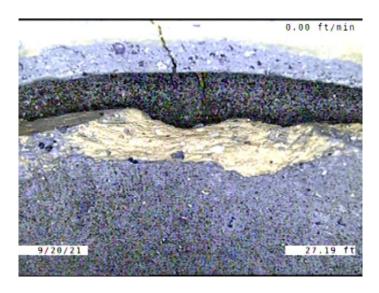
Code: SZ

Description: Surface Damage Other

Distance (ft): 27.2
Structural Grade: 0
O&M Grade: 0
Clock Start/From: 1

Remarks: A PIECE CHIPPED AWAY FROM THE

JOINT

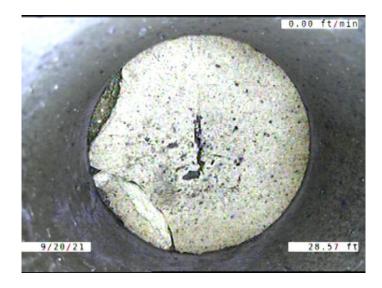
Code: **TFD**

Description: Tap Factory Defective

Distance (ft): 28.6
Structural Grade: 0

O&M Grade: 3

Remarks: CAP BROKEN

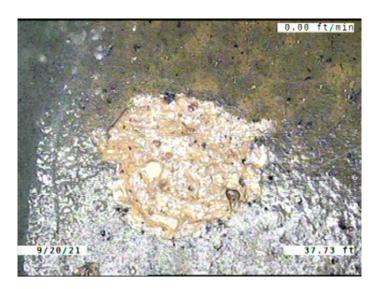
Code: SSS

Description: Surface Damage Surface Spalling

Distance (ft): 37.7
Structural Grade: 2
O&M Grade: 0
Clock Start/From: 4
Clock To:
1st Value:

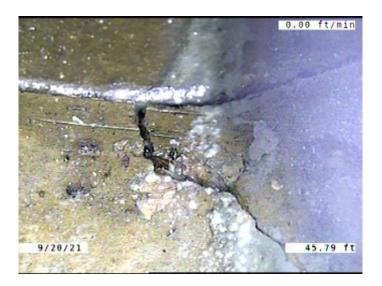
Code: B
Description: Broken

Distance (ft): 45.8
Structural Grade: 4

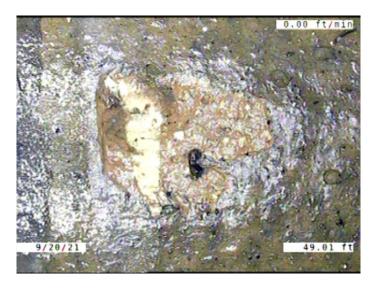
Code: SSS

Description: Surface Damage Surface Spalling

49.0 Distance (ft): Structural Grade: 2 O&M Grade: 0 Clock Start/From: 4 5 Clock To: 1st Value: 2nd Value: Value Percent: Continuous Index: Within 8" of Joint: NO

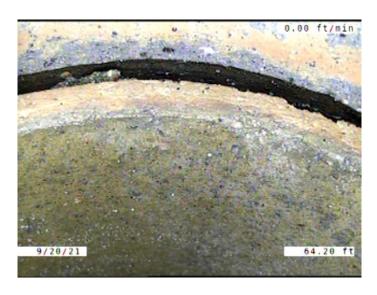
Code: **JOM**

Description: Joint Offset Medium

Distance (ft): 64.2
Structural Grade: 3
O&M Grade: 0

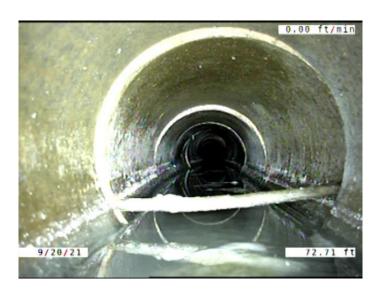
Code: OBJ

Description: Obstruction Wedged In The Joint

Distance (ft): 72.7
Structural Grade: 0
O&M Grade: 2
Clock Start/From: 4
Clock To: 8
1st Value:
2nd Value:

Within 8" of Joint: YES
Remarks: STICK

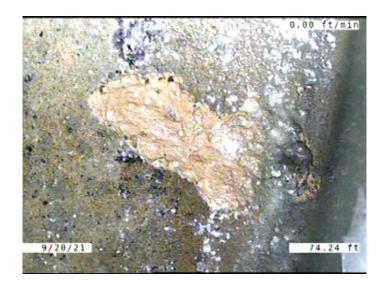
Code: SSS

Description: Surface Damage Surface Spalling

Distance (ft): 74.2
Structural Grade: 2
O&M Grade: 0
Clock Start/From: 3
Clock To: 4

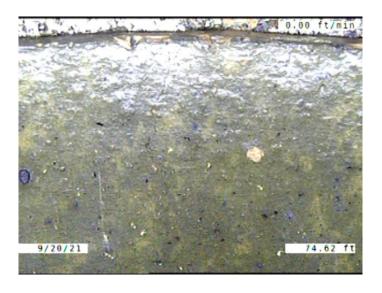
Code: FM

Description: Fracture Multiple

Distance (ft): 74.6
Structural Grade: 4

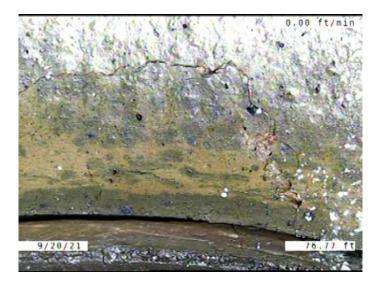
Code: CS

Description: Crack Spiral

Distance (ft): 76.8
Structural Grade: 2
O&M Grade: 0
Clock Start/From: 1
Clock To: 4

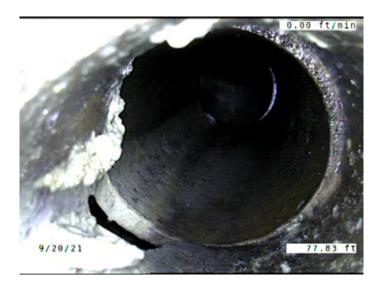
Code: **TFD**

Description: Tap Factory Defective

Distance (ft): 77.8
Structural Grade: 0
O&M Grade: 3
Clock Start/From: 11

Remarks: **SOIL VISIBLE**

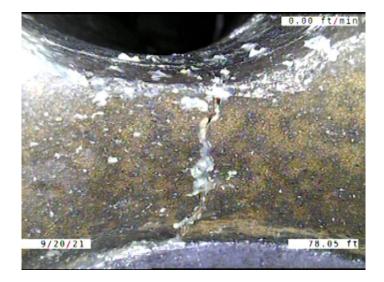
Code: FM

Description: Fracture Multiple

Distance (ft): 78.0
Structural Grade: 4
O&M Grade: 0
Clock Start/From: 10
Clock To: 11

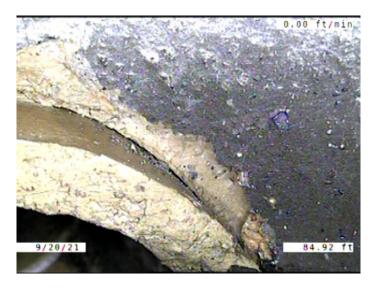
Code: SSS

Description: Surface Damage Surface Spalling

Distance (ft): 84.9
Structural Grade: 2
O&M Grade: 0
Clock Start/From: 1
Clock To: 3
1st Value:
2nd Value:
Value Percent:

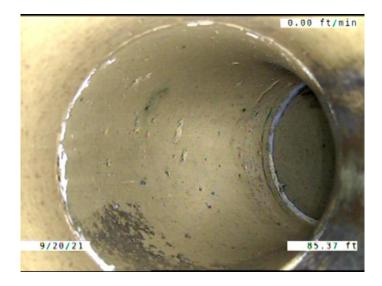
Code: TBI

Description: **Tap Break-in Intruding**

Distance (ft): 85.4 Structural Grade: 0 2 O&M Grade: Clock Start/From: 1

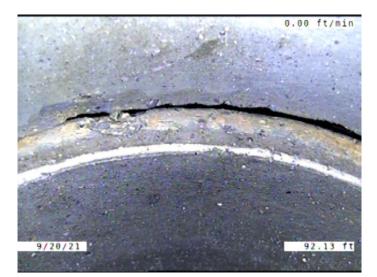
JOM Code:

Description: **Joint Offset Medium**

Distance (ft): 92.1 Structural Grade: 3 O&M Grade: 0

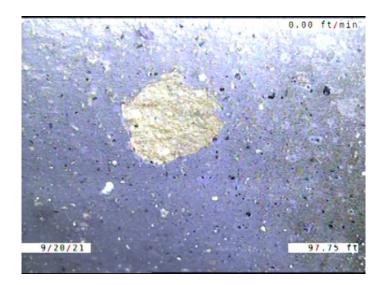
Code: SSS

Description: Surface Damage Surface Spalling

Distance (ft): 97.7
Structural Grade: 2
O&M Grade: 0
Clock Start/From: 3

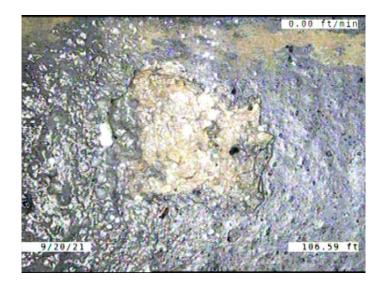
Code: SSS

Description: Surface Damage Surface Spalling

Distance (ft): 106.6
Structural Grade: 2
O&M Grade: 0
Clock Start/From: 3

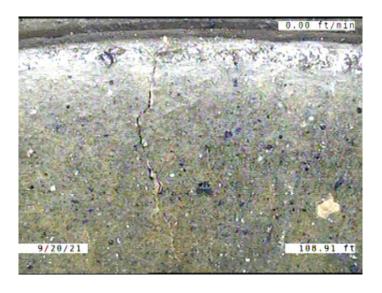
Code: CM

Description: Crack Multiple

Distance (ft): 108.9
Structural Grade: 3
O&M Grade: 0
Clock Start/From: 11
Clock To: 12
1st Value:
2nd Value:

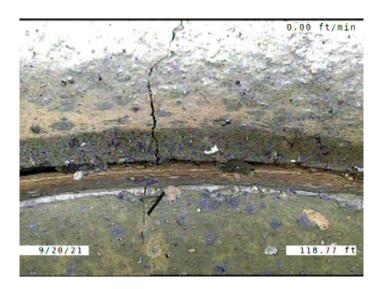
Code: CM

Description: Crack Multiple

Distance (ft): 118.8
Structural Grade: 3
O&M Grade: 0
Clock Start/From: 11
Clock To: 1
1st Value:
2nd Value:

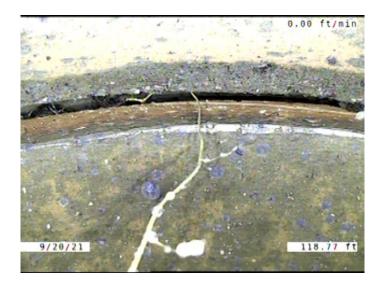
Code: RFJ

Description: Roots Fine Joint

Distance (ft): 118.8
Structural Grade: 0
O&M Grade: 1
Clock Start/From: 10
Clock To: 4

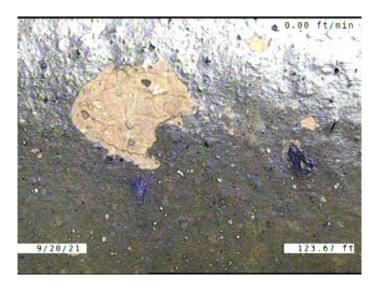
Code: SSS

Description: Surface Damage Surface Spalling

Distance (ft): 123.7
Structural Grade: 2
O&M Grade: 0
Clock Start/From: 3

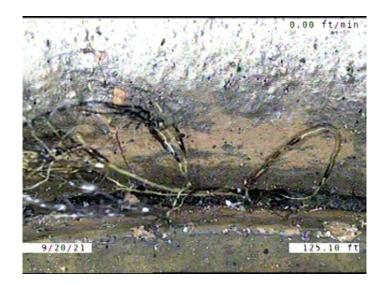
Code: RFJ
Description: Roots Fine Joint

Distance (ft): 125.1
Structural Grade: 0
O&M Grade: 1
Clock Start/From: 9
Clock To: 11
1st Value:
2nd Value:

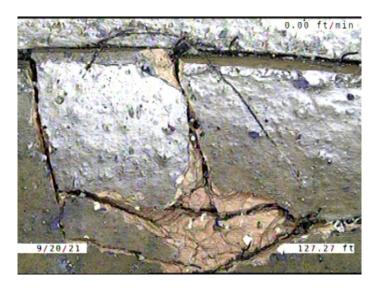
Code: B
Description: Broken

Distance (ft): 127.3
Structural Grade: 4
O&M Grade: 0
Clock Start/From: 2
Clock To: 4
1st Value:
2nd Value:
Value Percent:
Continuous Index:

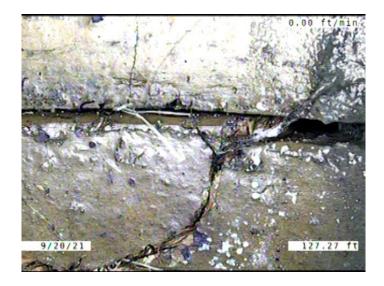
Code: RFJ
Description: Roots Fine Joint

Distance (ft): 127.3 Structural Grade: 0 O&M Grade: 1 Clock Start/From: 2 Clock To: 4 1st Value: 2nd Value: Value Percent: Continuous Index: Within 8" of Joint: YES

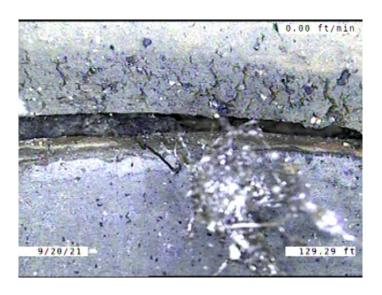
Code: RFJ

Description: Roots Fine Joint

Distance (ft): 129.3 Structural Grade: 0 O&M Grade: 1 Clock Start/From: 8 3 Clock To: 1st Value: 2nd Value: Value Percent: Continuous Index: **S03** Within 8" of Joint: YES

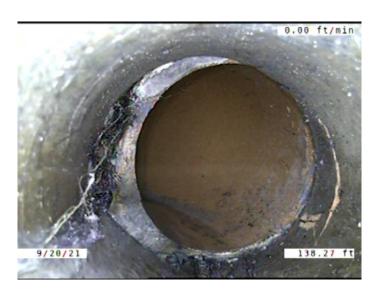
Code: **TFD**

Description: Tap Factory Defective

Distance (ft): 138.3
Structural Grade: 0
O&M Grade: 3
Clock Start/From: 11

Remarks: ROOTS GROWING IN THE JOINT

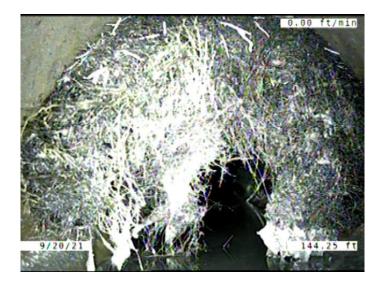
Code: CM

Description: Crack Multiple

Distance (ft): 144.3
Structural Grade: 3
O&M Grade: 0
Clock Start/From: 11
Clock To: 1

Code: RFJ

Description: Roots Fine Joint

Distance (ft): 144.3
Structural Grade: 0
O&M Grade: 1
Clock Start/From: 8
Clock To: 3
1st Value: 2nd Value:

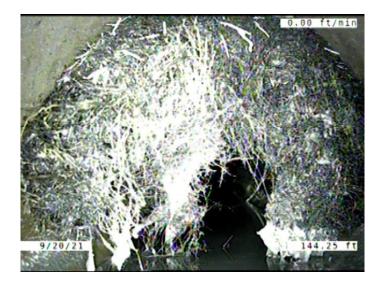
Code: **DSF**

Description: **Deposits Settled Fine**

Distance (ft): 144.3 Structural Grade: 0 2 O&M Grade: Clock Start/From: 5 Clock To: 7

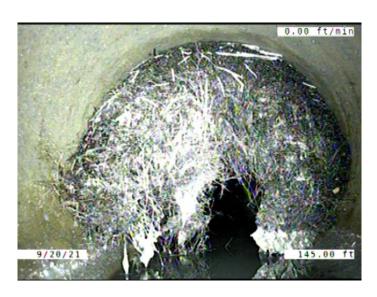
RBJ Code:

Description: **Roots Ball Joint**

Distance (ft): 145.0 Structural Grade: 0 O&M Grade: 4 Clock Start/From: 8 5 Clock To: 1st Value:

95.000

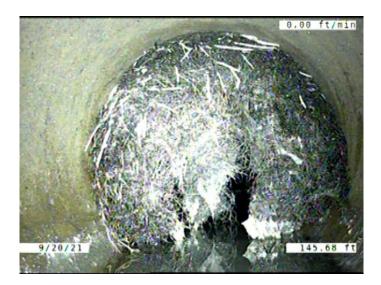
Code: MSA

Description: Miscellaneous Survey Abandoned

Remarks: CAMERA CANT MAKE IT PAST

ROOTS. MADE IT TO THE POINT OF
