RedZone  
ROBOTICS

Street:	West 39th Avenue		Flow Control:	Not Controlled	
City:	Hobart, IN		Year Renewed:		
Location:	Alley		Tape/Media #:		
Purpose:	Routine Assessment		Dia/Height:	10"	
Use:	Sanitary Sewage Pipe		Material:	VCP	
Drain Area:			Lining:	None	
Category:	NA				
Comment:					
Location Details:			Direction of Survey:	Upstream	
US MH:	M-503-022	DS MH:	M-503-023	Total Length Surveyed (ft):	145.7

**Thursday, December 30, 2021**

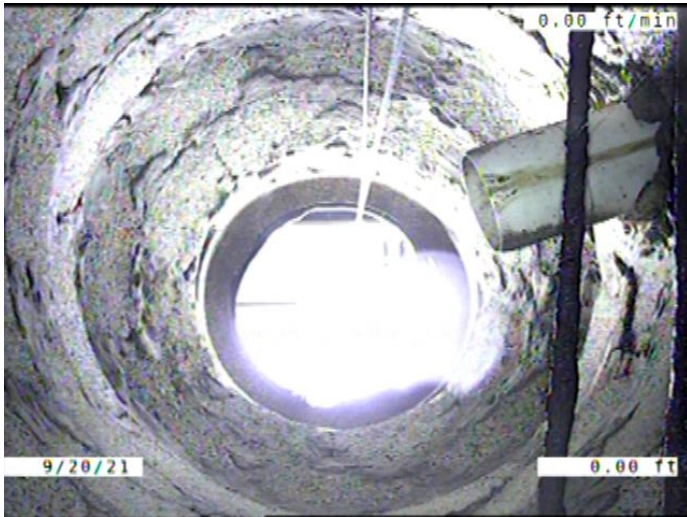
Code: **AMH**  
Description: **Manhole**

Distance (ft): **.0**  
Structural Grade: **0**  
O&M Grade: **0**  
Clock Start/From:  
Clock To:  
1st Value:  
2nd Value:  
Value Percent:  
Continuous Index:  
Within 8" of Joint: **NO**  
Remarks: **M-503-023**

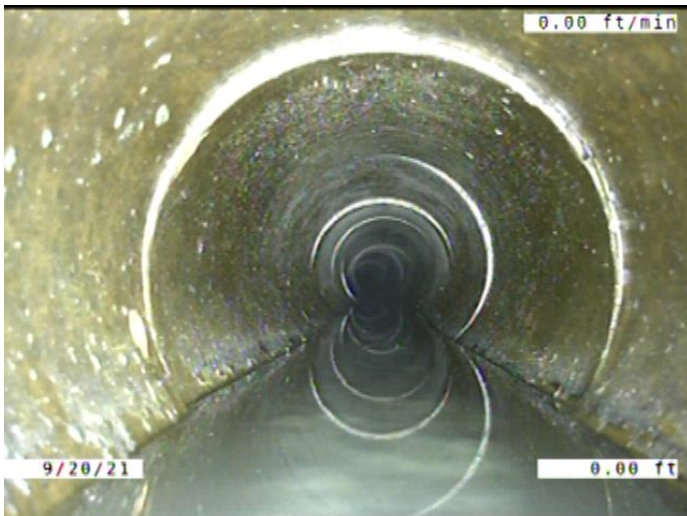
Code: **MWL**  
Description: **Miscellaneous Water Level**

Distance (ft): **.0**  
Structural Grade: **0**  
O&M Grade: **0**  
Clock Start/From:  
Clock To:  
1st Value:  
2nd Value:  
Value Percent: **5.000**  
Continuous Index:  
Within 8" of Joint: **NO**  
Remarks:

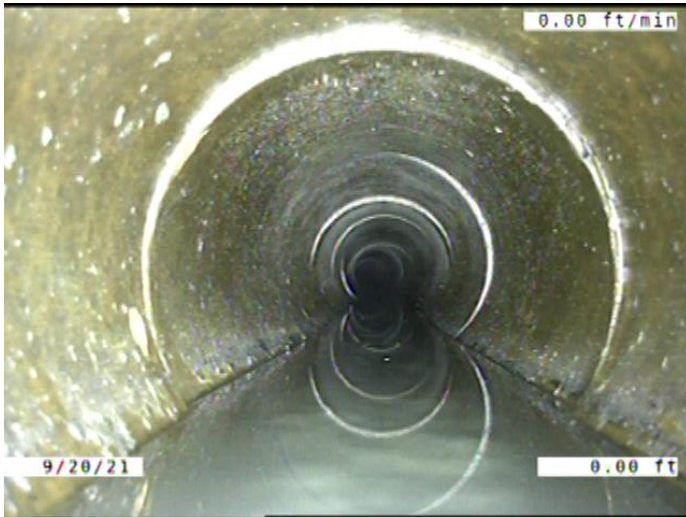
Code: **DSF**  
 Description: **Deposits Settled Fine**

Distance (ft): **.0**  
 Structural Grade: **0**  
 O&M Grade: **2**  
 Clock Start/From: **5**  
 Clock To: **7**  
 1st Value:  
 2nd Value:  
 Value Percent: **5.000**  
 Continuous Index: **S01**  
 Within 8" of Joint: **YES**  
 Remarks:

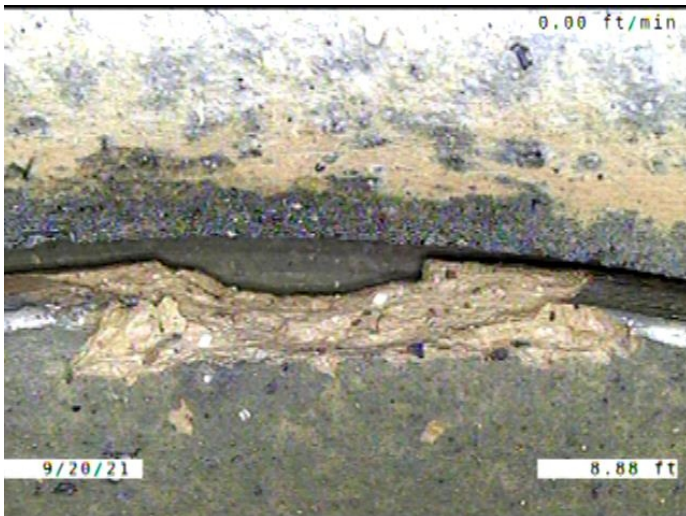
Code: **SZ**  
 Description: **Surface Damage Other**

Distance (ft): **8.9**  
 Structural Grade: **0**  
 O&M Grade: **0**  
 Clock Start/From: **12**  
 Clock To: **1**  
 1st Value:  
 2nd Value:  
 Value Percent:  
 Continuous Index:  
 Within 8" of Joint: **YES**  
 Remarks: **A PIECE CHIPPED AWAY FROM THE JOINT**

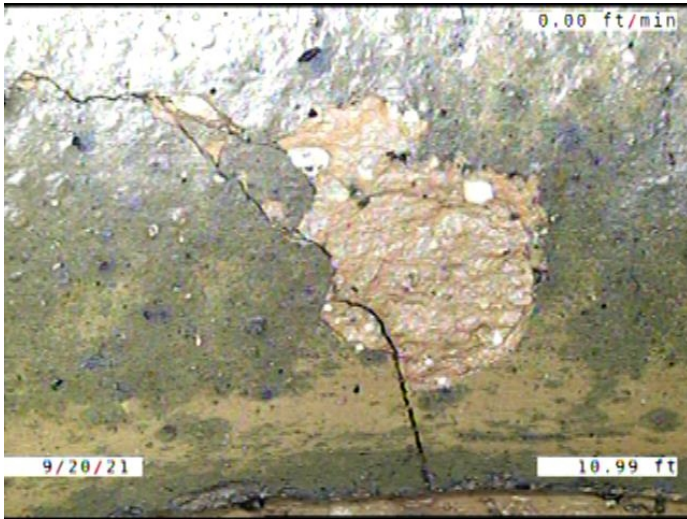
Code: **SSS**  
Description: **Surface Damage Surface Spalling**

Distance (ft): **11.0**  
Structural Grade: **2**  
O&M Grade: **0**  
Clock Start/From: **9**  
Clock To:  
1st Value:  
2nd Value:  
Value Percent:  
Continuous Index:  
Within 8" of Joint: **YES**  
Remarks:

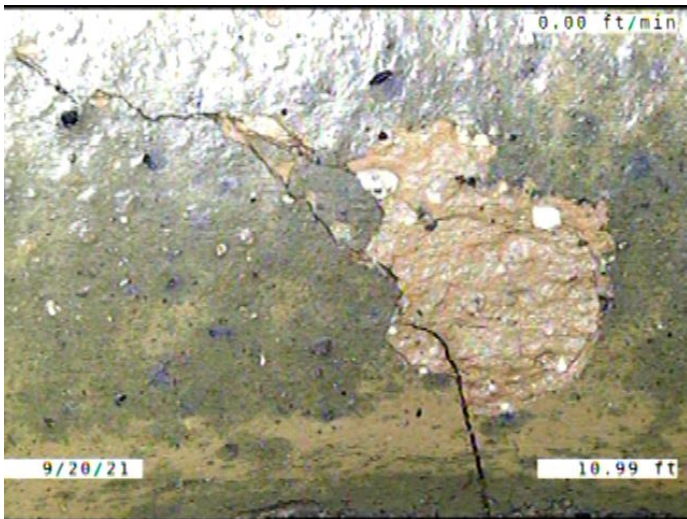
Code: **CM**  
Description: **Crack Multiple**

Distance (ft): **11.0**  
Structural Grade: **3**  
O&M Grade: **0**  
Clock Start/From: **8**  
Clock To: **9**  
1st Value:  
2nd Value:  
Value Percent:  
Continuous Index:  
Within 8" of Joint: **YES**  
Remarks:

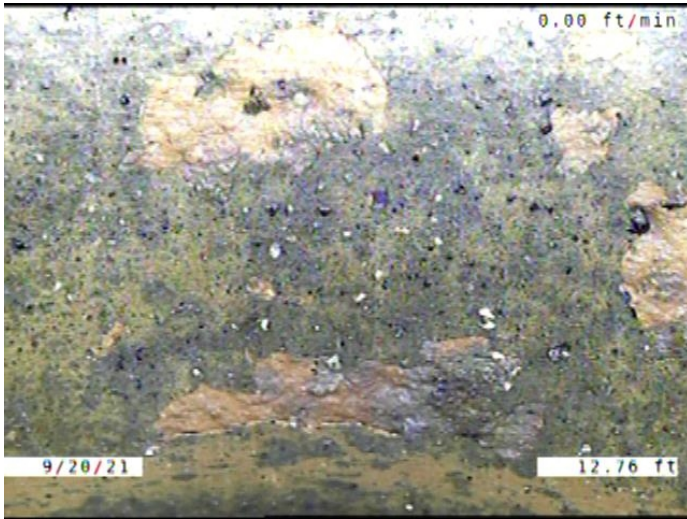
Code: **SSS**  
 Description: **Surface Damage Surface Spalling**

Distance (ft): **12.8**  
 Structural Grade: **2**  
 O&M Grade: **0**  
 Clock Start/From: **12**  
 Clock To: **2**  
 1st Value:  
 2nd Value:  
 Value Percent:  
 Continuous Index:  
 Within 8" of Joint: **YES**  
 Remarks:

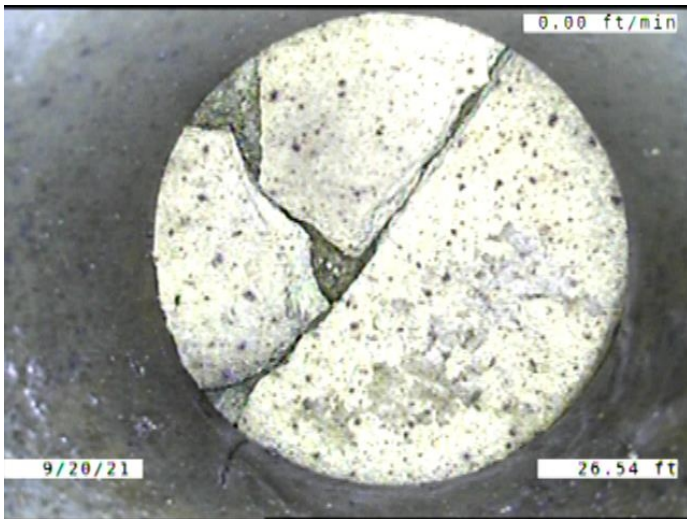
Code: **TFD**  
 Description: **Tap Factory Defective**

Distance (ft): **26.5**  
 Structural Grade: **0**  
 O&M Grade: **3**  
 Clock Start/From: **1**  
 Clock To:  
 1st Value: **4.000**  
 2nd Value:  
 Value Percent:  
 Continuous Index:  
 Within 8" of Joint: **YES**  
 Remarks: **CAP BROKEN**

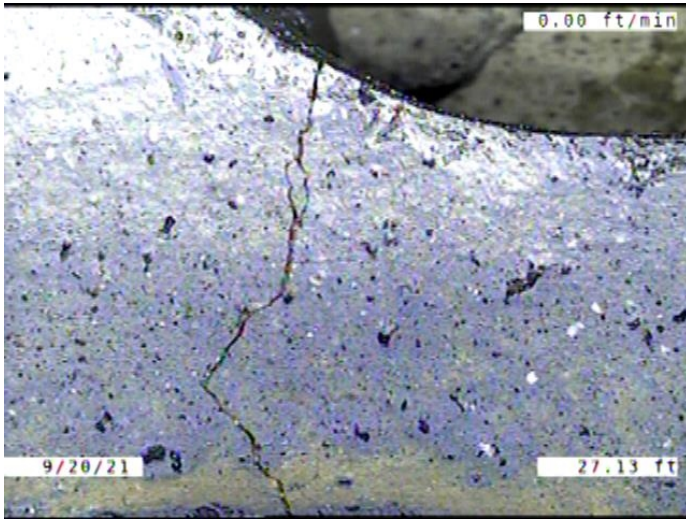
Code: **CL**  
 Description: **Crack Longitudinal**

Distance (ft): **27.1**  
 Structural Grade: **2**  
 O&M Grade: **0**  
 Clock Start/From: **1**  
 Clock To:  
 1st Value:  
 2nd Value:  
 Value Percent:  
 Continuous Index:  
 Within 8" of Joint: **YES**  
 Remarks:

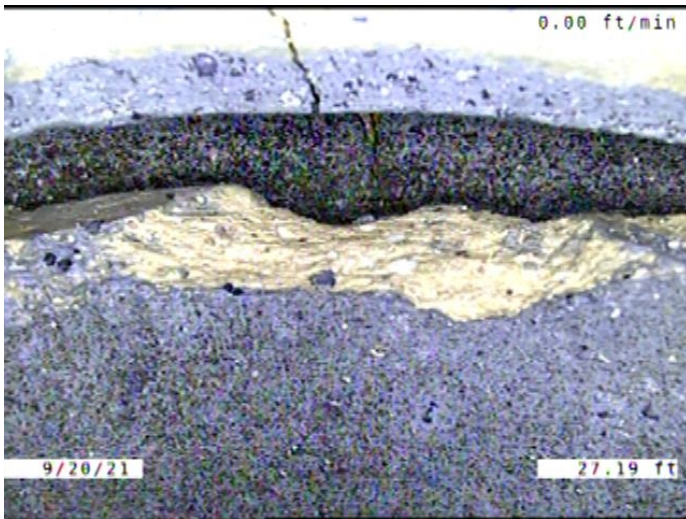
Code: **SZ**  
 Description: **Surface Damage Other**

Distance (ft): **27.2**  
 Structural Grade: **0**  
 O&M Grade: **0**  
 Clock Start/From: **1**  
 Clock To:  
 1st Value:  
 2nd Value:  
 Value Percent:  
 Continuous Index:  
 Within 8" of Joint: **YES**  
 Remarks: **A PIECE CHIPPED AWAY FROM THE JOINT**

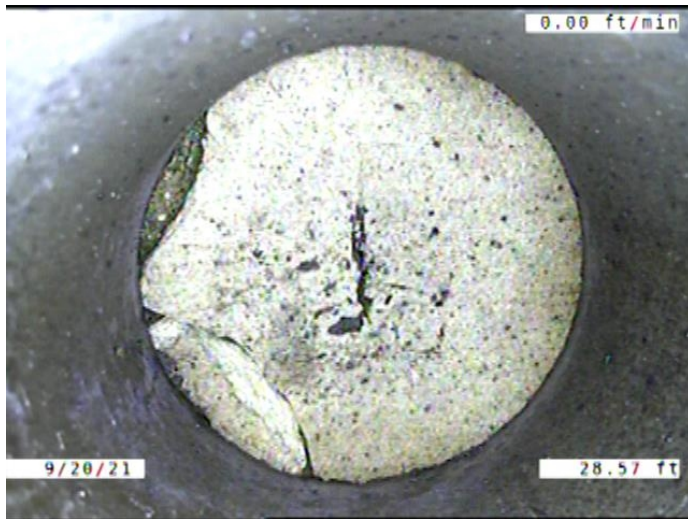
Code: **TFD**  
Description: **Tap Factory Defective**

Distance (ft): **28.6**  
Structural Grade: **0**  
O&M Grade: **3**  
Clock Start/From: **11**  
Clock To:  
1st Value: **4.000**  
2nd Value:  
Value Percent:  
Continuous Index:  
Within 8" of Joint: **YES**  
Remarks: **CAP BROKEN**

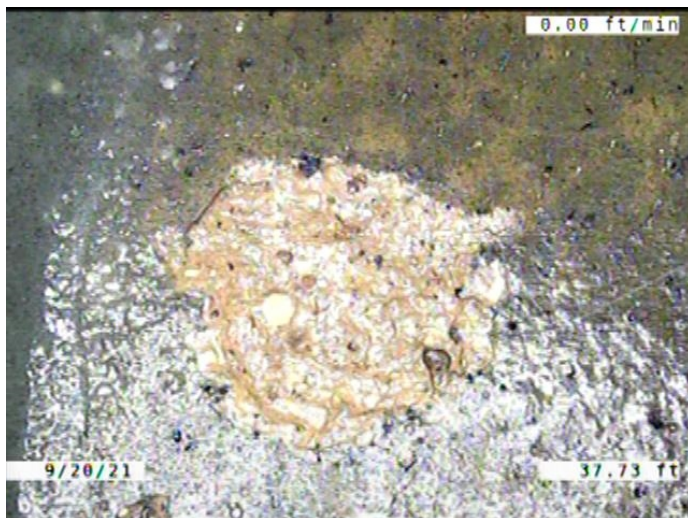
Code: **SSS**  
Description: **Surface Damage Surface Spalling**

Distance (ft): **37.7**  
Structural Grade: **2**  
O&M Grade: **0**  
Clock Start/From: **4**  
Clock To:  
1st Value:  
2nd Value:  
Value Percent:  
Continuous Index:  
Within 8" of Joint: **YES**  
Remarks:

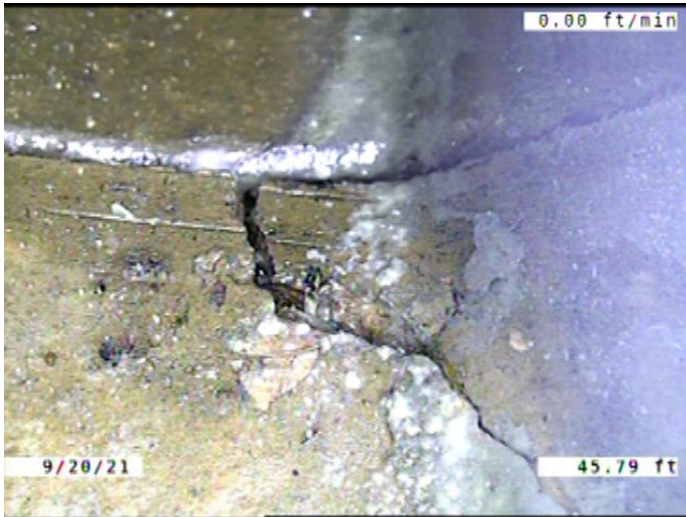
Code: **B**  
 Description: **Broken**

Distance (ft): **45.8**  
 Structural Grade: **4**  
 O&M Grade: **0**  
 Clock Start/From: **4**  
 Clock To: **8**  
 1st Value:  
 2nd Value:  
 Value Percent:  
 Continuous Index:  
 Within 8" of Joint: **YES**  
 Remarks:

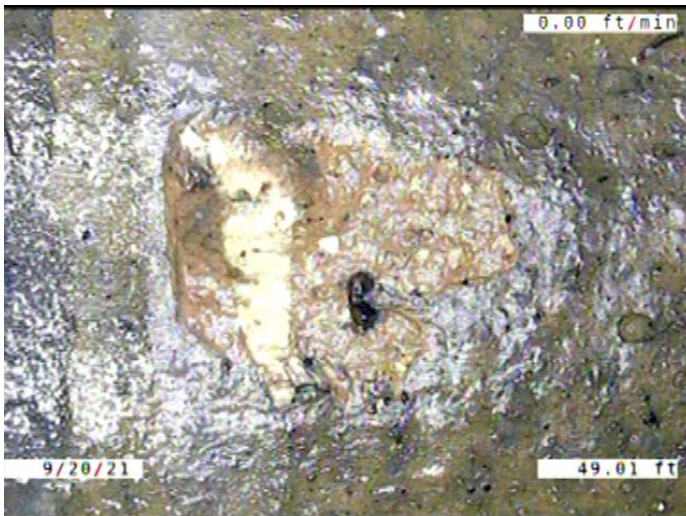
Code: **SSS**  
 Description: **Surface Damage Surface Spalling**

Distance (ft): **49.0**  
 Structural Grade: **2**  
 O&M Grade: **0**  
 Clock Start/From: **4**  
 Clock To: **5**  
 1st Value:  
 2nd Value:  
 Value Percent:  
 Continuous Index:  
 Within 8" of Joint: **NO**  
 Remarks:

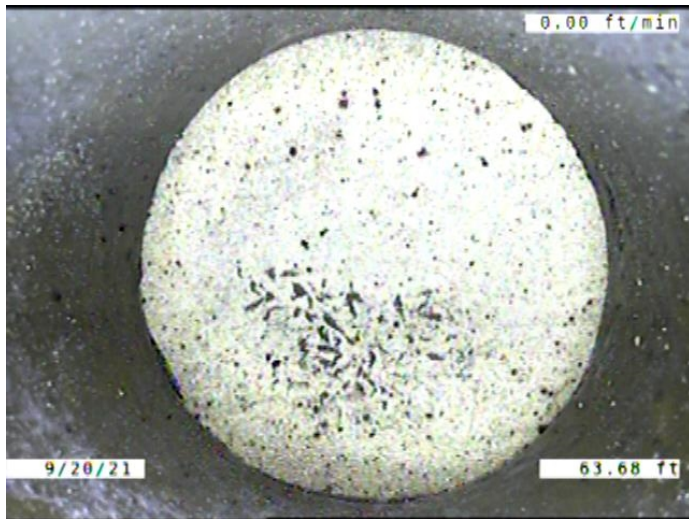
Code: **TFC**  
 Description: **Tap Factory Capped**

Distance (ft): **63.7**  
 Structural Grade: **0**  
 O&M Grade: **0**  
 Clock Start/From: **1**  
 Clock To:  
 1st Value: **4.000**  
 2nd Value:  
 Value Percent:  
 Continuous Index:  
 Within 8" of Joint: **YES**  
 Remarks:

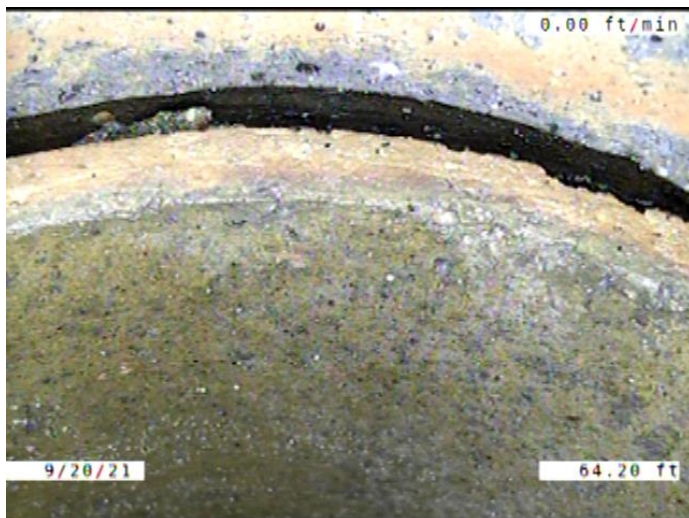
85.4	TBI	Tap Break-in Intruding	134	M 2
92.1	JOM	Joint Offset Medium	176	S 3
97.7	SSS	Surface Damage Surface Spalling	232	S 2
103.8	TFC	Tap Factory Capped	276	NA

Code: **JOM**  
 Description: **Joint Offset Medium**

Distance (ft): **64.2**  
 Structural Grade: **3**  
 O&M Grade: **0**  
 Clock Start/From:  
 Clock To:  
 1st Value:  
 2nd Value:  
 Value Percent:  
 Continuous Index:  
 Within 8" of Joint: **NO**  
 Remarks:

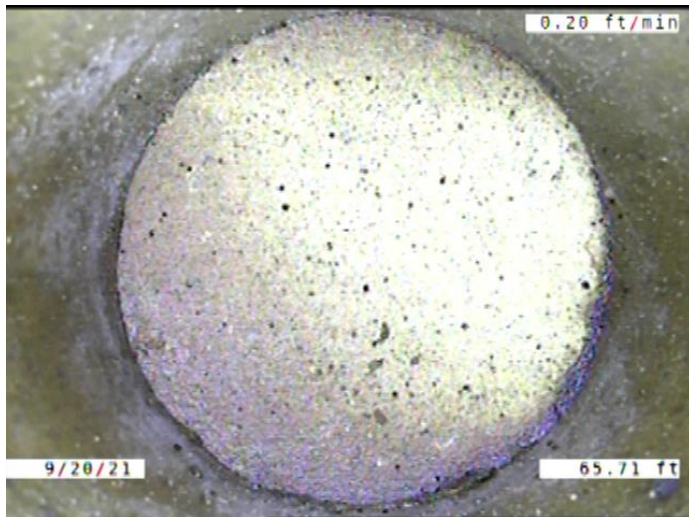
Code: **TFC**  
 Description: **Tap Factory Capped**

Distance (ft): **65.7**  
 Structural Grade: **0**  
 O&M Grade: **0**  
 Clock Start/From: **11**  
 Clock To:  
 1st Value: **4.000**  
 2nd Value:  
 Value Percent:  
 Continuous Index:  
 Within 8" of Joint: **YES**  
 Remarks:

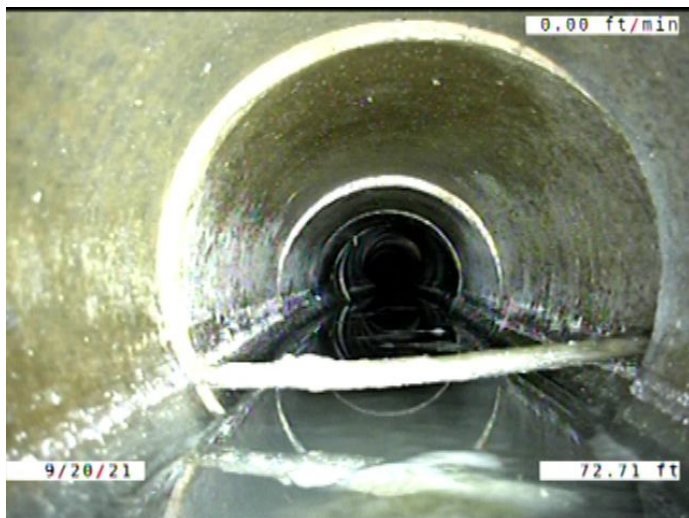
Code: **OBJ**  
 Description: **Obstruction Wedged In The Joint**

Distance (ft): **72.7**  
 Structural Grade: **0**  
 O&M Grade: **2**  
 Clock Start/From: **4**  
 Clock To: **8**  
 1st Value:  
 2nd Value:  
 Value Percent: **5.000**  
 Continuous Index:  
 Within 8" of Joint: **YES**  
 Remarks: **STICK**

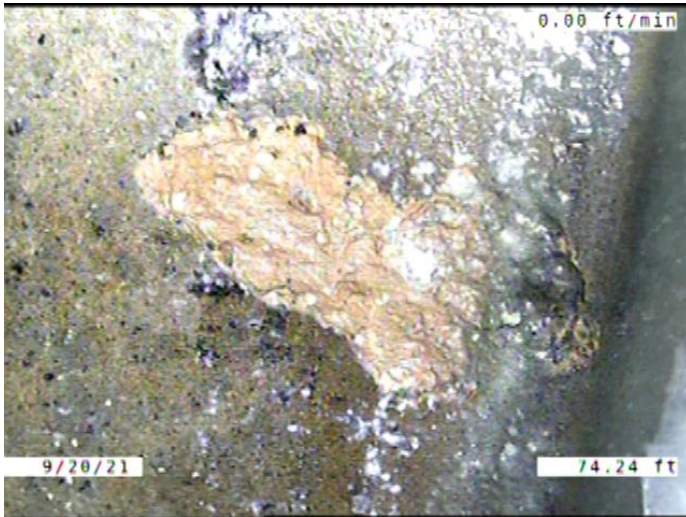
Code: **SSS**  
 Description: **Surface Damage Surface Spalling**

Distance (ft): **74.2**  
 Structural Grade: **2**  
 O&M Grade: **0**  
 Clock Start/From: **3**  
 Clock To: **4**  
 1st Value:  
 2nd Value:  
 Value Percent:  
 Continuous Index:  
 Within 8" of Joint: **YES**  
 Remarks:

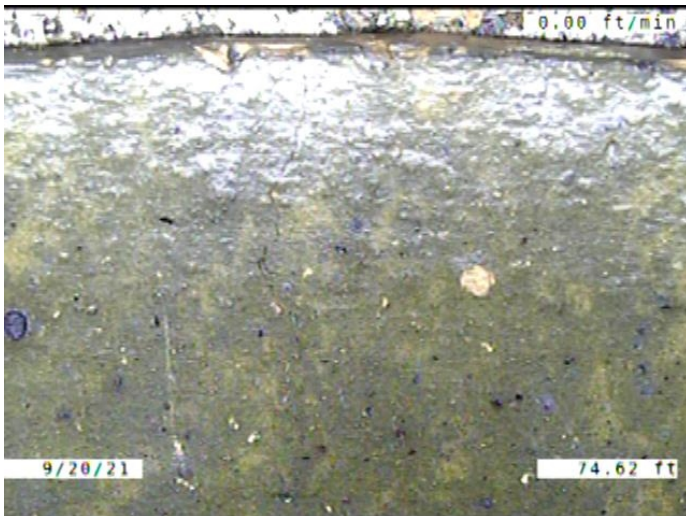
74.6	FM	Fracture Multiple	883	S 4
76.8	CS	Crack Spiral	0	S 2
77.8	TFD	Tap Factory Defective	2	M 3
78.0	FM	Fracture Multiple	34	S 4
84.9	SSS	Surface Damage Surface Spalling	118	S 2

Code: **FM**  
 Description: **Fracture Multiple**

Distance (ft): **74.6**  
 Structural Grade: **4**  
 O&M Grade: **0**  
 Clock Start/From: **11**  
 Clock To: **1**  
 1st Value:  
 2nd Value:  
 Value Percent:  
 Continuous Index:  
 Within 8" of Joint: **YES**  
 Remarks:

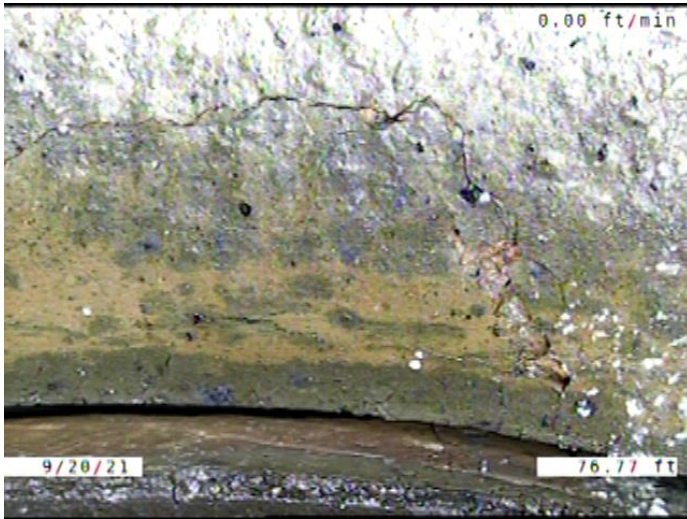
Code: **CS**  
 Description: **Crack Spiral**

Distance (ft): **76.8**  
 Structural Grade: **2**  
 O&M Grade: **0**  
 Clock Start/From: **1**  
 Clock To: **4**  
 1st Value:  
 2nd Value:  
 Value Percent:  
 Continuous Index:  
 Within 8" of Joint: **YES**  
 Remarks:

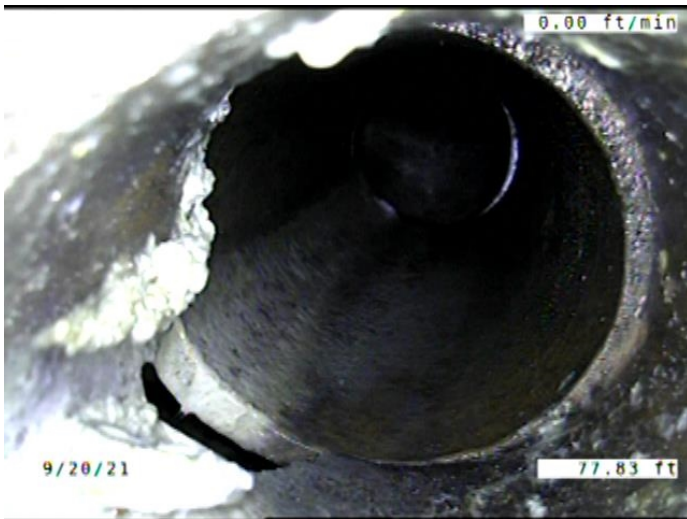
Code: **TFD**  
 Description: **Tap Factory Defective**

Distance (ft): **77.8**  
 Structural Grade: **0**  
 O&M Grade: **3**  
 Clock Start/From: **11**  
 Clock To:  
 1st Value: **4.000**  
 2nd Value:  
 Value Percent:  
 Continuous Index:  
 Within 8" of Joint: **YES**  
 Remarks: **SOIL VISIBLE**

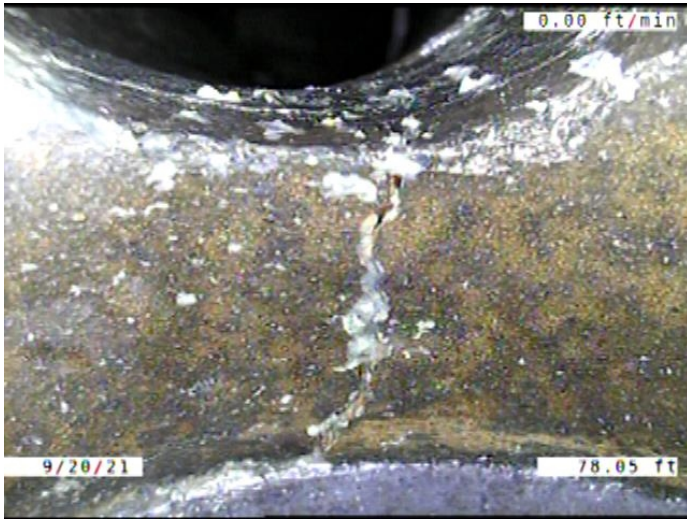
Code: **FM**  
 Description: **Fracture Multiple**

Distance (ft): **78.0**  
 Structural Grade: **4**  
 O&M Grade: **0**  
 Clock Start/From: **10**  
 Clock To: **11**  
 1st Value:  
 2nd Value:  
 Value Percent:  
 Continuous Index:  
 Within 8" of Joint: **YES**  
 Remarks:

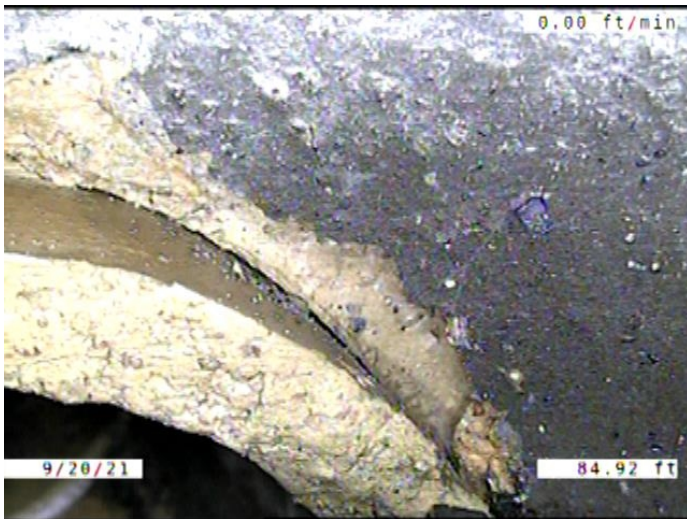
Code: **SSS**  
 Description: **Surface Damage Surface Spalling**

Distance (ft): **84.9**  
 Structural Grade: **2**  
 O&M Grade: **0**  
 Clock Start/From: **1**  
 Clock To: **3**  
 1st Value:  
 2nd Value:  
 Value Percent:  
 Continuous Index:  
 Within 8" of Joint: **YES**  
 Remarks:

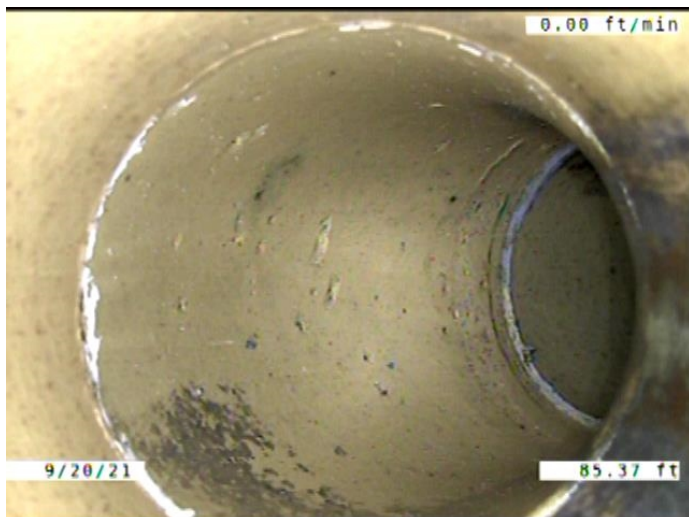
Code: **TBI**  
 Description: **Tap Break-in Intruding**

Distance (ft): **85.4**  
 Structural Grade: **0**  
 O&M Grade: **2**  
 Clock Start/From: **1**  
 Clock To:  
 1st Value: **4.000**  
 2nd Value: **1.000**  
 Value Percent:  
 Continuous Index:  
 Within 8" of Joint: **YES**  
 Remarks:

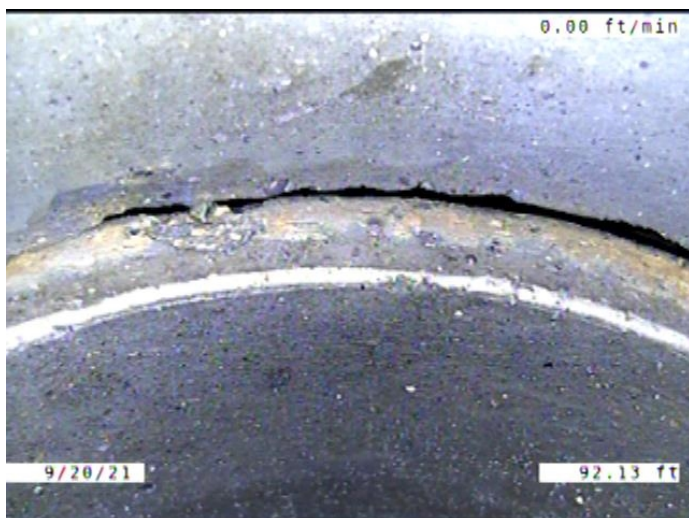
Code: **JOM**  
 Description: **Joint Offset Medium**

Distance (ft): **92.1**  
 Structural Grade: **3**  
 O&M Grade: **0**  
 Clock Start/From:  
 Clock To:  
 1st Value:  
 2nd Value:  
 Value Percent:  
 Continuous Index:  
 Within 8" of Joint: **NO**  
 Remarks:

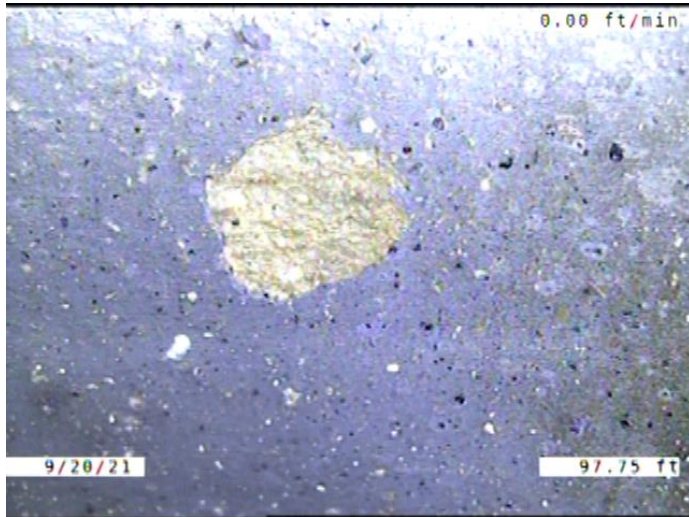
Code: **SSS**  
 Description: **Surface Damage Surface Spalling**

Distance (ft): **97.7**  
 Structural Grade: **2**  
 O&M Grade: **0**  
 Clock Start/From: **3**  
 Clock To:  
 1st Value:  
 2nd Value:  
 Value Percent:  
 Continuous Index:  
 Within 8" of Joint: **YES**  
 Remarks:

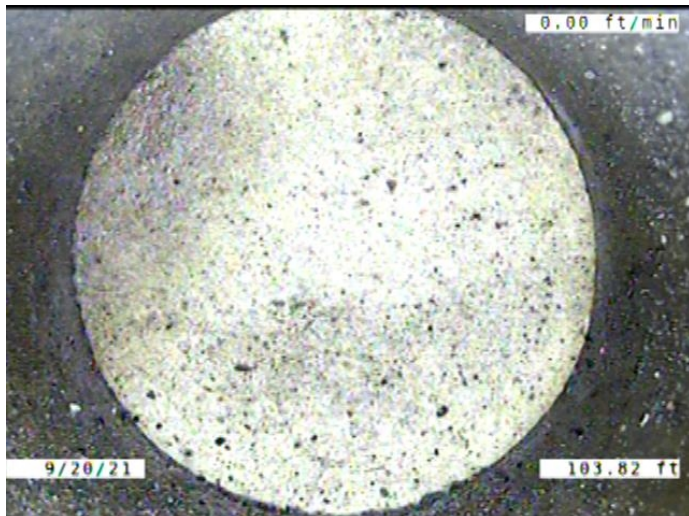
Code: **TFC**  
 Description: **Tap Factory Capped**

Distance (ft): **103.8**  
 Structural Grade: **0**  
 O&M Grade: **0**  
 Clock Start/From: **1**  
 Clock To:  
 1st Value: **4.000**  
 2nd Value:  
 Value Percent:  
 Continuous Index:  
 Within 8" of Joint: **YES**  
 Remarks:

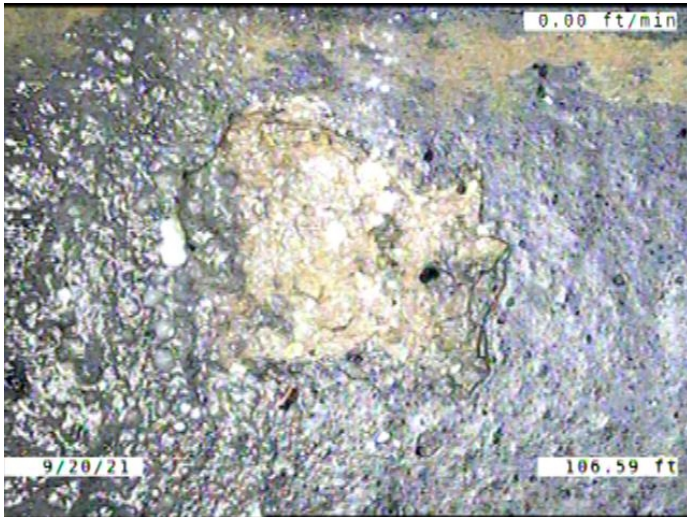
Code: **SSS**  
 Description: **Surface Damage Surface Spalling**

Distance (ft): **106.6**  
 Structural Grade: **2**  
 O&M Grade: **0**  
 Clock Start/From: **3**  
 Clock To:  
 1st Value:  
 2nd Value:  
 Value Percent:  
 Continuous Index:  
 Within 8" of Joint: **YES**  
 Remarks:

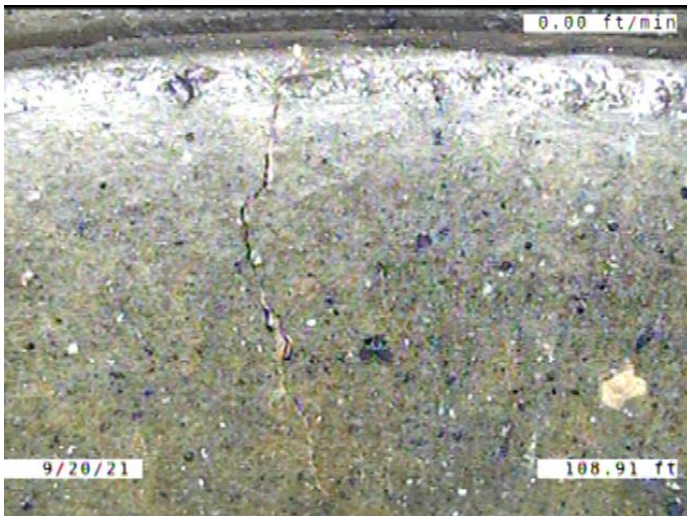
Code: **CM**  
 Description: **Crack Multiple**

Distance (ft): **108.9**  
 Structural Grade: **3**  
 O&M Grade: **0**  
 Clock Start/From: **11**  
 Clock To: **12**  
 1st Value:  
 2nd Value:  
 Value Percent:  
 Continuous Index:  
 Within 8" of Joint: **YES**  
 Remarks:

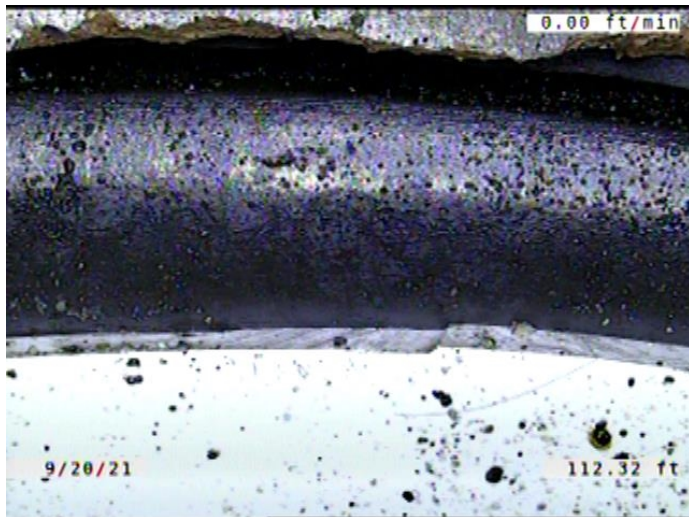
Code: **MMC**  
 Description: **Miscellaneous Material Change**

Distance (ft): **112.3**  
 Structural Grade: **0**  
 O&M Grade: **0**  
 Clock Start/From:  
 Clock To:  
 1st Value:  
 2nd Value:  
 Value Percent:  
 Continuous Index:  
 Within 8" of Joint: **NO**  
 Remarks: **VCP TO PVC**

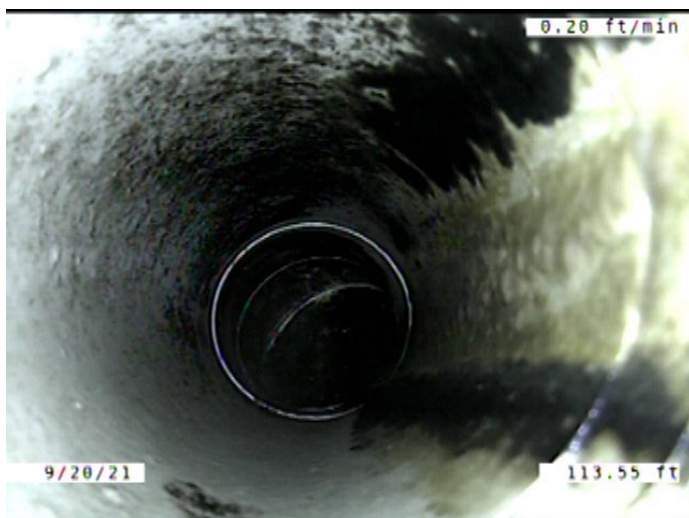
Code: **TF**  
 Description: **Tap Factory**

Distance (ft): **113.5**  
 Structural Grade: **0**  
 O&M Grade: **0**  
 Clock Start/From: **1**  
 Clock To:  
 1st Value: **4.000**  
 2nd Value:  
 Value Percent:  
 Continuous Index:  
 Within 8" of Joint: **YES**  
 Remarks:

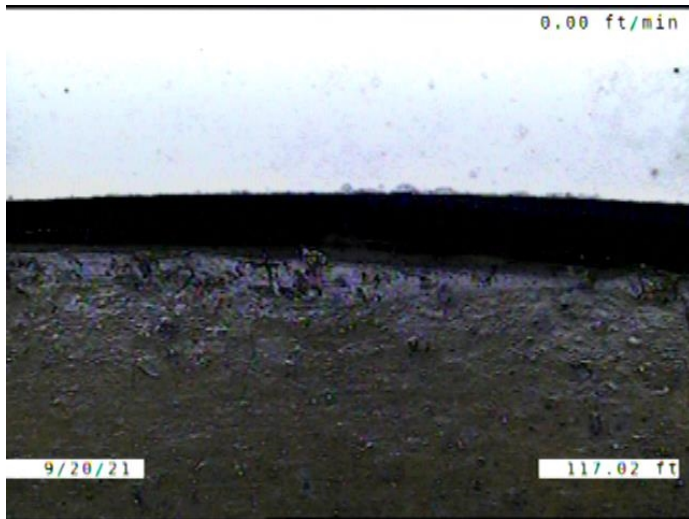
Code: **MMC**  
 Description: **Miscellaneous Material Change**

Distance (ft): **117.0**  
 Structural Grade: **0**  
 O&M Grade: **0**  
 Clock Start/From:  
 Clock To:  
 1st Value:  
 2nd Value:  
 Value Percent:  
 Continuous Index:  
 Within 8" of Joint: **NO**  
 Remarks: **PVC TO VCP**

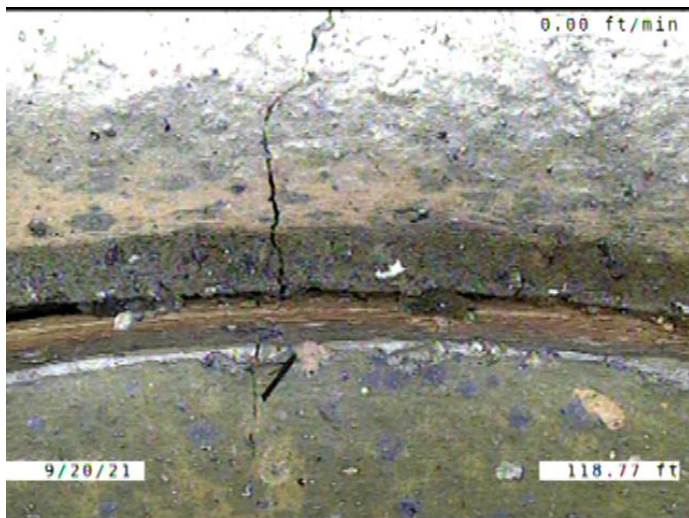
Code: **CM**  
 Description: **Crack Multiple**

Distance (ft): **118.8**  
 Structural Grade: **3**  
 O&M Grade: **0**  
 Clock Start/From: **11**  
 Clock To: **1**  
 1st Value:  
 2nd Value:  
 Value Percent:  
 Continuous Index: **S02**  
 Within 8" of Joint: **YES**  
 Remarks:

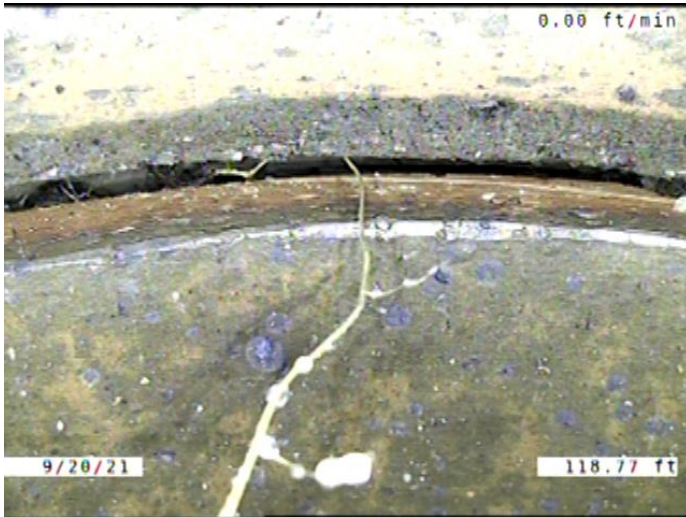
Code: **RFJ**  
 Description: **Roots Fine Joint**

Distance (ft): **118.8**  
 Structural Grade: **0**  
 O&M Grade: **1**  
 Clock Start/From: **10**  
 Clock To: **4**  
 1st Value:  
 2nd Value:  
 Value Percent:  
 Continuous Index:  
 Within 8" of Joint: **YES**  
 Remarks:

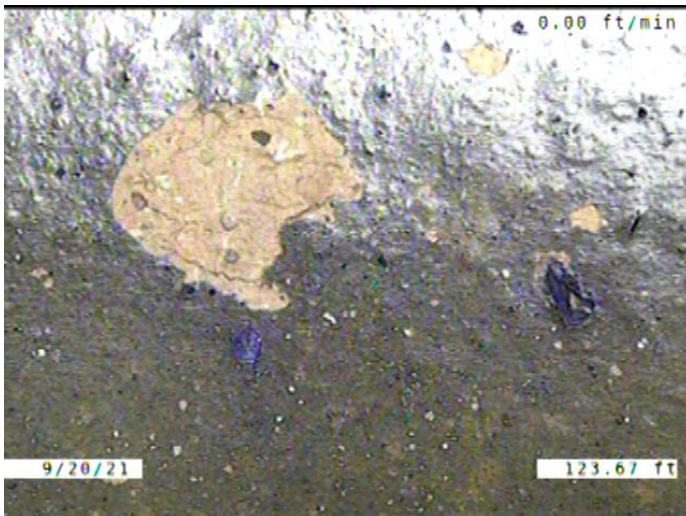
Code: **SSS**  
 Description: **Surface Damage Surface Spalling**

Distance (ft): **123.7**  
 Structural Grade: **2**  
 O&M Grade: **0**  
 Clock Start/From: **3**  
 Clock To:  
 1st Value:  
 2nd Value:  
 Value Percent:  
 Continuous Index:  
 Within 8" of Joint: **YES**  
 Remarks:

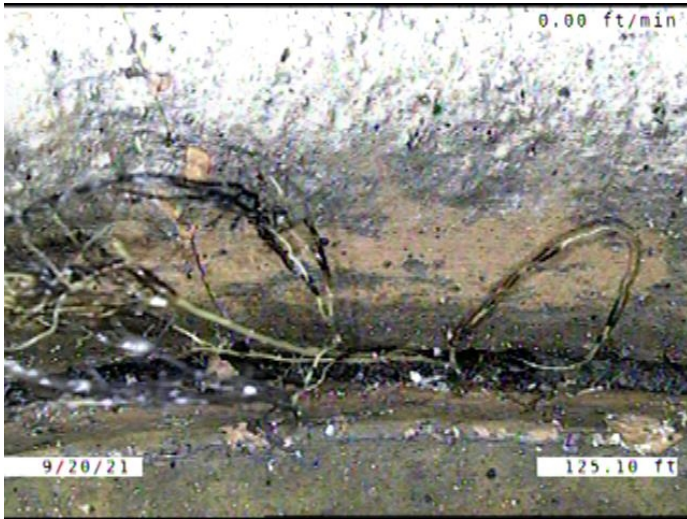
Code: **RFJ**  
 Description: **Roots Fine Joint**

Distance (ft): **125.1**  
 Structural Grade: **0**  
 O&M Grade: **1**  
 Clock Start/From: **9**  
 Clock To: **11**  
 1st Value:  
 2nd Value:  
 Value Percent:  
 Continuous Index:  
 Within 8" of Joint: **YES**  
 Remarks:

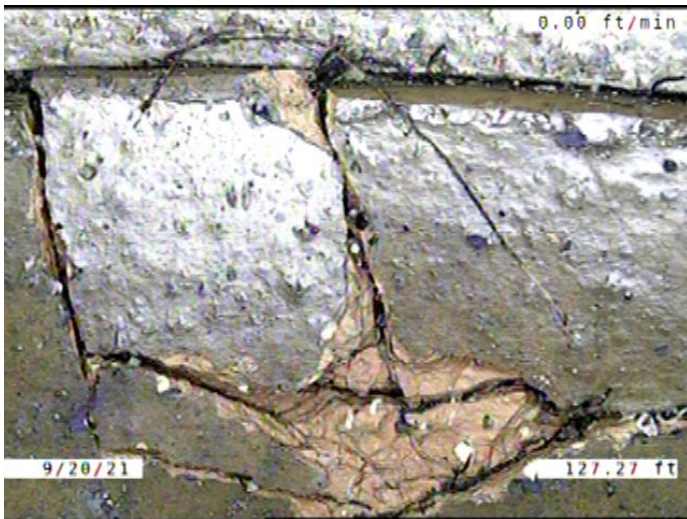
Code: **B**  
 Description: **Broken**

Distance (ft): **127.3**  
 Structural Grade: **4**  
 O&M Grade: **0**  
 Clock Start/From: **2**  
 Clock To: **4**  
 1st Value:  
 2nd Value:  
 Value Percent:  
 Continuous Index:  
 Within 8" of Joint: **YES**  
 Remarks:

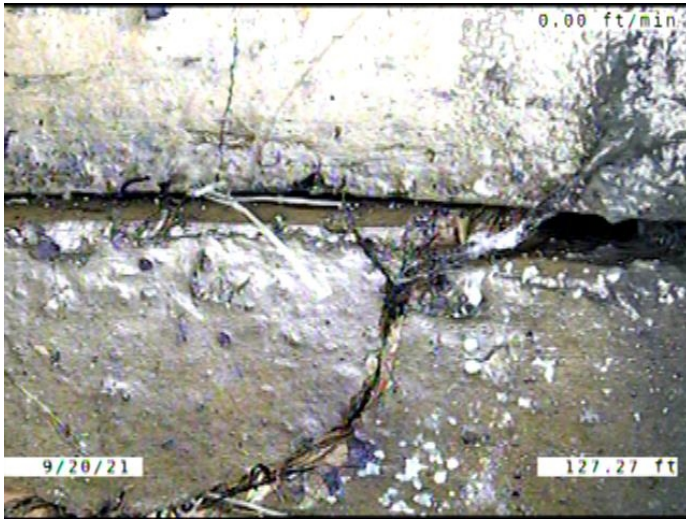
Code: **RFJ**  
 Description: **Roots Fine Joint**

Distance (ft): **127.3**  
 Structural Grade: **0**  
 O&M Grade: **1**  
 Clock Start/From: **2**  
 Clock To: **4**  
 1st Value:  
 2nd Value:  
 Value Percent:  
 Continuous Index:  
 Within 8" of Joint: **YES**  
 Remarks:

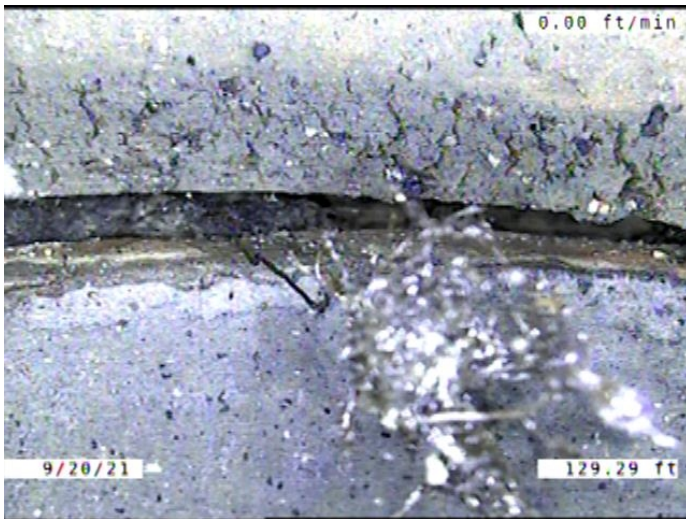
Code: **RFJ**  
 Description: **Roots Fine Joint**

Distance (ft): **129.3**  
 Structural Grade: **0**  
 O&M Grade: **1**  
 Clock Start/From: **8**  
 Clock To: **3**  
 1st Value:  
 2nd Value:  
 Value Percent:  
 Continuous Index: **S03**  
 Within 8" of Joint: **YES**  
 Remarks:

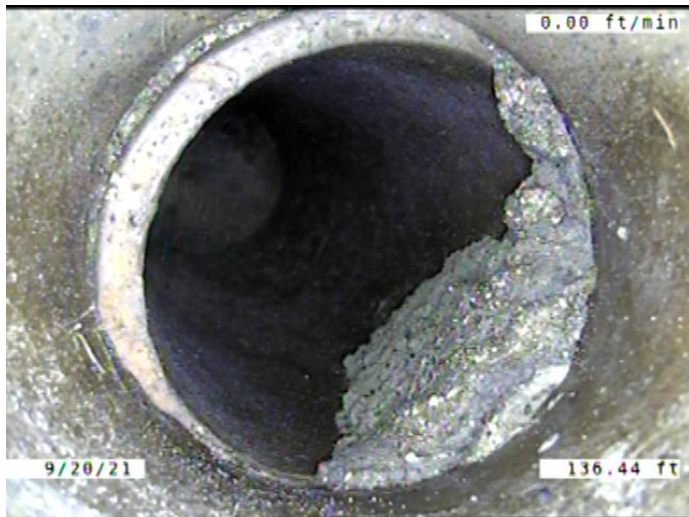
Code: **TF**  
 Description: **Tap Factory**

Distance (ft): **136.4**  
 Structural Grade: **0**  
 O&M Grade: **0**  
 Clock Start/From: **1**  
 Clock To:  
 1st Value: **4.000**  
 2nd Value:  
 Value Percent:  
 Continuous Index:  
 Within 8" of Joint: **YES**  
 Remarks: **LOOKS LIKE IT MIGHT BE CAPPED**

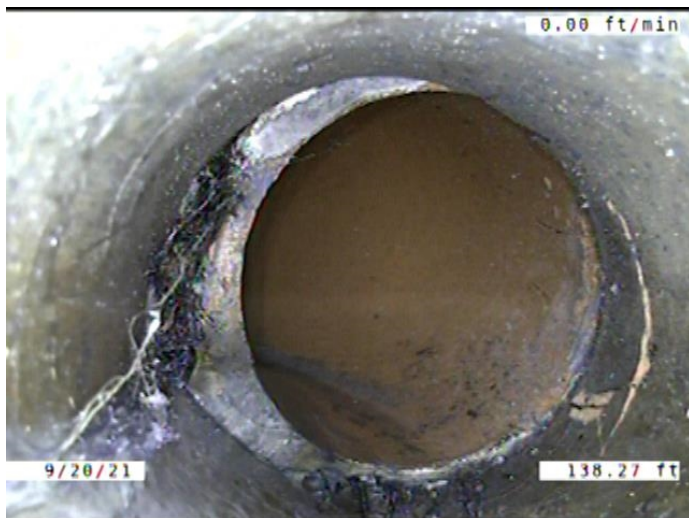
Code: **TFD**  
 Description: **Tap Factory Defective**

Distance (ft): **138.3**  
 Structural Grade: **0**  
 O&M Grade: **3**  
 Clock Start/From: **11**  
 Clock To:  
 1st Value: **4.000**  
 2nd Value:  
 Value Percent:  
 Continuous Index:  
 Within 8" of Joint: **YES**  
 Remarks: **ROOTS GROWING IN THE JOINT**

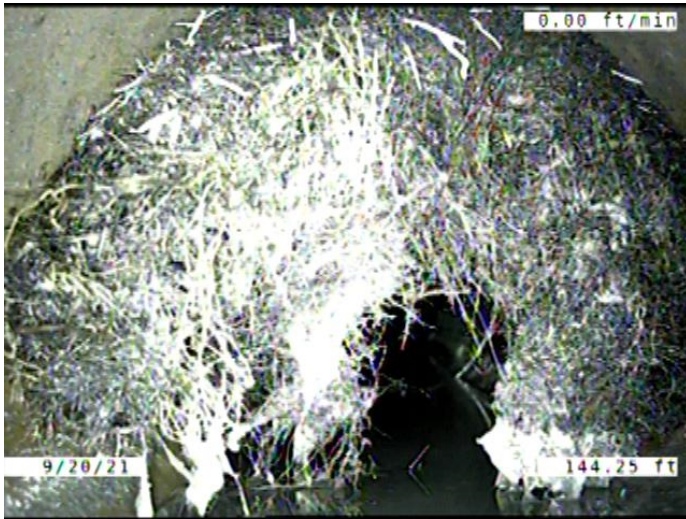
Code: **CM**  
 Description: **Crack Multiple**

Distance (ft): **144.3**  
 Structural Grade: **3**  
 O&M Grade: **0**  
 Clock Start/From: **11**  
 Clock To: **1**  
 1st Value:  
 2nd Value:  
 Value Percent:  
 Continuous Index: **F02**  
 Within 8" of Joint: **YES**  
 Remarks:

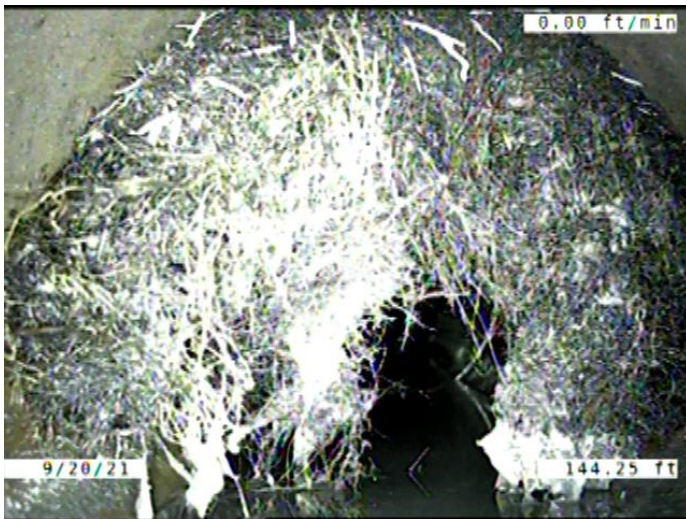
Code: **RFJ**  
 Description: **Roots Fine Joint**

Distance (ft): **144.3**  
 Structural Grade: **0**  
 O&M Grade: **1**  
 Clock Start/From: **8**  
 Clock To: **3**  
 1st Value:  
 2nd Value:  
 Value Percent:  
 Continuous Index: **F03**  
 Within 8" of Joint: **YES**  
 Remarks:

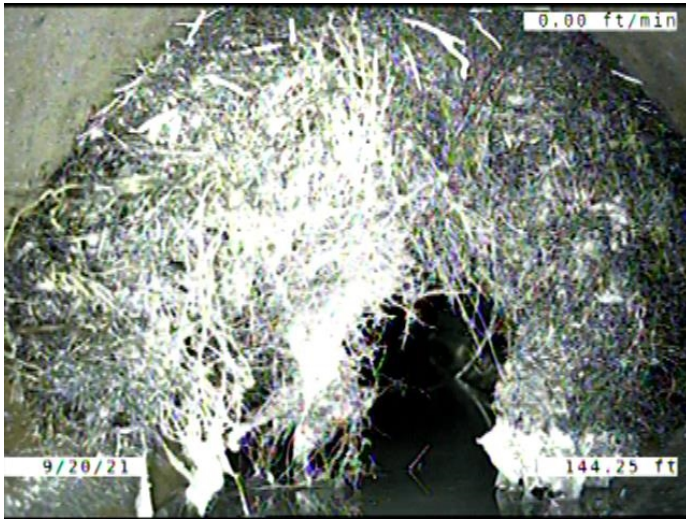
Code: **DSF**  
 Description: **Deposits Settled Fine**

Distance (ft): **144.3**  
 Structural Grade: **0**  
 O&M Grade: **2**  
 Clock Start/From: **5**  
 Clock To: **7**  
 1st Value:  
 2nd Value:  
 Value Percent: **5.000**  
 Continuous Index: **F01**  
 Within 8" of Joint: **YES**  
 Remarks:

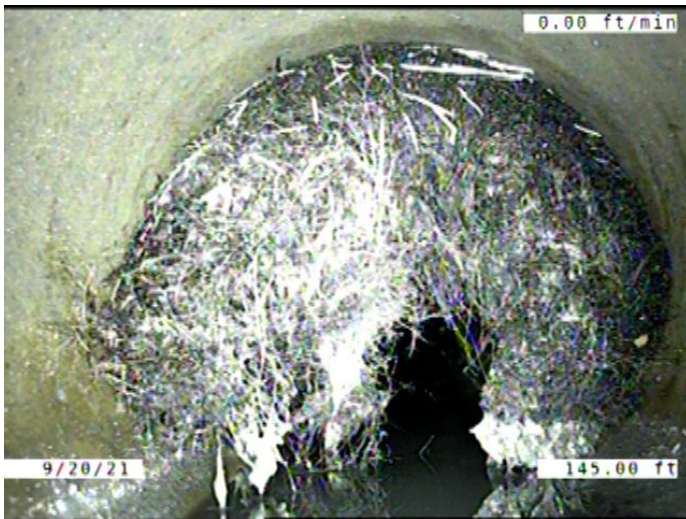
Code: **RBJ**  
 Description: **Roots Ball Joint**

Distance (ft): **145.0**  
 Structural Grade: **0**  
 O&M Grade: **4**  
 Clock Start/From: **8**  
 Clock To: **5**  
 1st Value:  
 2nd Value:  
 Value Percent: **95.000**  
 Continuous Index:  
 Within 8" of Joint: **YES**  
 Remarks:

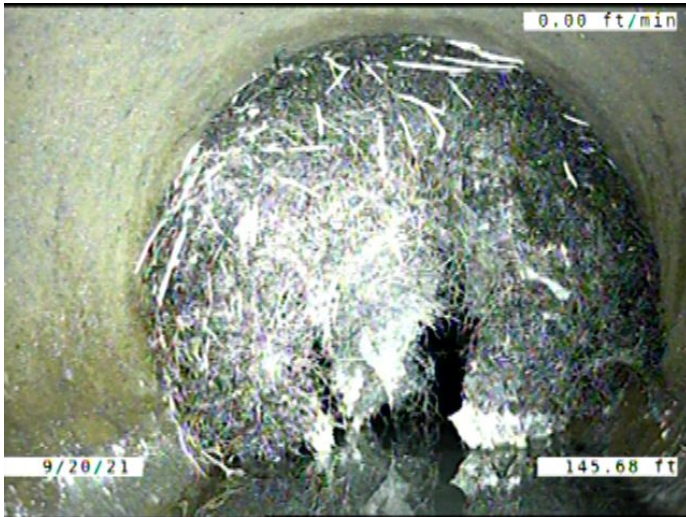
**MSA**

**Miscellaneous Survey Abandoned**

**145.7**

**CAMERA CANT MAKE IT PAST  
ROOTS. MADE IT TO THE POINT OF**
