Date:	09/20/2021	Weather:		Coding:	<b>PACP 7.0</b>
Pipe Length (ft):	180.0	Owner:	City of Hobart	Pre Clea	in: Heavy Cleaning
P.O.#:	YES502259	Surveyor:	S. Bucklin	PSR:	P-503-023-022
Customer:	City of Hobart	Clean Date:	09/04/2021	Shape:	С
Street:	West 39th Avenue		Flow Control:	Not Con	trolled
City:	Hobart, IN		Year Renewed:		
Location:	Alley		Tape/Media #:		
Purpose:	Routine Assessment		Dia/Height:	10"	
Use:	Sanitary Sewage Pipe	1	Material:	VCP	
Drain Area:			Lining:	None	
Category:	NA				
Comment:					
Location Details	:		Direction of Surv	vey: Downst	eam
US MH:	M-503-022	DS MH:	M-503-023	Total Length Surve	yed (ft): <b>30.7</b>
0&M Index:	2.15	O&M Quick:	413	<sup>3</sup> O&M Ratin	g: 28.00
tructural Index:	2.50	Structural Qu	uck: 312		
Overall Index:	2.20		413

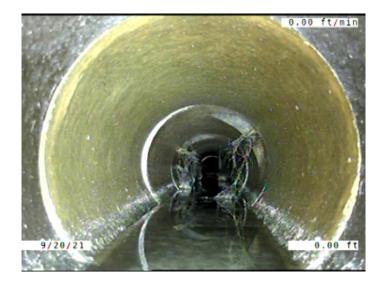
Code:	MWL
Description:	Miscellaneous Water Level
/0	
Distance (ft):	.0
Structural Grade:	0
O&M Grade:	0
Clock Start/From:	
Clock To:	
1st Value:	
2nd Value:	
Value Percent:	5.000
Continuous Index:	
Within 8" of Joint:	NO
Remarks:

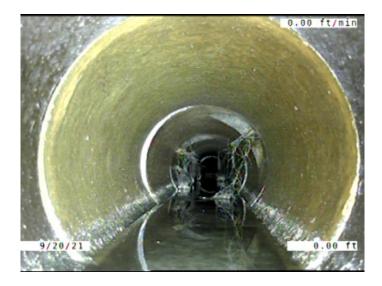
Code: Description:	DSF Deposits Settled Fine
Distance (ft): Structural Grade: O&M Grade: Clock Start/From: Clock To: 1st Value: 2nd Value:	.0 0 2 5 7
Value Percent: Continuous Index: Within 8" of Joint: Remarks:	5.000 S01 YES

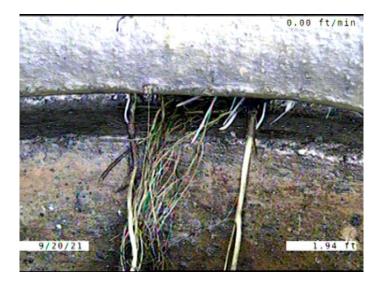
Code:	RFJ
Description:	<b>Roots Fine Joint</b>
Distance (ft):	1.9
Structural Grade:	0
O&M Grade:	1
Clock Start/From:	1
Clock To:	2
1st Value:	
2nd Value:	
Value Percent:	
Continuous Index:	
Within 8" of Joint:	YES
Remarks:

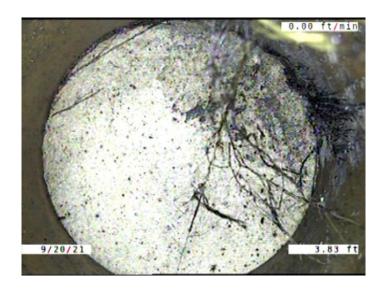
Code: Description:	TFC Tap Factory Capped
Distance (ft):	3.8
Structural Grade:	0
O&M Grade:	0
Clock Start/From:	2
Clock To:	
1st Value:	4.000
2nd Value:	
Value Percent:	
Continuous Index:	
Within 8" of Joint:	YES
Remarks:	ROOTS GROWING AROUND THE CAP

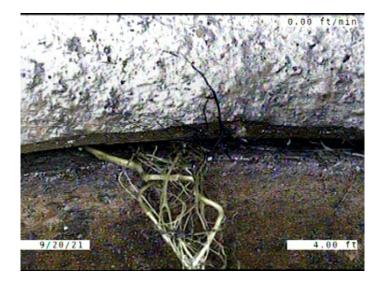
Code:	RFJ
Description:	<b>Roots Fine Joint</b>
Distance (ft):	4.0
Structural Grade:	0
O&M Grade:	1
Clock Start/From:	9
Clock To:	2
1st Value:	
2nd Value:	
Value Percent:	
Continuous Index:	
Within 8" of Joint:	YES
Remarks:

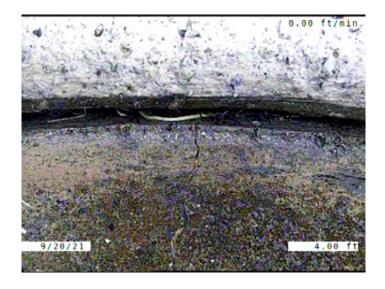
Code: Description:	CL Crack Longitudinal
Distance (ft):	4.0
Structural Grade:	2
O&M Grade:	0
Clock Start/From:	12
Clock To:	
1st Value:	
2nd Value:	
Value Percent:	
Continuous Index:	
Within 8" of Joint:	YES
Remarks:

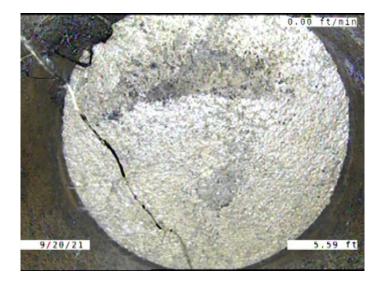
Code:	TFC
Description:	Tap Factory Capped
Distance (ft):	5.6
Structural Grade:	0
O&M Grade:	0
Clock Start/From:	11
Clock To:	
1st Value:	4.000
2nd Value:	
Value Percent:	
Continuous Index:	
Within 8" of Joint:	YES
Remarks:	ROOTS GROWING AROUND THE CAP

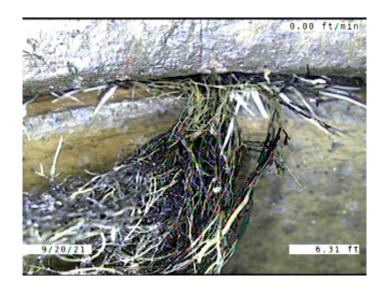
Code:	RMJ
Description:	Roots Medium Joint
Distance (ft): Structural Grade: O&M Grade: Clock Start/From: Clock To: 1st Value: 2nd Value: Value Percent: Continuous Index: Within 8" of Joint: Remarks:	6.3 0 3 9 2 5.000 \$02 YES

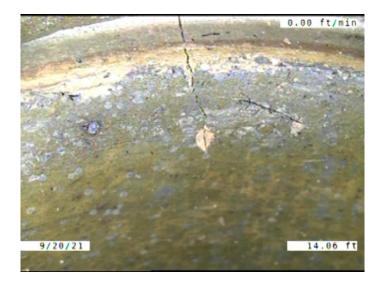
Code: Description:	CM Crack Multiple
Distance (ft):	14.1
Structural Grade:	3
O&M Grade:	0
Clock Start/From:	10
Clock To:	2
1st Value:	
2nd Value:	
Value Percent:	
Continuous Index:	
Within 8" of Joint:	YES
Remarks:

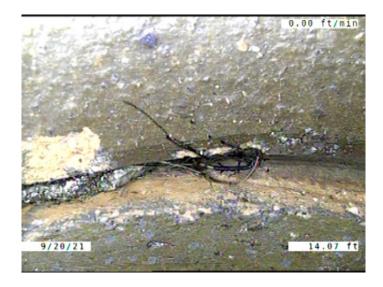
Code: Description:	RFJ Roots Fine Joint
Distance (ft):	14.1
Structural Grade:	0
O&M Grade:	1
Clock Start/From:	9
Clock To:	
1st Value:	
2nd Value:	
Value Percent:	
Continuous Index:	
Within 8" of Joint:	YES
Remarks:

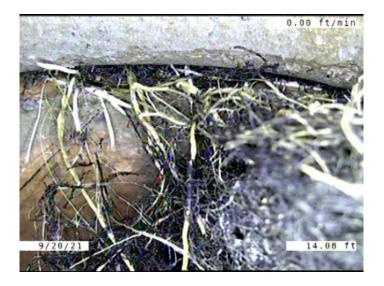
Code: Description:	RMJ Roots Medium Joint
Distance (ft): Structural Grade: O&M Grade: Clock Start/From:	14.1 0 3 12
Clock To: 1st Value: 2nd Value:	4
Value Percent: Continuous Index: Within 8" of Joint: Remarks:	20.000 YES

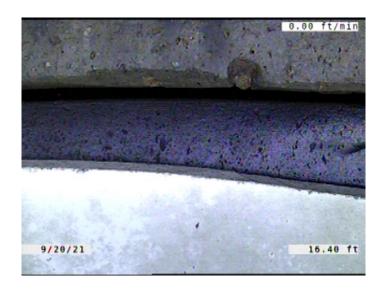
Code: Description:	MMC Miscellaneous Material Change
Distance (ft): Structural Grade: O&M Grade: Clock Start/From: Clock To: 1st Value: 2nd Value:	16.4 0 0
Value Percent: Continuous Index: Within 8" of Joint: Remarks:	NO VCP TO PVC

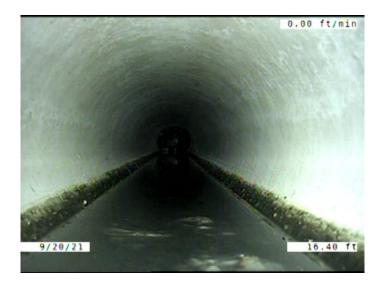
Code:	RMJ
Description:	<b>Roots Medium Joint</b>
Dictance (ft):	16.4
Distance (ft):	10.4
Structural Grade:	0
O&M Grade:	3
Clock Start/From:	9
Clock To:	2
1st Value:	
2nd Value:	
Value Percent:	5.000
Continuous Index:	F02
Within 8" of Joint:	YES
Remarks:

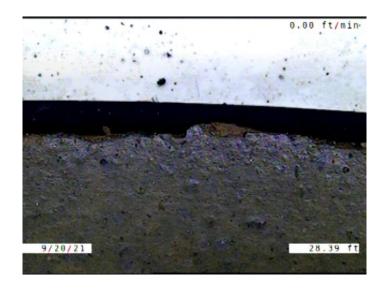
Code: Description:	MMC Miscellaneous Material Change
Distance (ft):	28.4
Structural Grade:	0
O&M Grade:	0
Clock Start/From:	
Clock To:	
1st Value:	
2nd Value:	
Value Percent:	
Continuous Index:	
Within 8" of Joint:	NO
Remarks:	ΡVC ΤΟ VCP

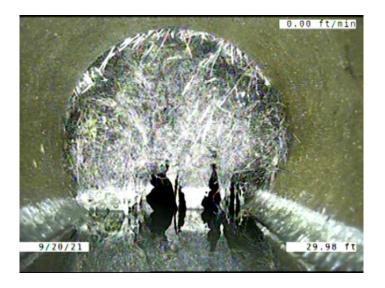
Code:	RBJ
Description:	<b>Roots Ball Joint</b>
Distance (ft):	30.0
Structural Grade:	0
O&M Grade:	4
Clock Start/From:	7
Clock To:	4
1st Value:	
2nd Value:	
Value Percent:	85.000
Continuous Index:	
Within 8" of Joint:	YES
Remarks:

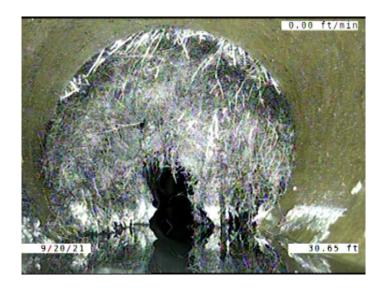
Distance (ft):30.7Structural Grade:0O&M Grade:2Clock Start/From:5Clock To:71st Value:2nd Value:Value Percent:5.000Continuous Index:F01Within 8" of Joint:YESRemarks:

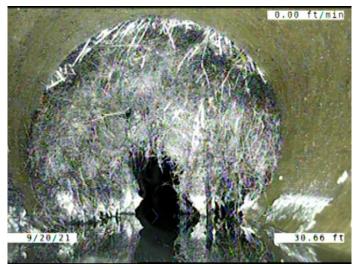
Code:	MSA
Description:	Miscellaneous Survey Abandoned
Distance (ft):	30.7
Structural Grade:	0
O&M Grade:	0
Clock Start/From:	
Clock To:	
1st Value:	
2nd Value:	
Value Percent:	
Continuous Index:	
Within 8" of Joint:	NO
Remarks:	CAMERA CANT MAKE IT PAST ROOTS
