## Profile/Photo Observation Report

Date:	<b>04/10/2018</b>	Weather:		Coding:	<b>PACP 6.0</b>
Pipe Length (ft):	<b>176.0</b>	Owner:	<b>NA</b>	Pre Clean:	<b>Not Known</b>
P.O.#:		Surveyor:	<b>Jen Costello</b>	PSR:	<b>P-503-024-023</b>
Customer:		Clean Date:	<b>01/01/1900</b>	Shape:	<b>C</b>

Street:	<b>ALLEY BETWEEN W 39TH PL &amp; W 39</b>	Flow Control:	<b>Not Controlled</b>
City:	<b>Hobart, IN</b>	Year Renewed:	
Location:	<b>Other</b>	Tape/Media #:	
Purpose:	<b>Not Known</b>	Dia/Height:	<b>10"</b>
Use:	<b>Sanitary</b>	Material:	<b>VCP</b>
Drain Area:	<b>NA</b>	Lining:	
Category:	<b>NA</b>		
Comment:

Location Details:		Direction of Survey:	<b>Downstream</b>
US MH:	<b>M-503-023</b>	DS MH:	<b>M-503-024</b>
		Total Length Surveyed (ft):	<b>22.7</b>

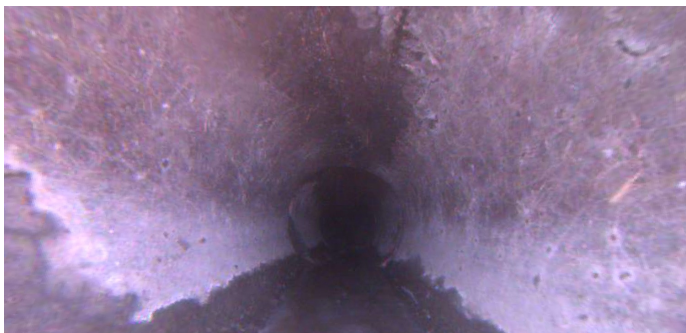
Code: **AMH**  
Description: **Manhole**

Distance (ft): **.0**  
Structural Grade: **0**  
O&M Grade: **0**  
Clock Start/From:  
Clock To:  
1st Value:  
2nd Value:  
Value Percent:  
Continuous Index:  
Within 8" of Joint: **NO**  
Remarks: **M-503-023**

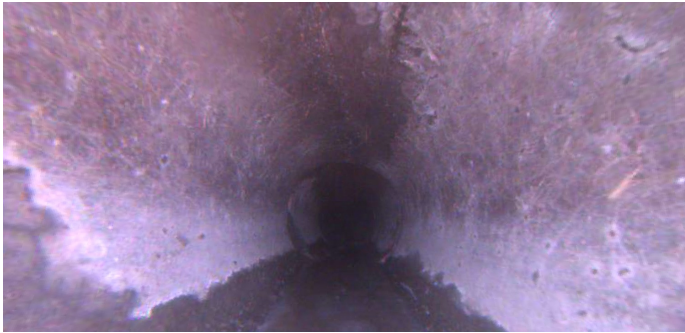
Code:	<b>MWL</b>
Description:	<b>Water Level</b>

Distance (ft):	<b>.0</b>
Structural Grade:	<b>0</b>
O&M Grade:	<b>0</b>
Clock Start/From:	
Clock To:	
1st Value:	
2nd Value:	
Value Percent:	<b>5.000</b>
Continuous Index:	
Within 8" of Joint:	<b>NO</b>
Remarks:

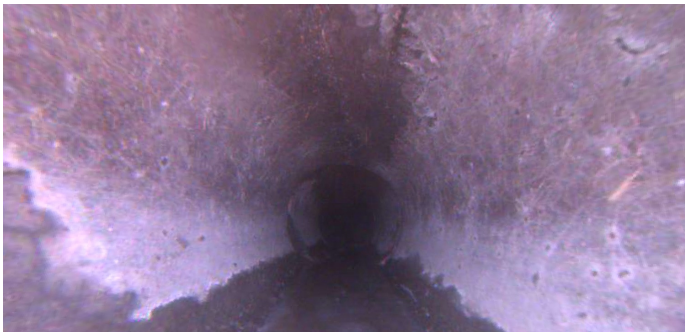
Code:	<b>CM</b>
Description:	<b>Crack Multiple</b>

Distance (ft):	<b>.0</b>
Structural Grade:	<b>3</b>
O&M Grade:	<b>0</b>
Clock Start/From:	<b>8</b>
Clock To:	<b>4</b>
1st Value:	
2nd Value:	
Value Percent:	
Continuous Index:	<b>S01</b>
Within 8" of Joint:	
Remarks:

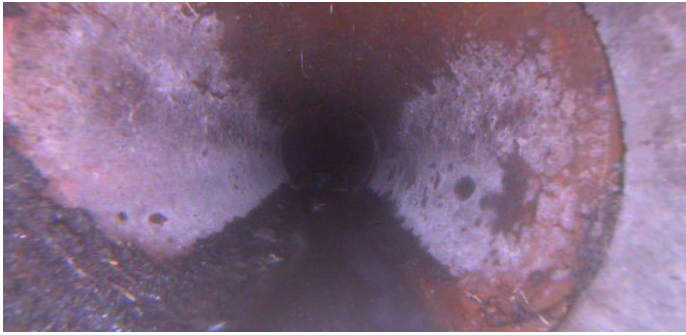
Code: **RFJ**  
Description: **Roots Fine Joint**

Distance (ft): **3.0**  
Structural Grade: **0**  
O&M Grade: **1**  
Clock Start/From: **8**  
Clock To: **4**  
1st Value:  
2nd Value:  
Value Percent:  
Continuous Index: **S02**  
Within 8" of Joint: **YES**  
Remarks:

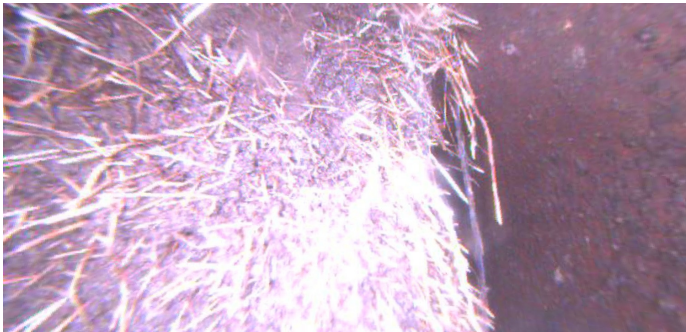
Code: **RBB**  
Description: **Roots Ball Barrel**

Distance (ft): **21.9**  
Structural Grade: **0**  
O&M Grade: **5**  
Clock Start/From: **5**  
Clock To: **12**  
1st Value:  
2nd Value:  
Value Percent: **60.000**  
Continuous Index:  
Within 8" of Joint: **NO**  
Remarks:

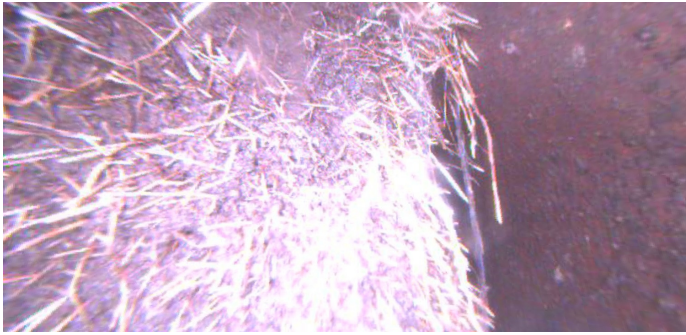
Code: **CM**  
Description: **Crack Multiple**

Distance (ft): **21.9**  
Structural Grade: **3**  
O&M Grade: **0**  
Clock Start/From: **8**  
Clock To: **4**  
1st Value:  
2nd Value:  
Value Percent:  
Continuous Index: **F01**  
Within 8" of Joint:  
Remarks:

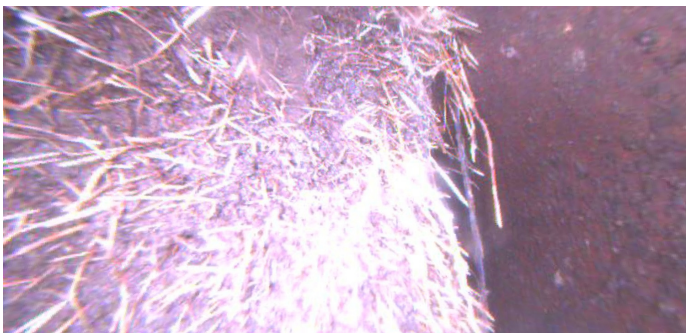
Code: **RFJ**  
Description: **Roots Fine Joint**

Distance (ft): **21.9**  
Structural Grade: **0**  
O&M Grade: **1**  
Clock Start/From: **8**  
Clock To: **4**  
1st Value:  
2nd Value:  
Value Percent:  
Continuous Index: **F02**  
Within 8" of Joint: **YES**  
Remarks:

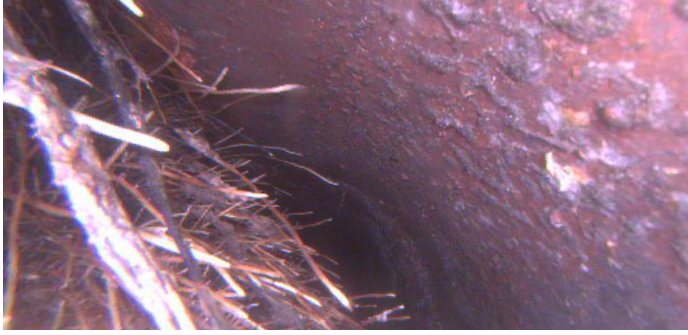
Code:	<b>MSA</b>
Description:	<b>Abandoned Survey</b>
Distance (ft):	<b>22.7</b>
Structural Grade:	<b>0</b>
O&M Grade:	<b>0</b>
Clock Start/From:	
Clock To:	
1st Value:	
2nd Value:	
Value Percent:	
Continuous Index:	
Within 8" of Joint:	<b>NO</b>
Remarks:	<b>rbb</b>
