Profile/Photo Observation Report

Date:	04/10/2018	Weather:		Coding:	PACP 6.0
Pipe Length (ft):	176.0	Owner:	NA	Pre Clean:	Not Known
P.O.#:		Surveyor:	Jen Costello	PSR:	P-503-024-023
Customer:		Clean Date:	01/01/1900	Shape:	C

Street:	W 40th ave	Flow Control:	Not Controlled
City:	Hobart, IN	Year Renewed:	
Location:	Other	Tape/Media #:	
Purpose:	Not Known	Dia/Height:	10"
Use:	Sanitary	Material:	VCP
Drain Area:	NA	Lining:	
Category:	NA		
Comment:

Location Details:		Direction of Survey:	Downstream
US MH:	M-503-023	DS MH:	M-503-024
		Total Length Surveyed (ft):	22.7

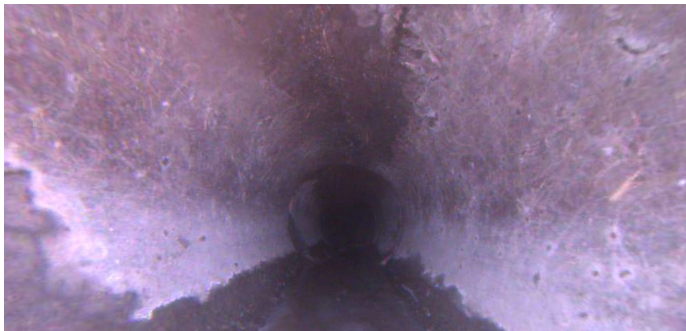
Code: **AMH**
Description: **Manhole**

Distance (ft): **.0**
Structural Grade: **0**
O&M Grade: **0**
Clock Start/From:
Clock To:
1st Value:
2nd Value:
Value Percent:
Continuous Index:
Within 8" of Joint: **NO**
Remarks: **M-503-023**

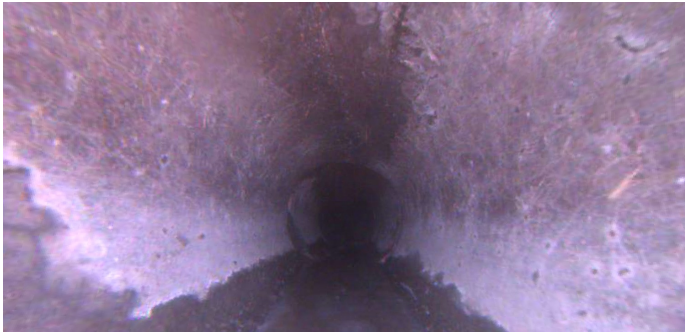
Code:	MWL
Description:	Water Level

Distance (ft):	.0
Structural Grade:	0
O&M Grade:	0
Clock Start/From:	
Clock To:	
1st Value:	
2nd Value:	
Value Percent:	5.000
Continuous Index:	
Within 8" of Joint:	NO
Remarks:

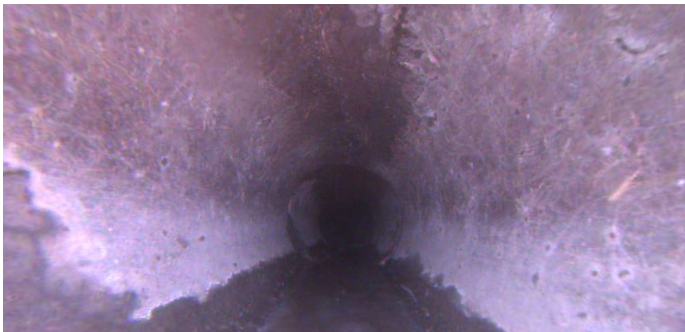
Code:	CM
Description:	Crack Multiple

Distance (ft):	.0
Structural Grade:	3
O&M Grade:	0
Clock Start/From:	8
Clock To:	4
1st Value:	
2nd Value:	
Value Percent:	
Continuous Index:	S01
Within 8" of Joint:	
Remarks:

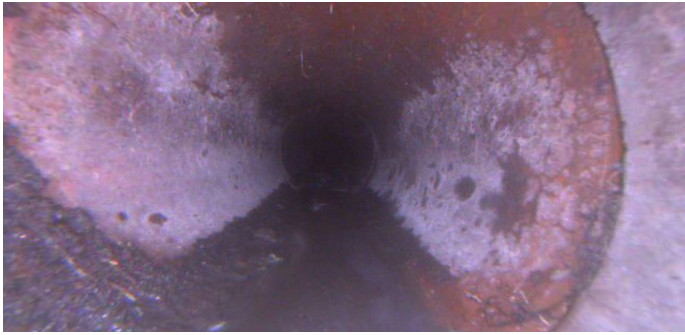
Code: **RFJ**
Description: **Roots Fine Joint**

Distance (ft): **3.0**
Structural Grade: **0**
O&M Grade: **1**
Clock Start/From: **8**
Clock To: **4**
1st Value:
2nd Value:
Value Percent:
Continuous Index: **S02**
Within 8" of Joint: **YES**
Remarks:

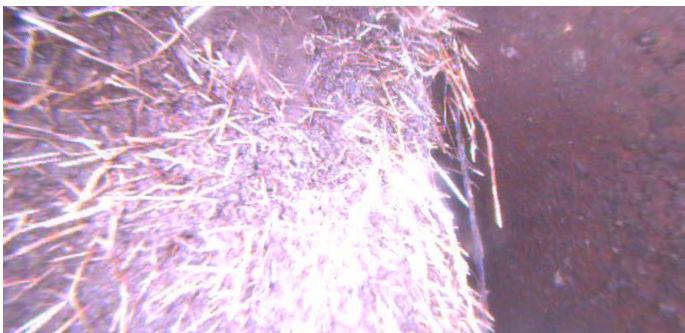
Code: **RBB**
Description: **Roots Ball Barrel**

Distance (ft): **21.9**
Structural Grade: **0**
O&M Grade: **5**
Clock Start/From: **5**
Clock To: **12**
1st Value:
2nd Value:
Value Percent: **60.000**
Continuous Index:
Within 8" of Joint: **NO**
Remarks:

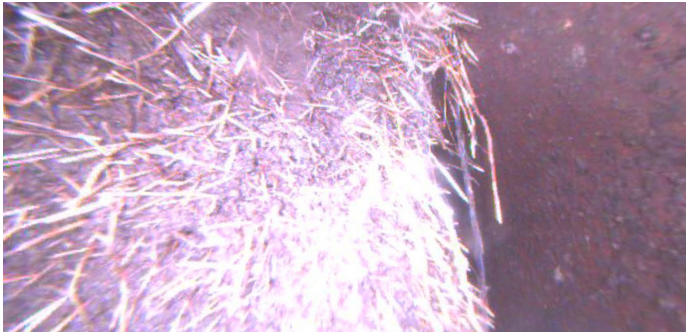
Code: **CM**
Description: **Crack Multiple**

Distance (ft): **21.9**
Structural Grade: **3**
O&M Grade: **0**
Clock Start/From: **8**
Clock To: **4**
1st Value:
2nd Value:
Value Percent:
Continuous Index: **F01**
Within 8" of Joint:
Remarks:

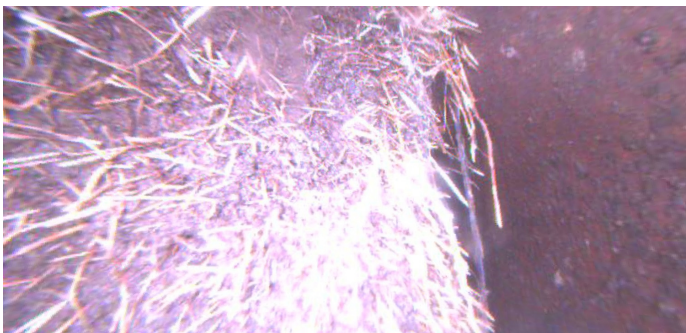
Code: **RFJ**
Description: **Roots Fine Joint**

Distance (ft): **21.9**
Structural Grade: **0**
O&M Grade: **1**
Clock Start/From: **8**
Clock To: **4**
1st Value:
2nd Value:
Value Percent:
Continuous Index: **F02**
Within 8" of Joint: **YES**
Remarks:

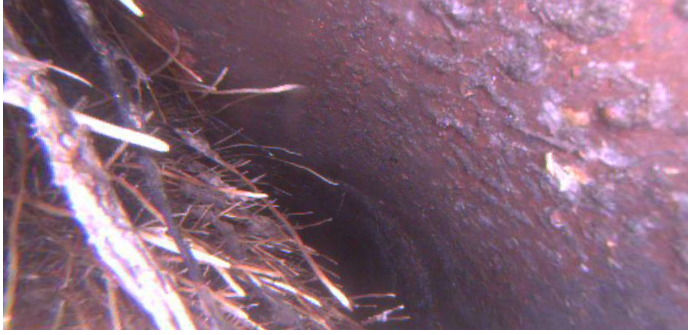
Code:	MSA
Description:	Abandoned Survey
Distance (ft):	22.7
Structural Grade:	0
O&M Grade:	0
Clock Start/From:	
Clock To:	
1st Value:	
2nd Value:	
Value Percent:	
Continuous Index:	
Within 8" of Joint:	NO
Remarks:	rbb
