Profile/Photo Observation Report

Date:	09/20/2021	Weather:		Coding:	PACP 7.0
Pipe Length (ft):	175.6	Owner:	City of Hobart	Pre Clean:	Heavy Cleaning
P.O.#:	YES502259	Surveyor:	S. Bucklin	PSR:	P-503-024-023
Customer:	City of Hobart	Clean Date:	09/04/2021	Shape:	C

Street:	West 39th Avenue	Flow Control:	Not Controlled
City:	Hobart, IN	Year Renewed:	
Location:	Alley	Tape/Media #:	
Purpose:	Routine Assessment	Dia/Height:	10"
Use:	Sanitary Sewage Pipe	Material:	VCP
Drain Area:		Lining:	None
Category:	NA		
Comment:			
Location Details:		Direction of Survey:	Upstream
US MH:	M-503-023	DS MH:	M-503-024
		Total Length Surveyed (ft):	175.6

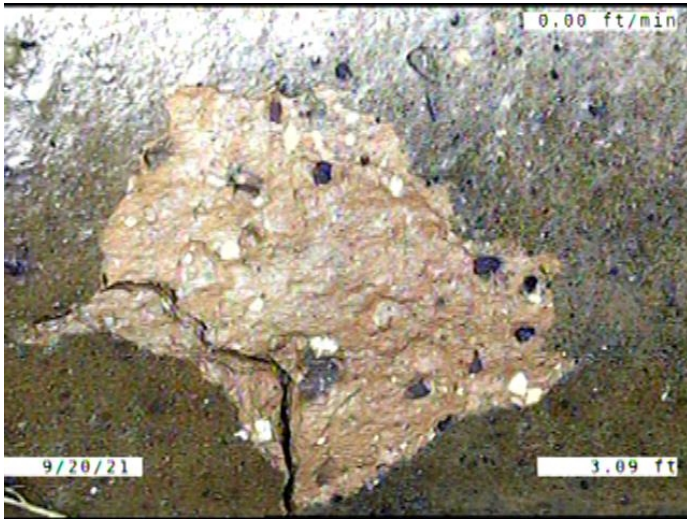
Code: **SSS**
Description: **Surface Damage Surface Spalling**

Distance (ft): **3.1**
Structural Grade: **2**
O&M Grade: **0**
Clock Start/From: **9**
Clock To: **10**
1st Value:
2nd Value:
Value Percent:
Continuous Index:
Within 8" of Joint: **YES**
Remarks:

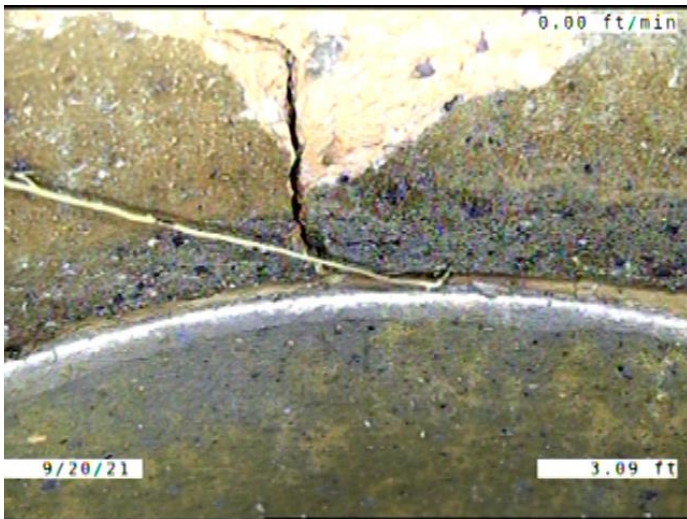
Code: **RFJ**
Description: **Roots Fine Joint**

Distance (ft): **3.1**
Structural Grade: **0**
O&M Grade: **1**
Clock Start/From: **10**
Clock To: **11**
1st Value:
2nd Value:
Value Percent:
Continuous Index:
Within 8" of Joint: **YES**
Remarks:

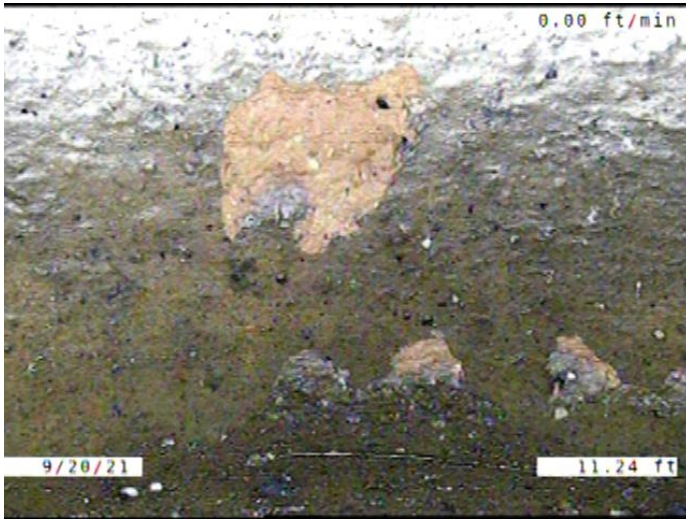
Code:	SSS
Description:	Surface Damage Surface Spalling
Distance (ft):	11.2
Structural Grade:	2
O&M Grade:	0
Clock Start/From:	11
Clock To:	
1st Value:	
2nd Value:	
Value Percent:	
Continuous Index:	
Within 8" of Joint:	YES
Remarks:

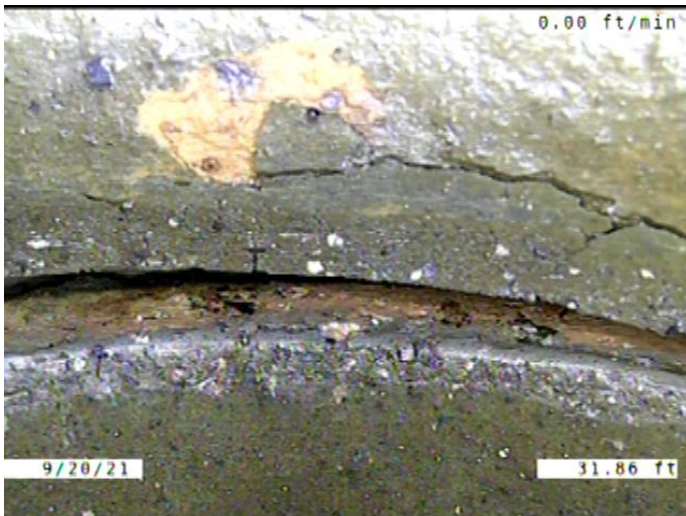
Code: **CM**
 Description: **Crack Multiple**

Distance (ft): **31.9**
 Structural Grade: **3**
 O&M Grade: **0**
 Clock Start/From: **2**
 Clock To: **4**
 1st Value:
 2nd Value:
 Value Percent:
 Continuous Index:
 Within 8" of Joint: **YES**
 Remarks:

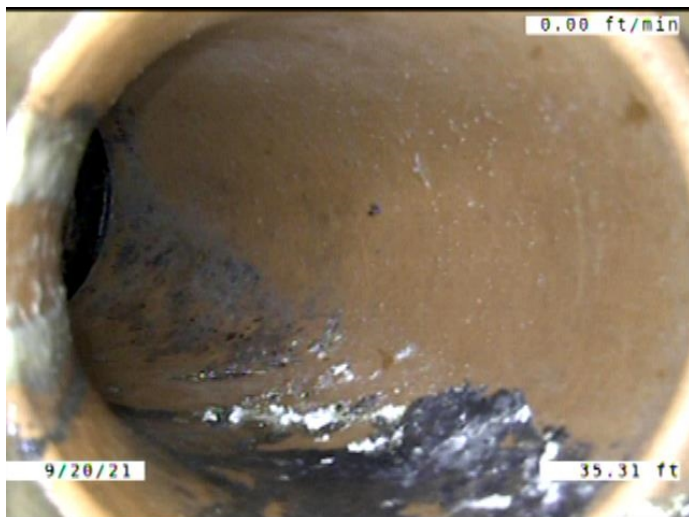
Code: **TBI**
 Description: **Tap Break-in Intruding**

Distance (ft): **35.3**
 Structural Grade: **0**
 O&M Grade: **2**
 Clock Start/From: **11**
 Clock To:
 1st Value: **4.000**
 2nd Value: **1.000**
 Value Percent:
 Continuous Index:
 Within 8" of Joint: **YES**
 Remarks: **CONSTANTLY RUNNING WATER**

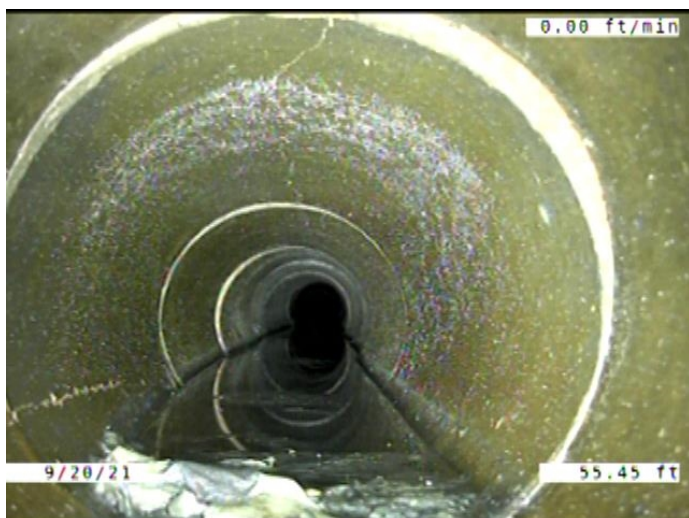
Code: **FM**
 Description: **Fracture Multiple**

Distance (ft): **55.5**
 Structural Grade: **4**
 O&M Grade: **0**
 Clock Start/From: **6**
 Clock To: **12**
 1st Value:
 2nd Value:
 Value Percent:
 Continuous Index:
 Within 8" of Joint: **YES**
 Remarks:

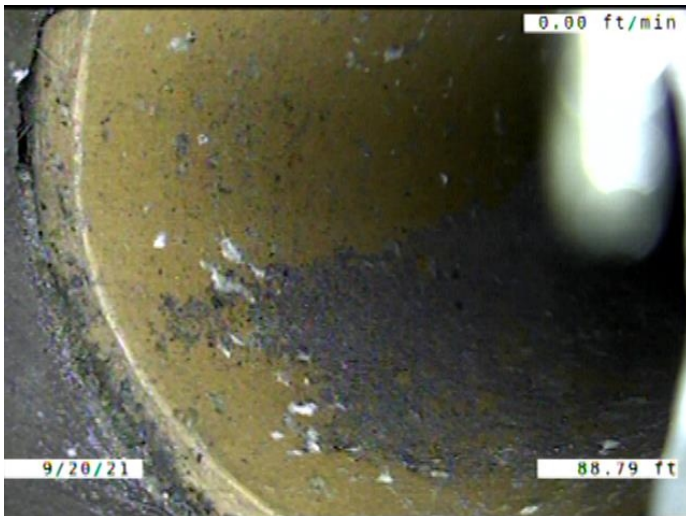
Code: **TBI**
Description: **Tap Break-in Intruding**

Distance (ft): **88.8**
Structural Grade: **0**
O&M Grade: **2**
Clock Start/From: **1**
Clock To:
1st Value: **4.000**
2nd Value: **1.000**
Value Percent:
Continuous Index:
Within 8" of Joint: **YES**
Remarks:

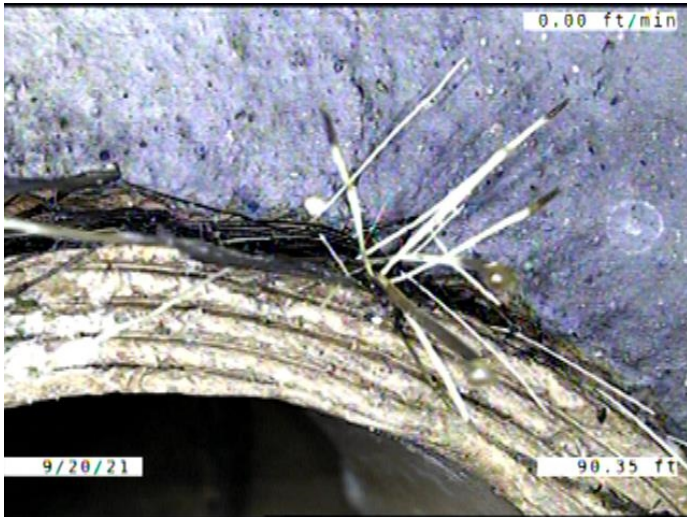
Code: **RFL**
 Description: **Roots Fine Lateral**

Distance (ft): **90.4**
 Structural Grade: **0**
 O&M Grade: **1**
 Clock Start/From: **9**
 Clock To: **12**
 1st Value:
 2nd Value:
 Value Percent:
 Continuous Index:
 Within 8" of Joint: **NO**
 Remarks:

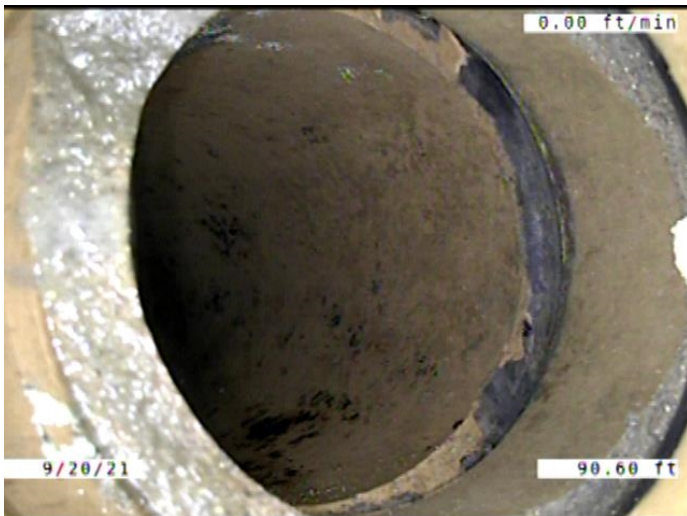
Code: **TBI**
 Description: **Tap Break-in Intruding**

Distance (ft): **90.6**
 Structural Grade: **0**
 O&M Grade: **2**
 Clock Start/From: **10**
 Clock To:
 1st Value: **4.000**
 2nd Value: **1.000**
 Value Percent:
 Continuous Index:
 Within 8" of Joint: **YES**
 Remarks:

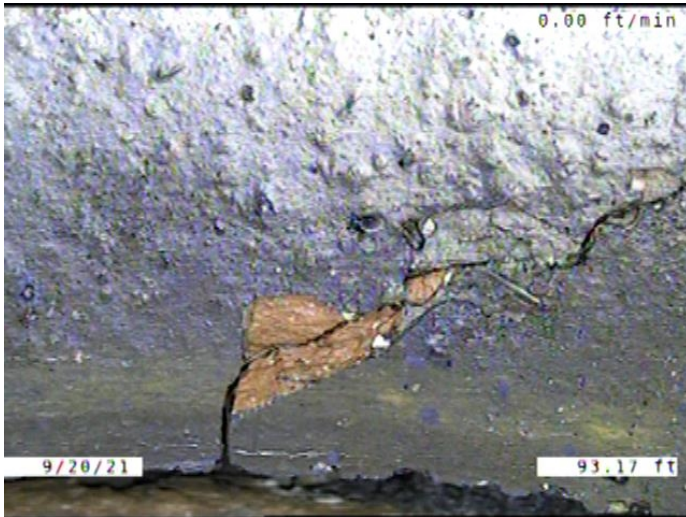
Code: **B**
 Description: **Broken**

Distance (ft): **93.2**
 Structural Grade: **4**
 O&M Grade: **0**
 Clock Start/From: **3**
 Clock To: **4**
 1st Value:
 2nd Value:
 Value Percent:
 Continuous Index:
 Within 8" of Joint: **YES**
 Remarks:

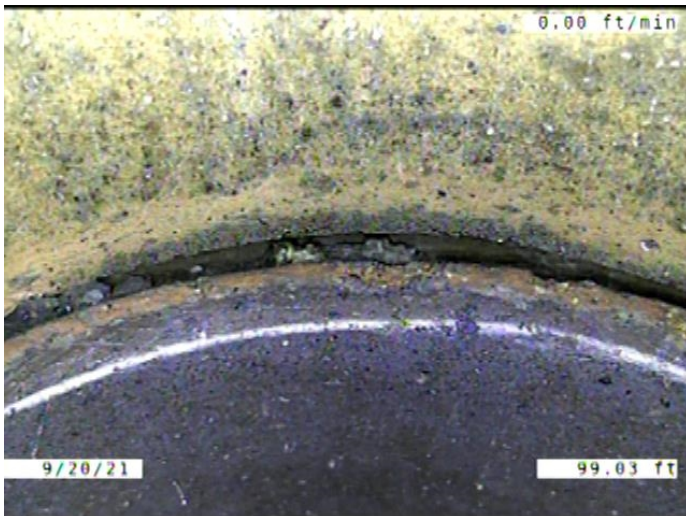
Code: **JOM**
 Description: **Joint Offset Medium**

Distance (ft): **99.0**
 Structural Grade: **3**
 O&M Grade: **0**
 Clock Start/From:
 Clock To:
 1st Value:
 2nd Value:
 Value Percent:
 Continuous Index:
 Within 8" of Joint: **NO**
 Remarks:

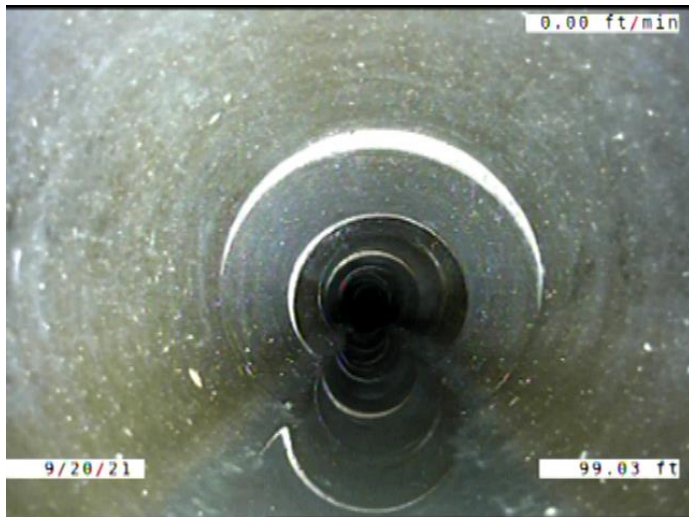
Code: **FM**
 Description: **Fracture Multiple**

Distance (ft): **99.0**
 Structural Grade: **4**
 O&M Grade: **0**
 Clock Start/From: **7**
 Clock To: **5**
 1st Value:
 2nd Value:
 Value Percent:
 Continuous Index: **F05**
 Within 8" of Joint: **YES**
 Remarks:

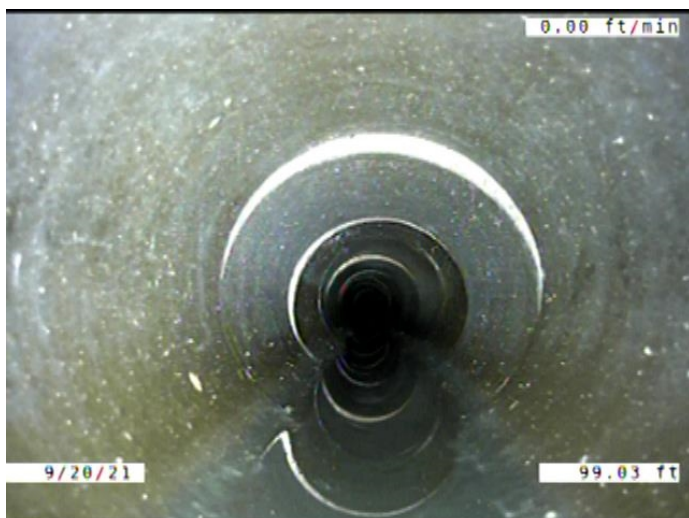
Code: **MWLS**
 Description: **Miscellaneous Water Level Sag**

Distance (ft): **99.0**
 Structural Grade: **2**
 O&M Grade: **0**
 Clock Start/From:
 Clock To:
 1st Value:
 2nd Value:
 Value Percent: **10.000**
 Continuous Index: **F03**
 Within 8" of Joint: **NO**
 Remarks:

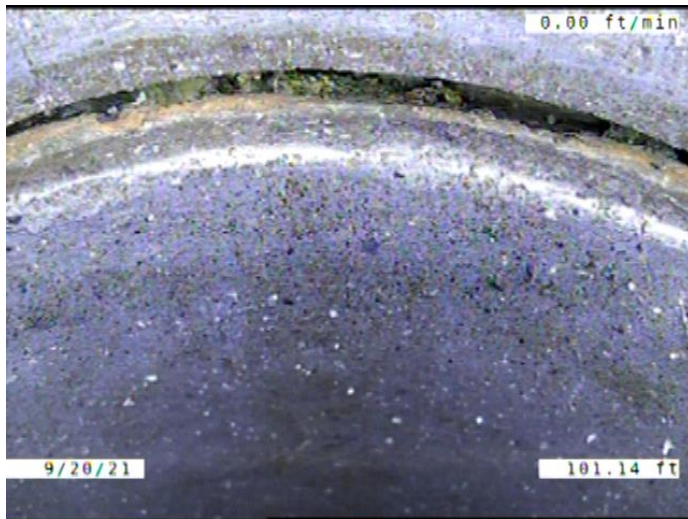
Code: **JOM**
 Description: **Joint Offset Medium**

Distance (ft): **101.1**
 Structural Grade: **3**
 O&M Grade: **0**
 Clock Start/From:
 Clock To:
 1st Value:
 2nd Value:
 Value Percent:
 Continuous Index:
 Within 8" of Joint: **NO**
 Remarks:

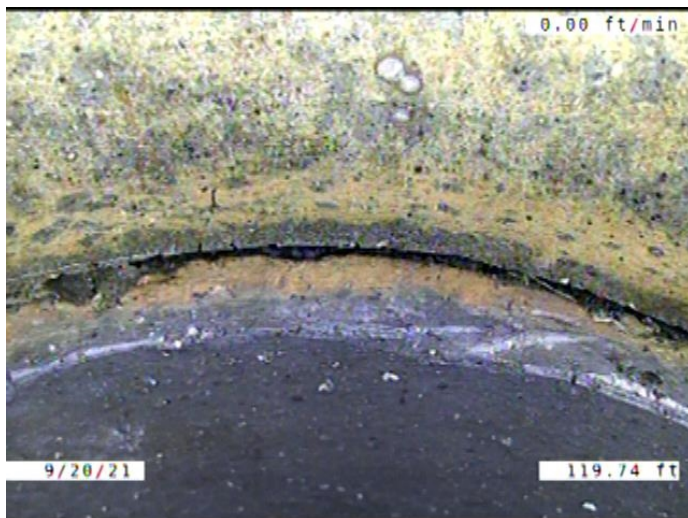
Code: **JOM**
Description: **Joint Offset Medium**

Distance (ft): **119.7**
Structural Grade: **3**
O&M Grade: **0**
Clock Start/From:
Clock To:
1st Value:
2nd Value:
Value Percent:
Continuous Index:
Within 8" of Joint: **NO**
Remarks:

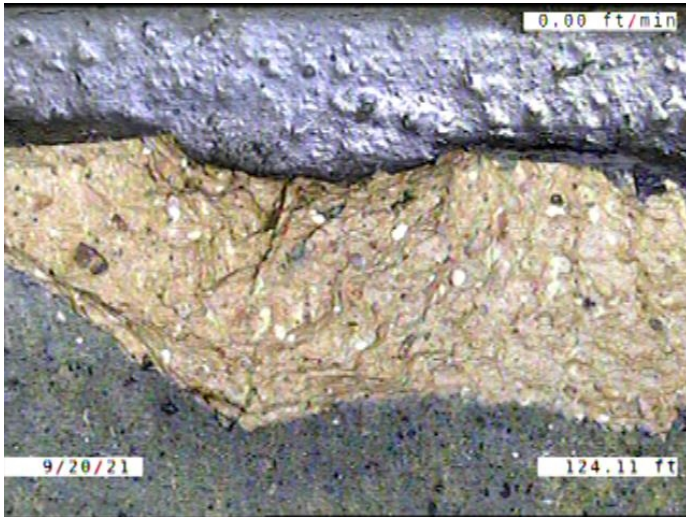
Code:	SZ
Description:	Surface Damage Other
Distance (ft):	124.1
Structural Grade:	0
O&M Grade:	0
Clock Start/From:	2
Clock To:	3
1st Value:	
2nd Value:	
Value Percent:	
Continuous Index:	
Within 8" of Joint:	YES
Remarks:	A PIECE CHIPPED AWAY FROM THE JOINT

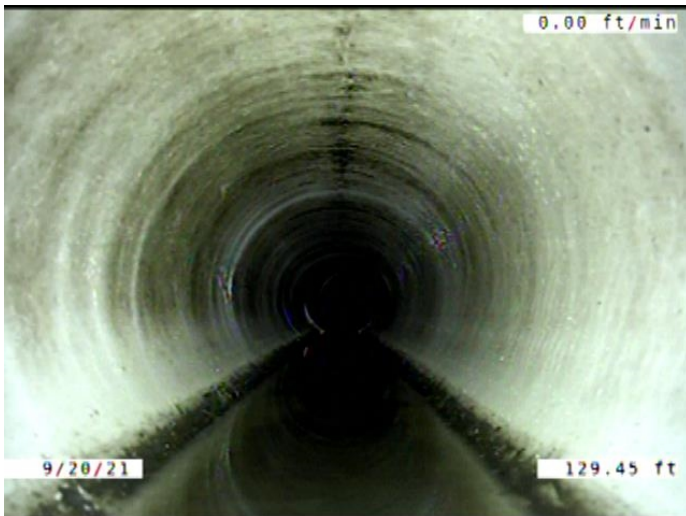
Code:	RFJ
Description:	Roots Fine Joint
Distance (ft):	129.4
Structural Grade:	0
O&M Grade:	1
Clock Start/From:	8
Clock To:	3
1st Value:	
2nd Value:	
Value Percent:	
Continuous Index:	F04
Within 8" of Joint:	YES
Remarks:

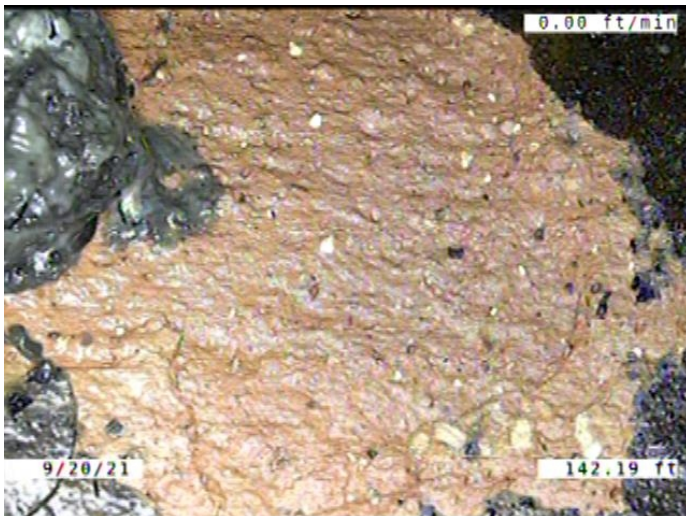
Code: **SSS**
 Description: **Surface Damage Surface Spalling**

Distance (ft): **142.2**
 Structural Grade: **2**
 O&M Grade: **0**
 Clock Start/From: **4**
 Clock To: **7**
 1st Value:
 2nd Value:
 Value Percent:
 Continuous Index:
 Within 8" of Joint: **YES**
 Remarks:

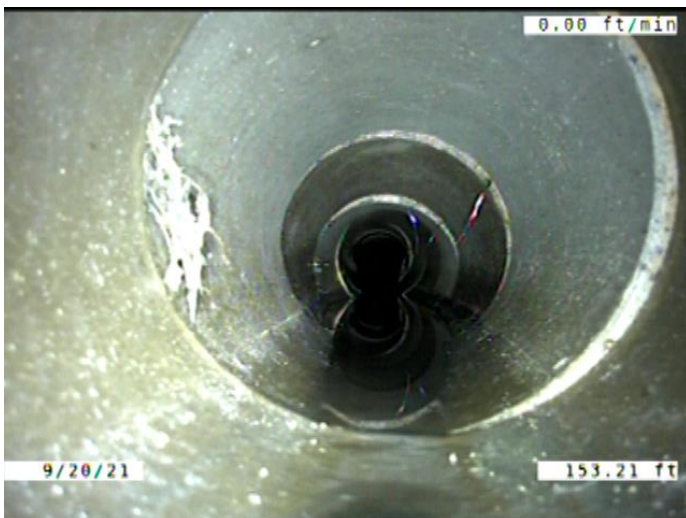
Code: **CM**
 Description: **Crack Multiple**

Distance (ft): **153.2**
 Structural Grade: **3**
 O&M Grade: **0**
 Clock Start/From: **9**
 Clock To: **4**
 1st Value:
 2nd Value:
 Value Percent:
 Continuous Index: **F07**
 Within 8" of Joint: **YES**
 Remarks:

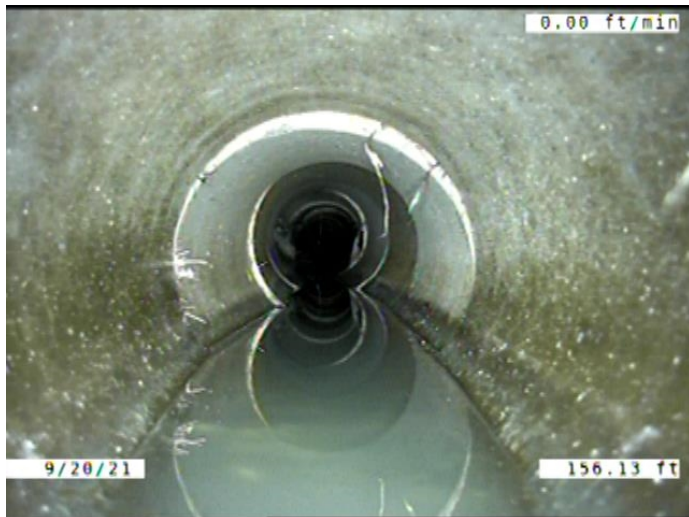
Code: **MWLS**
Description: **Miscellaneous Water Level Sag**

Distance (ft): **156.1**
Structural Grade: **2**
O&M Grade: **0**
Clock Start/From:
Clock To:
1st Value:
2nd Value:
Value Percent: **10.000**
Continuous Index: **S09**
Within 8" of Joint: **NO**
Remarks:

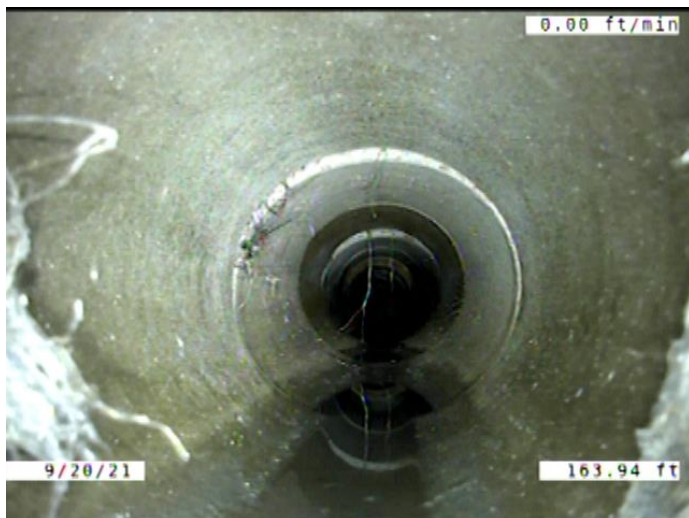
Code: **MWLS**
Description: **Miscellaneous Water Level Sag**

Distance (ft): **163.9**
Structural Grade: **2**
O&M Grade: **0**
Clock Start/From:
Clock To:
1st Value:
2nd Value:
Value Percent: **10.000**
Continuous Index: **F09**
Within 8" of Joint: **NO**
Remarks:

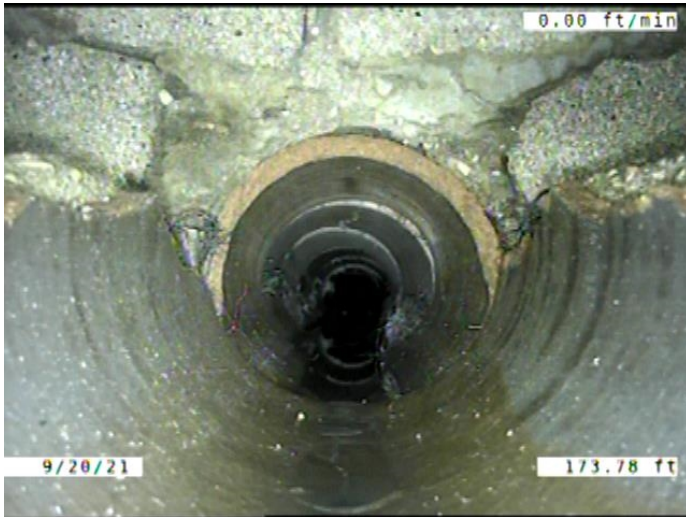
Code: **DSF**
 Description: **Deposits Settled Fine**

Distance (ft): **173.8**
 Structural Grade: **0**
 O&M Grade: **2**
 Clock Start/From: **5**
 Clock To: **7**
 1st Value:
 2nd Value:
 Value Percent: **5.000**
 Continuous Index: **F01**
 Within 8" of Joint: **YES**
 Remarks:

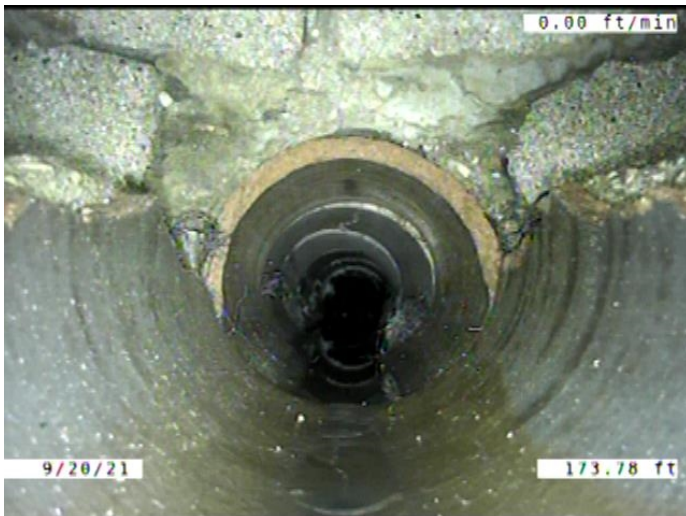
Code: **RFJ**
 Description: **Roots Fine Joint**

Distance (ft): **173.8**
 Structural Grade: **0**
 O&M Grade: **1**
 Clock Start/From: **8**
 Clock To: **2**
 1st Value:
 2nd Value:
 Value Percent:
 Continuous Index: **F08**
 Within 8" of Joint: **YES**
 Remarks:
