Profile/Photo Observation Report

Date:	09/20/2021	Weather:		Coding:	PACP 7.0
Pipe Length (ft):	175.6	Owner:	City of Hobart	Pre Clean:	Heavy Cleaning
P.O.#:	YES502259	Surveyor:	S. Bucklin	PSR:	P-503-024-023
Customer:	City of Hobart	Clean Date:	09/04/2021	Shape:	C

Street:	West 39th Avenue	Flow Control:	Not Controlled
City:	Hobart, IN	Year Renewed:	
Location:	Alley	Tape/Media #:	
Purpose:	Routine Assessment	Dia/Height:	10"
Use:	Sanitary Sewage Pipe	Material:	VCP
Drain Area:		Lining:	None
Category:	NA		
Comment:			
Location Details:		Direction of Survey:	Upstream
US MH:	M-503-023	DS MH:	M-503-024
		Total Length Surveyed (ft):	175.6

O&M Index:	1.62	O&M Quick:	5131	O&M Rating:	115.00
Structural Index:	2.76	Structural Quick:	4A38	Structural Rating:	102.00
Overall Index:	2.01	Overall Quick:	514A	Overall Rating:	217.00

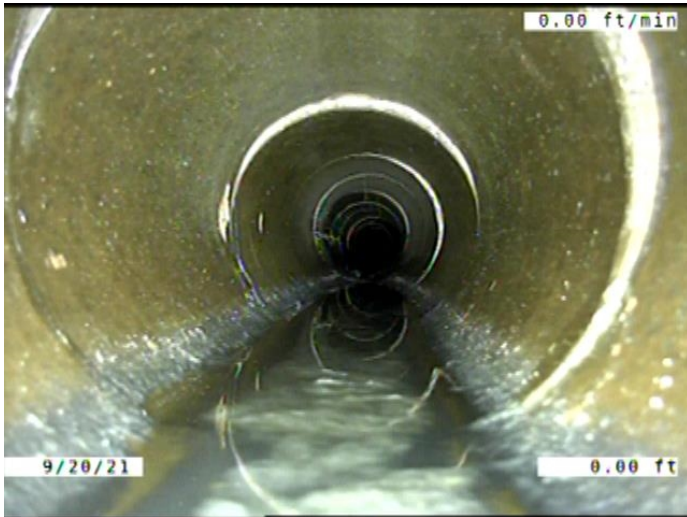
Code: **MWL**
Description: **Miscellaneous Water Level**

Distance (ft): **.0**
Structural Grade: **0**
O&M Grade: **0**
Clock Start/From:
Clock To:
1st Value:
2nd Value:
Value Percent: **5.000**
Continuous Index:
Within 8" of Joint: **NO**
Remarks:

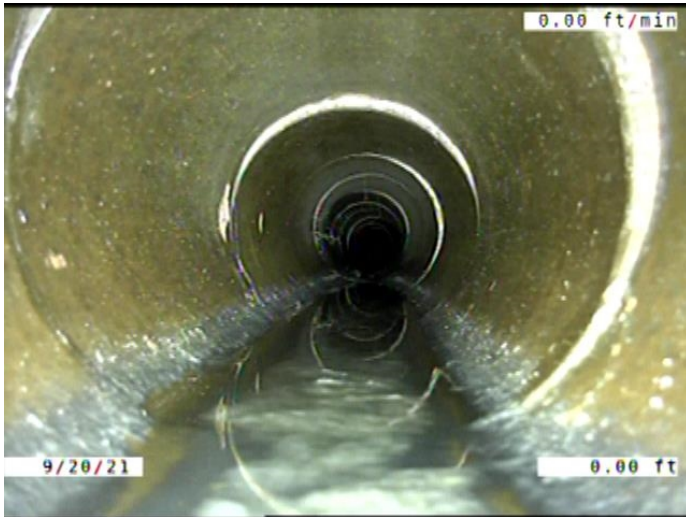
Code: **DSF**
 Description: **Deposits Settled Fine**

Distance (ft): **.0**
 Structural Grade: **0**
 O&M Grade: **2**
 Clock Start/From: **5**
 Clock To: **7**
 1st Value:
 2nd Value:
 Value Percent: **5.000**
 Continuous Index: **S01**
 Within 8" of Joint: **YES**
 Remarks:

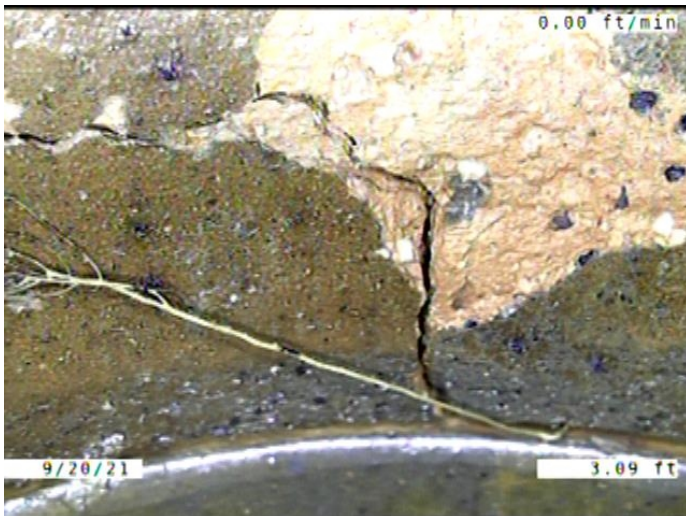
Code: **B**
 Description: **Broken**

Distance (ft): **3.1**
 Structural Grade: **4**
 O&M Grade: **0**
 Clock Start/From: **5**
 Clock To: **10**
 1st Value:
 2nd Value:
 Value Percent:
 Continuous Index:
 Within 8" of Joint: **YES**
 Remarks:

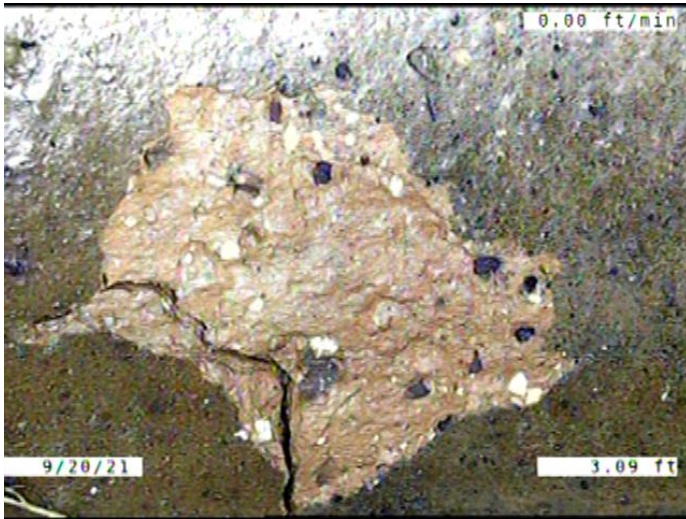
Code: **SSS**
 Description: **Surface Damage Surface Spalling**

Distance (ft): **3.1**
 Structural Grade: **2**
 O&M Grade: **0**
 Clock Start/From: **9**
 Clock To: **10**
 1st Value:
 2nd Value:
 Value Percent:
 Continuous Index:
 Within 8" of Joint: **YES**
 Remarks:

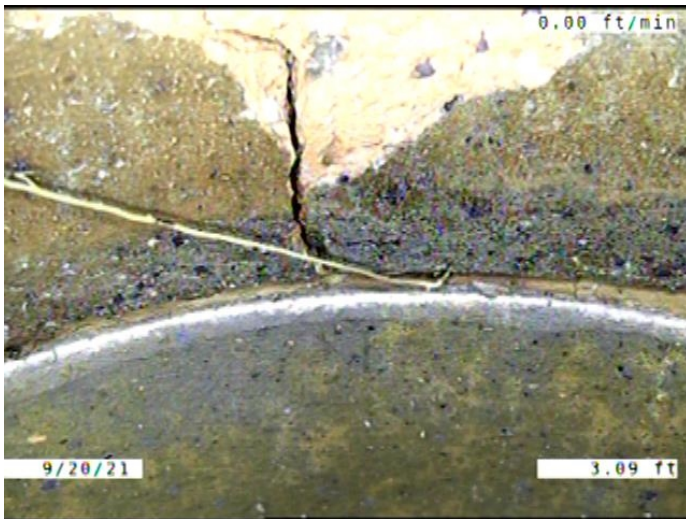
Code: **RFJ**
 Description: **Roots Fine Joint**

Distance (ft): **3.1**
 Structural Grade: **0**
 O&M Grade: **1**
 Clock Start/From: **10**
 Clock To: **11**
 1st Value:
 2nd Value:
 Value Percent:
 Continuous Index:
 Within 8" of Joint: **YES**
 Remarks:

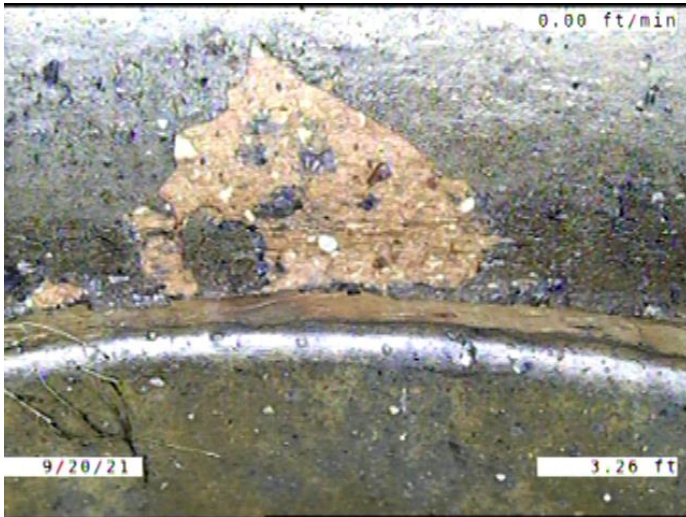
Code: **SSS**
 Description: **Surface Damage Surface Spalling**

Distance (ft): **3.3**
 Structural Grade: **2**
 O&M Grade: **0**
 Clock Start/From: **12**
 Clock To:
 1st Value:
 2nd Value:
 Value Percent:
 Continuous Index:
 Within 8" of Joint: **YES**
 Remarks:

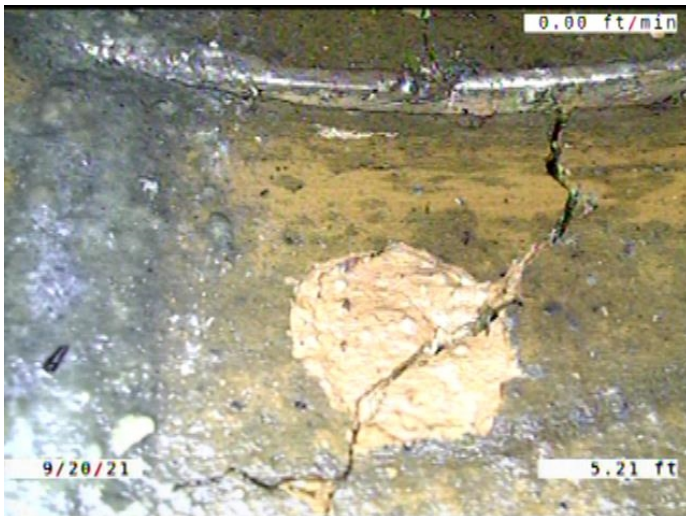
Code: **B**
 Description: **Broken**

Distance (ft): **5.2**
 Structural Grade: **4**
 O&M Grade: **0**
 Clock Start/From: **4**
 Clock To: **8**
 1st Value:
 2nd Value:
 Value Percent:
 Continuous Index:
 Within 8" of Joint: **YES**
 Remarks: **BOTH SIDES OF THE JOINT**

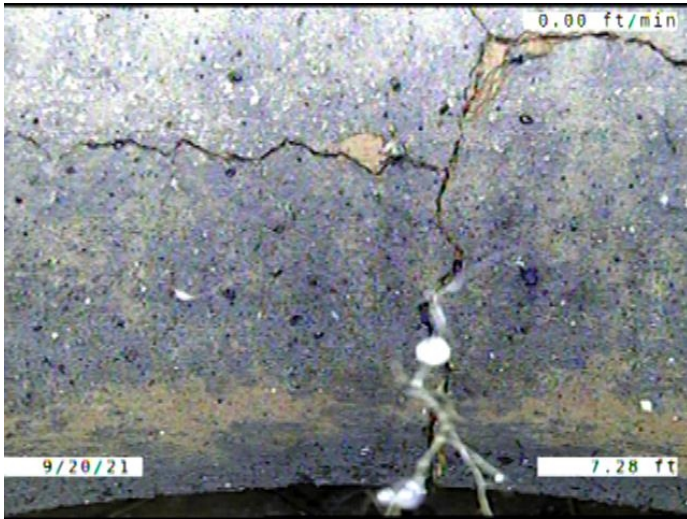
Code: **FM**
 Description: **Fracture Multiple**

Distance (ft): **7.3**
 Structural Grade: **4**
 O&M Grade: **0**
 Clock Start/From: **10**
 Clock To: **2**
 1st Value:
 2nd Value:
 Value Percent:
 Continuous Index:
 Within 8" of Joint: **YES**
 Remarks:

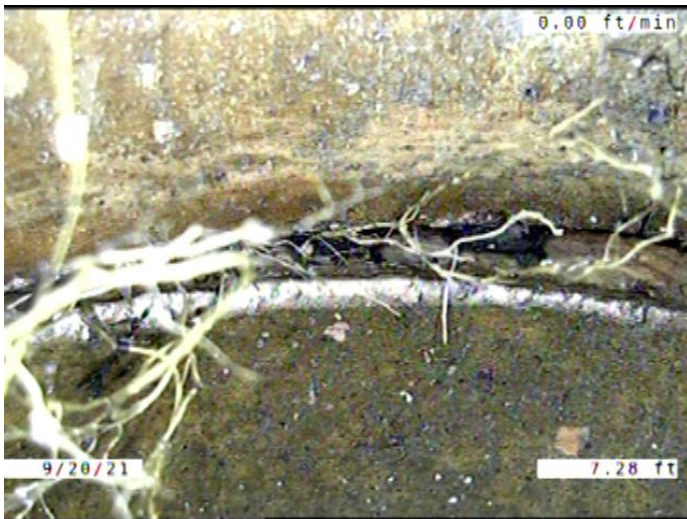
Code: **RFJ**
 Description: **Roots Fine Joint**

Distance (ft): **7.3**
 Structural Grade: **0**
 O&M Grade: **1**
 Clock Start/From: **8**
 Clock To: **3**
 1st Value:
 2nd Value:
 Value Percent:
 Continuous Index: **S04**
 Within 8" of Joint: **YES**
 Remarks:

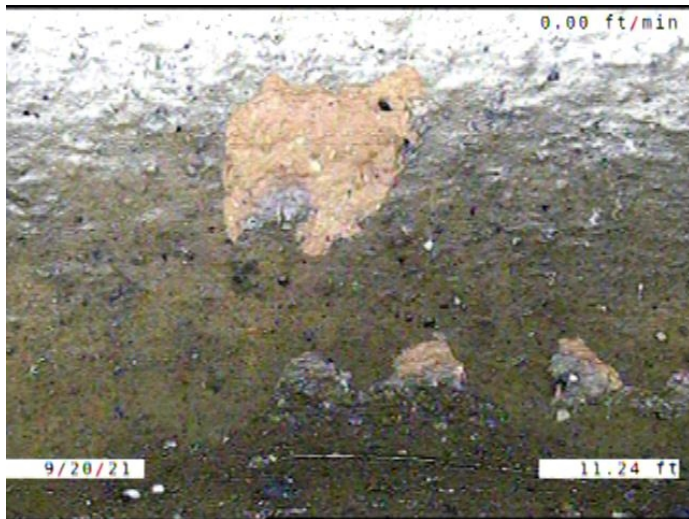
Code:	SSS
Description:	Surface Damage Surface Spalling
Distance (ft):	11.2
Structural Grade:	2
O&M Grade:	0
Clock Start/From:	11
Clock To:	
1st Value:	
2nd Value:	
Value Percent:	
Continuous Index:	
Within 8" of Joint:	YES
Remarks:

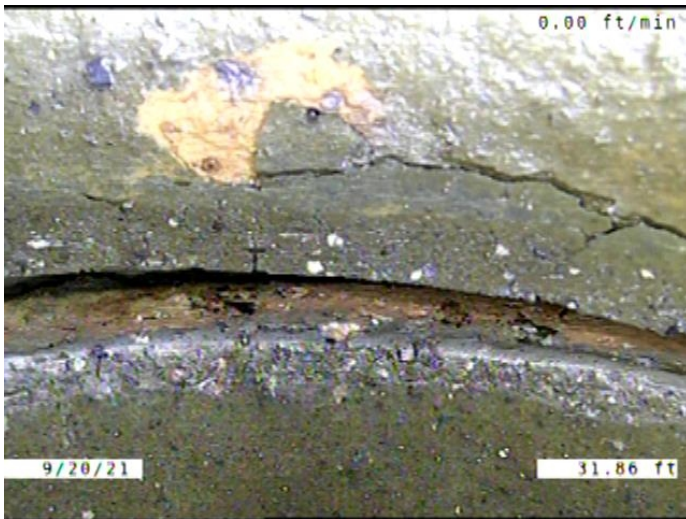
Code: **CM**
 Description: **Crack Multiple**

Distance (ft): **31.9**
 Structural Grade: **3**
 O&M Grade: **0**
 Clock Start/From: **2**
 Clock To: **4**
 1st Value:
 2nd Value:
 Value Percent:
 Continuous Index:
 Within 8" of Joint: **YES**
 Remarks:

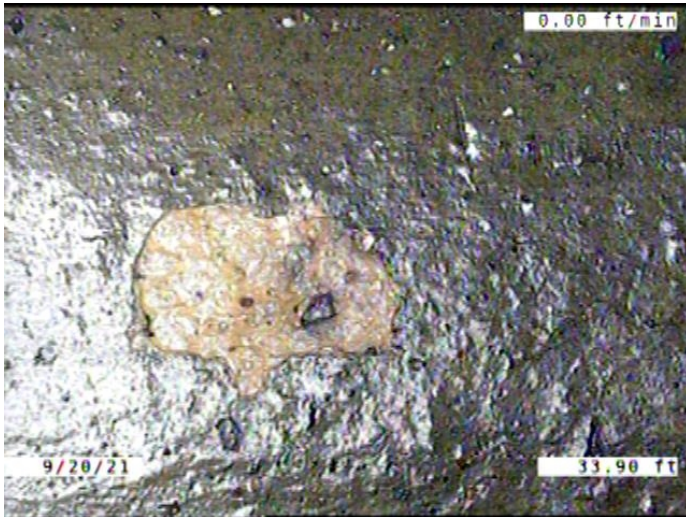
Code: **SSS**
 Description: **Surface Damage Surface Spalling**

Distance (ft): **33.9**
 Structural Grade: **2**
 O&M Grade: **0**
 Clock Start/From: **3**
 Clock To: **4**
 1st Value:
 2nd Value:
 Value Percent:
 Continuous Index:
 Within 8" of Joint: **YES**
 Remarks:

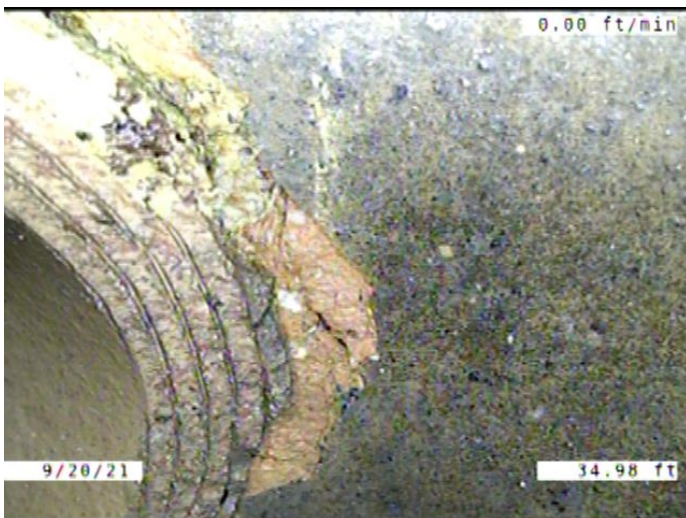
Code: **SSS**
 Description: **Surface Damage Surface Spalling**

Distance (ft): **35.0**
 Structural Grade: **2**
 O&M Grade: **0**
 Clock Start/From: **10**
 Clock To: **1**
 1st Value:
 2nd Value:
 Value Percent:
 Continuous Index:
 Within 8" of Joint: **YES**
 Remarks:

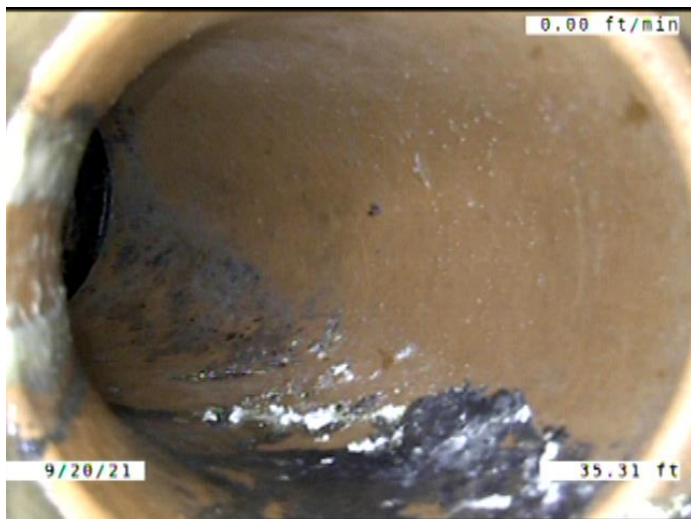
Code: **TBI**
 Description: **Tap Break-in Intruding**

Distance (ft): **35.3**
 Structural Grade: **0**
 O&M Grade: **2**
 Clock Start/From: **11**
 Clock To:
 1st Value: **4.000**
 2nd Value: **1.000**
 Value Percent:
 Continuous Index:
 Within 8" of Joint: **YES**
 Remarks: **CONSTANTLY RUNNING WATER**

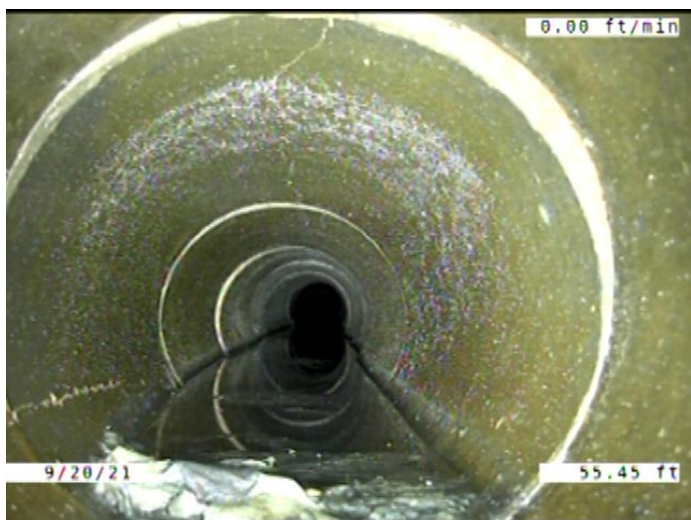
Code: **FM**
 Description: **Fracture Multiple**

Distance (ft): **55.5**
 Structural Grade: **4**
 O&M Grade: **0**
 Clock Start/From: **6**
 Clock To: **12**
 1st Value:
 2nd Value:
 Value Percent:
 Continuous Index:
 Within 8" of Joint: **YES**
 Remarks:

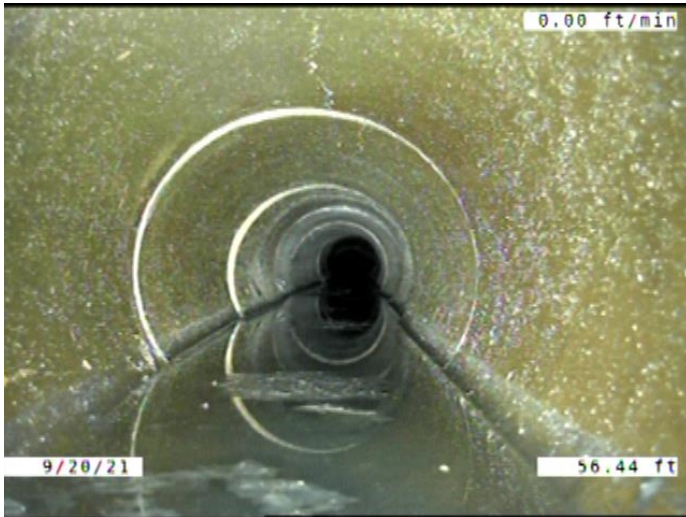
Code: **MWLS**
 Description: **Miscellaneous Water Level Sag**

Distance (ft): **56.4**
 Structural Grade: **2**
 O&M Grade: **0**
 Clock Start/From:
 Clock To:
 1st Value:
 2nd Value:
 Value Percent: **10.000**
 Continuous Index: **S03**
 Within 8" of Joint: **NO**
 Remarks:

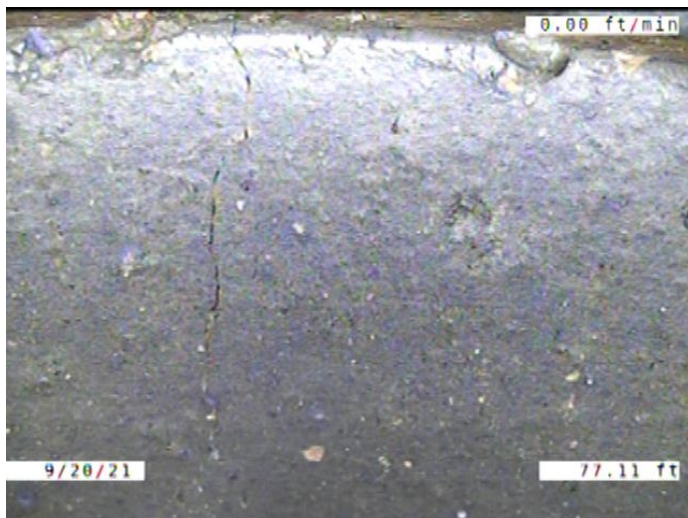
Code: **FM**
 Description: **Fracture Multiple**

Distance (ft): **77.1**
 Structural Grade: **4**
 O&M Grade: **0**
 Clock Start/From: **7**
 Clock To: **5**
 1st Value:
 2nd Value:
 Value Percent:
 Continuous Index: **S05**
 Within 8" of Joint: **YES**
 Remarks:

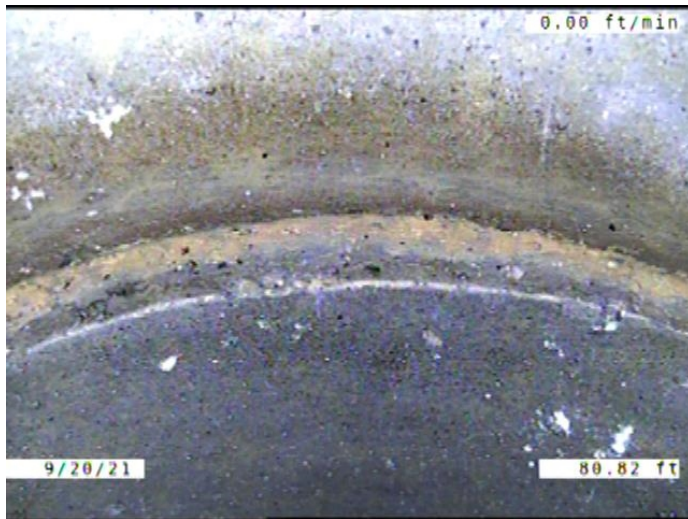
Code: **JOM**
 Description: **Joint Offset Medium**

Distance (ft): **80.8**
 Structural Grade: **3**
 O&M Grade: **0**
 Clock Start/From:
 Clock To:
 1st Value:
 2nd Value:
 Value Percent:
 Continuous Index:
 Within 8" of Joint: **NO**
 Remarks:

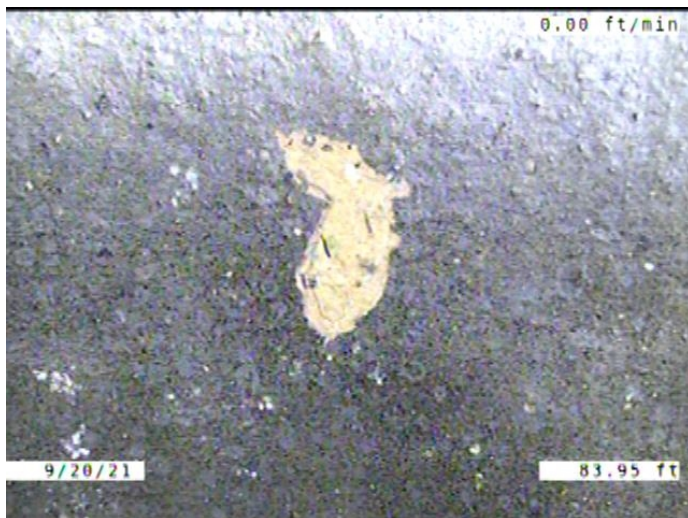
Code: **SSS**
 Description: **Surface Damage Surface Spalling**

Distance (ft): **83.9**
 Structural Grade: **2**
 O&M Grade: **0**
 Clock Start/From: **1**
 Clock To:
 1st Value:
 2nd Value:
 Value Percent:
 Continuous Index:
 Within 8" of Joint: **NO**
 Remarks:

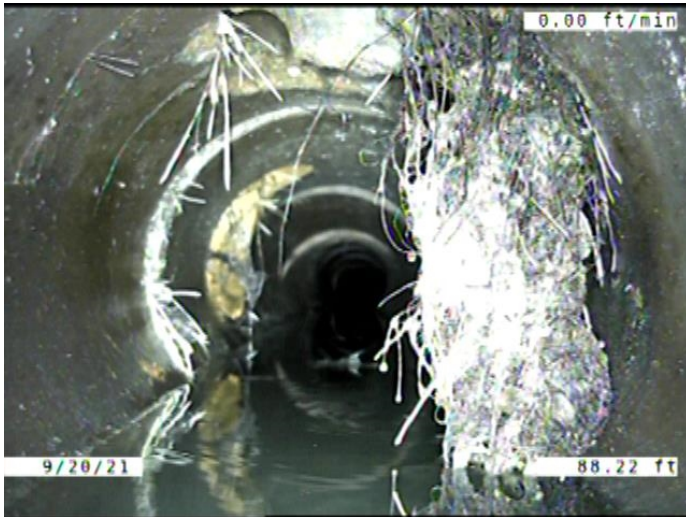
Code: **RML**
 Description: **Roots Medium Lateral**

Distance (ft): **88.2**
 Structural Grade: **0**
 O&M Grade: **3**
 Clock Start/From: **11**
 Clock To: **2**
 1st Value:
 2nd Value:
 Value Percent: **10.000**
 Continuous Index:
 Within 8" of Joint: **NO**
 Remarks:

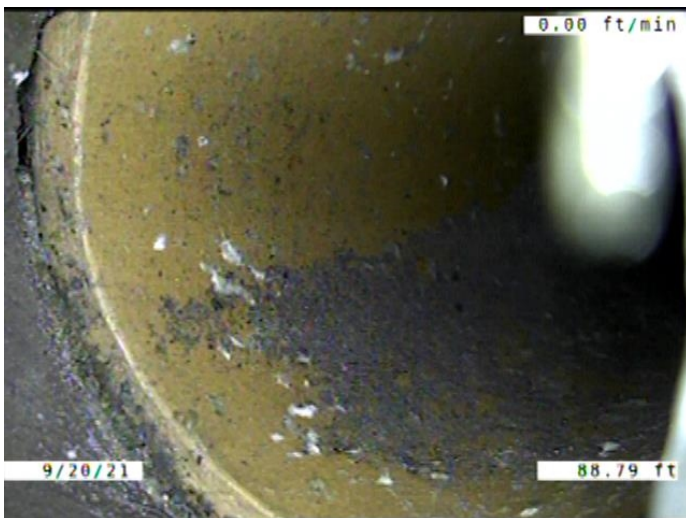
Code: **TBI**
 Description: **Tap Break-in Intruding**

Distance (ft): **88.8**
 Structural Grade: **0**
 O&M Grade: **2**
 Clock Start/From: **1**
 Clock To:
 1st Value: **4.000**
 2nd Value: **1.000**
 Value Percent:
 Continuous Index:
 Within 8" of Joint: **YES**
 Remarks:

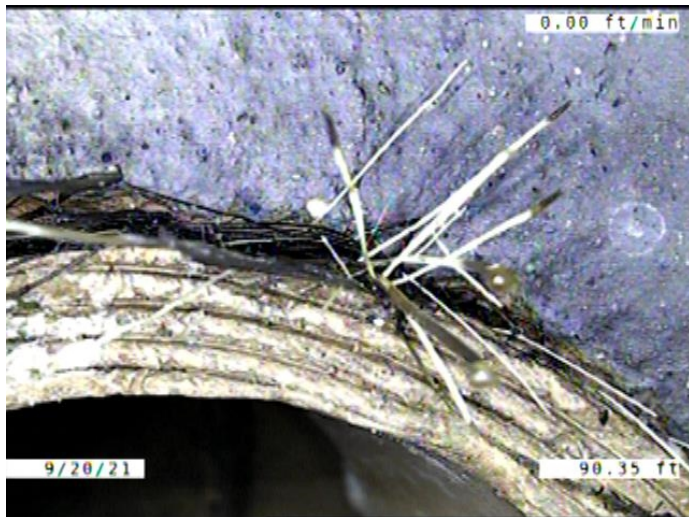
Code: **RFL**
 Description: **Roots Fine Lateral**

Distance (ft): **90.4**
 Structural Grade: **0**
 O&M Grade: **1**
 Clock Start/From: **9**
 Clock To: **12**
 1st Value:
 2nd Value:
 Value Percent:
 Continuous Index:
 Within 8" of Joint: **NO**
 Remarks:

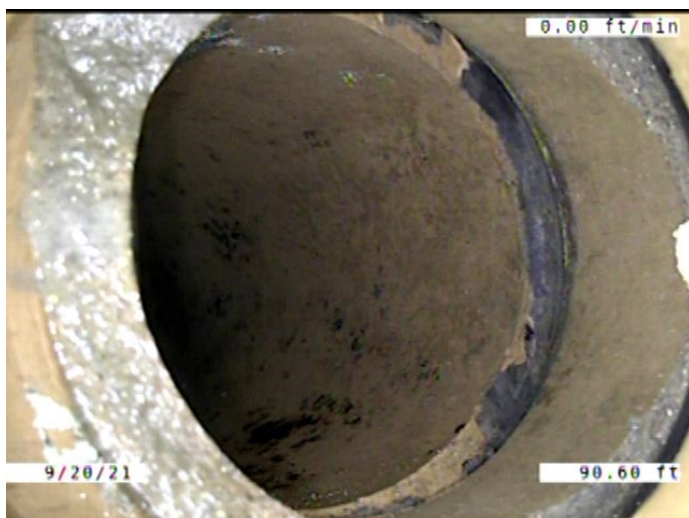
Code: **TBI**
 Description: **Tap Break-in Intruding**

Distance (ft): **90.6**
 Structural Grade: **0**
 O&M Grade: **2**
 Clock Start/From: **10**
 Clock To:
 1st Value: **4.000**
 2nd Value: **1.000**
 Value Percent:
 Continuous Index:
 Within 8" of Joint: **YES**
 Remarks:

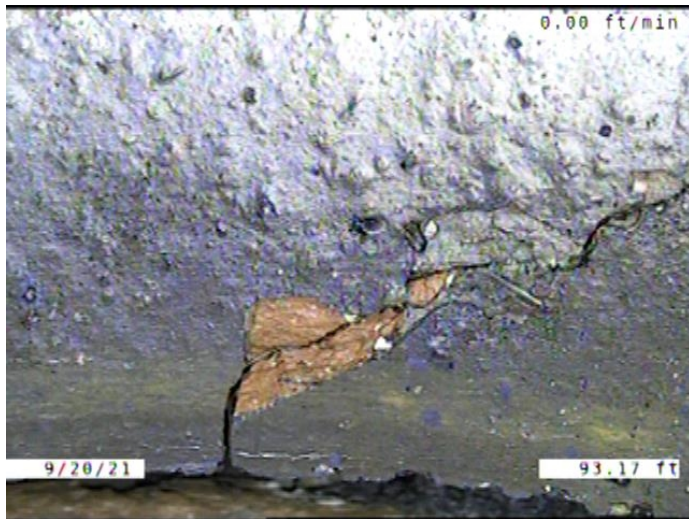
Code: **B**
 Description: **Broken**

Distance (ft): **93.2**
 Structural Grade: **4**
 O&M Grade: **0**
 Clock Start/From: **3**
 Clock To: **4**
 1st Value:
 2nd Value:
 Value Percent:
 Continuous Index:
 Within 8" of Joint: **YES**
 Remarks:

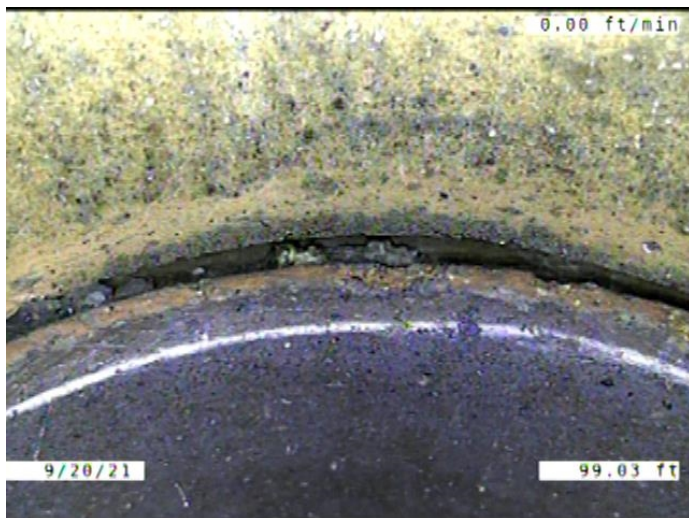
Code: **JOM**
 Description: **Joint Offset Medium**

Distance (ft): **99.0**
 Structural Grade: **3**
 O&M Grade: **0**
 Clock Start/From:
 Clock To:
 1st Value:
 2nd Value:
 Value Percent:
 Continuous Index:
 Within 8" of Joint: **NO**
 Remarks:

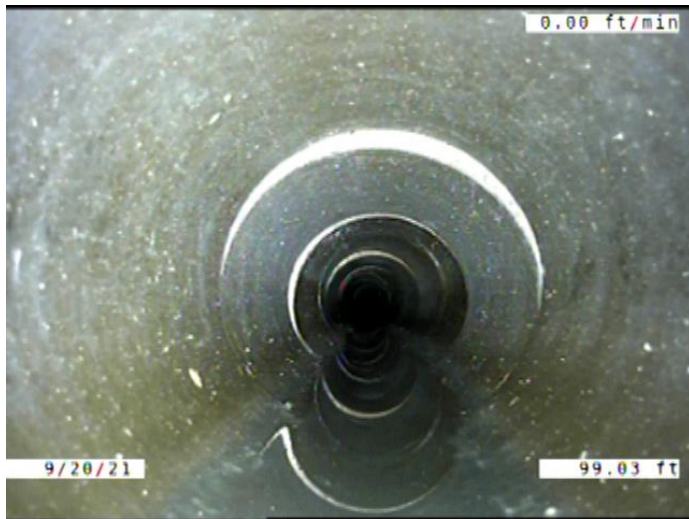
Code: **FM**
Description: **Fracture Multiple**

Distance (ft): **99.0**
Structural Grade: **4**
O&M Grade: **0**
Clock Start/From: **7**
Clock To: **5**
1st Value:
2nd Value:
Value Percent:
Continuous Index: **F05**
Within 8" of Joint: **YES**
Remarks:

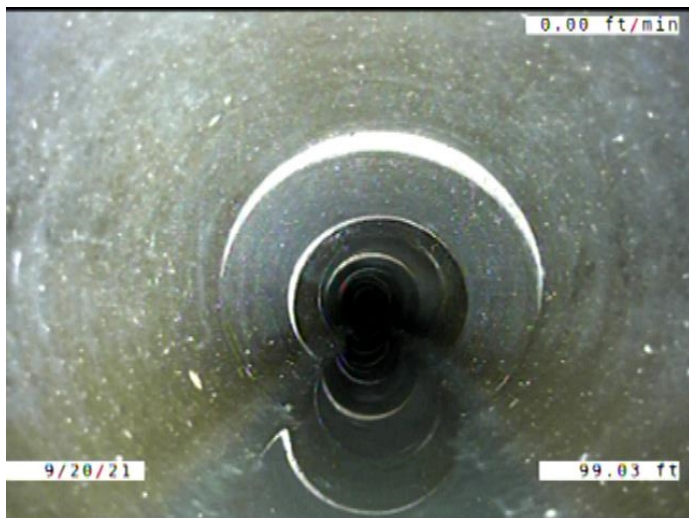
Code: **MWLS**
Description: **Miscellaneous Water Level Sag**

Distance (ft): **99.0**
Structural Grade: **2**
O&M Grade: **0**
Clock Start/From:
Clock To:
1st Value:
2nd Value:
Value Percent: **10.000**
Continuous Index: **F03**
Within 8" of Joint: **NO**
Remarks:

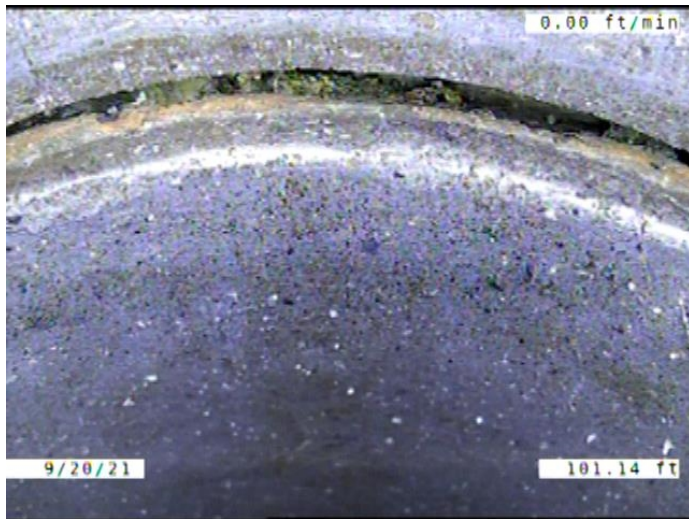
Code: **JOM**
 Description: **Joint Offset Medium**

Distance (ft): **101.1**
 Structural Grade: **3**
 O&M Grade: **0**
 Clock Start/From:
 Clock To:
 1st Value:
 2nd Value:
 Value Percent:
 Continuous Index:
 Within 8" of Joint: **NO**
 Remarks:

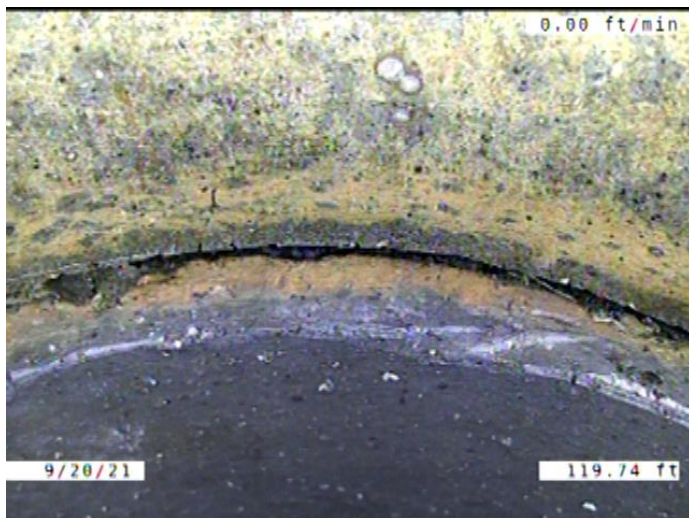
Code: **JOM**
Description: **Joint Offset Medium**

Distance (ft): **119.7**
Structural Grade: **3**
O&M Grade: **0**
Clock Start/From:
Clock To:
1st Value:
2nd Value:
Value Percent:
Continuous Index:
Within 8" of Joint: **NO**
Remarks:

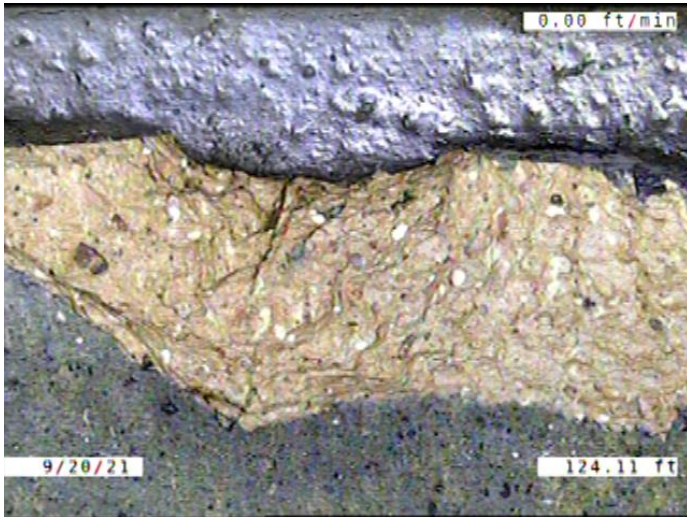
Code:	SZ
Description:	Surface Damage Other
Distance (ft):	124.1
Structural Grade:	0
O&M Grade:	0
Clock Start/From:	2
Clock To:	3
1st Value:	
2nd Value:	
Value Percent:	
Continuous Index:	
Within 8" of Joint:	YES
Remarks:	A PIECE CHIPPED AWAY FROM THE JOINT

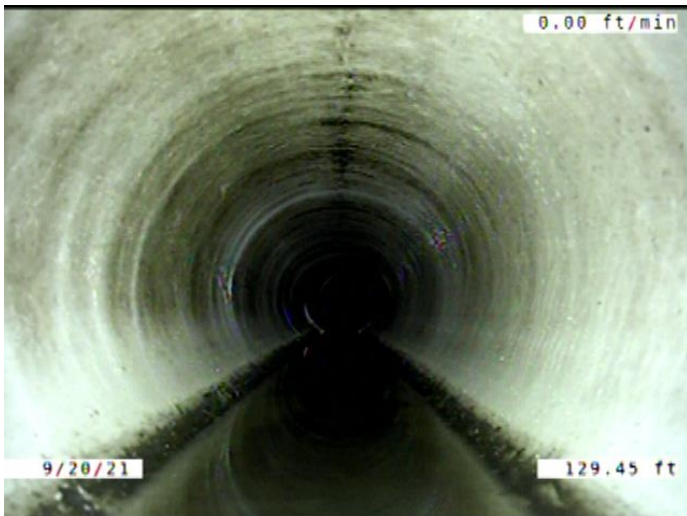
Code:	RFJ
Description:	Roots Fine Joint
Distance (ft):	129.4
Structural Grade:	0
O&M Grade:	1
Clock Start/From:	8
Clock To:	3
1st Value:	
2nd Value:	
Value Percent:	
Continuous Index:	F04
Within 8" of Joint:	YES
Remarks:

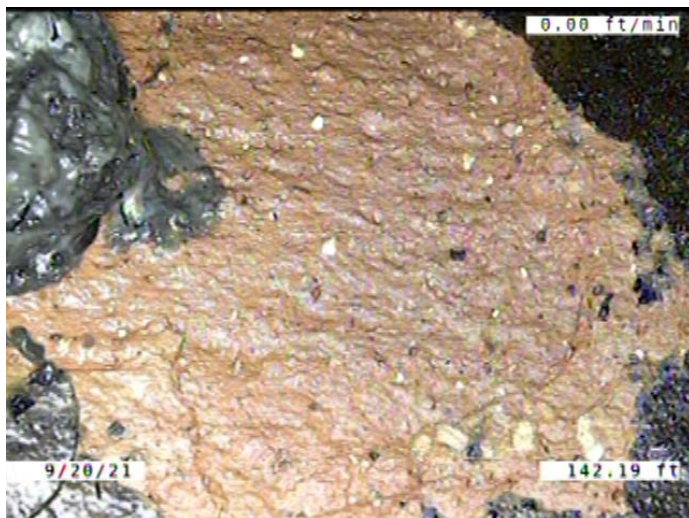
Code: **SSS**
 Description: **Surface Damage Surface Spalling**

Distance (ft): **142.2**
 Structural Grade: **2**
 O&M Grade: **0**
 Clock Start/From: **4**
 Clock To: **7**
 1st Value:
 2nd Value:
 Value Percent:
 Continuous Index:
 Within 8" of Joint: **YES**
 Remarks:

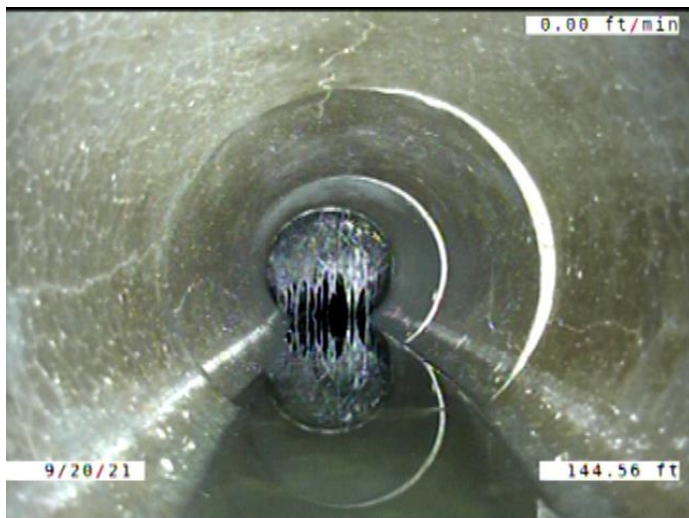
Code: **CM**
 Description: **Crack Multiple**

Distance (ft): **144.6**
 Structural Grade: **3**
 O&M Grade: **0**
 Clock Start/From: **9**
 Clock To: **4**
 1st Value:
 2nd Value:
 Value Percent:
 Continuous Index: **S07**
 Within 8" of Joint: **YES**
 Remarks:

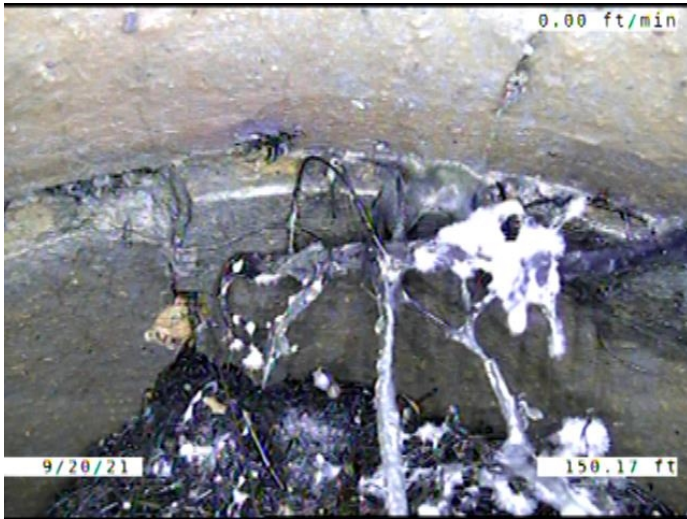
Code: **RFJ**
 Description: **Roots Fine Joint**

Distance (ft): **150.2**
 Structural Grade: **0**
 O&M Grade: **1**
 Clock Start/From: **8**
 Clock To: **2**
 1st Value:
 2nd Value:
 Value Percent:
 Continuous Index: **S08**
 Within 8" of Joint: **YES**
 Remarks:

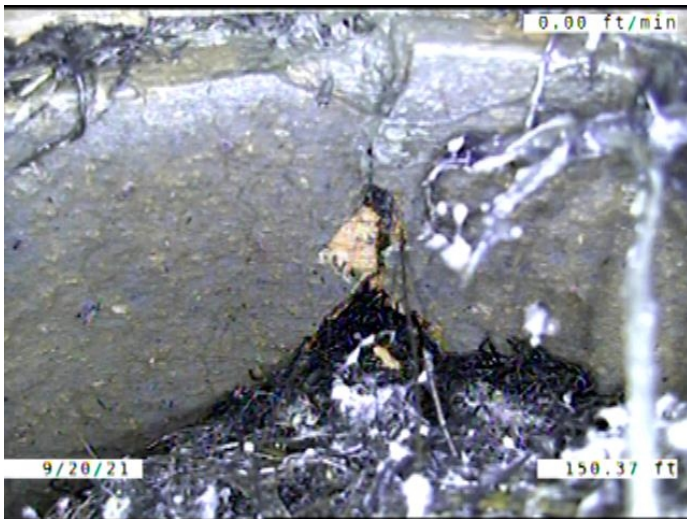
Code: **B**
 Description: **Broken**

Distance (ft): **150.4**
 Structural Grade: **4**
 O&M Grade: **0**
 Clock Start/From: **11**
 Clock To: **4**
 1st Value:
 2nd Value:
 Value Percent:
 Continuous Index:
 Within 8" of Joint: **YES**
 Remarks:

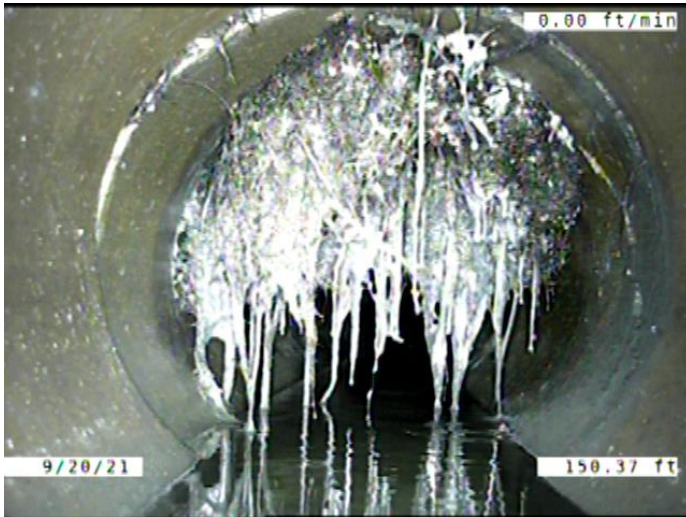
Code: **RBB**
 Description: **Roots Ball Barrel**

Distance (ft): **150.4**
 Structural Grade: **0**
 O&M Grade: **5**
 Clock Start/From: **9**
 Clock To: **2**
 1st Value:
 2nd Value:
 Value Percent: **60.000**
 Continuous Index:
 Within 8" of Joint: **NO**
 Remarks:

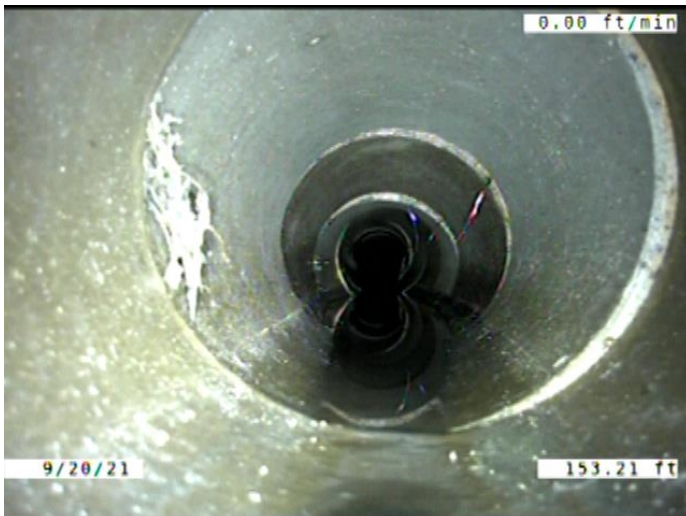
Code: **CM**
 Description: **Crack Multiple**

Distance (ft): **153.2**
 Structural Grade: **3**
 O&M Grade: **0**
 Clock Start/From: **9**
 Clock To: **4**
 1st Value:
 2nd Value:
 Value Percent:
 Continuous Index: **F07**
 Within 8" of Joint: **YES**
 Remarks:

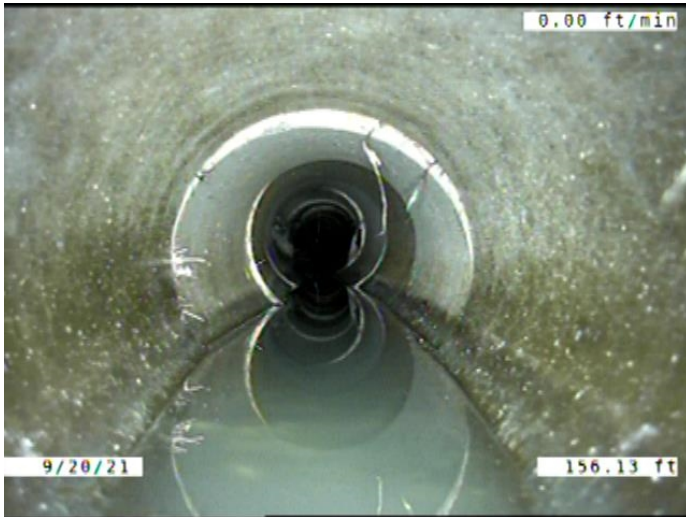
Code: **MWLS**
Description: **Miscellaneous Water Level Sag**

Distance (ft): **156.1**
Structural Grade: **2**
O&M Grade: **0**
Clock Start/From:
Clock To:
1st Value:
2nd Value:
Value Percent: **10.000**
Continuous Index: **S09**
Within 8" of Joint: **NO**
Remarks:

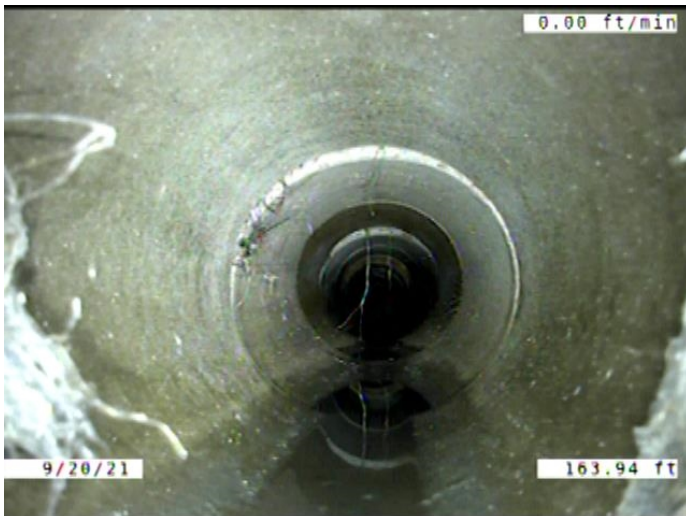
Code: **MWLS**
Description: **Miscellaneous Water Level Sag**

Distance (ft): **163.9**
Structural Grade: **2**
O&M Grade: **0**
Clock Start/From:
Clock To:
1st Value:
2nd Value:
Value Percent: **10.000**
Continuous Index: **F09**
Within 8" of Joint: **NO**
Remarks:

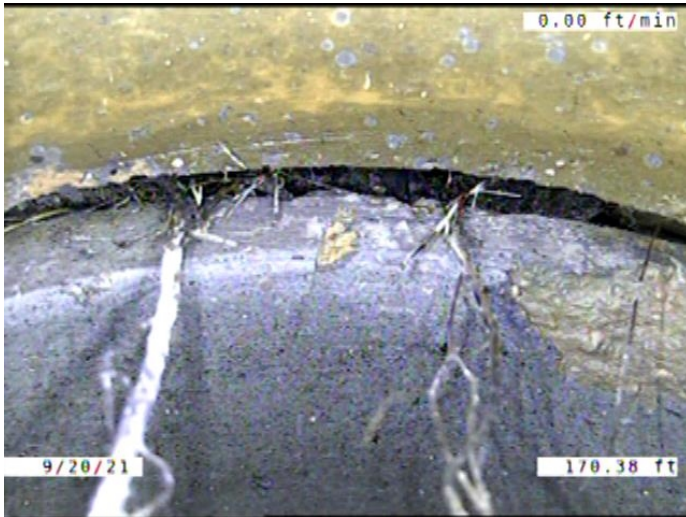
Code: **JOM**
 Description: **Joint Offset Medium**

Distance (ft): **170.4**
 Structural Grade: **3**
 O&M Grade: **0**
 Clock Start/From:
 Clock To:
 1st Value:
 2nd Value:
 Value Percent:
 Continuous Index:
 Within 8" of Joint: **NO**
 Remarks:

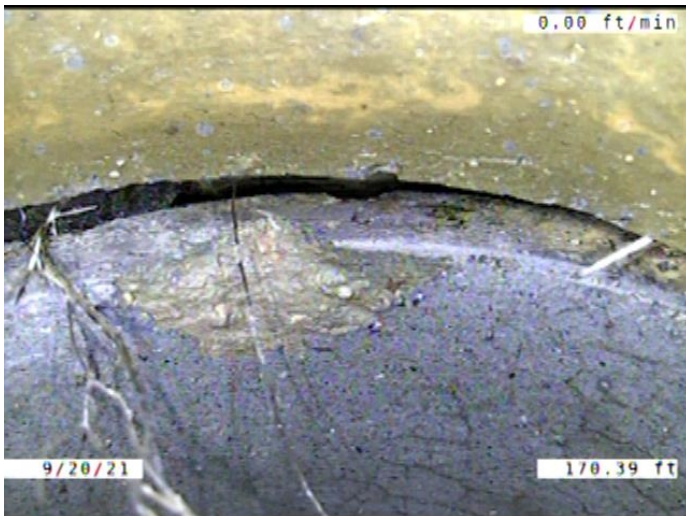
Code: **SSS**
 Description: **Surface Damage Surface Spalling**

Distance (ft): **170.4**
 Structural Grade: **2**
 O&M Grade: **0**
 Clock Start/From: **1**
 Clock To:
 1st Value:
 2nd Value:
 Value Percent:
 Continuous Index:
 Within 8" of Joint: **YES**
 Remarks:

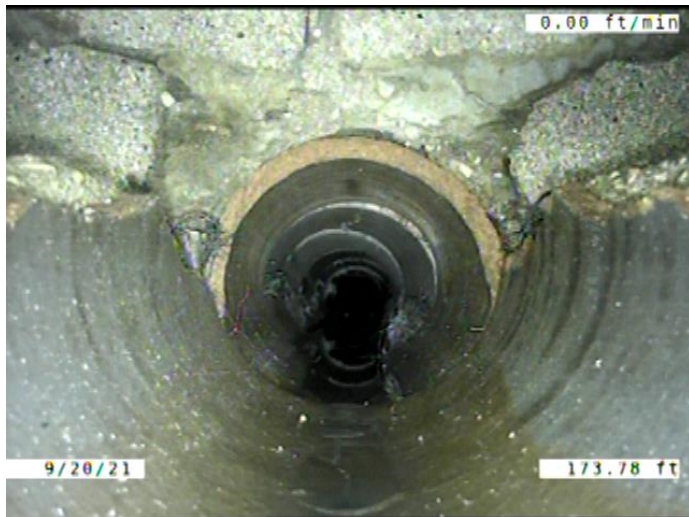
Code: **DSF**
 Description: **Deposits Settled Fine**

Distance (ft): **173.8**
 Structural Grade: **0**
 O&M Grade: **2**
 Clock Start/From: **5**
 Clock To: **7**
 1st Value:
 2nd Value:
 Value Percent: **5.000**
 Continuous Index: **F01**
 Within 8" of Joint: **YES**
 Remarks:

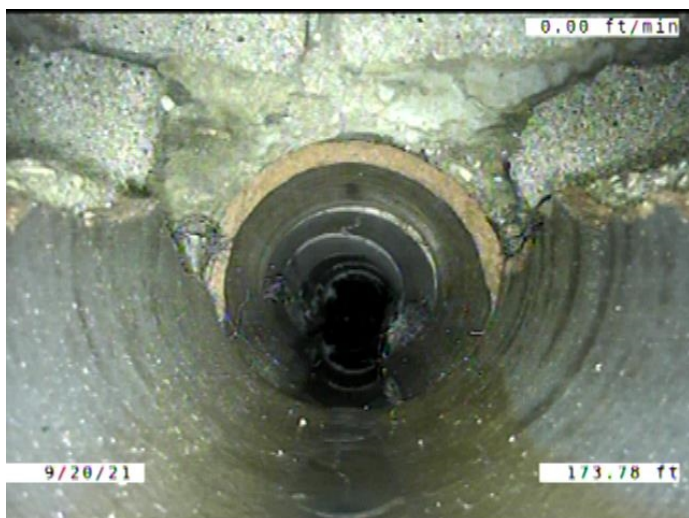
Code: **RFJ**
 Description: **Roots Fine Joint**

Distance (ft): **173.8**
 Structural Grade: **0**
 O&M Grade: **1**
 Clock Start/From: **8**
 Clock To: **2**
 1st Value:
 2nd Value:
 Value Percent:
 Continuous Index: **F08**
 Within 8" of Joint: **YES**
 Remarks:
