## Profile/Photo Observation Report

Street:	<b>ALLEY BETWEEN W 39TH PL &amp; W 39</b>	Flow Control:	<b>Not Controlled</b>
City:	<b>Hobart, IN</b>	Year Renewed:	
Location:	<b>Other</b>	Tape/Media #:	
Purpose:	<b>Not Known</b>	Dia/Height:	<b>10"</b>
Use:	<b>Sanitary</b>	Material:	<b>VCP</b>
Drain Area:	<b>NA</b>	Lining:	
Category:	<b>NA</b>		
Comment:

Location Details:		Direction of Survey:	<b>Downstream</b>
US MH:	<b>M-503-024</b>	DS MH:	<b>M-503-025</b>
		Total Length Surveyed (ft):	<b>170.1</b>

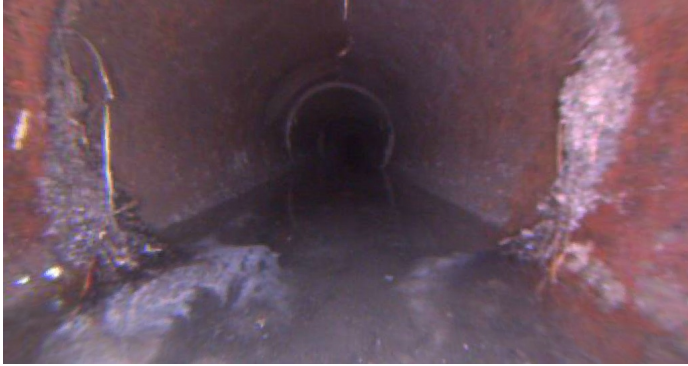
Code: **AMH**  
Description: **Manhole**

Distance (ft): **.0**  
Structural Grade: **0**  
O&M Grade: **0**  
Clock Start/From:  
Clock To:  
1st Value:  
2nd Value:  
Value Percent:  
Continuous Index:  
Within 8" of Joint: **NO**  
Remarks: **M-503-024**

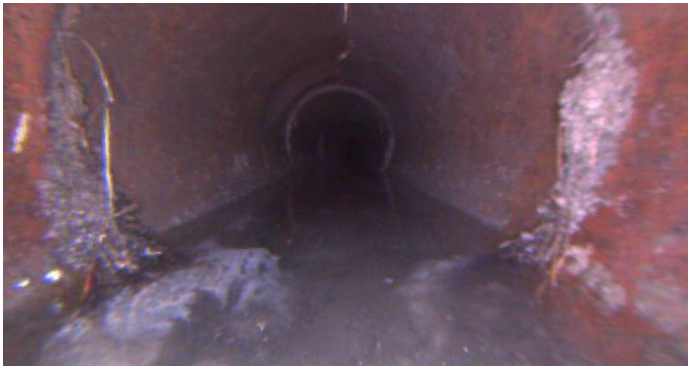
Code: **MWL**  
Description: **Water Level**

Distance (ft): **.0**  
Structural Grade: **0**  
O&M Grade: **0**  
Clock Start/From:  
Clock To:  
1st Value:  
2nd Value:  
Value Percent: **10.000**  
Continuous Index:  
Within 8" of Joint: **NO**  
Remarks:

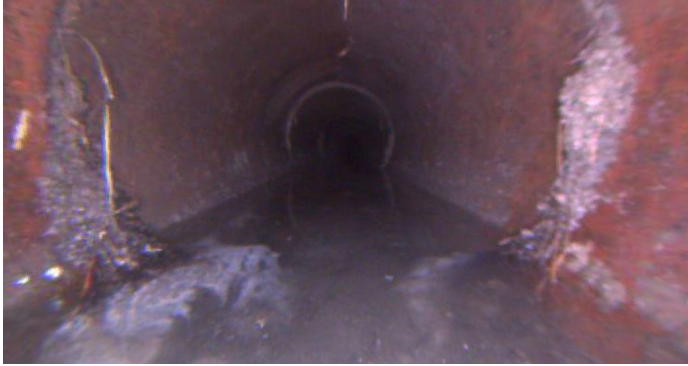
Code:	<b>RFJ</b>
Description:	<b>Roots Fine Joint</b>
Distance (ft):	<b>.0</b>
Structural Grade:	<b>0</b>
O&M Grade:	<b>1</b>
Clock Start/From:	<b>7</b>
Clock To:	<b>5</b>
1st Value:	
2nd Value:	
Value Percent:	
Continuous Index:	
Within 8" of Joint:	<b>YES</b>
Remarks:

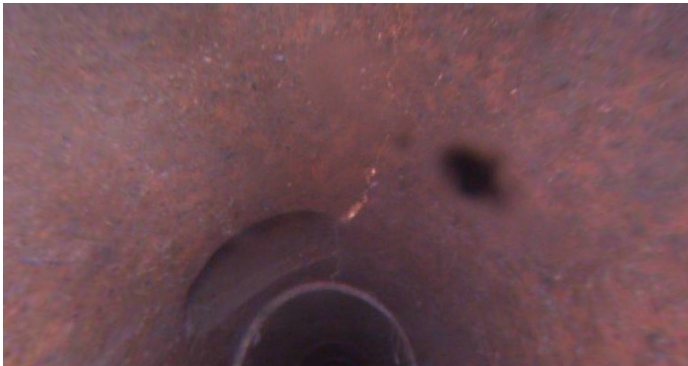
Code:	<b>CL</b>
Description:	<b>Crack Longitudinal</b>
Distance (ft):	<b>1.0</b>
Structural Grade:	<b>2</b>
O&M Grade:	<b>0</b>
Clock Start/From:	<b>12</b>
Clock To:	
1st Value:	
2nd Value:	
Value Percent:	
Continuous Index:	<b>S02</b>
Within 8" of Joint:	
Remarks:

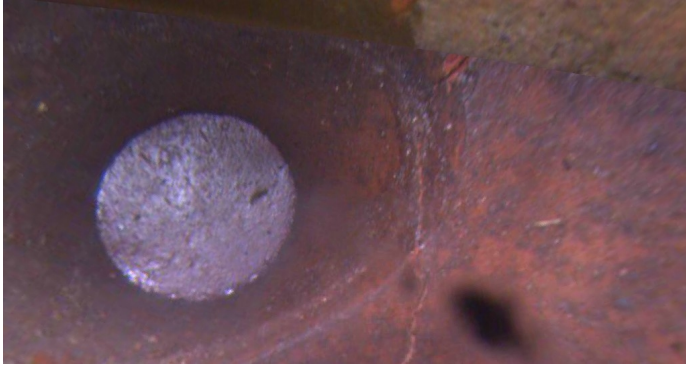
Code: **TFC**  
Description: **Tap Factory Capped**

Distance (ft): **2.4**  
Structural Grade: **0**  
O&M Grade: **0**  
Clock Start/From: **10**  
Clock To:  
1st Value: **4.000**  
2nd Value:  
Value Percent:  
Continuous Index:  
Within 8" of Joint:  
Remarks:

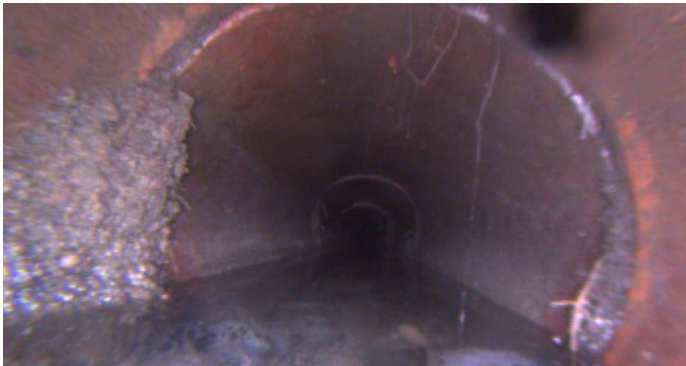
Code: **RFJ**  
Description: **Roots Fine Joint**

Distance (ft): **4.6**  
Structural Grade: **0**  
O&M Grade: **1**  
Clock Start/From: **7**  
Clock To: **5**  
1st Value:  
2nd Value:  
Value Percent:  
Continuous Index: **S01**  
Within 8" of Joint: **YES**  
Remarks:

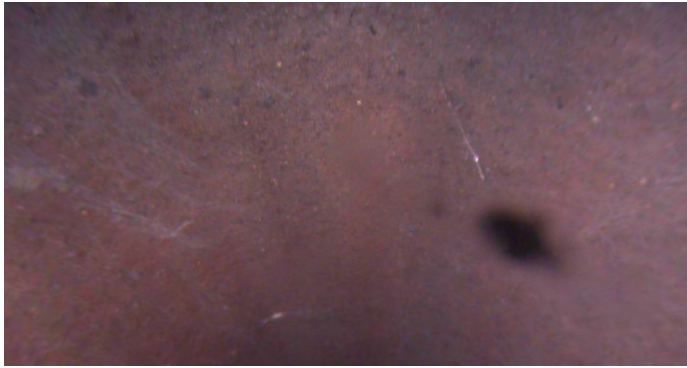
Code: **CL**  
Description: **Crack Longitudinal**

Distance (ft): **13.4**  
Structural Grade: **2**  
O&M Grade: **0**  
Clock Start/From: **12**  
Clock To:  
1st Value:  
2nd Value:  
Value Percent:  
Continuous Index: **F02**  
Within 8" of Joint:  
Remarks:

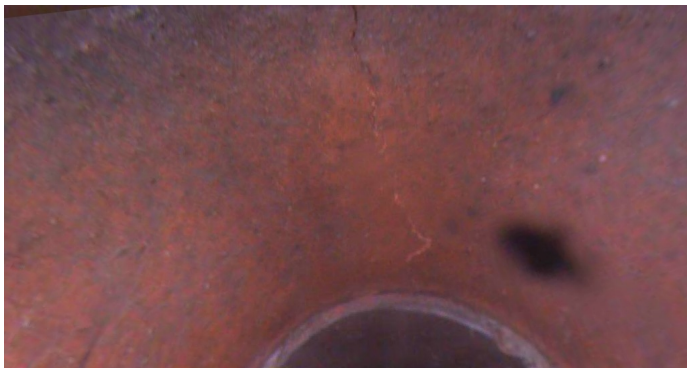
Code: **CL**  
Description: **Crack Longitudinal**

Distance (ft): **16.3**  
Structural Grade: **2**  
O&M Grade: **0**  
Clock Start/From: **12**  
Clock To:  
1st Value:  
2nd Value:  
Value Percent:  
Continuous Index: **S03**  
Within 8" of Joint: **YES**  
Remarks:

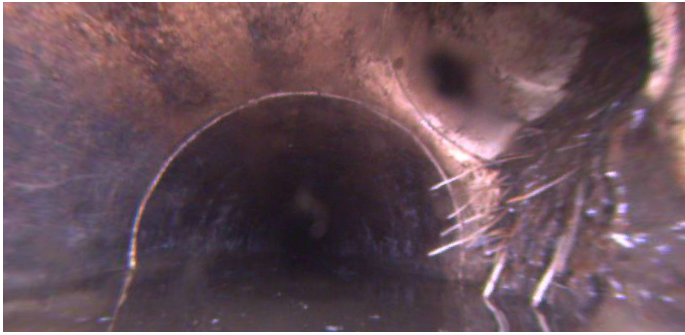
Code: **MMC**  
Description: **Material Change**

Distance (ft): **39.7**  
Structural Grade: **0**  
O&M Grade: **0**  
Clock Start/From:  
Clock To:  
1st Value:  
2nd Value:  
Value Percent:  
Continuous Index:  
Within 8" of Joint: **NO**  
Remarks: **pvc**

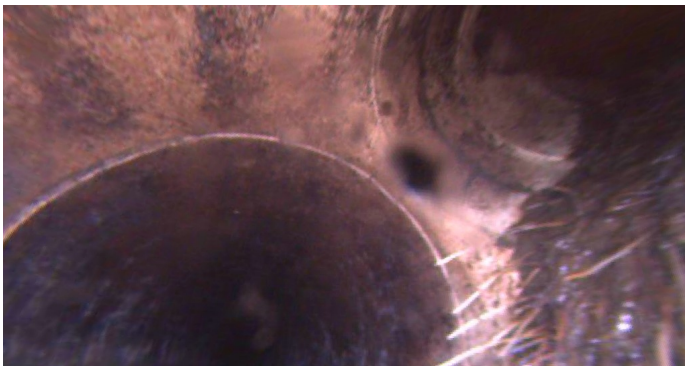
Code: **TFD**  
Description: **Tap Factory Defective**

Distance (ft): **39.8**  
Structural Grade: **0**  
O&M Grade: **2**  
Clock Start/From: **2**  
Clock To:  
1st Value: **4.000**  
2nd Value:  
Value Percent:  
Continuous Index:  
Within 8" of Joint:  
Remarks: **Roots**

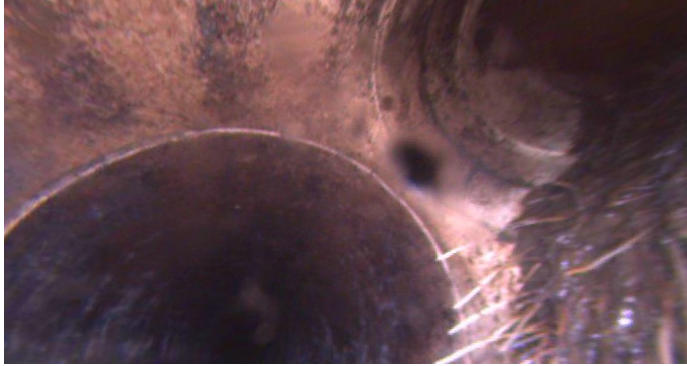
Code: **RFL**  
Description: **Roots Fine Lateral**

Distance (ft): **39.8**  
Structural Grade: **0**  
O&M Grade: **1**  
Clock Start/From: **2**  
Clock To:  
1st Value:  
2nd Value:  
Value Percent:  
Continuous Index:  
Within 8" of Joint: **NO**  
Remarks:

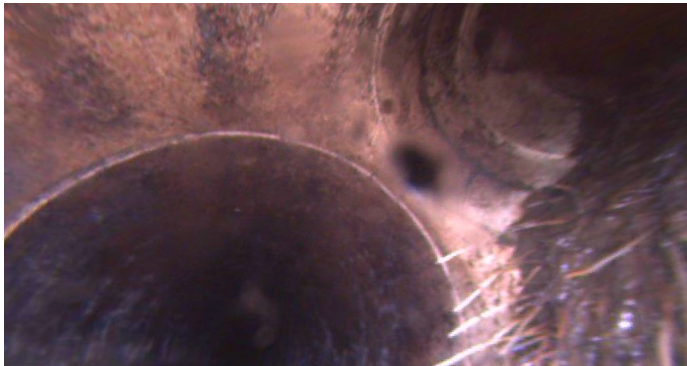
Code: **CL**  
Description: **Crack Longitudinal**

Distance (ft): **39.8**  
Structural Grade: **2**  
O&M Grade: **0**  
Clock Start/From: **12**  
Clock To:  
1st Value:  
2nd Value:  
Value Percent:  
Continuous Index: **F03**  
Within 8" of Joint: **YES**  
Remarks:

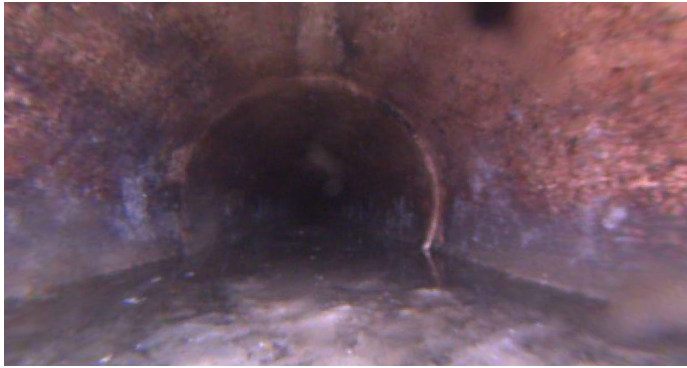
Code:	<b>RFJ</b>
Description:	<b>Roots Fine Joint</b>
Distance (ft):	<b>48.6</b>
Structural Grade:	<b>0</b>
O&M Grade:	<b>1</b>
Clock Start/From:	<b>7</b>
Clock To:	<b>5</b>
1st Value:	
2nd Value:	
Value Percent:	
Continuous Index:	<b>F01</b>
Within 8" of Joint:	<b>YES</b>
Remarks:

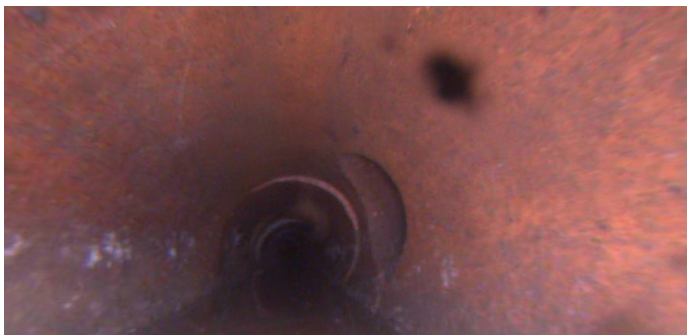
Code:	<b>MMC</b>
Description:	<b>Material Change</b>
Distance (ft):	<b>68.0</b>
Structural Grade:	<b>0</b>
O&M Grade:	<b>0</b>
Clock Start/From:	
Clock To:	
1st Value:	
2nd Value:	
Value Percent:	
Continuous Index:	
Within 8" of Joint:	<b>NO</b>
Remarks:	<b>VCP</b>

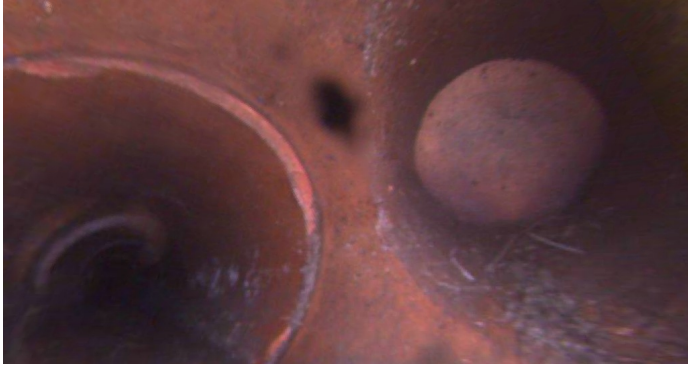
Code: **TFC**  
Description: **Tap Factory Capped**

Distance (ft): **69.1**  
Structural Grade: **0**  
O&M Grade: **0**  
Clock Start/From: **3**  
Clock To:  
1st Value: **4.000**  
2nd Value:  
Value Percent:  
Continuous Index:  
Within 8" of Joint:  
Remarks:

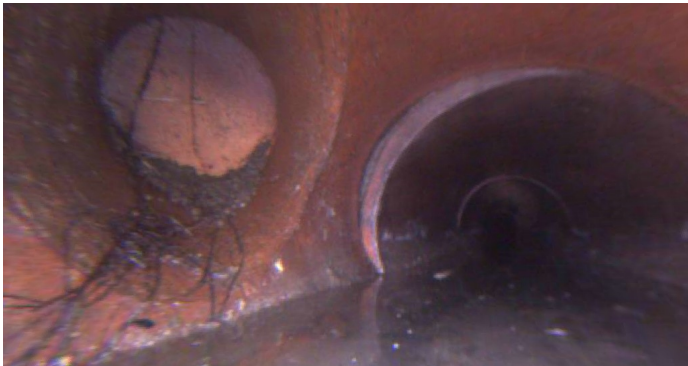
Code: **TFD**  
Description: **Tap Factory Defective**

Distance (ft): **71.0**  
Structural Grade: **0**  
O&M Grade: **2**  
Clock Start/From: **9**  
Clock To:  
1st Value: **4.000**  
2nd Value:  
Value Percent:  
Continuous Index:  
Within 8" of Joint:  
Remarks: **ROOTS, CAPPED**

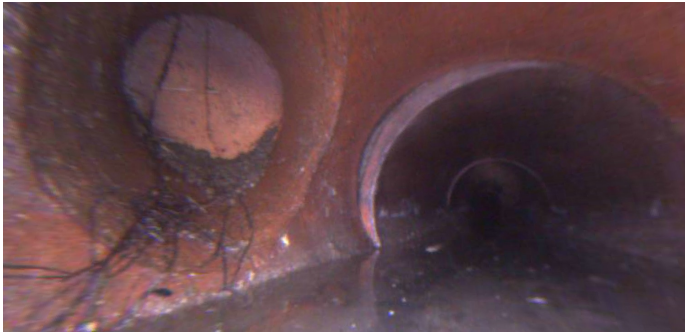
Code: **RFL**  
Description: **Roots Fine Lateral**

Distance (ft): **71.0**  
Structural Grade: **0**  
O&M Grade: **1**  
Clock Start/From: **9**  
Clock To:  
1st Value:  
2nd Value:  
Value Percent:  
Continuous Index:  
Within 8" of Joint: **NO**  
Remarks:

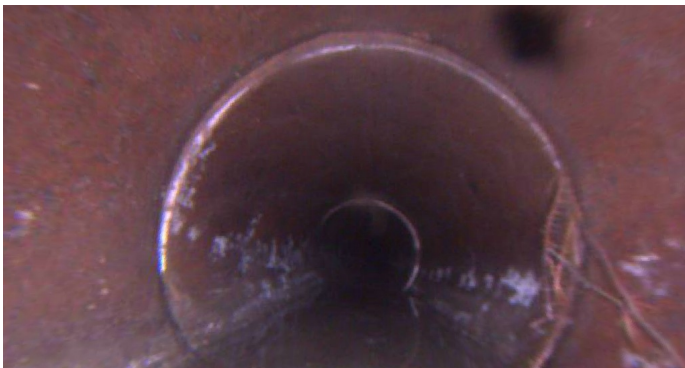
Code: **RFJ**  
Description: **Roots Fine Joint**

Distance (ft): **77.4**  
Structural Grade: **0**  
O&M Grade: **1**  
Clock Start/From: **4**  
Clock To: **5**  
1st Value:  
2nd Value:  
Value Percent:  
Continuous Index:  
Within 8" of Joint: **YES**  
Remarks:

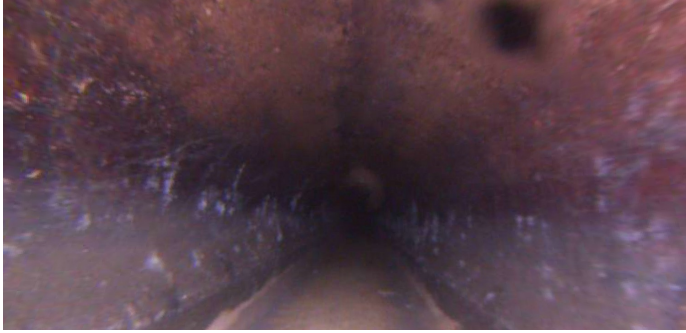
Code: **MMC**  
Description: **Material Change**

Distance (ft): **79.7**  
Structural Grade: **0**  
O&M Grade: **0**  
Clock Start/From:  
Clock To:  
1st Value:  
2nd Value:  
Value Percent:  
Continuous Index:  
Within 8" of Joint: **NO**  
Remarks: **pvc**

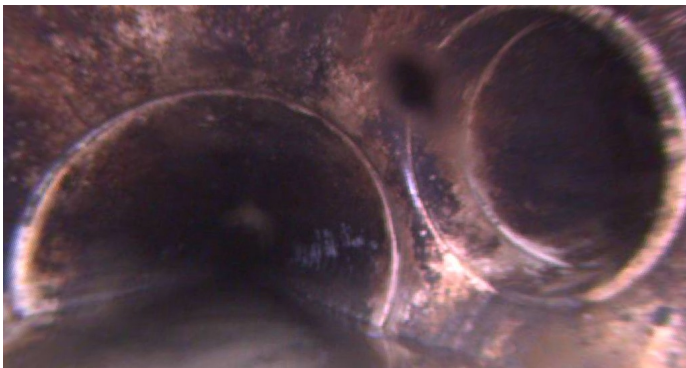
Code: **TF**  
Description: **Tap Factory**

Distance (ft): **111.2**  
Structural Grade: **0**  
O&M Grade: **0**  
Clock Start/From: **4**  
Clock To:  
1st Value: **4.000**  
2nd Value:  
Value Percent:  
Continuous Index:  
Within 8" of Joint:  
Remarks:

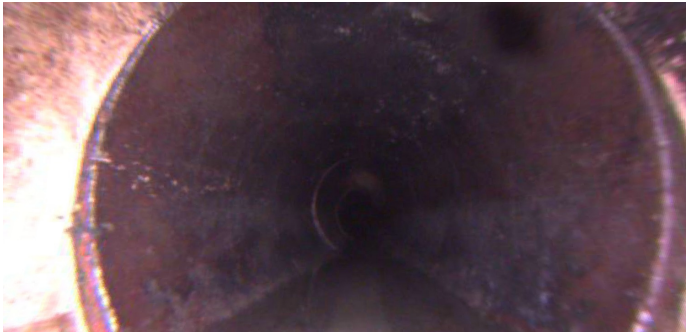
Code: **MMC**  
Description: **Material Change**

Distance (ft): **145.8**  
Structural Grade: **0**  
O&M Grade: **0**  
Clock Start/From:  
Clock To:  
1st Value:  
2nd Value:  
Value Percent:  
Continuous Index:  
Within 8" of Joint: **NO**  
Remarks: **VCP**

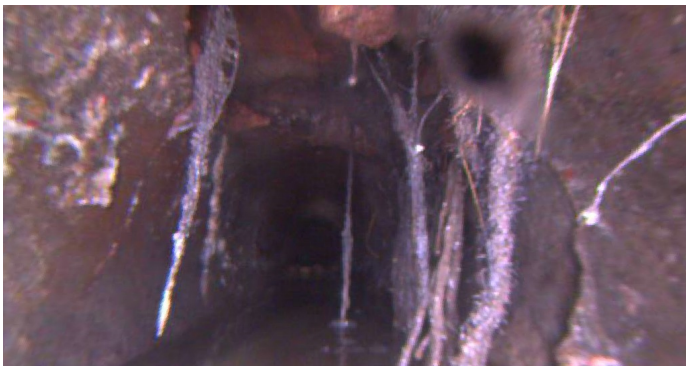
Code: **TBD**  
Description: **Tap Break-in Defective**

Distance (ft): **166.0**  
Structural Grade: **0**  
O&M Grade: **3**  
Clock Start/From: **12**  
Clock To:  
1st Value: **4.000**  
2nd Value:  
Value Percent:  
Continuous Index:  
Within 8" of Joint:  
Remarks: **Roots**

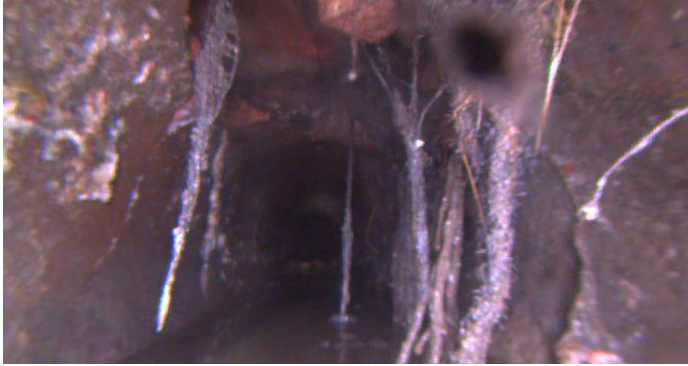
Code: **RFL**  
Description: **Roots Fine Lateral**

Distance (ft): **166.0**  
Structural Grade: **0**  
O&M Grade: **1**  
Clock Start/From: **12**  
Clock To:  
1st Value:  
2nd Value:  
Value Percent:  
Continuous Index:  
Within 8" of Joint: **NO**  
Remarks:

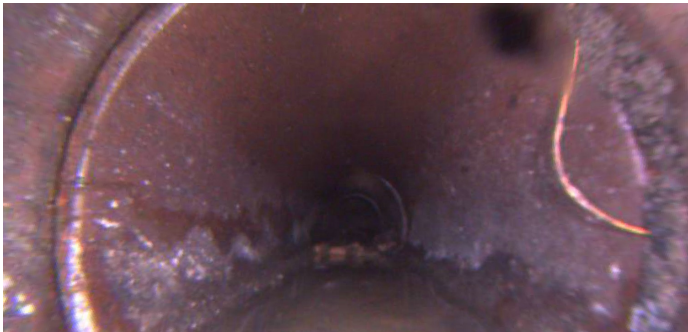
Code: **RFJ**  
Description: **Roots Fine Joint**

Distance (ft): **167.6**  
Structural Grade: **0**  
O&M Grade: **1**  
Clock Start/From: **2**  
Clock To: **4**  
1st Value:  
2nd Value:  
Value Percent:  
Continuous Index:  
Within 8" of Joint: **YES**  
Remarks:

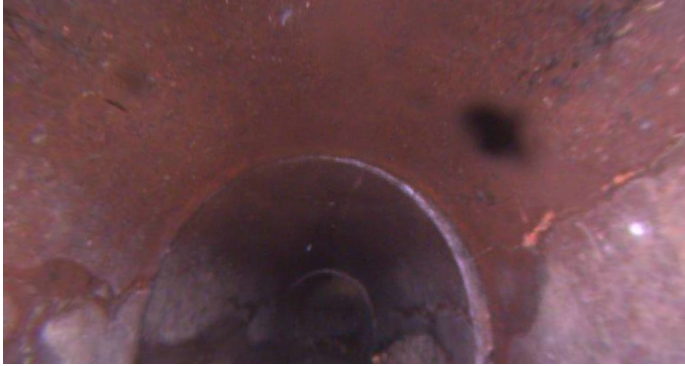
Code: **FM**  
Description: **Fracture Multiple**

Distance (ft): **169.1**  
Structural Grade: **4**  
O&M Grade: **0**  
Clock Start/From: **8**  
Clock To: **4**  
1st Value:  
2nd Value:  
Value Percent:  
Continuous Index:  
Within 8" of Joint: **YES**  
Remarks:

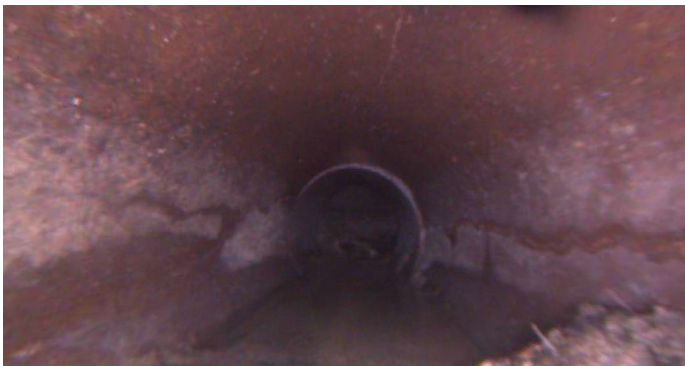
Code: **MSA**  
Description: **Abandoned Survey**

Distance (ft): **170.1**  
Structural Grade: **0**  
O&M Grade: **0**  
Clock Start/From:  
Clock To:  
1st Value:  
2nd Value:  
Value Percent:  
Continuous Index:  
Within 8" of Joint: **NO**  
Remarks: **Debris**
