Profile/Photo Observation Report

Date:	04/10/2018	Weather:		Coding:	PACP 6.0
Pipe Length (ft):	177.5	Owner:	NA	Pre Clean:	Not Known
P.O.#:		Surveyor:	Mark Ruby	PSR:	P-503-025-024
Customer:		Clean Date:	01/01/1900	Shape:	C

Street:	W 40th ave	Flow Control:	Not Controlled
City:	Hobart, IN	Year Renewed:	
Location:	Other	Tape/Media #:	
Purpose:	Not Known	Dia/Height:	10"
Use:	Sanitary	Material:	VCP
Drain Area:	NA	Lining:	
Category:	NA		
Comment:

Location Details:		Direction of Survey:	Downstream
US MH:	M-503-024	DS MH:	M-503-025
		Total Length Surveyed (ft):	170.1

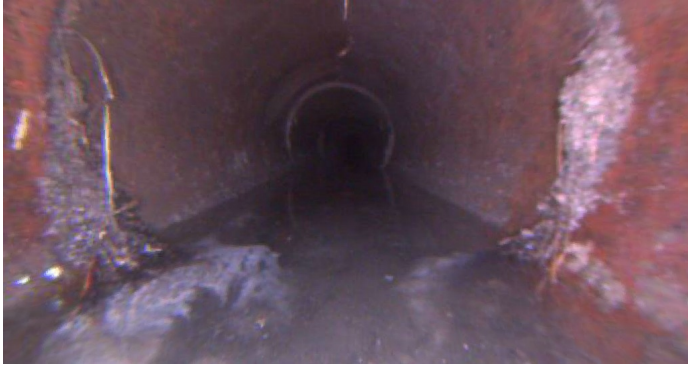
Code: **AMH**
Description: **Manhole**

Distance (ft): **.0**
Structural Grade: **0**
O&M Grade: **0**
Clock Start/From:
Clock To:
1st Value:
2nd Value:
Value Percent:
Continuous Index:
Within 8" of Joint: **NO**
Remarks: **M-503-024**

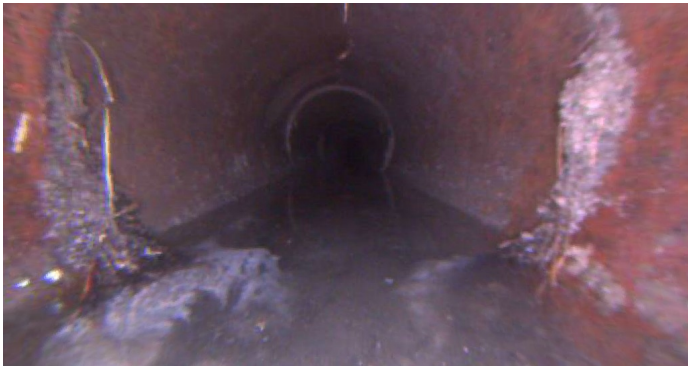
Code: **MWL**
Description: **Water Level**

Distance (ft): **.0**
Structural Grade: **0**
O&M Grade: **0**
Clock Start/From:
Clock To:
1st Value:
2nd Value:
Value Percent: **10.000**
Continuous Index:
Within 8" of Joint: **NO**
Remarks:

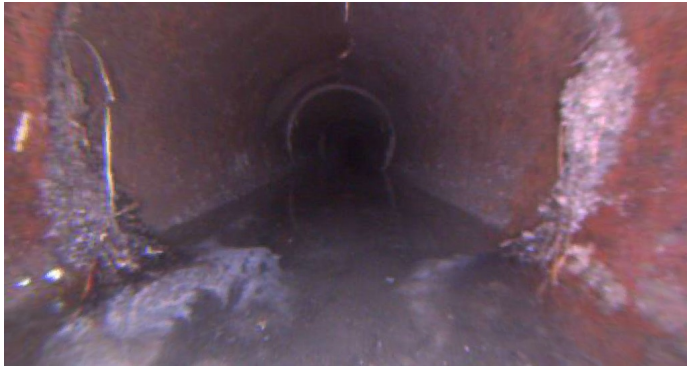
Code: **RFJ**
Description: **Roots Fine Joint**

Distance (ft): **.0**
Structural Grade: **0**
O&M Grade: **1**
Clock Start/From: **7**
Clock To: **5**
1st Value:
2nd Value:
Value Percent:
Continuous Index:
Within 8" of Joint: **YES**
Remarks:

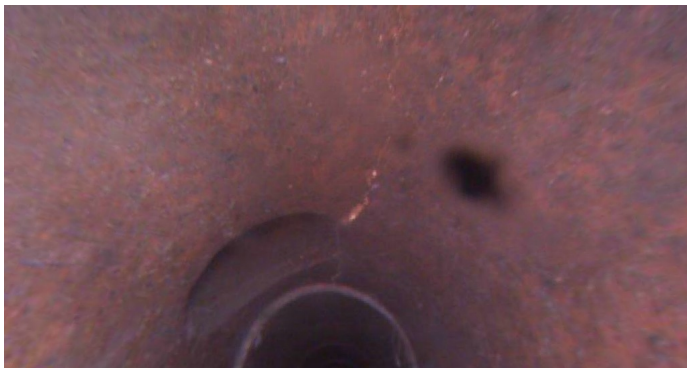
Code: **CL**
Description: **Crack Longitudinal**

Distance (ft): **1.0**
Structural Grade: **2**
O&M Grade: **0**
Clock Start/From: **12**
Clock To:
1st Value:
2nd Value:
Value Percent:
Continuous Index: **S02**
Within 8" of Joint:
Remarks:

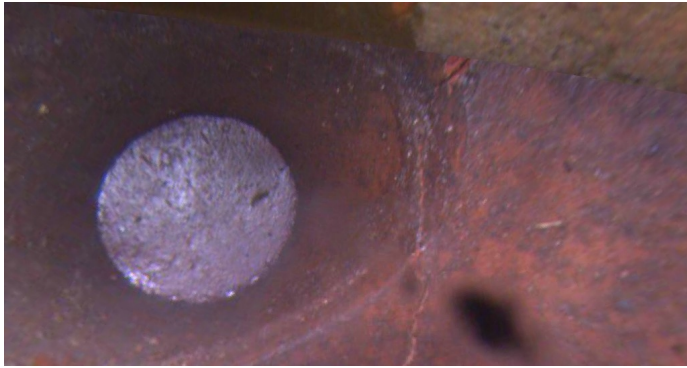
Code: **TFC**
Description: **Tap Factory Capped**

Distance (ft): **2.4**
Structural Grade: **0**
O&M Grade: **0**
Clock Start/From: **10**
Clock To:
1st Value: **4.000**
2nd Value:
Value Percent:
Continuous Index:
Within 8" of Joint:
Remarks:

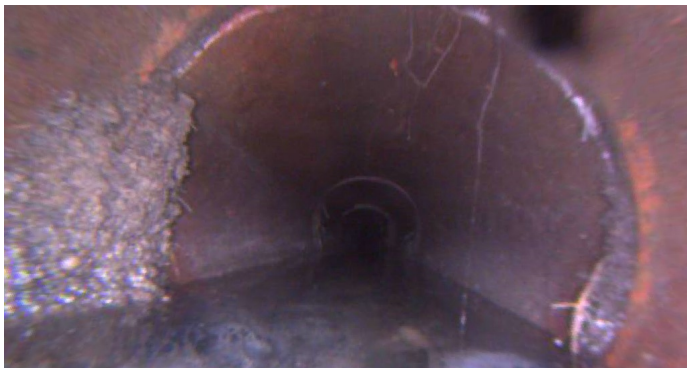
Code: **RFJ**
Description: **Roots Fine Joint**

Distance (ft): **4.6**
Structural Grade: **0**
O&M Grade: **1**
Clock Start/From: **7**
Clock To: **5**
1st Value:
2nd Value:
Value Percent:
Continuous Index: **S01**
Within 8" of Joint: **YES**
Remarks:

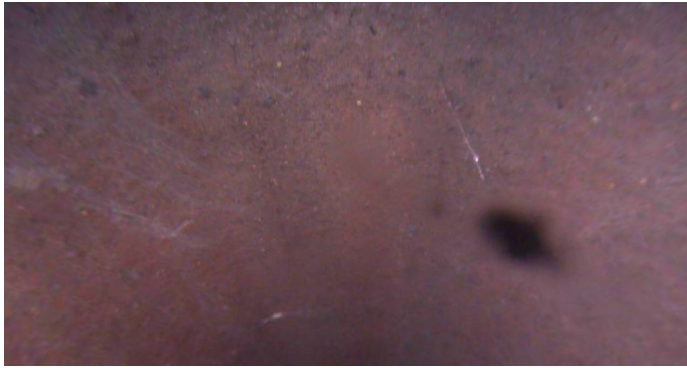
Code: **CL**
Description: **Crack Longitudinal**

Distance (ft): **13.4**
Structural Grade: **2**
O&M Grade: **0**
Clock Start/From: **12**
Clock To:
1st Value:
2nd Value:
Value Percent:
Continuous Index: **F02**
Within 8" of Joint:
Remarks:

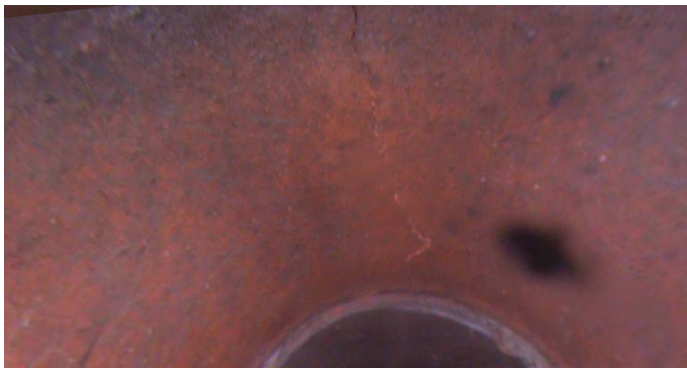
Code: **CL**
Description: **Crack Longitudinal**

Distance (ft): **16.3**
Structural Grade: **2**
O&M Grade: **0**
Clock Start/From: **12**
Clock To:
1st Value:
2nd Value:
Value Percent:
Continuous Index: **S03**
Within 8" of Joint: **YES**
Remarks:

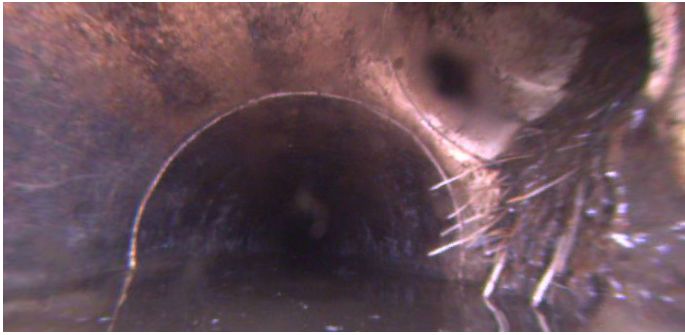
Code: **MMC**
Description: **Material Change**

Distance (ft): **39.7**
Structural Grade: **0**
O&M Grade: **0**
Clock Start/From:
Clock To:
1st Value:
2nd Value:
Value Percent:
Continuous Index:
Within 8" of Joint: **NO**
Remarks: **pvc**

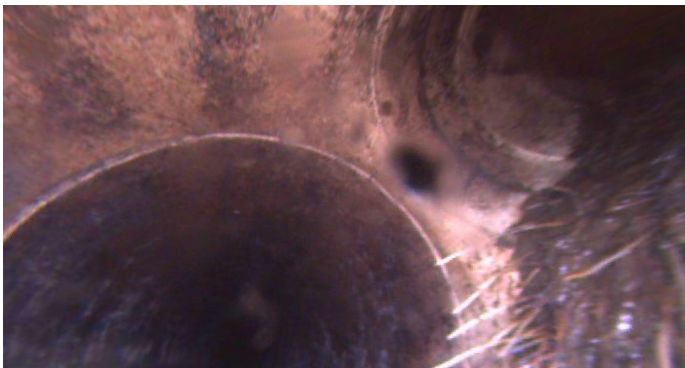
Code: **TFD**
Description: **Tap Factory Defective**

Distance (ft): **39.8**
Structural Grade: **0**
O&M Grade: **2**
Clock Start/From: **2**
Clock To:
1st Value: **4.000**
2nd Value:
Value Percent:
Continuous Index:
Within 8" of Joint:
Remarks: **Roots**

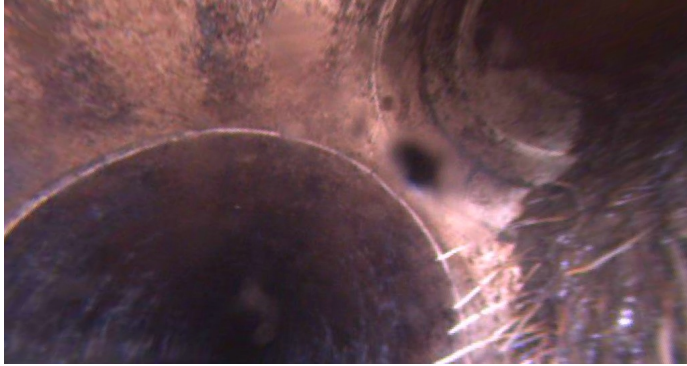
Code: **RFL**
Description: **Roots Fine Lateral**

Distance (ft): **39.8**
Structural Grade: **0**
O&M Grade: **1**
Clock Start/From: **2**
Clock To:
1st Value:
2nd Value:
Value Percent:
Continuous Index:
Within 8" of Joint: **NO**
Remarks:

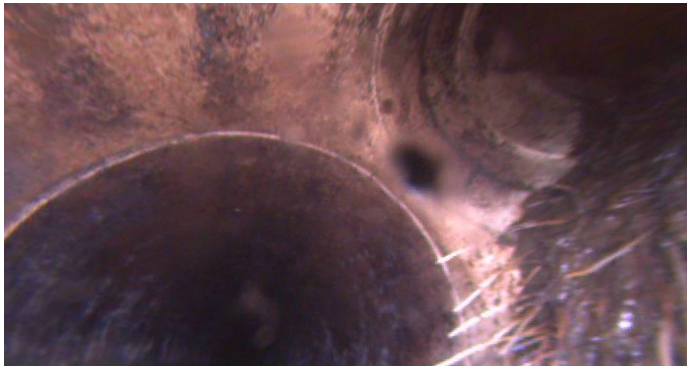
Code: **CL**
Description: **Crack Longitudinal**

Distance (ft): **39.8**
Structural Grade: **2**
O&M Grade: **0**
Clock Start/From: **12**
Clock To:
1st Value:
2nd Value:
Value Percent:
Continuous Index: **F03**
Within 8" of Joint: **YES**
Remarks:

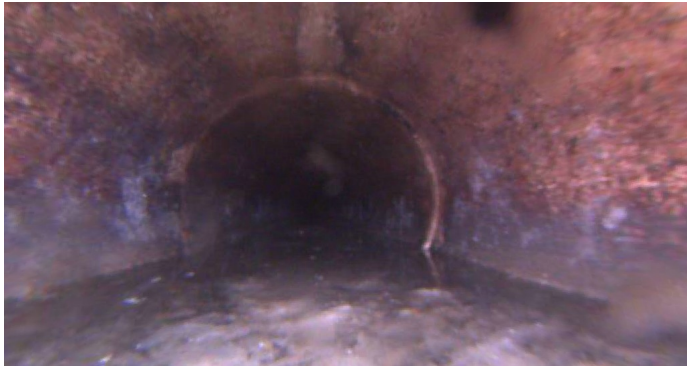
Code: **RFJ**
Description: **Roots Fine Joint**

Distance (ft): **48.6**
Structural Grade: **0**
O&M Grade: **1**
Clock Start/From: **7**
Clock To: **5**
1st Value:
2nd Value:
Value Percent:
Continuous Index: **F01**
Within 8" of Joint: **YES**
Remarks:

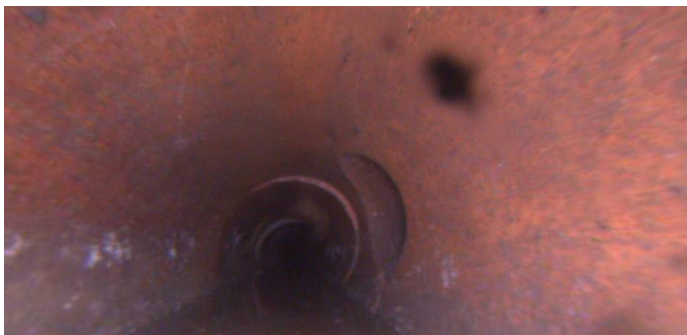
Code: **MMC**
Description: **Material Change**

Distance (ft): **68.0**
Structural Grade: **0**
O&M Grade: **0**
Clock Start/From:
Clock To:
1st Value:
2nd Value:
Value Percent:
Continuous Index:
Within 8" of Joint: **NO**
Remarks: **VCP**

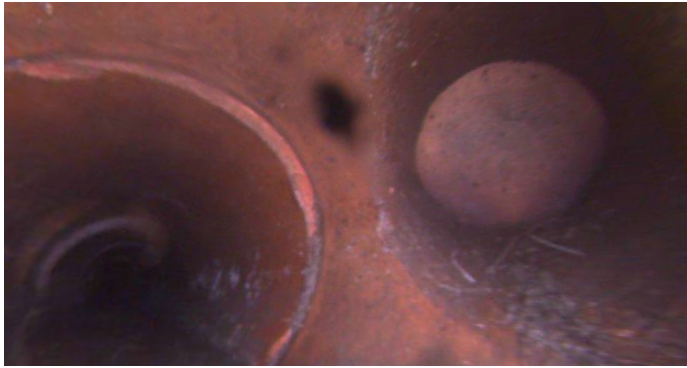
Code: **TFC**
Description: **Tap Factory Capped**

Distance (ft): **69.1**
Structural Grade: **0**
O&M Grade: **0**
Clock Start/From: **3**
Clock To:
1st Value: **4.000**
2nd Value:
Value Percent:
Continuous Index:
Within 8" of Joint:
Remarks:

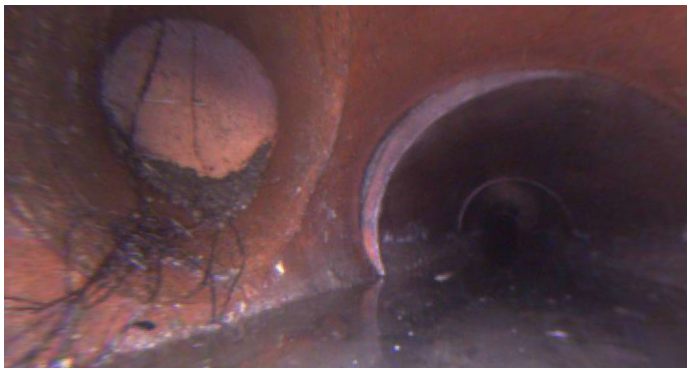
Code: **TFD**
Description: **Tap Factory Defective**

Distance (ft): **71.0**
Structural Grade: **0**
O&M Grade: **2**
Clock Start/From: **9**
Clock To:
1st Value: **4.000**
2nd Value:
Value Percent:
Continuous Index:
Within 8" of Joint:
Remarks: **ROOTS, CAPPED**

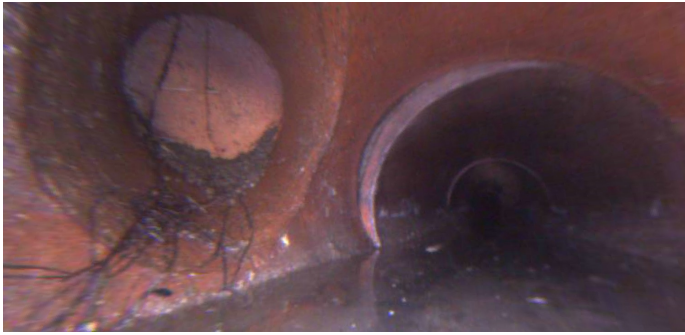
Code: **RFL**
Description: **Roots Fine Lateral**

Distance (ft): **71.0**
Structural Grade: **0**
O&M Grade: **1**
Clock Start/From: **9**
Clock To:
1st Value:
2nd Value:
Value Percent:
Continuous Index:
Within 8" of Joint: **NO**
Remarks:

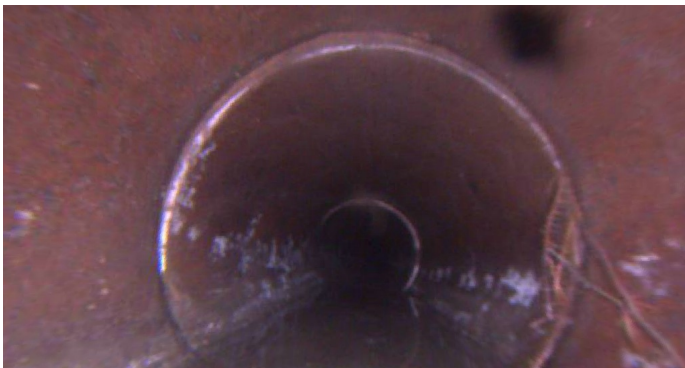
Code: **RFJ**
Description: **Roots Fine Joint**

Distance (ft): **77.4**
Structural Grade: **0**
O&M Grade: **1**
Clock Start/From: **4**
Clock To: **5**
1st Value:
2nd Value:
Value Percent:
Continuous Index:
Within 8" of Joint: **YES**
Remarks:

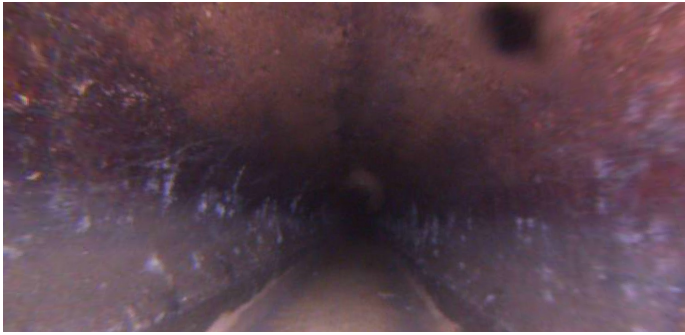
Code: **MMC**
Description: **Material Change**

Distance (ft): **79.7**
Structural Grade: **0**
O&M Grade: **0**
Clock Start/From:
Clock To:
1st Value:
2nd Value:
Value Percent:
Continuous Index:
Within 8" of Joint: **NO**
Remarks: **pvc**

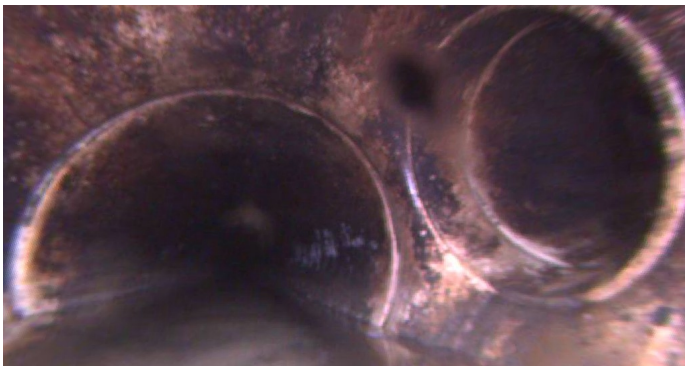
Code: **TF**
Description: **Tap Factory**

Distance (ft): **111.2**
Structural Grade: **0**
O&M Grade: **0**
Clock Start/From: **4**
Clock To:
1st Value: **4.000**
2nd Value:
Value Percent:
Continuous Index:
Within 8" of Joint:
Remarks:

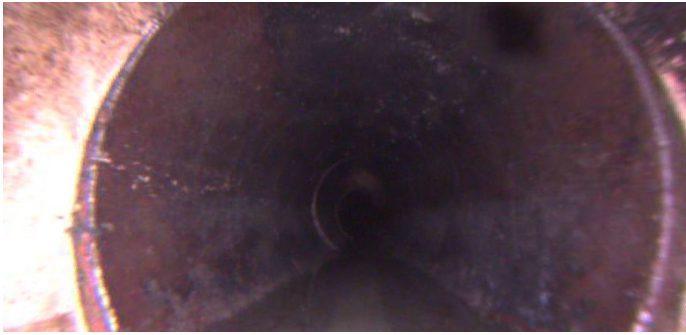
Code: **MMC**
Description: **Material Change**

Distance (ft): **145.8**
Structural Grade: **0**
O&M Grade: **0**
Clock Start/From:
Clock To:
1st Value:
2nd Value:
Value Percent:
Continuous Index:
Within 8" of Joint: **NO**
Remarks: **VCP**

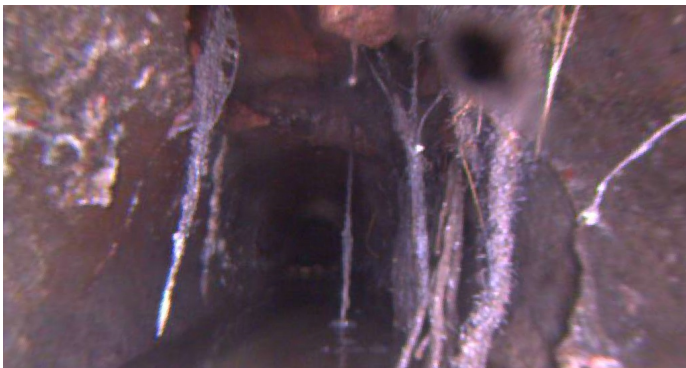
Code: **TBD**
Description: **Tap Break-in Defective**

Distance (ft): **166.0**
Structural Grade: **0**
O&M Grade: **3**
Clock Start/From: **12**
Clock To:
1st Value: **4.000**
2nd Value:
Value Percent:
Continuous Index:
Within 8" of Joint:
Remarks: **Roots**

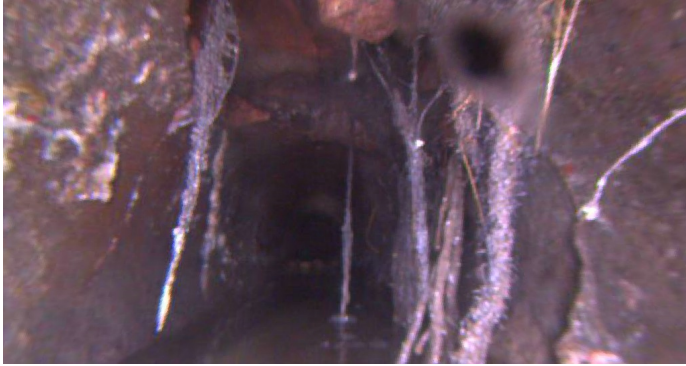
Code: **RFL**
Description: **Roots Fine Lateral**

Distance (ft): **166.0**
Structural Grade: **0**
O&M Grade: **1**
Clock Start/From: **12**
Clock To:
1st Value:
2nd Value:
Value Percent:
Continuous Index:
Within 8" of Joint: **NO**
Remarks:

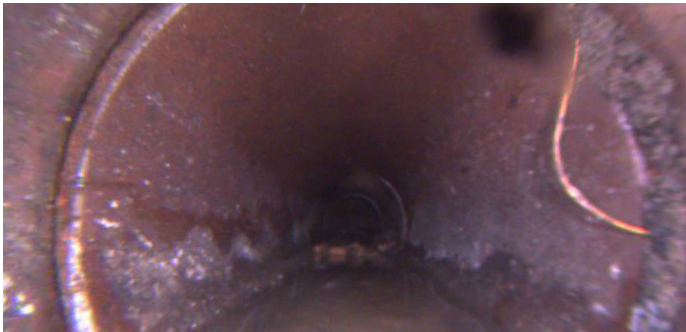
Code: **RFJ**
Description: **Roots Fine Joint**

Distance (ft): **167.6**
Structural Grade: **0**
O&M Grade: **1**
Clock Start/From: **2**
Clock To: **4**
1st Value:
2nd Value:
Value Percent:
Continuous Index:
Within 8" of Joint: **YES**
Remarks:

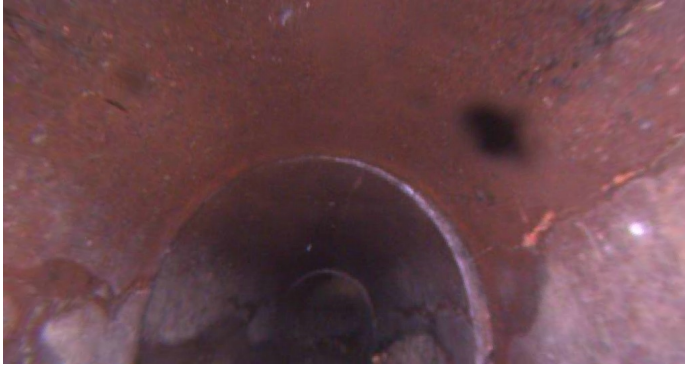
Code: **FM**
Description: **Fracture Multiple**

Distance (ft): **169.1**
Structural Grade: **4**
O&M Grade: **0**
Clock Start/From: **8**
Clock To: **4**
1st Value:
2nd Value:
Value Percent:
Continuous Index:
Within 8" of Joint: **YES**
Remarks:

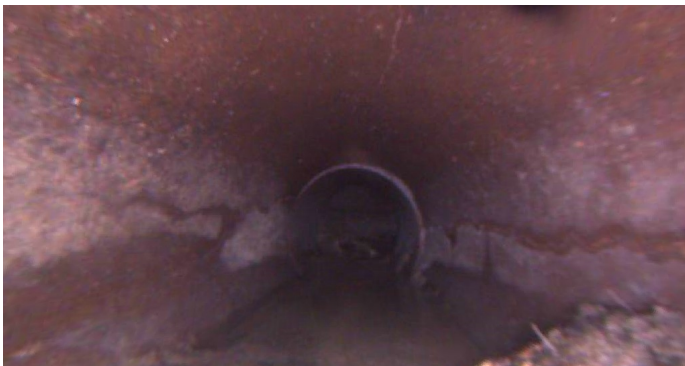
Code: **MSA**
Description: **Abandoned Survey**

Distance (ft): **170.1**
Structural Grade: **0**
O&M Grade: **0**
Clock Start/From:
Clock To:
1st Value:
2nd Value:
Value Percent:
Continuous Index:
Within 8" of Joint: **NO**
Remarks: **Debris**
