Profile/Photo Observation Report

Street: West 41st Avenue Flow Control: Not Controlled

US MH: M-503-026 DS MH: M-503-026.1 Total Length Surveyed (ft): 1.8

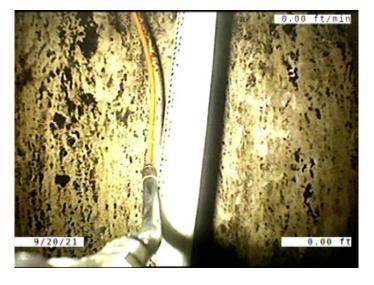
Description:	Manhole
Distance (ft):	.0
Structural Grade:	0
O&M Grade:	0
Clock Start/From:	
Clock To:	
1st Value:	
2nd Value:	
Value Percent:	
Continuous Index:	
Within 8" of Joint:	NO
Remarks:	M-503-026.1

AMH

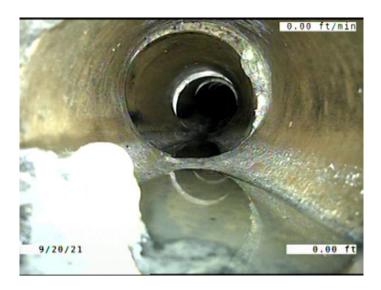
Code: MWL

Description: Miscellaneous Water Level

Distance (ft): .0
Structural Grade: 0
O&M Grade: 0

5.000

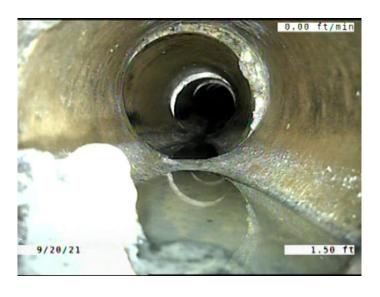
Code: MGO

Description: Miscellaneous General Observation

Distance (ft): 1.5
Structural Grade: 0
O&M Grade: 0
Clock Start/From:

Remarks: DROP INTO THE MANHOLE. HAD TO

START IN THE PIPE.

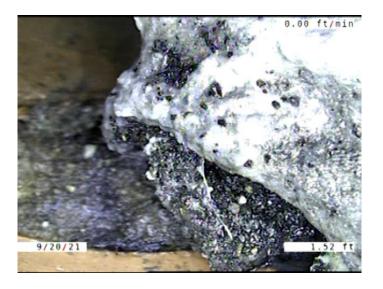
Code: DAE

Description: Deposits Attached Encrustation

Distance (ft): 1.5
Structural Grade: 0
O&M Grade: 2
Clock Start/From: 6
Clock To: 10

Value Percent: 10.000

YES

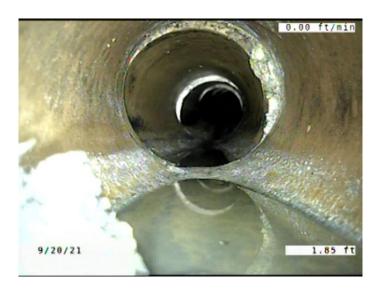
Code: MSA

Description: Miscellaneous Survey Abandoned

Distance (ft): 1.8
Structural Grade: 0

Remarks: CAMERA CANT MAKE IT PAST

ENCRUSTATIOIN
