## Profile/Photo Observation Report

Street:	<b>W 41ST AVE</b>	Flow Control:	<b>Not Controlled</b>
City:	<b>Hobart, IN</b>	Year Renewed:	
Location:	<b>Other</b>	Tape/Media #:	
Purpose:	<b>Not Known</b>	Dia/Height:	<b>10"</b>
Use:	<b>Sanitary</b>	Material:	<b>VCP</b>
Drain Area:	<b>NA</b>	Lining:	
Category:	<b>NA</b>		
Comment:

Location Details:		Direction of Survey:	<b>Upstream</b>
US MH:	<b>M-503-026</b>	DS MH:	<b>M-504-090</b>
		Total Length Surveyed (ft):	<b>12.5</b>

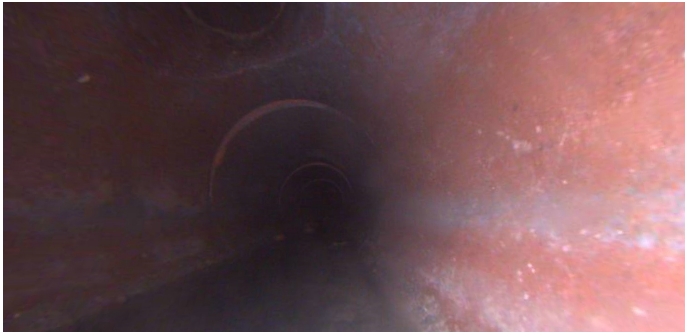
Code:	<b>MWL</b>
Description:	<b>Water Level</b>

Distance (ft):	<b>.0</b>
Structural Grade:	<b>0</b>
O&M Grade:	<b>0</b>
Clock Start/From:	
Clock To:	
1st Value:	
2nd Value:	
Value Percent:	<b>10.000</b>
Continuous Index:	
Within 8" of Joint:	<b>NO</b>
Remarks:

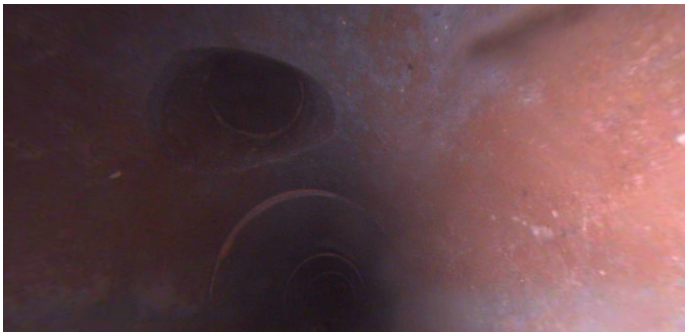
Code:	<b>TF</b>
Description:	<b>Tap Factory</b>

Distance (ft):	<b>.0</b>
Structural Grade:	<b>0</b>
O&M Grade:	<b>0</b>
Clock Start/From:	<b>12</b>
Clock To:	
1st Value:	<b>4.000</b>
2nd Value:	
Value Percent:	
Continuous Index:	
Within 8" of Joint:	
Remarks:

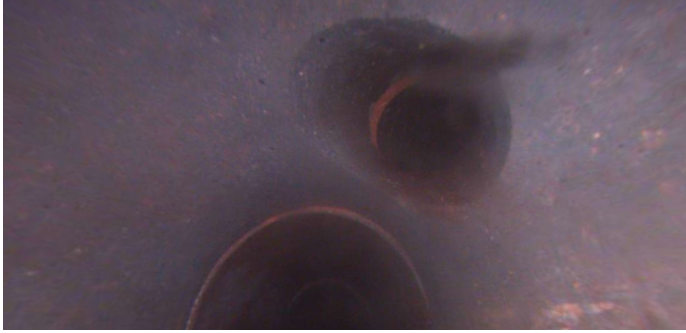
Code: **TF**  
Description: **Tap Factory**

Distance (ft): **3.6**  
Structural Grade: **0**  
O&M Grade: **0**  
Clock Start/From: **1**  
Clock To:  
1st Value: **4.000**  
2nd Value:  
Value Percent:  
Continuous Index:  
Within 8" of Joint:  
Remarks:

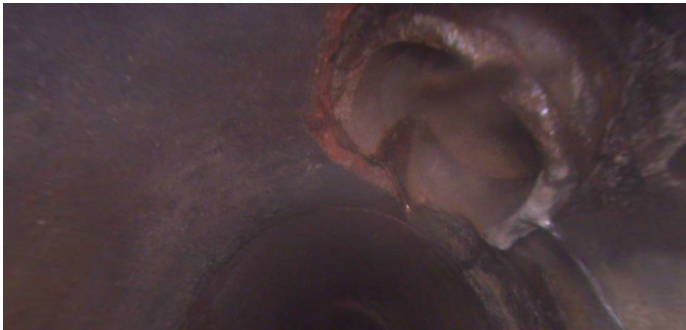
Code: **TBI**  
Description: **Tap Break-in Intruding**

Distance (ft): **8.0**  
Structural Grade: **0**  
O&M Grade: **2**  
Clock Start/From: **1**  
Clock To:  
1st Value: **4.000**  
2nd Value: **1.000**  
Value Percent:  
Continuous Index:  
Within 8" of Joint:  
Remarks:

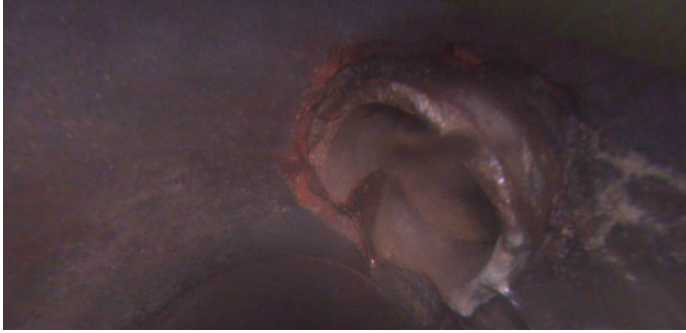
Code: **RFC**  
Description: **Roots Fine Connection**

Distance (ft): **8.0**  
Structural Grade: **0**  
O&M Grade: **1**  
Clock Start/From: **1**  
Clock To: **2**  
1st Value:  
2nd Value:  
Value Percent:  
Continuous Index:  
Within 8" of Joint: **NO**  
Remarks:

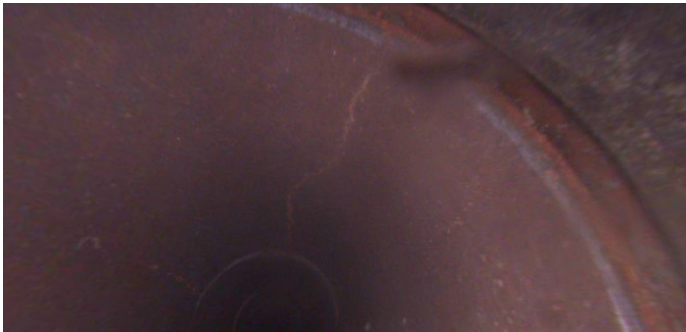
Code: **CL**  
Description: **Crack Longitudinal**

Distance (ft): **10.9**  
Structural Grade: **2**  
O&M Grade: **0**  
Clock Start/From: **1**  
Clock To:  
1st Value:  
2nd Value:  
Value Percent:  
Continuous Index:  
Within 8" of Joint: **YES**  
Remarks:

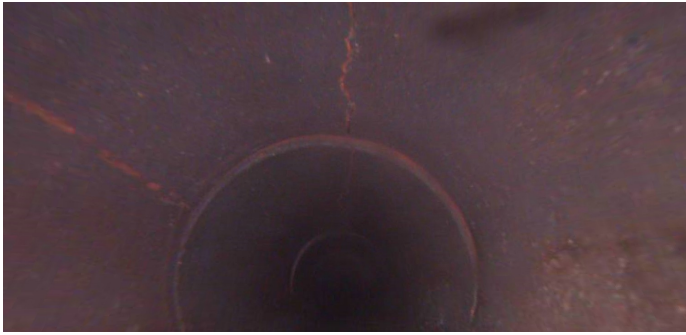
Code: **FM**  
Description: **Fracture Multiple**

Distance (ft): **12.2**  
Structural Grade: **4**  
O&M Grade: **0**  
Clock Start/From: **10**  
Clock To: **2**  
1st Value:  
2nd Value:  
Value Percent:  
Continuous Index:  
Within 8" of Joint: **YES**  
Remarks:

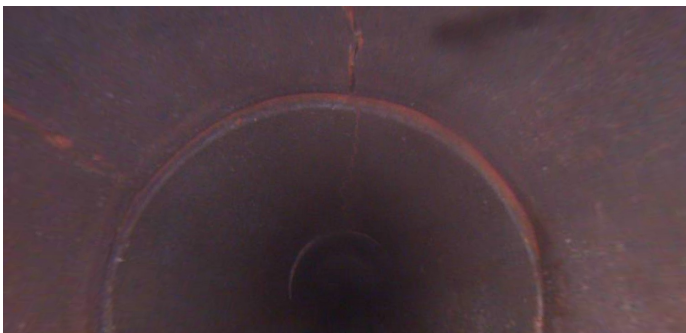
Code: **MSA**  
Description: **Abandoned Survey**

Distance (ft): **12.5**  
Structural Grade: **0**  
O&M Grade: **0**  
Clock Start/From:  
Clock To:  
1st Value:  
2nd Value:  
Value Percent:  
Continuous Index:  
Within 8" of Joint: **NO**  
Remarks: **debris under water**
