## Profile/Photo Observation Report

Date:	<b>04/09/2018</b>	Weather:		Coding:	<b>PACP 6.0</b>
Pipe Length (ft):	<b>166.6</b>	Owner:	<b>NA</b>	Pre Clean:	<b>Not Known</b>
P.O.#:		Surveyor:	<b>Jen Costello</b>	PSR:	<b>P-503-026-090</b>
Customer:		Clean Date:	<b>01/01/1900</b>	Shape:	<b>C</b>

Street:	<b>W 40th ave</b>	Flow Control:	<b>Not Controlled</b>
City:	<b>Hobart, IN</b>	Year Renewed:	
Location:	<b>Other</b>	Tape/Media #:	
Purpose:	<b>Not Known</b>	Dia/Height:	<b>10"</b>
Use:	<b>Sanitary</b>	Material:	<b>VCP</b>
Drain Area:	<b>NA</b>	Lining:	
Category:	<b>NA</b>		
Comment:

Location Details:		Direction of Survey:	<b>Upstream</b>
US MH:	<b>M-503-026</b>	DS MH:	<b>M-504-090</b>
		Total Length Surveyed (ft):	<b>12.5</b>

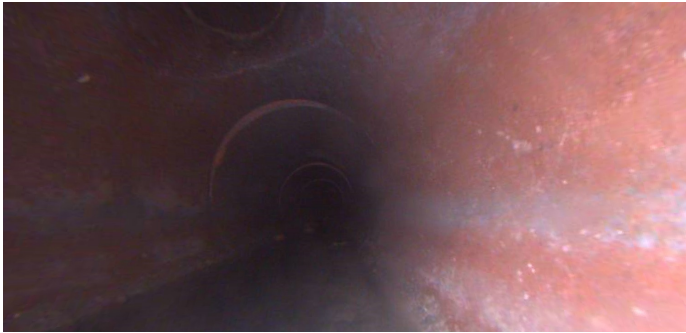
Code:	<b>MWL</b>
Description:	<b>Water Level</b>

Distance (ft):	<b>.0</b>
Structural Grade:	<b>0</b>
O&M Grade:	<b>0</b>
Clock Start/From:	
Clock To:	
1st Value:	
2nd Value:	
Value Percent:	<b>10.000</b>
Continuous Index:	
Within 8" of Joint:	<b>NO</b>
Remarks:

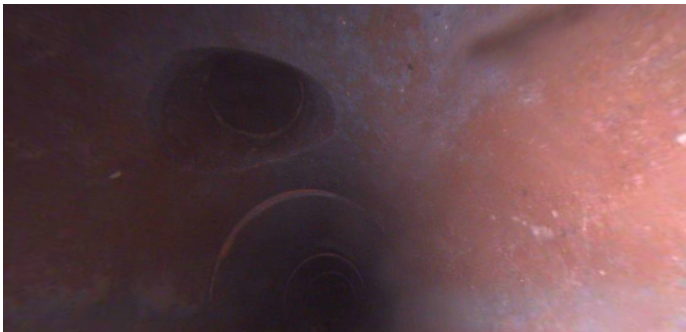
Code:	<b>TF</b>
Description:	<b>Tap Factory</b>

Distance (ft):	<b>.0</b>
Structural Grade:	<b>0</b>
O&M Grade:	<b>0</b>
Clock Start/From:	<b>12</b>
Clock To:	
1st Value:	<b>4.000</b>
2nd Value:	
Value Percent:	
Continuous Index:	
Within 8" of Joint:	
Remarks:

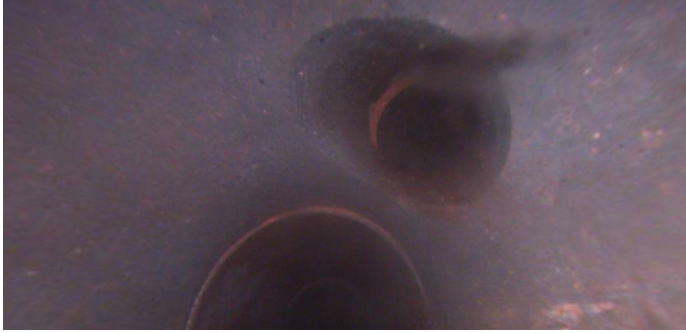
Code: **TF**  
Description: **Tap Factory**

Distance (ft): **3.6**  
Structural Grade: **0**  
O&M Grade: **0**  
Clock Start/From: **1**  
Clock To:  
1st Value: **4.000**  
2nd Value:  
Value Percent:  
Continuous Index:  
Within 8" of Joint:  
Remarks:

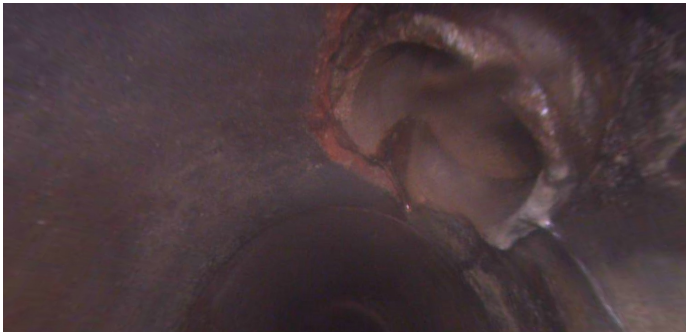
Code: **TBI**  
Description: **Tap Break-in Intruding**

Distance (ft): **8.0**  
Structural Grade: **0**  
O&M Grade: **2**  
Clock Start/From: **1**  
Clock To:  
1st Value: **4.000**  
2nd Value: **1.000**  
Value Percent:  
Continuous Index:  
Within 8" of Joint:  
Remarks:

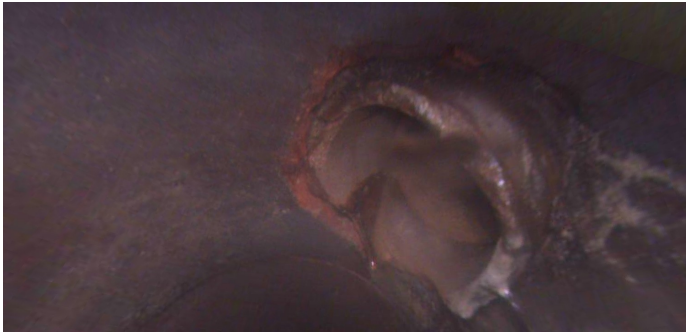
Code: **RFC**  
Description: **Roots Fine Connection**

Distance (ft): **8.0**  
Structural Grade: **0**  
O&M Grade: **1**  
Clock Start/From: **1**  
Clock To: **2**  
1st Value:  
2nd Value:  
Value Percent:  
Continuous Index:  
Within 8" of Joint: **NO**  
Remarks:

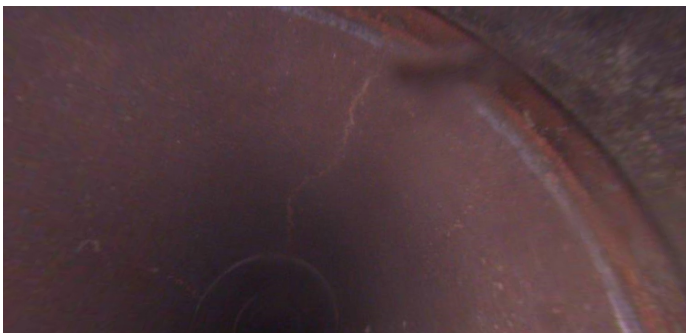
Code: **CL**  
Description: **Crack Longitudinal**

Distance (ft): **10.9**  
Structural Grade: **2**  
O&M Grade: **0**  
Clock Start/From: **1**  
Clock To:  
1st Value:  
2nd Value:  
Value Percent:  
Continuous Index:  
Within 8" of Joint: **YES**  
Remarks:

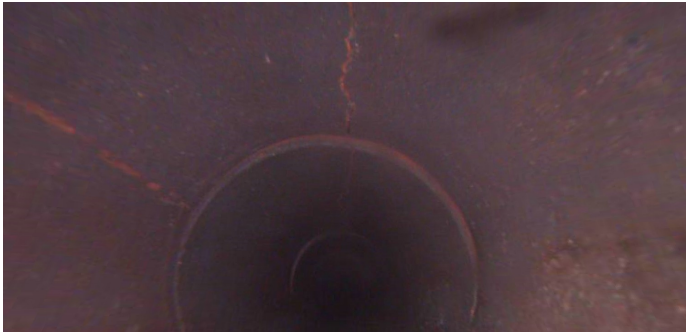
Code: **FM**  
Description: **Fracture Multiple**

Distance (ft): **12.2**  
Structural Grade: **4**  
O&M Grade: **0**  
Clock Start/From: **10**  
Clock To: **2**  
1st Value:  
2nd Value:  
Value Percent:  
Continuous Index:  
Within 8" of Joint: **YES**  
Remarks:

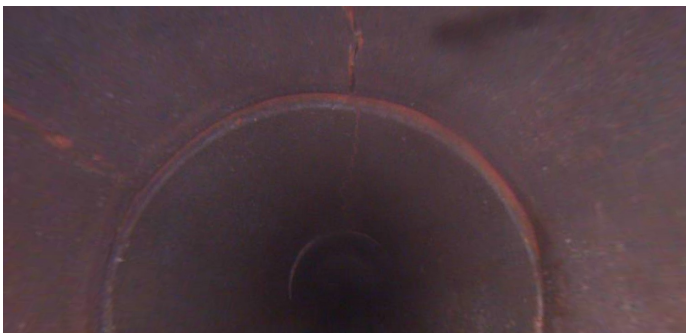
Code: **MSA**  
Description: **Abandoned Survey**

Distance (ft): **12.5**  
Structural Grade: **0**  
O&M Grade: **0**  
Clock Start/From:  
Clock To:  
1st Value:  
2nd Value:  
Value Percent:  
Continuous Index:  
Within 8" of Joint: **NO**  
Remarks: **debris under water**
