Profile/Photo Observation Report

Date:	04/09/2018	Weather:		Coding:	PACP 6.0
Pipe Length (ft):	166.6	Owner:	NA	Pre Clean:	Not Known
P.O.#:		Surveyor:	Byrd Fitzgerald	PSR:	P-503-026-090
Customer:		Clean Date:	01/01/1900	Shape:	C

Street:	W 41ST AVE	Flow Control:	Not Controlled
City:	Hobart, IN	Year Renewed:	
Location:	Other	Tape/Media #:	
Purpose:	Not Known	Dia/Height:	10"
Use:	Sanitary	Material:	VCP
Drain Area:	NA	Lining:	
Category:	NA		
Comment:

Location Details:		Direction of Survey:	Upstream
US MH:	M-503-026	DS MH:	M-504-090
		Total Length Surveyed (ft):	39.2

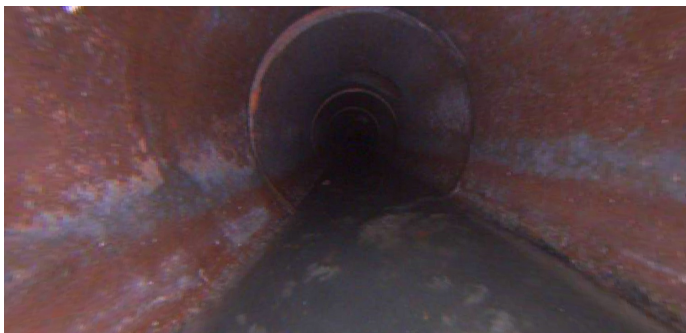
Code: **AMH**
Description: **Manhole**

Distance (ft): **.0**
Structural Grade: **0**
O&M Grade: **0**
Clock Start/From:
Clock To:
1st Value:
2nd Value:
Value Percent:
Continuous Index:
Within 8" of Joint: **NO**
Remarks: **M-504-090**

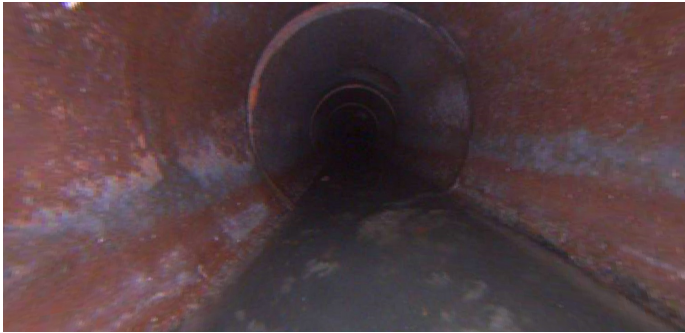
Code:	MWL
Description:	Water Level

Distance (ft):	.0
Structural Grade:	0
O&M Grade:	0
Clock Start/From:	
Clock To:	
1st Value:	
2nd Value:	
Value Percent:	5.000
Continuous Index:	
Within 8" of Joint:	NO
Remarks:

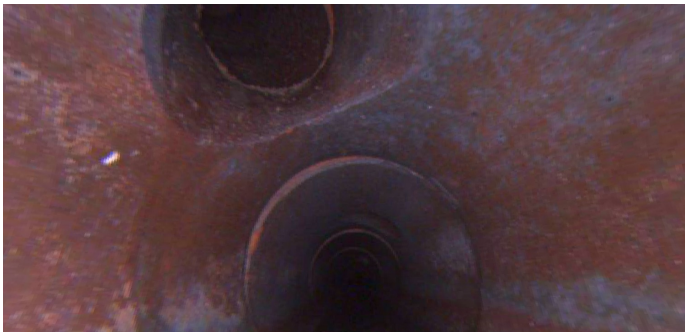
Code:	TF
Description:	Tap Factory

Distance (ft):	.0
Structural Grade:	0
O&M Grade:	0
Clock Start/From:	11
Clock To:	
1st Value:	4.000
2nd Value:	
Value Percent:	
Continuous Index:	
Within 8" of Joint:	YES
Remarks:

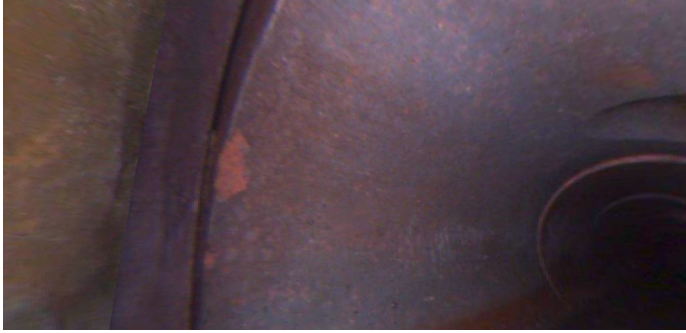
Code: **MGO**
Description: **General Observation**

Distance (ft): **2.5**
Structural Grade: **0**
O&M Grade: **0**
Clock Start/From:
Clock To:
1st Value:
2nd Value:
Value Percent:
Continuous Index:
Within 8" of Joint: **NO**
Remarks: **chip at joint**

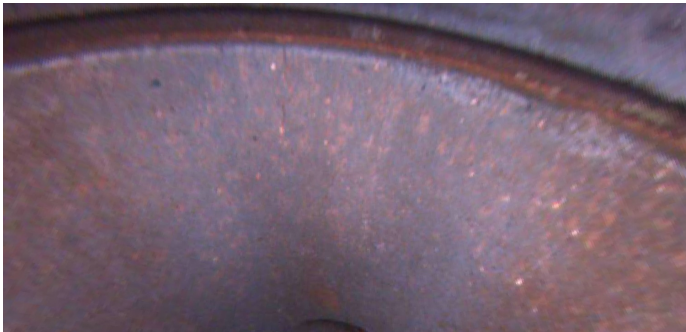
Code: **CL**
Description: **Crack Longitudinal**

Distance (ft): **2.5**
Structural Grade: **2**
O&M Grade: **0**
Clock Start/From: **12**
Clock To:
1st Value:
2nd Value:
Value Percent:
Continuous Index:
Within 8" of Joint: **YES**
Remarks:

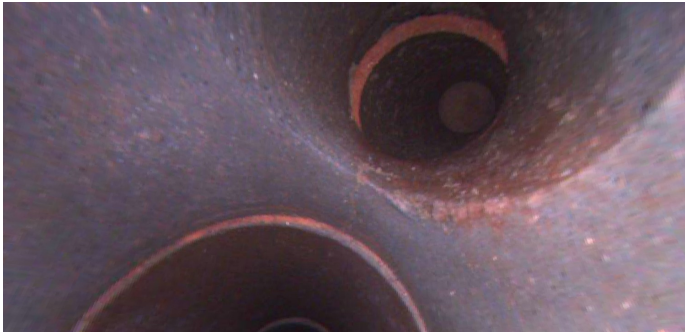
Code: **TF**
Description: **Tap Factory**

Distance (ft): **3.6**
Structural Grade: **0**
O&M Grade: **0**
Clock Start/From: **1**
Clock To:
1st Value: **4.000**
2nd Value:
Value Percent:
Continuous Index:
Within 8" of Joint: **YES**
Remarks:

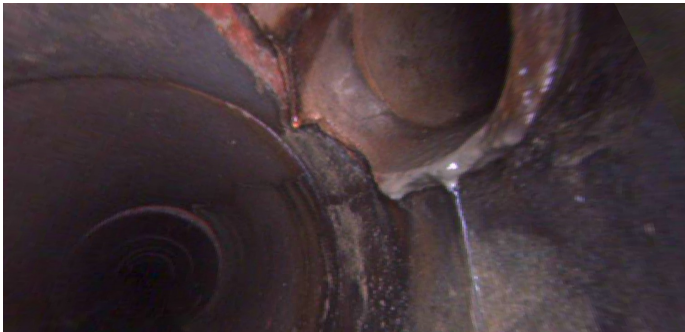
Code: **TB**
Description: **Tap Break-in**

Distance (ft): **7.9**
Structural Grade: **0**
O&M Grade: **0**
Clock Start/From: **1**
Clock To:
1st Value: **4.000**
2nd Value:
Value Percent:
Continuous Index:
Within 8" of Joint: **YES**
Remarks:

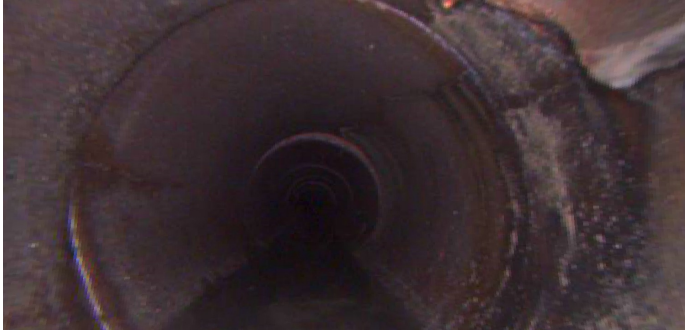
Code: **CM**
Description: **Crack Multiple**

Distance (ft): **7.9**
Structural Grade: **3**
O&M Grade: **0**
Clock Start/From: **9**
Clock To: **5**
1st Value:
2nd Value:
Value Percent:
Continuous Index: **S01**
Within 8" of Joint: **YES**
Remarks: **wandering**

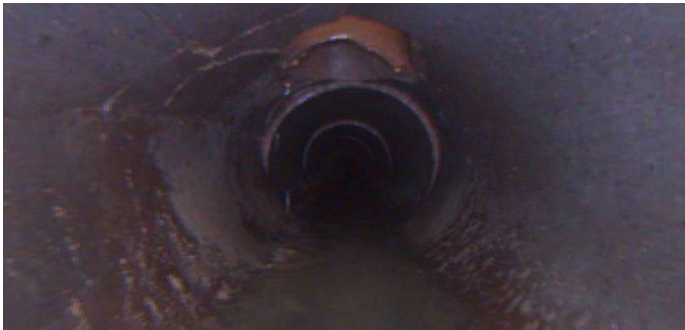
Code: **TB**
Description: **Tap Break-in**

Distance (ft): **17.0**
Structural Grade: **0**
O&M Grade: **0**
Clock Start/From: **12**
Clock To:
1st Value: **4.000**
2nd Value:
Value Percent:
Continuous Index:
Within 8" of Joint: **YES**
Remarks:

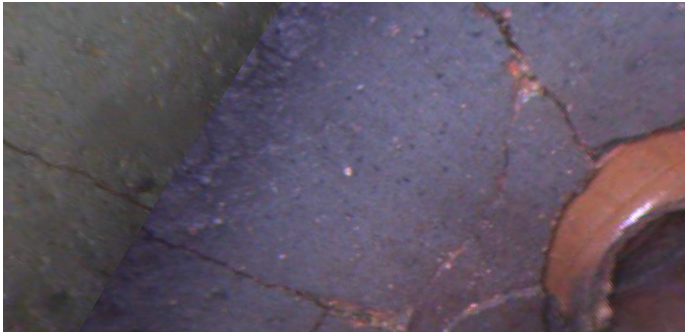
Code: **FM**
Description: **Fracture Multiple**

Distance (ft): **17.6**
Structural Grade: **4**
O&M Grade: **0**
Clock Start/From: **7**
Clock To: **12**
1st Value:
2nd Value:
Value Percent:
Continuous Index:
Within 8" of Joint:
Remarks:

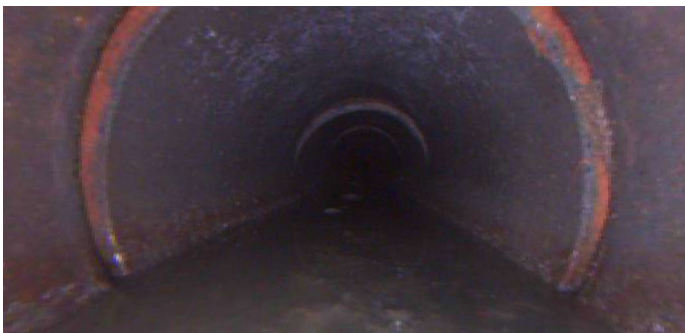
Code: **DSZ**
Description: **Deposits Settled Other**

Distance (ft): **26.7**
Structural Grade: **0**
O&M Grade: **2**
Clock Start/From: **6**
Clock To:
1st Value:
2nd Value:
Value Percent: **5.000**
Continuous Index: **S02**
Within 8" of Joint: **NO**
Remarks: **tissue**

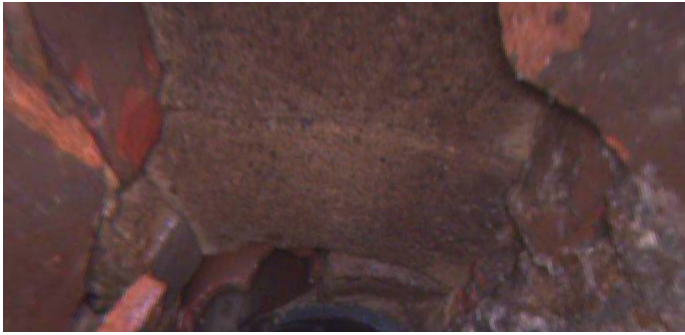
Code: **RPP**
Description: **Repair Patch**

Distance (ft): **38.8**
Structural Grade: **0**
O&M Grade: **0**
Clock Start/From: **10**
Clock To: **2**
1st Value:
2nd Value:
Value Percent:
Continuous Index:
Within 8" of Joint: **NO**
Remarks: **former access point patched**

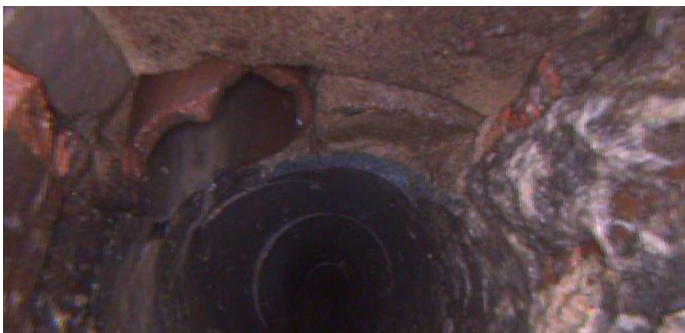
Code: **TB**
Description: **Tap Break-in**

Distance (ft): **39.2**
Structural Grade: **0**
O&M Grade: **0**
Clock Start/From: **11**
Clock To:
1st Value: **4.000**
2nd Value:
Value Percent:
Continuous Index:
Within 8" of Joint:
Remarks:

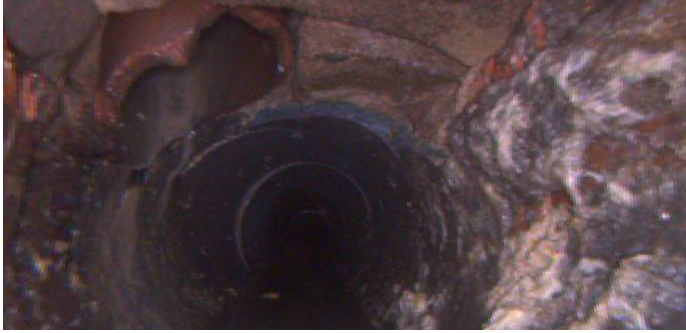
Code: **MSA**
Description: **Abandoned Survey**

Distance (ft): **39.2**
Structural Grade: **0**
O&M Grade: **0**
Clock Start/From:
Clock To:
1st Value:
2nd Value:
Value Percent:
Continuous Index:
Within 8" of Joint: **NO**
Remarks: **no blockage**

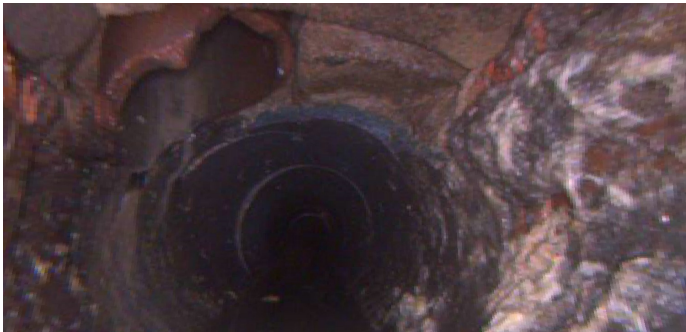
Code: **CM**
Description: **Crack Multiple**

Distance (ft): **39.2**
Structural Grade: **3**
O&M Grade: **0**
Clock Start/From: **9**
Clock To: **5**
1st Value:
2nd Value:
Value Percent:
Continuous Index: **F01**
Within 8" of Joint: **YES**
Remarks: **wandering**

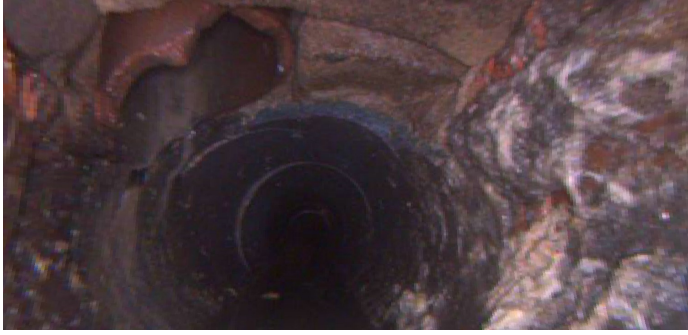
Code:	DSZ
Description:	Deposits Settled Other
Distance (ft):	39.2
Structural Grade:	0
O&M Grade:	2
Clock Start/From:	6
Clock To:	
1st Value:	
2nd Value:	
Value Percent:	5.000
Continuous Index:	F02
Within 8" of Joint:	NO
Remarks:	tissue
