Profile/Photo Observation Report

Date:	04/09/2018	Weather:		Coding:	PACP 6.0
Pipe Length (ft):	166.6	Owner:	NA	Pre Clean:	Not Known
P.O.#:		Surveyor:	Byrd Fitzgerald	PSR:	P-503-026-090
Customer:		Clean Date:	01/01/1900	Shape:	C

Street:	W 40th ave	Flow Control:	Not Controlled
City:	Hobart, IN	Year Renewed:	
Location:	Other	Tape/Media #:	
Purpose:	Not Known	Dia/Height:	10"
Use:	Sanitary	Material:	VCP
Drain Area:	NA	Lining:	
Category:	NA		
Comment:			
Location Details:		Direction of Survey:	Upstream
US MH:	M-503-026	DS MH:	M-504-090
		Total Length Surveyed (ft):	39.2

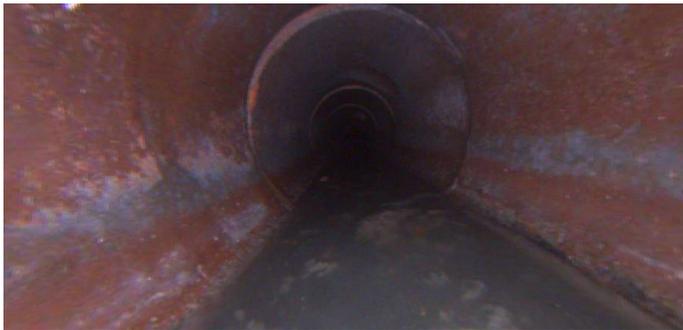
Code: **AMH**
 Description: **Manhole**
 Distance (ft): **.0**
 Structural Grade: **0**
 O&M Grade: **0**
 Clock Start/From:
 Clock To:
 1st Value:
 2nd Value:
 Value Percent:
 Continuous Index:
 Within 8" of Joint: **NO**
 Remarks: **M-504-090**

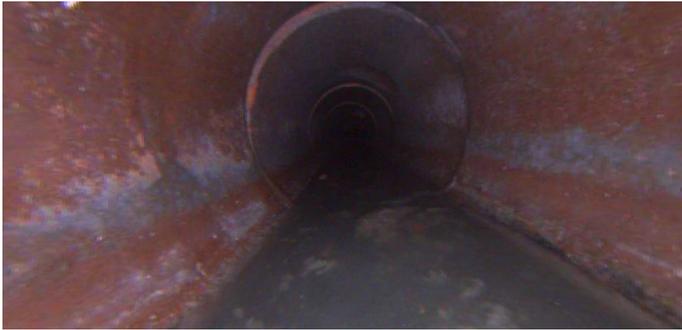
Code: **MWL**
Description: **Water Level**

Distance (ft): **.0**
Structural Grade: **0**
O&M Grade: **0**
Clock Start/From:
Clock To:
1st Value:
2nd Value:
Value Percent: **5.000**
Continuous Index:
Within 8" of Joint: **NO**
Remarks:

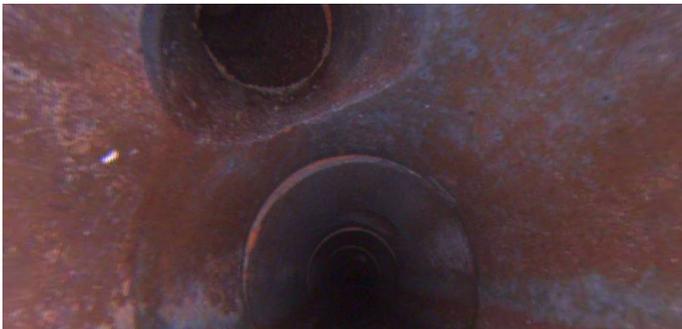
Code: **TF**
Description: **Tap Factory**

Distance (ft): **.0**
Structural Grade: **0**
O&M Grade: **0**
Clock Start/From: **11**
Clock To:
1st Value: **4.000**
2nd Value:
Value Percent:
Continuous Index:
Within 8" of Joint: **YES**
Remarks:

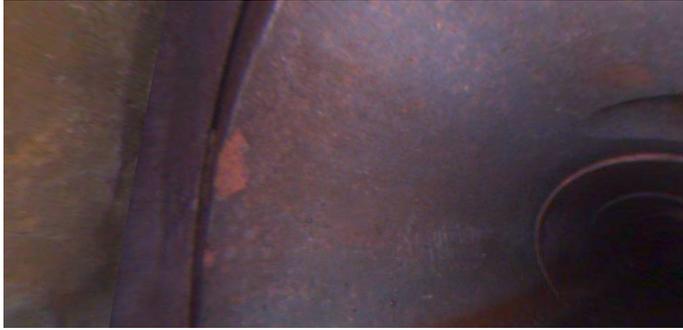
Code: **MGO**
Description: **General Observation**

Distance (ft): **2.5**
Structural Grade: **0**
O&M Grade: **0**
Clock Start/From:
Clock To:
1st Value:
2nd Value:
Value Percent:
Continuous Index:
Within 8" of Joint: **NO**
Remarks: **chip at joint**

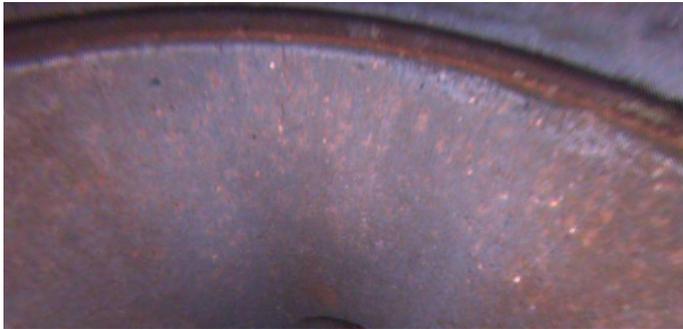
Code: **CL**
Description: **Crack Longitudinal**

Distance (ft): **2.5**
Structural Grade: **2**
O&M Grade: **0**
Clock Start/From: **12**
Clock To:
1st Value:
2nd Value:
Value Percent:
Continuous Index:
Within 8" of Joint: **YES**
Remarks:

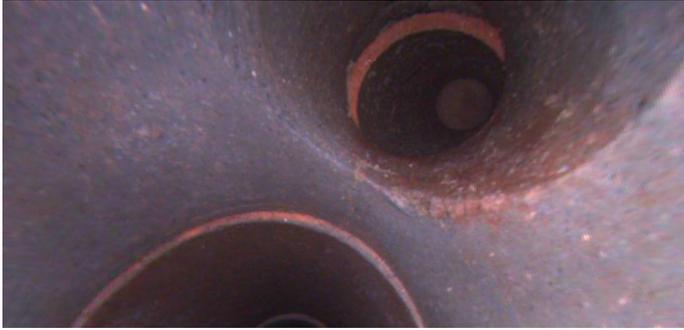
Code: **TF**
Description: **Tap Factory**

Distance (ft): **3.6**
Structural Grade: **0**
O&M Grade: **0**
Clock Start/From: **1**
Clock To:
1st Value: **4.000**
2nd Value:
Value Percent:
Continuous Index:
Within 8" of Joint: **YES**
Remarks:

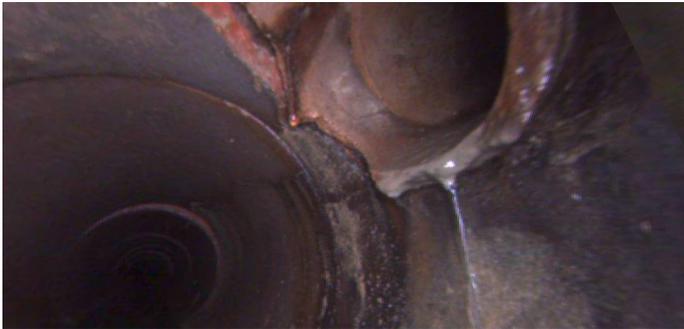
Code: **TB**
Description: **Tap Break-in**

Distance (ft): **7.9**
Structural Grade: **0**
O&M Grade: **0**
Clock Start/From: **1**
Clock To:
1st Value: **4.000**
2nd Value:
Value Percent:
Continuous Index:
Within 8" of Joint: **YES**
Remarks:

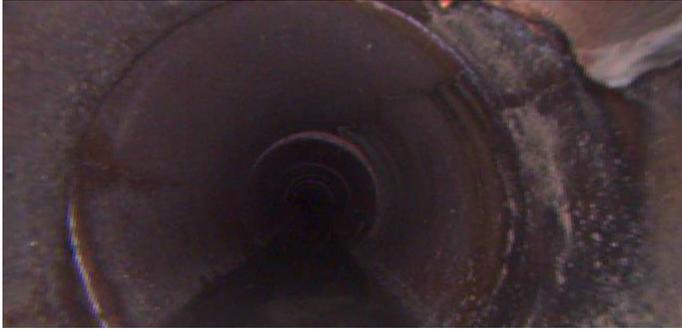
Code: **CM**
Description: **Crack Multiple**

Distance (ft): **7.9**
Structural Grade: **3**
O&M Grade: **0**
Clock Start/From: **9**
Clock To: **5**
1st Value:
2nd Value:
Value Percent:
Continuous Index: **S01**
Within 8" of Joint: **YES**
Remarks: **wandering**

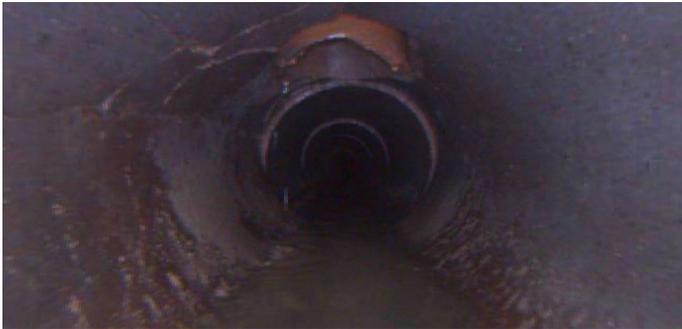
Code: **TB**
Description: **Tap Break-in**

Distance (ft): **17.0**
Structural Grade: **0**
O&M Grade: **0**
Clock Start/From: **12**
Clock To:
1st Value: **4.000**
2nd Value:
Value Percent:
Continuous Index:
Within 8" of Joint: **YES**
Remarks:

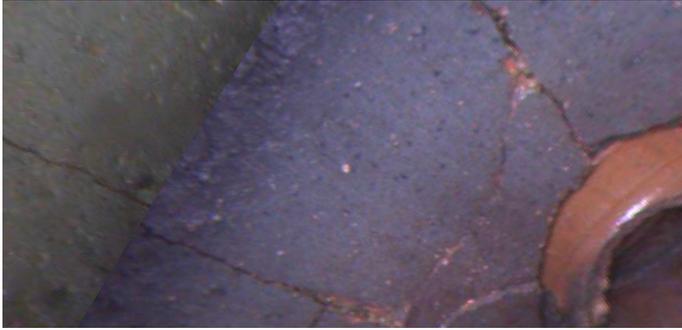
Code: **FM**
Description: **Fracture Multiple**

Distance (ft): **17.6**
Structural Grade: **4**
O&M Grade: **0**
Clock Start/From: **7**
Clock To: **12**
1st Value:
2nd Value:
Value Percent:
Continuous Index:
Within 8" of Joint:
Remarks:

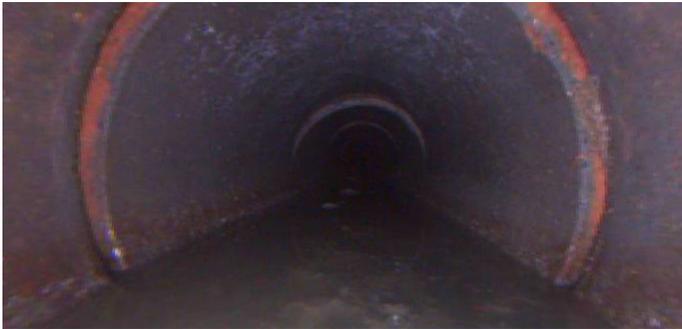
Code: **DSZ**
Description: **Deposits Settled Other**

Distance (ft): **26.7**
Structural Grade: **0**
O&M Grade: **2**
Clock Start/From: **6**
Clock To:
1st Value:
2nd Value:
Value Percent: **5.000**
Continuous Index: **S02**
Within 8" of Joint: **NO**
Remarks: **tissue**

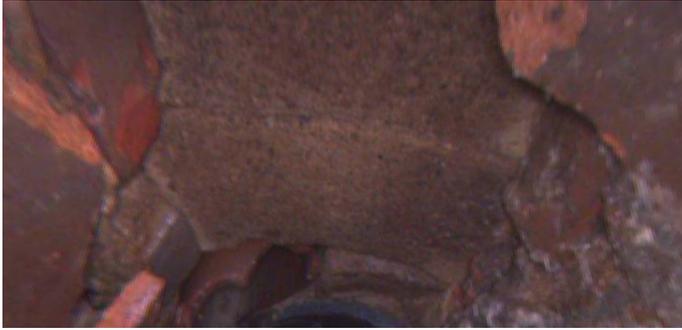
Code: **RPP**
Description: **Repair Patch**

Distance (ft): **38.8**
Structural Grade: **0**
O&M Grade: **0**
Clock Start/From: **10**
Clock To: **2**
1st Value:
2nd Value:
Value Percent:
Continuous Index:
Within 8" of Joint: **NO**
Remarks: **former access point patched**

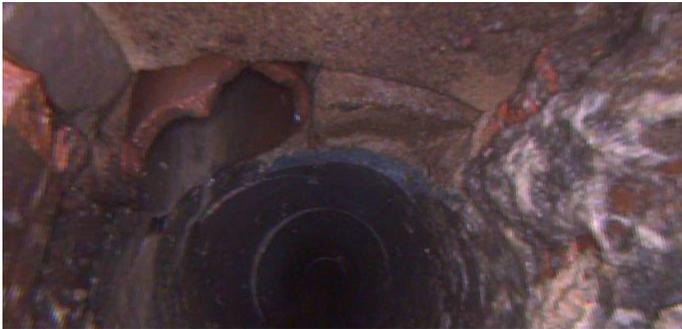
Code: **TB**
Description: **Tap Break-in**

Distance (ft): **39.2**
Structural Grade: **0**
O&M Grade: **0**
Clock Start/From: **11**
Clock To:
1st Value: **4.000**
2nd Value:
Value Percent:
Continuous Index:
Within 8" of Joint:
Remarks:

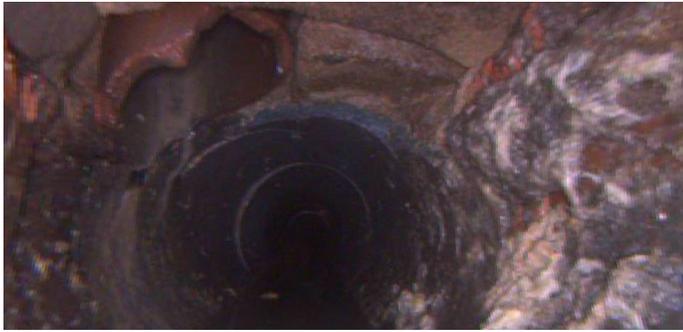
Code: **MSA**
Description: **Abandoned Survey**

Distance (ft): **39.2**
Structural Grade: **0**
O&M Grade: **0**
Clock Start/From:
Clock To:
1st Value:
2nd Value:
Value Percent:
Continuous Index:
Within 8" of Joint: **NO**
Remarks: **no blockage**

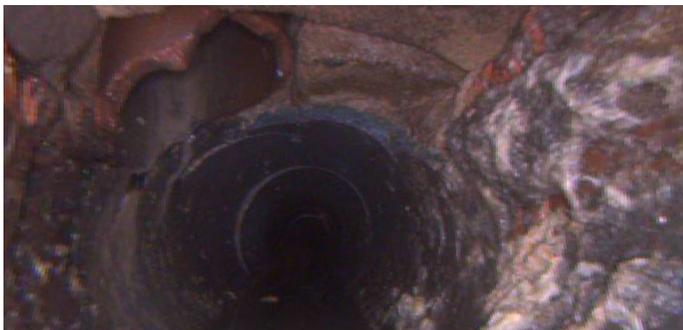
Code: **CM**
Description: **Crack Multiple**

Distance (ft): **39.2**
Structural Grade: **3**
O&M Grade: **0**
Clock Start/From: **9**
Clock To: **5**
1st Value:
2nd Value:
Value Percent:
Continuous Index: **F01**
Within 8" of Joint: **YES**
Remarks: **wandering**

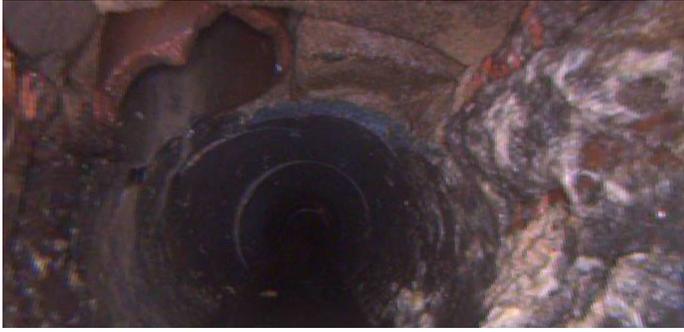
Code: **DSZ**
Description: **Deposits Settled Other**

Distance (ft): **39.2**
Structural Grade: **0**
O&M Grade: **2**
Clock Start/From: **6**
Clock To:
1st Value:
2nd Value:
Value Percent: **5.000**
Continuous Index: **F02**
Within 8" of Joint: **NO**
Remarks: **tissue**
