Profile/Photo Observation Report

Date:	09/20/2021	Weather:		Coding:	PACP 7.0
Pipe Length (ft):	157.2	Owner:	City of Hobart	Pre Clean:	Light Cleaning
P.O.#:	YES502259	Surveyor:	S. Bucklin	PSR:	P-503-026-090
Customer:	City of Hobart	Clean Date:	08/28/2021	Shape:	C

Street:	West 41st Avenue	Flow Control:	Not Controlled
City:	Hobart, IN	Year Renewed:	
Location:	Local rural streets with light traffic, t	Tape/Media #:	
Purpose:	Routine Assessment	Dia/Height:	12"
Use:	Sanitary Sewage Pipe	Material:	VCP
Drain Area:		Lining:	None
Category:	NA		
Comment:			
Location Details:		Direction of Survey:	Downstream
US MH:	M-503-026	DS MH:	M-504-090
		Total Length Surveyed (ft):	157.2

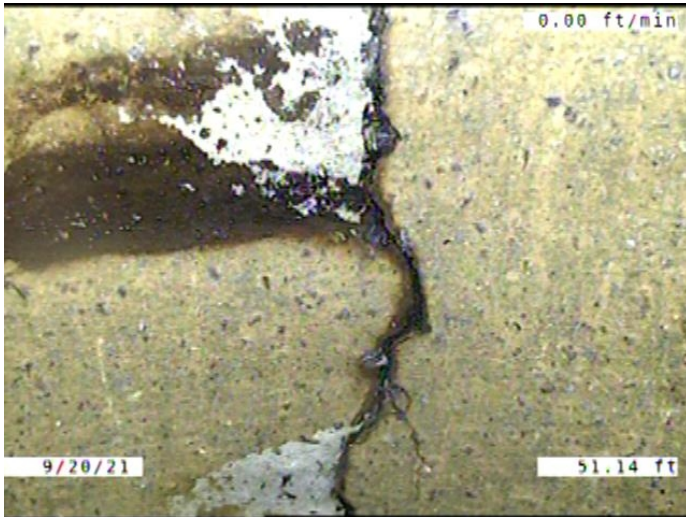
Code: **ISB**
 Description: **Infiltration Stain Barrel**

Distance (ft): **51.1**
 Structural Grade: **0**
 O&M Grade: **1**
 Clock Start/From: **8**
 Clock To: **4**
 1st Value:
 2nd Value:
 Value Percent:
 Continuous Index: **S04**
 Within 8" of Joint: **YES**
 Remarks:

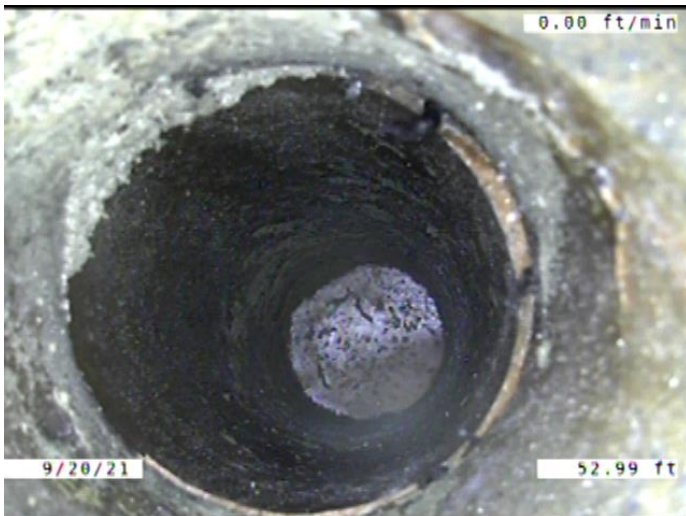
Code: **TFD**
 Description: **Tap Factory Defective**

Distance (ft): **53.0**
 Structural Grade: **0**
 O&M Grade: **3**
 Clock Start/From: **11**
 Clock To:
 1st Value: **4.000**
 2nd Value:
 Value Percent:
 Continuous Index:
 Within 8" of Joint: **YES**
 Remarks: **CAPPED**

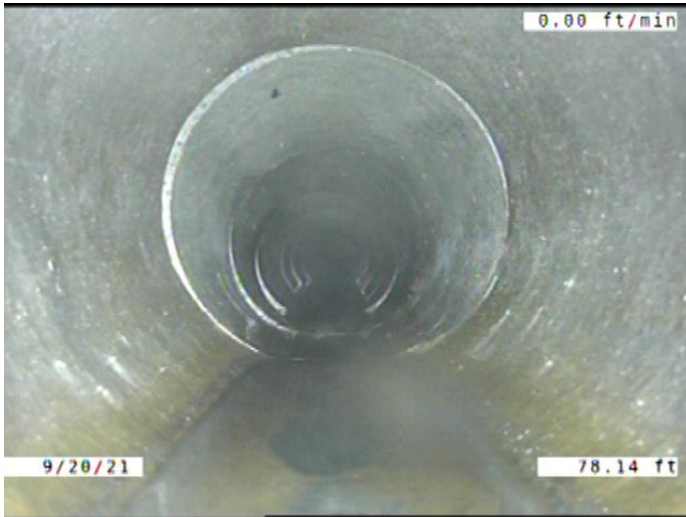
Code: **ISB**
 Description: **Infiltration Stain Barrel**

Distance (ft): **78.1**
 Structural Grade: **0**
 O&M Grade: **1**
 Clock Start/From: **8**
 Clock To: **4**
 1st Value:
 2nd Value:
 Value Percent:
 Continuous Index: **F04**
 Within 8" of Joint: **YES**
 Remarks:

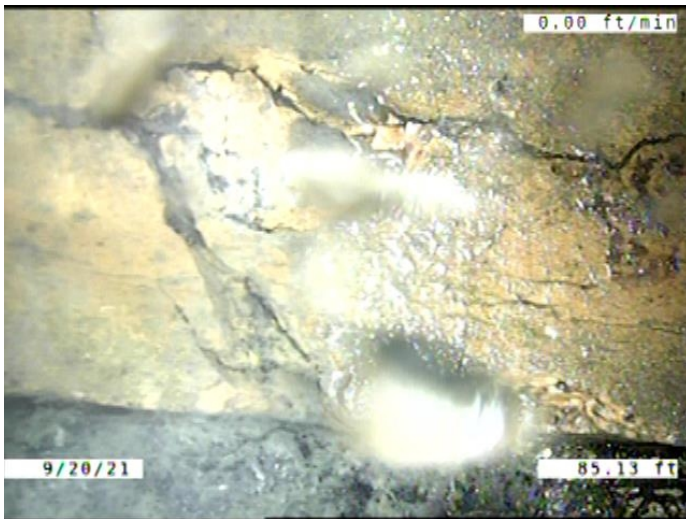
Code: **B**
 Description: **Broken**

Distance (ft): **85.1**
 Structural Grade: **4**
 O&M Grade: **0**
 Clock Start/From: **3**
 Clock To: **7**
 1st Value:
 2nd Value:
 Value Percent:
 Continuous Index:
 Within 8" of Joint: **YES**
 Remarks:

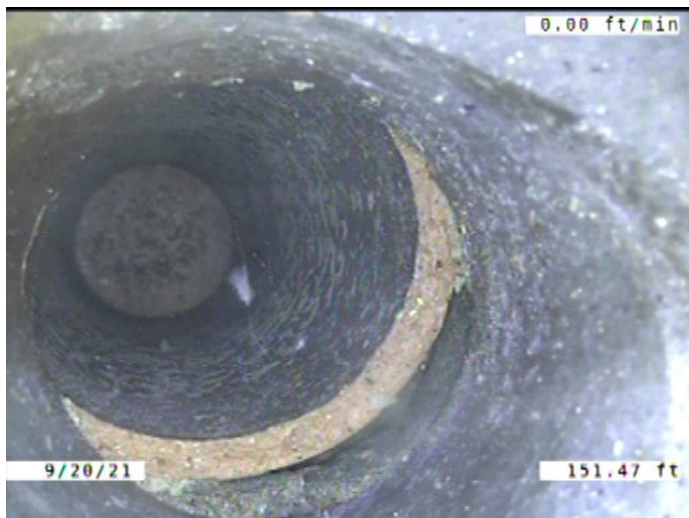
Code: **TFD**
 Description: **Tap Factory Defective**

Distance (ft): **151.5**
 Structural Grade: **0**
 O&M Grade: **3**
 Clock Start/From: **11**
 Clock To:
 1st Value: **4.000**
 2nd Value:
 Value Percent:
 Continuous Index:
 Within 8" of Joint: **YES**
 Remarks: **LOOKS CAPPED**

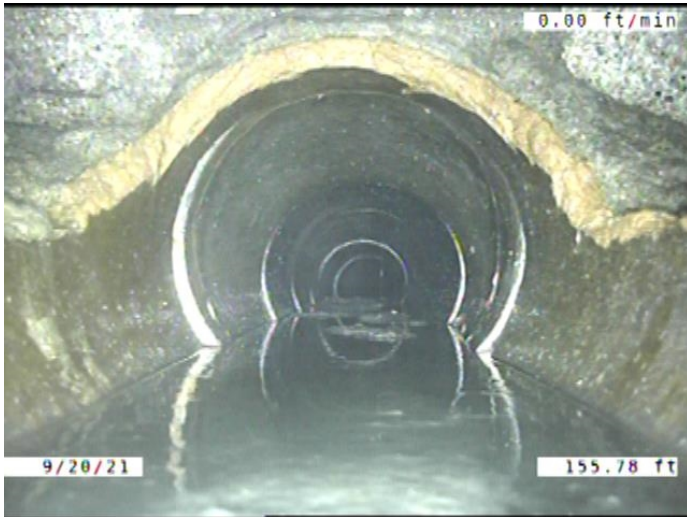
Code: **FM**
Description: **Fracture Multiple**

Distance (ft): **155.8**
Structural Grade: **4**
O&M Grade: **0**
Clock Start/From: **12**
Clock To: **12**
1st Value:
2nd Value:
Value Percent:
Continuous Index: **F02**
Within 8" of Joint: **YES**
Remarks:

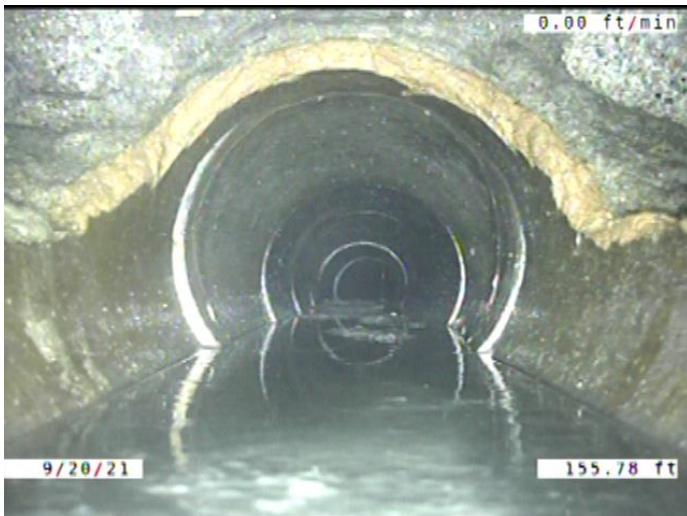
Code: **DSF**
Description: **Deposits Settled Fine**

Distance (ft): **155.8**
Structural Grade: **0**
O&M Grade: **2**
Clock Start/From: **5**
Clock To: **7**
1st Value:
2nd Value:
Value Percent: **5.000**
Continuous Index: **F01**
Within 8" of Joint: **YES**
Remarks:
