Profile/Photo Observation Report

Date:	09/20/2021	Weather:		Coding:	PACP 7.0
Pipe Length (ft):	157.2	Owner:	City of Hobart	Pre Clean:	Light Cleaning
P.O.#:	YES502259	Surveyor:	S. Bucklin	PSR:	P-503-026-090
Customer:	City of Hobart	Clean Date:	08/28/2021	Shape:	C

Street:	West 41st Avenue	Flow Control:	Not Controlled
City:	Hobart, IN	Year Renewed:	
Location:	Local rural streets with light traffic, t	Tape/Media #:	
Purpose:	Routine Assessment	Dia/Height:	12"
Use:	Sanitary Sewage Pipe	Material:	VCP
Drain Area:		Lining:	None
Category:	NA		
Comment:			
Location Details:		Direction of Survey:	Downstream
US MH:	M-503-026	DS MH:	M-504-090
		Total Length Surveyed (ft):	157.2

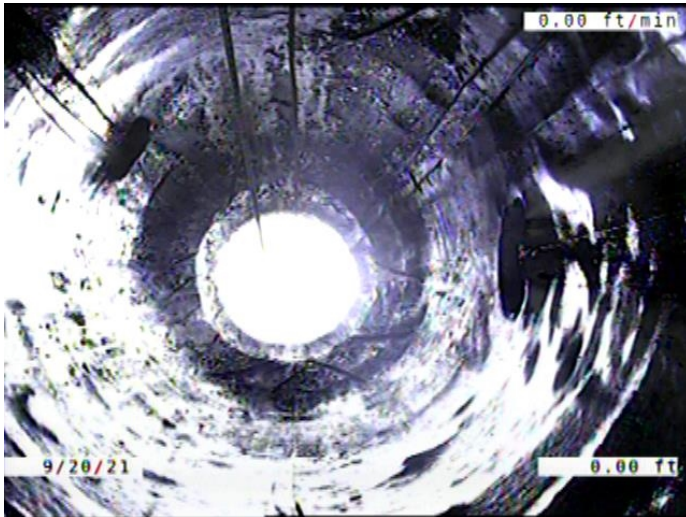
Code: **AMH**
 Description: **Manhole**

Distance (ft): **.0**
 Structural Grade: **0**
 O&M Grade: **0**
 Clock Start/From:
 Clock To:
 1st Value:
 2nd Value:
 Value Percent:
 Continuous Index:
 Within 8" of Joint: **NO**
 Remarks: **M-503-026**

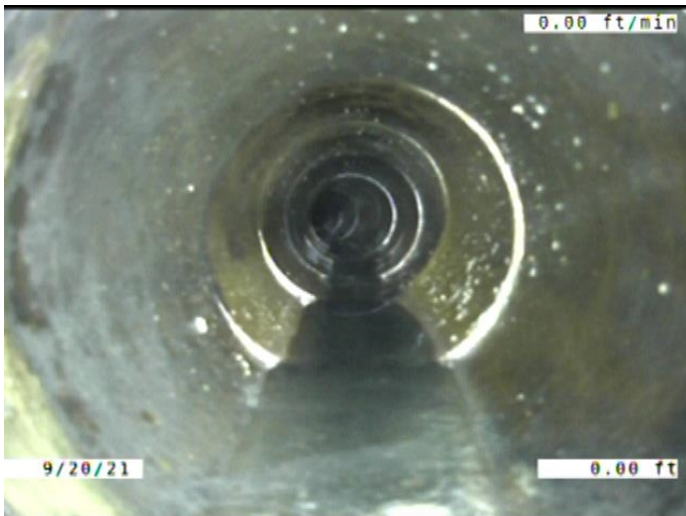
Code: **MWL**
 Description: **Miscellaneous Water Level**

Distance (ft): **.0**
 Structural Grade: **0**
 O&M Grade: **0**
 Clock Start/From:
 Clock To:
 1st Value:
 2nd Value:
 Value Percent: **5.000**
 Continuous Index:
 Within 8" of Joint: **NO**
 Remarks:

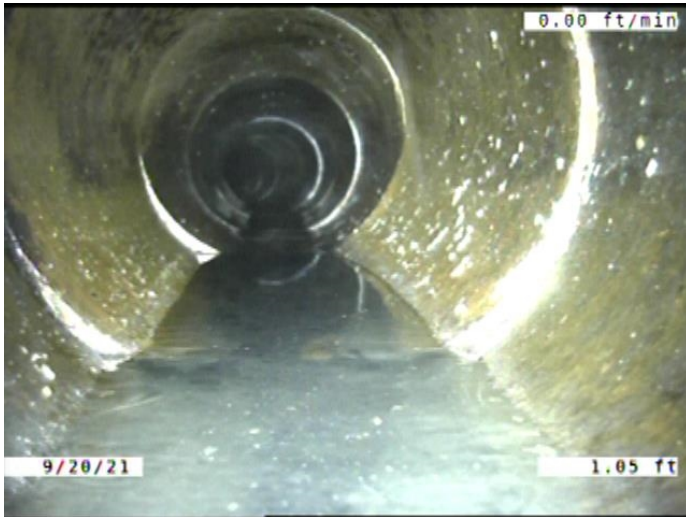
Code: **DSF**
 Description: **Deposits Settled Fine**

Distance (ft): **1.0**
 Structural Grade: **0**
 O&M Grade: **2**
 Clock Start/From: **5**
 Clock To: **7**
 1st Value:
 2nd Value:
 Value Percent: **5.000**
 Continuous Index: **S01**
 Within 8" of Joint: **YES**
 Remarks:

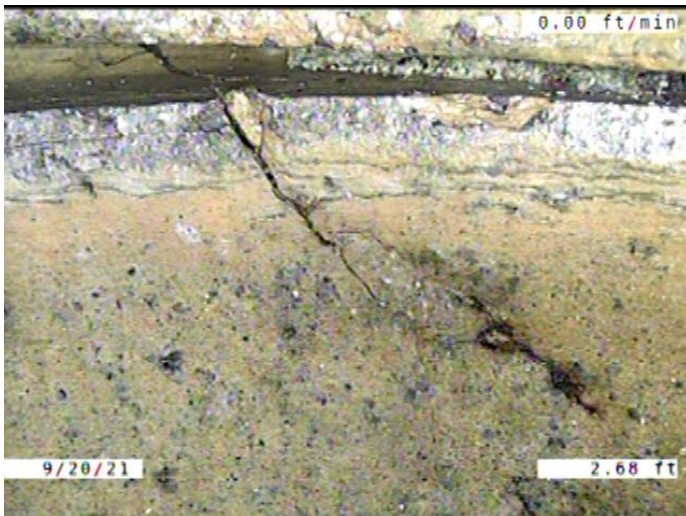
Code: **FS**
 Description: **Fracture Spiral**

Distance (ft): **2.7**
 Structural Grade: **3**
 O&M Grade: **0**
 Clock Start/From: **2**
 Clock To: **3**
 1st Value:
 2nd Value:
 Value Percent:
 Continuous Index:
 Within 8" of Joint: **YES**
 Remarks:

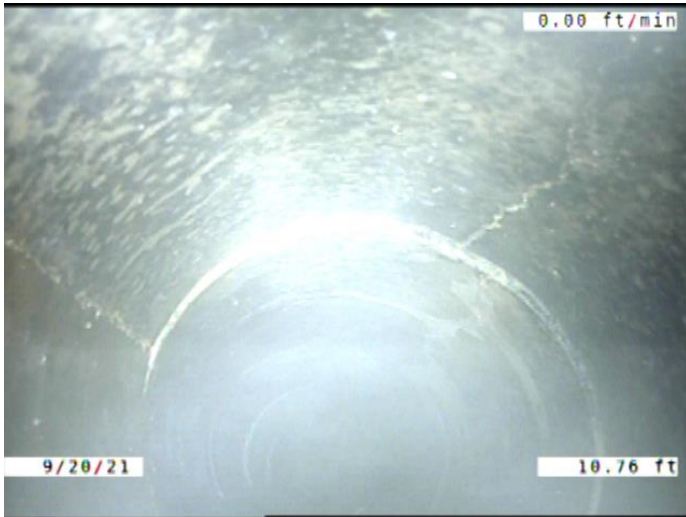
Code: **FM**
 Description: **Fracture Multiple**

Distance (ft): **10.8**
 Structural Grade: **4**
 O&M Grade: **0**
 Clock Start/From: **12**
 Clock To: **12**
 1st Value:
 2nd Value:
 Value Percent:
 Continuous Index: **S02**
 Within 8" of Joint: **YES**
 Remarks:

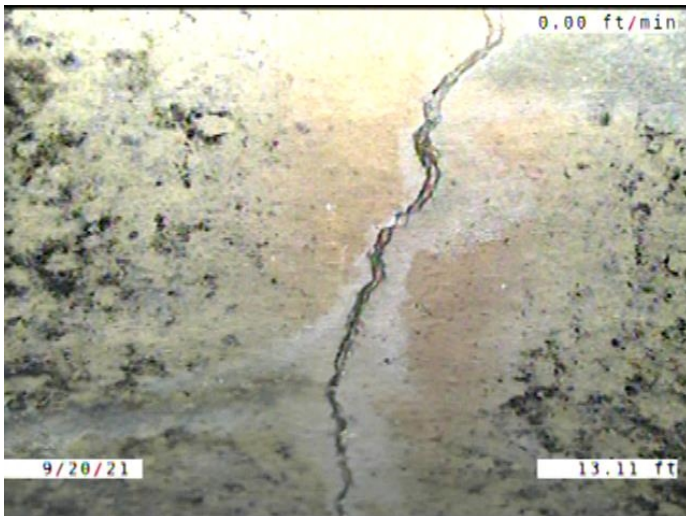
Code: **ISB**
 Description: **Infiltration Stain Barrel**

Distance (ft): **13.1**
 Structural Grade: **0**
 O&M Grade: **1**
 Clock Start/From: **8**
 Clock To: **4**
 1st Value:
 2nd Value:
 Value Percent:
 Continuous Index: **S03**
 Within 8" of Joint: **YES**
 Remarks:

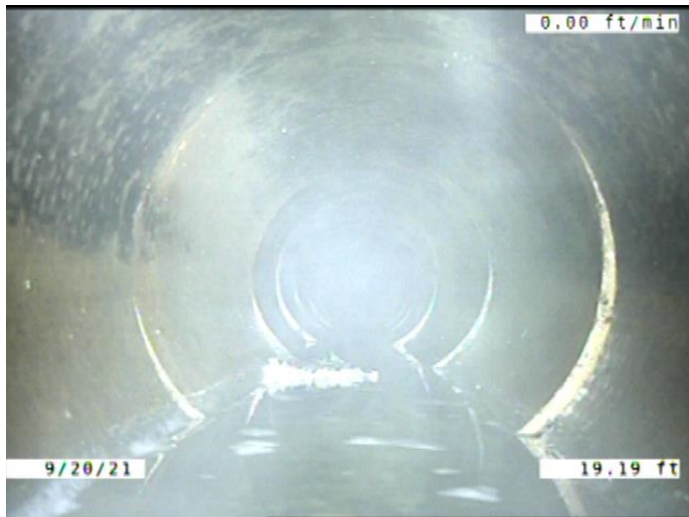
Code: **ISB**
 Description: **Infiltration Stain Barrel**

Distance (ft): **19.2**
 Structural Grade: **0**
 O&M Grade: **1**
 Clock Start/From: **8**
 Clock To: **4**
 1st Value:
 2nd Value:
 Value Percent:
 Continuous Index: **F03**
 Within 8" of Joint: **YES**
 Remarks:

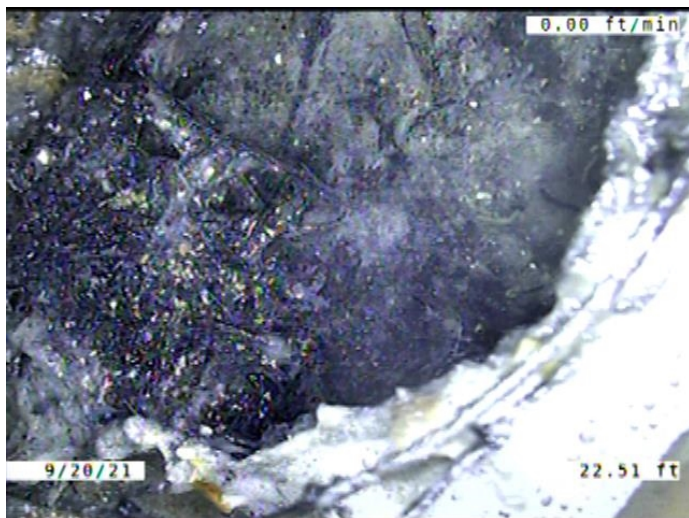
Code: **OBZ**
 Description: **Obstruction Other**

Distance (ft): **22.5**
 Structural Grade: **0**
 O&M Grade: **2**
 Clock Start/From: **6**
 Clock To: **8**
 1st Value:
 2nd Value:
 Value Percent: **5.000**
 Continuous Index:
 Within 8" of Joint: **YES**
 Remarks: **LEAVES**

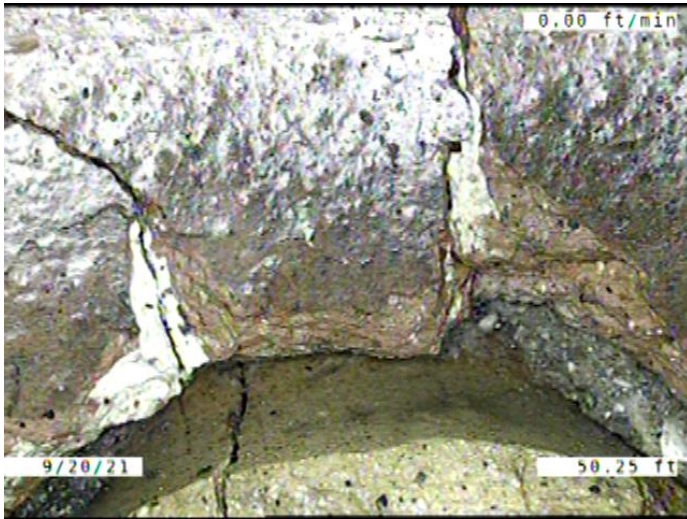
Code: **B**
 Description: **Broken**

Distance (ft): **50.2**
 Structural Grade: **4**
 O&M Grade: **0**
 Clock Start/From: **9**
 Clock To: **2**
 1st Value:
 2nd Value:
 Value Percent:
 Continuous Index:
 Within 8" of Joint: **YES**
 Remarks:

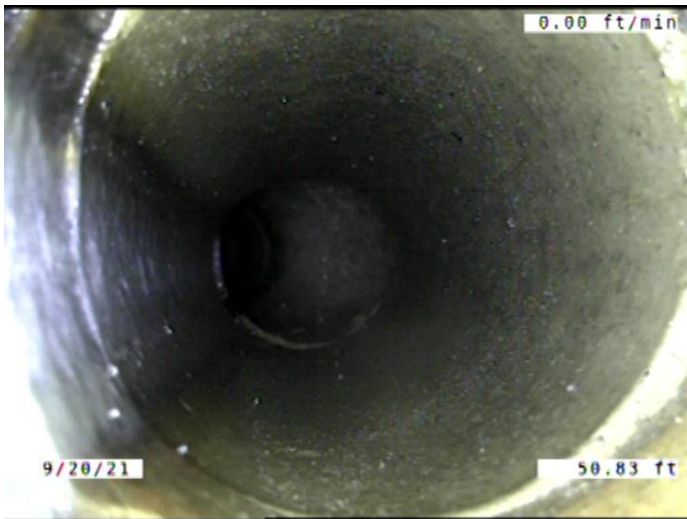
Code: **TBI**
 Description: **Tap Break-in Intruding**

Distance (ft): **50.8**
 Structural Grade: **0**
 O&M Grade: **2**
 Clock Start/From: **11**
 Clock To:
 1st Value: **4.000**
 2nd Value: **1.000**
 Value Percent:
 Continuous Index:
 Within 8" of Joint: **YES**
 Remarks: **CONSTANTLY RUNNING WATER**

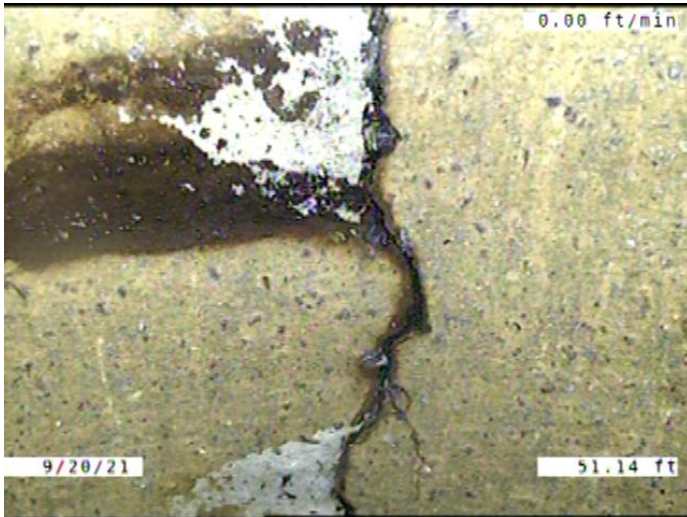
Code: **ISB**
Description: **Infiltration Stain Barrel**

Distance (ft): **51.1**
Structural Grade: **0**
O&M Grade: **1**
Clock Start/From: **8**
Clock To: **4**
1st Value:
2nd Value:
Value Percent:
Continuous Index: **S04**
Within 8" of Joint: **YES**
Remarks:

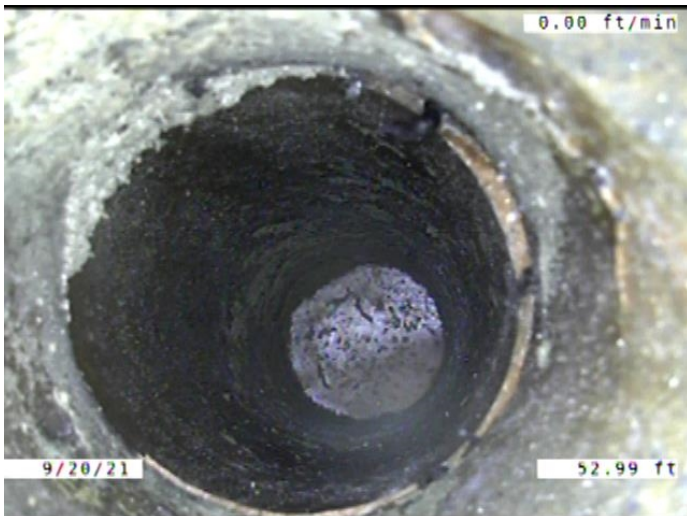
Code: **TFD**
Description: **Tap Factory Defective**

Distance (ft): **53.0**
Structural Grade: **0**
O&M Grade: **3**
Clock Start/From: **11**
Clock To:
1st Value: **4.000**
2nd Value:
Value Percent:
Continuous Index:
Within 8" of Joint: **YES**
Remarks: **CAPPED**

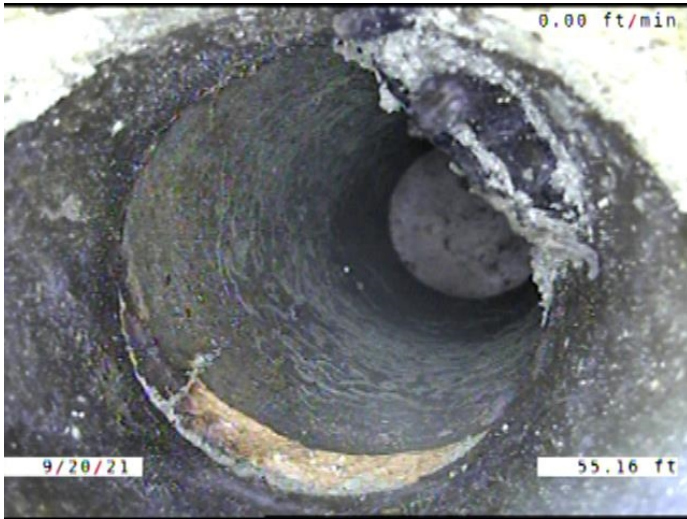
Code: **TFD**
Description: **Tap Factory Defective**

Distance (ft): **55.2**
Structural Grade: **0**
O&M Grade: **3**
Clock Start/From: **1**
Clock To:
1st Value: **4.000**
2nd Value:
Value Percent:
Continuous Index:
Within 8" of Joint: **YES**
Remarks: **LOOKS CAPPED**

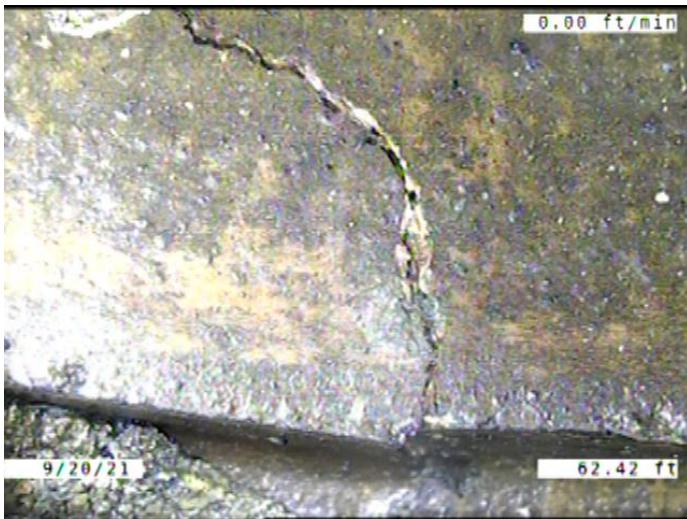
Code: **B**
Description: **Broken**

Distance (ft): **62.4**
Structural Grade: **4**
O&M Grade: **0**
Clock Start/From: **3**
Clock To: **4**
1st Value:
2nd Value:
Value Percent:
Continuous Index:
Within 8" of Joint: **YES**
Remarks:

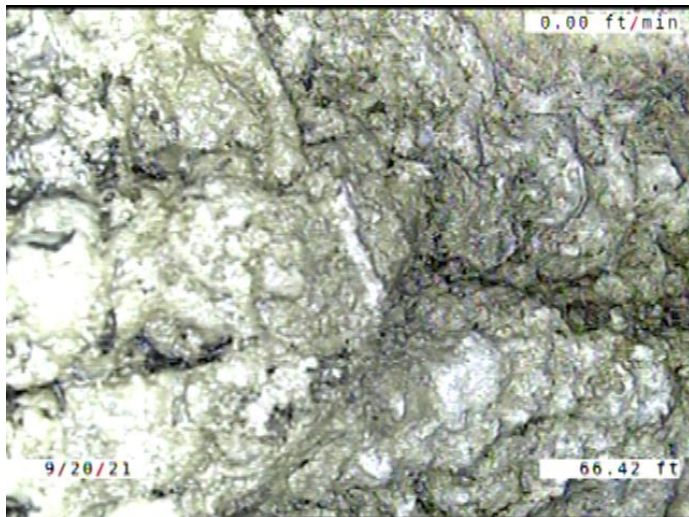
Code: **DAE**
 Description: **Deposits Attached Encrustation**

Distance (ft): **66.4**
 Structural Grade: **0**
 O&M Grade: **2**
 Clock Start/From: **8**
 Clock To: **10**
 1st Value:
 2nd Value:
 Value Percent: **5.000**
 Continuous Index:
 Within 8" of Joint: **YES**
 Remarks:

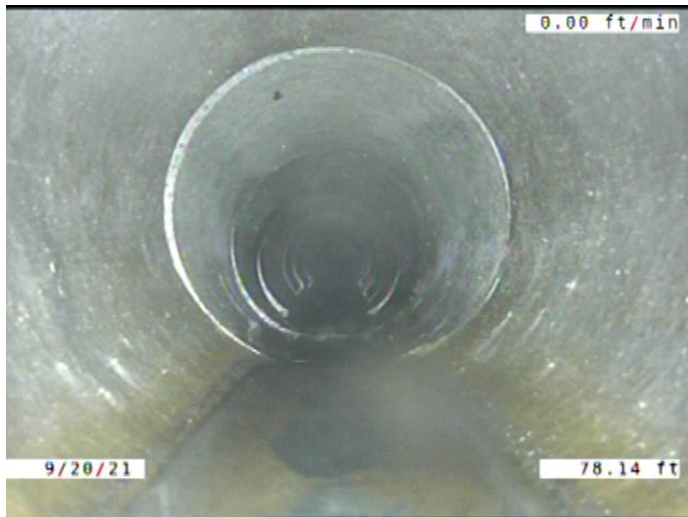
Code: **ISB**
 Description: **Infiltration Stain Barrel**

Distance (ft): **78.1**
 Structural Grade: **0**
 O&M Grade: **1**
 Clock Start/From: **8**
 Clock To: **4**
 1st Value:
 2nd Value:
 Value Percent:
 Continuous Index: **F04**
 Within 8" of Joint: **YES**
 Remarks:

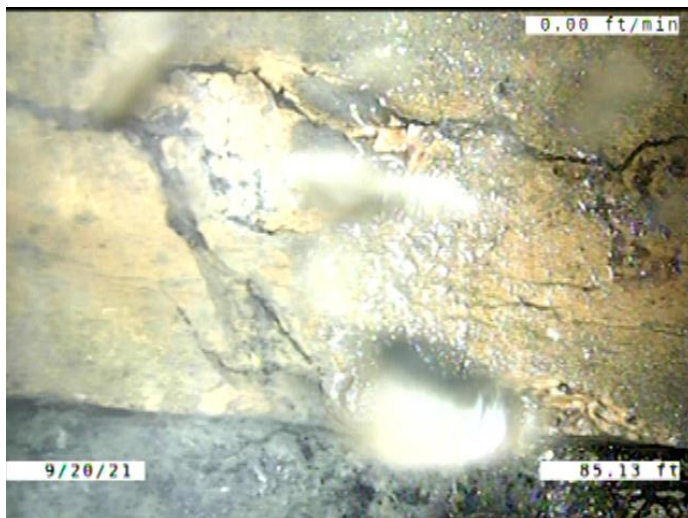
Code: **B**
 Description: **Broken**

Distance (ft): **85.1**
 Structural Grade: **4**
 O&M Grade: **0**
 Clock Start/From: **3**
 Clock To: **7**
 1st Value:
 2nd Value:
 Value Percent:
 Continuous Index:
 Within 8" of Joint: **YES**
 Remarks:

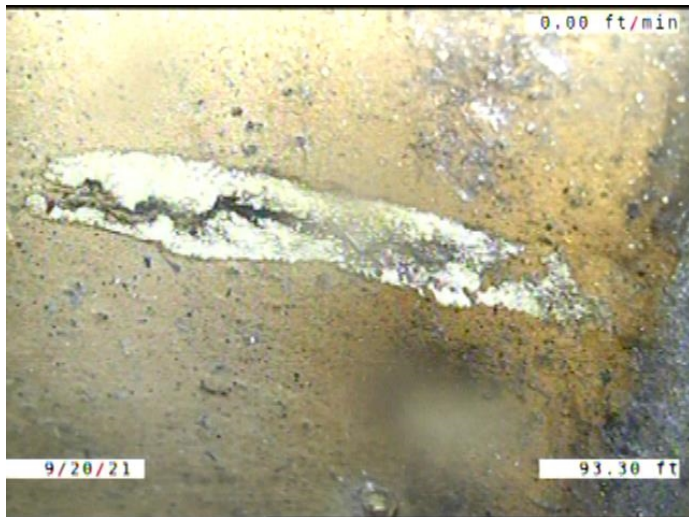
Code: **DAE**
 Description: **Deposits Attached Encrustation**

Distance (ft): **93.3**
 Structural Grade: **0**
 O&M Grade: **2**
 Clock Start/From: **3**
 Clock To: **4**
 1st Value:
 2nd Value:
 Value Percent: **5.000**
 Continuous Index:
 Within 8" of Joint: **YES**
 Remarks:

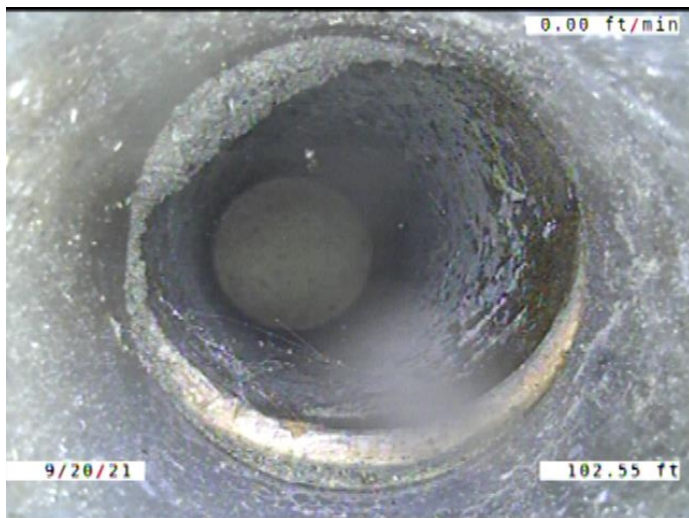
Code: **TF**
 Description: **Tap Factory**

Distance (ft): **102.5**
 Structural Grade: **0**
 O&M Grade: **0**
 Clock Start/From: **11**
 Clock To:
 1st Value: **4.000**
 2nd Value:
 Value Percent:
 Continuous Index:
 Within 8" of Joint: **YES**
 Remarks: **LOOKS CAPPED**

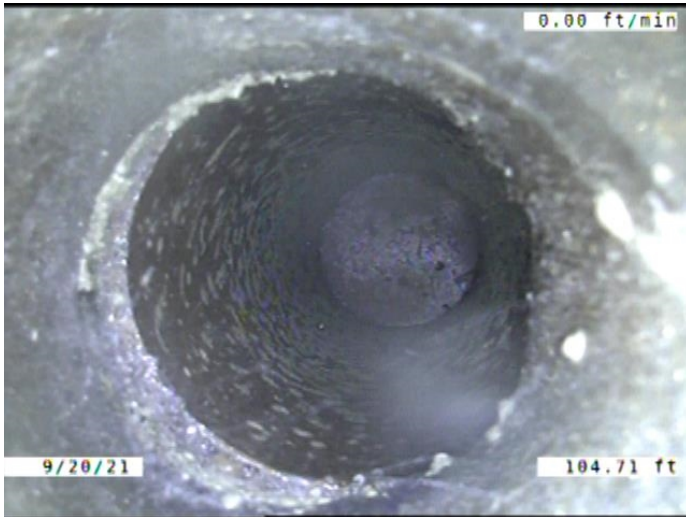
Code: **TF**
Description: **Tap Factory**

Distance (ft): **104.7**
Structural Grade: **0**
O&M Grade: **0**
Clock Start/From: **1**
Clock To:
1st Value: **4.000**
2nd Value:
Value Percent:
Continuous Index:
Within 8" of Joint: **YES**
Remarks: **LOOKS CAPPED**

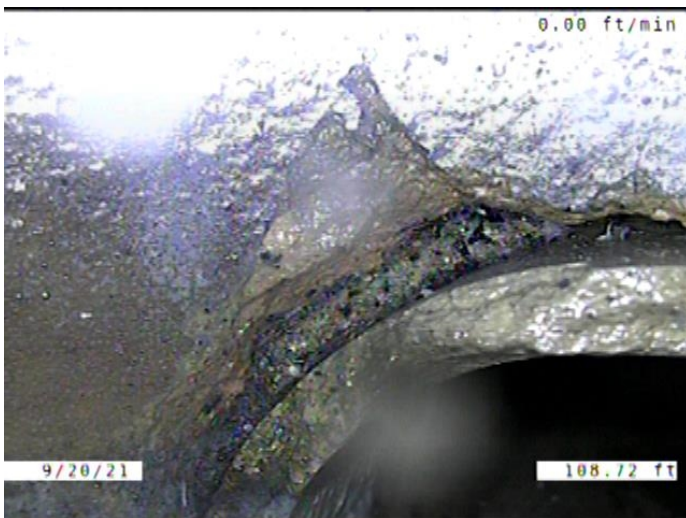
Code: **SSS**
Description: **Surface Damage Surface Spalling**

Distance (ft): **108.7**
Structural Grade: **2**
O&M Grade: **0**
Clock Start/From: **10**
Clock To: **1**
1st Value:
2nd Value:
Value Percent:
Continuous Index:
Within 8" of Joint: **YES**
Remarks:

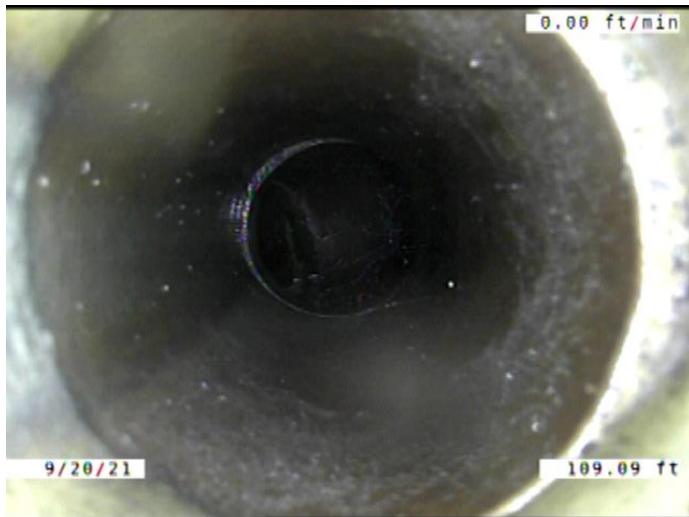
Code: **TBI**
 Description: **Tap Break-in Intruding**

Distance (ft): **109.1**
 Structural Grade: **0**
 O&M Grade: **2**
 Clock Start/From: **11**
 Clock To:
 1st Value: **4.000**
 2nd Value: **1.000**
 Value Percent:
 Continuous Index:
 Within 8" of Joint: **YES**
 Remarks:

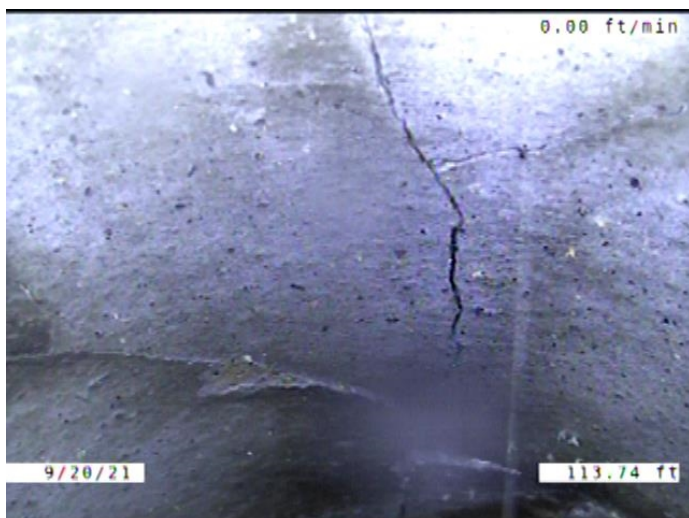
Code: **B**
 Description: **Broken**

Distance (ft): **113.7**
 Structural Grade: **4**
 O&M Grade: **0**
 Clock Start/From: **12**
 Clock To: **12**
 1st Value:
 2nd Value:
 Value Percent:
 Continuous Index:
 Within 8" of Joint: **YES**
 Remarks:

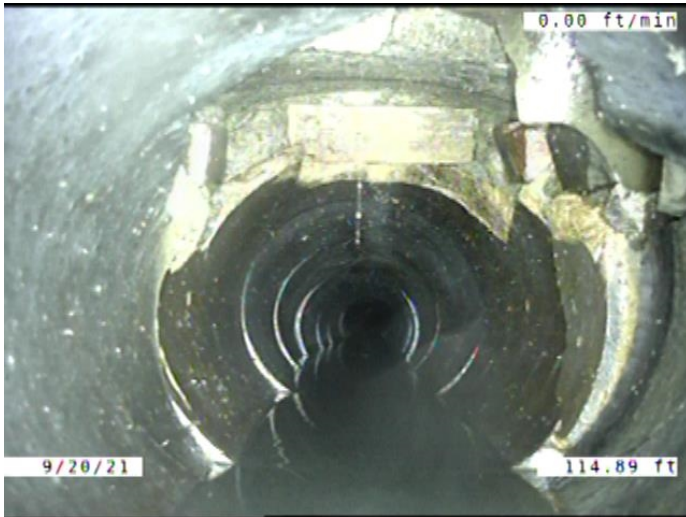
Code: **RPPD**
 Description: **Point Repair Patch Patch Defective**

Distance (ft): **114.9**
 Structural Grade: **4**
 O&M Grade: **0**
 Clock Start/From: **10**
 Clock To: **2**
 1st Value:
 2nd Value:
 Value Percent:
 Continuous Index:
 Within 8" of Joint: **YES**
 Remarks: **LOOKS LIKE THE PIPE WAS PAVED OVER BUT THE PIPE WALL IS MISSING**

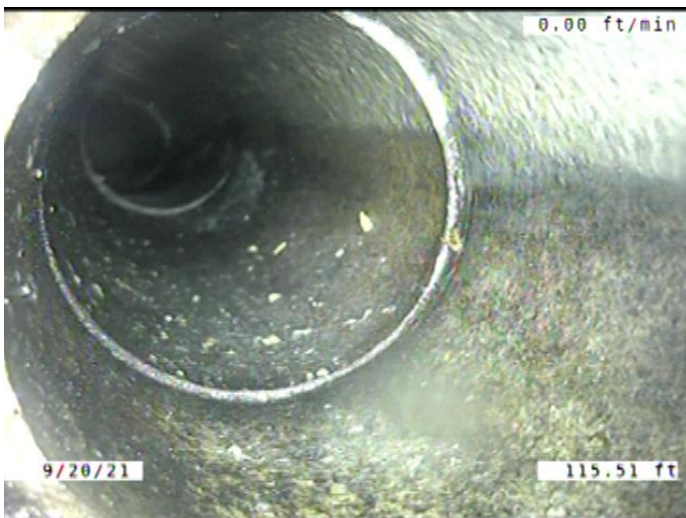
Code: **TBD**
 Description: **Tap Break-in/Hammer Defective**

Distance (ft): **115.5**
 Structural Grade: **0**
 O&M Grade: **3**
 Clock Start/From: **1**
 Clock To:
 1st Value: **4.000**
 2nd Value:
 Value Percent:
 Continuous Index:
 Within 8" of Joint: **YES**
 Remarks: **Defective**

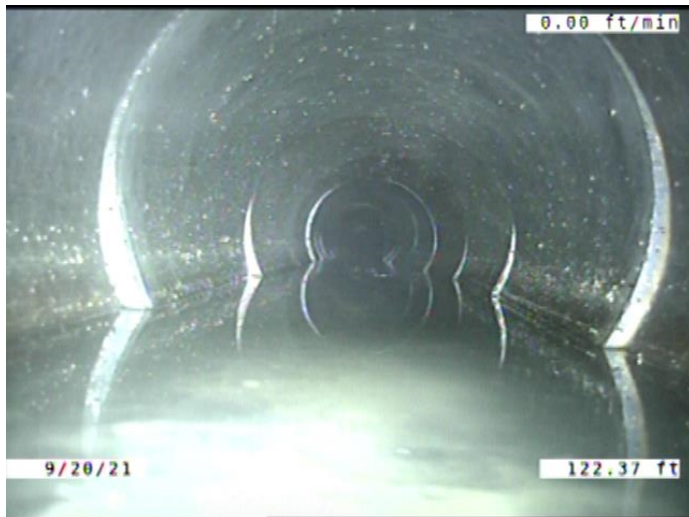
Code: **MWLS**
 Description: **Miscellaneous Water Level Sag**

Distance (ft): **122.4**
 Structural Grade: **2**
 O&M Grade: **0**
 Clock Start/From:
 Clock To:
 1st Value:
 2nd Value:
 Value Percent: **10.000**
 Continuous Index: **S07**
 Within 8" of Joint: **NO**
 Remarks:

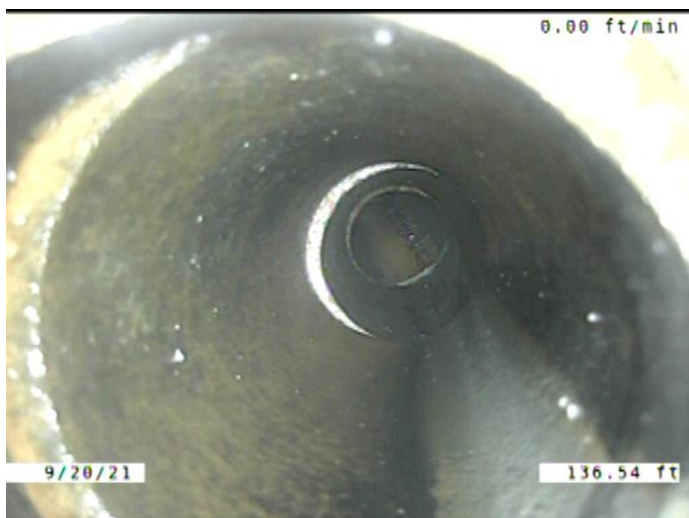
Code: **TB**
 Description: **Tap Break-in/Hammer**

Distance (ft): **136.5**
 Structural Grade: **0**
 O&M Grade: **0**
 Clock Start/From: **1**
 Clock To:
 1st Value: **4.000**
 2nd Value:
 Value Percent:
 Continuous Index:
 Within 8" of Joint: **YES**
 Remarks:

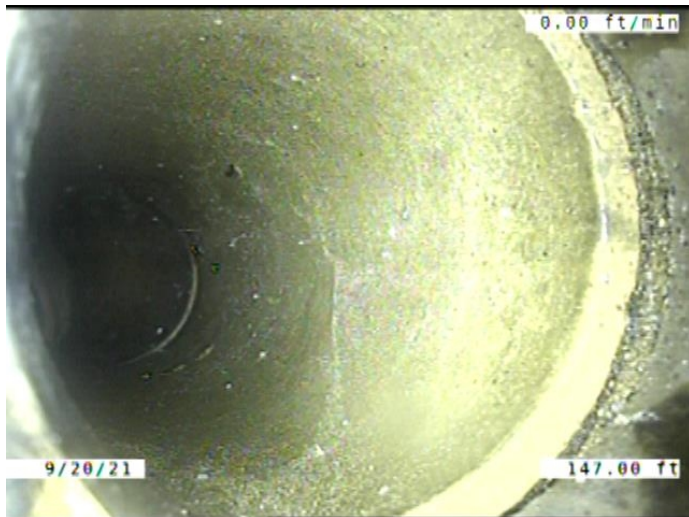
Code: **TBI**
 Description: **Tap Break-in Intruding**

Distance (ft): **147.0**
 Structural Grade: **0**
 O&M Grade: **2**
 Clock Start/From: **11**
 Clock To:
 1st Value: **4.000**
 2nd Value: **3.000**
 Value Percent:
 Continuous Index:
 Within 8" of Joint: **YES**
 Remarks:

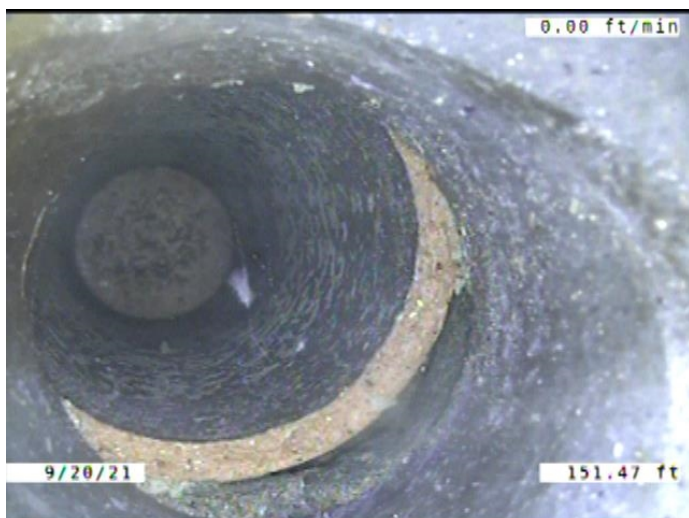
Code: **TFD**
 Description: **Tap Factory Defective**

Distance (ft): **151.5**
 Structural Grade: **0**
 O&M Grade: **3**
 Clock Start/From: **11**
 Clock To:
 1st Value: **4.000**
 2nd Value:
 Value Percent:
 Continuous Index:
 Within 8" of Joint: **YES**
 Remarks: **LOOKS CAPPED**

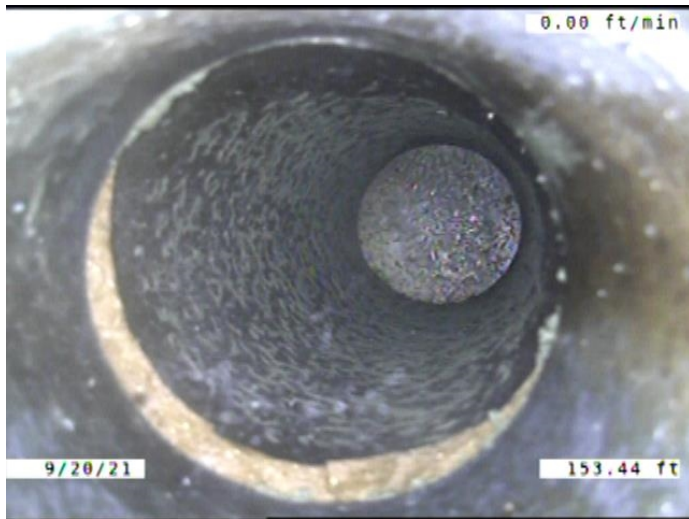
Code: **TF**
 Description: **Tap Factory**

Distance (ft): **153.4**
 Structural Grade: **0**
 O&M Grade: **0**
 Clock Start/From: **1**
 Clock To:
 1st Value: **4.000**
 2nd Value:
 Value Percent:
 Continuous Index:
 Within 8" of Joint: **YES**
 Remarks: **LOOKS CAPPED**

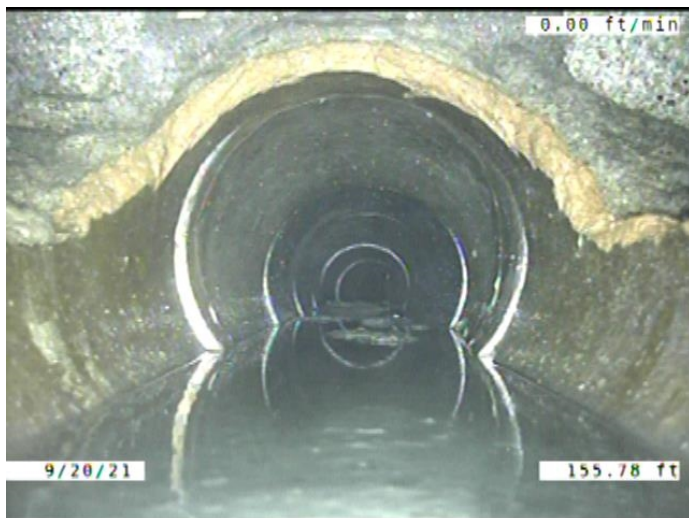
Code: **MWLS**
 Description: **Miscellaneous Water Level Sag**

Distance (ft): **155.8**
 Structural Grade: **2**
 O&M Grade: **0**
 Clock Start/From:
 Clock To:
 1st Value:
 2nd Value:
 Value Percent: **10.000**
 Continuous Index: **F07**
 Within 8" of Joint: **NO**
 Remarks:

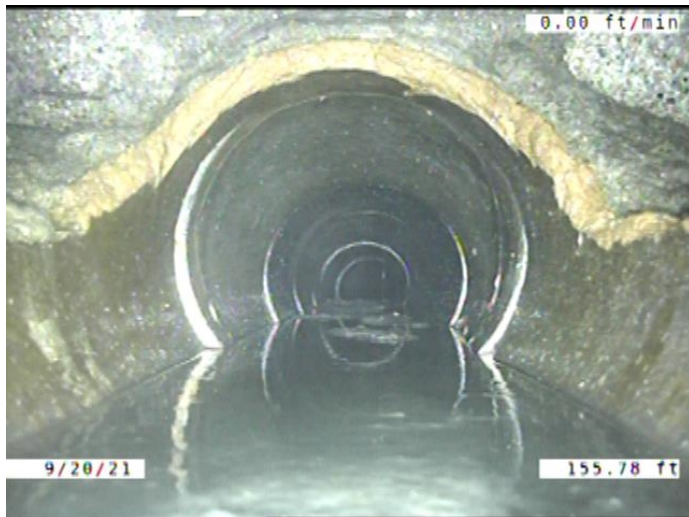
Code: **FM**
 Description: **Fracture Multiple**

Distance (ft): **155.8**
 Structural Grade: **4**
 O&M Grade: **0**
 Clock Start/From: **12**
 Clock To: **12**
 1st Value:
 2nd Value:
 Value Percent:
 Continuous Index: **F02**
 Within 8" of Joint: **YES**
 Remarks:

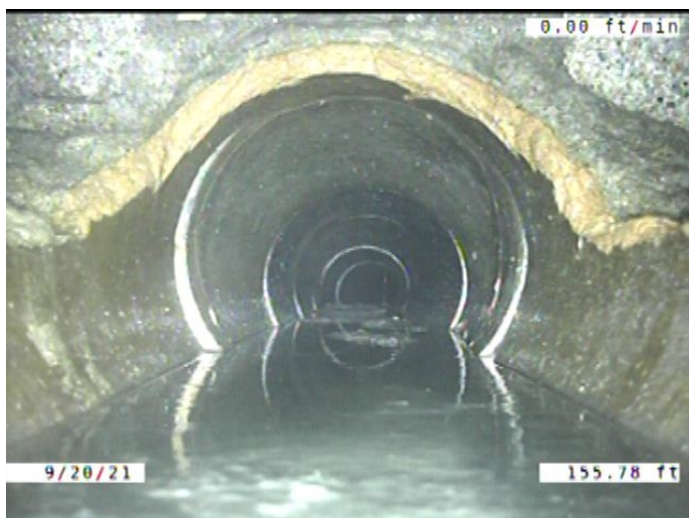
Code: **DSF**
 Description: **Deposits Settled Fine**

Distance (ft): **155.8**
 Structural Grade: **0**
 O&M Grade: **2**
 Clock Start/From: **5**
 Clock To: **7**
 1st Value:
 2nd Value:
 Value Percent: **5.000**
 Continuous Index: **F01**
 Within 8" of Joint: **YES**
 Remarks:

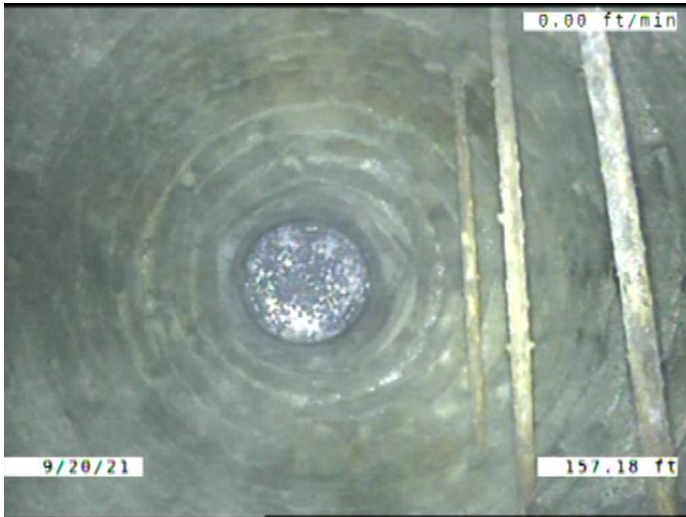
Code:	AMH
Description:	Manhole
Distance (ft):	157.2
Structural Grade:	0
O&M Grade:	0
Clock Start/From:	
Clock To:	
1st Value:	
2nd Value:	
Value Percent:	
Continuous Index:	
Within 8" of Joint:	NO
Remarks:	M-504-090
