Profile/Photo Observation Report

Date:	04/09/2018	Weather:		Coding:	PACP 6.0
Pipe Length (ft):	218.3	Owner:	NA	Pre Clean:	Not Known
P.O.#:		Surveyor:	Byrd Fitzgerald	PSR:	P-503-027.5-027
Customer:		Clean Date:	01/01/1900	Shape:	C

Street:	W 40th ave	Flow Control:	Not Controlled
City:	Hobart, IN	Year Renewed:	
Location:	Other	Tape/Media #:	
Purpose:	Not Known	Dia/Height:	10"
Use:	Sanitary	Material:	VCP
Drain Area:	NA	Lining:	
Category:	NA		
Comment:

Location Details:		Direction of Survey:	Upstream
US MH:	M-503-027	DS MH:	M-503-027.5
		Total Length Surveyed (ft):	29.7

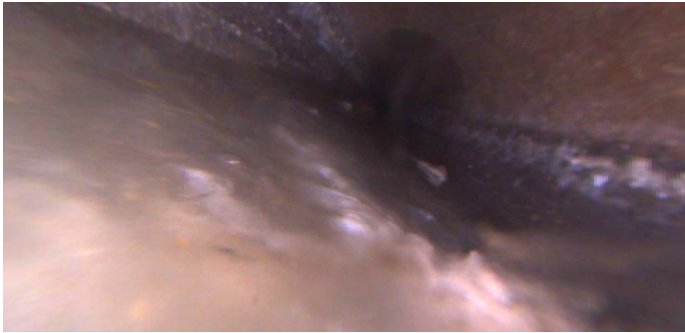
Code:	MWL
Description:	Water Level

Distance (ft):	.0
Structural Grade:	0
O&M Grade:	0
Clock Start/From:	
Clock To:	
1st Value:	
2nd Value:	
Value Percent:	15.000
Continuous Index:	
Within 8" of Joint:	NO
Remarks:

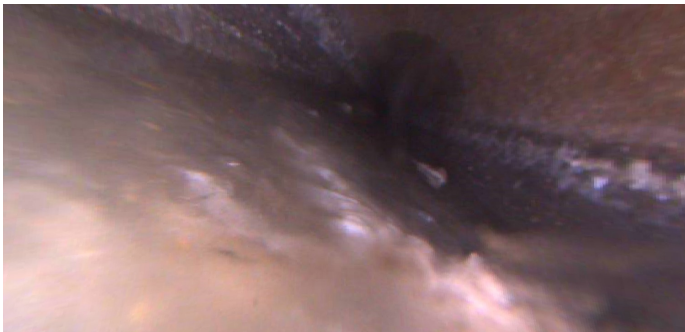
Code:	DSZ
Description:	Deposits Settled Other

Distance (ft):	.0
Structural Grade:	0
O&M Grade:	2
Clock Start/From:	6
Clock To:	
1st Value:	
2nd Value:	
Value Percent:	5.000
Continuous Index:	S01
Within 8" of Joint:	NO
Remarks:	tissue

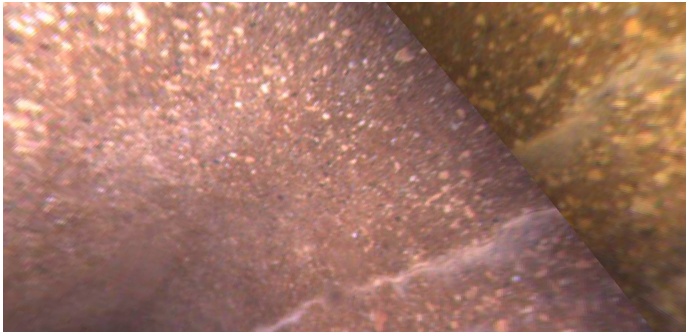
Code: **SAV**
Description: **Surface Aggregate Visible**

Distance (ft): **3.7**
Structural Grade: **3**
O&M Grade: **0**
Clock Start/From: **7**
Clock To: **5**
1st Value:
2nd Value:
Value Percent:
Continuous Index: **S02**
Within 8" of Joint:
Remarks:

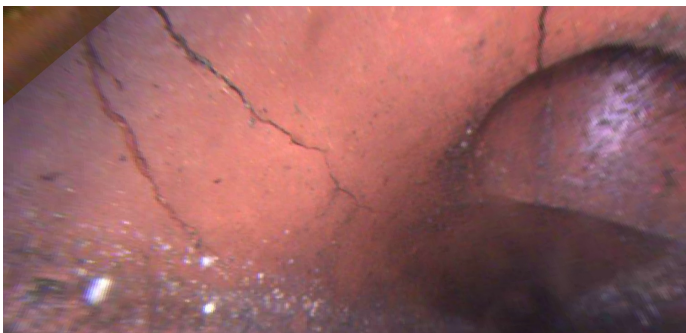
Code: **CM**
Description: **Crack Multiple**

Distance (ft): **21.1**
Structural Grade: **3**
O&M Grade: **0**
Clock Start/From: **7**
Clock To: **1**
1st Value:
2nd Value:
Value Percent:
Continuous Index: **S03**
Within 8" of Joint: **YES**
Remarks: **wandering**

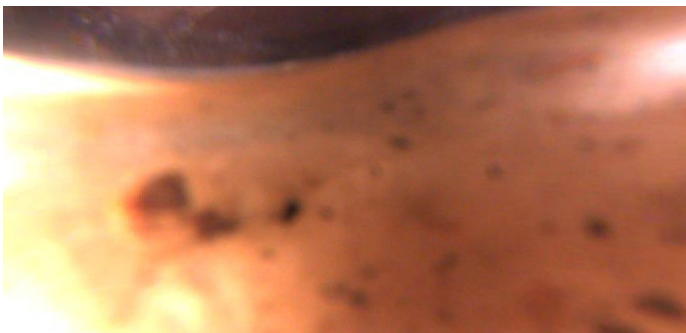
Code: **MCU**
Description: **Camera Underwater**

Distance (ft): **24.5**
Structural Grade: **0**
O&M Grade: **4**
Clock Start/From:
Clock To:
1st Value:
2nd Value:
Value Percent:
Continuous Index:
Within 8" of Joint: **NO**
Remarks:

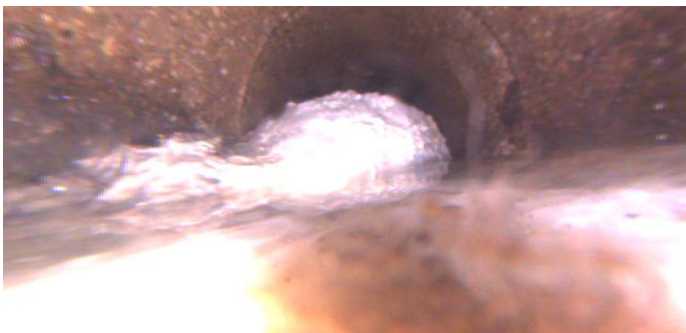
Code: **DSZ**
Description: **Deposits Settled Other**

Distance (ft): **29.2**
Structural Grade: **0**
O&M Grade: **4**
Clock Start/From: **6**
Clock To:
1st Value:
2nd Value:
Value Percent: **25.000**
Continuous Index:
Within 8" of Joint: **NO**
Remarks: **unknown**
