Profile/Photo Observation Report

Date:	09/08/2021	Weather:		Coding:	PACP 7.0
Pipe Length (ft):	213.8	Owner:	City of Hobart	Pre Clean:	Light Cleaning
P.O.#:	YES502259	Surveyor:	S. Bucklin	PSR:	P-503-027.5-027
Customer:	City of Hobart	Clean Date:	08/28/2021	Shape:	C

Street:	North Virginia Street	Flow Control:	Not Controlled
City:	Hobart, IN	Year Renewed:	
Location:	Local rural streets with light traffic, t	Tape/Media #:	
Purpose:	Routine Assessment	Dia/Height:	10"
Use:	Sanitary Sewage Pipe	Material:	CP
Drain Area:		Lining:	None
Category:	NA		
Comment:			
Location Details:		Direction of Survey:	Upstream
US MH:	M-503-027	DS MH:	M-503-027.5
		Total Length Surveyed (ft):	213.8

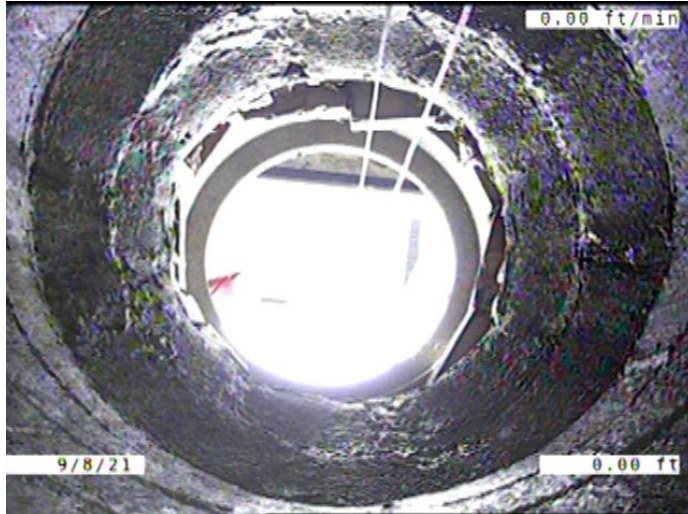
Code: **AMH**
 Description: **Manhole**

Distance (ft): **.0**
 Structural Grade: **0**
 O&M Grade: **0**
 Clock Start/From:
 Clock To:
 1st Value:
 2nd Value:
 Value Percent:
 Continuous Index:
 Within 8" of Joint: **NO**
 Remarks: **M-503-027.5**

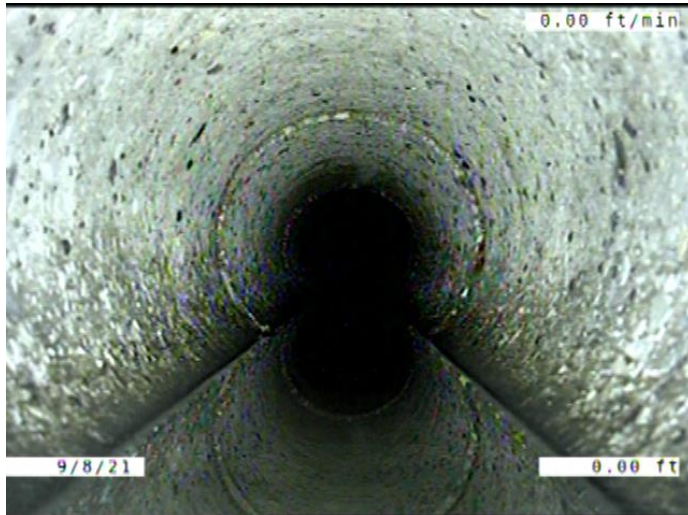
Code: **MWL**
 Description: **Miscellaneous Water Level**

Distance (ft): **.0**
 Structural Grade: **0**
 O&M Grade: **0**
 Clock Start/From:
 Clock To:
 1st Value:
 2nd Value:
 Value Percent: **5.000**
 Continuous Index:
 Within 8" of Joint: **NO**
 Remarks:

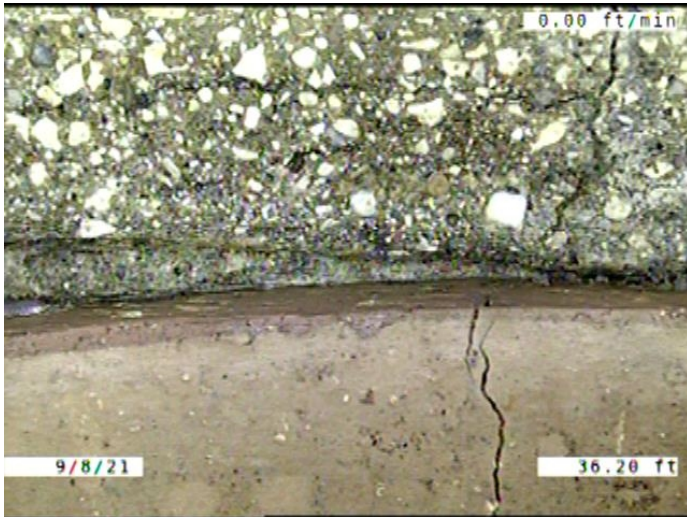
Code: **MMC**
 Description: **Miscellaneous Material Change**

Distance (ft): **36.2**
 Structural Grade: **0**
 O&M Grade: **0**
 Clock Start/From:
 Clock To:
 1st Value:
 2nd Value:
 Value Percent:
 Continuous Index:
 Within 8" of Joint: **NO**
 Remarks: **CONCRETE TO VCP**

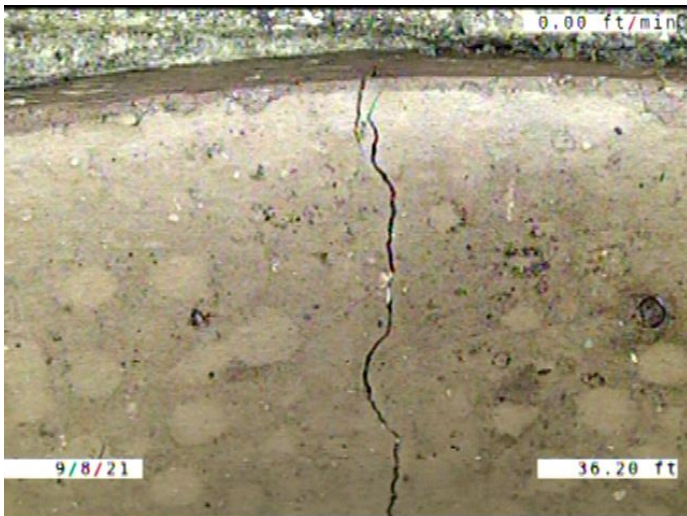
Code: **FM**
 Description: **Fracture Multiple**

Distance (ft): **36.2**
 Structural Grade: **4**
 O&M Grade: **0**
 Clock Start/From: **11**
 Clock To: **1**
 1st Value:
 2nd Value:
 Value Percent:
 Continuous Index: **S01**
 Within 8" of Joint: **YES**
 Remarks:

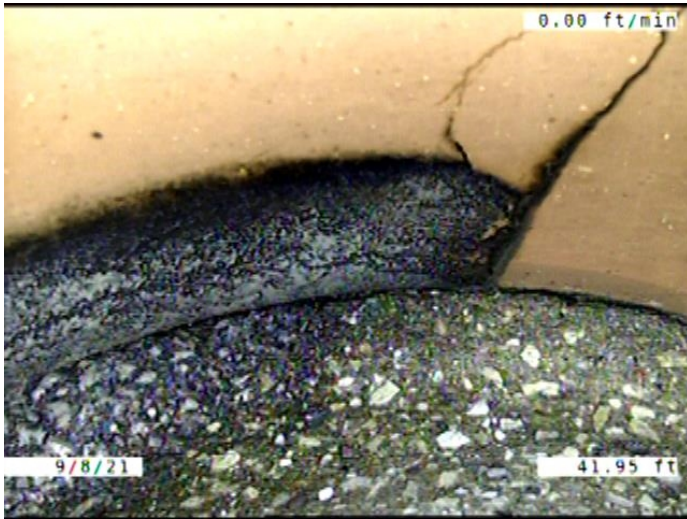
Code: **ISB**
 Description: **Infiltration Stain Barrel**

Distance (ft): **42.0**
 Structural Grade: **0**
 O&M Grade: **1**
 Clock Start/From: **8**
 Clock To: **11**
 1st Value:
 2nd Value:
 Value Percent:
 Continuous Index:
 Within 8" of Joint: **YES**
 Remarks:

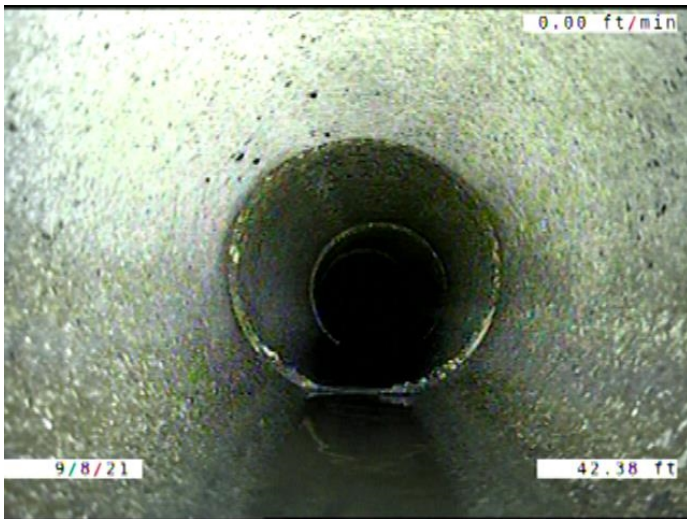
Code: **FM**
 Description: **Fracture Multiple**

Distance (ft): **42.4**
 Structural Grade: **4**
 O&M Grade: **0**
 Clock Start/From: **11**
 Clock To: **1**
 1st Value:
 2nd Value:
 Value Percent:
 Continuous Index: **F01**
 Within 8" of Joint: **YES**
 Remarks:

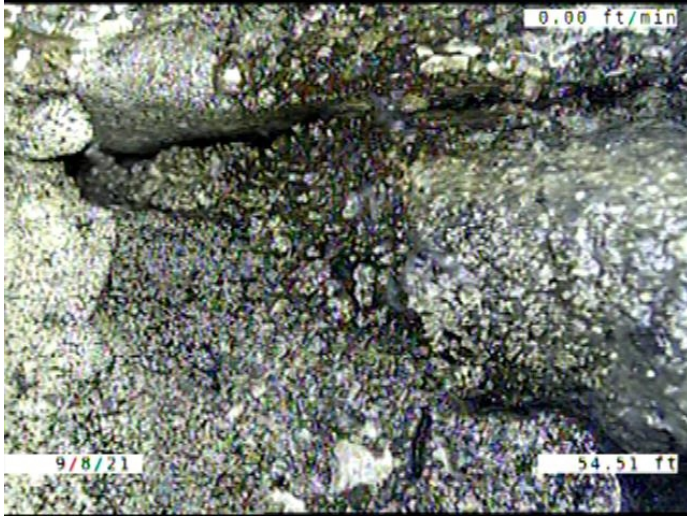
Code: **DAE**
Description: **Deposits Attached Encrustation**

Distance (ft): **54.5**
Structural Grade: **0**
O&M Grade: **2**
Clock Start/From: **7**
Clock To: **8**
1st Value:
2nd Value:
Value Percent: **5.000**
Continuous Index:
Within 8" of Joint: **YES**
Remarks:

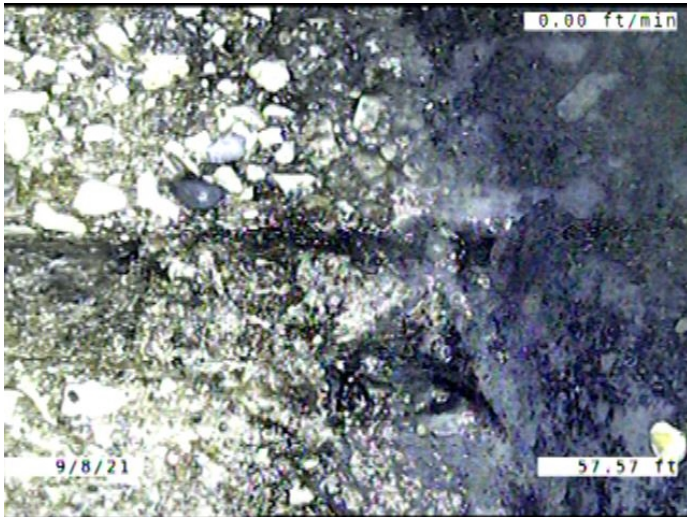
Code: **DAE**
Description: **Deposits Attached Encrustation**

Distance (ft): **57.6**
Structural Grade: **0**
O&M Grade: **2**
Clock Start/From: **4**
Clock To: **7**
1st Value:
2nd Value:
Value Percent: **5.000**
Continuous Index: **S03**
Within 8" of Joint: **YES**
Remarks:

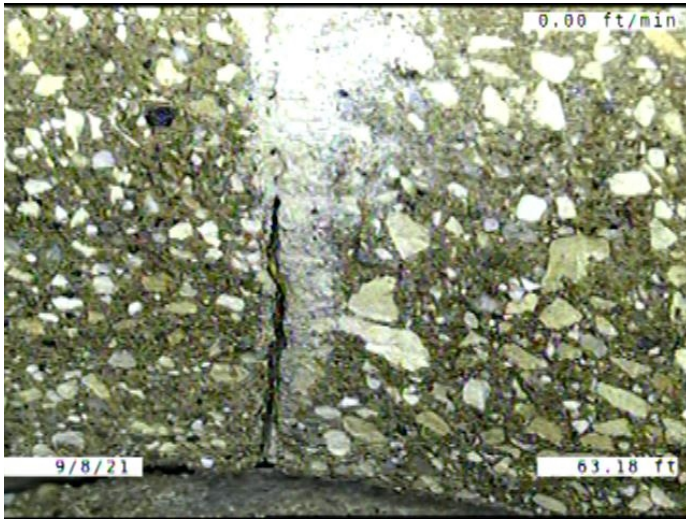
Code: **FS**
Description: **Fracture Spiral**

Distance (ft): **63.2**
Structural Grade: **3**
O&M Grade: **0**
Clock Start/From: **1**
Clock To: **3**
1st Value:
2nd Value:
Value Percent:
Continuous Index:
Within 8" of Joint: **YES**
Remarks:

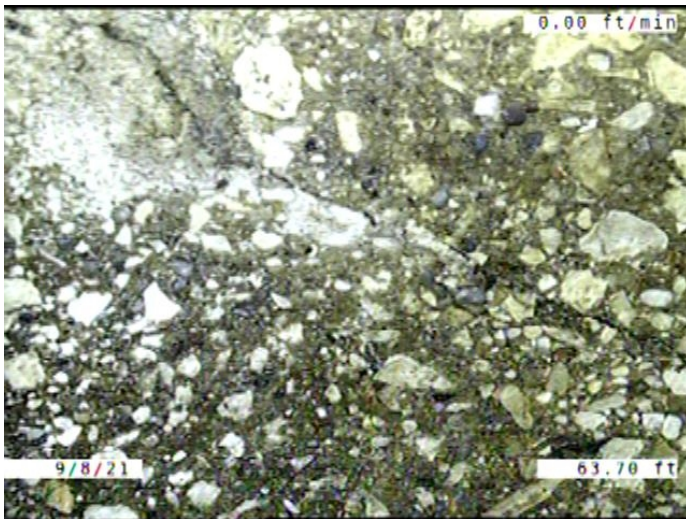
Code: **CM**
Description: **Crack Multiple**

Distance (ft): **63.7**
Structural Grade: **3**
O&M Grade: **0**
Clock Start/From: **7**
Clock To: **11**
1st Value:
2nd Value:
Value Percent:
Continuous Index:
Within 8" of Joint: **YES**
Remarks:

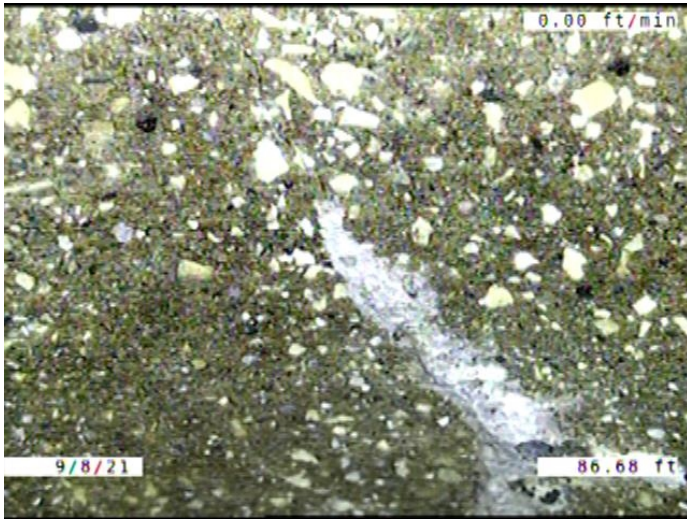
Code: **FS**
Description: **Fracture Spiral**

Distance (ft): **86.7**
Structural Grade: **3**
O&M Grade: **0**
Clock Start/From: **12**
Clock To: **1**
1st Value:
2nd Value:
Value Percent:
Continuous Index:
Within 8" of Joint: **YES**
Remarks:

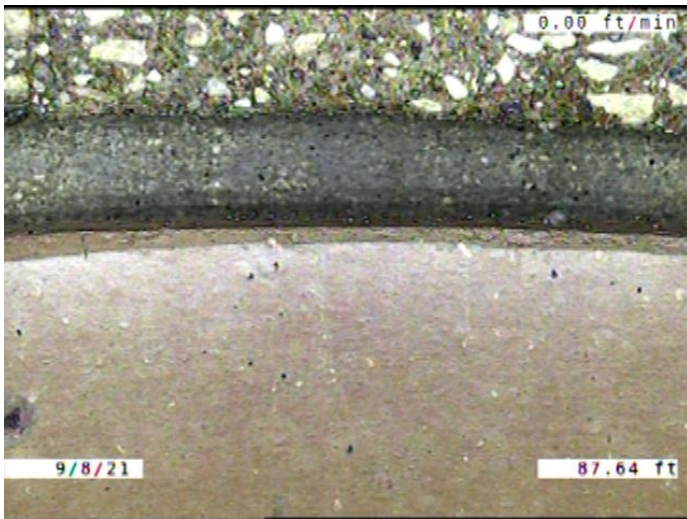
Code: **MMC**
Description: **Miscellaneous Material Change**

Distance (ft): **87.6**
Structural Grade: **0**
O&M Grade: **0**
Clock Start/From:
Clock To:
1st Value:
2nd Value:
Value Percent:
Continuous Index:
Within 8" of Joint: **NO**
Remarks: **CONCRETE TO VCP**

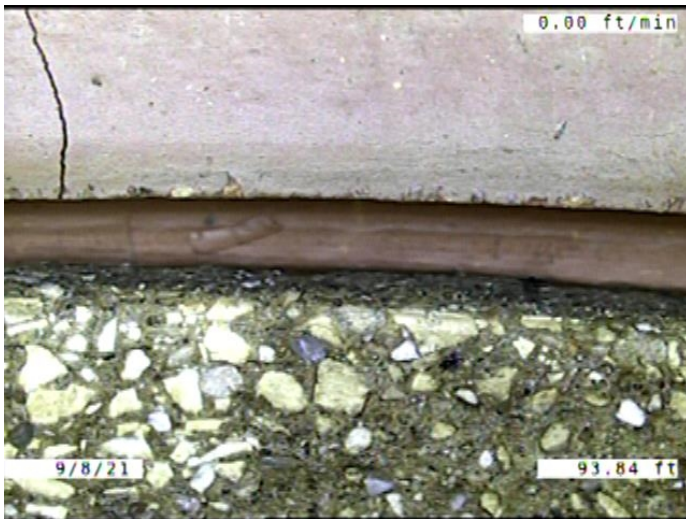
Code: **MMC**
 Description: **Miscellaneous Material Change**

Distance (ft): **93.8**
 Structural Grade: **0**
 O&M Grade: **0**
 Clock Start/From:
 Clock To:
 1st Value:
 2nd Value:
 Value Percent:
 Continuous Index:
 Within 8" of Joint: **NO**
 Remarks: **VCP TO CONCRETE**

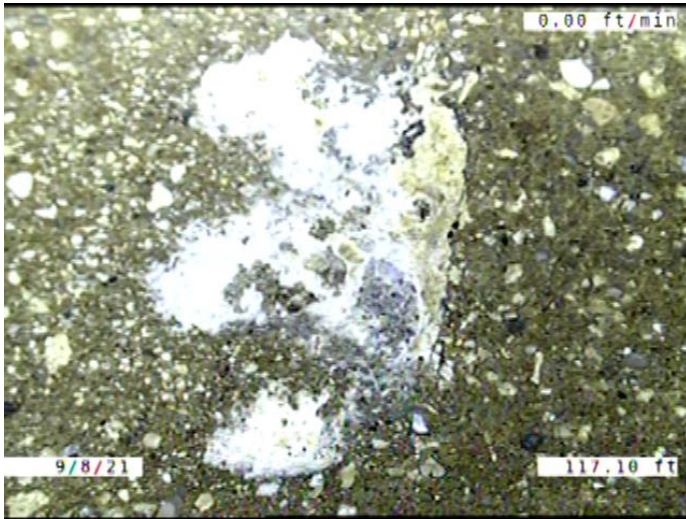
Code: **DAE**
 Description: **Deposits Attached Encrustation**

Distance (ft): **117.1**
 Structural Grade: **0**
 O&M Grade: **2**
 Clock Start/From: **10**
 Clock To:
 1st Value:
 2nd Value:
 Value Percent: **5.000**
 Continuous Index:
 Within 8" of Joint: **NO**
 Remarks:

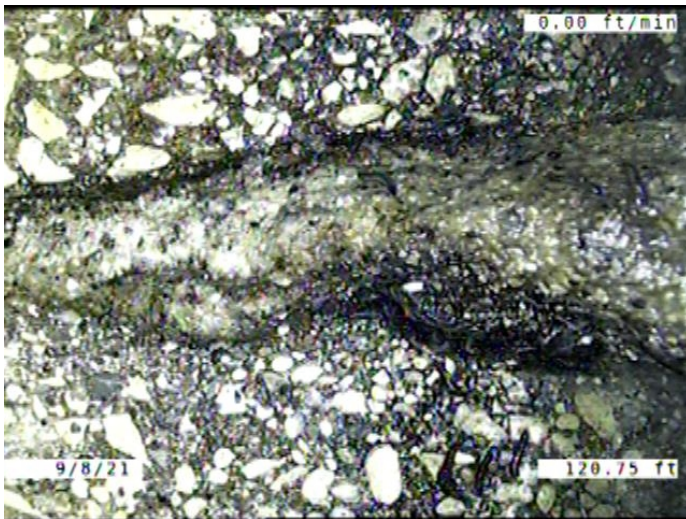
Code: **DAE**
 Description: **Deposits Attached Encrustation**

Distance (ft): **120.7**
 Structural Grade: **0**
 O&M Grade: **2**
 Clock Start/From: **4**
 Clock To: **8**
 1st Value:
 2nd Value:
 Value Percent: **5.000**
 Continuous Index: **S04**
 Within 8" of Joint: **YES**
 Remarks:

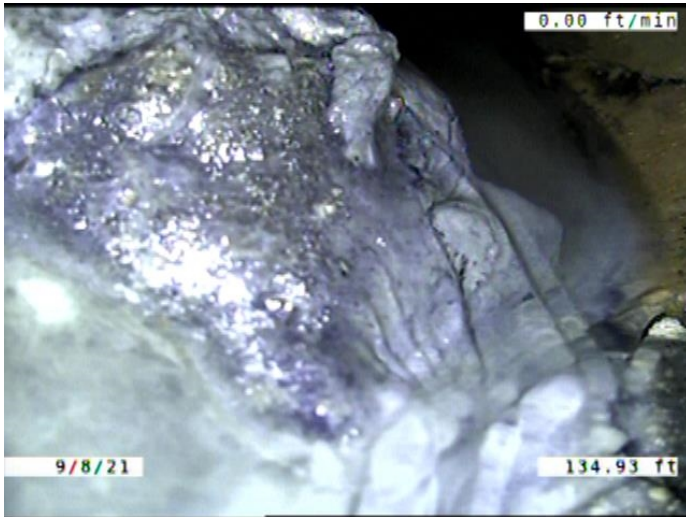
Code: **DAE**
 Description: **Deposits Attached Encrustation**

Distance (ft): **134.9**
 Structural Grade: **0**
 O&M Grade: **3**
 Clock Start/From: **4**
 Clock To: **8**
 1st Value:
 2nd Value:
 Value Percent: **15.000**
 Continuous Index:
 Within 8" of Joint: **YES**
 Remarks:

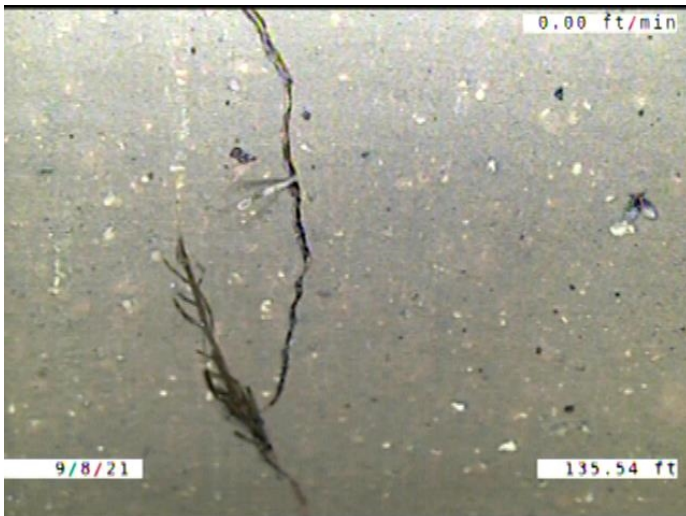
Code: **FM**
 Description: **Fracture Multiple**

Distance (ft): **135.5**
 Structural Grade: **4**
 O&M Grade: **0**
 Clock Start/From: **8**
 Clock To: **4**
 1st Value:
 2nd Value:
 Value Percent:
 Continuous Index: **S05**
 Within 8" of Joint: **YES**
 Remarks:

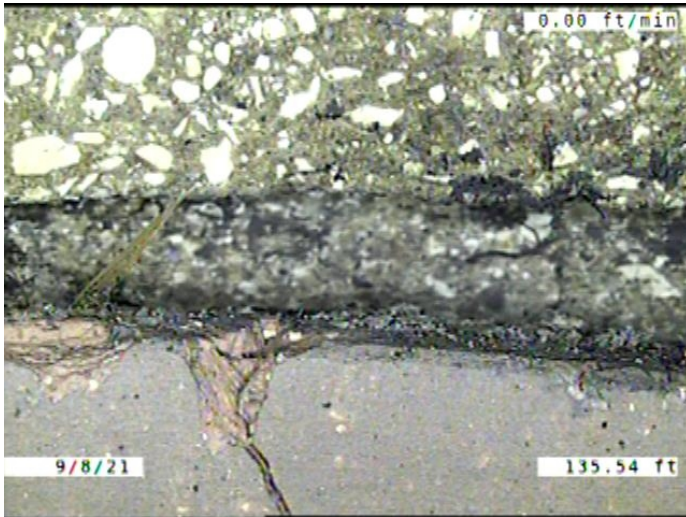
Code: **MMC**
 Description: **Miscellaneous Material Change**

Distance (ft): **135.5**
 Structural Grade: **0**
 O&M Grade: **0**
 Clock Start/From:
 Clock To:
 1st Value:
 2nd Value:
 Value Percent:
 Continuous Index:
 Within 8" of Joint: **NO**
 Remarks: **CONCRETE TO VCP**

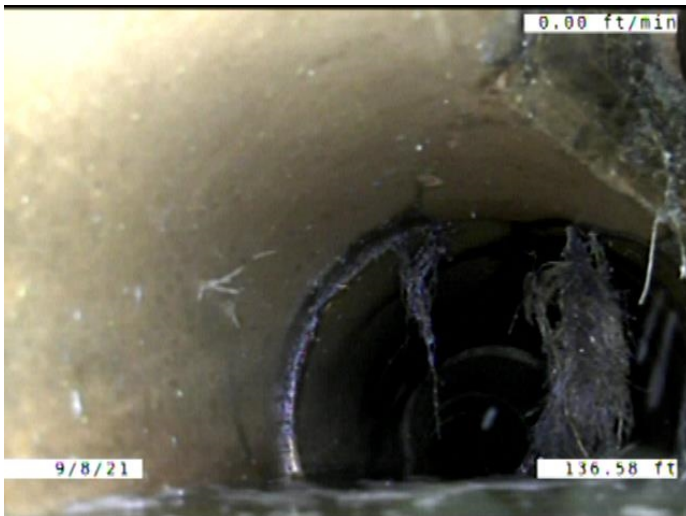
Code: **MWL**
 Description: **Miscellaneous Water Level**

Distance (ft): **136.6**
 Structural Grade: **0**
 O&M Grade: **0**
 Clock Start/From:
 Clock To:
 1st Value:
 2nd Value:
 Value Percent: **15.000**
 Continuous Index:
 Within 8" of Joint: **NO**
 Remarks:

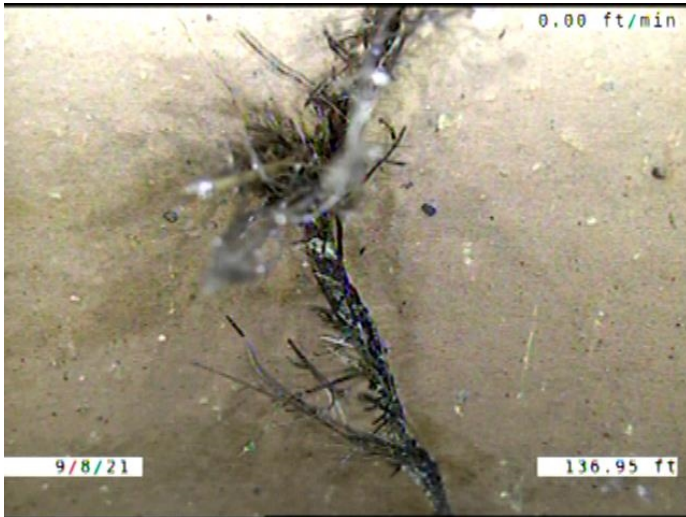
Code: **RFB**
 Description: **Roots Fine Barrel**

Distance (ft): **137.0**
 Structural Grade: **0**
 O&M Grade: **2**
 Clock Start/From: **11**
 Clock To: **3**
 1st Value:
 2nd Value:
 Value Percent:
 Continuous Index:
 Within 8" of Joint: **NO**
 Remarks:

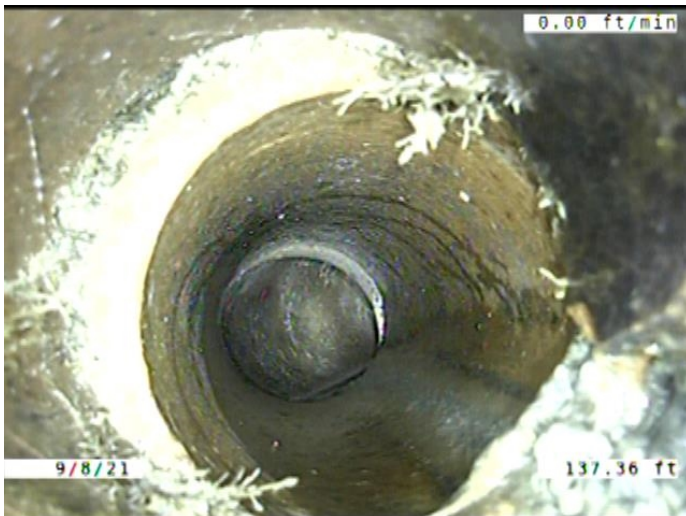
Code: **TFD**
 Description: **Tap Factory Defective**

Distance (ft): **137.4**
 Structural Grade: **0**
 O&M Grade: **3**
 Clock Start/From: **1**
 Clock To:
 1st Value: **4.000**
 2nd Value:
 Value Percent:
 Continuous Index:
 Within 8" of Joint: **YES**
 Remarks: **Defective**

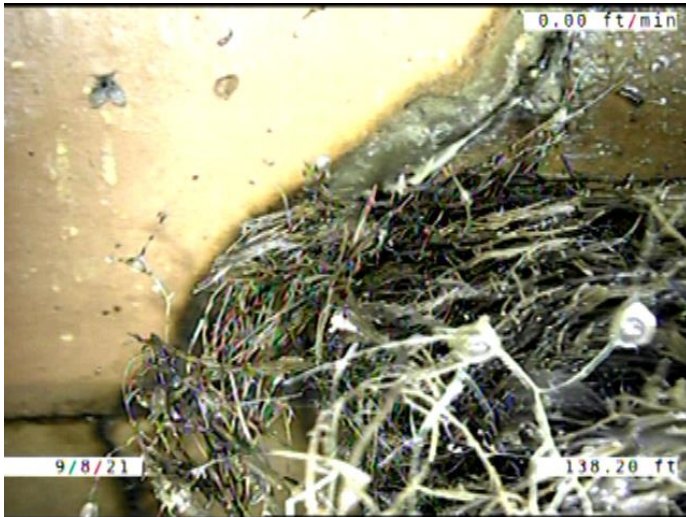
Code: **RMJ**
 Description: **Roots Medium Joint**

Distance (ft): **138.2**
 Structural Grade: **0**
 O&M Grade: **3**
 Clock Start/From: **1**
 Clock To:
 1st Value:
 2nd Value:
 Value Percent: **5.000**
 Continuous Index:
 Within 8" of Joint: **YES**
 Remarks:

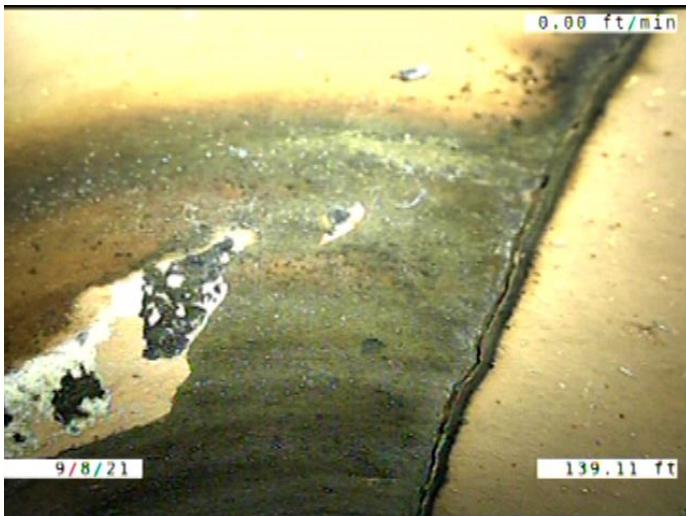
Code: **ISB**
 Description: **Infiltration Stain Barrel**

Distance (ft): **139.1**
 Structural Grade: **0**
 O&M Grade: **1**
 Clock Start/From: **9**
 Clock To: **12**
 1st Value:
 2nd Value:
 Value Percent:
 Continuous Index:
 Within 8" of Joint: **YES**
 Remarks:

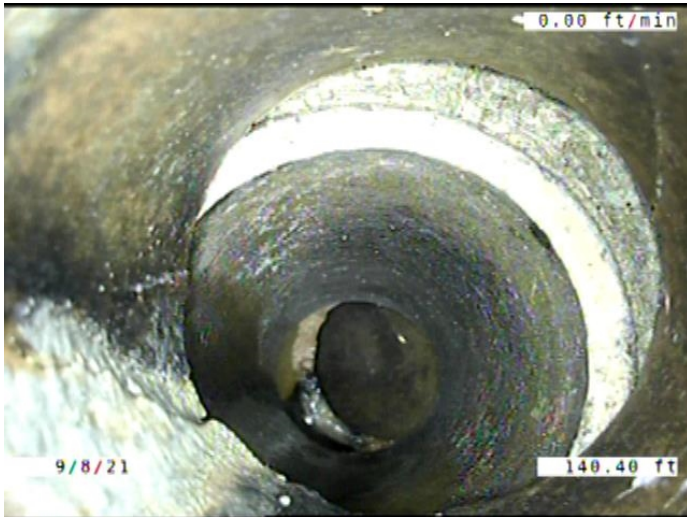
Code: **TFD**
 Description: **Tap Factory Defective**

Distance (ft): **140.4**
 Structural Grade: **0**
 O&M Grade: **3**
 Clock Start/From: **11**
 Clock To:
 1st Value: **4.000**
 2nd Value:
 Value Percent:
 Continuous Index:
 Within 8" of Joint: **YES**
 Remarks: **Defective**

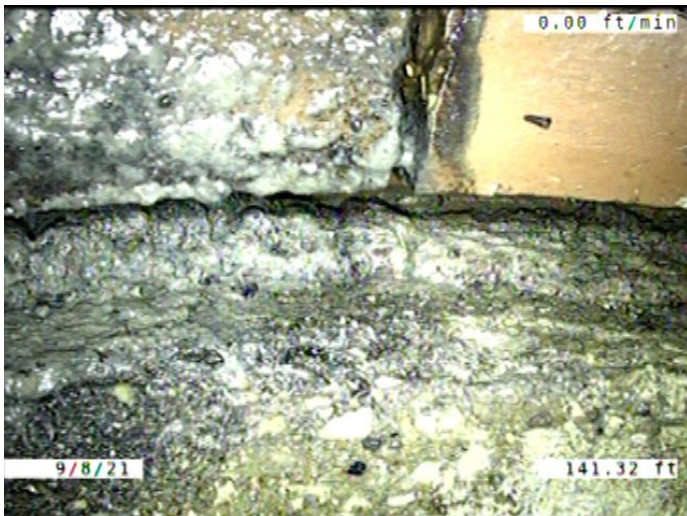
Code: **MMC**
 Description: **Miscellaneous Material Change**

Distance (ft): **141.3**
 Structural Grade: **0**
 O&M Grade: **0**
 Clock Start/From:
 Clock To:
 1st Value:
 2nd Value:
 Value Percent:
 Continuous Index:
 Within 8" of Joint: **NO**
 Remarks: **VCP TO CONCRETE**

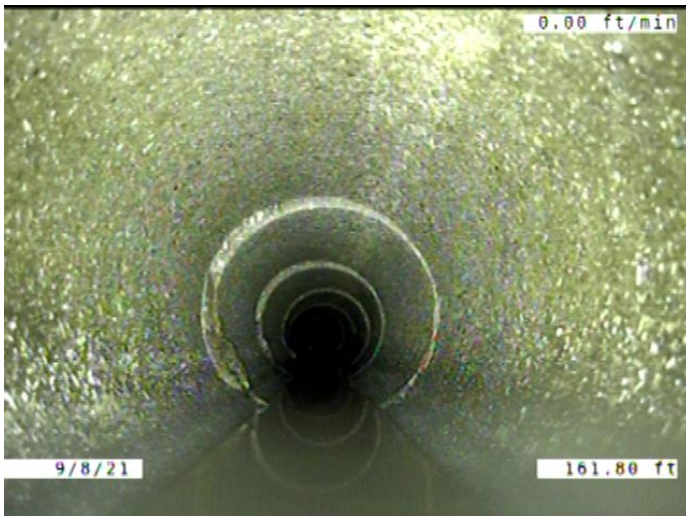
Code: **MWL**
Description: **Miscellaneous Water Level**

Distance (ft): **161.8**
Structural Grade: **0**
O&M Grade: **0**
Clock Start/From:
Clock To:
1st Value:
2nd Value:
Value Percent: **5.000**
Continuous Index:
Within 8" of Joint: **NO**
Remarks:

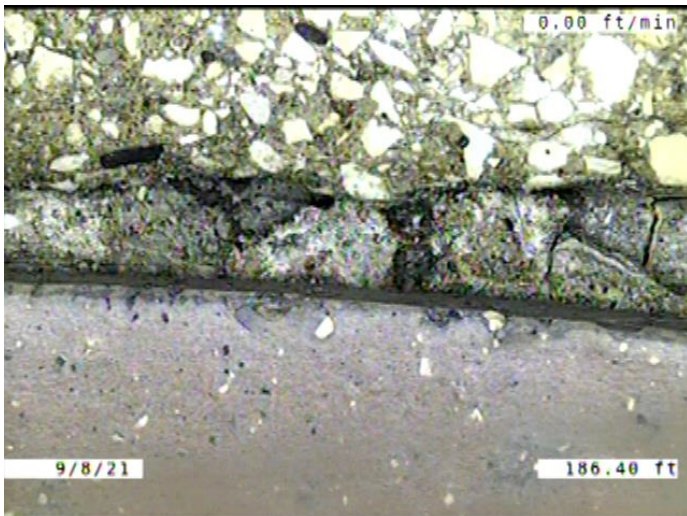
Code: **MMC**
 Description: **Miscellaneous Material Change**

Distance (ft): **186.4**
 Structural Grade: **0**
 O&M Grade: **0**
 Clock Start/From:
 Clock To:
 1st Value:
 2nd Value:
 Value Percent:
 Continuous Index:
 Within 8" of Joint: **NO**
 Remarks: **CONCRETE TO VCP**

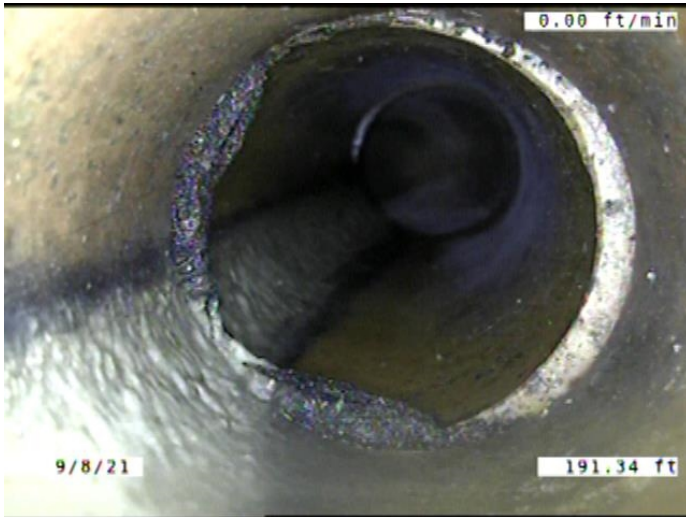
Code: **TF**
 Description: **Tap Factory**

Distance (ft): **191.3**
 Structural Grade: **0**
 O&M Grade: **0**
 Clock Start/From: **11**
 Clock To:
 1st Value: **4.000**
 2nd Value:
 Value Percent:
 Continuous Index:
 Within 8" of Joint: **YES**
 Remarks:

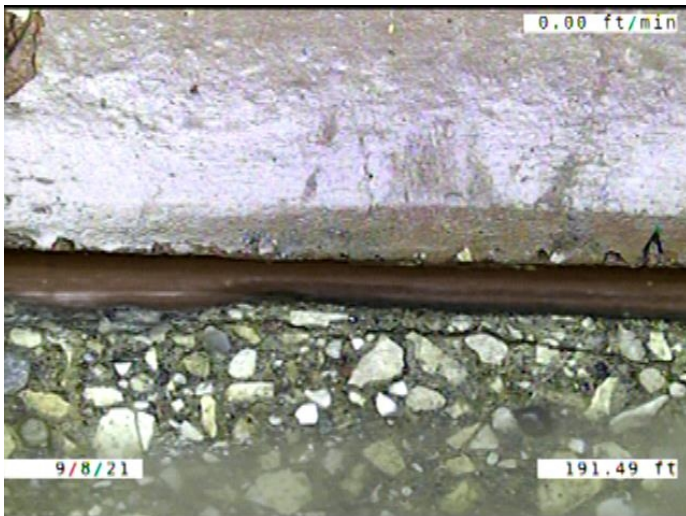
Code: **MMC**
 Description: **Miscellaneous Material Change**

Distance (ft): **191.5**
 Structural Grade: **0**
 O&M Grade: **0**
 Clock Start/From:
 Clock To:
 1st Value:
 2nd Value:
 Value Percent:
 Continuous Index:
 Within 8" of Joint: **NO**
 Remarks: **VCP TO CONCRETE**

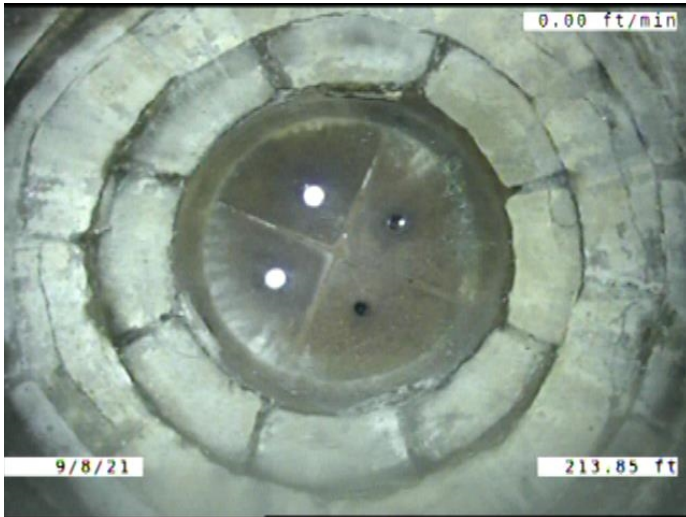
Code:	AMH
Description:	Manhole
Distance (ft):	213.8
Structural Grade:	0
O&M Grade:	0
Clock Start/From:	
Clock To:	
1st Value:	
2nd Value:	
Value Percent:	
Continuous Index:	
Within 8" of Joint:	NO
Remarks:	M-503-027
