Profile/Photo Observation Report

Date:	09/08/2021	Weather:		Coding:	PACP 7.0
Pipe Length (ft):	213.8	Owner:	City of Hobart	Pre Clean:	Light Cleaning
P.O.#:	YES502259	Surveyor:	S. Bucklin	PSR:	P-503-027.5-027
Customer:	City of Hobart	Clean Date:	08/28/2021	Shape:	C

Street:	North Virginia Street	Flow Control:	Not Controlled
City:	Hobart, IN	Year Renewed:	
Location:	Local rural streets with light traffic, t	Tape/Media #:	
Purpose:	Routine Assessment	Dia/Height:	10"
Use:	Sanitary Sewage Pipe	Material:	CP
Drain Area:		Lining:	None
Category:	NA		
Comment:			
Location Details:		Direction of Survey:	Upstream
US MH:	M-503-027	DS MH:	M-503-027.5
		Total Length Surveyed (ft):	213.8

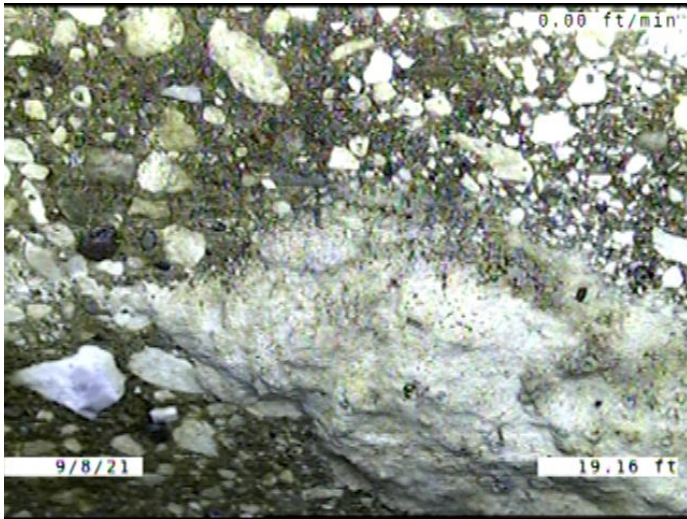
Code: **DAE**
 Description: **Deposits Attached Encrustation**

Distance (ft): **19.2**
 Structural Grade: **0**
 O&M Grade: **2**
 Clock Start/From: **3**
 Clock To:
 1st Value:
 2nd Value:
 Value Percent: **5.000**
 Continuous Index:
 Within 8" of Joint: **NO**
 Remarks:

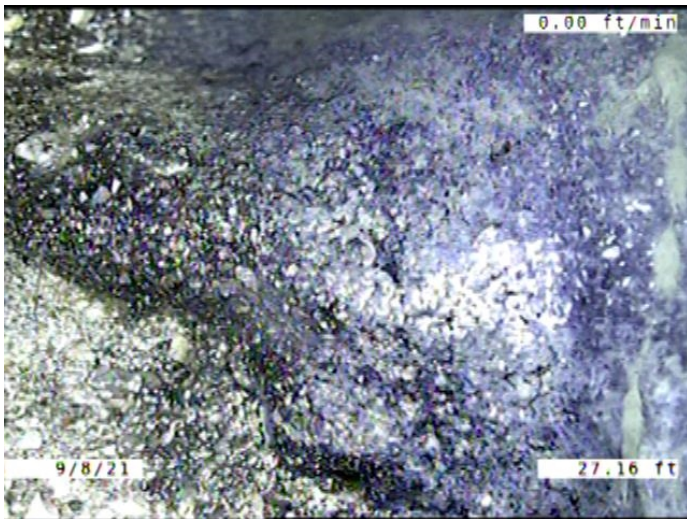
Code: **DAE**
 Description: **Deposits Attached Encrustation**

Distance (ft): **27.2**
 Structural Grade: **0**
 O&M Grade: **2**
 Clock Start/From: **4**
 Clock To: **8**
 1st Value:
 2nd Value:
 Value Percent: **5.000**
 Continuous Index:
 Within 8" of Joint: **YES**
 Remarks:

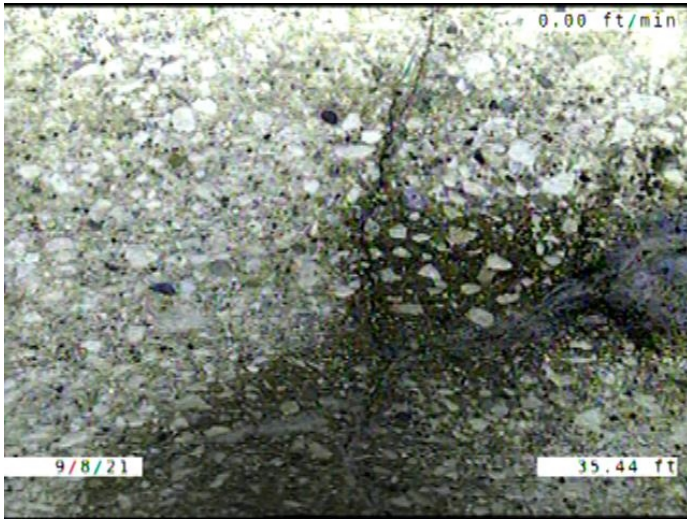
Code: **CM**
 Description: **Crack Multiple**

Distance (ft): **35.4**
 Structural Grade: **3**
 O&M Grade: **0**
 Clock Start/From: **12**
 Clock To: **2**
 1st Value:
 2nd Value:
 Value Percent:
 Continuous Index:
 Within 8" of Joint: **YES**
 Remarks:

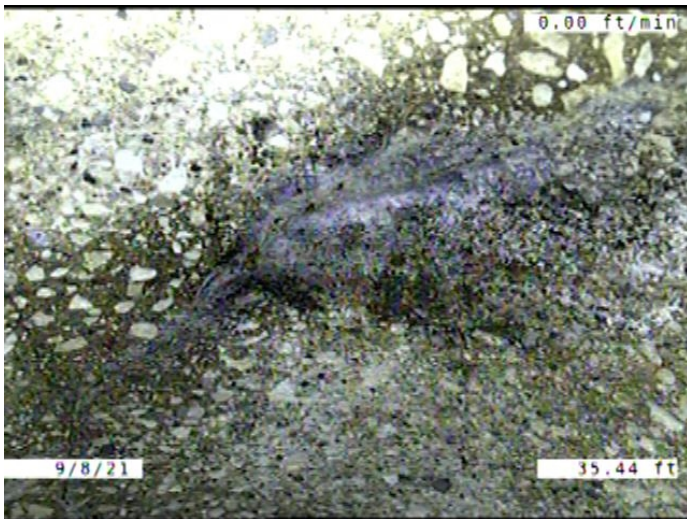
Code: **ISB**
 Description: **Infiltration Stain Barrel**

Distance (ft): **35.4**
 Structural Grade: **0**
 O&M Grade: **1**
 Clock Start/From: **1**
 Clock To: **3**
 1st Value:
 2nd Value:
 Value Percent:
 Continuous Index:
 Within 8" of Joint: **YES**
 Remarks:

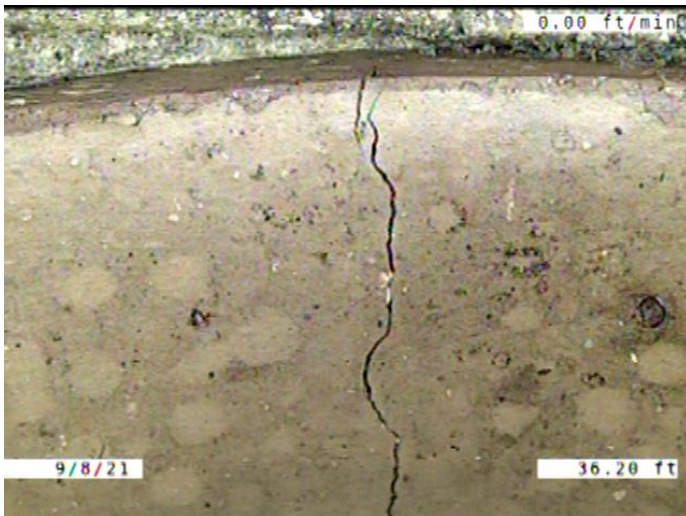
Code: **FM**
 Description: **Fracture Multiple**

Distance (ft): **36.2**
 Structural Grade: **4**
 O&M Grade: **0**
 Clock Start/From: **11**
 Clock To: **1**
 1st Value:
 2nd Value:
 Value Percent:
 Continuous Index: **S01**
 Within 8" of Joint: **YES**
 Remarks:

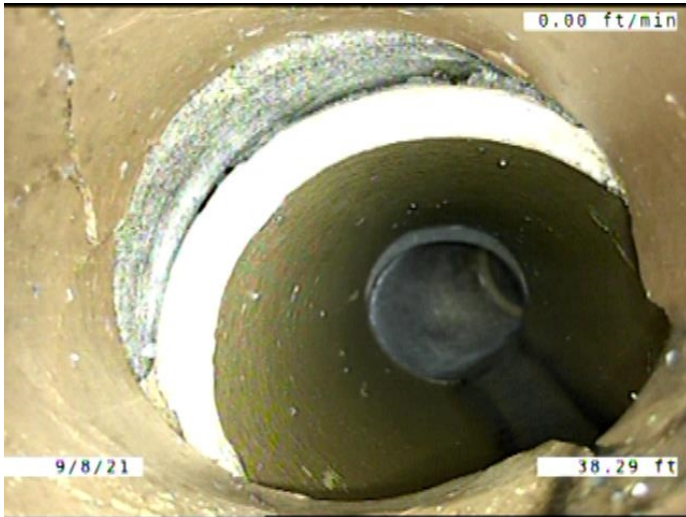
Code: **TFD**
 Description: **Tap Factory Defective**

Distance (ft): **38.3**
 Structural Grade: **0**
 O&M Grade: **3**
 Clock Start/From: **1**
 Clock To:
 1st Value: **4.000**
 2nd Value:
 Value Percent:
 Continuous Index:
 Within 8" of Joint: **YES**
 Remarks: **Defective**

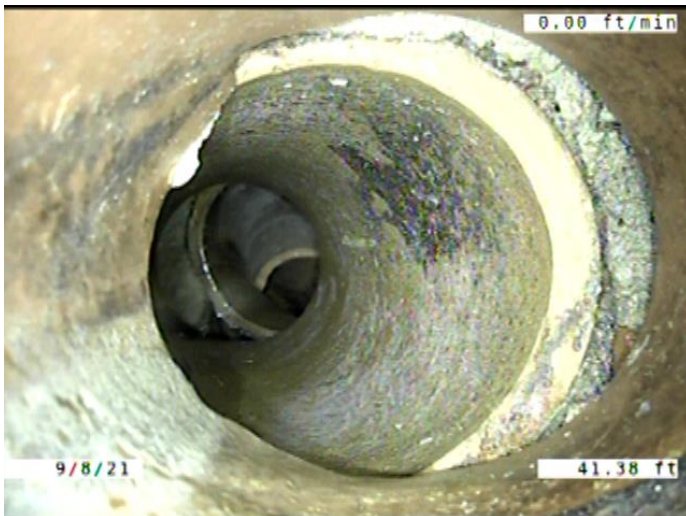
Code: **TFD**
 Description: **Tap Factory Defective**

Distance (ft): **41.4**
 Structural Grade: **0**
 O&M Grade: **3**
 Clock Start/From: **11**
 Clock To:
 1st Value: **4.000**
 2nd Value:
 Value Percent:
 Continuous Index:
 Within 8" of Joint: **YES**
 Remarks: **Defective**

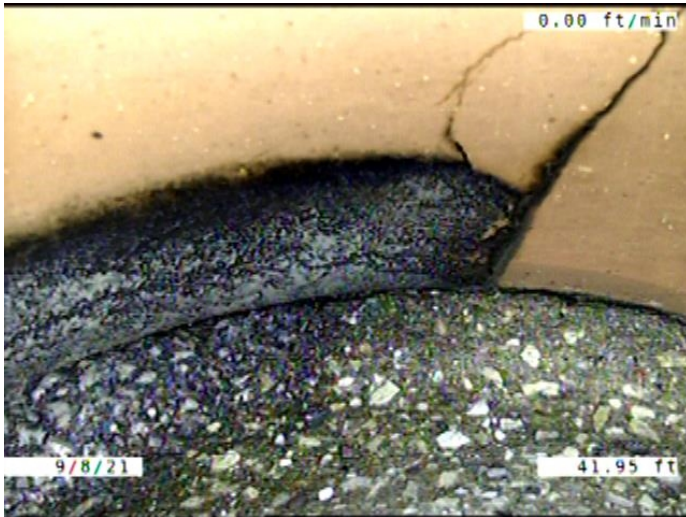
Code: **ISB**
 Description: **Infiltration Stain Barrel**

Distance (ft): **42.0**
 Structural Grade: **0**
 O&M Grade: **1**
 Clock Start/From: **8**
 Clock To: **11**
 1st Value:
 2nd Value:
 Value Percent:
 Continuous Index:
 Within 8" of Joint: **YES**
 Remarks:

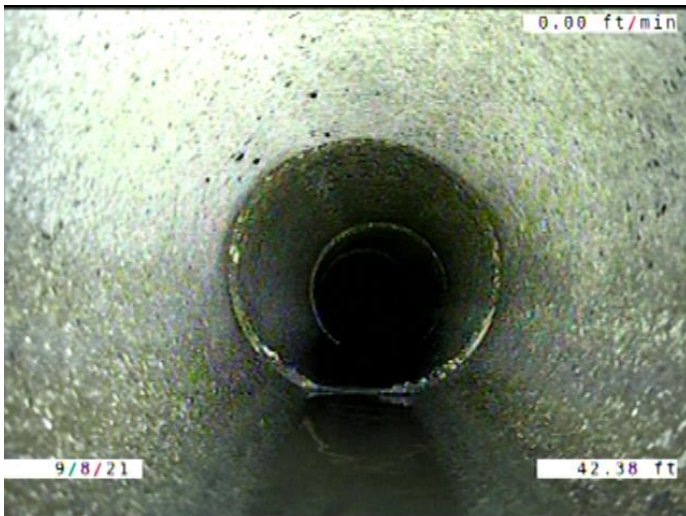
Code: **FM**
 Description: **Fracture Multiple**

Distance (ft): **42.4**
 Structural Grade: **4**
 O&M Grade: **0**
 Clock Start/From: **11**
 Clock To: **1**
 1st Value:
 2nd Value:
 Value Percent:
 Continuous Index: **F01**
 Within 8" of Joint: **YES**
 Remarks:

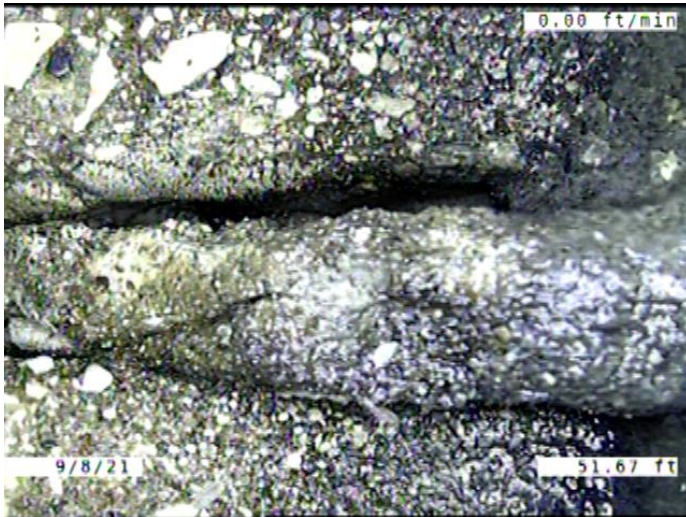
Code: **DAE**
 Description: **Deposits Attached Encrustation**

Distance (ft): **51.7**
 Structural Grade: **0**
 O&M Grade: **2**
 Clock Start/From: **7**
 Clock To: **8**
 1st Value:
 2nd Value:
 Value Percent: **5.000**
 Continuous Index:
 Within 8" of Joint: **YES**
 Remarks:

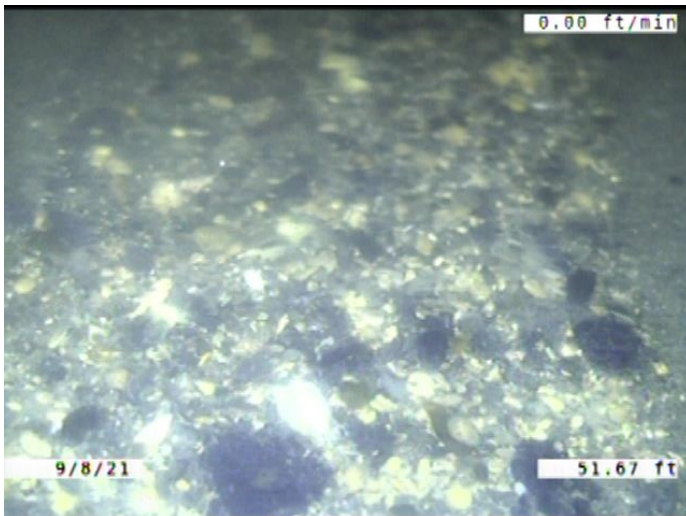
Code: **DSF**
 Description: **Deposits Settled Fine**

Distance (ft): **51.7**
 Structural Grade: **0**
 O&M Grade: **2**
 Clock Start/From: **5**
 Clock To: **7**
 1st Value:
 2nd Value:
 Value Percent: **5.000**
 Continuous Index: **S02**
 Within 8" of Joint: **YES**
 Remarks:

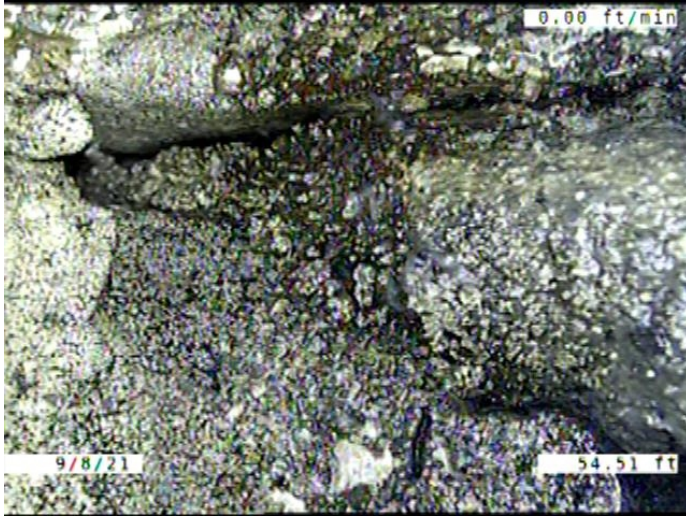
Code: **DAE**
 Description: **Deposits Attached Encrustation**

Distance (ft): **54.5**
 Structural Grade: **0**
 O&M Grade: **2**
 Clock Start/From: **7**
 Clock To: **8**
 1st Value:
 2nd Value:
 Value Percent: **5.000**
 Continuous Index:
 Within 8" of Joint: **YES**
 Remarks:

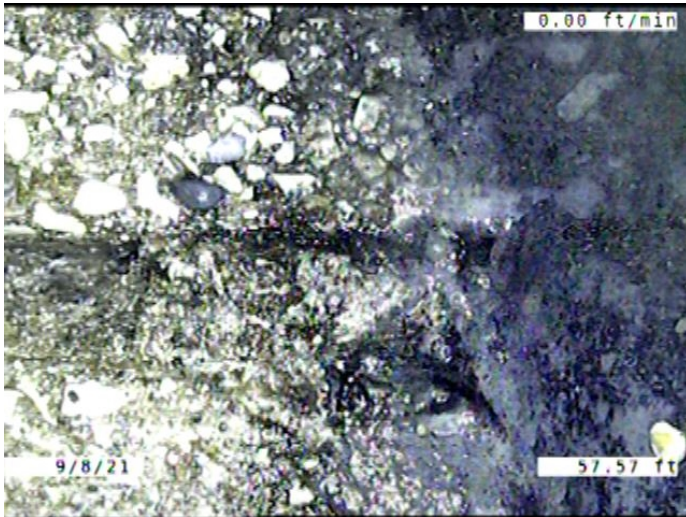
Code: **DAE**
 Description: **Deposits Attached Encrustation**

Distance (ft): **57.6**
 Structural Grade: **0**
 O&M Grade: **2**
 Clock Start/From: **4**
 Clock To: **7**
 1st Value:
 2nd Value:
 Value Percent: **5.000**
 Continuous Index: **S03**
 Within 8" of Joint: **YES**
 Remarks:

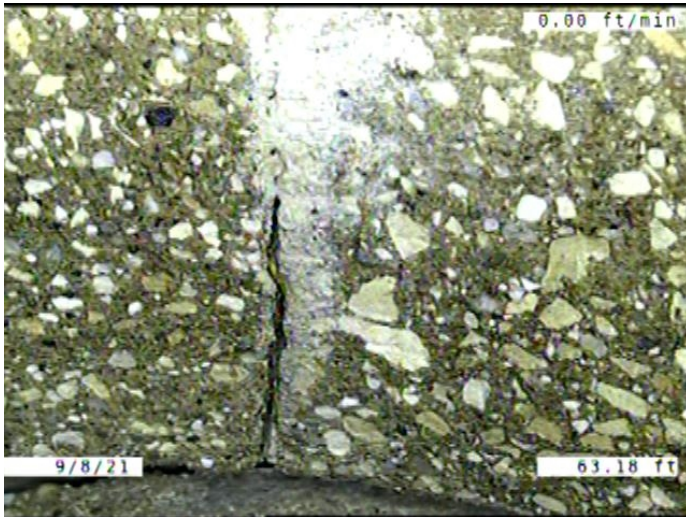
Code: **FS**
 Description: **Fracture Spiral**

Distance (ft): **63.2**
 Structural Grade: **3**
 O&M Grade: **0**
 Clock Start/From: **1**
 Clock To: **3**
 1st Value:
 2nd Value:
 Value Percent:
 Continuous Index:
 Within 8" of Joint: **YES**
 Remarks:

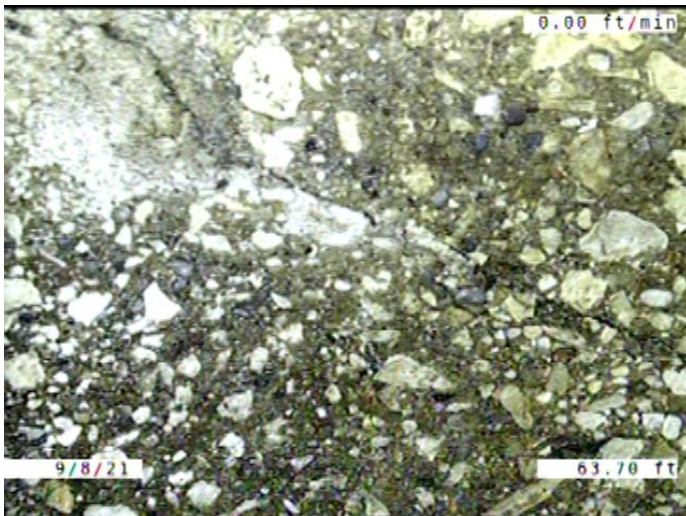
Code: **CM**
 Description: **Crack Multiple**

Distance (ft): **63.7**
 Structural Grade: **3**
 O&M Grade: **0**
 Clock Start/From: **7**
 Clock To: **11**
 1st Value:
 2nd Value:
 Value Percent:
 Continuous Index:
 Within 8" of Joint: **YES**
 Remarks:

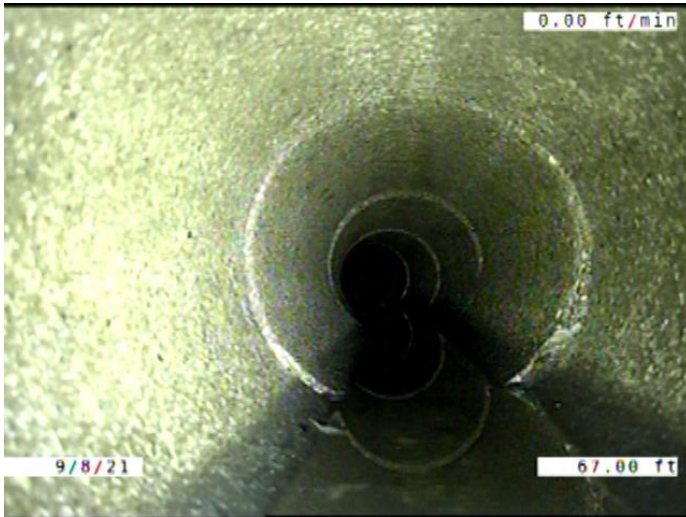
Code: **DAE**
 Description: **Deposits Attached Encrustation**

Distance (ft): **67.0**
 Structural Grade: **0**
 O&M Grade: **2**
 Clock Start/From: **4**
 Clock To: **7**
 1st Value:
 2nd Value:
 Value Percent: **5.000**
 Continuous Index: **F03**
 Within 8" of Joint: **YES**
 Remarks:

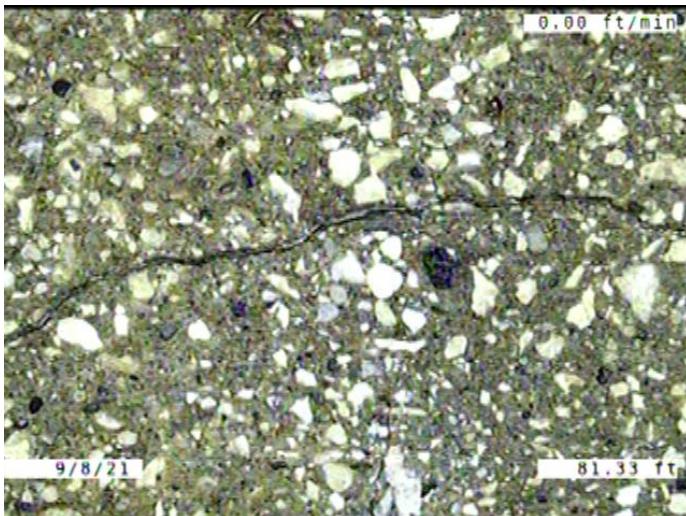
81.3	FM	Fracture Multiple	948	S 4
86.7	FS	Fracture Spiral	1005	S 3
87.6	MMC	Miscellaneous Material Change	1050	NA
89.7	TFD	Tap Factory Defective	1102	M 3
90.5	DAE	Deposits Attached Encrustation	1129	M 2

Code: **FM**
 Description: **Fracture Multiple**

Distance (ft): **81.3**
 Structural Grade: **4**
 O&M Grade: **0**
 Clock Start/From: **11**
 Clock To: **3**
 1st Value:
 2nd Value:
 Value Percent:
 Continuous Index:
 Within 8" of Joint: **YES**
 Remarks:

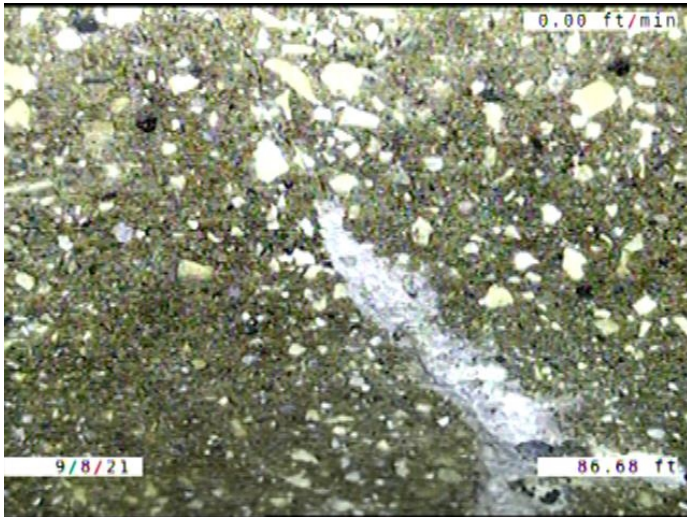
Code: **FS**
 Description: **Fracture Spiral**

Distance (ft): **86.7**
 Structural Grade: **3**
 O&M Grade: **0**
 Clock Start/From: **12**
 Clock To: **1**
 1st Value:
 2nd Value:
 Value Percent:
 Continuous Index:
 Within 8" of Joint: **YES**
 Remarks:

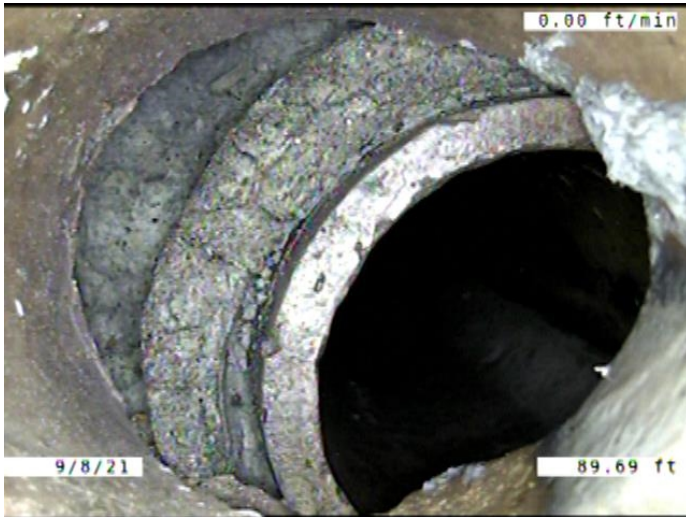
Code: **TFD**
 Description: **Tap Factory Defective**

Distance (ft): **89.7**
 Structural Grade: **0**
 O&M Grade: **3**
 Clock Start/From: **1**
 Clock To:
 1st Value: **4.000**
 2nd Value:
 Value Percent:
 Continuous Index:
 Within 8" of Joint: **YES**
 Remarks: **Defective**

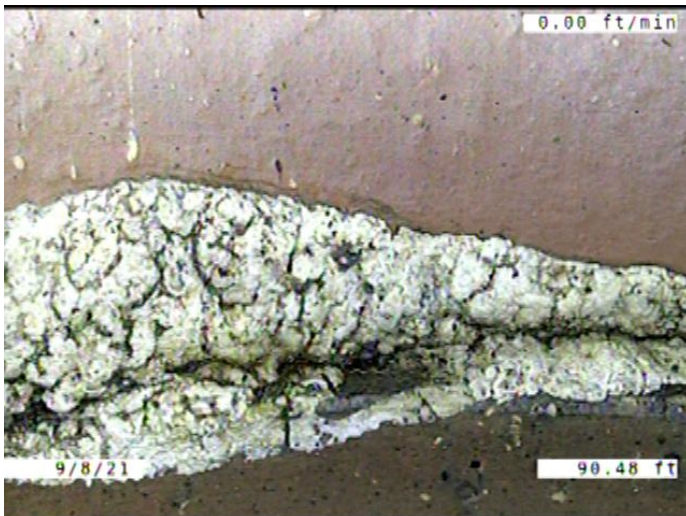
Code: **DAE**
 Description: **Deposits Attached Encrustation**

Distance (ft): **90.5**
 Structural Grade: **0**
 O&M Grade: **2**
 Clock Start/From: **9**
 Clock To: **11**
 1st Value:
 2nd Value:
 Value Percent: **5.000**
 Continuous Index:
 Within 8" of Joint: **YES**
 Remarks:

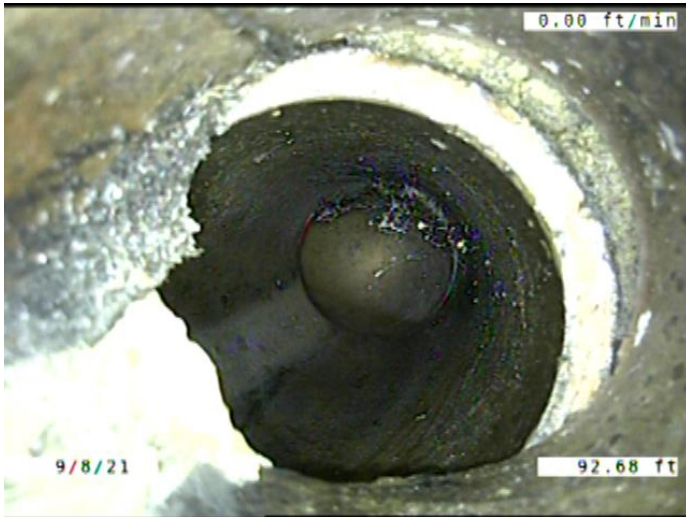
Code: **TFD**
 Description: **Tap Factory Defective**

Distance (ft): **92.7**
 Structural Grade: **0**
 O&M Grade: **3**
 Clock Start/From: **11**
 Clock To:
 1st Value: **4.000**
 2nd Value:
 Value Percent:
 Continuous Index:
 Within 8" of Joint: **YES**
 Remarks: **Defective**

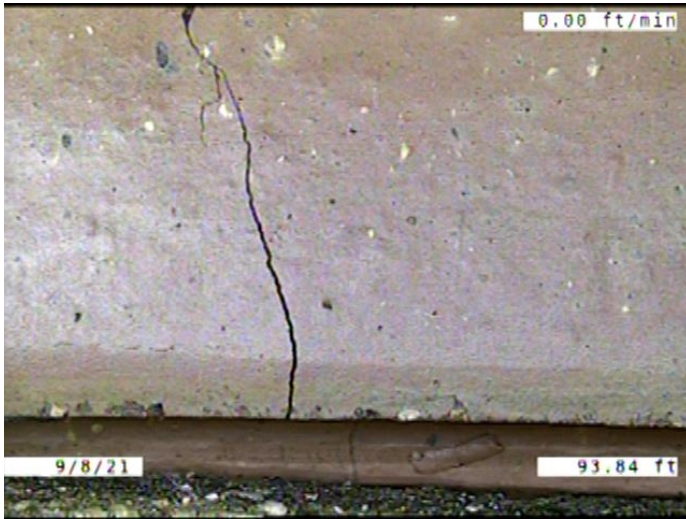
Code: **CM**
Description: **Crack Multiple**

Distance (ft): **93.8**
Structural Grade: **3**
O&M Grade: **0**
Clock Start/From: **11**
Clock To: **12**
1st Value:
2nd Value:
Value Percent:
Continuous Index:
Within 8" of Joint: **NO**
Remarks:

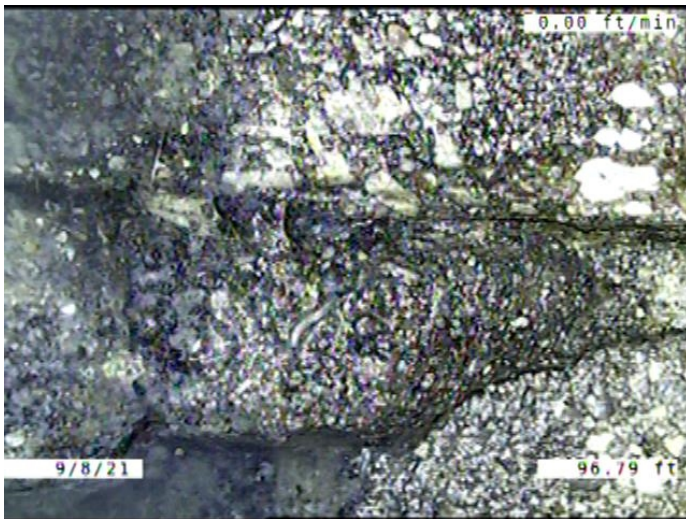
Code: **DAE**
Description: **Deposits Attached Encrustation**

Distance (ft): **96.8**
Structural Grade: **0**
O&M Grade: **2**
Clock Start/From: **3**
Clock To: **9**
1st Value:
2nd Value:
Value Percent: **5.000**
Continuous Index:
Within 8" of Joint: **YES**
Remarks:

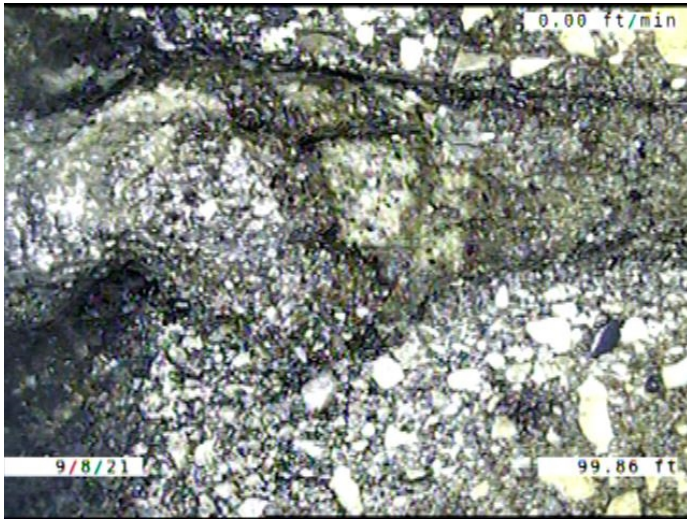
Code: **DAE**
 Description: **Deposits Attached Encrustation**

Distance (ft): **99.9**
 Structural Grade: **0**
 O&M Grade: **2**
 Clock Start/From: **3**
 Clock To: **4**
 1st Value:
 2nd Value:
 Value Percent: **5.000**
 Continuous Index:
 Within 8" of Joint: **YES**
 Remarks:

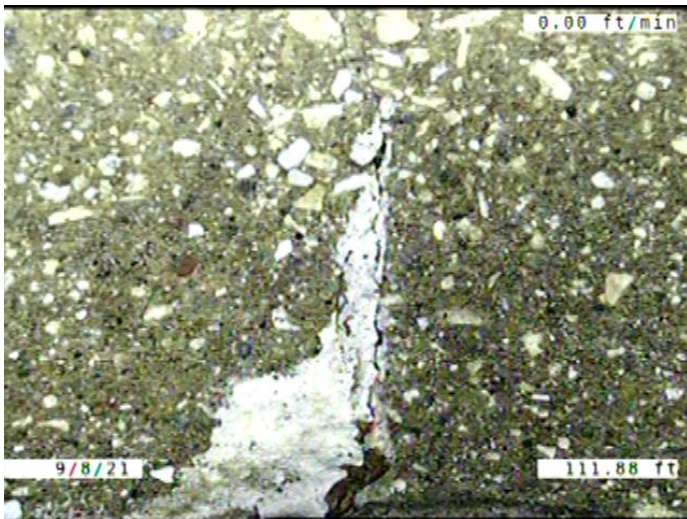
Code: **CL**
 Description: **Crack Longitudinal**

Distance (ft): **111.9**
 Structural Grade: **2**
 O&M Grade: **0**
 Clock Start/From: **10**
 Clock To:
 1st Value:
 2nd Value:
 Value Percent:
 Continuous Index:
 Within 8" of Joint: **YES**
 Remarks:

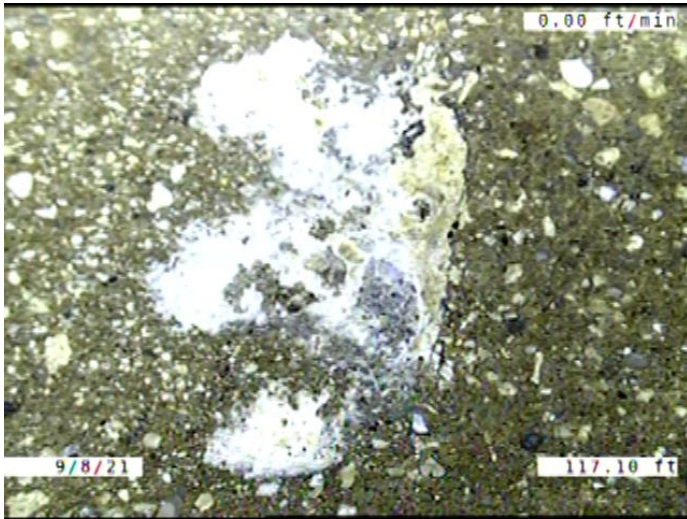
Code: **DAE**
 Description: **Deposits Attached Encrustation**

Distance (ft): **117.1**
 Structural Grade: **0**
 O&M Grade: **2**
 Clock Start/From: **10**
 Clock To:
 1st Value:
 2nd Value:
 Value Percent: **5.000**
 Continuous Index:
 Within 8" of Joint: **NO**
 Remarks:

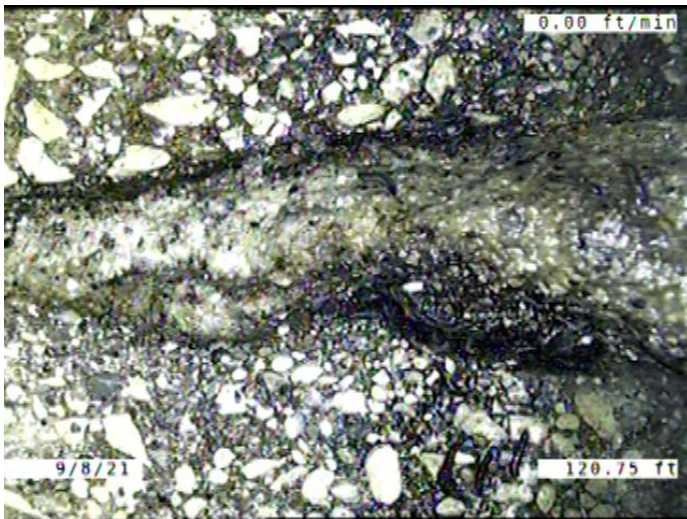
Code: **DAE**
 Description: **Deposits Attached Encrustation**

Distance (ft): **120.7**
 Structural Grade: **0**
 O&M Grade: **2**
 Clock Start/From: **4**
 Clock To: **8**
 1st Value:
 2nd Value:
 Value Percent: **5.000**
 Continuous Index: **S04**
 Within 8" of Joint: **YES**
 Remarks:

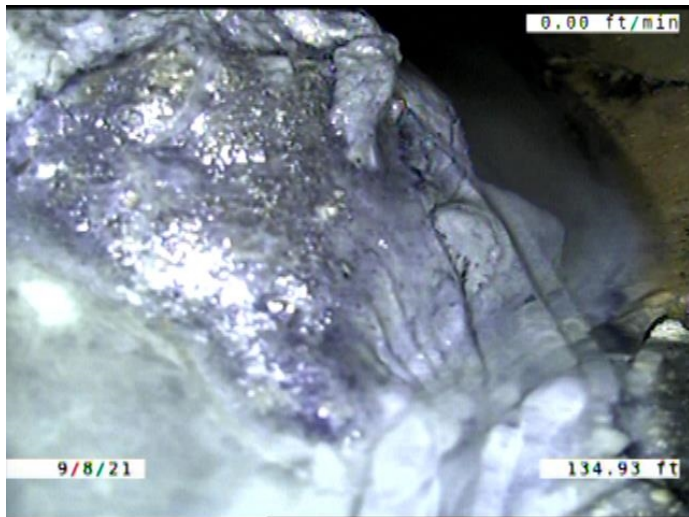
Code: **DAE**
 Description: **Deposits Attached Encrustation**

Distance (ft): **134.9**
 Structural Grade: **0**
 O&M Grade: **3**
 Clock Start/From: **4**
 Clock To: **8**
 1st Value:
 2nd Value:
 Value Percent: **15.000**
 Continuous Index:
 Within 8" of Joint: **YES**
 Remarks:

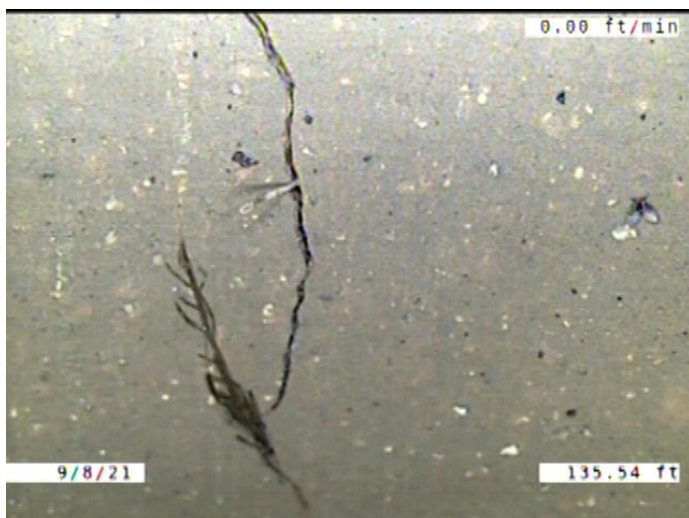
Code: **FM**
 Description: **Fracture Multiple**

Distance (ft): **135.5**
 Structural Grade: **4**
 O&M Grade: **0**
 Clock Start/From: **8**
 Clock To: **4**
 1st Value:
 2nd Value:
 Value Percent:
 Continuous Index: **S05**
 Within 8" of Joint: **YES**
 Remarks:

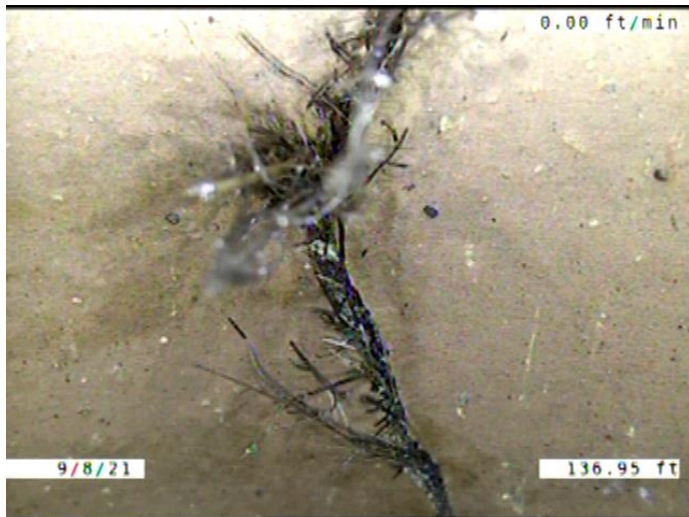
Code: **RFB**
 Description: **Roots Fine Barrel**

Distance (ft): **137.0**
 Structural Grade: **0**
 O&M Grade: **2**
 Clock Start/From: **11**
 Clock To: **3**
 1st Value:
 2nd Value:
 Value Percent:
 Continuous Index:
 Within 8" of Joint: **NO**
 Remarks:

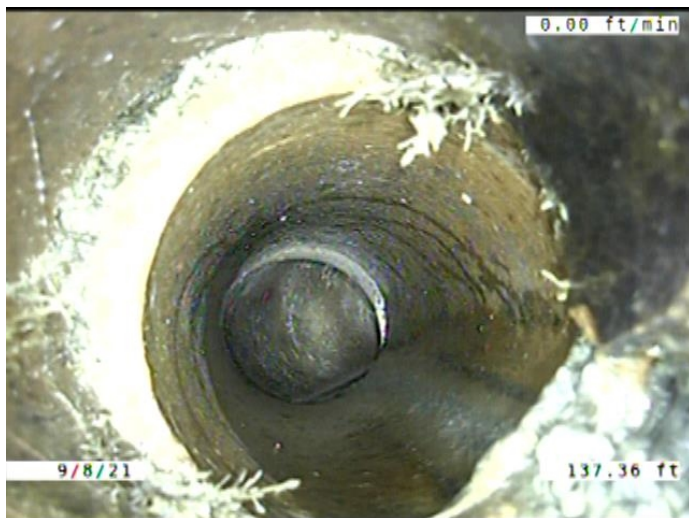
Code: **TFD**
 Description: **Tap Factory Defective**

Distance (ft): **137.4**
 Structural Grade: **0**
 O&M Grade: **3**
 Clock Start/From: **1**
 Clock To:
 1st Value: **4.000**
 2nd Value:
 Value Percent:
 Continuous Index:
 Within 8" of Joint: **YES**
 Remarks: **Defective**

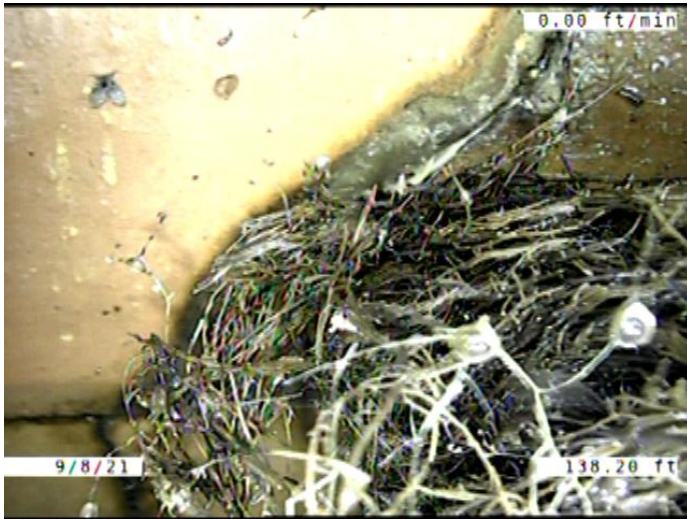
Code: **RMJ**
 Description: **Roots Medium Joint**

Distance (ft): **138.2**
 Structural Grade: **0**
 O&M Grade: **3**
 Clock Start/From: **1**
 Clock To:
 1st Value:
 2nd Value:
 Value Percent: **5.000**
 Continuous Index:
 Within 8" of Joint: **YES**
 Remarks:

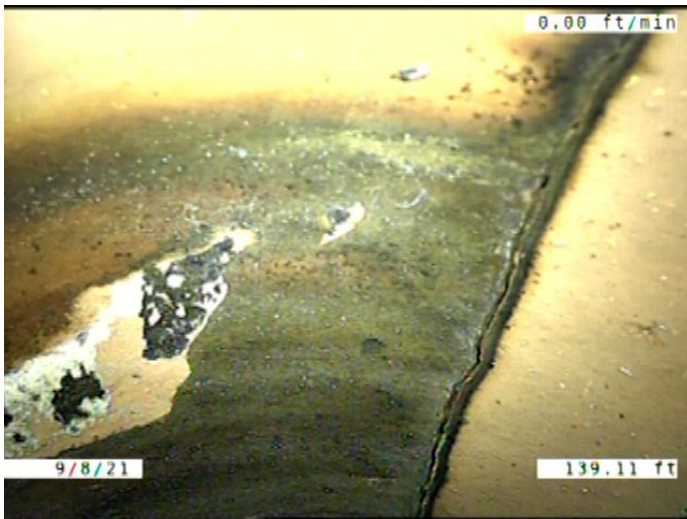
Code: **ISB**
 Description: **Infiltration Stain Barrel**

Distance (ft): **139.1**
 Structural Grade: **0**
 O&M Grade: **1**
 Clock Start/From: **9**
 Clock To: **12**
 1st Value:
 2nd Value:
 Value Percent:
 Continuous Index:
 Within 8" of Joint: **YES**
 Remarks:

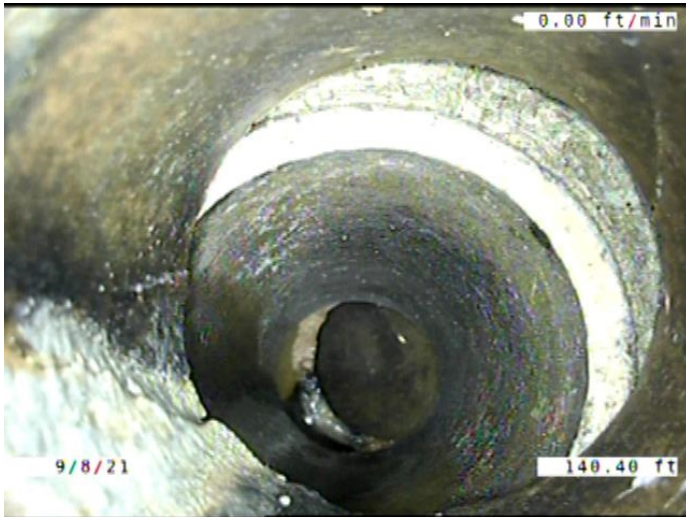
Code: **TFD**
 Description: **Tap Factory Defective**

Distance (ft): **140.4**
 Structural Grade: **0**
 O&M Grade: **3**
 Clock Start/From: **11**
 Clock To:
 1st Value: **4.000**
 2nd Value:
 Value Percent:
 Continuous Index:
 Within 8" of Joint: **YES**
 Remarks: **Defective**

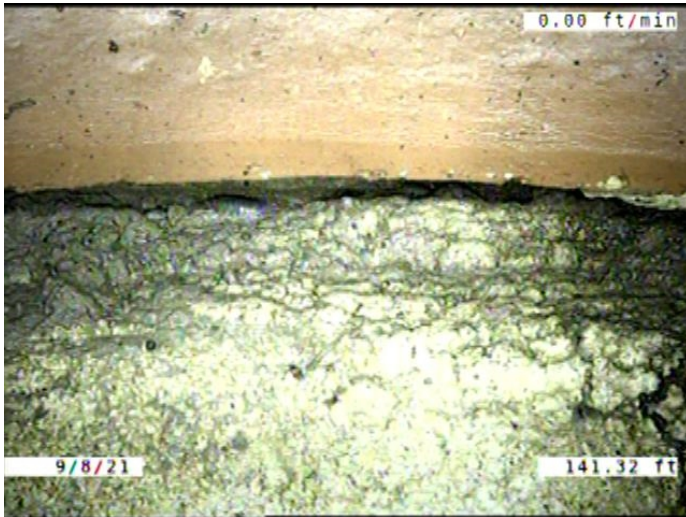
Code: **DAE**
Description: **Deposits Attached Encrustation**

Distance (ft): **141.3**
Structural Grade: **0**
O&M Grade: **2**
Clock Start/From: **9**
Clock To: **3**
1st Value:
2nd Value:
Value Percent: **5.000**
Continuous Index:
Within 8" of Joint: **YES**
Remarks:

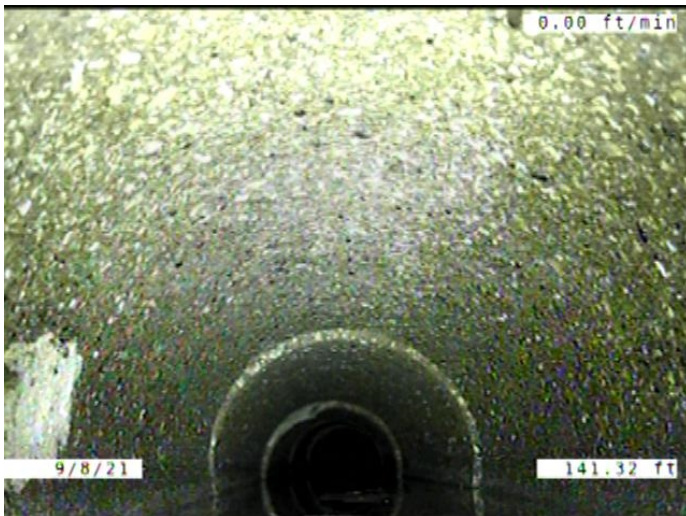
Code: **DAE**
Description: **Deposits Attached Encrustation**

Distance (ft): **141.3**
Structural Grade: **0**
O&M Grade: **2**
Clock Start/From: **4**
Clock To: **8**
1st Value:
2nd Value:
Value Percent: **5.000**
Continuous Index: **F04**
Within 8" of Joint: **YES**
Remarks:

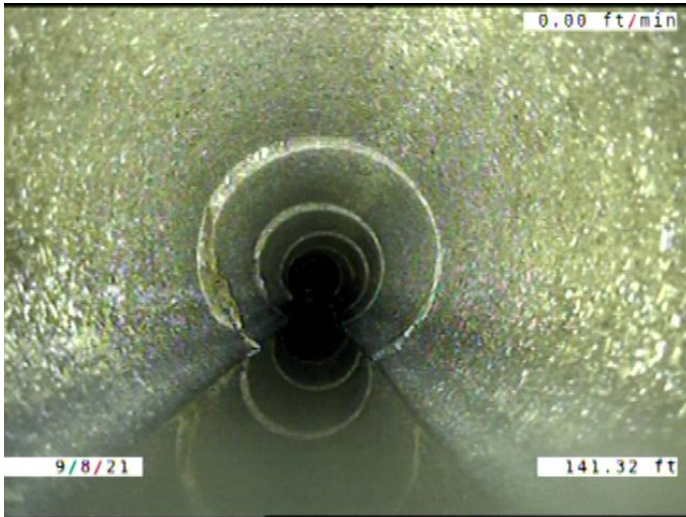
Code: **FM**
 Description: **Fracture Multiple**

Distance (ft): **141.3**
 Structural Grade: **4**
 O&M Grade: **0**
 Clock Start/From: **8**
 Clock To: **4**
 1st Value:
 2nd Value:
 Value Percent:
 Continuous Index: **F05**
 Within 8" of Joint: **YES**
 Remarks:

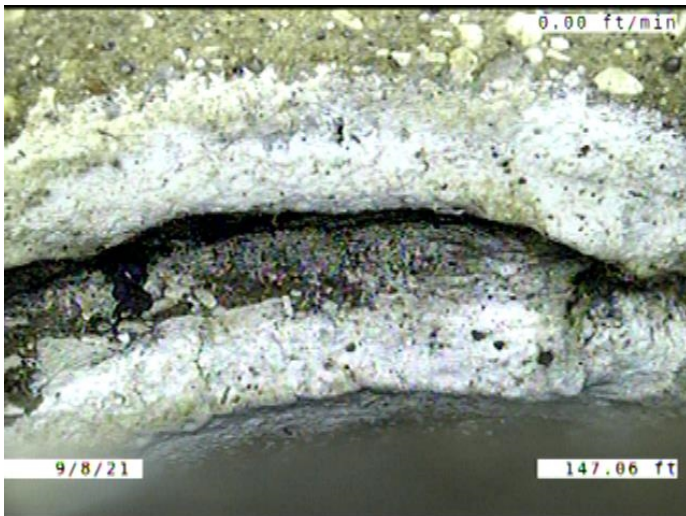
Code: **DAE**
 Description: **Deposits Attached Encrustation**

Distance (ft): **147.1**
 Structural Grade: **0**
 O&M Grade: **2**
 Clock Start/From: **10**
 Clock To: **12**
 1st Value:
 2nd Value:
 Value Percent: **5.000**
 Continuous Index:
 Within 8" of Joint: **YES**
 Remarks:

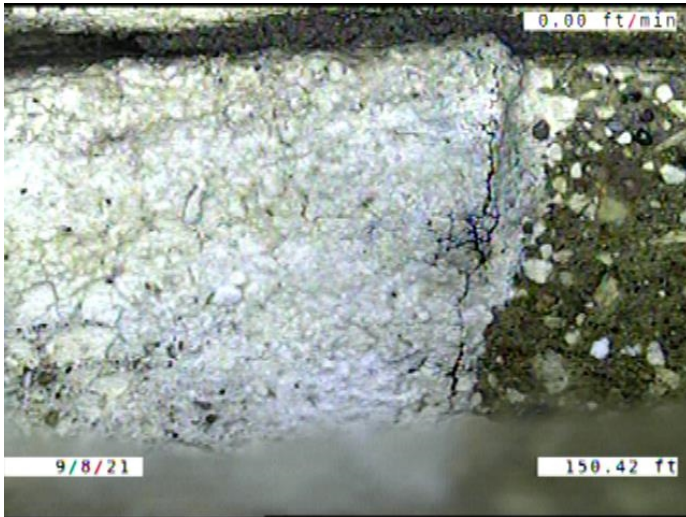
Code: **DAE**
 Description: **Deposits Attached Encrustation**

Distance (ft): **150.4**
 Structural Grade: **0**
 O&M Grade: **2**
 Clock Start/From: **10**
 Clock To: **11**
 1st Value:
 2nd Value:
 Value Percent: **5.000**
 Continuous Index:
 Within 8" of Joint: **YES**
 Remarks:

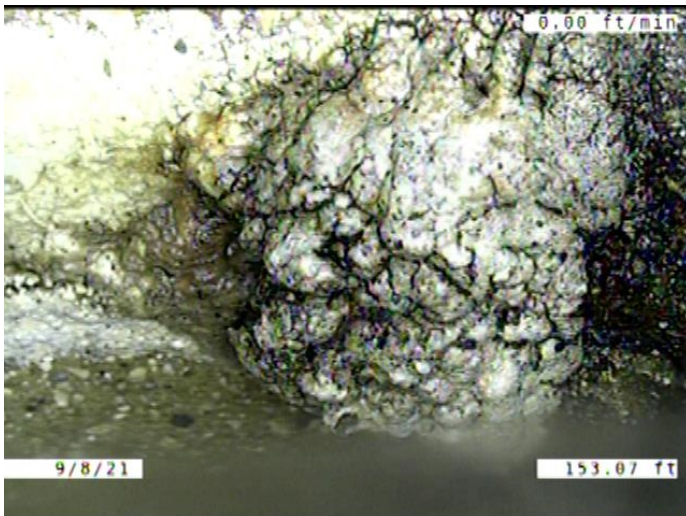
Code: **DAE**
 Description: **Deposits Attached Encrustation**

Distance (ft): **153.1**
 Structural Grade: **0**
 O&M Grade: **2**
 Clock Start/From: **9**
 Clock To: **3**
 1st Value:
 2nd Value:
 Value Percent: **5.000**
 Continuous Index:
 Within 8" of Joint: **YES**
 Remarks:

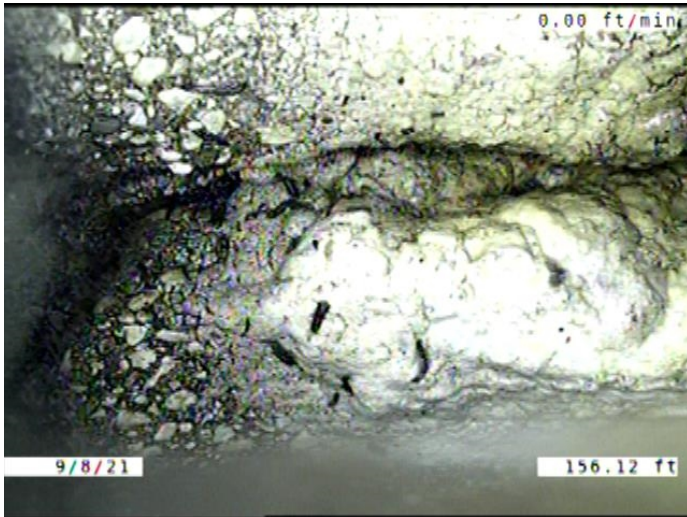
Code: **DAE**
 Description: **Deposits Attached Encrustation**

Distance (ft): **156.1**
 Structural Grade: **0**
 O&M Grade: **2**
 Clock Start/From: **9**
 Clock To: **11**
 1st Value:
 2nd Value:
 Value Percent: **5.000**
 Continuous Index:
 Within 8" of Joint: **YES**
 Remarks:

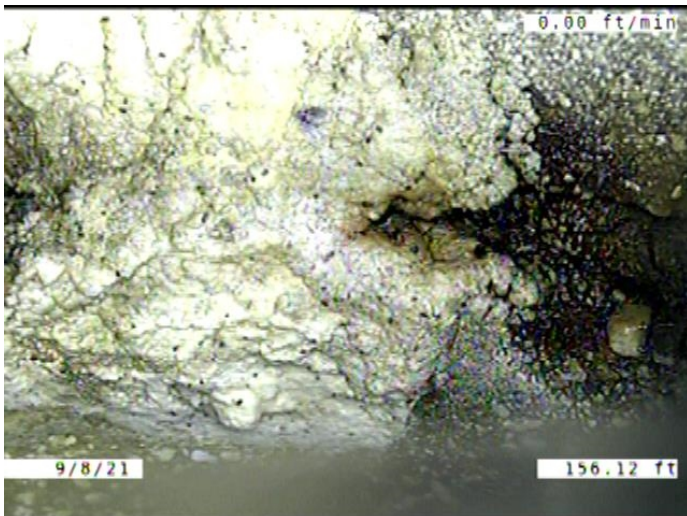
Code: **DAE**
 Description: **Deposits Attached Encrustation**

Distance (ft): **156.1**
 Structural Grade: **0**
 O&M Grade: **2**
 Clock Start/From: **1**
 Clock To: **4**
 1st Value:
 2nd Value:
 Value Percent: **5.000**
 Continuous Index:
 Within 8" of Joint: **YES**
 Remarks:

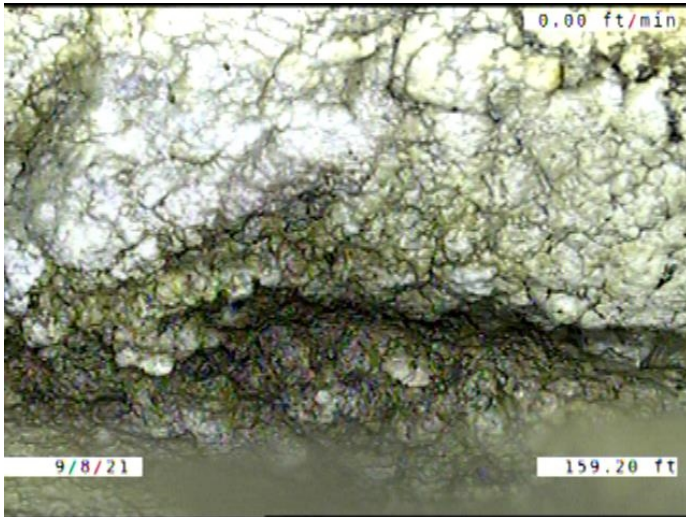
Code: **DAE**
 Description: **Deposits Attached Encrustation**

Distance (ft): **159.2**
 Structural Grade: **0**
 O&M Grade: **2**
 Clock Start/From: **9**
 Clock To: **3**
 1st Value:
 2nd Value:
 Value Percent: **5.000**
 Continuous Index:
 Within 8" of Joint: **YES**
 Remarks:

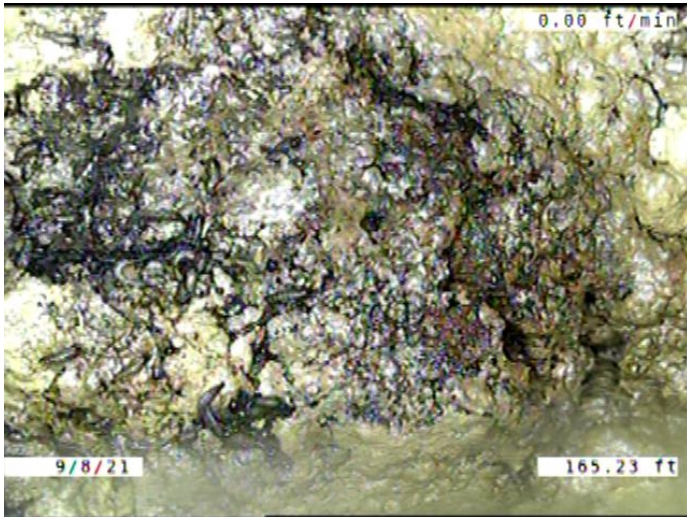
Code: **DAE**
 Description: **Deposits Attached Encrustation**

Distance (ft): **165.2**
 Structural Grade: **0**
 O&M Grade: **2**
 Clock Start/From: **2**
 Clock To: **10**
 1st Value:
 2nd Value:
 Value Percent: **5.000**
 Continuous Index: **S06**
 Within 8" of Joint: **YES**
 Remarks:

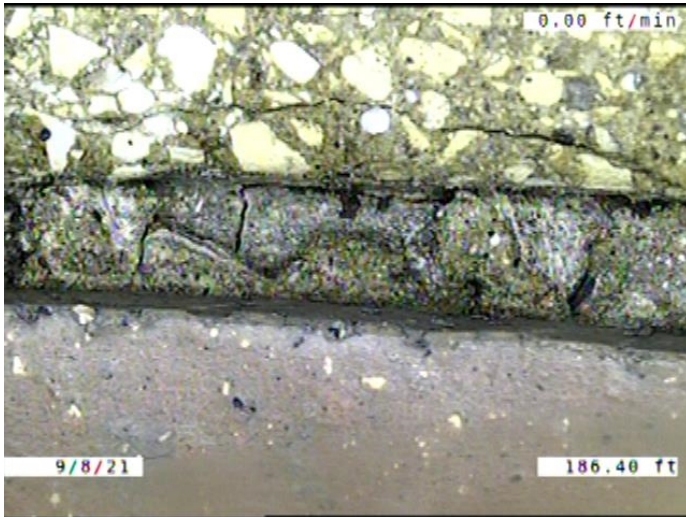
Code: **FM**
Description: **Fracture Multiple**

Distance (ft): **186.4**
Structural Grade: **4**
O&M Grade: **0**
Clock Start/From: **8**
Clock To: **3**
1st Value:
2nd Value:
Value Percent:
Continuous Index: **S07**
Within 8" of Joint: **YES**
Remarks:

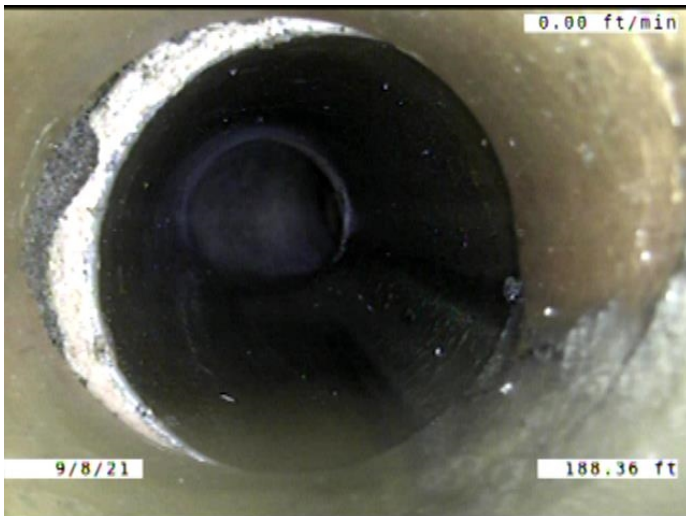
Code: **TFD**
Description: **Tap Factory Defective**

Distance (ft): **188.4**
Structural Grade: **0**
O&M Grade: **3**
Clock Start/From: **1**
Clock To:
1st Value: **4.000**
2nd Value:
Value Percent:
Continuous Index:
Within 8" of Joint: **YES**
Remarks: **Defective**

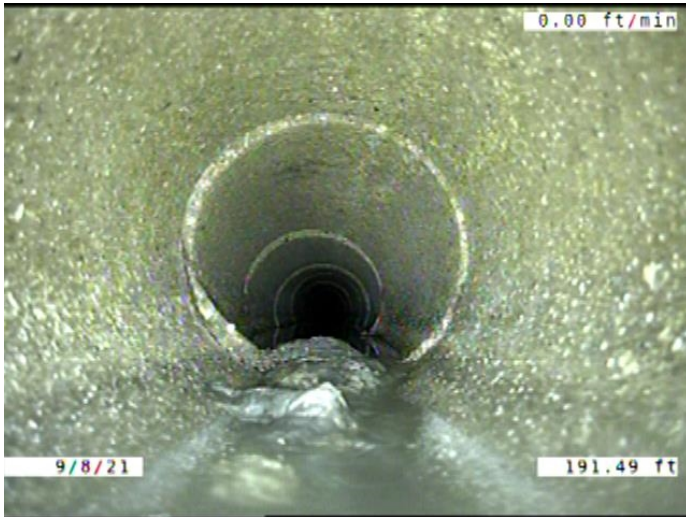
Code: **FM**
 Description: **Fracture Multiple**

Distance (ft): **191.5**
 Structural Grade: **4**
 O&M Grade: **0**
 Clock Start/From: **8**
 Clock To: **3**
 1st Value:
 2nd Value:
 Value Percent:
 Continuous Index: **F07**
 Within 8" of Joint: **YES**
 Remarks:

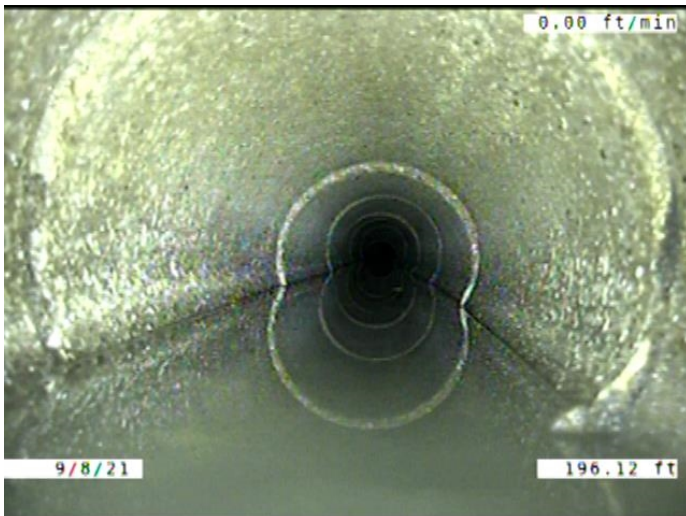
Code: **MWLS**
 Description: **Miscellaneous Water Level Sag**

Distance (ft): **196.1**
 Structural Grade: **2**
 O&M Grade: **0**
 Clock Start/From:
 Clock To:
 1st Value:
 2nd Value:
 Value Percent: **15.000**
 Continuous Index: **S08**
 Within 8" of Joint: **NO**
 Remarks:

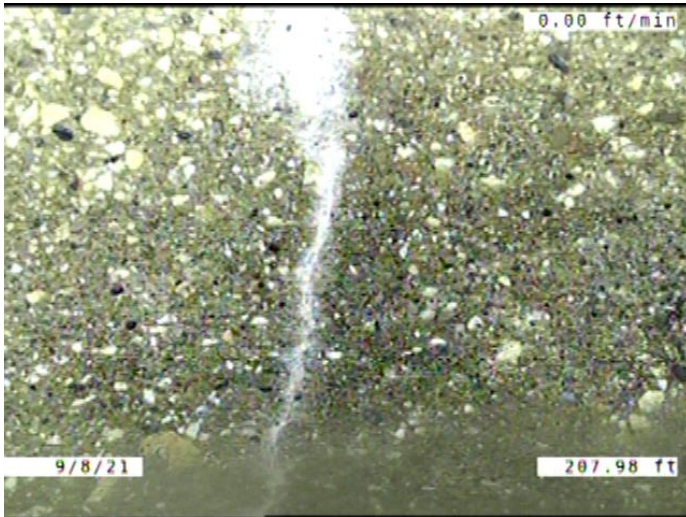
Code: **CL**
 Description: **Crack Longitudinal**

Distance (ft): **208.0**
 Structural Grade: **2**
 O&M Grade: **0**
 Clock Start/From: **11**
 Clock To:
 1st Value:
 2nd Value:
 Value Percent:
 Continuous Index:
 Within 8" of Joint: **YES**
 Remarks:

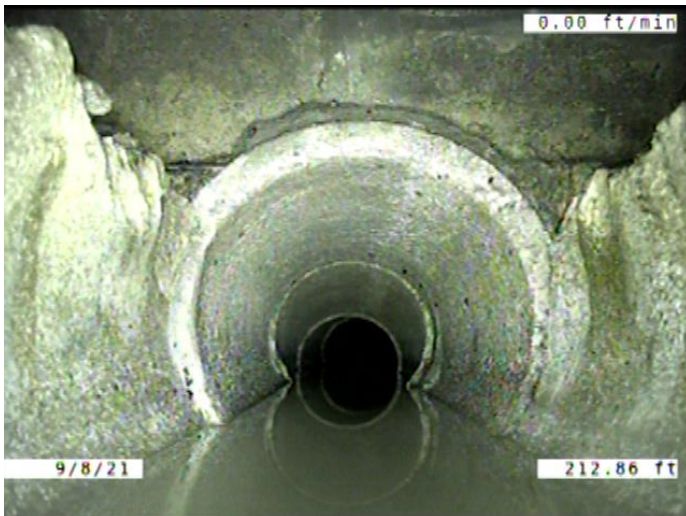
Code: **DSF**
 Description: **Deposits Settled Fine**

Distance (ft): **212.9**
 Structural Grade: **0**
 O&M Grade: **2**
 Clock Start/From: **5**
 Clock To: **7**
 1st Value:
 2nd Value:
 Value Percent: **5.000**
 Continuous Index: **F02**
 Within 8" of Joint: **YES**
 Remarks:

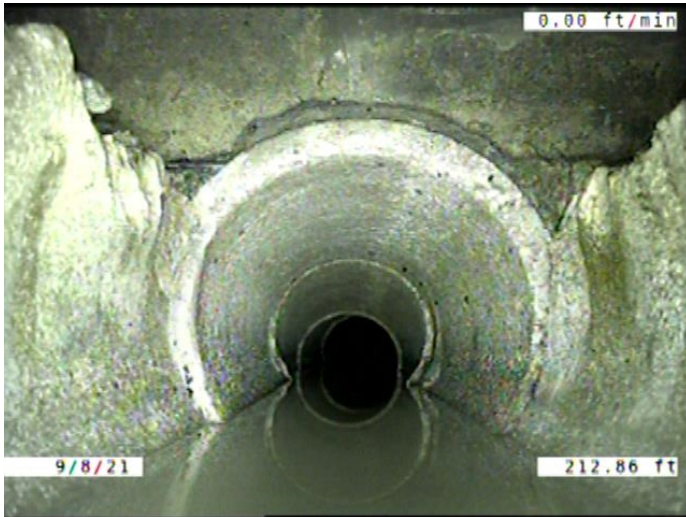
Code: **DAE**
Description: **Deposits Attached Encrustation**

Distance (ft): **212.9**
Structural Grade: **0**
O&M Grade: **2**
Clock Start/From: **2**
Clock To: **10**
1st Value:
2nd Value:
Value Percent: **5.000**
Continuous Index: **F06**
Within 8" of Joint: **YES**
Remarks:

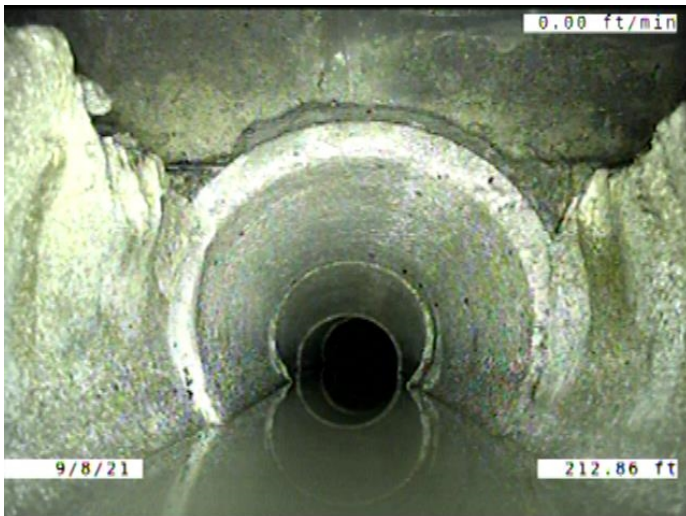
Code: **MWLS**
Description: **Miscellaneous Water Level Sag**

Distance (ft): **212.9**
Structural Grade: **2**
O&M Grade: **0**
Clock Start/From:
Clock To:
1st Value:
2nd Value:
Value Percent: **15.000**
Continuous Index: **F08**
Within 8" of Joint: **NO**
Remarks:
