# Profile/Photo Observation Report

Date:	<b>09/01/2021</b>	Weather:		Coding:	<b>PACP 7.0</b>
Pipe Length (ft):	<b>317.0</b>	Owner:	<b>City of Hobart</b>	Pre Clean:	<b>Heavy Cleaning</b>
P.O.#:	<b>YES502259</b>	Surveyor:	<b>S. Bucklin</b>	PSR:	<b>P-504-027-108</b>
Customer:	<b>City of Hobart</b>	Clean Date:	<b>08/28/2021</b>	Shape:	<b>C</b>

Street:	<b>North Delaware Street</b>	Flow Control:	<b>Not Controlled</b>
City:	<b>Hobart, IN</b>	Year Renewed:	
Location:	<b>Alley</b>	Tape/Media #:	
Purpose:	<b>Routine Assessment</b>	Dia/Height:	<b>12"</b>
Use:	<b>Sanitary Sewage Pipe</b>	Material:	<b>CP</b>
Drain Area:		Lining:	
Category:	<b>NA</b>		
Comment:			
Location Details:		Direction of Survey:	<b>Downstream</b>
US MH:	<b>M-503-027</b>	DS MH:	<b>M-504-108</b>
		Total Length Surveyed (ft):	<b>185.2</b>

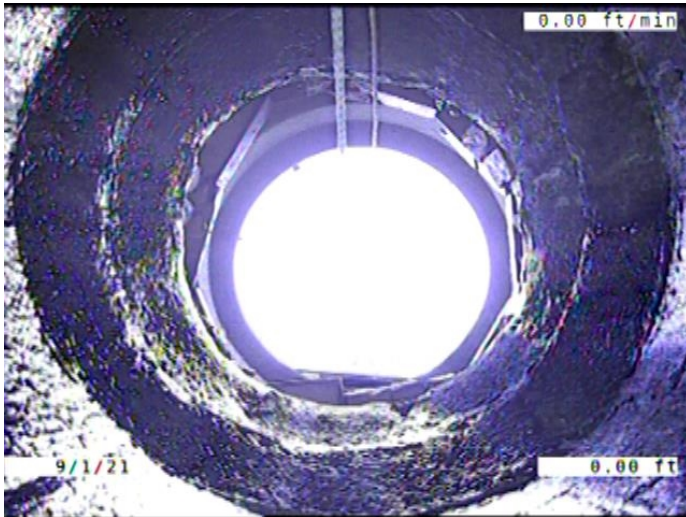
Code: **AMH**  
Description: **Manhole**

Distance (ft): **.0**  
Structural Grade: **0**  
O&M Grade: **0**  
Clock Start/From:  
Clock To:  
1st Value:  
2nd Value:  
Value Percent:  
Continuous Index:  
Within 8" of Joint: **NO**  
Remarks: **M-503-027**

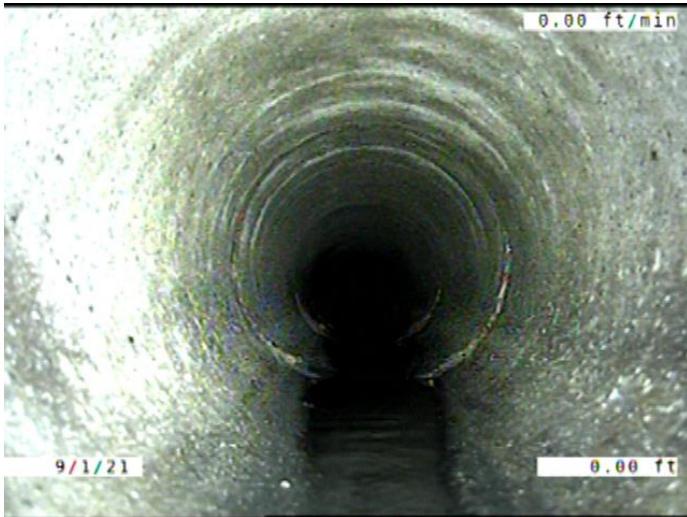
Code: **MWL**  
 Description: **Miscellaneous Water Level**

Distance (ft): **.0**  
 Structural Grade: **0**  
 O&M Grade: **0**  
 Clock Start/From:  
 Clock To:  
 1st Value:  
 2nd Value:  
 Value Percent: **5.000**  
 Continuous Index:  
 Within 8" of Joint: **NO**  
 Remarks:

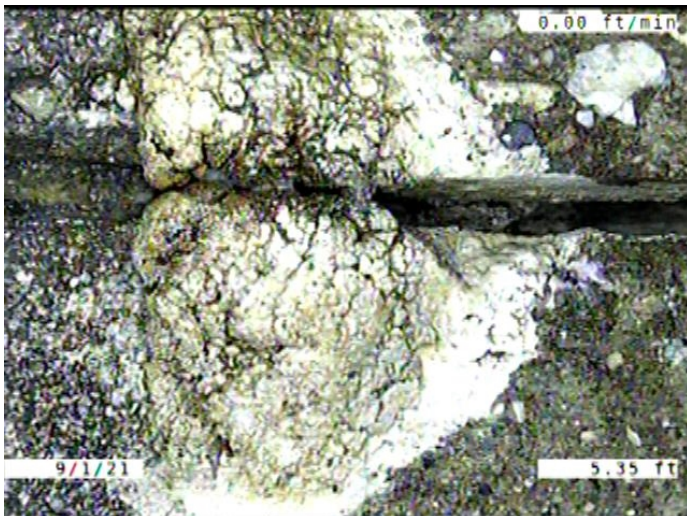
Code: **DAE**  
 Description: **Deposits Attached Encrustation**

Distance (ft): **5.4**  
 Structural Grade: **0**  
 O&M Grade: **2**  
 Clock Start/From: **4**  
 Clock To:  
 1st Value:  
 2nd Value:  
 Value Percent: **5.000**  
 Continuous Index:  
 Within 8" of Joint: **YES**  
 Remarks:

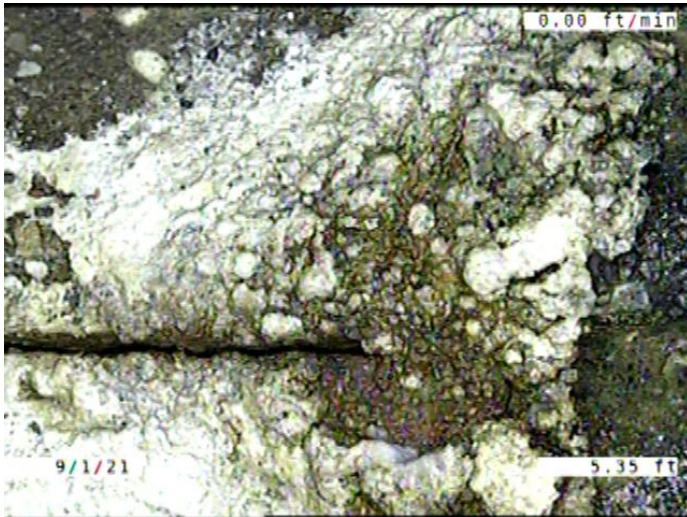
Code: **DAE**  
 Description: **Deposits Attached Encrustation**

Distance (ft): **5.4**  
 Structural Grade: **0**  
 O&M Grade: **2**  
 Clock Start/From: **7**  
 Clock To: **9**  
 1st Value:  
 2nd Value:  
 Value Percent: **5.000**  
 Continuous Index:  
 Within 8" of Joint: **YES**  
 Remarks:

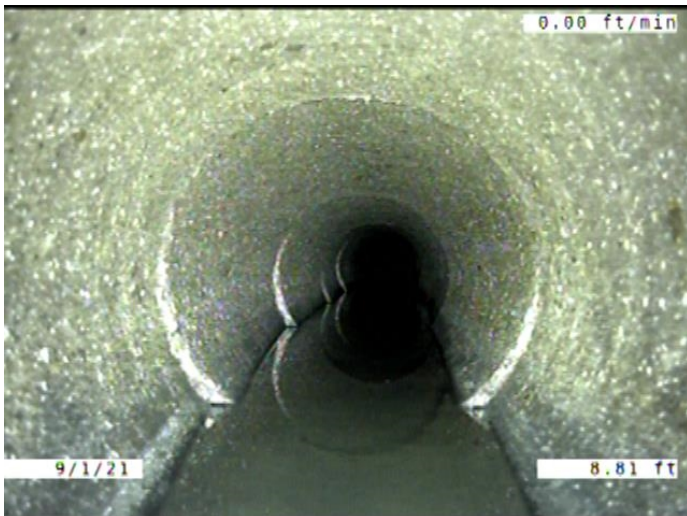
Code: **MWLS**  
 Description: **Miscellaneous Water Level Sag**

Distance (ft): **8.8**  
 Structural Grade: **2**  
 O&M Grade: **0**  
 Clock Start/From:  
 Clock To:  
 1st Value:  
 2nd Value:  
 Value Percent: **5.000**  
 Continuous Index: **S01**  
 Within 8" of Joint: **NO**  
 Remarks:

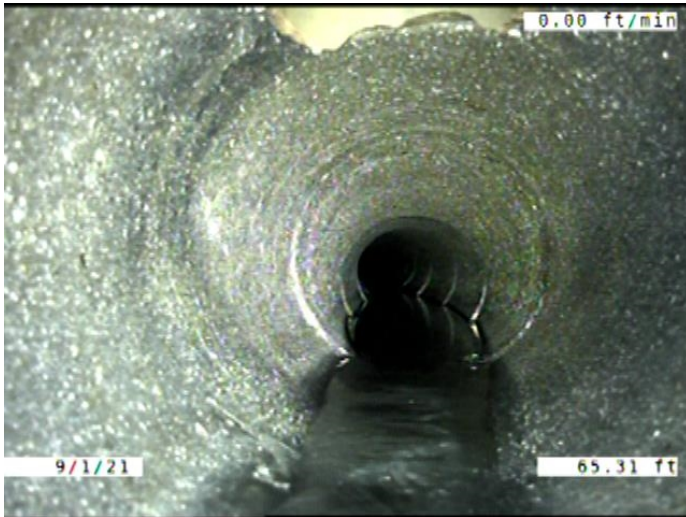
Code: **MWLS**  
 Description: **Miscellaneous Water Level Sag**

Distance (ft): **65.3**  
 Structural Grade: **2**  
 O&M Grade: **0**  
 Clock Start/From:  
 Clock To:  
 1st Value:  
 2nd Value:  
 Value Percent: **5.000**  
 Continuous Index: **F01**  
 Within 8" of Joint: **NO**  
 Remarks:

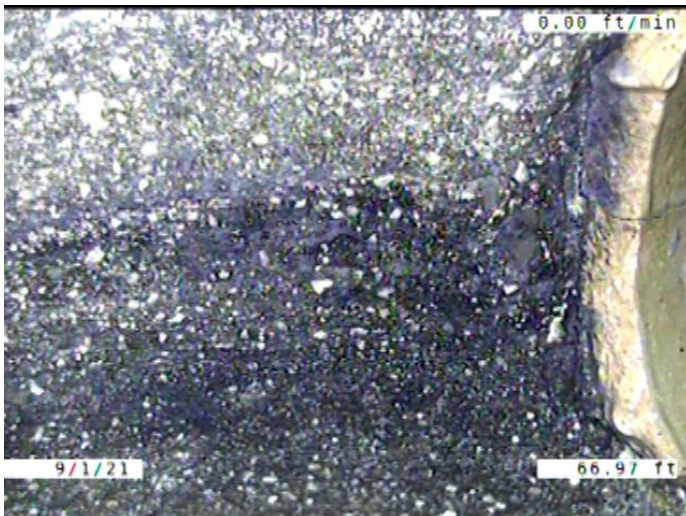
Code: **CM**  
 Description: **Crack Multiple**

Distance (ft): **67.0**  
 Structural Grade: **3**  
 O&M Grade: **0**  
 Clock Start/From: **7**  
 Clock To: **5**  
 1st Value:  
 2nd Value:  
 Value Percent:  
 Continuous Index:  
 Within 8" of Joint: **YES**  
 Remarks:

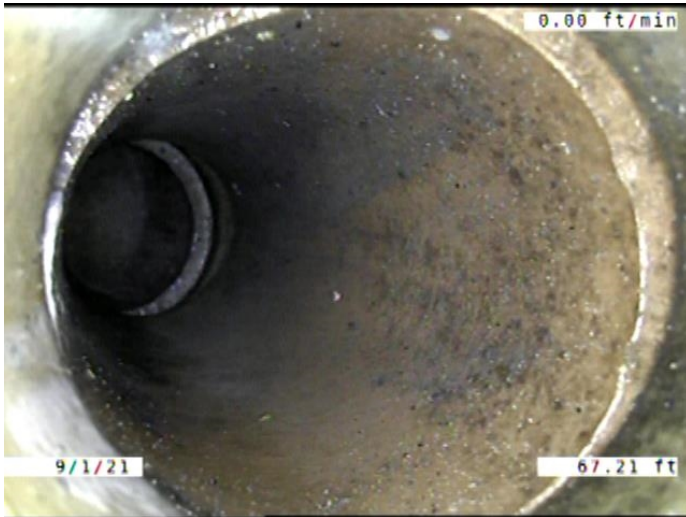
Code: **TBD**  
 Description: **Tap Break-in/Hammer Defective**

Distance (ft): **67.2**  
 Structural Grade: **0**  
 O&M Grade: **3**  
 Clock Start/From: **12**  
 Clock To:  
 1st Value: **4.000**  
 2nd Value:  
 Value Percent:  
 Continuous Index:  
 Within 8" of Joint: **NO**  
 Remarks: **Debris**

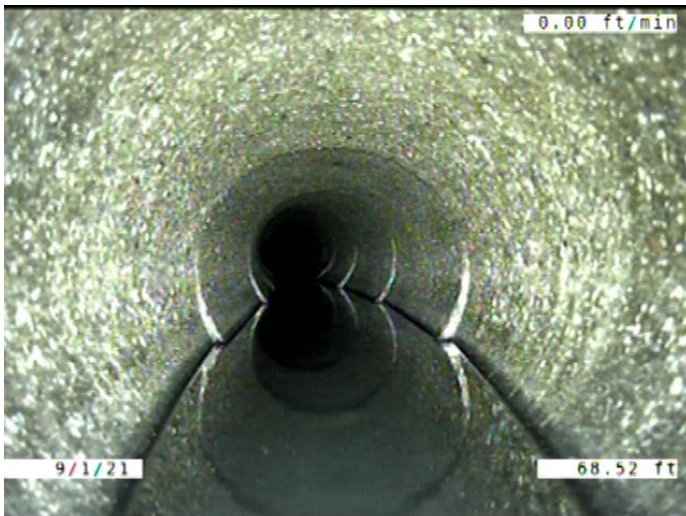
Code: **MWLS**  
 Description: **Miscellaneous Water Level Sag**

Distance (ft): **68.5**  
 Structural Grade: **2**  
 O&M Grade: **0**  
 Clock Start/From:  
 Clock To:  
 1st Value:  
 2nd Value:  
 Value Percent: **10.000**  
 Continuous Index: **S02**  
 Within 8" of Joint: **NO**  
 Remarks:

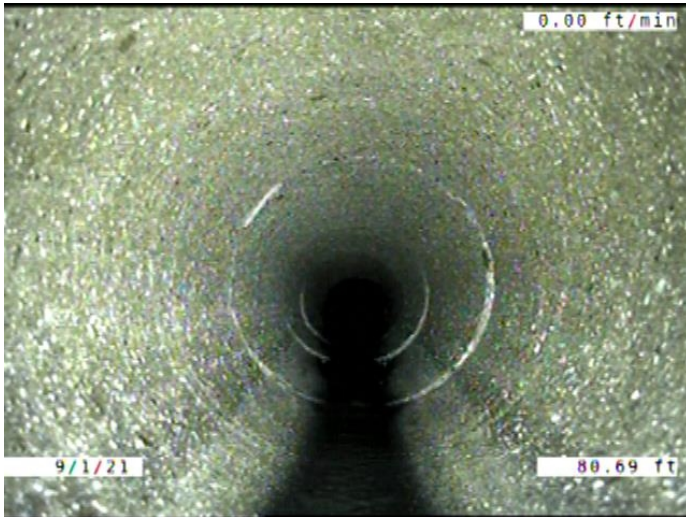
Code: **MWLS**  
Description: **Miscellaneous Water Level Sag**

Distance (ft): **80.7**  
Structural Grade: **2**  
O&M Grade: **0**  
Clock Start/From:  
Clock To:  
1st Value:  
2nd Value:  
Value Percent: **10.000**  
Continuous Index: **F02**  
Within 8" of Joint: **NO**  
Remarks:

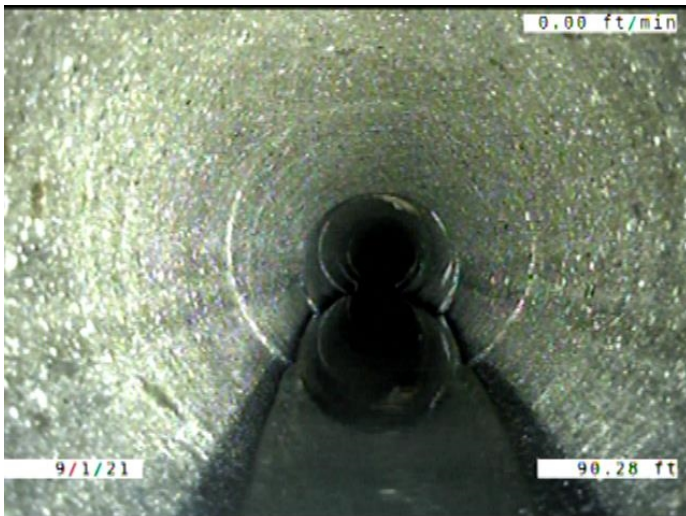
Code: **MWLS**  
Description: **Miscellaneous Water Level Sag**

Distance (ft): **90.3**  
Structural Grade: **2**  
O&M Grade: **0**  
Clock Start/From:  
Clock To:  
1st Value:  
2nd Value:  
Value Percent: **5.000**  
Continuous Index: **S03**  
Within 8" of Joint: **NO**  
Remarks:

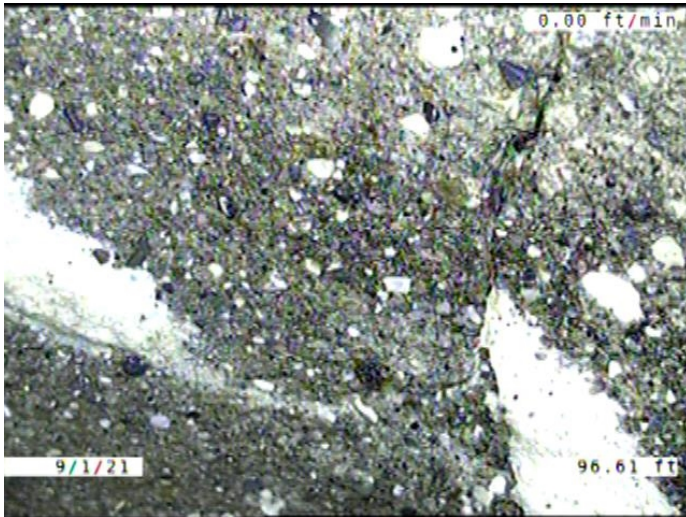
Code: **FM**  
 Description: **Fracture Multiple**

Distance (ft): **96.6**  
 Structural Grade: **4**  
 O&M Grade: **0**  
 Clock Start/From: **12**  
 Clock To: **3**  
 1st Value:  
 2nd Value:  
 Value Percent:  
 Continuous Index:  
 Within 8" of Joint: **YES**  
 Remarks:

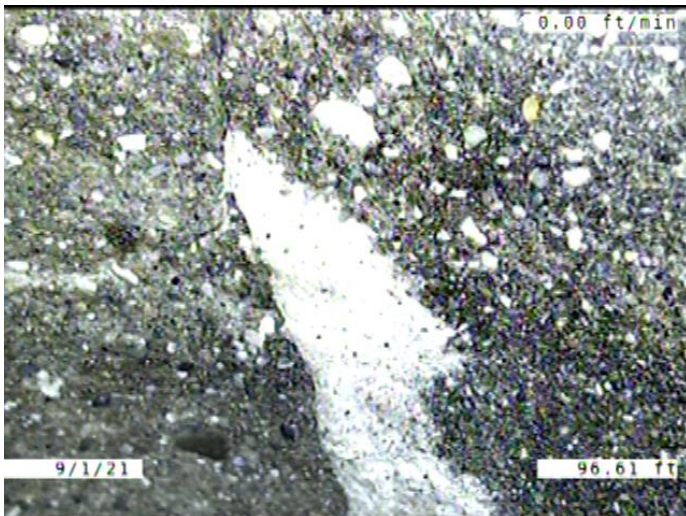
Code: **ISB**  
 Description: **Infiltration Stain Barrel**

Distance (ft): **96.6**  
 Structural Grade: **0**  
 O&M Grade: **1**  
 Clock Start/From: **1**  
 Clock To: **4**  
 1st Value:  
 2nd Value:  
 Value Percent:  
 Continuous Index:  
 Within 8" of Joint: **YES**  
 Remarks:

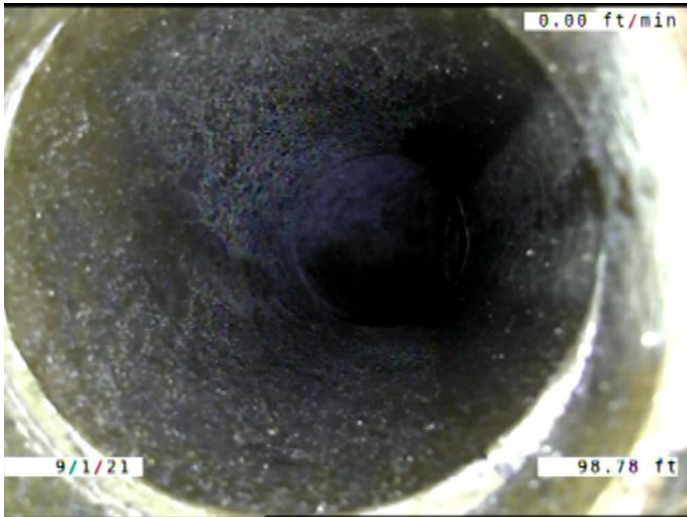
Code: **TB**  
 Description: **Tap Break-in/Hammer**

Distance (ft): **98.8**  
 Structural Grade: **0**  
 O&M Grade: **0**  
 Clock Start/From: **1**  
 Clock To:  
 1st Value: **4.000**  
 2nd Value:  
 Value Percent:  
 Continuous Index:  
 Within 8" of Joint: **NO**  
 Remarks:

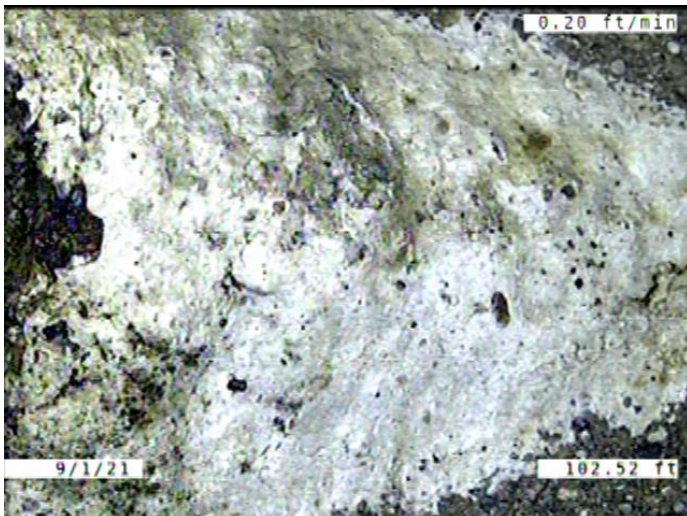
Code: **DAE**  
 Description: **Deposits Attached Encrustation**

Distance (ft): **102.5**  
 Structural Grade: **0**  
 O&M Grade: **2**  
 Clock Start/From: **2**  
 Clock To: **4**  
 1st Value:  
 2nd Value:  
 Value Percent: **5.000**  
 Continuous Index:  
 Within 8" of Joint: **YES**  
 Remarks:

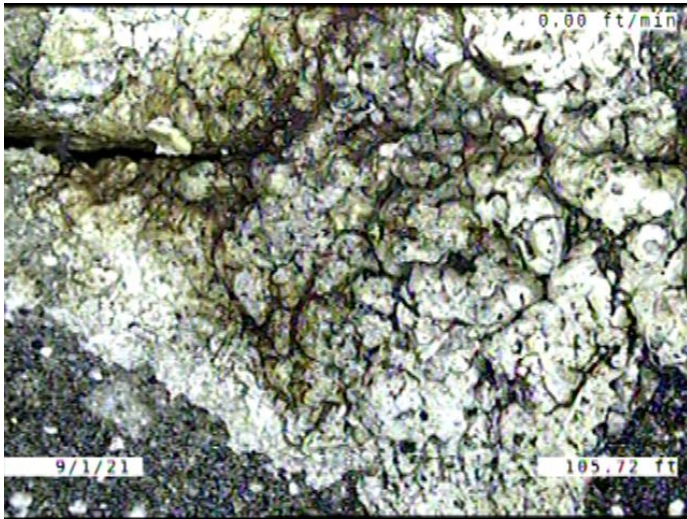
Code: **DAE**  
 Description: **Deposits Attached Encrustation**

Distance (ft): **105.7**  
 Structural Grade: **0**  
 O&M Grade: **2**  
 Clock Start/From: **8**  
 Clock To: **9**  
 1st Value:  
 2nd Value:  
 Value Percent: **5.000**  
 Continuous Index:  
 Within 8" of Joint: **YES**  
 Remarks:

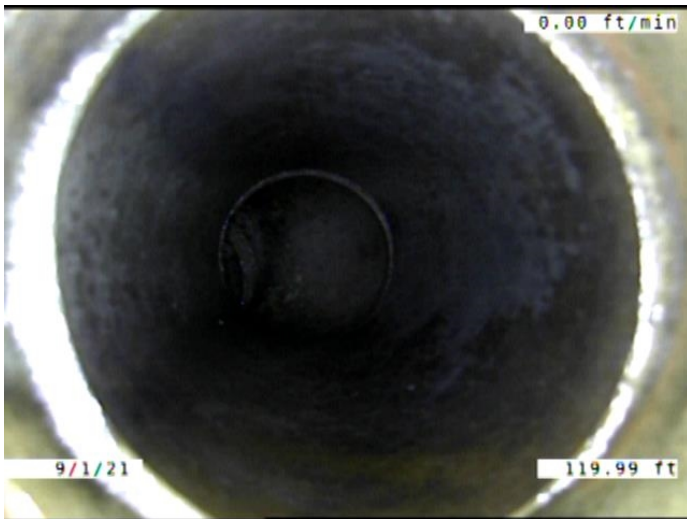
Code: **TB**  
 Description: **Tap Break-in/Hammer**

Distance (ft): **120.0**  
 Structural Grade: **0**  
 O&M Grade: **0**  
 Clock Start/From: **12**  
 Clock To:  
 1st Value: **4.000**  
 2nd Value:  
 Value Percent:  
 Continuous Index:  
 Within 8" of Joint: **YES**  
 Remarks:

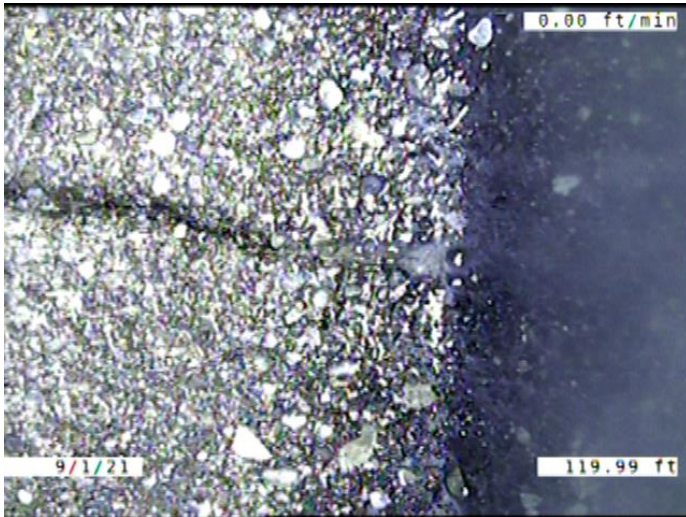
Code: **FM**  
 Description: **Fracture Multiple**

Distance (ft): **120.0**  
 Structural Grade: **4**  
 O&M Grade: **0**  
 Clock Start/From: **8**  
 Clock To: **4**  
 1st Value:  
 2nd Value:  
 Value Percent:  
 Continuous Index:  
 Within 8" of Joint: **NO**  
 Remarks:

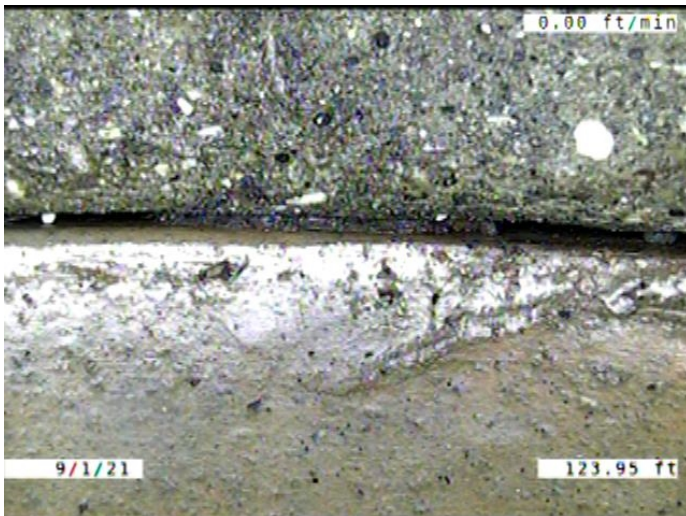
Code: **MMC**  
 Description: **Miscellaneous Material Change**

Distance (ft): **124.0**  
 Structural Grade: **0**  
 O&M Grade: **0**  
 Clock Start/From:  
 Clock To:  
 1st Value:  
 2nd Value:  
 Value Percent:  
 Continuous Index:  
 Within 8" of Joint: **NO**  
 Remarks: **CONCRETE TO VCP**

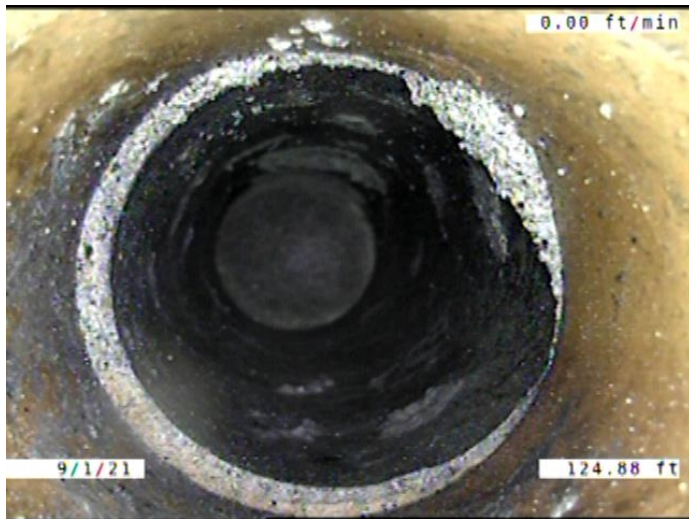
Code: **TFC**  
 Description: **Tap Factory Capped**

Distance (ft): **124.9**  
 Structural Grade: **0**  
 O&M Grade: **0**  
 Clock Start/From: **12**  
 Clock To:  
 1st Value: **4.000**  
 2nd Value:  
 Value Percent:  
 Continuous Index:  
 Within 8" of Joint: **YES**  
 Remarks:

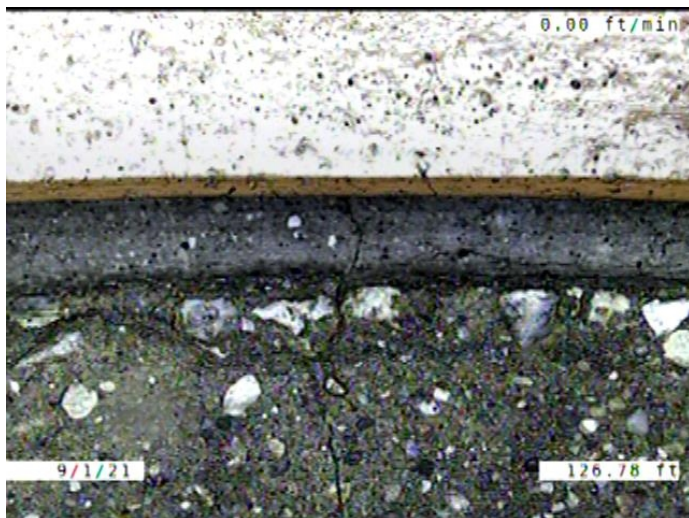
Code: **MMC**  
 Description: **Miscellaneous Material Change**

Distance (ft): **126.8**  
 Structural Grade: **0**  
 O&M Grade: **0**  
 Clock Start/From:  
 Clock To:  
 1st Value:  
 2nd Value:  
 Value Percent:  
 Continuous Index:  
 Within 8" of Joint: **NO**  
 Remarks: **VCP TO CONCRETE**

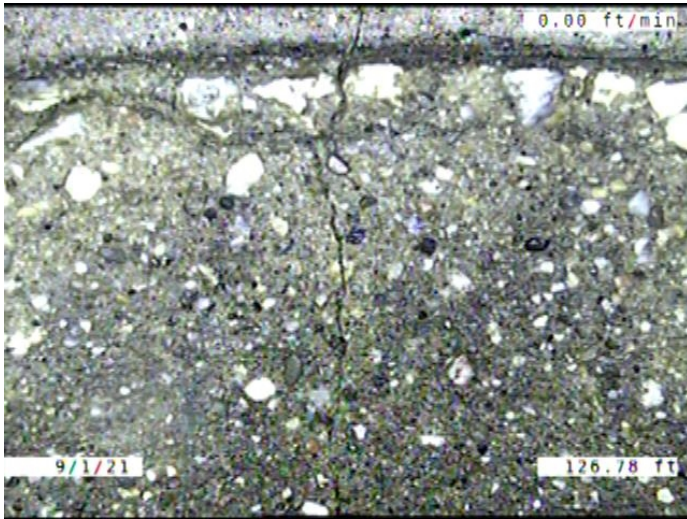
Code: **CL**  
Description: **Crack Longitudinal**

Distance (ft): **126.8**  
Structural Grade: **2**  
O&M Grade: **0**  
Clock Start/From: **12**  
Clock To:  
1st Value:  
2nd Value:  
Value Percent:  
Continuous Index:  
Within 8" of Joint: **YES**  
Remarks:

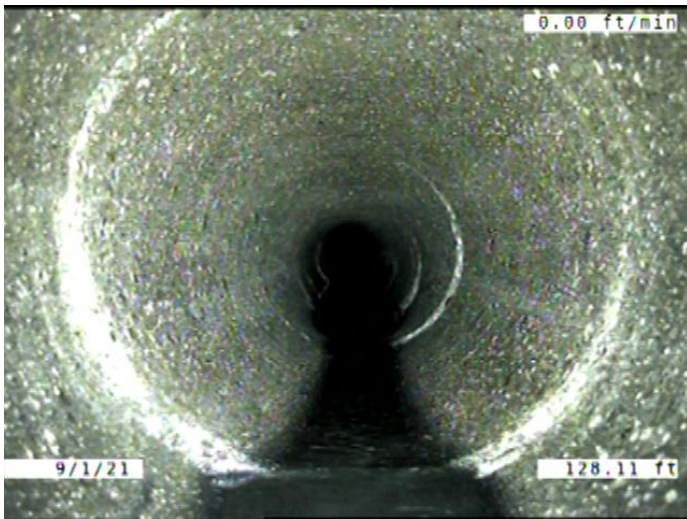
Code: **MWLS**  
Description: **Miscellaneous Water Level Sag**

Distance (ft): **128.1**  
Structural Grade: **2**  
O&M Grade: **0**  
Clock Start/From:  
Clock To:  
1st Value:  
2nd Value:  
Value Percent: **5.000**  
Continuous Index: **F03**  
Within 8" of Joint: **NO**  
Remarks:

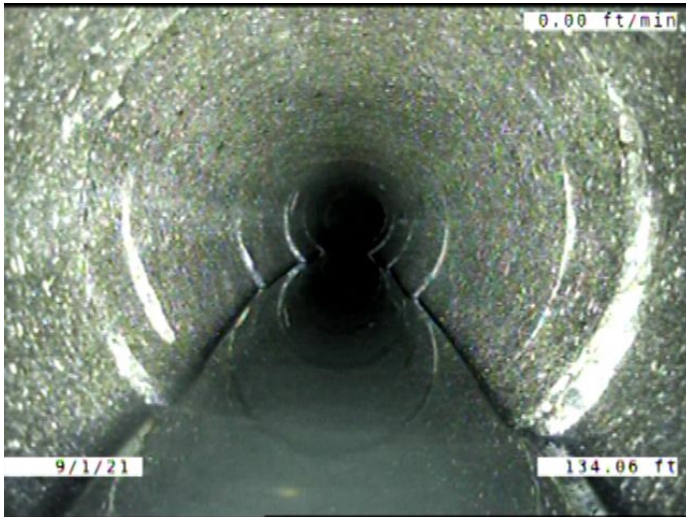
Code: **MWLS**  
Description: **Miscellaneous Water Level Sag**

Distance (ft): **134.1**  
Structural Grade: **2**  
O&M Grade: **0**  
Clock Start/From:  
Clock To:  
1st Value:  
2nd Value:  
Value Percent: **5.000**  
Continuous Index: **S04**  
Within 8" of Joint: **NO**  
Remarks:

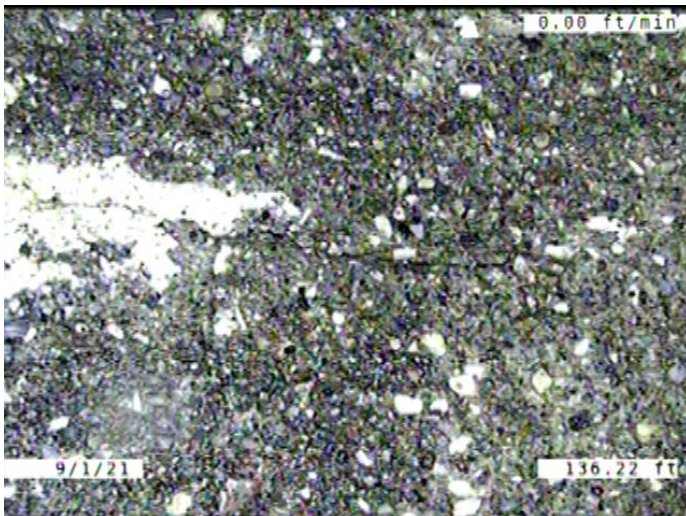
Code: **CM**  
Description: **Crack Multiple**

Distance (ft): **136.2**  
Structural Grade: **3**  
O&M Grade: **0**  
Clock Start/From: **12**  
Clock To: **12**  
1st Value:  
2nd Value:  
Value Percent:  
Continuous Index:  
Within 8" of Joint: **YES**  
Remarks:

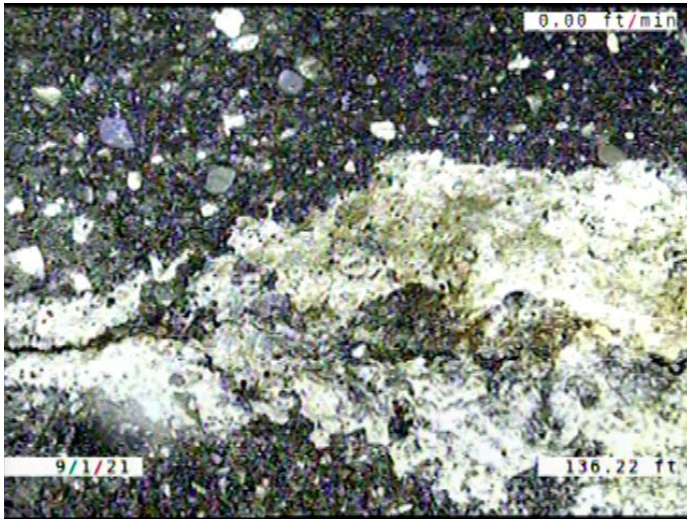
Code: **ISB**  
Description: **Infiltration Stain Barrel**

Distance (ft): **136.2**  
Structural Grade: **0**  
O&M Grade: **1**  
Clock Start/From: **7**  
Clock To: **9**  
1st Value:  
2nd Value:  
Value Percent:  
Continuous Index:  
Within 8" of Joint: **YES**  
Remarks:

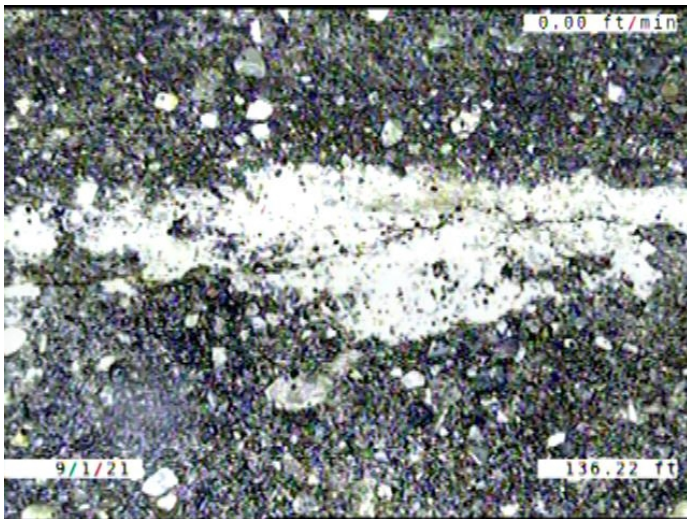
Code: **ISB**  
Description: **Infiltration Stain Barrel**

Distance (ft): **136.2**  
Structural Grade: **0**  
O&M Grade: **1**  
Clock Start/From: **2**  
Clock To: **4**  
1st Value:  
2nd Value:  
Value Percent:  
Continuous Index:  
Within 8" of Joint: **YES**  
Remarks:

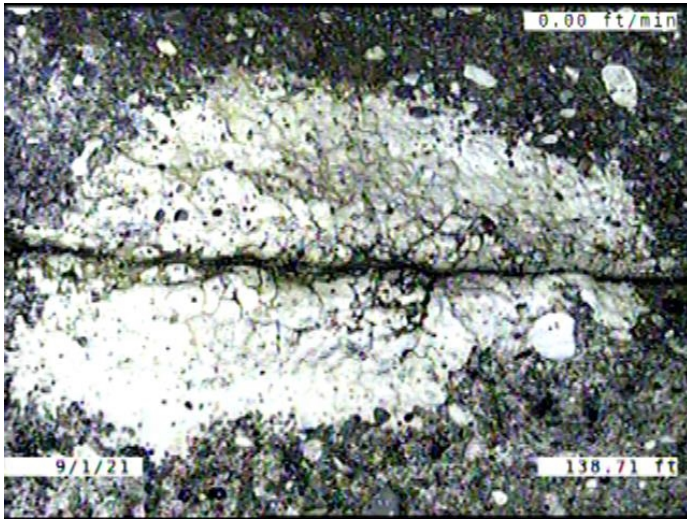
Code: **ISJ**  
 Description: **Infiltration Stain Joint**

Distance (ft): **138.7**  
 Structural Grade: **0**  
 O&M Grade: **1**  
 Clock Start/From: **2**  
 Clock To: **3**  
 1st Value:  
 2nd Value:  
 Value Percent:  
 Continuous Index:  
 Within 8" of Joint: **YES**  
 Remarks:

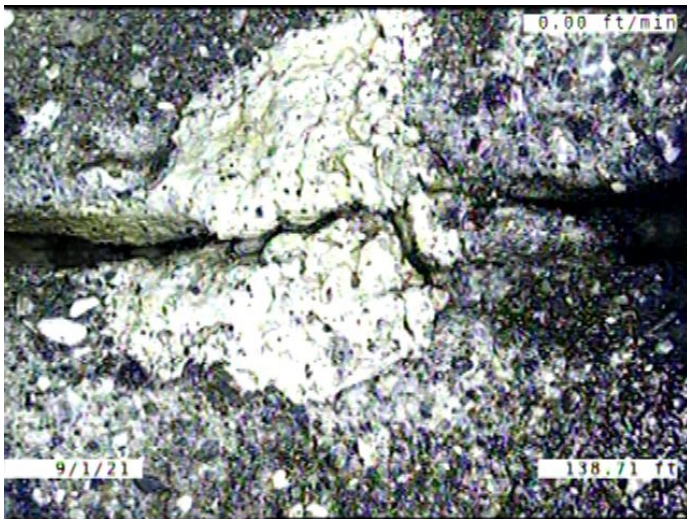
Code: **ISJ**  
 Description: **Infiltration Stain Joint**

Distance (ft): **138.7**  
 Structural Grade: **0**  
 O&M Grade: **1**  
 Clock Start/From: **8**  
 Clock To: **9**  
 1st Value:  
 2nd Value:  
 Value Percent:  
 Continuous Index:  
 Within 8" of Joint: **YES**  
 Remarks:

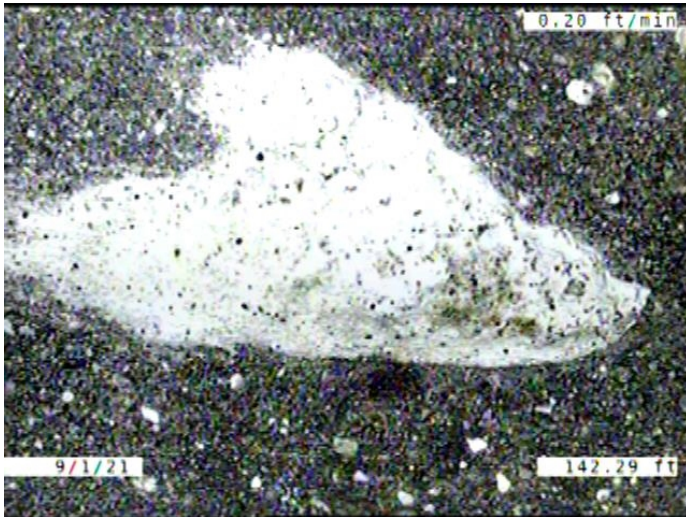
Code: **ISB**  
Description: **Infiltration Stain Barrel**

Distance (ft): **142.3**  
Structural Grade: **0**  
O&M Grade: **1**  
Clock Start/From: **9**  
Clock To: **10**  
1st Value:  
2nd Value:  
Value Percent:  
Continuous Index:  
Within 8" of Joint: **NO**  
Remarks:

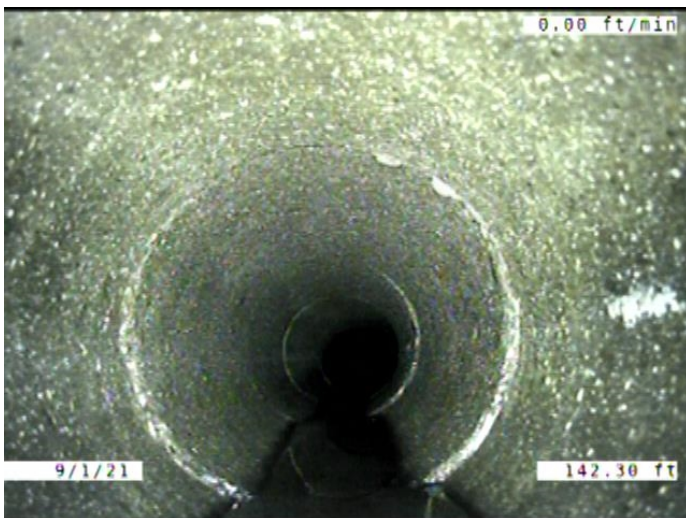
Code: **MWLS**  
Description: **Miscellaneous Water Level Sag**

Distance (ft): **142.3**  
Structural Grade: **2**  
O&M Grade: **0**  
Clock Start/From:  
Clock To:  
1st Value:  
2nd Value:  
Value Percent: **5.000**  
Continuous Index: **F04**  
Within 8" of Joint: **NO**  
Remarks:

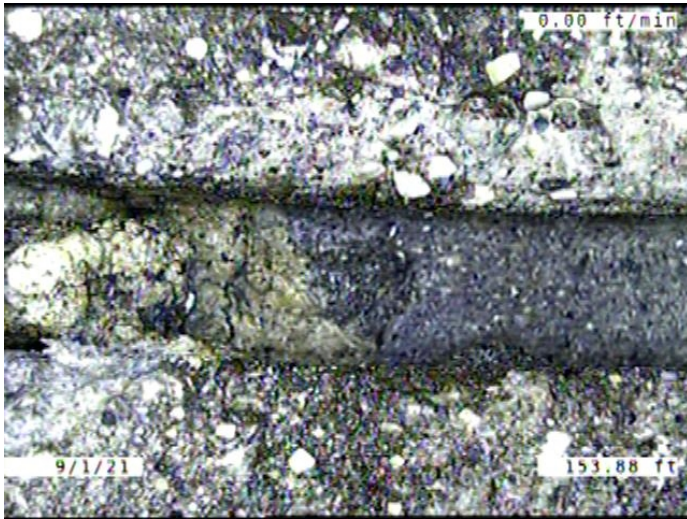
Code: **JAM**  
Description: **Joint Angular Medium**

Distance (ft): **153.9**  
Structural Grade: **3**  
O&M Grade: **0**  
Clock Start/From:  
Clock To:  
1st Value:  
2nd Value:  
Value Percent:  
Continuous Index:  
Within 8" of Joint: **NO**  
Remarks:

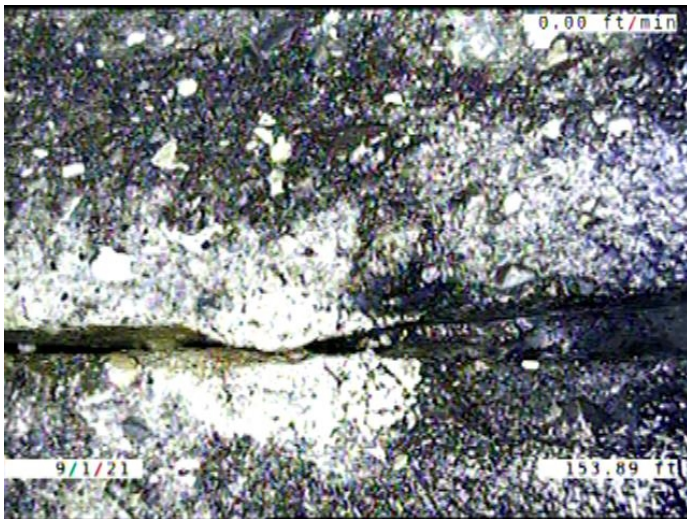
Code: **ISJ**  
Description: **Infiltration Stain Joint**

Distance (ft): **153.9**  
Structural Grade: **0**  
O&M Grade: **1**  
Clock Start/From: **7**  
Clock To: **5**  
1st Value:  
2nd Value:  
Value Percent:  
Continuous Index:  
Within 8" of Joint: **YES**  
Remarks:

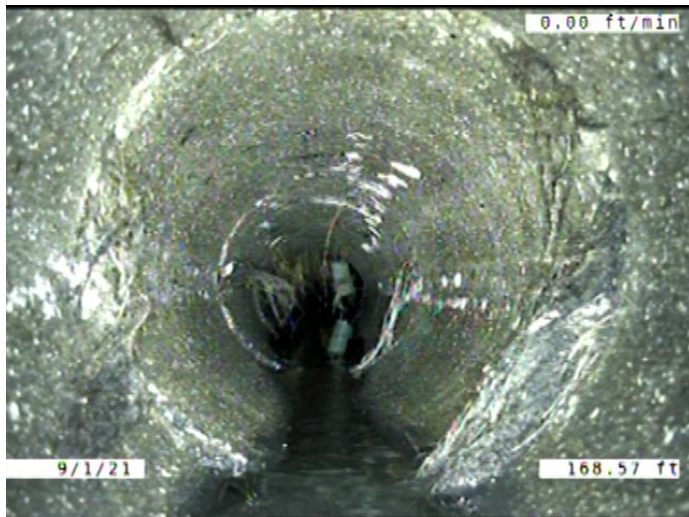
Code: **RMJ**  
 Description: **Roots Medium Joint**

Distance (ft): **168.6**  
 Structural Grade: **0**  
 O&M Grade: **3**  
 Clock Start/From: **7**  
 Clock To: **5**  
 1st Value:  
 2nd Value:  
 Value Percent: **5.000**  
 Continuous Index:  
 Within 8" of Joint: **YES**  
 Remarks:

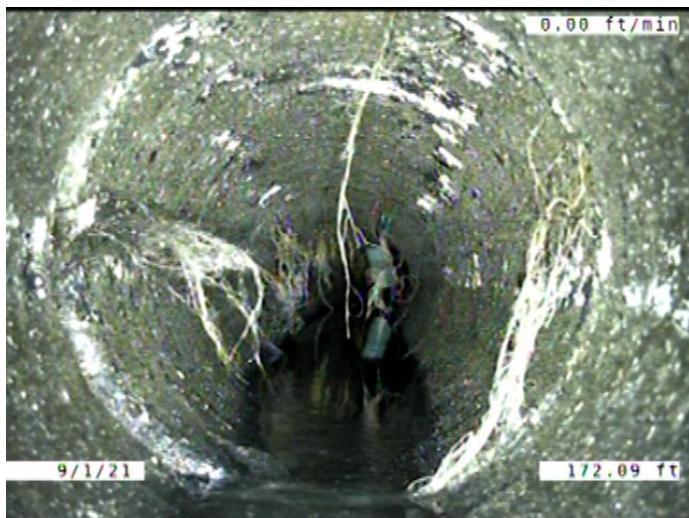
Code: **RMJ**  
 Description: **Roots Medium Joint**

Distance (ft): **172.1**  
 Structural Grade: **0**  
 O&M Grade: **3**  
 Clock Start/From: **9**  
 Clock To: **3**  
 1st Value:  
 2nd Value:  
 Value Percent: **5.000**  
 Continuous Index:  
 Within 8" of Joint: **YES**  
 Remarks:

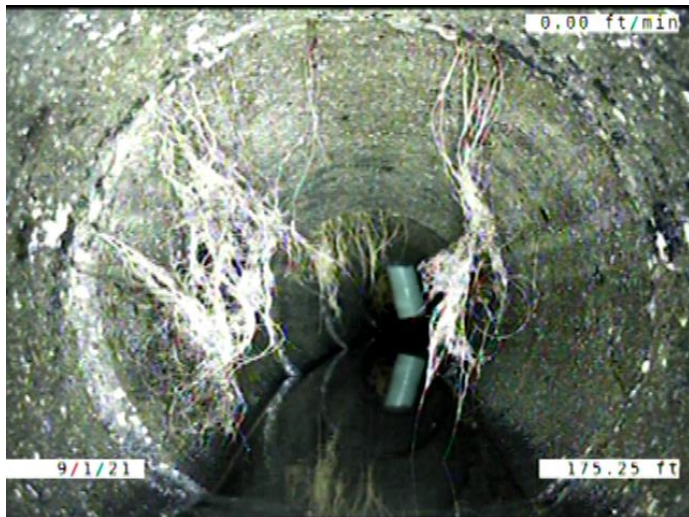
Code: **RMJ**  
 Description: **Roots Medium Joint**

Distance (ft): **175.2**  
 Structural Grade: **0**  
 O&M Grade: **3**  
 Clock Start/From: **9**  
 Clock To: **1**  
 1st Value:  
 2nd Value:  
 Value Percent: **5.000**  
 Continuous Index:  
 Within 8" of Joint: **YES**  
 Remarks:

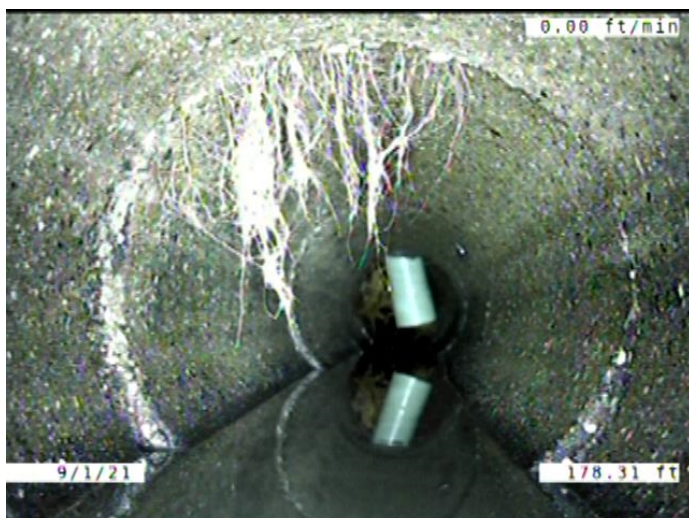
Code: **RMJ**  
 Description: **Roots Medium Joint**

Distance (ft): **178.3**  
 Structural Grade: **0**  
 O&M Grade: **3**  
 Clock Start/From: **10**  
 Clock To: **1**  
 1st Value:  
 2nd Value:  
 Value Percent: **5.000**  
 Continuous Index:  
 Within 8" of Joint: **YES**  
 Remarks:

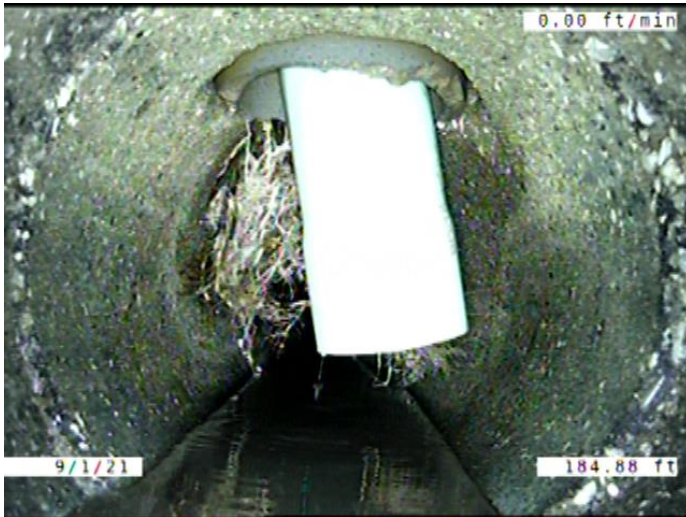
Code: **TBI**  
 Description: **Tap Break-in Intruding**

Distance (ft): **184.9**  
 Structural Grade: **0**  
 O&M Grade: **2**  
 Clock Start/From: **12**  
 Clock To:  
 1st Value: **4.000**  
 2nd Value: **8.000**  
 Value Percent:  
 Continuous Index:  
 Within 8" of Joint: **NO**  
 Remarks:

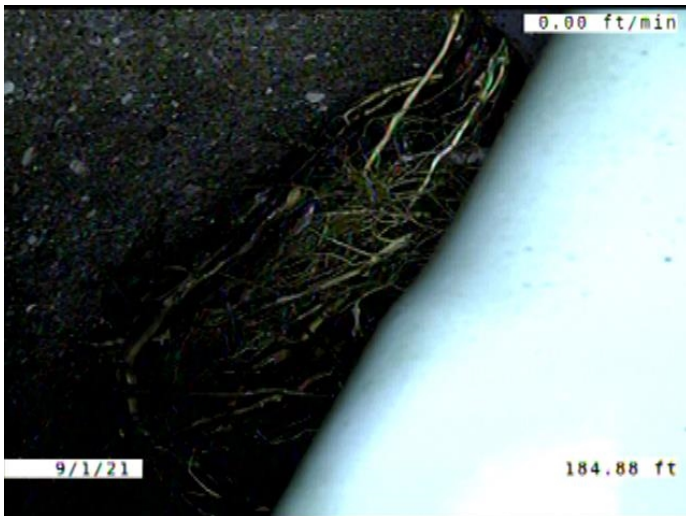
Code: **RML**  
 Description: **Roots Medium Lateral**

Distance (ft): **184.9**  
 Structural Grade: **0**  
 O&M Grade: **3**  
 Clock Start/From: **11**  
 Clock To: **1**  
 1st Value:  
 2nd Value:  
 Value Percent: **10.000**  
 Continuous Index:  
 Within 8" of Joint: **NO**  
 Remarks:

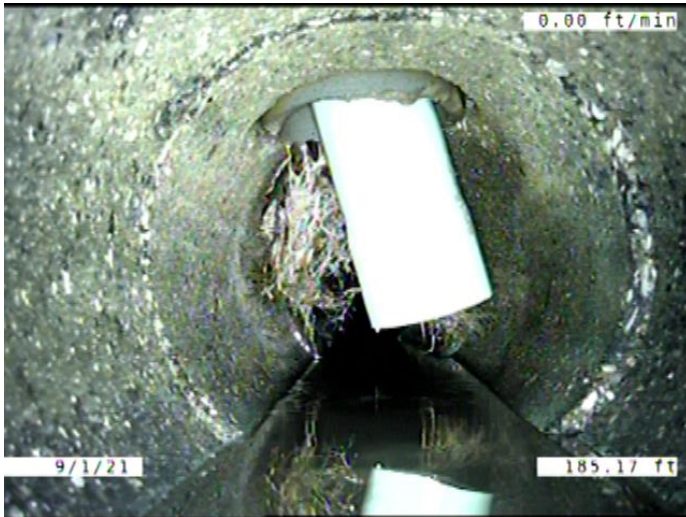
**MSA**

**Miscellaneous Survey Abandoned**

**CAMERA CANT MAKE IT PAST  
PROTRUDING TAP. MADE IT TO THE**
