Profile/Photo Observation Report

Date:	09/01/2021	Weather:		Coding:	PACP 7.0
Pipe Length (ft):	317.0	Owner:	City of Hobart	Pre Clean:	Heavy Cleaning
P.O.#:	YES502259	Surveyor:	S. Bucklin	PSR:	P-504-027-108
Customer:	City of Hobart	Clean Date:	08/28/2021	Shape:	C

Street:	North Delaware Street	Flow Control:	Not Controlled
City:	Hobart, IN	Year Renewed:	
Location:	Alley	Tape/Media #:	
Purpose:	Routine Assessment	Dia/Height:	12"
Use:	Sanitary Sewage Pipe	Material:	CP
Drain Area:		Lining:	
Category:	NA		
Comment:			
Location Details:		Direction of Survey:	Downstream
US MH:	M-503-027	DS MH:	M-504-108
		Total Length Surveyed (ft):	185.2

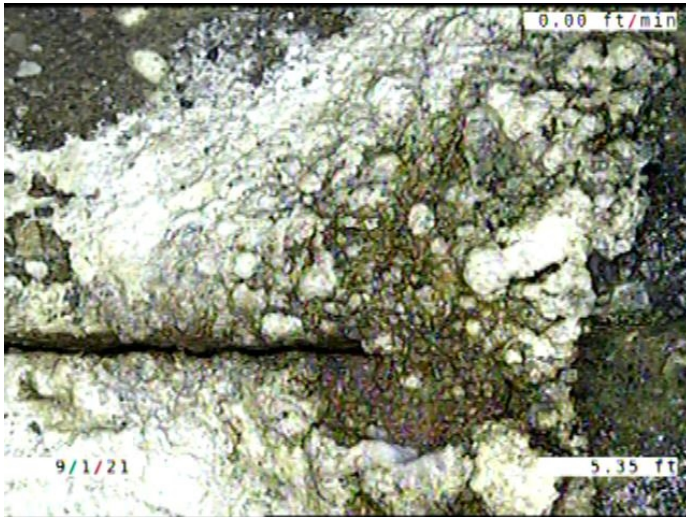
Code:	DAE
Description:	Deposits Attached Encrustation
Distance (ft):	5.4
Structural Grade:	0
O&M Grade:	2
Clock Start/From:	7
Clock To:	9
1st Value:	
2nd Value:	
Value Percent:	5.000
Continuous Index:	
Within 8" of Joint:	YES
Remarks:

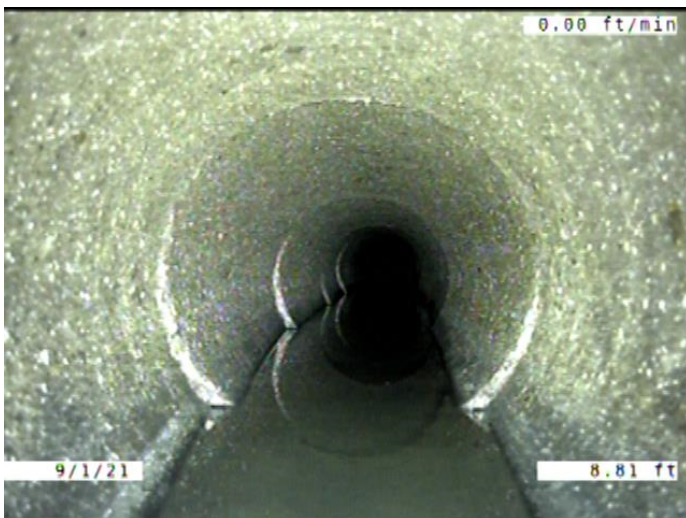
Code:	MWLS
Description:	Miscellaneous Water Level Sag
Distance (ft):	8.8
Structural Grade:	2
O&M Grade:	0
Clock Start/From:	
Clock To:	
1st Value:	
2nd Value:	
Value Percent:	5.000
Continuous Index:	S01
Within 8" of Joint:	NO
Remarks:

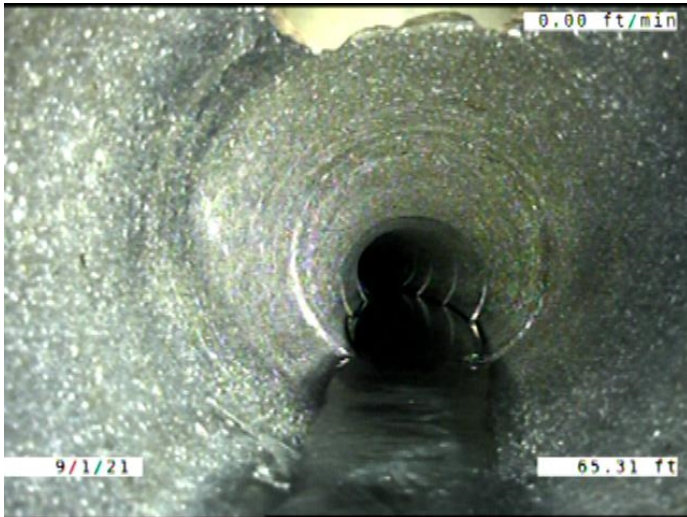
Code: **MWLS**
 Description: **Miscellaneous Water Level Sag**

Distance (ft): **65.3**
 Structural Grade: **2**
 O&M Grade: **0**
 Clock Start/From:
 Clock To:
 1st Value:
 2nd Value:
 Value Percent: **5.000**
 Continuous Index: **F01**
 Within 8" of Joint: **NO**
 Remarks:

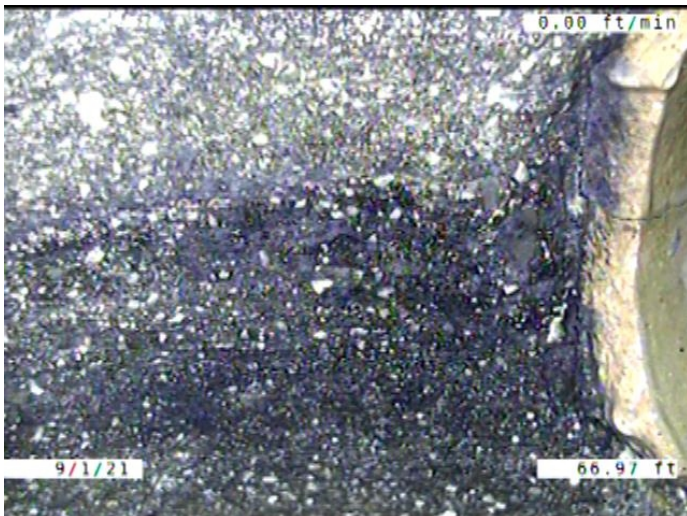
Code: **CM**
 Description: **Crack Multiple**

Distance (ft): **67.0**
 Structural Grade: **3**
 O&M Grade: **0**
 Clock Start/From: **7**
 Clock To: **5**
 1st Value:
 2nd Value:
 Value Percent:
 Continuous Index:
 Within 8" of Joint: **YES**
 Remarks:

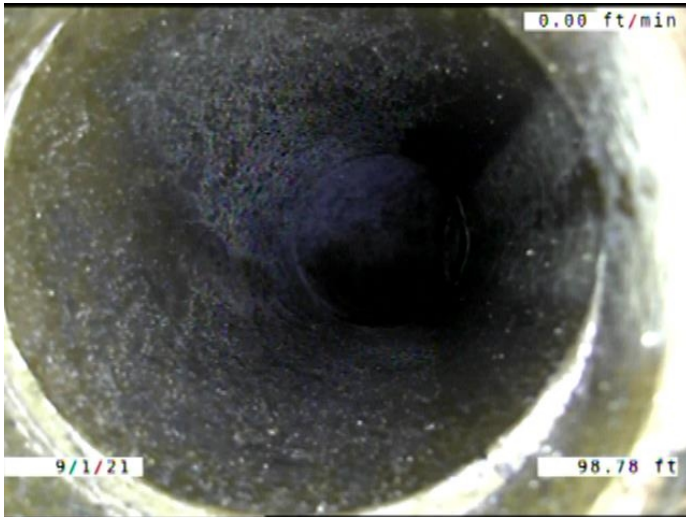
Code: **TB**
 Description: **Tap Break-in/Hammer**

Distance (ft): **98.8**
 Structural Grade: **0**
 O&M Grade: **0**
 Clock Start/From: **1**
 Clock To:
 1st Value: **4.000**
 2nd Value:
 Value Percent:
 Continuous Index:
 Within 8" of Joint: **NO**
 Remarks:

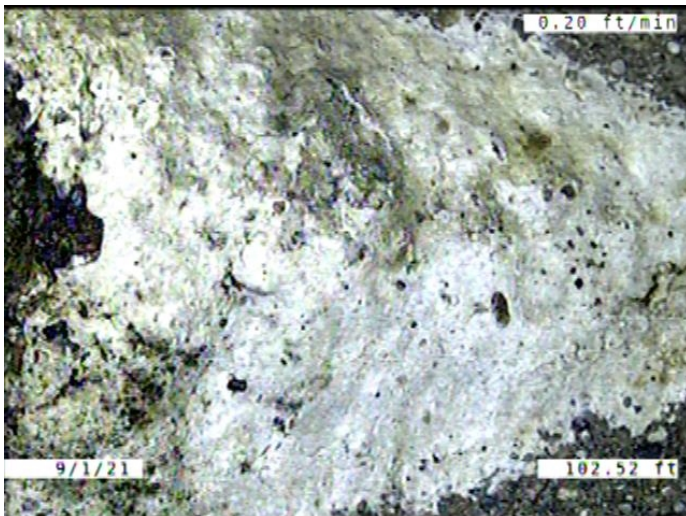
Code: **DAE**
 Description: **Deposits Attached Encrustation**

Distance (ft): **102.5**
 Structural Grade: **0**
 O&M Grade: **2**
 Clock Start/From: **2**
 Clock To: **4**
 1st Value:
 2nd Value:
 Value Percent: **5.000**
 Continuous Index:
 Within 8" of Joint: **YES**
 Remarks:

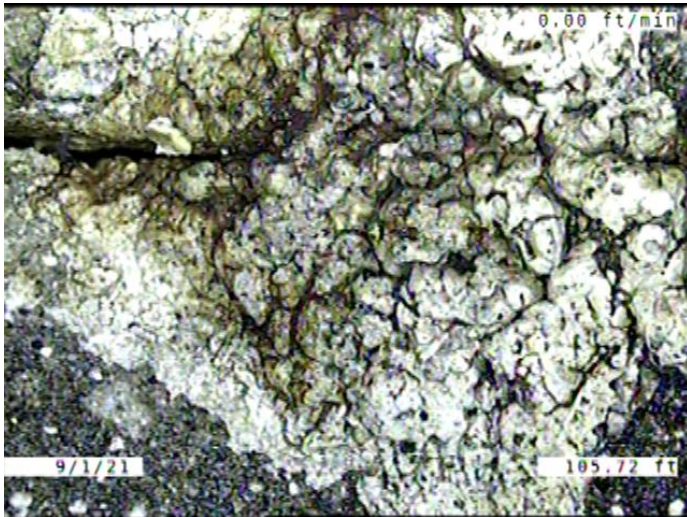
Code: **DAE**
 Description: **Deposits Attached Encrustation**

Distance (ft): **105.7**
 Structural Grade: **0**
 O&M Grade: **2**
 Clock Start/From: **8**
 Clock To: **9**
 1st Value:
 2nd Value:
 Value Percent: **5.000**
 Continuous Index:
 Within 8" of Joint: **YES**
 Remarks:

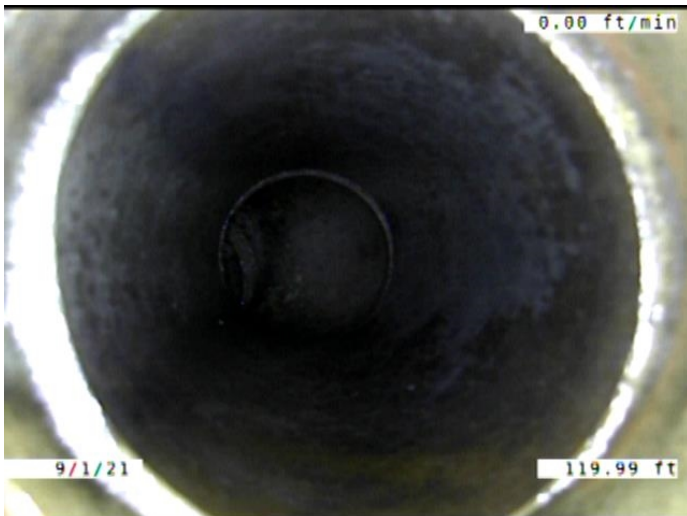
Code: **TB**
 Description: **Tap Break-in/Hammer**

Distance (ft): **120.0**
 Structural Grade: **0**
 O&M Grade: **0**
 Clock Start/From: **12**
 Clock To:
 1st Value: **4.000**
 2nd Value:
 Value Percent:
 Continuous Index:
 Within 8" of Joint: **YES**
 Remarks:

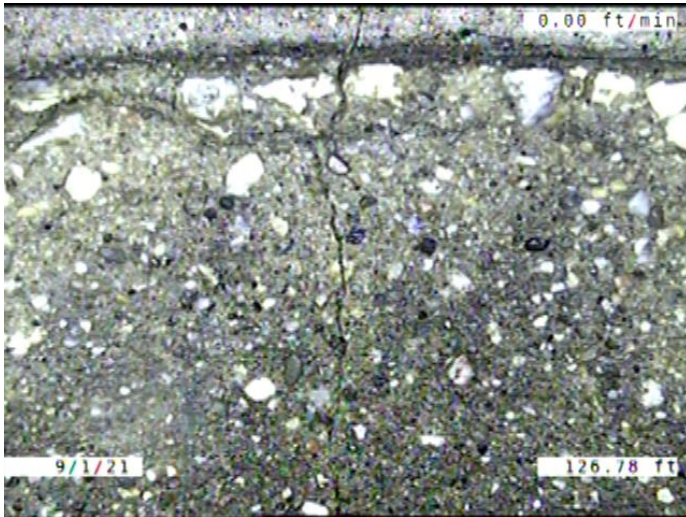
Code: **CL**
 Description: **Crack Longitudinal**

Distance (ft): **126.8**
 Structural Grade: **2**
 O&M Grade: **0**
 Clock Start/From: **12**
 Clock To:
 1st Value:
 2nd Value:
 Value Percent:
 Continuous Index:
 Within 8" of Joint: **YES**
 Remarks:

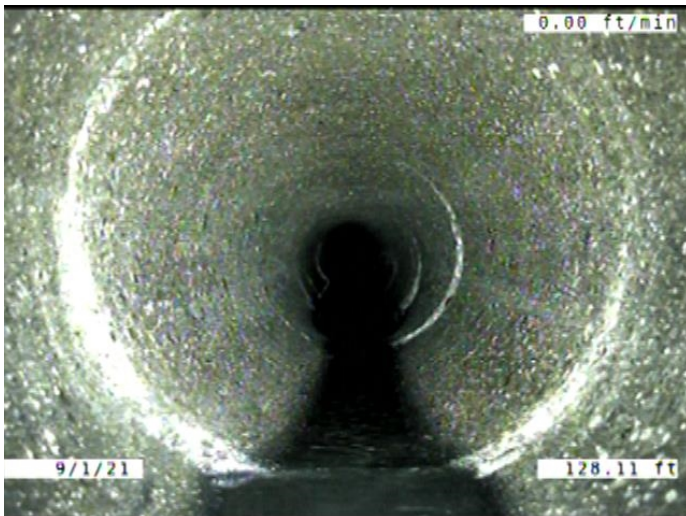
Code: **MWLS**
 Description: **Miscellaneous Water Level Sag**

Distance (ft): **128.1**
 Structural Grade: **2**
 O&M Grade: **0**
 Clock Start/From:
 Clock To:
 1st Value:
 2nd Value:
 Value Percent: **5.000**
 Continuous Index: **F03**
 Within 8" of Joint: **NO**
 Remarks:

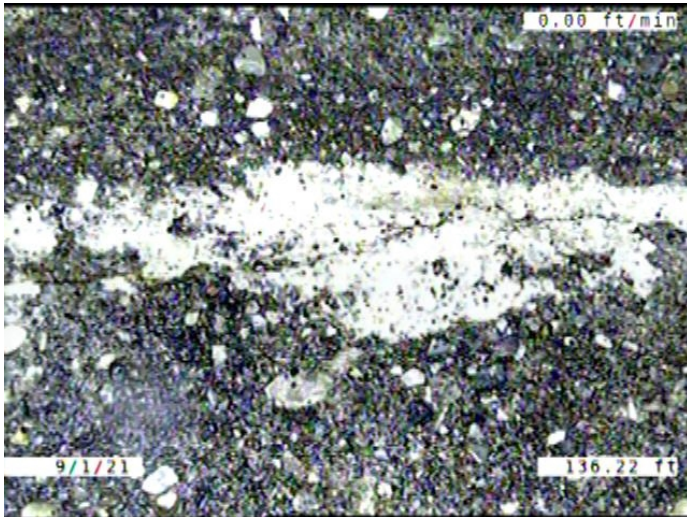
Code: **ISB**
 Description: **Infiltration Stain Barrel**

Distance (ft): **136.2**
 Structural Grade: **0**
 O&M Grade: **1**
 Clock Start/From: **2**
 Clock To: **4**
 1st Value:
 2nd Value:
 Value Percent:
 Continuous Index:
 Within 8" of Joint: **YES**
 Remarks:

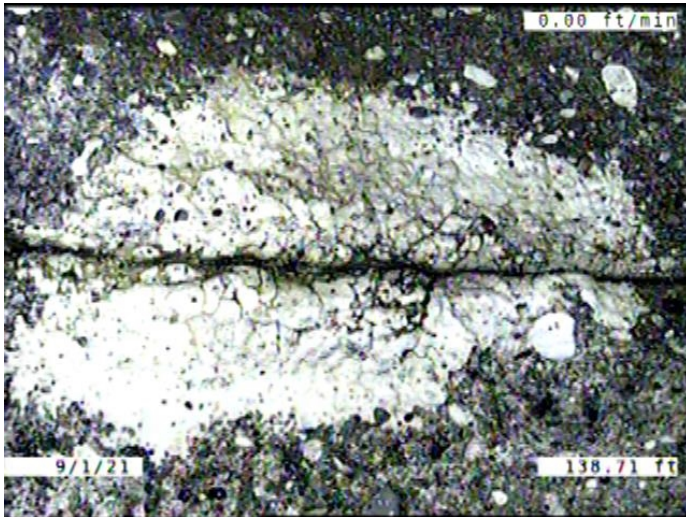
Code: **ISJ**
 Description: **Infiltration Stain Joint**

Distance (ft): **138.7**
 Structural Grade: **0**
 O&M Grade: **1**
 Clock Start/From: **2**
 Clock To: **3**
 1st Value:
 2nd Value:
 Value Percent:
 Continuous Index:
 Within 8" of Joint: **YES**
 Remarks:

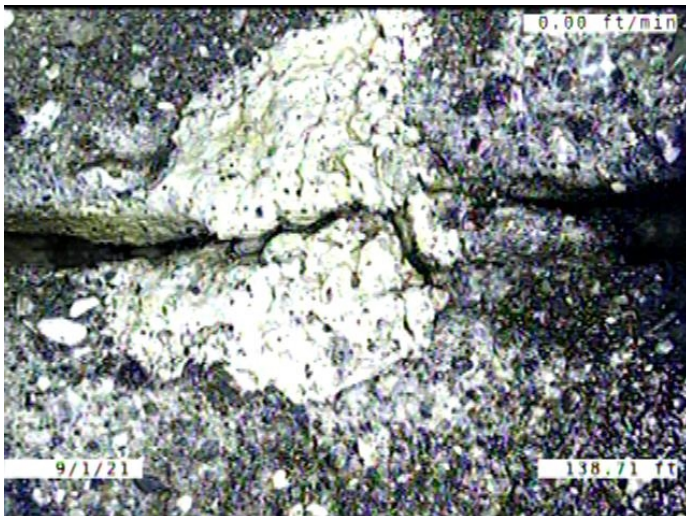
Code: **ISJ**
 Description: **Infiltration Stain Joint**

Distance (ft): **138.7**
 Structural Grade: **0**
 O&M Grade: **1**
 Clock Start/From: **8**
 Clock To: **9**
 1st Value:
 2nd Value:
 Value Percent:
 Continuous Index:
 Within 8" of Joint: **YES**
 Remarks:

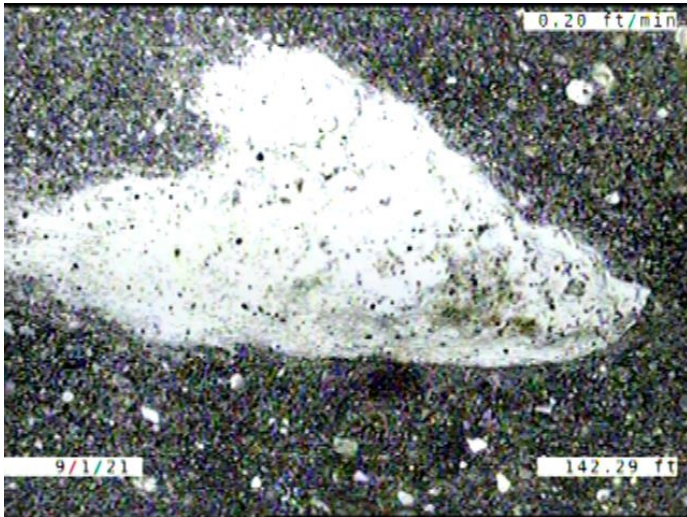
Code: **ISB**
 Description: **Infiltration Stain Barrel**

Distance (ft): **142.3**
 Structural Grade: **0**
 O&M Grade: **1**
 Clock Start/From: **9**
 Clock To: **10**
 1st Value:
 2nd Value:
 Value Percent:
 Continuous Index:
 Within 8" of Joint: **NO**
 Remarks:

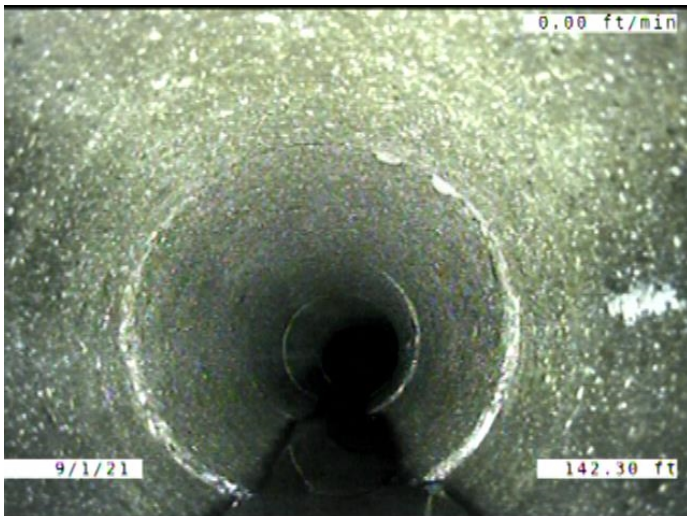
Code: **MWLS**
 Description: **Miscellaneous Water Level Sag**

Distance (ft): **142.3**
 Structural Grade: **2**
 O&M Grade: **0**
 Clock Start/From:
 Clock To:
 1st Value:
 2nd Value:
 Value Percent: **5.000**
 Continuous Index: **F04**
 Within 8" of Joint: **NO**
 Remarks:

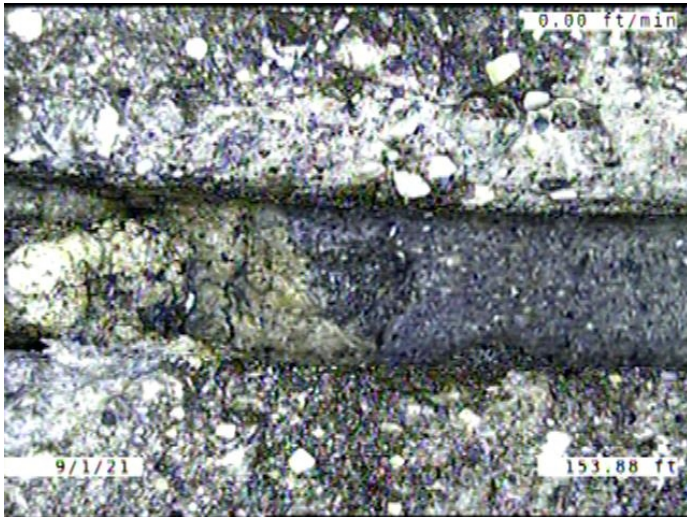
Code: **JAM**
 Description: **Joint Angular Medium**

Distance (ft): **153.9**
 Structural Grade: **3**
 O&M Grade: **0**
 Clock Start/From:
 Clock To:
 1st Value:
 2nd Value:
 Value Percent:
 Continuous Index:
 Within 8" of Joint: **NO**
 Remarks:

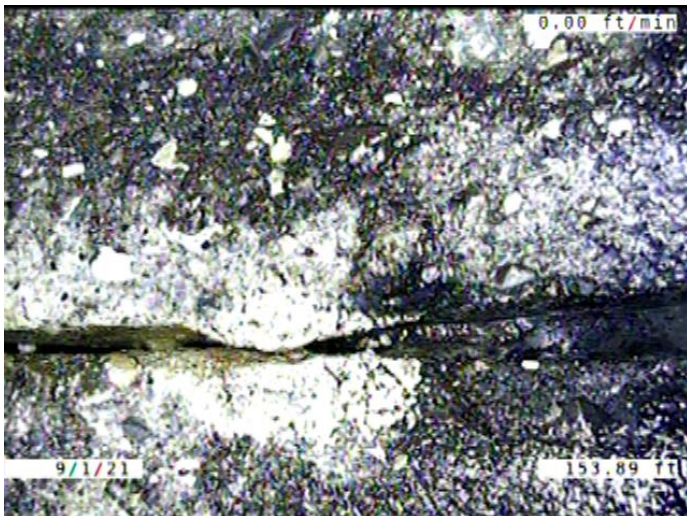
Code: **ISJ**
 Description: **Infiltration Stain Joint**

Distance (ft): **153.9**
 Structural Grade: **0**
 O&M Grade: **1**
 Clock Start/From: **7**
 Clock To: **5**
 1st Value:
 2nd Value:
 Value Percent:
 Continuous Index:
 Within 8" of Joint: **YES**
 Remarks:

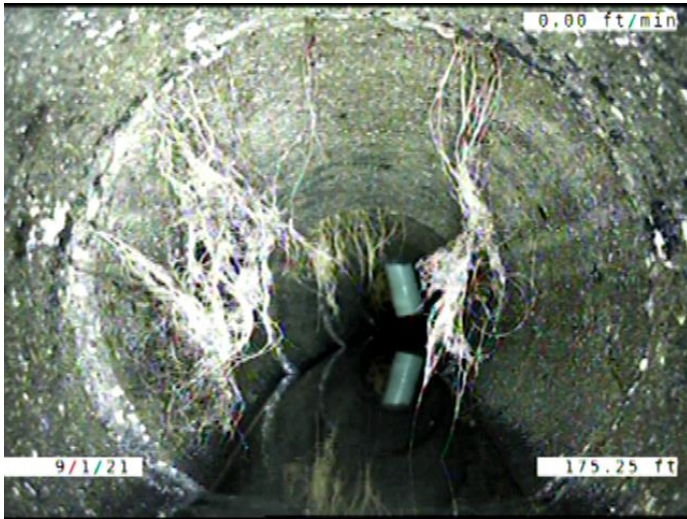
Code: **RMJ**
 Description: **Roots Medium Joint**

Distance (ft): **175.2**
 Structural Grade: **0**
 O&M Grade: **3**
 Clock Start/From: **9**
 Clock To: **1**
 1st Value:
 2nd Value:
 Value Percent: **5.000**
 Continuous Index:
 Within 8" of Joint: **YES**
 Remarks:

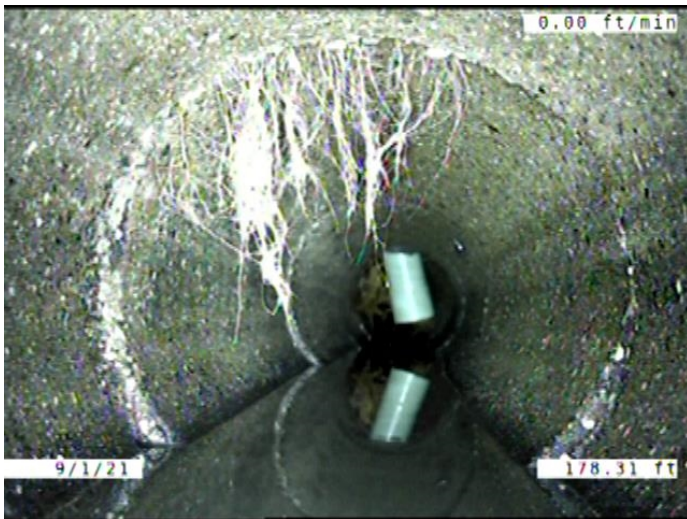
Code: **RMJ**
 Description: **Roots Medium Joint**

Distance (ft): **178.3**
 Structural Grade: **0**
 O&M Grade: **3**
 Clock Start/From: **10**
 Clock To: **1**
 1st Value:
 2nd Value:
 Value Percent: **5.000**
 Continuous Index:
 Within 8" of Joint: **YES**
 Remarks:

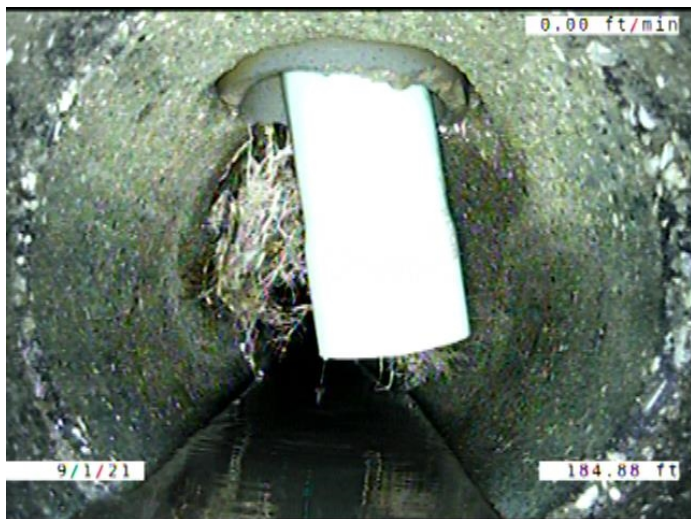
Code: **TBI**
 Description: **Tap Break-in Intruding**

Distance (ft): **184.9**
 Structural Grade: **0**
 O&M Grade: **2**
 Clock Start/From: **12**
 Clock To:
 1st Value: **4.000**
 2nd Value: **8.000**
 Value Percent:
 Continuous Index:
 Within 8" of Joint: **NO**
 Remarks:

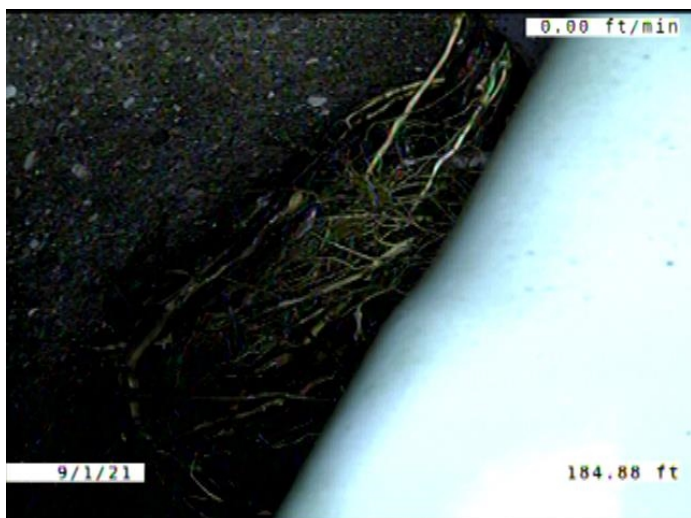
Code: **RML**
 Description: **Roots Medium Lateral**

Distance (ft): **184.9**
 Structural Grade: **0**
 O&M Grade: **3**
 Clock Start/From: **11**
 Clock To: **1**
 1st Value:
 2nd Value:
 Value Percent: **10.000**
 Continuous Index:
 Within 8" of Joint: **NO**
 Remarks:
