Profile/Photo Observation Report

Date:	09/01/2021	Weather:		Coding:	PACP 7.0
Pipe Length (ft):	317.0	Owner:	City of Hobart	Pre Clean:	Heavy Cleaning
P.O.#:	YES502259	Surveyor:	S. Bucklin	PSR:	P-504-027-108
Customer:	City of Hobart	Clean Date:	08/28/2021	Shape:	C

Street:	North Delaware Street	Flow Control:	Not Controlled
City:	Hobart, IN	Year Renewed:	
Location:	Alley	Tape/Media #:	
Purpose:	Routine Assessment	Dia/Height:	12"
Use:	Sanitary Sewage Pipe	Material:	CP
Drain Area:		Lining:	
Category:	NA		
Comment:			
Location Details:		Direction of Survey:	Upstream
US MH:	M-503-027	DS MH:	M-504-108
		Total Length Surveyed (ft):	128.5

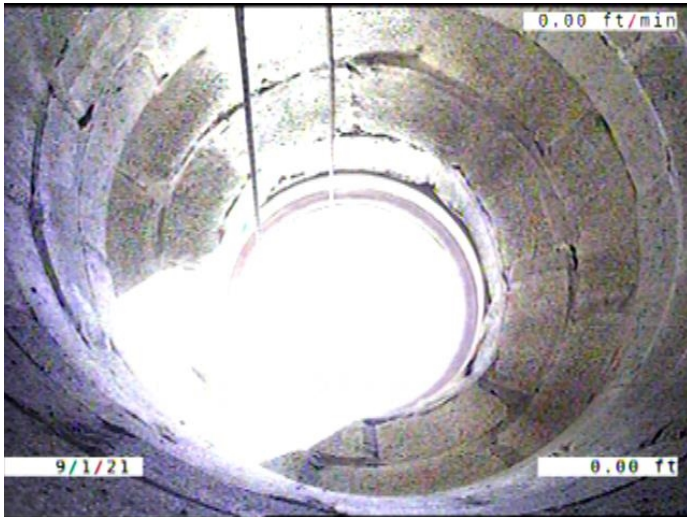
Code: **AMH**
 Description: **Manhole**

Distance (ft): **.0**
 Structural Grade: **0**
 O&M Grade: **0**
 Clock Start/From:
 Clock To:
 1st Value:
 2nd Value:
 Value Percent:
 Continuous Index:
 Within 8" of Joint: **NO**
 Remarks: **M-504-108**

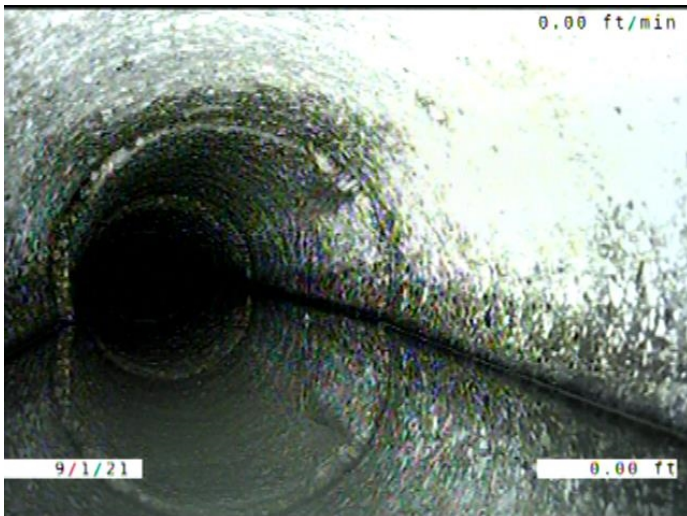
Code: **MWL**
 Description: **Miscellaneous Water Level**

Distance (ft): **.0**
 Structural Grade: **0**
 O&M Grade: **0**
 Clock Start/From:
 Clock To:
 1st Value:
 2nd Value:
 Value Percent: **20.000**
 Continuous Index:
 Within 8" of Joint: **NO**
 Remarks:

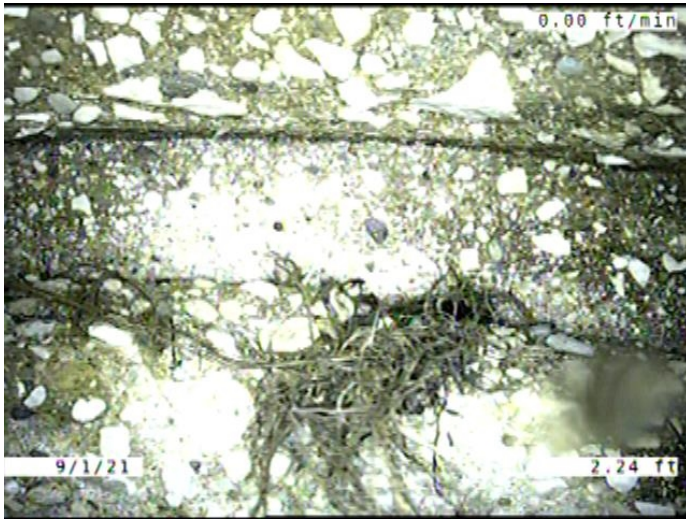
Code: **RFJ**
Description: **Roots Fine Joint**

Distance (ft): **2.2**
Structural Grade: **0**
O&M Grade: **1**
Clock Start/From: **10**
Clock To: **2**
1st Value:
2nd Value:
Value Percent:
Continuous Index:
Within 8" of Joint: **YES**
Remarks:

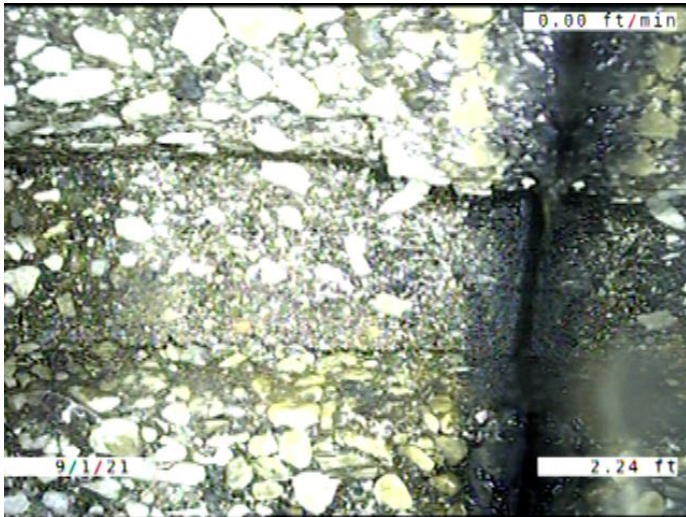
Code: **JAM**
Description: **Joint Angular Medium**

Distance (ft): **2.2**
Structural Grade: **3**
O&M Grade: **0**
Clock Start/From:
Clock To:
1st Value:
2nd Value:
Value Percent:
Continuous Index:
Within 8" of Joint: **NO**
Remarks:

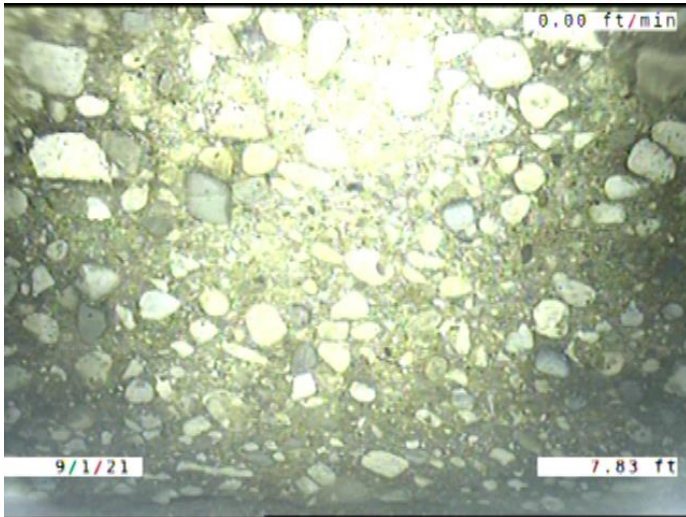
Code:	MGO
Description:	Miscellaneous General Observation
Distance (ft):	7.8
Structural Grade:	0
O&M Grade:	0
Clock Start/From:	
Clock To:	
1st Value:	
2nd Value:	
Value Percent:	
Continuous Index:	
Within 8" of Joint:	NO
Remarks:	MCU, but section is rerun around 10:00 in and asset does not go under

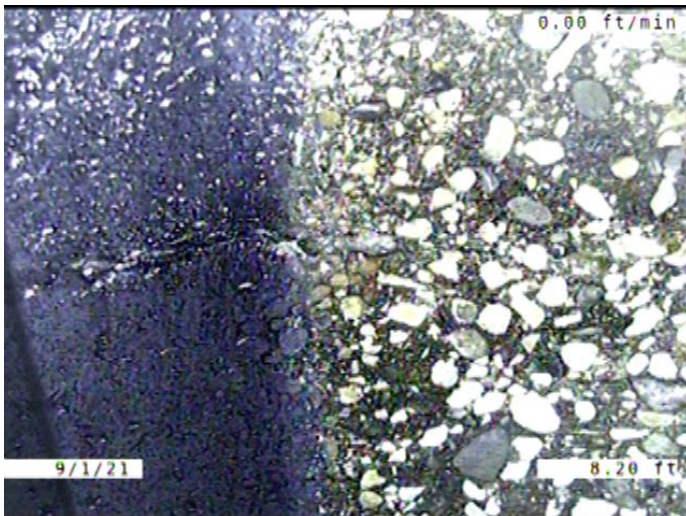
Code:	CS
Description:	Crack Spiral
Distance (ft):	8.2
Structural Grade:	2
O&M Grade:	0
Clock Start/From:	4
Clock To:	8
1st Value:	
2nd Value:	
Value Percent:	
Continuous Index:	
Within 8" of Joint:	NO
Remarks:

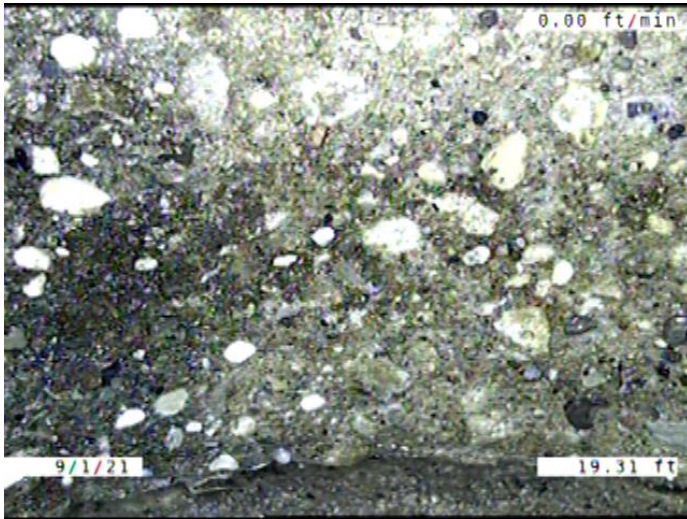
Code: **CS**
 Description: **Crack Spiral**

Distance (ft): **19.3**
 Structural Grade: **2**
 O&M Grade: **0**
 Clock Start/From: **10**
 Clock To: **5**
 1st Value:
 2nd Value:
 Value Percent:
 Continuous Index:
 Within 8" of Joint: **YES**
 Remarks:

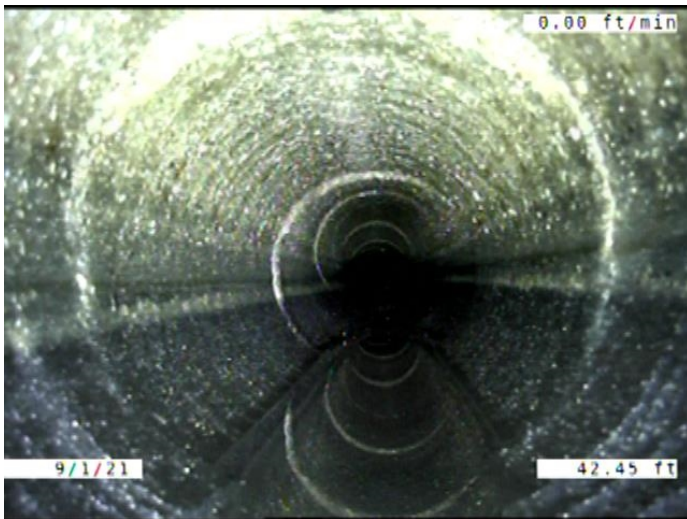
Code: **MWLS**
 Description: **Miscellaneous Water Level Sag**

Distance (ft): **42.5**
 Structural Grade: **2**
 O&M Grade: **0**
 Clock Start/From:
 Clock To:
 1st Value:
 2nd Value:
 Value Percent: **5.000**
 Continuous Index: **S02**
 Within 8" of Joint: **NO**
 Remarks:

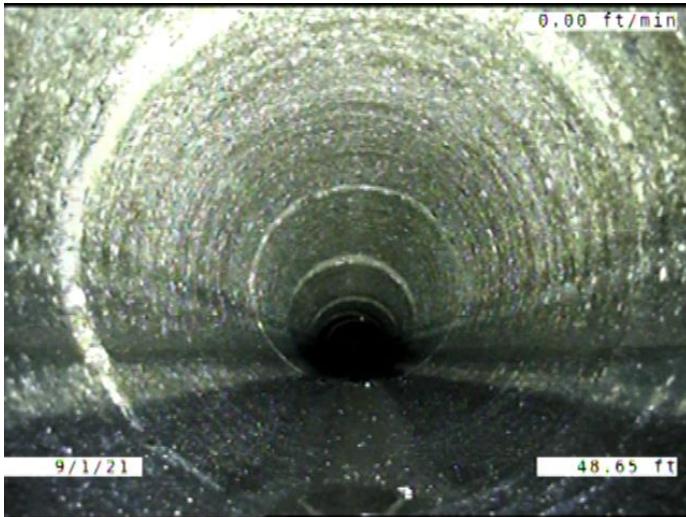
Code: **MWLS**
Description: **Miscellaneous Water Level Sag**

Distance (ft): **48.6**
Structural Grade: **2**
O&M Grade: **0**
Clock Start/From:
Clock To:
1st Value:
2nd Value:
Value Percent: **5.000**
Continuous Index: **F02**
Within 8" of Joint: **NO**
Remarks:

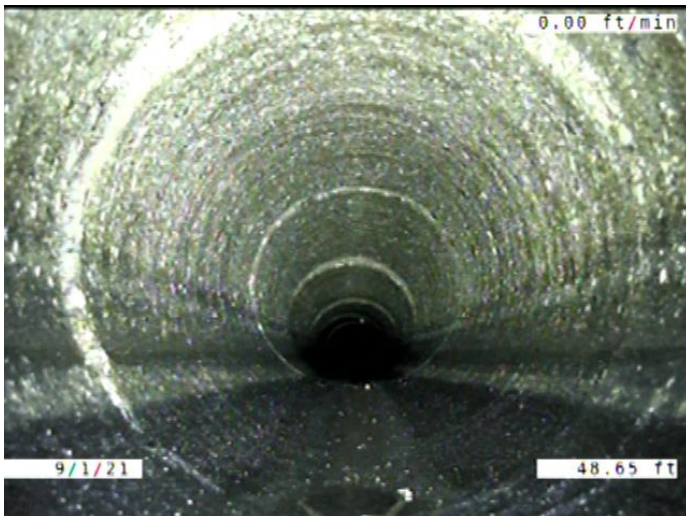
Code: **MWL**
Description: **Miscellaneous Water Level**

Distance (ft): **48.6**
Structural Grade: **0**
O&M Grade: **0**
Clock Start/From:
Clock To:
1st Value:
2nd Value:
Value Percent: **5.000**
Continuous Index:
Within 8" of Joint: **NO**
Remarks:

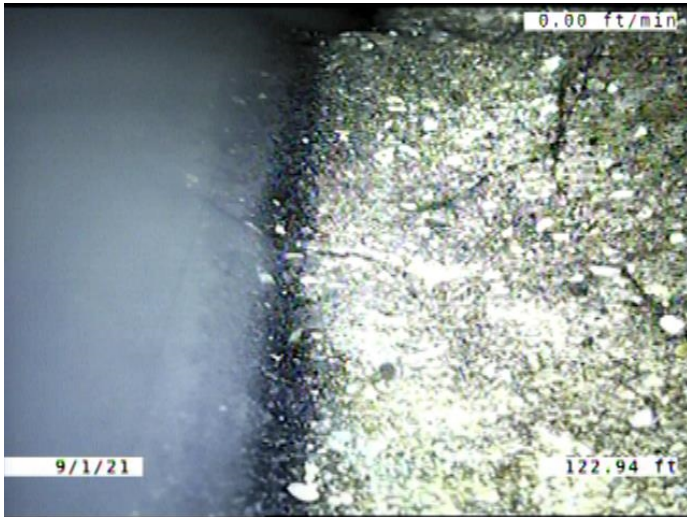
Code: **FM**
 Description: **Fracture Multiple**

Distance (ft): **122.9**
 Structural Grade: **4**
 O&M Grade: **0**
 Clock Start/From: **4**
 Clock To: **8**
 1st Value:
 2nd Value:
 Value Percent:
 Continuous Index:
 Within 8" of Joint: **YES**
 Remarks:

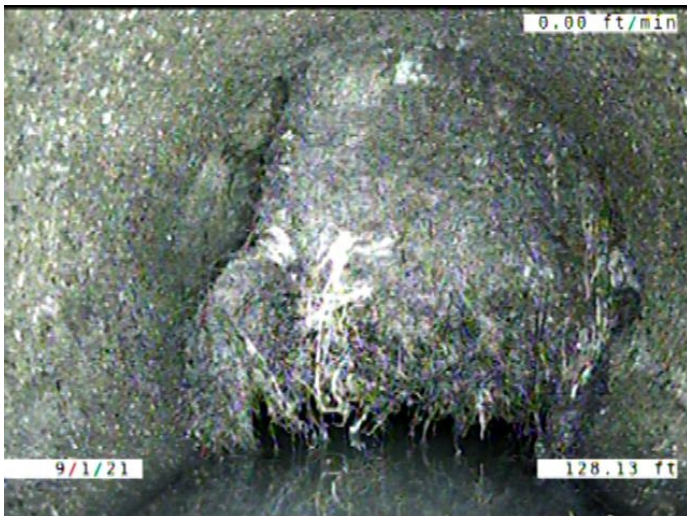
Code: **RBJ**
 Description: **Roots Ball Joint**

Distance (ft): **128.1**
 Structural Grade: **0**
 O&M Grade: **4**
 Clock Start/From: **7**
 Clock To: **5**
 1st Value:
 2nd Value:
 Value Percent: **85.000**
 Continuous Index:
 Within 8" of Joint: **YES**
 Remarks:
