## Profile/Photo Observation Report

Date:	<b>09/01/2021</b>	Weather:		Coding:	<b>PACP 7.0</b>
Pipe Length (ft):	<b>317.0</b>	Owner:	<b>City of Hobart</b>	Pre Clean:	<b>Heavy Cleaning</b>
P.O.#:	<b>YES502259</b>	Surveyor:	<b>S. Bucklin</b>	PSR:	<b>P-504-027-108</b>
Customer:	<b>City of Hobart</b>	Clean Date:	<b>08/28/2021</b>	Shape:	<b>C</b>

Street:	<b>North Delaware Street</b>	Flow Control:	<b>Not Controlled</b>
City:	<b>Hobart, IN</b>	Year Renewed:	
Location:	<b>Alley</b>	Tape/Media #:	
Purpose:	<b>Routine Assessment</b>	Dia/Height:	<b>12"</b>
Use:	<b>Sanitary Sewage Pipe</b>	Material:	<b>CP</b>
Drain Area:		Lining:	
Category:	<b>NA</b>		
Comment:

Location Details:		Direction of Survey:	<b>Upstream</b>
US MH:	<b>M-503-027</b>	DS MH:	<b>M-504-108</b>
		Total Length Surveyed (ft):	<b>128.5</b>

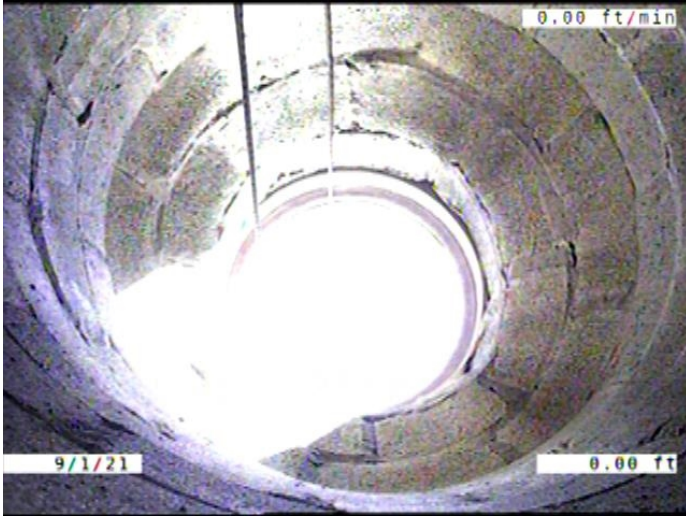
Code: **AMH**  
Description: **Manhole**

Distance (ft): **.0**  
Structural Grade: **0**  
O&M Grade: **0**  
Clock Start/From:  
Clock To:  
1st Value:  
2nd Value:  
Value Percent:  
Continuous Index:  
Within 8" of Joint: **NO**  
Remarks: **M-504-108**

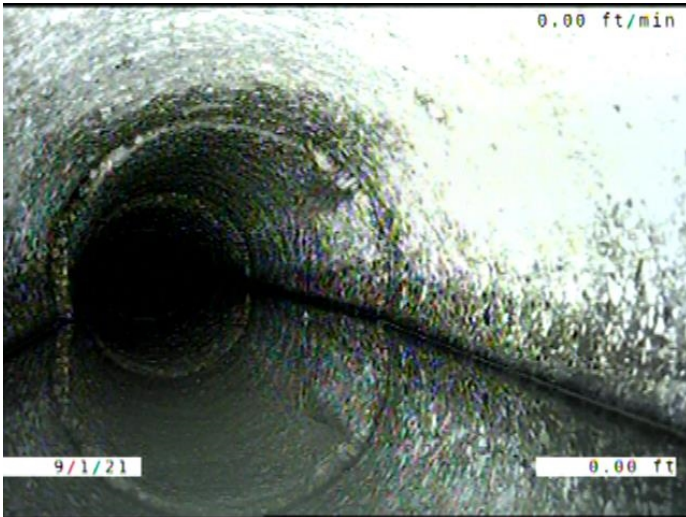
Code: **MWL**  
Description: **Miscellaneous Water Level**

Distance (ft): **.0**  
Structural Grade: **0**  
O&M Grade: **0**  
Clock Start/From:  
Clock To:  
1st Value:  
2nd Value:  
Value Percent: **20.000**  
Continuous Index:  
Within 8" of Joint: **NO**  
Remarks:

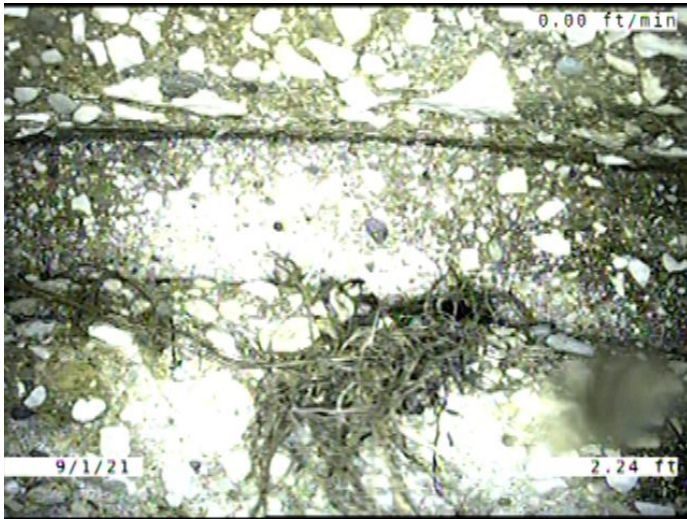
Code: **RFJ**  
 Description: **Roots Fine Joint**

Distance (ft): **2.2**  
 Structural Grade: **0**  
 O&M Grade: **1**  
 Clock Start/From: **10**  
 Clock To: **2**  
 1st Value:  
 2nd Value:  
 Value Percent:  
 Continuous Index:  
 Within 8" of Joint: **YES**  
 Remarks:

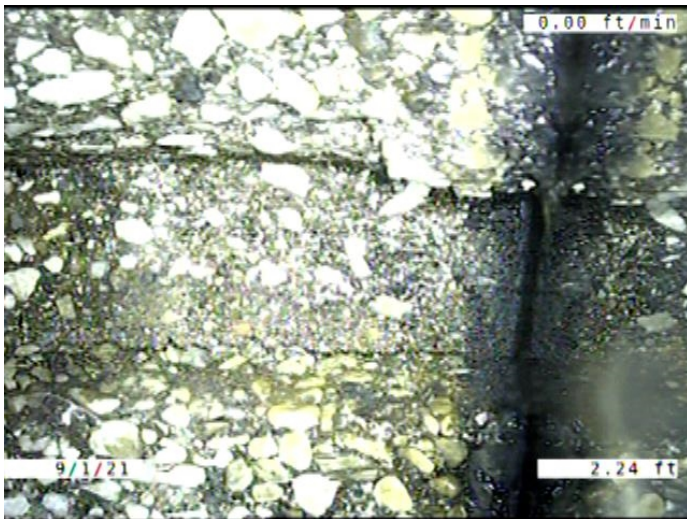
Code: **JAM**  
 Description: **Joint Angular Medium**

Distance (ft): **2.2**  
 Structural Grade: **3**  
 O&M Grade: **0**  
 Clock Start/From:  
 Clock To:  
 1st Value:  
 2nd Value:  
 Value Percent:  
 Continuous Index:  
 Within 8" of Joint: **NO**  
 Remarks:

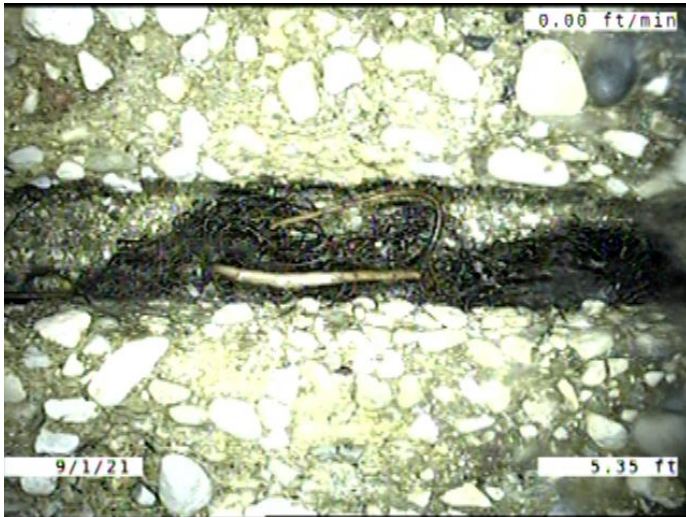
Code: **RFJ**  
 Description: **Roots Fine Joint**

Distance (ft): **5.4**  
 Structural Grade: **0**  
 O&M Grade: **1**  
 Clock Start/From: **10**  
 Clock To: **2**  
 1st Value:  
 2nd Value:  
 Value Percent:  
 Continuous Index:  
 Within 8" of Joint: **YES**  
 Remarks:

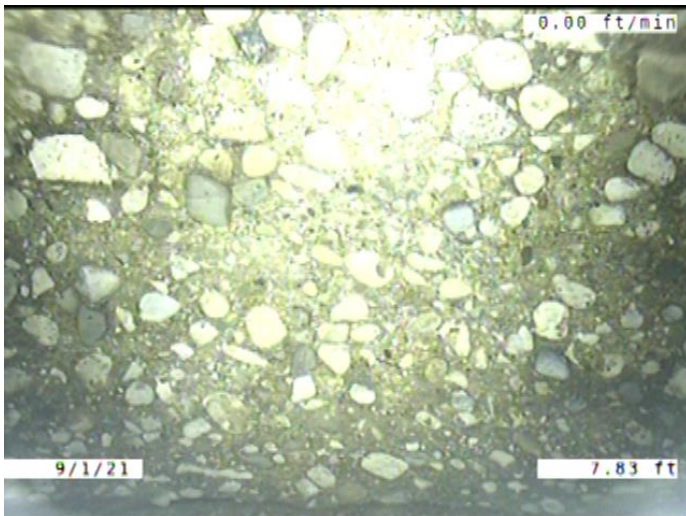
Code: **MWL**  
 Description: **Miscellaneous Water Level**

Distance (ft): **7.8**  
 Structural Grade: **0**  
 O&M Grade: **0**  
 Clock Start/From:  
 Clock To:  
 1st Value:  
 2nd Value:  
 Value Percent: **30.000**  
 Continuous Index:  
 Within 8" of Joint: **NO**  
 Remarks:

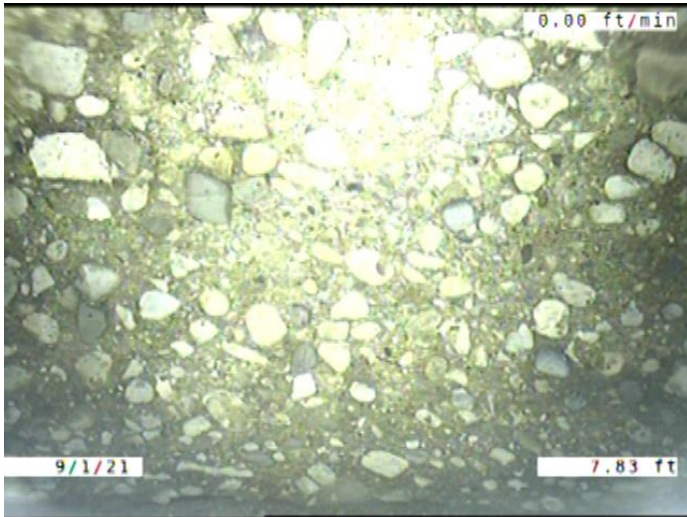
Code:	<b>MGO</b>
Description:	<b>Miscellaneous General Observation</b>
Distance (ft):	<b>7.8</b>
Structural Grade:	<b>0</b>
O&M Grade:	<b>0</b>
Clock Start/From:	
Clock To:	
1st Value:	
2nd Value:	
Value Percent:	
Continuous Index:	
Within 8" of Joint:	<b>NO</b>
Remarks:	<b>MCU, but section is rerun around 10:00 in and asset does not go under</b>

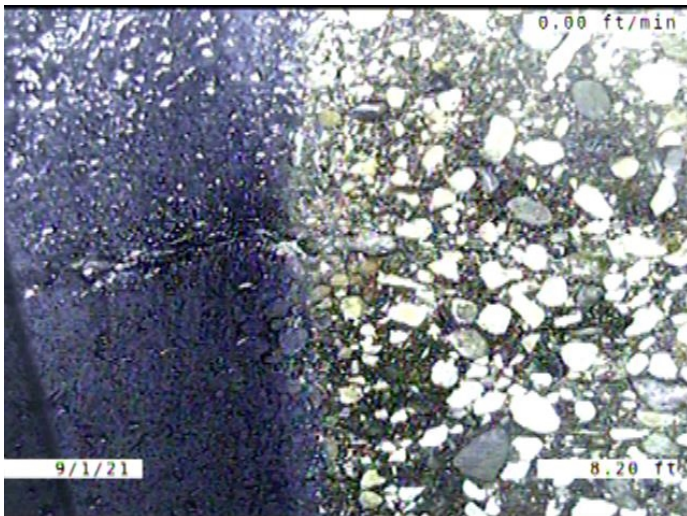
Code:	<b>CS</b>
Description:	<b>Crack Spiral</b>
Distance (ft):	<b>8.2</b>
Structural Grade:	<b>2</b>
O&M Grade:	<b>0</b>
Clock Start/From:	<b>4</b>
Clock To:	<b>8</b>
1st Value:	
2nd Value:	
Value Percent:	
Continuous Index:	
Within 8" of Joint:	<b>NO</b>
Remarks:

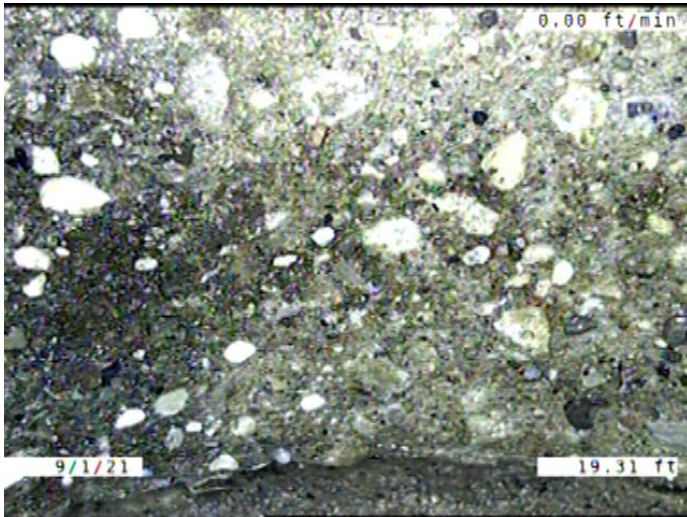
Code: **CS**  
 Description: **Crack Spiral**

Distance (ft): **19.3**  
 Structural Grade: **2**  
 O&M Grade: **0**  
 Clock Start/From: **10**  
 Clock To: **5**  
 1st Value:  
 2nd Value:  
 Value Percent:  
 Continuous Index:  
 Within 8" of Joint: **YES**  
 Remarks:

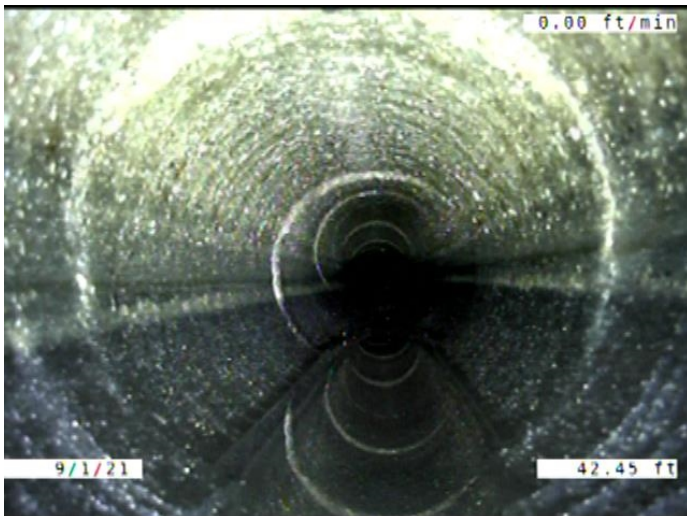
Code: **MWLS**  
 Description: **Miscellaneous Water Level Sag**

Distance (ft): **42.5**  
 Structural Grade: **2**  
 O&M Grade: **0**  
 Clock Start/From:  
 Clock To:  
 1st Value:  
 2nd Value:  
 Value Percent: **5.000**  
 Continuous Index: **S02**  
 Within 8" of Joint: **NO**  
 Remarks:

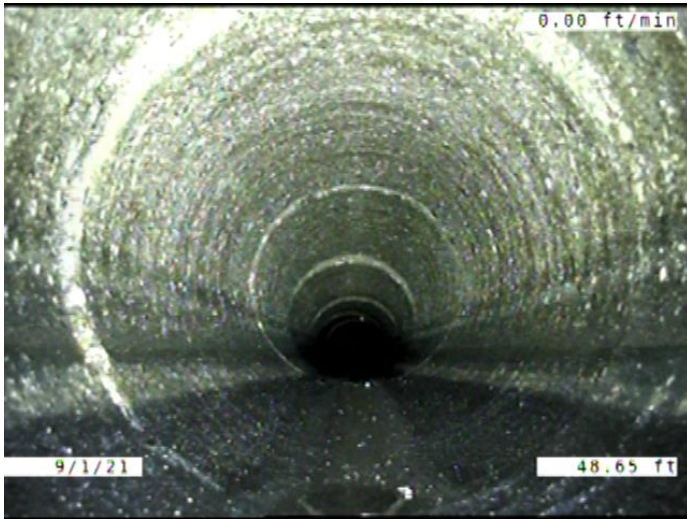
Code: **MWLS**  
Description: **Miscellaneous Water Level Sag**

Distance (ft): **48.6**  
Structural Grade: **2**  
O&M Grade: **0**  
Clock Start/From:  
Clock To:  
1st Value:  
2nd Value:  
Value Percent: **5.000**  
Continuous Index: **F02**  
Within 8" of Joint: **NO**  
Remarks:

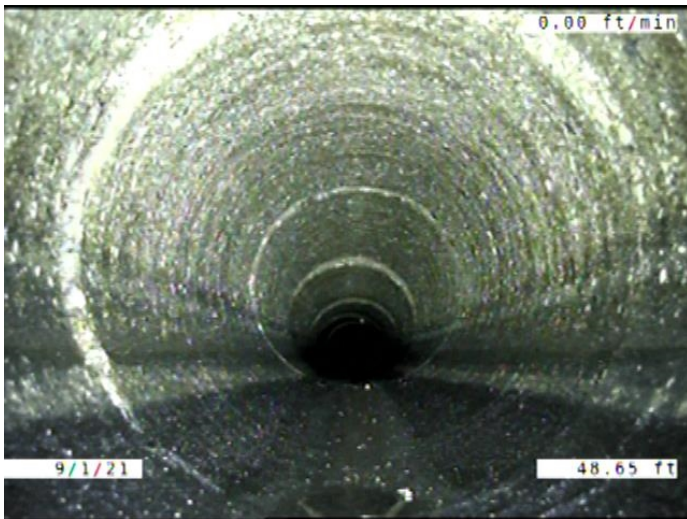
Code: **MWL**  
Description: **Miscellaneous Water Level**

Distance (ft): **48.6**  
Structural Grade: **0**  
O&M Grade: **0**  
Clock Start/From:  
Clock To:  
1st Value:  
2nd Value:  
Value Percent: **5.000**  
Continuous Index:  
Within 8" of Joint: **NO**  
Remarks:

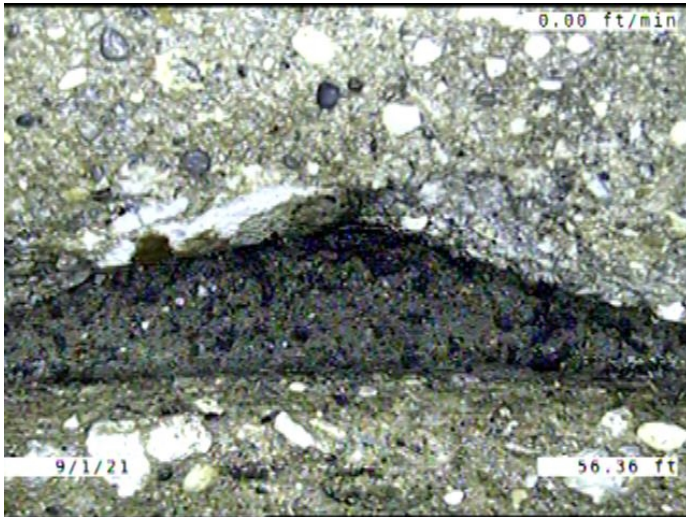
Code: **SMW**  
 Description: **Surface Damage Missing Wall**

Distance (ft): **56.4**  
 Structural Grade: **5**  
 O&M Grade: **0**  
 Clock Start/From: **11**  
 Clock To: **12**  
 1st Value:  
 2nd Value:  
 Value Percent:  
 Continuous Index:  
 Within 8" of Joint: **YES**  
 Remarks:

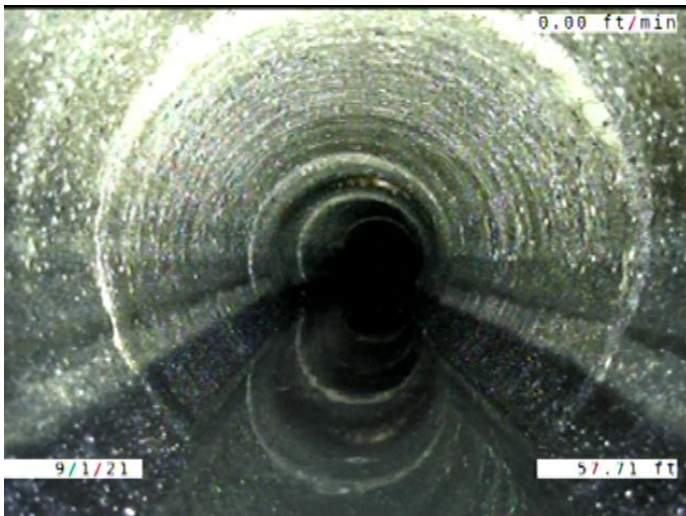
Code: **MWLS**  
 Description: **Miscellaneous Water Level Sag**

Distance (ft): **57.7**  
 Structural Grade: **2**  
 O&M Grade: **0**  
 Clock Start/From:  
 Clock To:  
 1st Value:  
 2nd Value:  
 Value Percent: **5.000**  
 Continuous Index: **S03**  
 Within 8" of Joint: **NO**  
 Remarks:

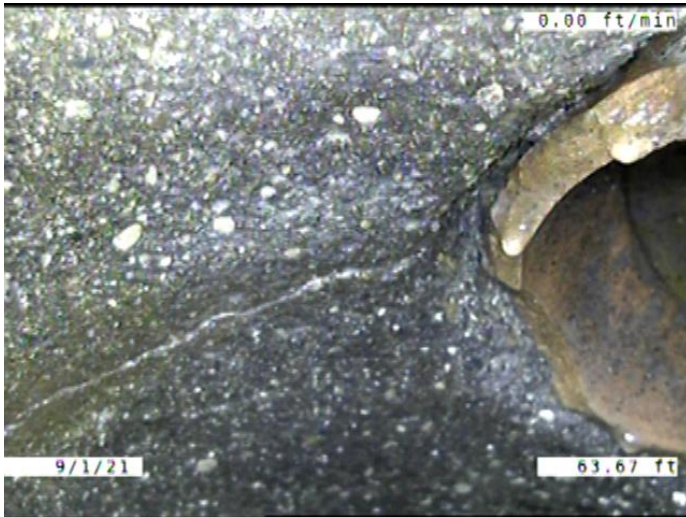
Code: **FM**  
 Description: **Fracture Multiple**

Distance (ft): **63.7**  
 Structural Grade: **4**  
 O&M Grade: **0**  
 Clock Start/From: **12**  
 Clock To: **12**  
 1st Value:  
 2nd Value:  
 Value Percent:  
 Continuous Index:  
 Within 8" of Joint: **NO**  
 Remarks:

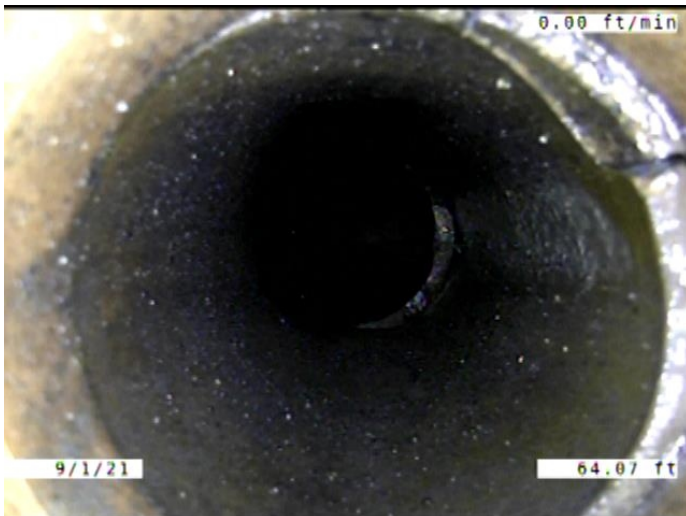
Code: **TBD**  
 Description: **Tap Break-in/Hammer Defective**

Distance (ft): **64.1**  
 Structural Grade: **0**  
 O&M Grade: **3**  
 Clock Start/From: **1**  
 Clock To:  
 1st Value: **4.000**  
 2nd Value:  
 Value Percent:  
 Continuous Index:  
 Within 8" of Joint: **NO**  
 Remarks: **Debris**

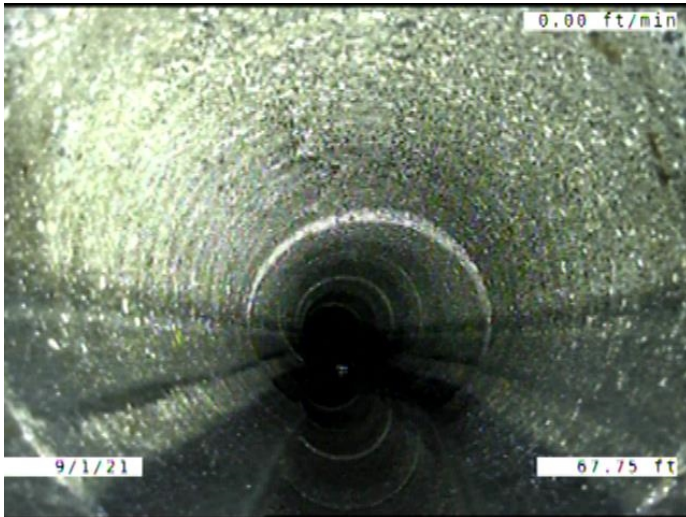
Code: **MWLS**  
 Description: **Miscellaneous Water Level Sag**

Distance (ft): **67.7**  
 Structural Grade: **2**  
 O&M Grade: **0**  
 Clock Start/From:  
 Clock To:  
 1st Value:  
 2nd Value:  
 Value Percent: **5.000**  
 Continuous Index: **F03**  
 Within 8" of Joint: **NO**  
 Remarks:

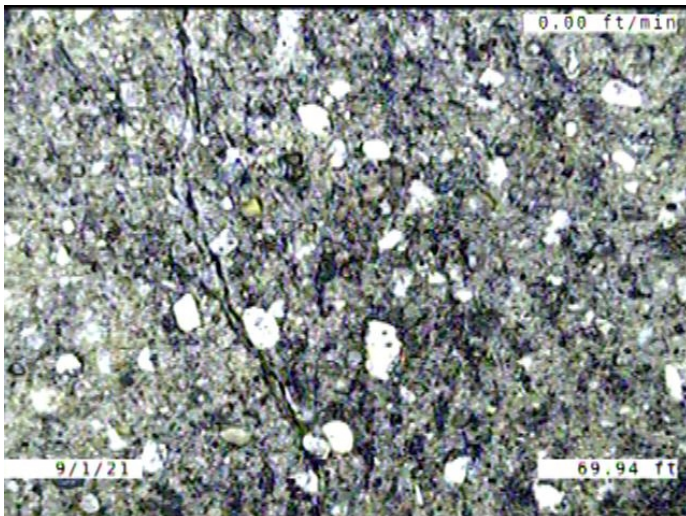
Code: **FL**  
 Description: **Fracture Longitudinal**

Distance (ft): **69.9**  
 Structural Grade: **3**  
 O&M Grade: **0**  
 Clock Start/From: **12**  
 Clock To:  
 1st Value:  
 2nd Value:  
 Value Percent:  
 Continuous Index: **S04**  
 Within 8" of Joint: **YES**  
 Remarks:

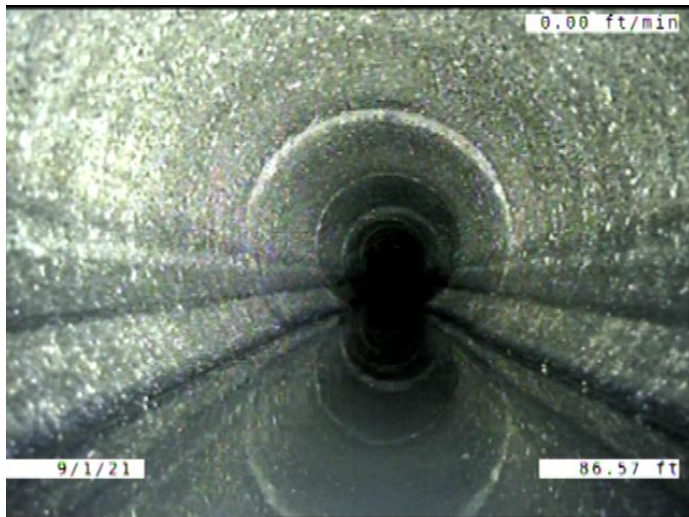
Code: **FL**  
 Description: **Fracture Longitudinal**

Distance (ft): **86.6**  
 Structural Grade: **3**  
 O&M Grade: **0**  
 Clock Start/From: **12**  
 Clock To:  
 1st Value:  
 2nd Value:  
 Value Percent:  
 Continuous Index: **F04**  
 Within 8" of Joint: **YES**  
 Remarks:

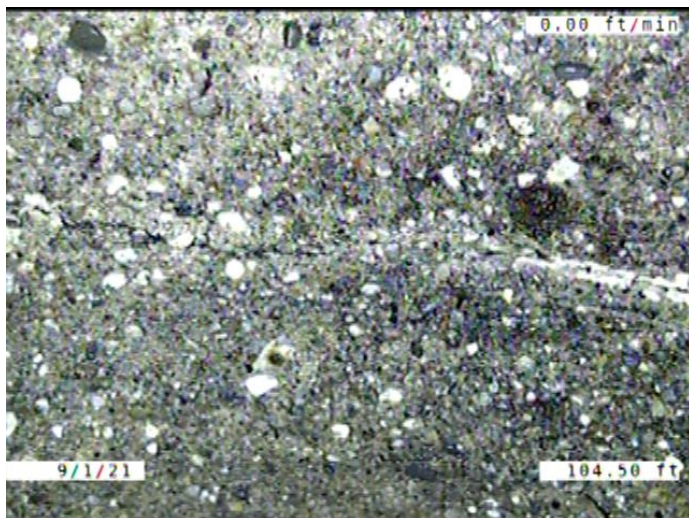
Code: **CM**  
 Description: **Crack Multiple**

Distance (ft): **104.5**  
 Structural Grade: **3**  
 O&M Grade: **0**  
 Clock Start/From: **12**  
 Clock To: **12**  
 1st Value:  
 2nd Value:  
 Value Percent:  
 Continuous Index:  
 Within 8" of Joint: **YES**  
 Remarks:

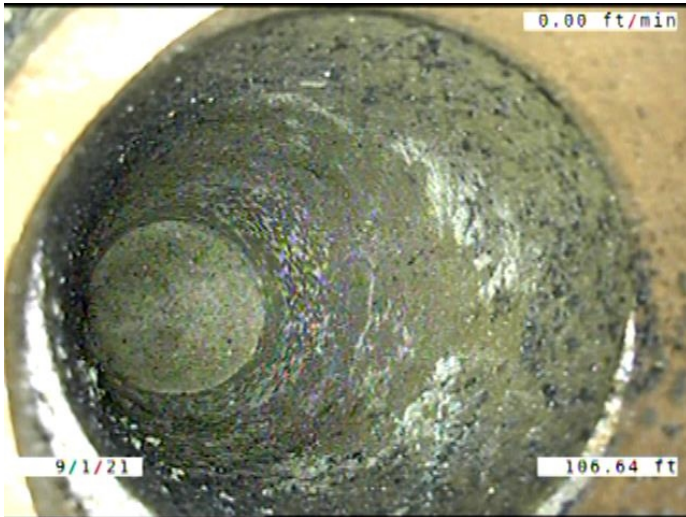
Code: **TB**  
 Description: **Tap Break-in/Hammer**

Distance (ft): **106.6**  
 Structural Grade: **0**  
 O&M Grade: **0**  
 Clock Start/From: **11**  
 Clock To:  
 1st Value: **4.000**  
 2nd Value:  
 Value Percent:  
 Continuous Index:  
 Within 8" of Joint: **NO**  
 Remarks:

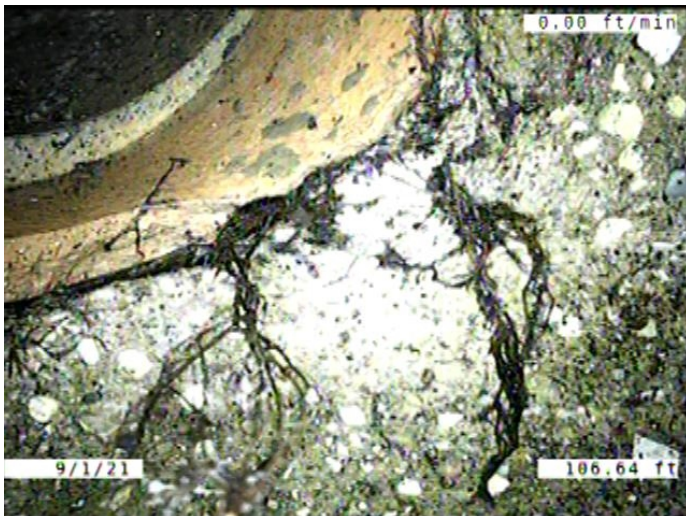
Code: **RFL**  
 Description: **Roots Fine Lateral**

Distance (ft): **106.6**  
 Structural Grade: **0**  
 O&M Grade: **1**  
 Clock Start/From: **11**  
 Clock To: **12**  
 1st Value:  
 2nd Value:  
 Value Percent:  
 Continuous Index:  
 Within 8" of Joint: **NO**  
 Remarks:

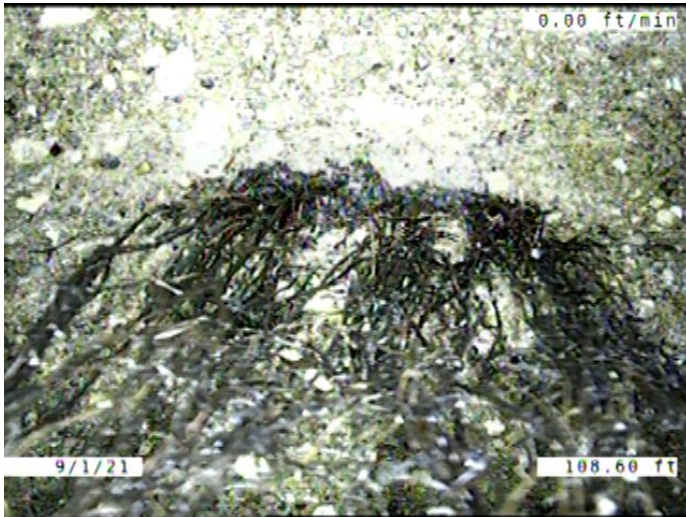
Code: **RMJ**  
Description: **Roots Medium Joint**

Distance (ft): **108.6**  
Structural Grade: **0**  
O&M Grade: **3**  
Clock Start/From: **8**  
Clock To: **2**  
1st Value:  
2nd Value:  
Value Percent: **5.000**  
Continuous Index:  
Within 8" of Joint: **YES**  
Remarks:

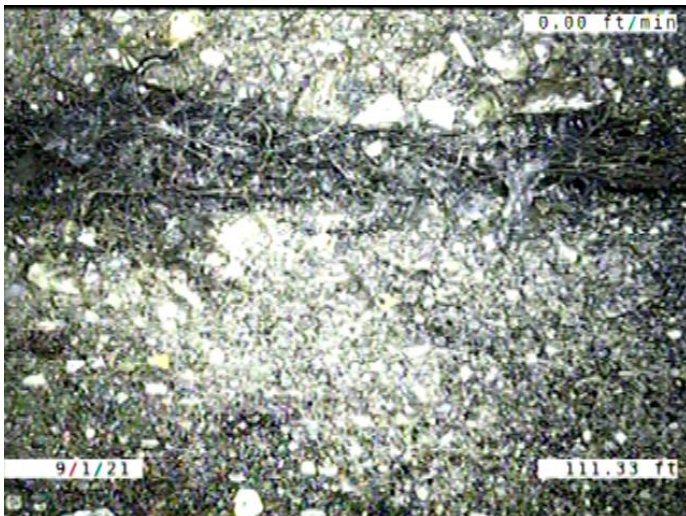
Code: **RFJ**  
Description: **Roots Fine Joint**

Distance (ft): **111.3**  
Structural Grade: **0**  
O&M Grade: **1**  
Clock Start/From: **3**  
Clock To: **4**  
1st Value:  
2nd Value:  
Value Percent:  
Continuous Index:  
Within 8" of Joint: **YES**  
Remarks:

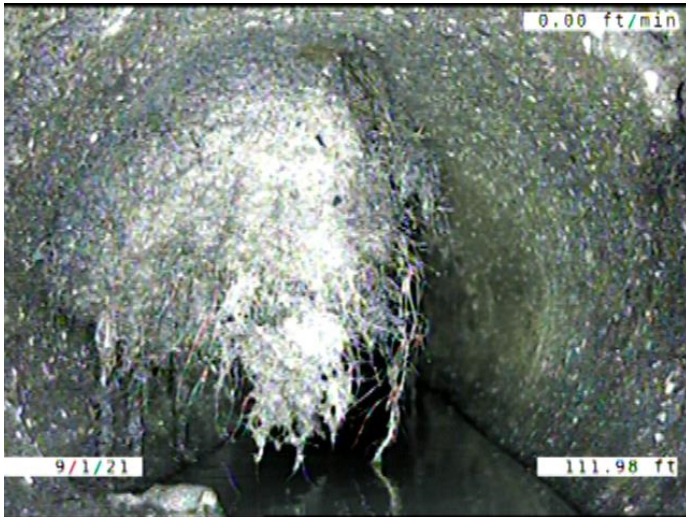
Code: **RMJ**  
 Description: **Roots Medium Joint**

Distance (ft): **112.0**  
 Structural Grade: **0**  
 O&M Grade: **3**  
 Clock Start/From: **8**  
 Clock To: **12**  
 1st Value:  
 2nd Value:  
 Value Percent: **30.000**  
 Continuous Index:  
 Within 8" of Joint: **YES**  
 Remarks:

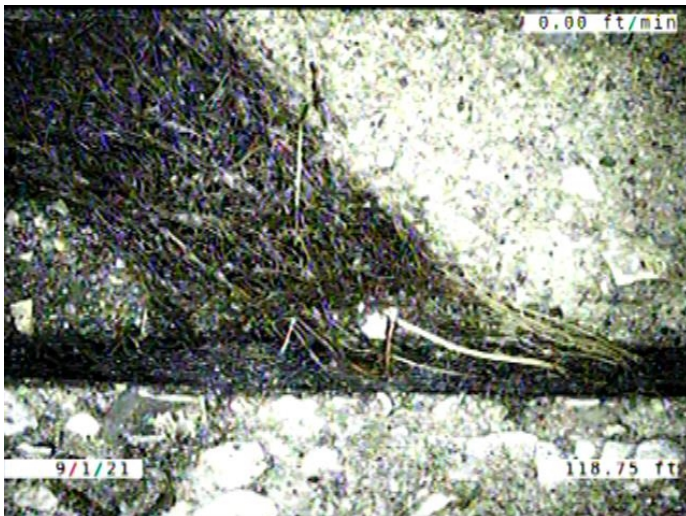
Code: **RMJ**  
 Description: **Roots Medium Joint**

Distance (ft): **118.7**  
 Structural Grade: **0**  
 O&M Grade: **3**  
 Clock Start/From: **3**  
 Clock To: **4**  
 1st Value:  
 2nd Value:  
 Value Percent: **5.000**  
 Continuous Index:  
 Within 8" of Joint: **YES**  
 Remarks:

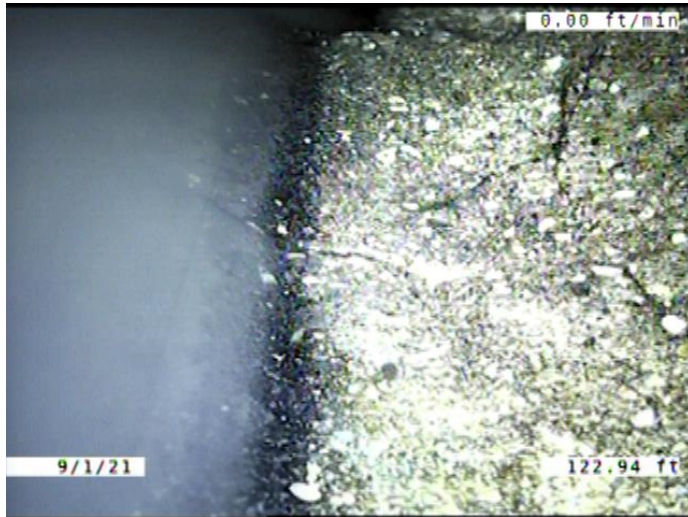
Code: **FM**  
 Description: **Fracture Multiple**

Distance (ft): **122.9**  
 Structural Grade: **4**  
 O&M Grade: **0**  
 Clock Start/From: **4**  
 Clock To: **8**  
 1st Value:  
 2nd Value:  
 Value Percent:  
 Continuous Index:  
 Within 8" of Joint: **YES**  
 Remarks:

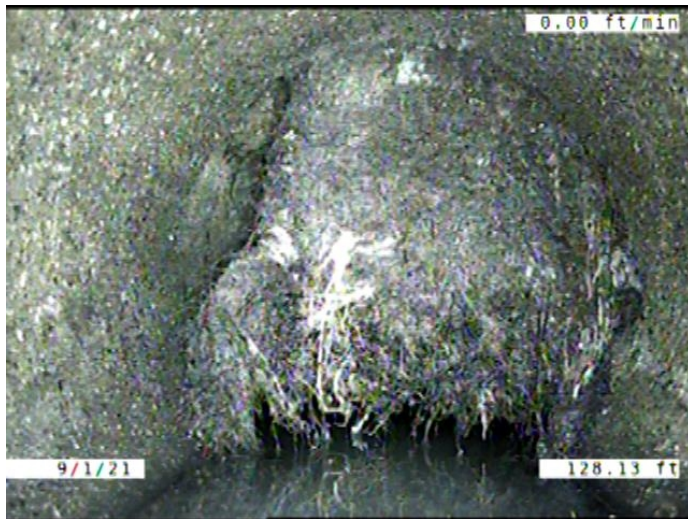
Code: **RBJ**  
 Description: **Roots Ball Joint**

Distance (ft): **128.1**  
 Structural Grade: **0**  
 O&M Grade: **4**  
 Clock Start/From: **7**  
 Clock To: **5**  
 1st Value:  
 2nd Value:  
 Value Percent: **85.000**  
 Continuous Index:  
 Within 8" of Joint: **YES**  
 Remarks:

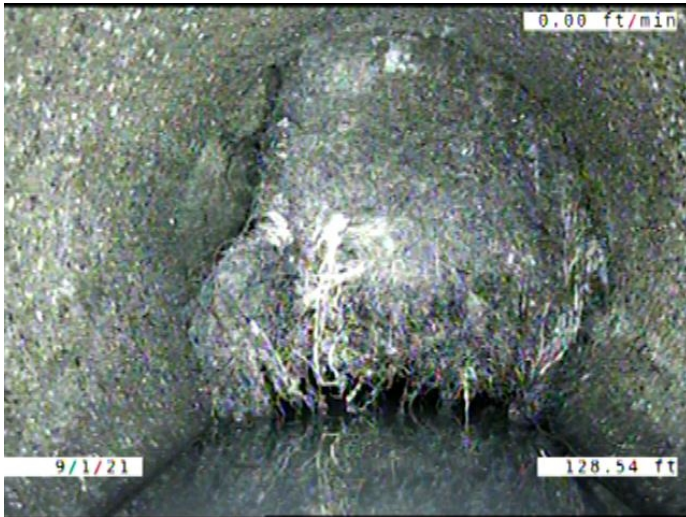
Code:	MSA
Description:	Miscellaneous Survey Abandoned
Distance (ft):	128.5
Structural Grade:	0
O&M Grade:	0
Clock Start/From:	
Clock To:	
1st Value:	
2nd Value:	
Value Percent:	
Continuous Index:	
Within 8" of Joint:	NO
Remarks:	CAMERA CANT MAKE IT PAST ROOT BALL
