## Profile/Photo Observation Report

Street:	<b>N VIRGINIA ST</b>	Flow Control:	<b>Not Controlled</b>
City:	<b>Hobart, IN</b>	Year Renewed:	
Location:	<b>Other</b>	Tape/Media #:	
Purpose:	<b>Not Known</b>	Dia/Height:	<b>10"</b>
Use:	<b>Sanitary</b>	Material:	<b>VCP</b>
Drain Area:	<b>NA</b>	Lining:	
Category:	<b>NA</b>		
Comment:

Location Details:		Direction of Survey:	<b>Downstream</b>
US MH:	<b>M-503-027.5</b>	DS MH:	<b>M-503-028</b>
		Total Length Surveyed (ft):	<b>8.4</b>

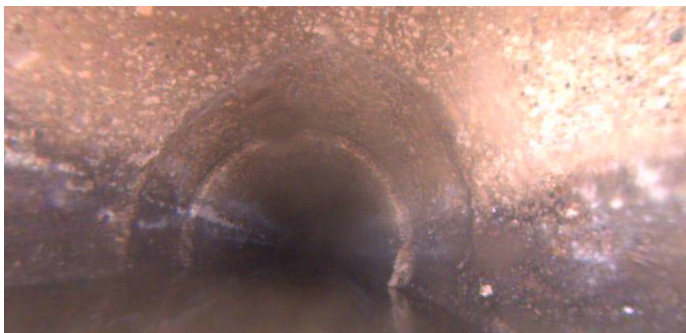
Code: **AMH**  
Description: **Manhole**

Distance (ft): **.0**  
Structural Grade: **0**  
O&M Grade: **0**  
Clock Start/From:  
Clock To:  
1st Value:  
2nd Value:  
Value Percent:  
Continuous Index:  
Within 8" of Joint: **NO**  
Remarks: **M-503-027.5**

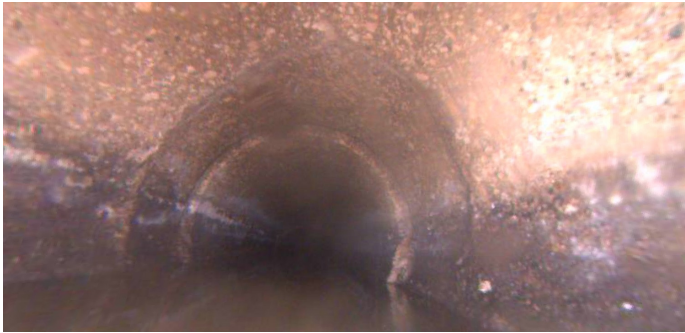
Code:	<b>MWL</b>
Description:	<b>Water Level</b>

Distance (ft):	<b>.0</b>
Structural Grade:	<b>0</b>
O&M Grade:	<b>0</b>
Clock Start/From:	
Clock To:	
1st Value:	
2nd Value:	
Value Percent:	<b>40.000</b>
Continuous Index:	
Within 8" of Joint:	<b>NO</b>
Remarks:

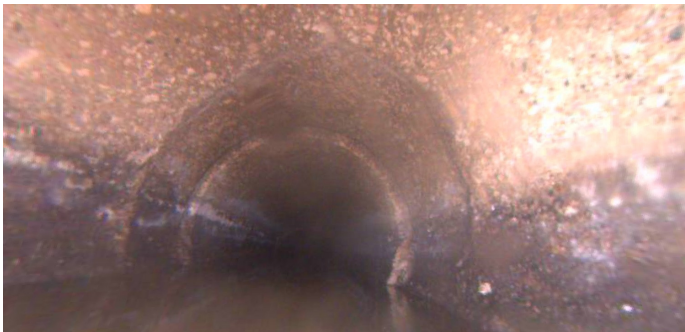
Code:	<b>SAP</b>
Description:	<b>Surface Aggregate Projecting</b>

Distance (ft):	<b>.0</b>
Structural Grade:	<b>3</b>
O&M Grade:	<b>0</b>
Clock Start/From:	<b>8</b>
Clock To:	<b>4</b>
1st Value:	
2nd Value:	
Value Percent:	
Continuous Index:	<b>S01</b>
Within 8" of Joint:	
Remarks:

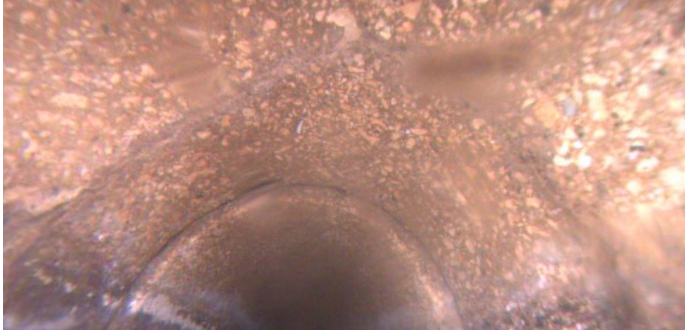
Code: **FC**  
Description: **Fracture Circumferential**

Distance (ft): **1.1**  
Structural Grade: **2**  
O&M Grade: **0**  
Clock Start/From: **8**  
Clock To: **4**  
1st Value:  
2nd Value:  
Value Percent:  
Continuous Index:  
Within 8" of Joint:  
Remarks:

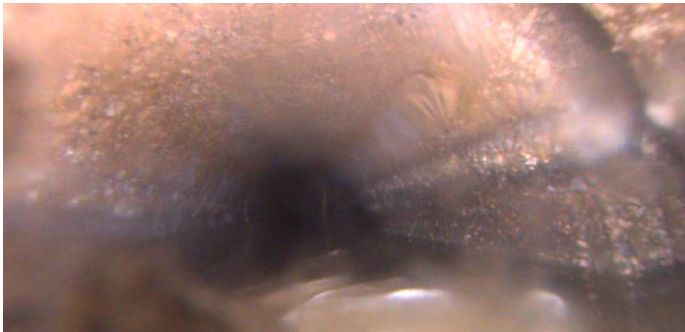
Code: **SAP**  
Description: **Surface Aggregate Projecting**

Distance (ft): **8.4**  
Structural Grade: **3**  
O&M Grade: **0**  
Clock Start/From: **8**  
Clock To: **4**  
1st Value:  
2nd Value:  
Value Percent:  
Continuous Index: **F01**  
Within 8" of Joint:  
Remarks:

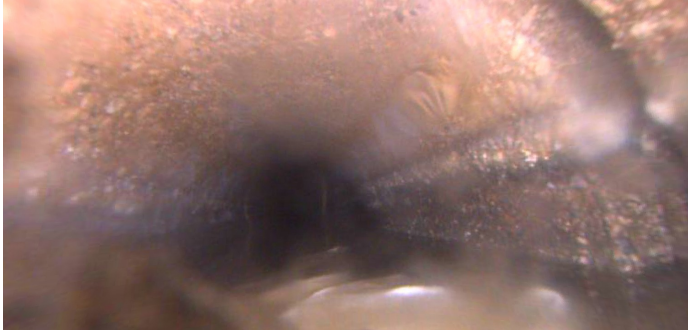
Code:	<b>MSA</b>
Description:	<b>Abandoned Survey</b>
Distance (ft):	<b>8.4</b>
Structural Grade:	<b>0</b>
O&M Grade:	<b>0</b>
Clock Start/From:	
Clock To:	
1st Value:	
2nd Value:	
Value Percent:	
Continuous Index:	
Within 8" of Joint:	<b>NO</b>
Remarks:	<b>DEBRIS UNDER WATER</b>
