## Profile/Photo Observation Report

Street:	<b>W 40th ave</b>	Flow Control:	<b>Not Controlled</b>
City:	<b>Hobart, IN</b>	Year Renewed:	
Location:	<b>Other</b>	Tape/Media #:	
Purpose:	<b>Not Known</b>	Dia/Height:	<b>10"</b>
Use:	<b>Sanitary</b>	Material:	<b>VCP</b>
Drain Area:	<b>NA</b>	Lining:	
Category:	<b>NA</b>		
Comment:

Location Details:		Direction of Survey:	<b>Downstream</b>
US MH:	<b>M-503-027.5</b>	DS MH:	<b>M-503-028</b>
		Total Length Surveyed (ft):	<b>8.4</b>

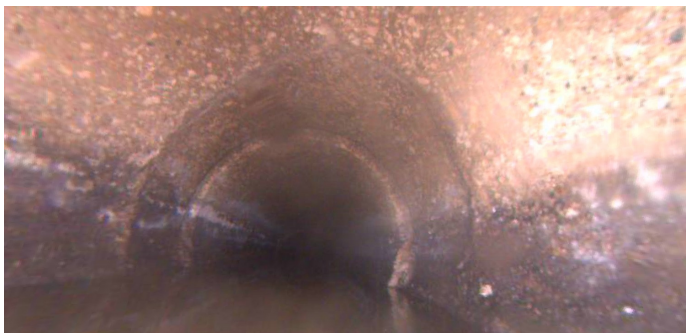
Code: **AMH**  
 Description: **Manhole**

Distance (ft): **.0**  
 Structural Grade: **0**  
 O&M Grade: **0**  
 Clock Start/From:  
 Clock To:  
 1st Value:  
 2nd Value:  
 Value Percent:  
 Continuous Index:  
 Within 8" of Joint: **NO**  
 Remarks: **M-503-027.5**

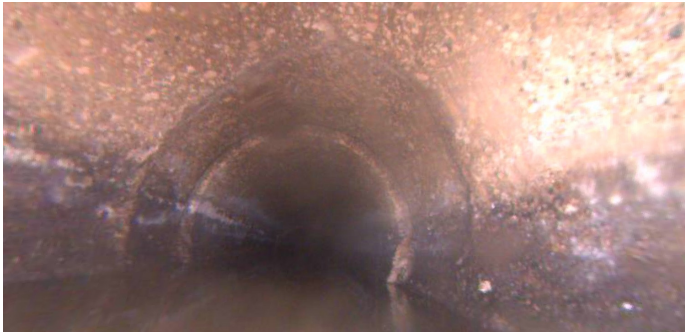
Code:	<b>MWL</b>
Description:	<b>Water Level</b>

Distance (ft):	<b>.0</b>
Structural Grade:	<b>0</b>
O&M Grade:	<b>0</b>
Clock Start/From:	
Clock To:	
1st Value:	
2nd Value:	
Value Percent:	<b>40.000</b>
Continuous Index:	
Within 8" of Joint:	<b>NO</b>
Remarks:

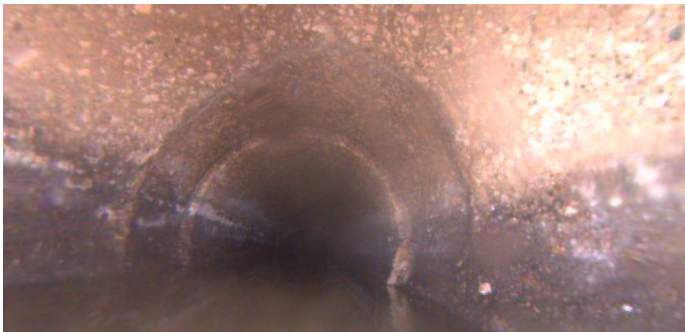
Code:	<b>SAP</b>
Description:	<b>Surface Aggregate Projecting</b>

Distance (ft):	<b>.0</b>
Structural Grade:	<b>3</b>
O&M Grade:	<b>0</b>
Clock Start/From:	<b>8</b>
Clock To:	<b>4</b>
1st Value:	
2nd Value:	
Value Percent:	
Continuous Index:	<b>S01</b>
Within 8" of Joint:	
Remarks:

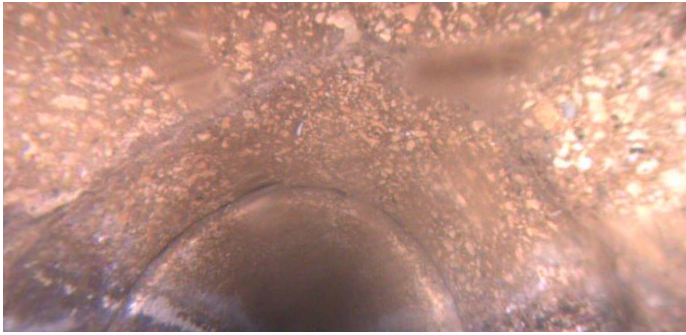
Code: **FC**  
Description: **Fracture Circumferential**

Distance (ft): **1.1**  
Structural Grade: **2**  
O&M Grade: **0**  
Clock Start/From: **8**  
Clock To: **4**  
1st Value:  
2nd Value:  
Value Percent:  
Continuous Index:  
Within 8" of Joint:  
Remarks:

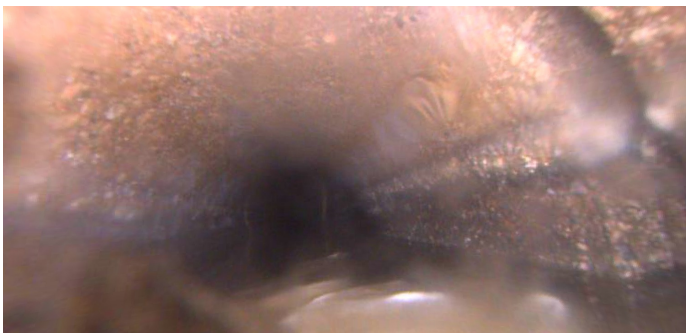
Code: **SAP**  
Description: **Surface Aggregate Projecting**

Distance (ft): **8.4**  
Structural Grade: **3**  
O&M Grade: **0**  
Clock Start/From: **8**  
Clock To: **4**  
1st Value:  
2nd Value:  
Value Percent:  
Continuous Index: **F01**  
Within 8" of Joint:  
Remarks:

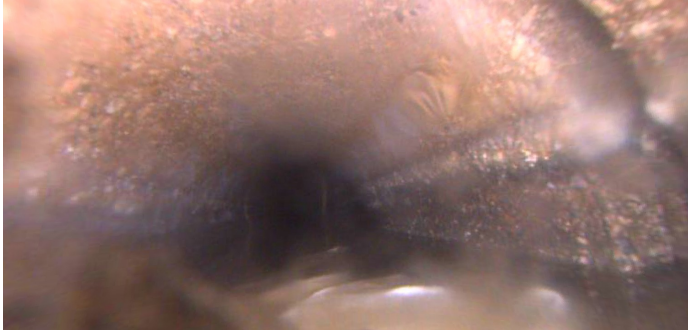
Code:	<b>MSA</b>
Description:	<b>Abandoned Survey</b>
Distance (ft):	<b>8.4</b>
Structural Grade:	<b>0</b>
O&M Grade:	<b>0</b>
Clock Start/From:	
Clock To:	
1st Value:	
2nd Value:	
Value Percent:	
Continuous Index:	
Within 8" of Joint:	<b>NO</b>
Remarks:	<b>DEBRIS UNDER WATER</b>
