Profile/Photo Observation Report

Date:	04/09/2018	Weather:		Coding:	PACP 6.0
Pipe Length (ft):	230.8	Owner:	NA	Pre Clean:	Not Known
P.O.#:		Surveyor:	Byrd Fitzgerald	PSR:	P-504-028-027.5
Customer:		Clean Date:	01/01/1900	Shape:	C

Location Details:		Direction of Survey:	Upstream
US MH:	M-503-027.5	DS MH:	M-503-028
		Total Length Surveyed (ft):	34.6

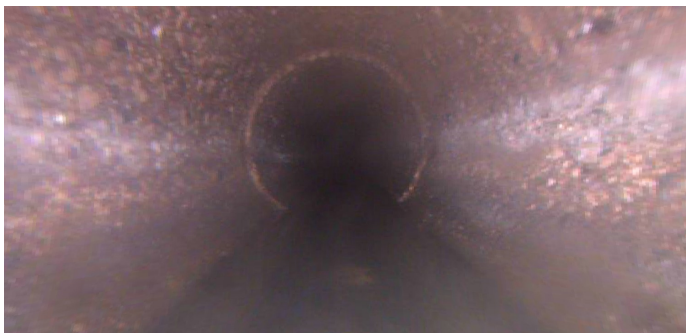
Code: **AMH**
Description: **Manhole**

Distance (ft): **.0**
Structural Grade: **0**
O&M Grade: **0**
Clock Start/From:
Clock To:
1st Value:
2nd Value:
Value Percent:
Continuous Index:
Within 8" of Joint: **NO**
Remarks: **M-503-028**

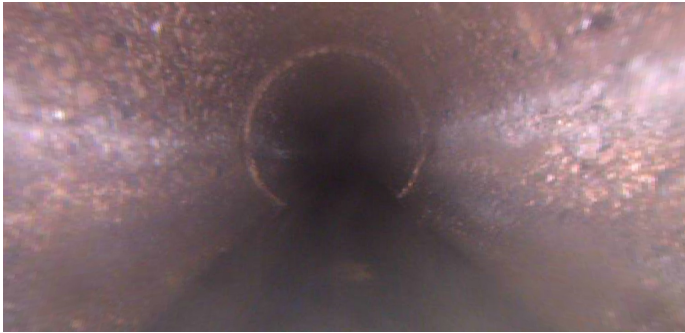
Code:	MWL
Description:	Water Level

Distance (ft):	.0
Structural Grade:	0
O&M Grade:	0
Clock Start/From:	
Clock To:	
1st Value:	
2nd Value:	
Value Percent:	5.000
Continuous Index:	
Within 8" of Joint:	NO
Remarks:

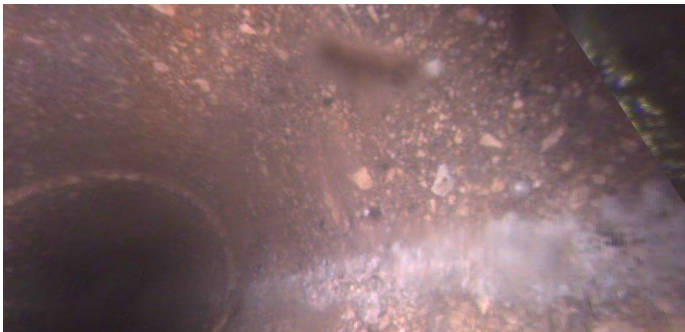
Code:	SAV
Description:	Surface Aggregate Visible

Distance (ft):	.0
Structural Grade:	3
O&M Grade:	0
Clock Start/From:	7
Clock To:	5
1st Value:	
2nd Value:	
Value Percent:	
Continuous Index:	S01
Within 8" of Joint:	
Remarks:

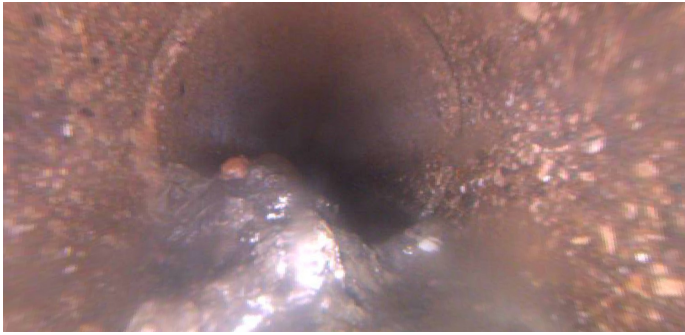
Code: **DSZ**
Description: **Deposits Settled Other**

Distance (ft): **26.4**
Structural Grade: **0**
O&M Grade: **4**
Clock Start/From: **6**
Clock To:
1st Value:
2nd Value:
Value Percent: **25.000**
Continuous Index:
Within 8" of Joint: **YES**
Remarks: **unknown**

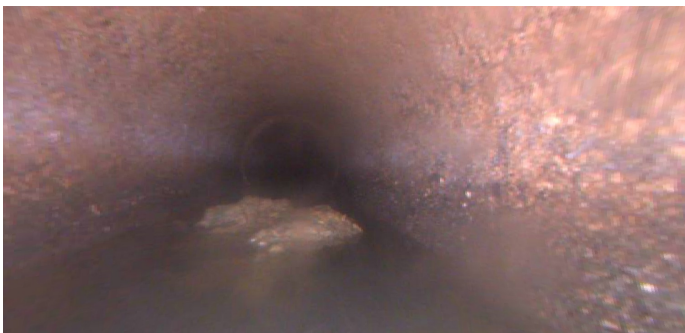
Code: **DSZ**
Description: **Deposits Settled Other**

Distance (ft): **30.6**
Structural Grade: **0**
O&M Grade: **2**
Clock Start/From: **6**
Clock To:
1st Value:
2nd Value:
Value Percent: **5.000**
Continuous Index:
Within 8" of Joint: **NO**
Remarks: **debris**

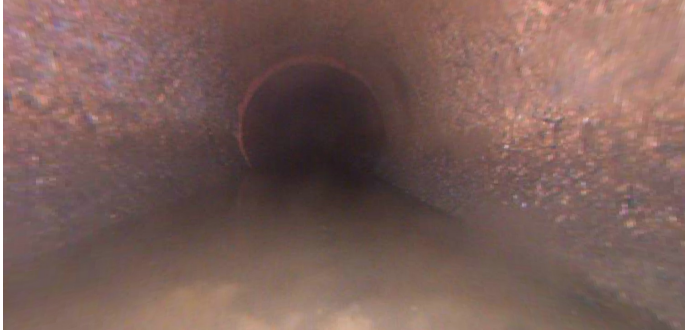
Code: **MSA**
Description: **Abandoned Survey**

Distance (ft): **34.6**
Structural Grade: **0**
O&M Grade: **0**
Clock Start/From:
Clock To:
1st Value:
2nd Value:
Value Percent:
Continuous Index:
Within 8" of Joint: **NO**
Remarks: **no blockage**

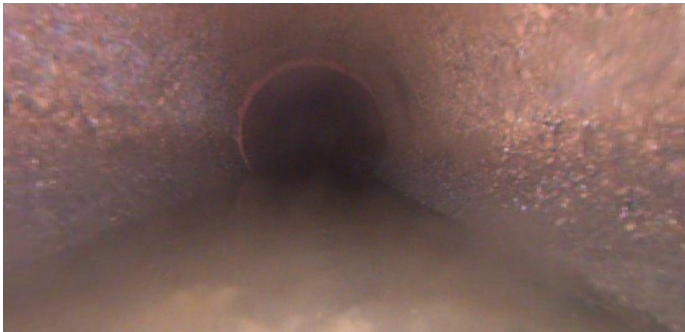
Code: **SAV**
Description: **Surface Aggregate Visible**

Distance (ft): **34.6**
Structural Grade: **3**
O&M Grade: **0**
Clock Start/From: **7**
Clock To: **5**
1st Value:
2nd Value:
Value Percent:
Continuous Index: **F01**
Within 8" of Joint:
Remarks:
