Profile/Photo Observation Report

Date:	04/09/2018	Weather:		Coding:	PACP 6.0
Pipe Length (ft):	230.8	Owner:	NA	Pre Clean:	Not Known
P.O.#:		Surveyor:	Mark Ruby	PSR:	P-504-028-027.5
Customer:		Clean Date:	01/01/1900	Shape:	C

Street:	N VIRGINIA ST	Flow Control:	Not Controlled
City:	Hobart, IN	Year Renewed:	
Location:	Other	Tape/Media #:	
Purpose:	Not Known	Dia/Height:	10"
Use:	Sanitary	Material:	VCP
Drain Area:	NA	Lining:	
Category:	NA		
Comment:			
Location Details:		Direction of Survey:	Upstream
US MH:	M-503-027.5	DS MH:	M-503-028
		Total Length Surveyed (ft):	207.4

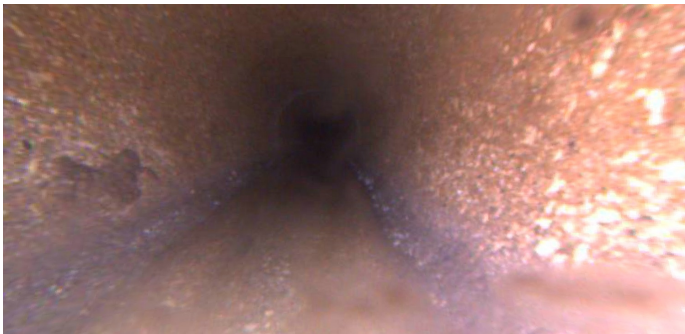
Code: **SAV**
Description: **Surface Aggregate Visible**

Distance (ft): **.0**
Structural Grade: **3**
O&M Grade: **0**
Clock Start/From: **8**
Clock To: **4**
1st Value:
2nd Value:
Value Percent:
Continuous Index: **S02**
Within 8" of Joint:
Remarks:

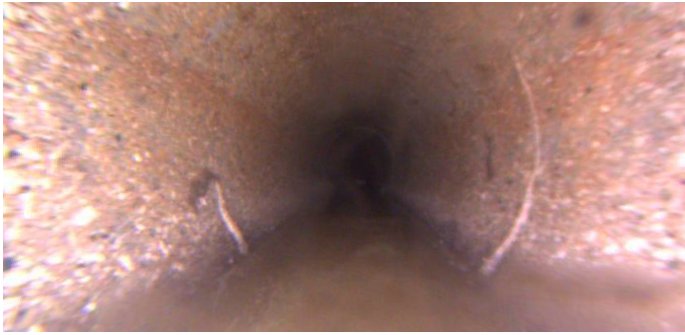
Code: **FC**
Description: **Fracture Circumferential**

Distance (ft): **6.9**
Structural Grade: **2**
O&M Grade: **0**
Clock Start/From: **2**
Clock To: **9**
1st Value:
2nd Value:
Value Percent:
Continuous Index:
Within 8" of Joint:
Remarks:

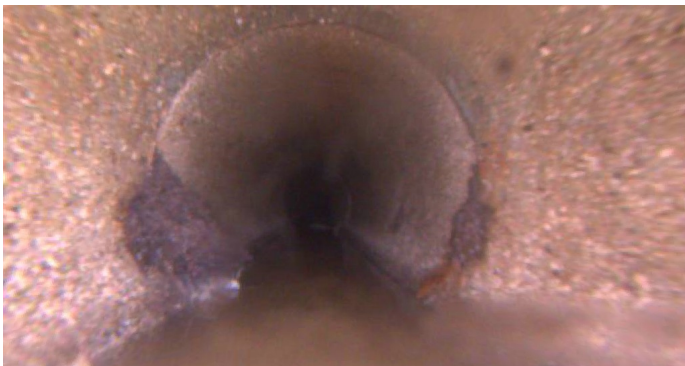
Code: **RMJ**
Description: **Roots Medium Joint**

Distance (ft): **21.2**
Structural Grade: **0**
O&M Grade: **3**
Clock Start/From: **7**
Clock To: **5**
1st Value:
2nd Value:
Value Percent: **5.000**
Continuous Index:
Within 8" of Joint: **YES**
Remarks:

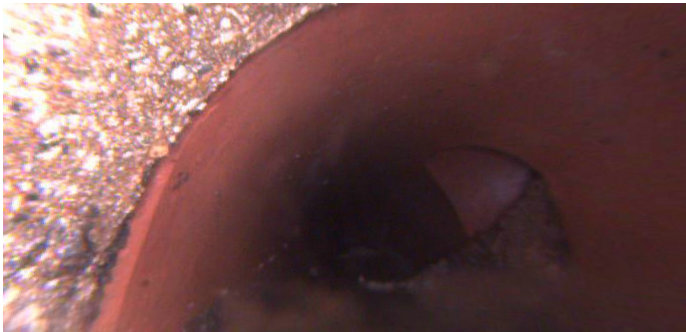
Code: **SAV**
Description: **Surface Aggregate Visible**

Distance (ft): **36.7**
Structural Grade: **3**
O&M Grade: **0**
Clock Start/From: **8**
Clock To: **4**
1st Value:
2nd Value:
Value Percent:
Continuous Index: **F02**
Within 8" of Joint:
Remarks:

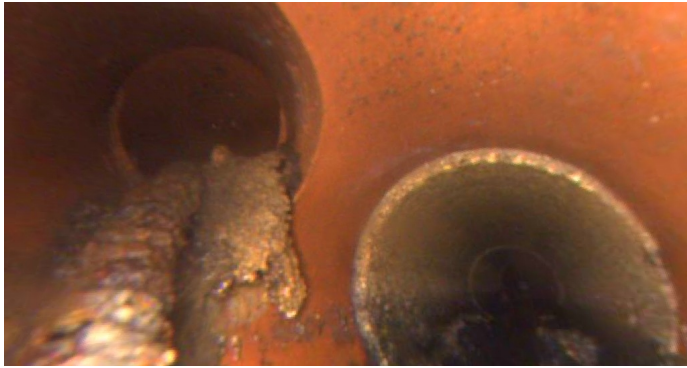
Code: **TFD**
Description: **Tap Factory Defective**

Distance (ft): **38.0**
Structural Grade: **0**
O&M Grade: **2**
Clock Start/From: **2**
Clock To:
1st Value: **4.000**
2nd Value:
Value Percent:
Continuous Index:
Within 8" of Joint:

Remarks: **Debris, Photo taken from rear camera.**

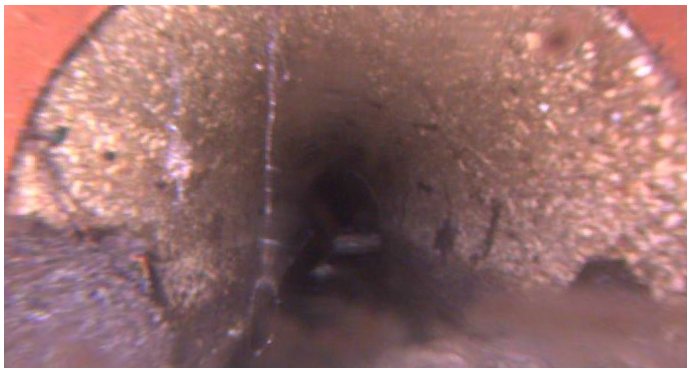
Code: **RFJ**
Description: **Roots Fine Joint**

Distance (ft): **39.6**
Structural Grade: **0**
O&M Grade: **1**
Clock Start/From: **7**
Clock To:
1st Value:
2nd Value:
Value Percent:
Continuous Index:
Within 8" of Joint: **YES**

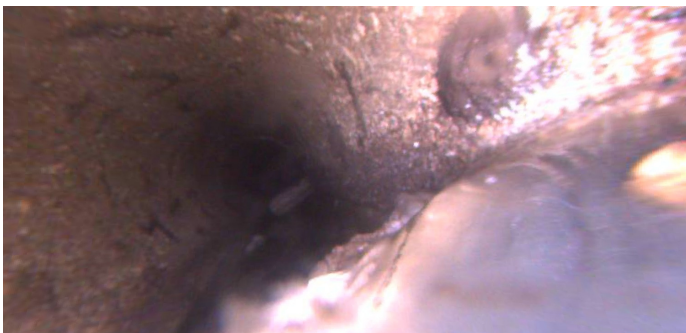
Code: **SAP**
Description: **Surface Aggregate Projecting**

Distance (ft): **39.9**
Structural Grade: **3**
O&M Grade: **0**
Clock Start/From: **8**
Clock To: **4**
1st Value:
2nd Value:
Value Percent:
Continuous Index: **S03**
Within 8" of Joint:
Remarks:

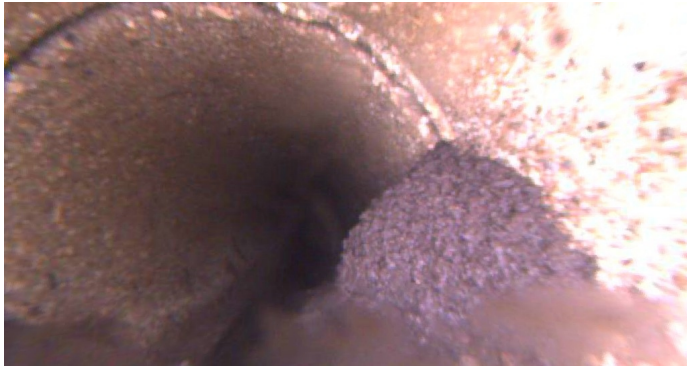
Code: **RFJ**
Description: **Roots Fine Joint**

Distance (ft): **42.4**
Structural Grade: **0**
O&M Grade: **1**
Clock Start/From: **7**
Clock To: **5**
1st Value:
2nd Value:
Value Percent:
Continuous Index:
Within 8" of Joint: **YES**
Remarks:

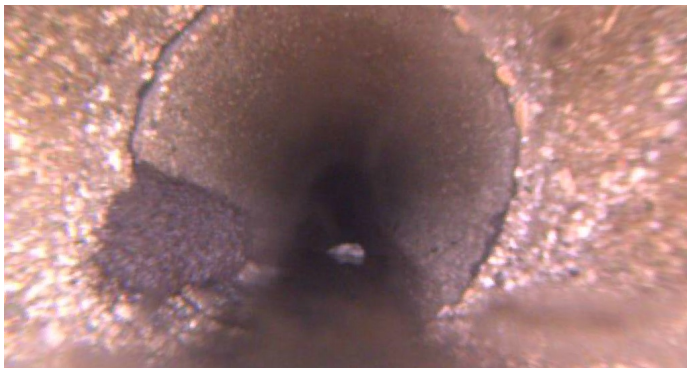
Code: **RFJ**
Description: **Roots Fine Joint**

Distance (ft): **48.2**
Structural Grade: **0**
O&M Grade: **1**
Clock Start/From: **7**
Clock To: **5**
1st Value:
2nd Value:
Value Percent:
Continuous Index: **S01**
Within 8" of Joint: **YES**
Remarks:

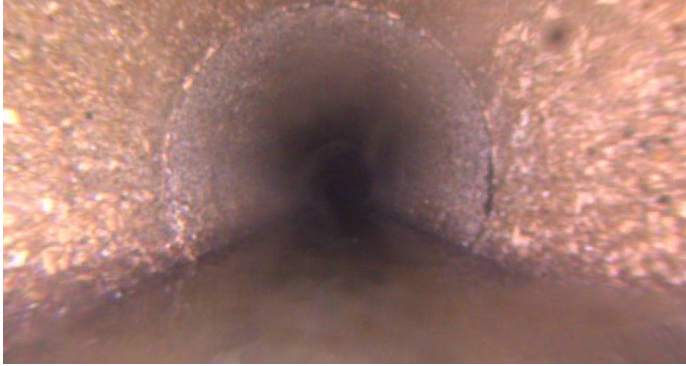
Code: **RFJ**
Description: **Roots Fine Joint**

Distance (ft): **59.9**
Structural Grade: **0**
O&M Grade: **1**
Clock Start/From: **7**
Clock To: **5**
1st Value:
2nd Value:
Value Percent:
Continuous Index: **F01**
Within 8" of Joint: **YES**
Remarks:

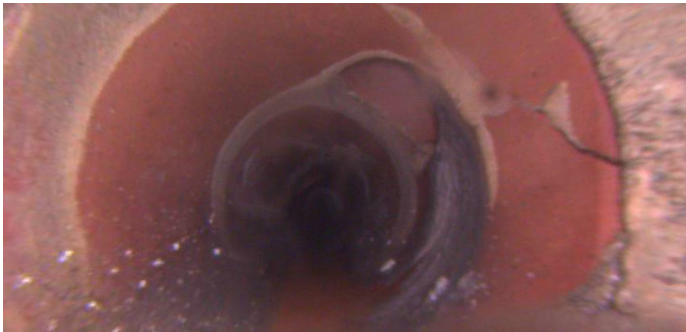
Code: **SAP**
Description: **Surface Aggregate Projecting**

Distance (ft): **81.1**
Structural Grade: **3**
O&M Grade: **0**
Clock Start/From: **8**
Clock To: **4**
1st Value:
2nd Value:
Value Percent:
Continuous Index: **F03**
Within 8" of Joint:
Remarks:

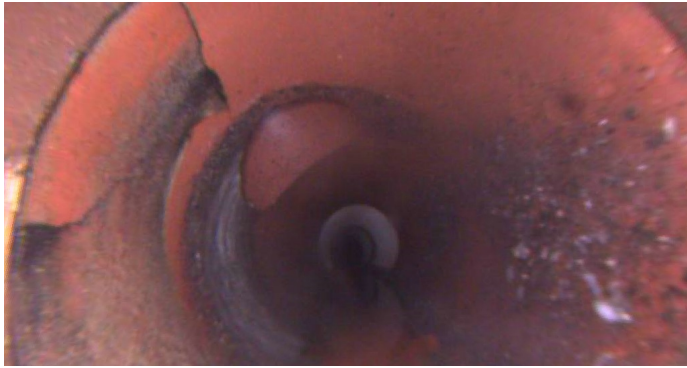
Code: **FM**
Description: **Fracture Multiple**

Distance (ft): **84.1**
Structural Grade: **4**
O&M Grade: **0**
Clock Start/From: **8**
Clock To: **10**
1st Value:
2nd Value:
Value Percent:
Continuous Index:
Within 8" of Joint: **YES**
Remarks:

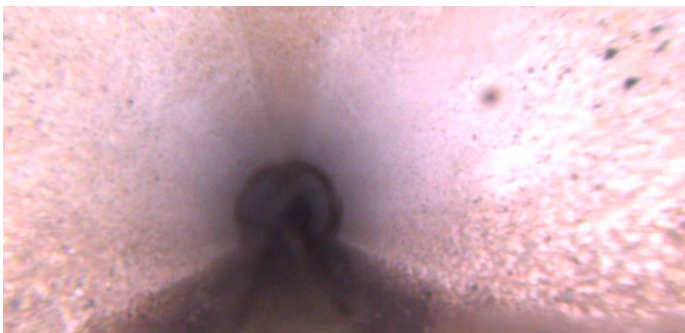
Code: **SAP**
Description: **Surface Aggregate Projecting**

Distance (ft): **87.4**
Structural Grade: **3**
O&M Grade: **0**
Clock Start/From: **8**
Clock To: **4**
1st Value:
2nd Value:
Value Percent:
Continuous Index: **S04**
Within 8" of Joint:
Remarks:

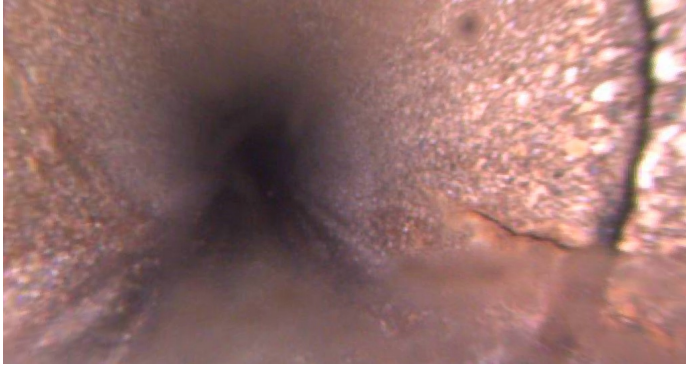
Code: **FL**
Description: **Fracture Longitudinal**

Distance (ft): **102.1**
Structural Grade: **3**
O&M Grade: **0**
Clock Start/From: **4**
Clock To:
1st Value:
2nd Value:
Value Percent:
Continuous Index:
Within 8" of Joint: **YES**
Remarks:

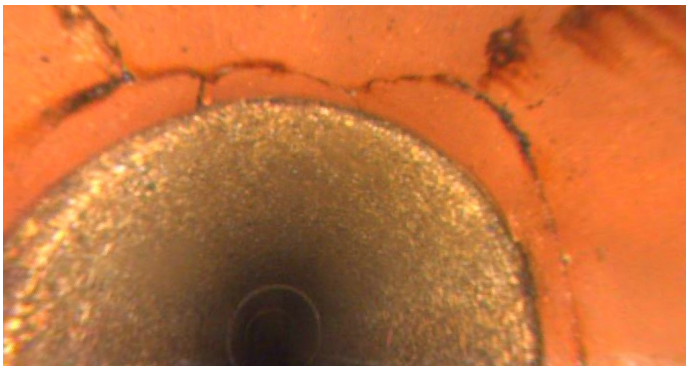
Code: **FM**
Description: **Fracture Multiple**

Distance (ft): **132.4**
Structural Grade: **4**
O&M Grade: **0**
Clock Start/From: **5**
Clock To: **7**
1st Value:
2nd Value:
Value Percent:
Continuous Index:
Within 8" of Joint: **YES**
Remarks: **Photo taken from rear camera.**

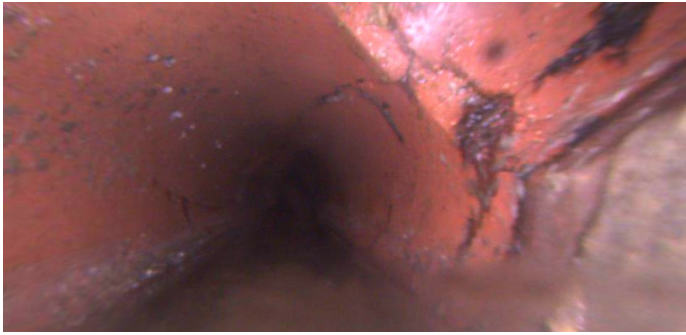
Code: **SAP**
Description: **Surface Aggregate Projecting**

Distance (ft): **132.4**
Structural Grade: **3**
O&M Grade: **0**
Clock Start/From: **8**
Clock To: **4**
1st Value:
2nd Value:
Value Percent:
Continuous Index: **F04**
Within 8" of Joint:
Remarks:

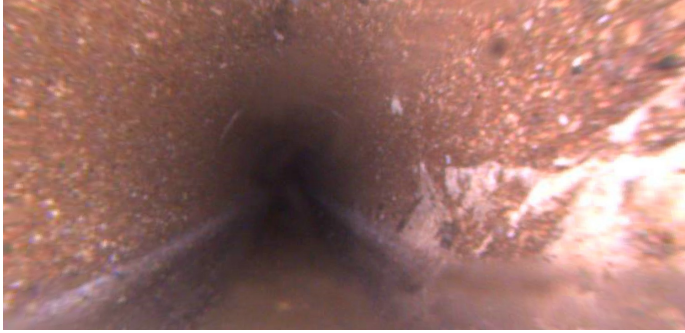
Code: **SAP**
Description: **Surface Aggregate Projecting**

Distance (ft): **137.9**
Structural Grade: **3**
O&M Grade: **0**
Clock Start/From: **8**
Clock To: **4**
1st Value:
2nd Value:
Value Percent:
Continuous Index: **S05**
Within 8" of Joint:
Remarks:

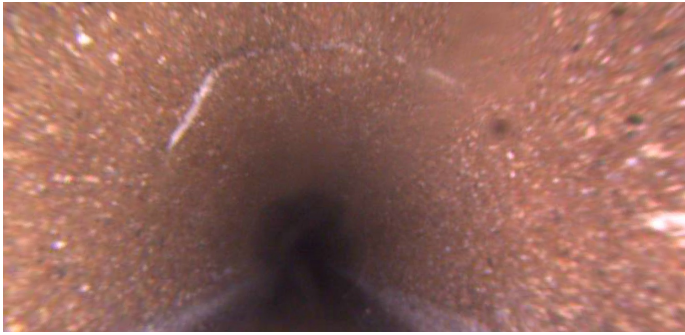
Code: **CC**
Description: **Crack Circumferential**

Distance (ft): **138.9**
Structural Grade: **1**
O&M Grade: **0**
Clock Start/From: **10**
Clock To: **2**
1st Value:
2nd Value:
Value Percent:
Continuous Index:
Within 8" of Joint:
Remarks:

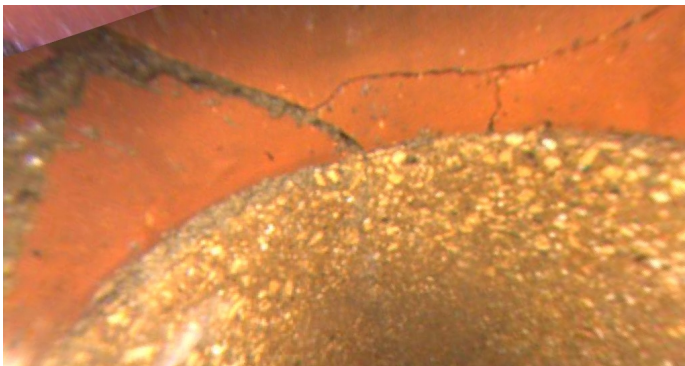
Code: **FM**
Description: **Fracture Multiple**

Distance (ft): **179.7**
Structural Grade: **4**
O&M Grade: **0**
Clock Start/From: **5**
Clock To: **7**
1st Value:
2nd Value:
Value Percent:
Continuous Index:
Within 8" of Joint: **YES**
Remarks: **Photo taken from rear camera.**

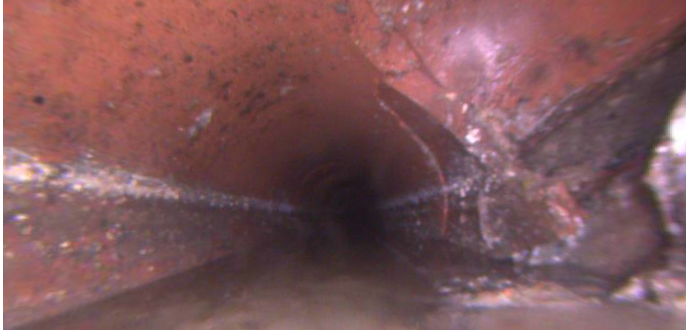
Code: **SAP**
Description: **Surface Aggregate Projecting**

Distance (ft): **179.7**
Structural Grade: **3**
O&M Grade: **0**
Clock Start/From: **8**
Clock To: **4**
1st Value:
2nd Value:
Value Percent:
Continuous Index: **F05**
Within 8" of Joint:
Remarks:

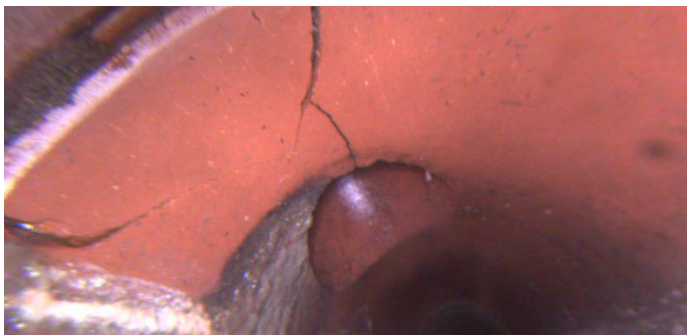
Code: **FM**
Description: **Fracture Multiple**

Distance (ft): **182.4**
Structural Grade: **4**
O&M Grade: **0**
Clock Start/From: **9**
Clock To: **11**
1st Value:
2nd Value:
Value Percent:
Continuous Index:
Within 8" of Joint: **YES**
Remarks:

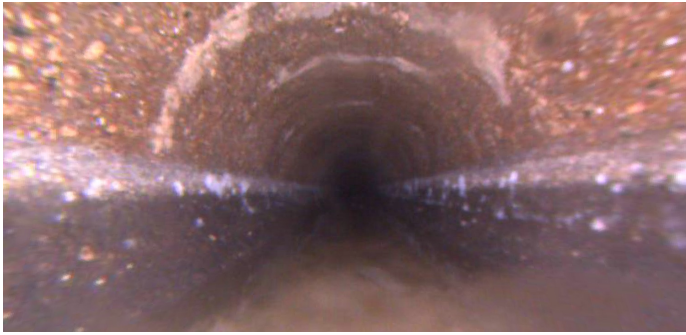
Code: **SAP**
Description: **Surface Aggregate Projecting**

Distance (ft): **185.6**
Structural Grade: **3**
O&M Grade: **0**
Clock Start/From: **8**
Clock To: **4**
1st Value:
2nd Value:
Value Percent:
Continuous Index: **S06**
Within 8" of Joint:
Remarks:

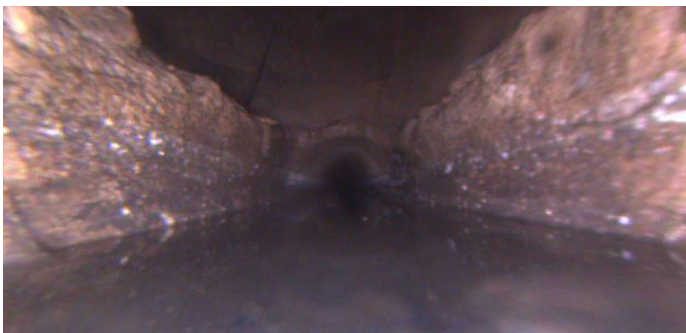
Code: **SAP**
Description: **Surface Aggregate Projecting**

Distance (ft): **205.9**
Structural Grade: **3**
O&M Grade: **0**
Clock Start/From: **8**
Clock To: **4**
1st Value:
2nd Value:
Value Percent:
Continuous Index: **F06**
Within 8" of Joint:
Remarks:
