Profile/Photo Observation Report

Date:	09/29/2018	Weather:		Coding:	PACP 6.0
Pipe Length (ft):	302.1	Owner:	NA	Pre Clean:	Not Known
P.O.#:		Surveyor:	Selasie Honu	PSR:	P-503-029-030
Customer:		Clean Date:	01/01/1900	Shape:	C

Street:	N DELAWARE ST	Flow Control:	Not Controlled
City:	Hobart, IN	Year Renewed:	
Location:	Light Highway	Tape/Media #:	
Purpose:	Routine Assessment	Dia/Height:	10"
Use:	Sanitary	Material:	VCP
Drain Area:	NA	Lining:	
Category:	NA		
Comment:

Location Details:		Direction of Survey:	Downstream
US MH:	M-503-030	DS MH:	M-503-029
		Total Length Surveyed (ft):	154.0

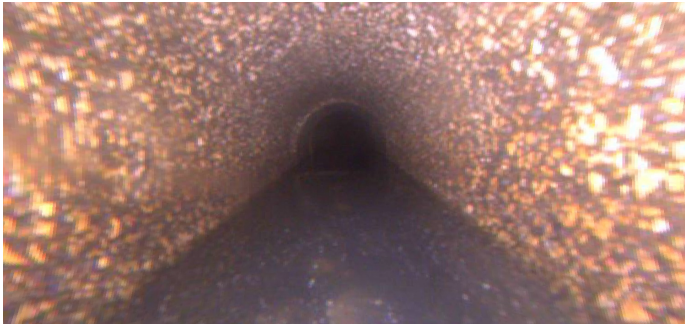
Code: **AMH**
Description: **Manhole**

Distance (ft): **.0**
Structural Grade: **0**
O&M Grade: **0**
Clock Start/From:
Clock To:
1st Value:
2nd Value:
Value Percent:
Continuous Index:
Within 8" of Joint: **NO**
Remarks: **M-503-030**

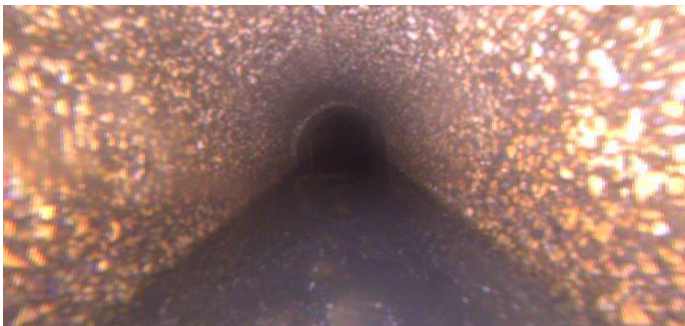
Code: **MWL**
Description: **Water Level**

Distance (ft): **.0**
Structural Grade: **0**
O&M Grade: **0**
Clock Start/From:
Clock To:
1st Value:
2nd Value:
Value Percent: **5.000**
Continuous Index:
Within 8" of Joint: **NO**
Remarks:

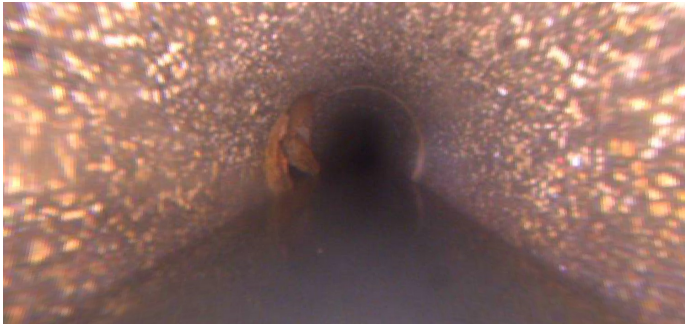
Code: **TF**
Description: **Tap Factory**

Distance (ft): **9.8**
Structural Grade: **0**
O&M Grade: **0**
Clock Start/From: **9**
Clock To:
1st Value: **4.000**
2nd Value:
Value Percent:
Continuous Index:
Within 8" of Joint:
Remarks:

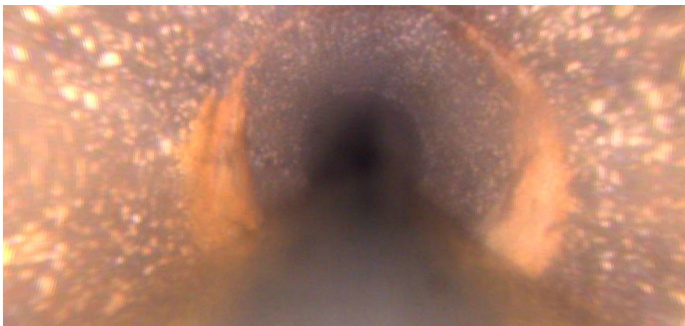
Code: **IS**
Description: **Infil Stain**

Distance (ft): **19.6**
Structural Grade: **0**
O&M Grade: **0**
Clock Start/From: **8**
Clock To: **4**
1st Value:
2nd Value:
Value Percent:
Continuous Index:
Within 8" of Joint: **YES**
Remarks:

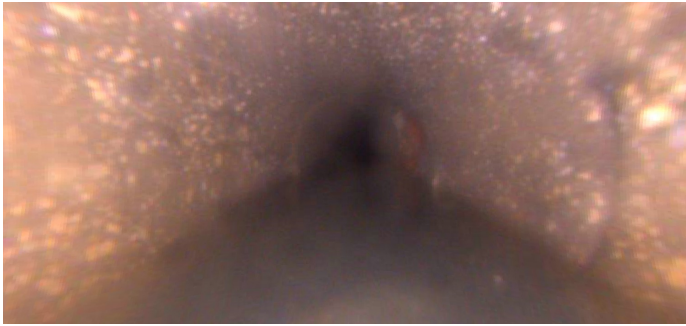
Code: **TF**
Description: **Tap Factory**

Distance (ft): **32.6**
Structural Grade: **0**
O&M Grade: **0**
Clock Start/From: **3**
Clock To:
1st Value: **4.000**
2nd Value:
Value Percent:
Continuous Index:
Within 8" of Joint:
Remarks:

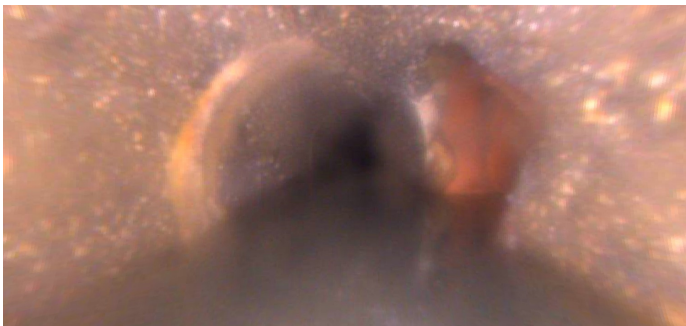
Code: **IS**
Description: **Infil Stain**

Distance (ft): **33.5**
Structural Grade: **0**
O&M Grade: **0**
Clock Start/From: **8**
Clock To: **12**
1st Value:
2nd Value:
Value Percent:
Continuous Index:
Within 8" of Joint: **YES**
Remarks:

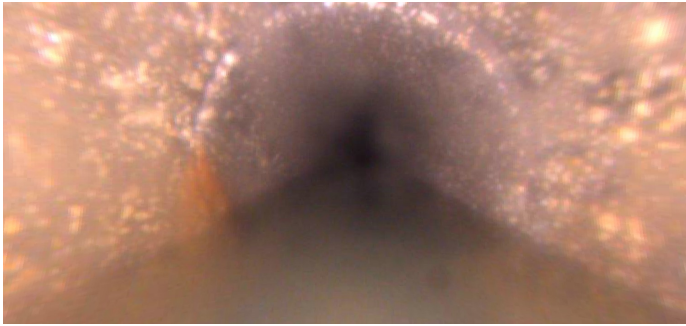
Code: **IS**
Description: **Infil Stain**

Distance (ft): **47.6**
Structural Grade: **0**
O&M Grade: **0**
Clock Start/From: **8**
Clock To: **9**
1st Value:
2nd Value:
Value Percent:
Continuous Index:
Within 8" of Joint: **YES**
Remarks:

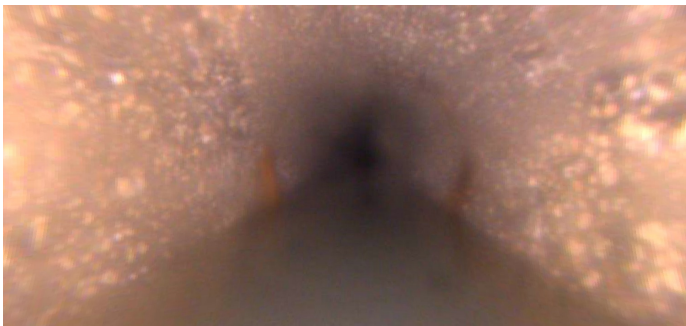
Code: **IS**
Description: **Infil Stain**

Distance (ft): **54.2**
Structural Grade: **0**
O&M Grade: **0**
Clock Start/From: **8**
Clock To: **4**
1st Value:
2nd Value:
Value Percent:
Continuous Index:
Within 8" of Joint: **YES**
Remarks:

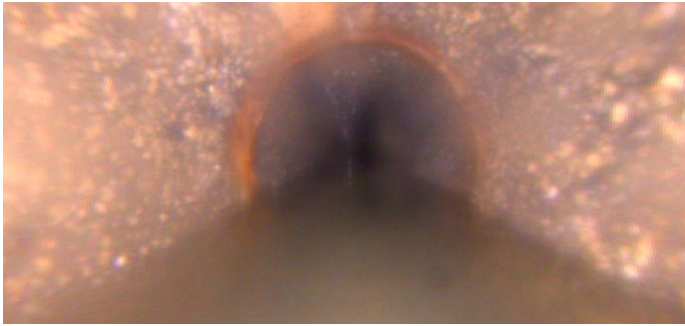
Code: **IS**
Description: **Infil Stain**

Distance (ft): **59.4**
Structural Grade: **0**
O&M Grade: **0**
Clock Start/From: **8**
Clock To: **4**
1st Value:
2nd Value:
Value Percent:
Continuous Index:
Within 8" of Joint: **YES**
Remarks:

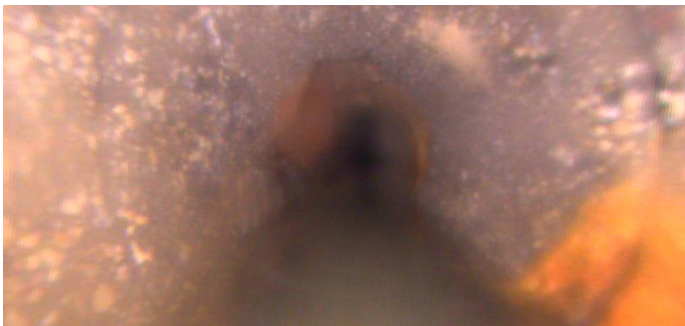
Code: **TF**
Description: **Tap Factory**

Distance (ft): **62.8**
Structural Grade: **0**
O&M Grade: **0**
Clock Start/From: **10**
Clock To:
1st Value: **4.000**
2nd Value:
Value Percent:
Continuous Index:
Within 8" of Joint:
Remarks:

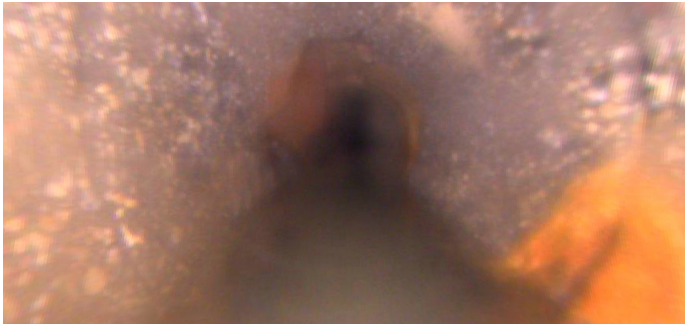
Code: **IS**
Description: **Infil Stain**

Distance (ft): **62.9**
Structural Grade: **0**
O&M Grade: **0**
Clock Start/From: **8**
Clock To: **4**
1st Value:
2nd Value:
Value Percent:
Continuous Index:
Within 8" of Joint: **YES**
Remarks:

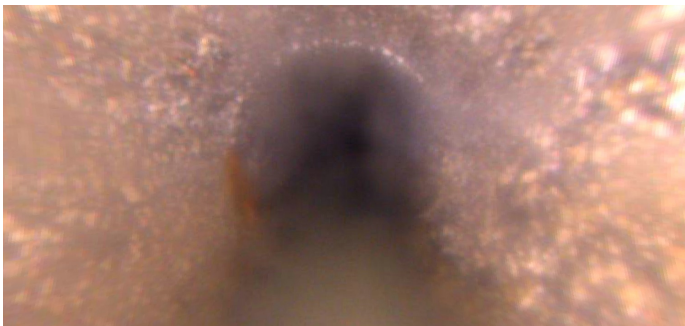
Code: **IS**
Description: **Infil Stain**

Distance (ft): **65.3**
Structural Grade: **0**
O&M Grade: **0**
Clock Start/From: **8**
Clock To: **9**
1st Value:
2nd Value:
Value Percent:
Continuous Index:
Within 8" of Joint: **YES**
Remarks:

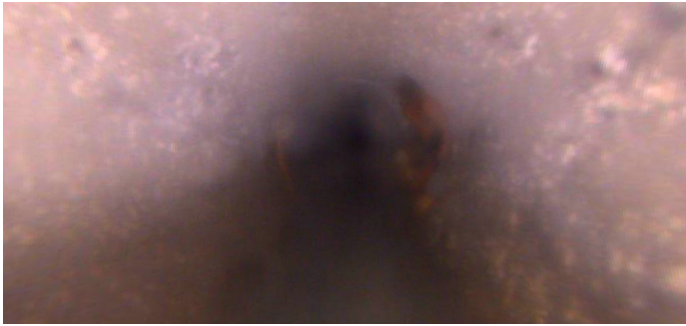
Code: **TF**
Description: **Tap Factory**

Distance (ft): **75.5**
Structural Grade: **0**
O&M Grade: **0**
Clock Start/From: **2**
Clock To:
1st Value: **4.000**
2nd Value:
Value Percent:
Continuous Index:
Within 8" of Joint:
Remarks:

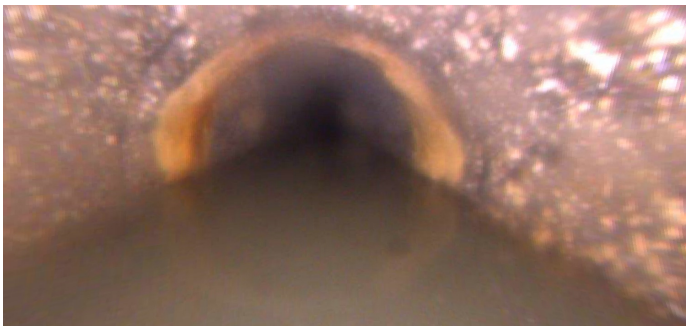
Code: **IS**
Description: **Infil Stain**

Distance (ft): **101.8**
Structural Grade: **0**
O&M Grade: **0**
Clock Start/From: **8**
Clock To: **4**
1st Value:
2nd Value:
Value Percent:
Continuous Index:
Within 8" of Joint: **YES**
Remarks:

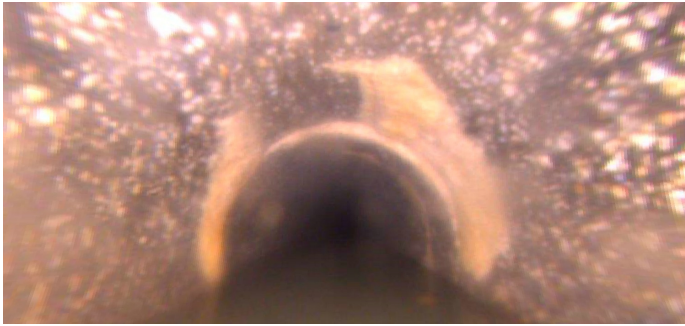
Code: **FL**
Description: **Fracture Longitudinal**

Distance (ft): **104.6**
Structural Grade: **3**
O&M Grade: **0**
Clock Start/From: **12**
Clock To:
1st Value:
2nd Value:
Value Percent:
Continuous Index:
Within 8" of Joint: **YES**
Remarks:

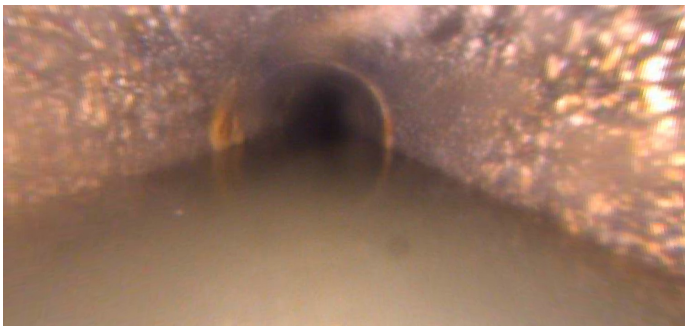
Code: **DAE**
Description: **Deposits Attached Encrustation**

Distance (ft): **107.2**
Structural Grade: **0**
O&M Grade: **2**
Clock Start/From: **8**
Clock To: **4**
1st Value:
2nd Value:
Value Percent: **10.000**
Continuous Index:
Within 8" of Joint: **YES**
Remarks:

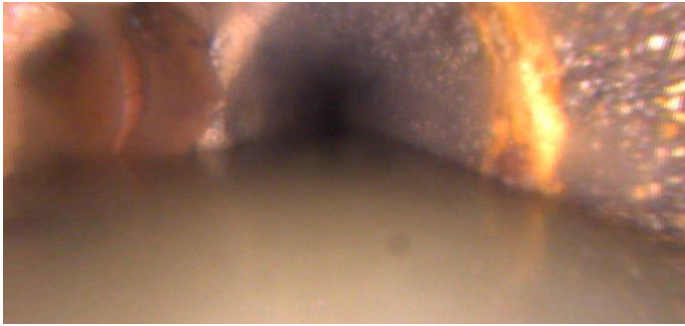
Code: **TF**
Description: **Tap Factory**

Distance (ft): **108.8**
Structural Grade: **0**
O&M Grade: **0**
Clock Start/From: **9**
Clock To:
1st Value: **4.000**
2nd Value:
Value Percent:
Continuous Index:
Within 8" of Joint:
Remarks:

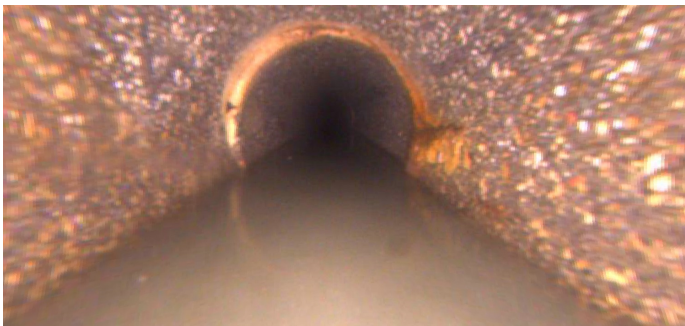
Code: **FL**
Description: **Fracture Longitudinal**

Distance (ft): **113.2**
Structural Grade: **3**
O&M Grade: **0**
Clock Start/From: **3**
Clock To:
1st Value:
2nd Value:
Value Percent:
Continuous Index:
Within 8" of Joint: **YES**
Remarks:

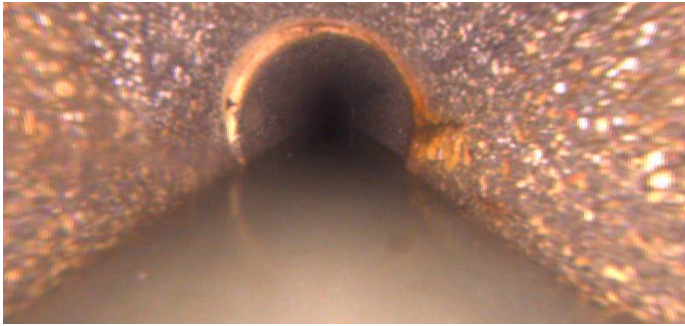
Code: **IS**
Description: **Infil Stain**

Distance (ft): **113.2**
Structural Grade: **0**
O&M Grade: **0**
Clock Start/From: **8**
Clock To: **4**
1st Value:
2nd Value:
Value Percent:
Continuous Index:
Within 8" of Joint: **YES**
Remarks:

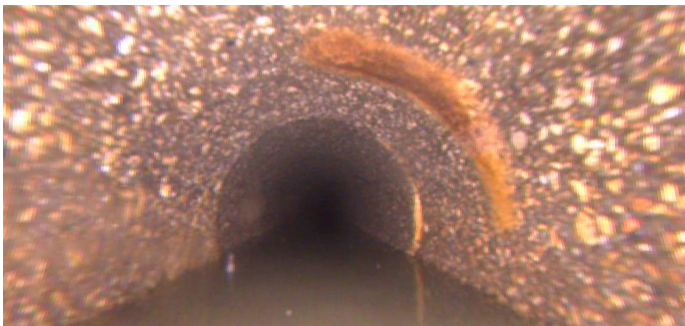
Code: **IS**
Description: **Infil Stain**

Distance (ft): **119.4**
Structural Grade: **0**
O&M Grade: **0**
Clock Start/From: **12**
Clock To: **3**
1st Value:
2nd Value:
Value Percent:
Continuous Index:
Within 8" of Joint: **NO**
Remarks:

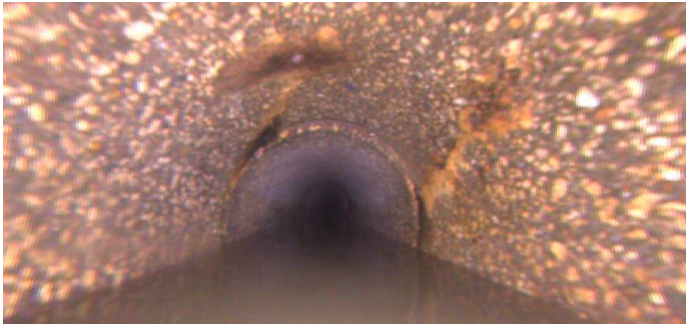
Code: **IS**
Description: **Infil Stain**

Distance (ft): **125.4**
Structural Grade: **0**
O&M Grade: **0**
Clock Start/From: **8**
Clock To: **4**
1st Value:
2nd Value:
Value Percent:
Continuous Index:
Within 8" of Joint: **YES**
Remarks:

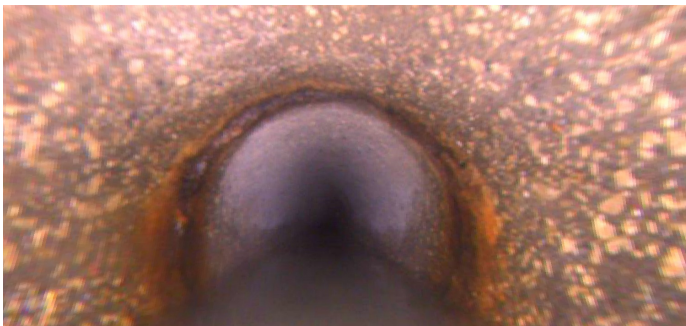
Code: **IS**
Description: **Infil Stain**

Distance (ft): **128.9**
Structural Grade: **0**
O&M Grade: **0**
Clock Start/From: **8**
Clock To: **4**
1st Value:
2nd Value:
Value Percent:
Continuous Index:
Within 8" of Joint: **YES**
Remarks:

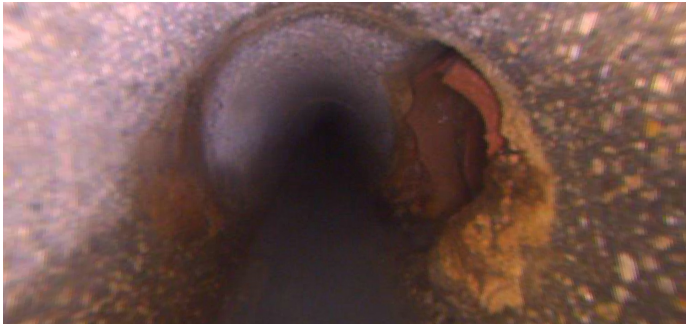
Code: **TF**
Description: **Tap Factory**

Distance (ft): **133.2**
Structural Grade: **0**
O&M Grade: **0**
Clock Start/From: **3**
Clock To:
1st Value: **4.000**
2nd Value:
Value Percent:
Continuous Index:
Within 8" of Joint:
Remarks:

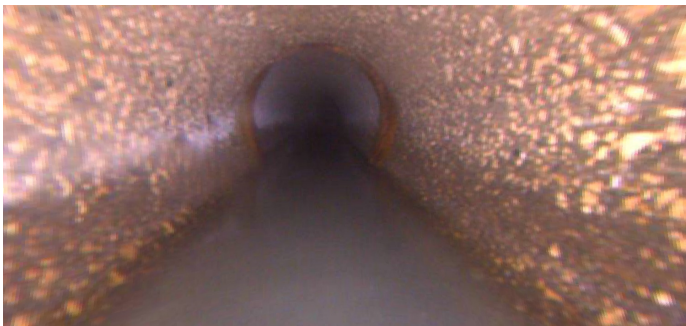
Code: **IS**
Description: **Infil Stain**

Distance (ft): **137.2**
Structural Grade: **0**
O&M Grade: **0**
Clock Start/From: **8**
Clock To: **4**
1st Value:
2nd Value:
Value Percent:
Continuous Index:
Within 8" of Joint: **YES**
Remarks:

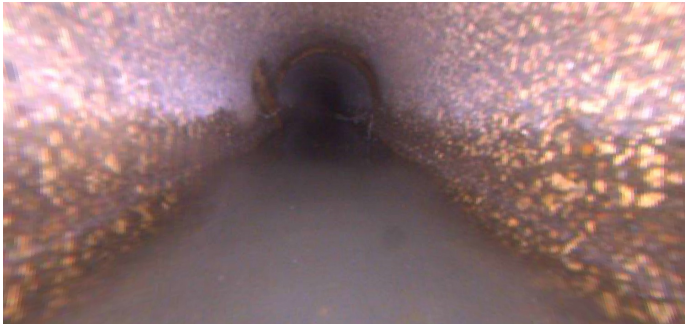
Code: **IS**
Description: **Infil Stain**

Distance (ft): **139.7**
Structural Grade: **0**
O&M Grade: **0**
Clock Start/From: **8**
Clock To: **4**
1st Value:
2nd Value:
Value Percent:
Continuous Index:
Within 8" of Joint: **YES**
Remarks:

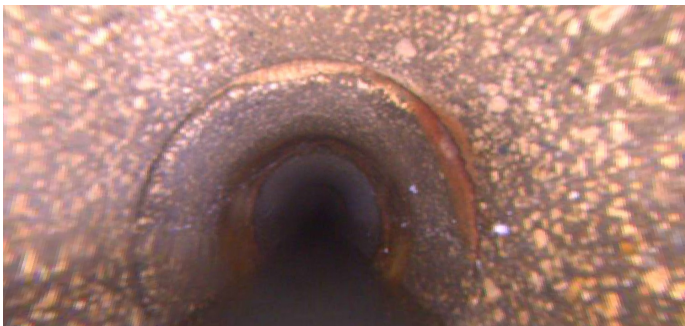
Code: **IS**
Description: **Infil Stain**

Distance (ft): **144.0**
Structural Grade: **0**
O&M Grade: **0**
Clock Start/From: **1**
Clock To: **3**
1st Value:
2nd Value:
Value Percent:
Continuous Index:
Within 8" of Joint: **YES**
Remarks:

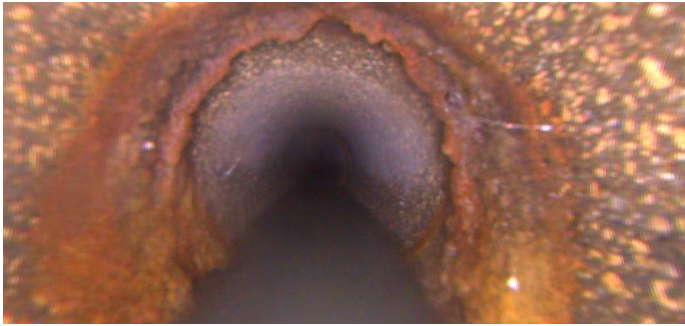
Code: **DAE**
Description: **Deposits Attached Encrustation**

Distance (ft): **144.7**
Structural Grade: **0**
O&M Grade: **3**
Clock Start/From: **8**
Clock To: **4**
1st Value:
2nd Value:
Value Percent: **20.000**
Continuous Index:
Within 8" of Joint: **YES**
Remarks:

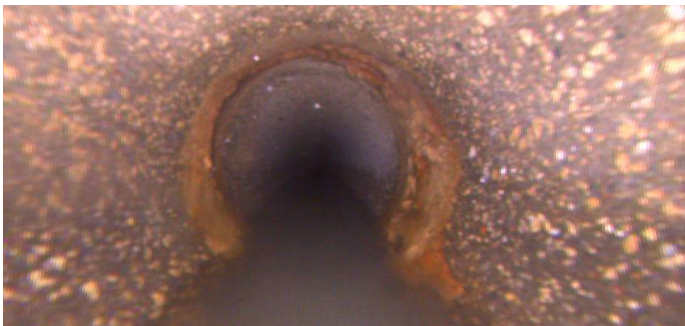
Code: **DAE**
Description: **Deposits Attached Encrustation**

Distance (ft): **146.8**
Structural Grade: **0**
O&M Grade: **2**
Clock Start/From: **8**
Clock To: **4**
1st Value:
2nd Value:
Value Percent: **10.000**
Continuous Index:
Within 8" of Joint: **YES**
Remarks:

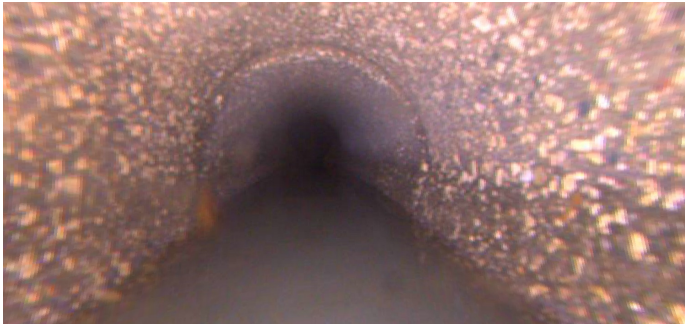
Code: **IS**
Description: **Infil Stain**

Distance (ft): **149.9**
Structural Grade: **0**
O&M Grade: **0**
Clock Start/From: **8**
Clock To:
1st Value:
2nd Value:
Value Percent:
Continuous Index:
Within 8" of Joint: **YES**
Remarks:

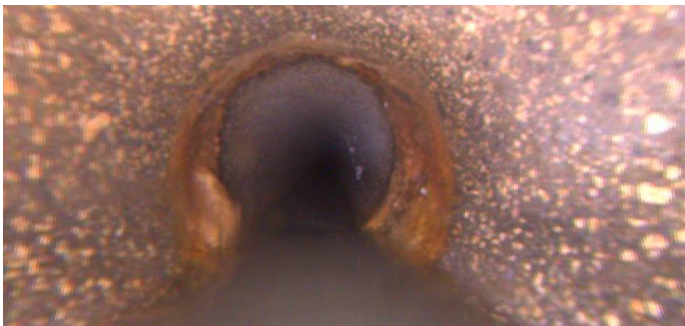
Code: **DAE**
Description: **Deposits Attached Encrustation**

Distance (ft): **152.8**
Structural Grade: **0**
O&M Grade: **3**
Clock Start/From: **8**
Clock To: **4**
1st Value:
2nd Value:
Value Percent: **20.000**
Continuous Index:
Within 8" of Joint: **YES**
Remarks:

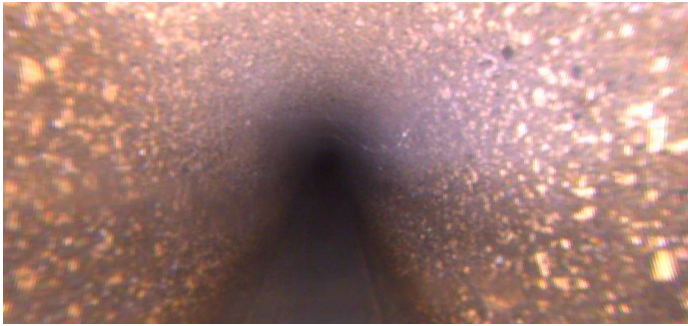
Code:	MSA
Description:	Abandoned Survey
Distance (ft):	154.0
Structural Grade:	0
O&M Grade:	0
Clock Start/From:	
Clock To:	
1st Value:	
2nd Value:	
Value Percent:	
Continuous Index:	
Within 8" of Joint:	NO
Remarks:	camera stopped
